HCP 157

Groom's House Gate Conservation, Hampton Court Palace

An Archaeological Evaluation

January 2017

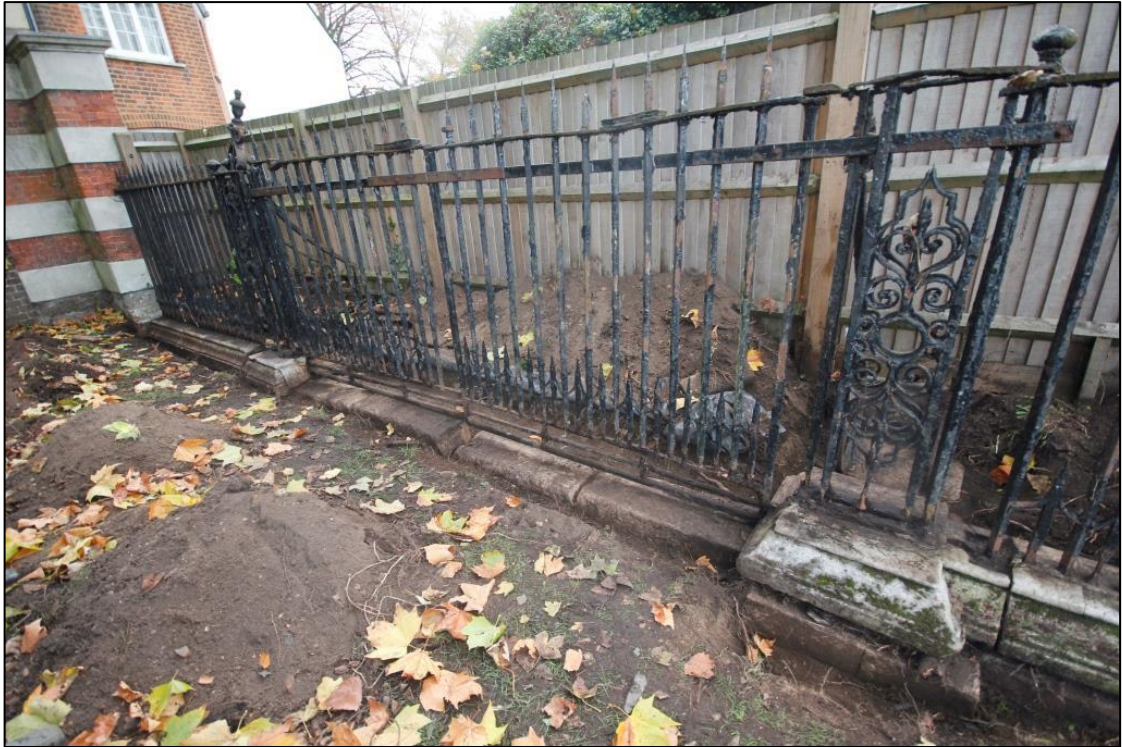
Figure 2: General view of Groom's House Gate after soil clearance viewed from the south-west

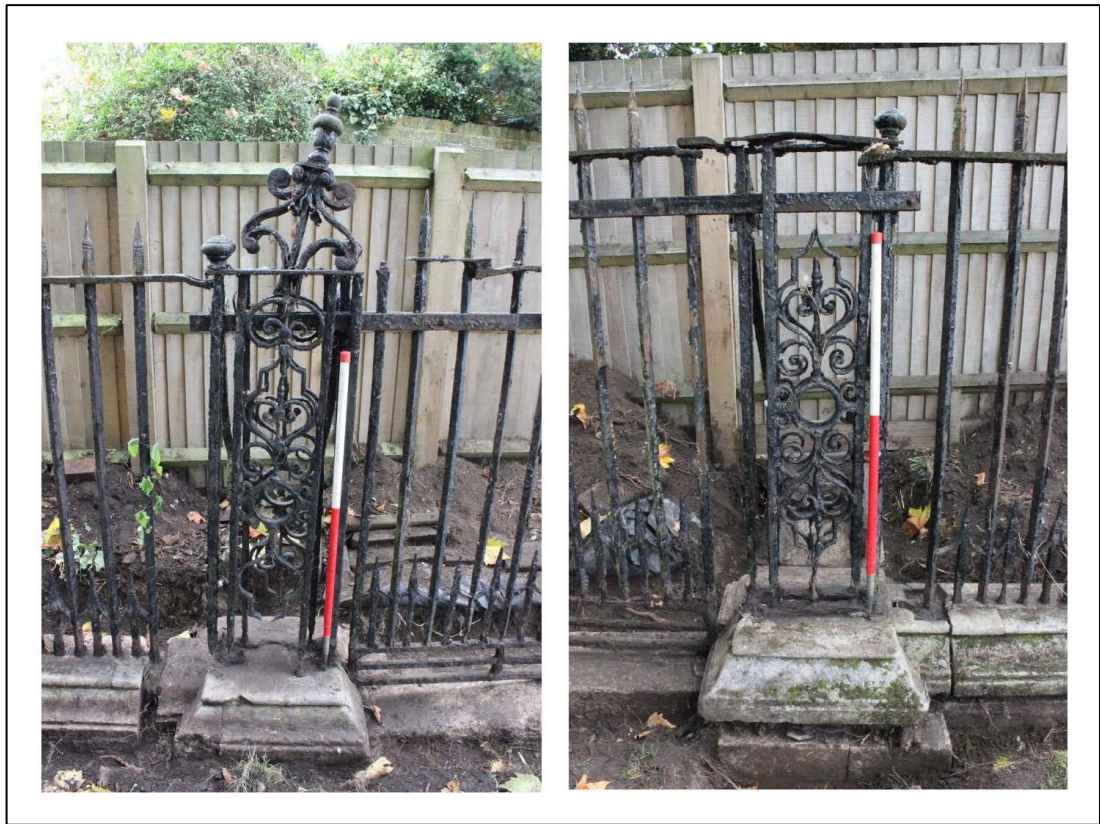
- 4.8 The wrought-iron box piers **(1009) and (1010)** were in an advanced state of disrepair in a similar way to those located at the 20th Century Garden Gate. They were heavily corroded, with parts missing including the finial on the southern box pier **(1010)**. The backstays connected to and supporting the box-piers, were both in a fair state of conservation, though were marked by the effects of corrosion. Only the southern-most backstay was fully exposed showing sweeping, curved lines (Fig. 4). It was connected to a dressed roughly rectangular Portland stone block **(1013)**.

Figure 3: Groom's House Gate box-piers, (1009) and (1010)

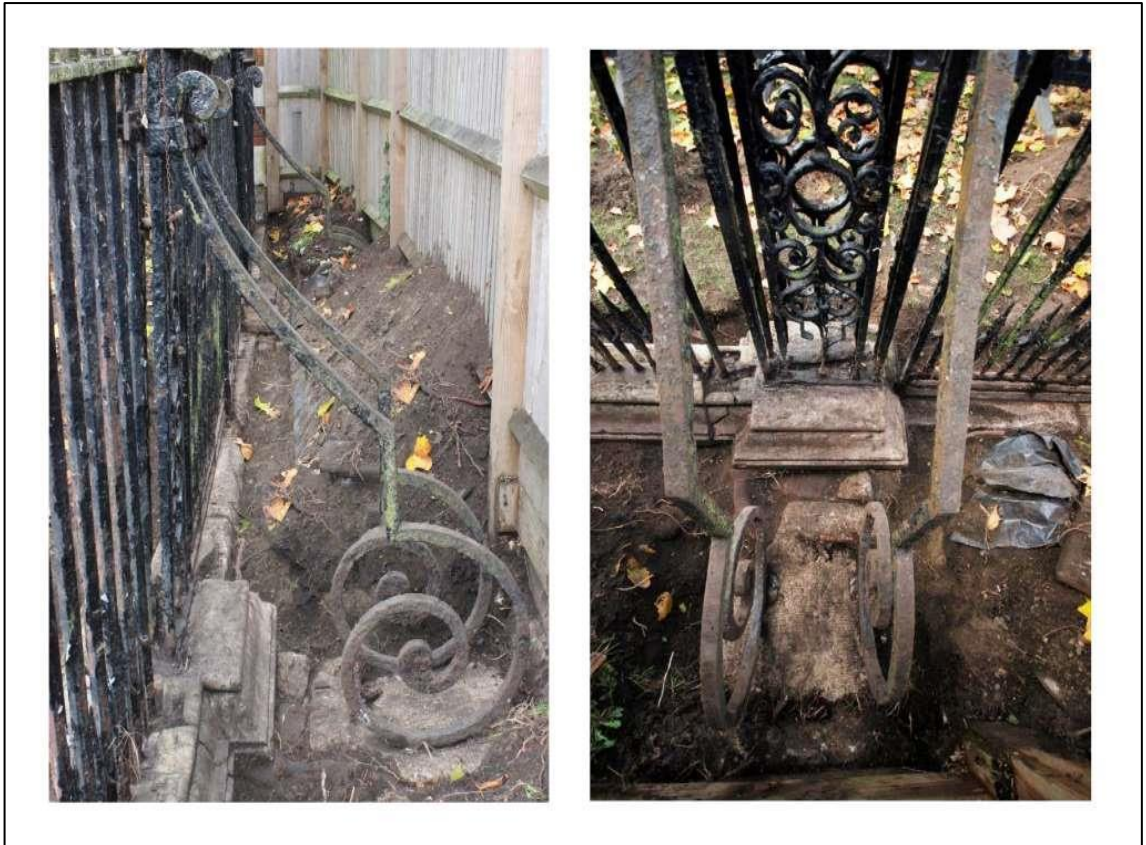
Figure 4: Backstay (1012) supporting the southern box-pier (1010)

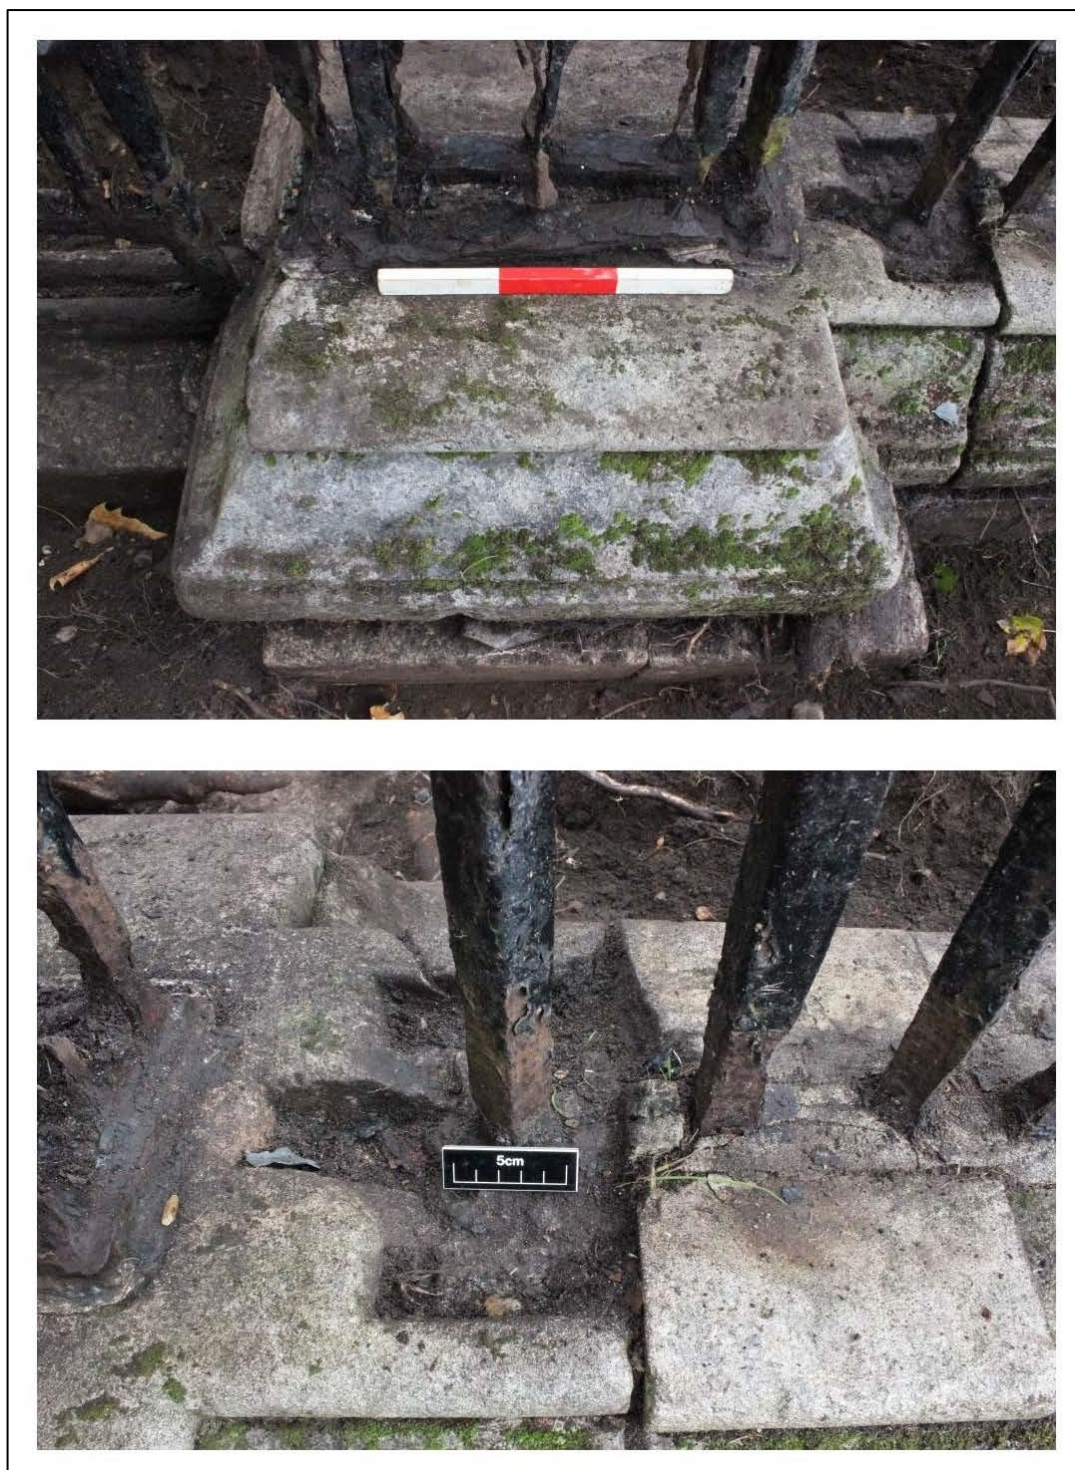
Figure 5: Top - Detail at the base of the southern box pier (1010). Bottom – recess cut into the southern plinth stone (1008)

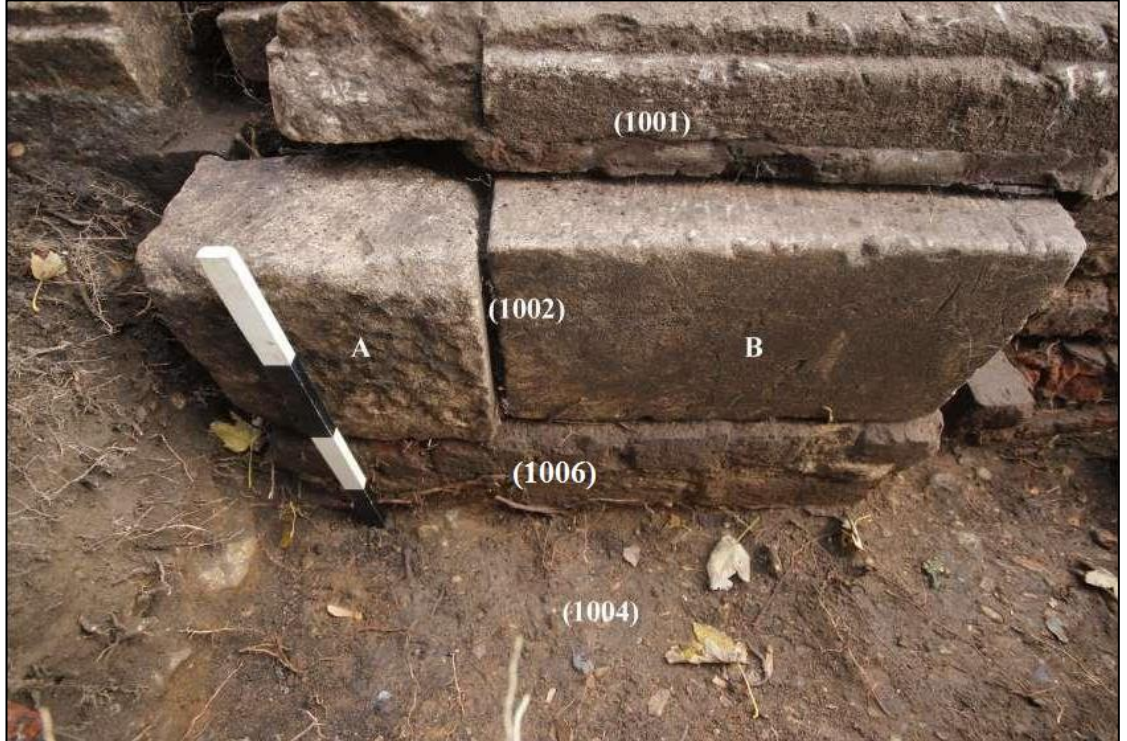
- 4.4 Overlying the brick foundation were three elements, the northern plinth stone bases (**1002**), the southern plinth stone bases (**1008**), and the threshold (**1003**). All these structural elements were composed of dressed Portland stone. The plinth stone bases (**1002**) and (**1008**) supported the plinth stone caps (**1001**) and (**1007**), which in turn supported the ornamental wrought-iron box piers. The Northern plinth stone base (**1002**) was made up two squared blocks of Portland stone; Blocks A and B. Block A measured 0.23 m x 0.23 m x 0.14 m and had a mottled face with small chiselled indents, whilst block B measured 0.23 m x 0.45 m x 0.27 m and had a smooth finish; it was overlain by plinth stone cap (**1001**). The southern plinth stone base (**1008**) was comprised of three squared blocks of stone; Blocks G, H, and I (see table 2), which were overlain by plinth stone cap (**1007**). Blocks G and Block H both had a narrow rectangular recess cut into their uppermost face measuring 0.18 m x 0.05 m containing a redundant small iron fixture. Block G also had a Lewis Hole cut into northern end of the upper-most face (Figure 7). Block I filled the space behind Block G.

Figure 7: Northern plinth stone base and cap and brick foundation beneath the southern box-pier

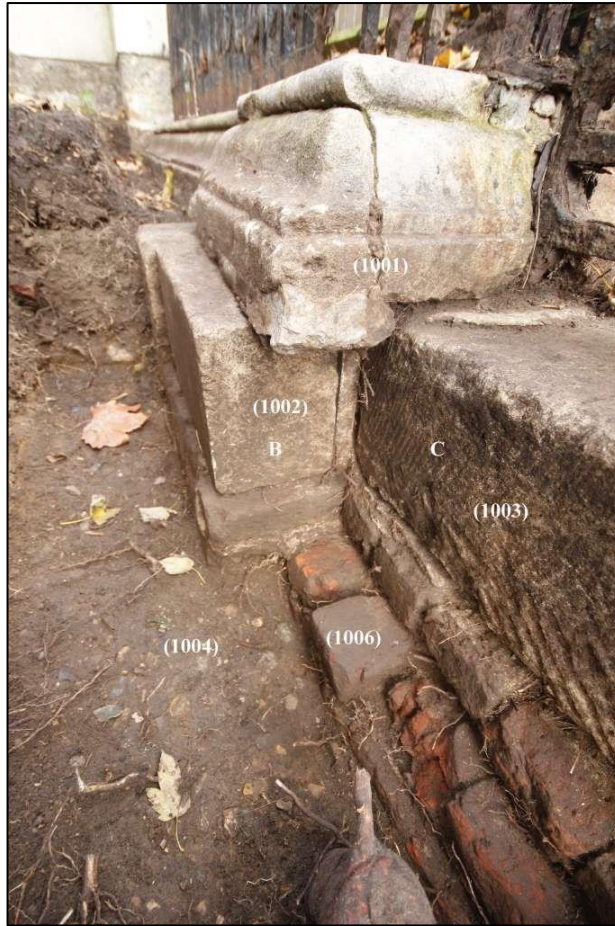
- 4.6 The northern plinth stone cap (**1001**) measured 0.67 m x 0.67 m x 0.20 m and was composed of dressed Portland stone (Figs. 8 and 9). A small extended section to the north creating a ‘T’-shape connected the plinth stone cap to the railing plinth and measured a length of 0.1 m and a width of 0.4 m. It partially sat on threshold (**1003**) as well as plinth stone (**1002**) in between which was a 0.03 m thick layer of hard cementitious mortar. The wrought-iron box-pier was partially secured to the top of the stone cap by a hard cementitious mortar that has in great part weathered away; at the same time the base of the box pier was heavily corroded with the vast majority missing. The plinth stone cap was split into three parts. This architectural element has clearly been disturbed as it is slightly off-centre in relation to the stone blocks below (**1002**), and the railing plinth probably due to having been knocked by passing vehicles.

Figure 8: View of the southern plinth stones and brickwork

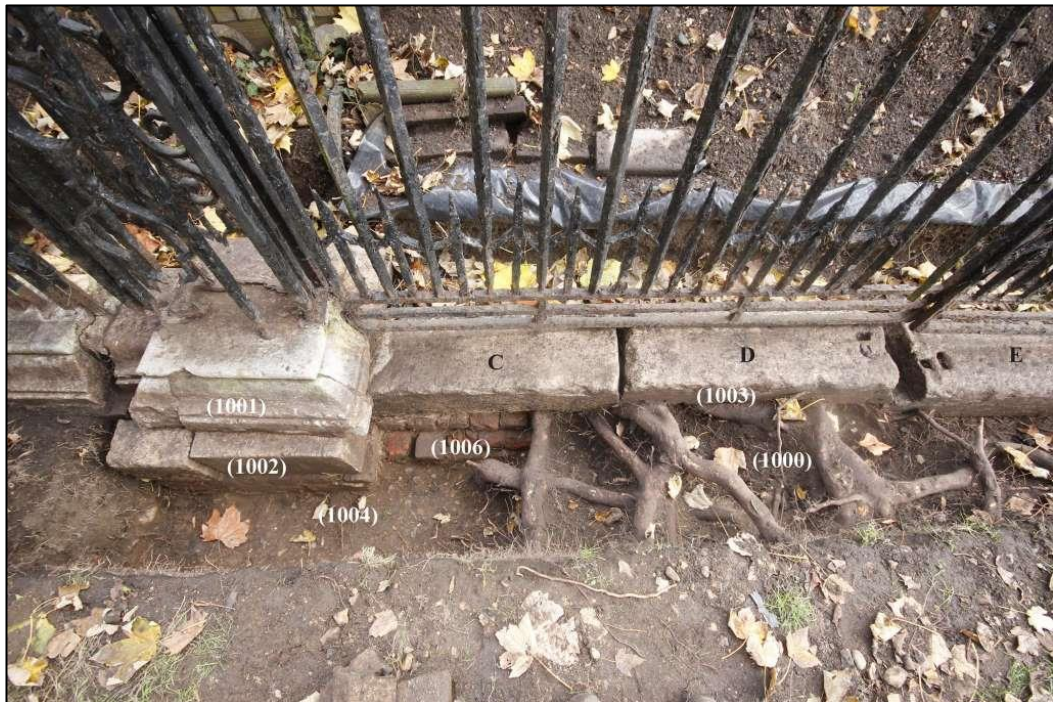
- 4.5 The gate threshold (**1003**) was composed of four squared blocks of Portland stone: Blocks C, D, E, and F (see table 3). Blocks C and D had been displaced 0.07 m upwards by the growth of tree roots. Block F had a patch a cementitious mortar securing the gate fixtures to the northern end of the stone, the western face had pronounced tool marks on the lower half. Block D was weathered and worn on the southern end with two keep holes on the upper face, one with lead caulking still present. Block E also had two keep holes on its upper face. The threshold was partially overlain by plinth stone caps (**1001**) (north) and (**1007**) (south).

Figure 9: View of the damage caused to the threshold by the Plane Tree roots
