Condition Survey and Emergency Conservation Treatment

PETERBOROUGH CATHEDRAL

THE NAVE CEILING ST PETER, ST PAUL AND PSALTERY PLAYER LOZENGES

October 1997

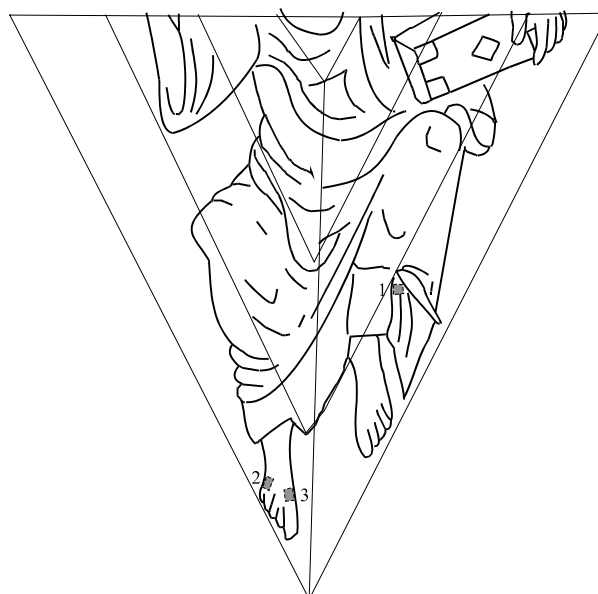
Tests on St Peters feet (Ref: 31 II/III)

Test	Materials & Methods	Results
1	<p>Flaking blue drapery on east side foot Area relaxed for 5 mins with PP70°C, small nozzle. A 15% soln. of Plectol in water/IMS (1:1) was injected & heat continued during injection. NB The IMS was introduced into the Plectol to attempt to reduce the amount of water involved. The heat was then removed and a pad of dry cotton wool was used to press back the flake, through tissue. The process was repeated with damp cotton wool to remove excess consolidant and then finally repeated with a dry pad.</p>	<p>The flake relaxed nicely with the heat and relaid well, without any obvious blanching; also the Plectol/water/IMS works and travels well. But when the tissue was removed immediately it was clear that it had stuck partially to the residual consolidant, which had been dried by the PP. Therefore it appears to be a mistake to apply heat once the consolidant has been applied. However, the heat both relaxes the flake & dries off residual moisture. The aim was to reduce the water content and as the PP was all but dry, the only extraneous water was from the damp swab.</p>

2	<p>Little toe of right foot Same test as 1. but no heat after injection, until tissue removed.</p>	<p>Appears to work well but there is a slight sticking of the tissue to the surface.</p>
3	<p>Right foot, adjacent to big toe PP90°C same settings and treatment, but more attention paid to removing excess consolidant.</p>	<p>Immediate impression is that it works well - Good (improved/quicker) flake relaxation (2mins rather than 5 mins); Tissue releases better than in tests 1&2 though there is a v. slight tackiness, it is not enough to cause undue concern; No apparent blanching.</p>

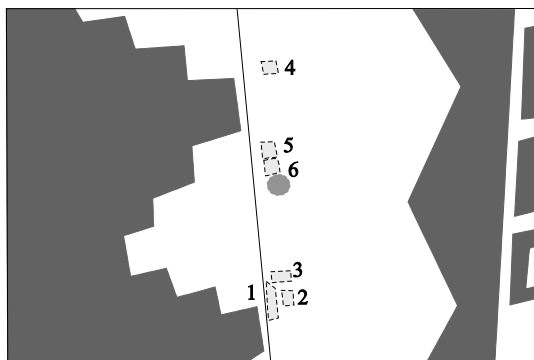
Tests carried out on chevron panel, north side St Peter over ladder (ref. 30/1)

Test	Materials & Methods	Results
1	Glue softened with PP 100°C (max. Mist, med. nozzle) & removed with wet swab	Glue readily removed & seems to remove ingrained dirt also. Some blanching evident
2	Cold water swab on non-glue area	Removes surface dirt only
3	Warm water swab on non-glue area	Removes surface dirt only, slight blanching
4	PP at 60°C (mist 5/small nozzle) on non-glue area; dirt removed with cold water swab	This test was to see whether the PP removes ingrained & surface dirt & whether it causes blanching. No blanching occurred.
5	PP at 60°C (mist 5/med. nozzle) on glue area; glue removed with cold water swab	Dissolves glue well, though not as readily as 1. Evident blanching.
6	PP at 40°C (mist 5/med. nozzle) on glue area; glue removed with cold water swab	Dissolves glue adequately

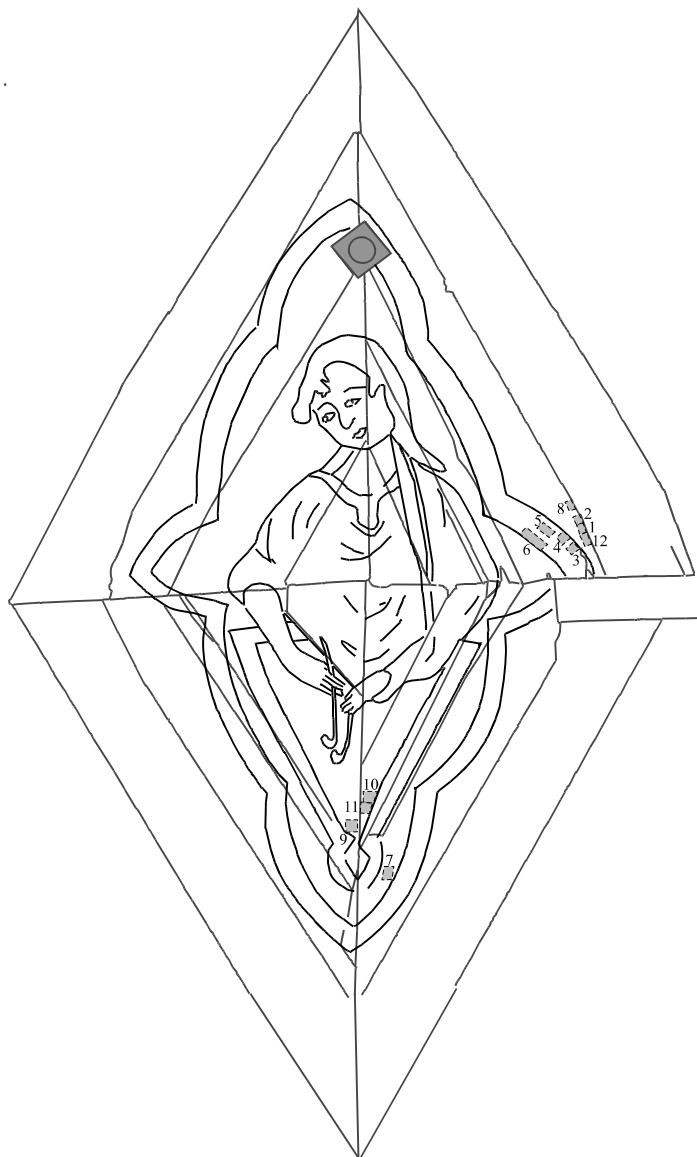
Extensive testing carried out on the Psaltery fig. for paint re-attachment; glue removal; flake relaxation & cleaning. Refer to diagram for position of tests.

Psaltery fig chosen because of similar paint layer flaking to SS Paul & Peter

Test	Materials & Methods	Results
1	PP 50°C (mist 2/med. nozzle) on glue	Effective glue & dirt removal; minor blanching.
2	Cold water swab on non-glue (control)	Removed surface dirt but less effectively than 1
3	Cold water swab	Removed surface dirt: acceptable level of cleaning
4	PP as 1. Cleaned with cold water swab. Test for blanching, as though attempting to relax flake.	Possibly slight blanching occurred
5	PP 40°C (mist 2) on curled flake	After 2-3 mins. The flake was successfully relaxed
6	PP cold moisture (mist 1) for 15 mins	Flakes brittle before application: after 15 mins. responded slightly, but still too brittle to risk relaxing. When attempted 1 flake cracked.

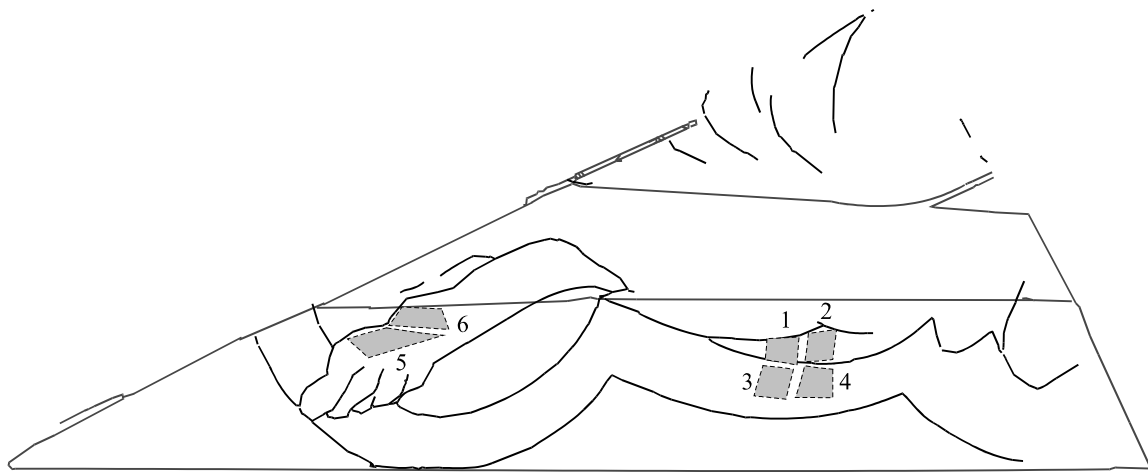
Tests for blanching on St Paul replacement board (*Ref: 27/II*).

#	Materials & Methods	Results
1	Damp (water) swab held on red drapery for 20sec, then dry swab for 10 sec	Blanching evident after 1-2mins
2	Damp (IMS) swab for 20 sec, then dry swab for 10 sec	No obvious blanching, but slight white ring/'tidemark' around test area
3	As 1.on blue/green cusped frame	Very significant blanching evident after 2 mins
4	As 2. .on blue/green cusped frame	Slight ring; no obvious blanching
5	As 1. on flesh tones	Blanching evident as it dried
6	As 2. on flesh tones	'Tidemark' ; insignificant blanching

The assumption is that the moisture is causing the blanching, yet some moisture is required for the refixing process to work effectively. Need to establish a method of fixing using the minimum (if any) amount of water necessary.
