**PETERBOROUGH CATHEDRAL: THE NAVE CEILING**

**PHASE 1: ROWS 36 - 40**

**CONDITION SURVEY AND CONSERVATION TREATMENT**

**JANUARY - JUNE 1998**

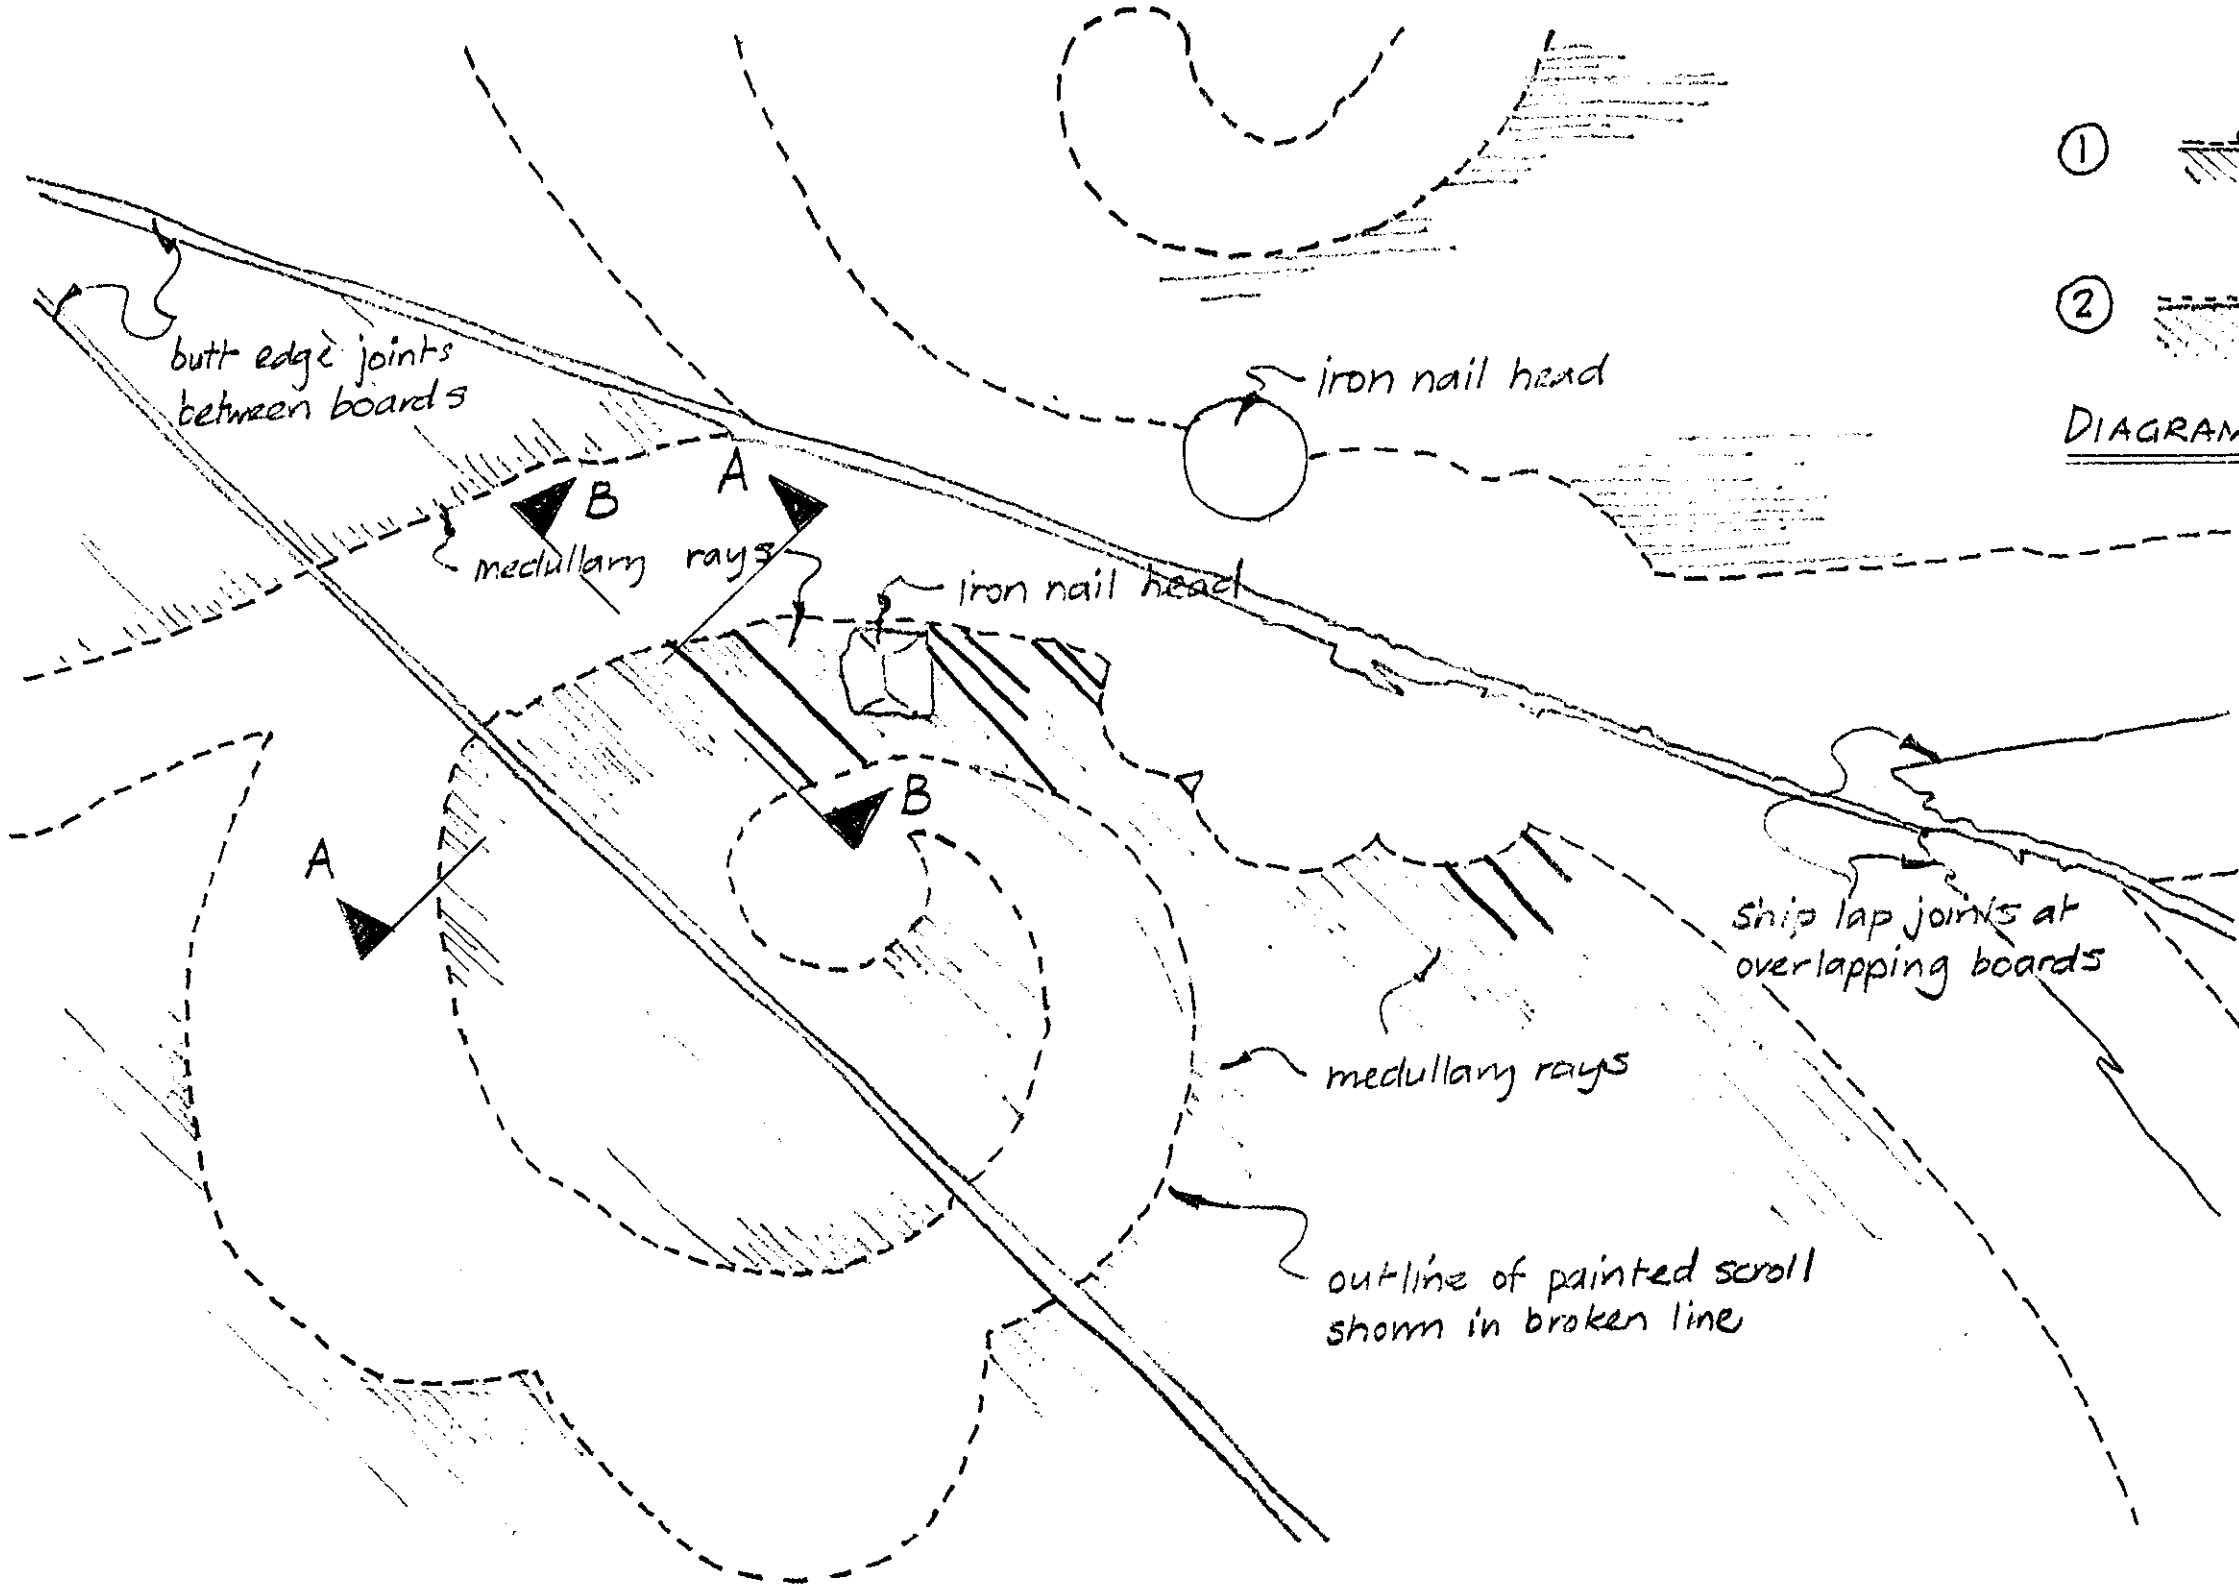
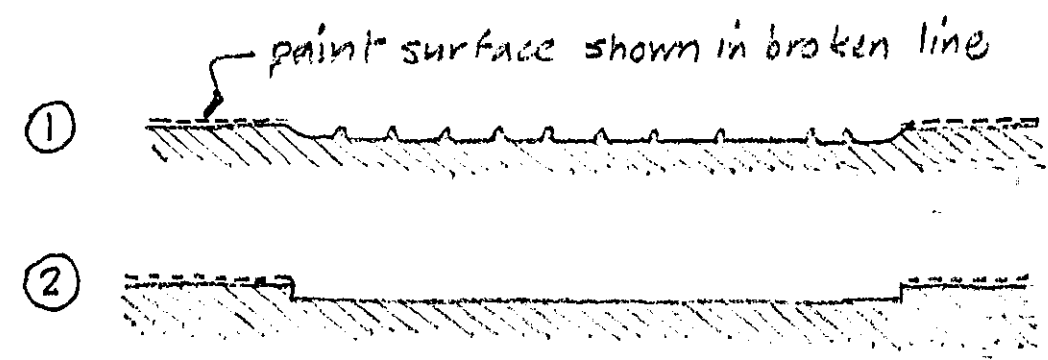
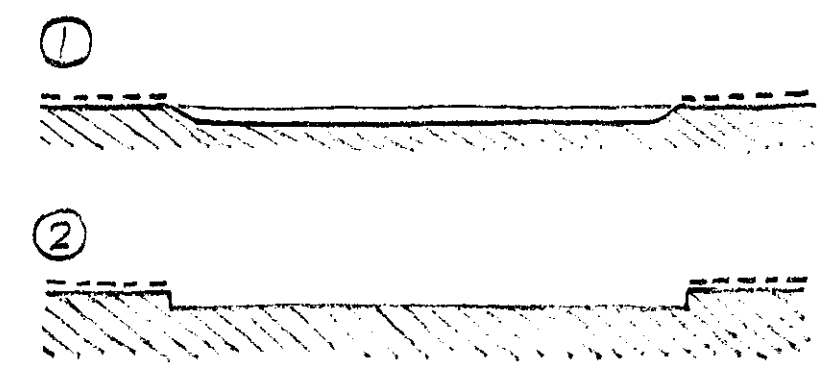
DIAGRAMMATIC SECTION A - A

showing ① as existing with medullary rays continuous with level of painted scroll surface and ② as re-constructed with shallow carved surface.

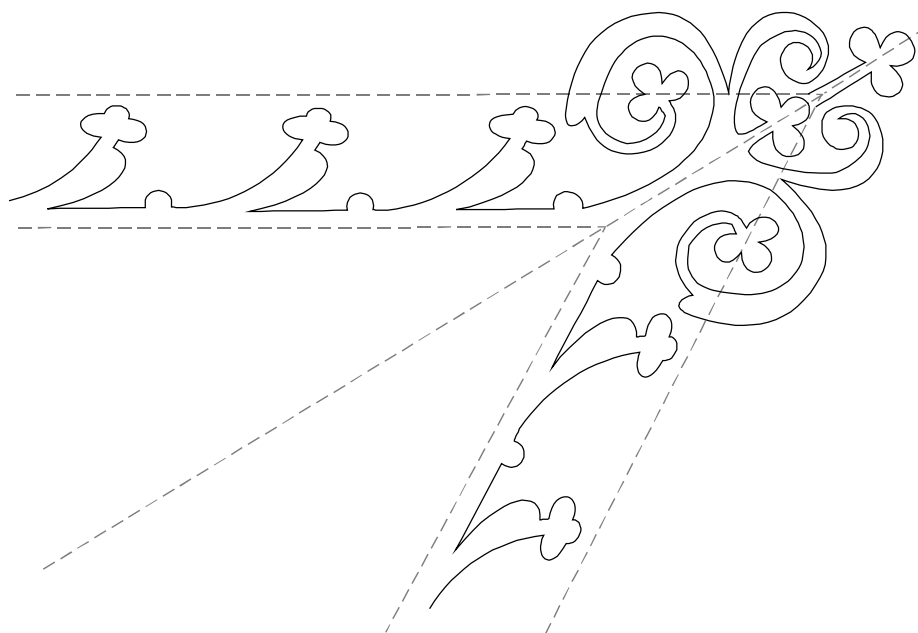
A trefoil pattern terminating in an elaborate scroll design is discernible, with raking light, under the extended chevron pattern on many original oak boards (see **Figure 6**) and **Plates 286-289**). There is clear visual evidence that the overlying extended chevron design was painted in the 1740s. Sample analysis indicates that a combination of vermilion with lead white was employed to create the underlying trefoil pattern. From samples taken in 1997 Howard concluded the design was unlikely to be original as the lead white overpaint covering the pink trefoil layer appeared to have been painted almost wet-on-wet. However, her preliminary 1998 findings suggest that the trefoil design may indeed be original. Visual examination suggests that the relief effect first thought simply to be impasto paint is in many places too pronounced for the thickness of the paint. Furthermore, the impasto effect appears and fades along the boards with no evidence that some of the layer may have flaked. These observations - coupled with Howard's finding in 1997 that a similar pink layer was detected in a sample taken from an area further along the board, but where no trace of an underlying design is visible even in raking light - may suggest that a thin, less stable, original background paint layer may have been partially lost at an early date. The surface of the exposed areas of board deteriorated marginally as a result of environmental factors before being overpainted in the 1740s, while the protected timber under the original oil-based paint of the trefoil design was unaffected. This is just one theory that may explain the phenomenon. Further paint sample analysis is required to test the hypothesis.

**Figure 6.** Outline of the trefoil pattern which terminates in an elaborate scroll design. It is discernible, with raking light, under the extended chevron pattern on many of the original oak boards.

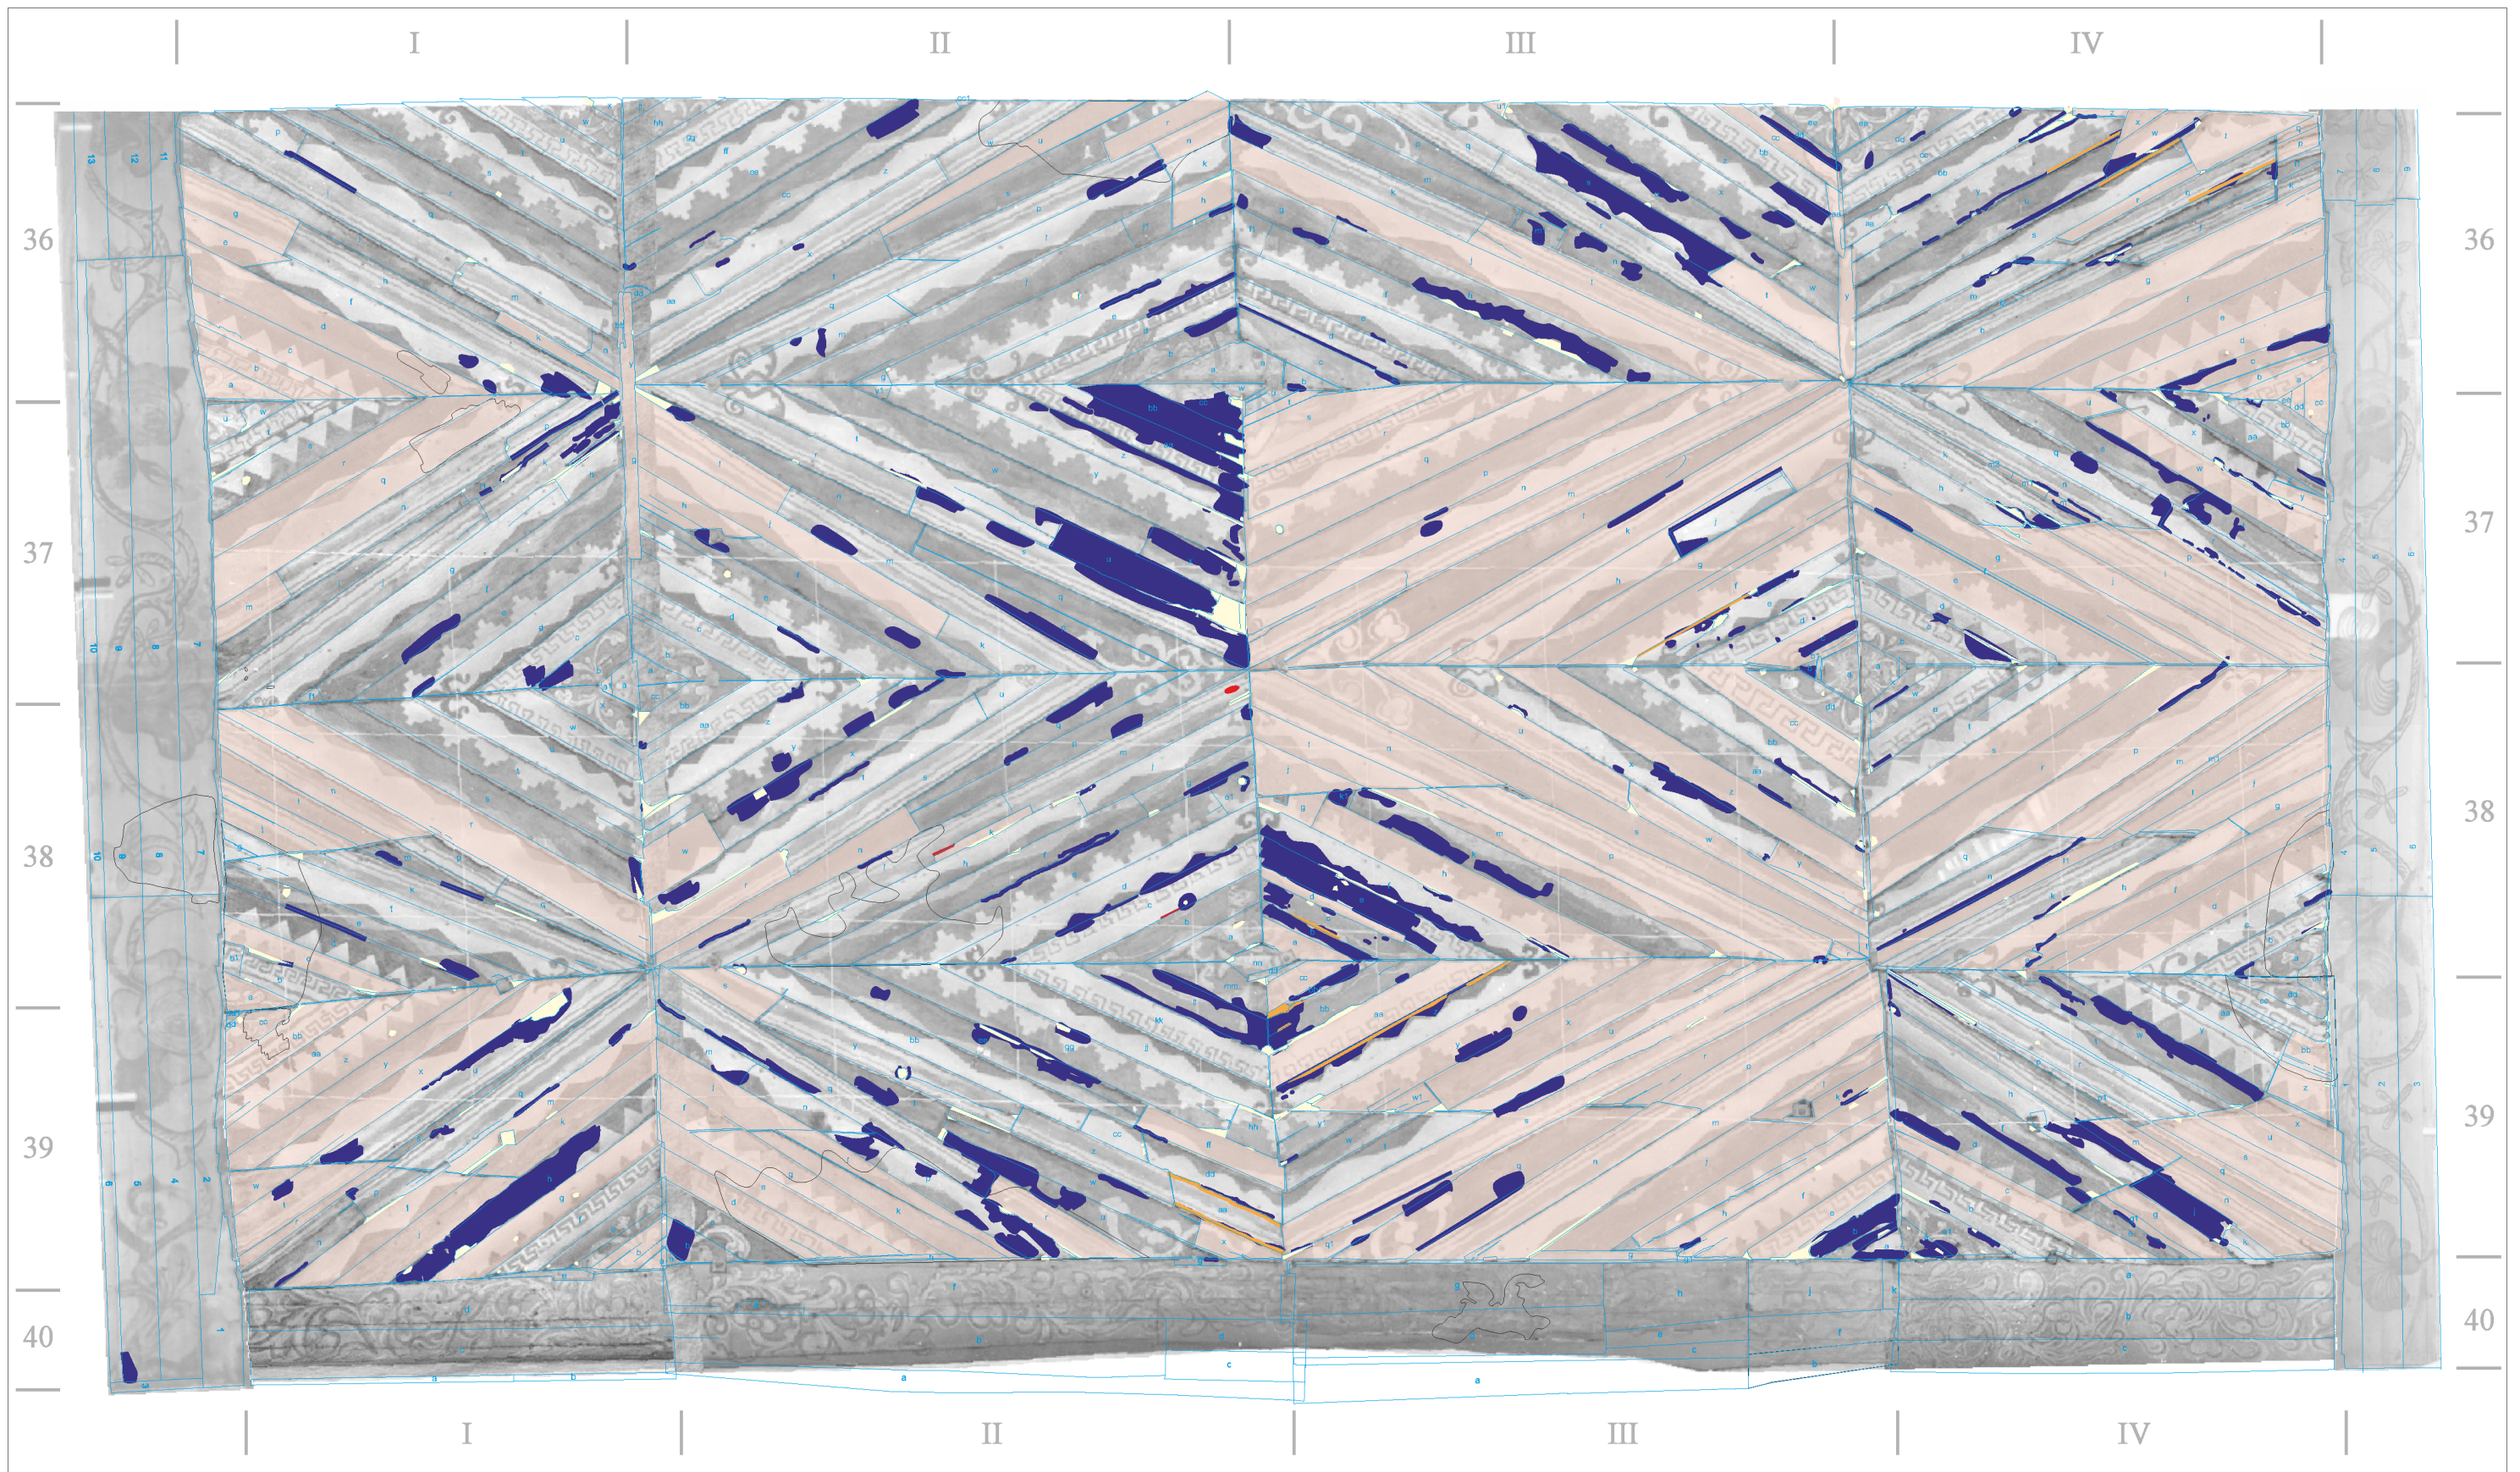
STAGE **CONDITION SURVEY  
AND TREATMENT** DESCRIPTION **Lower Side of Structure  
Damage to Ceiling Boards**

Wood losses are mostly found in areas of infestation.

The shot damage appears random, it is interesting to note the single board in *Panel 40 III* which must have been moved since it was shot damaged.

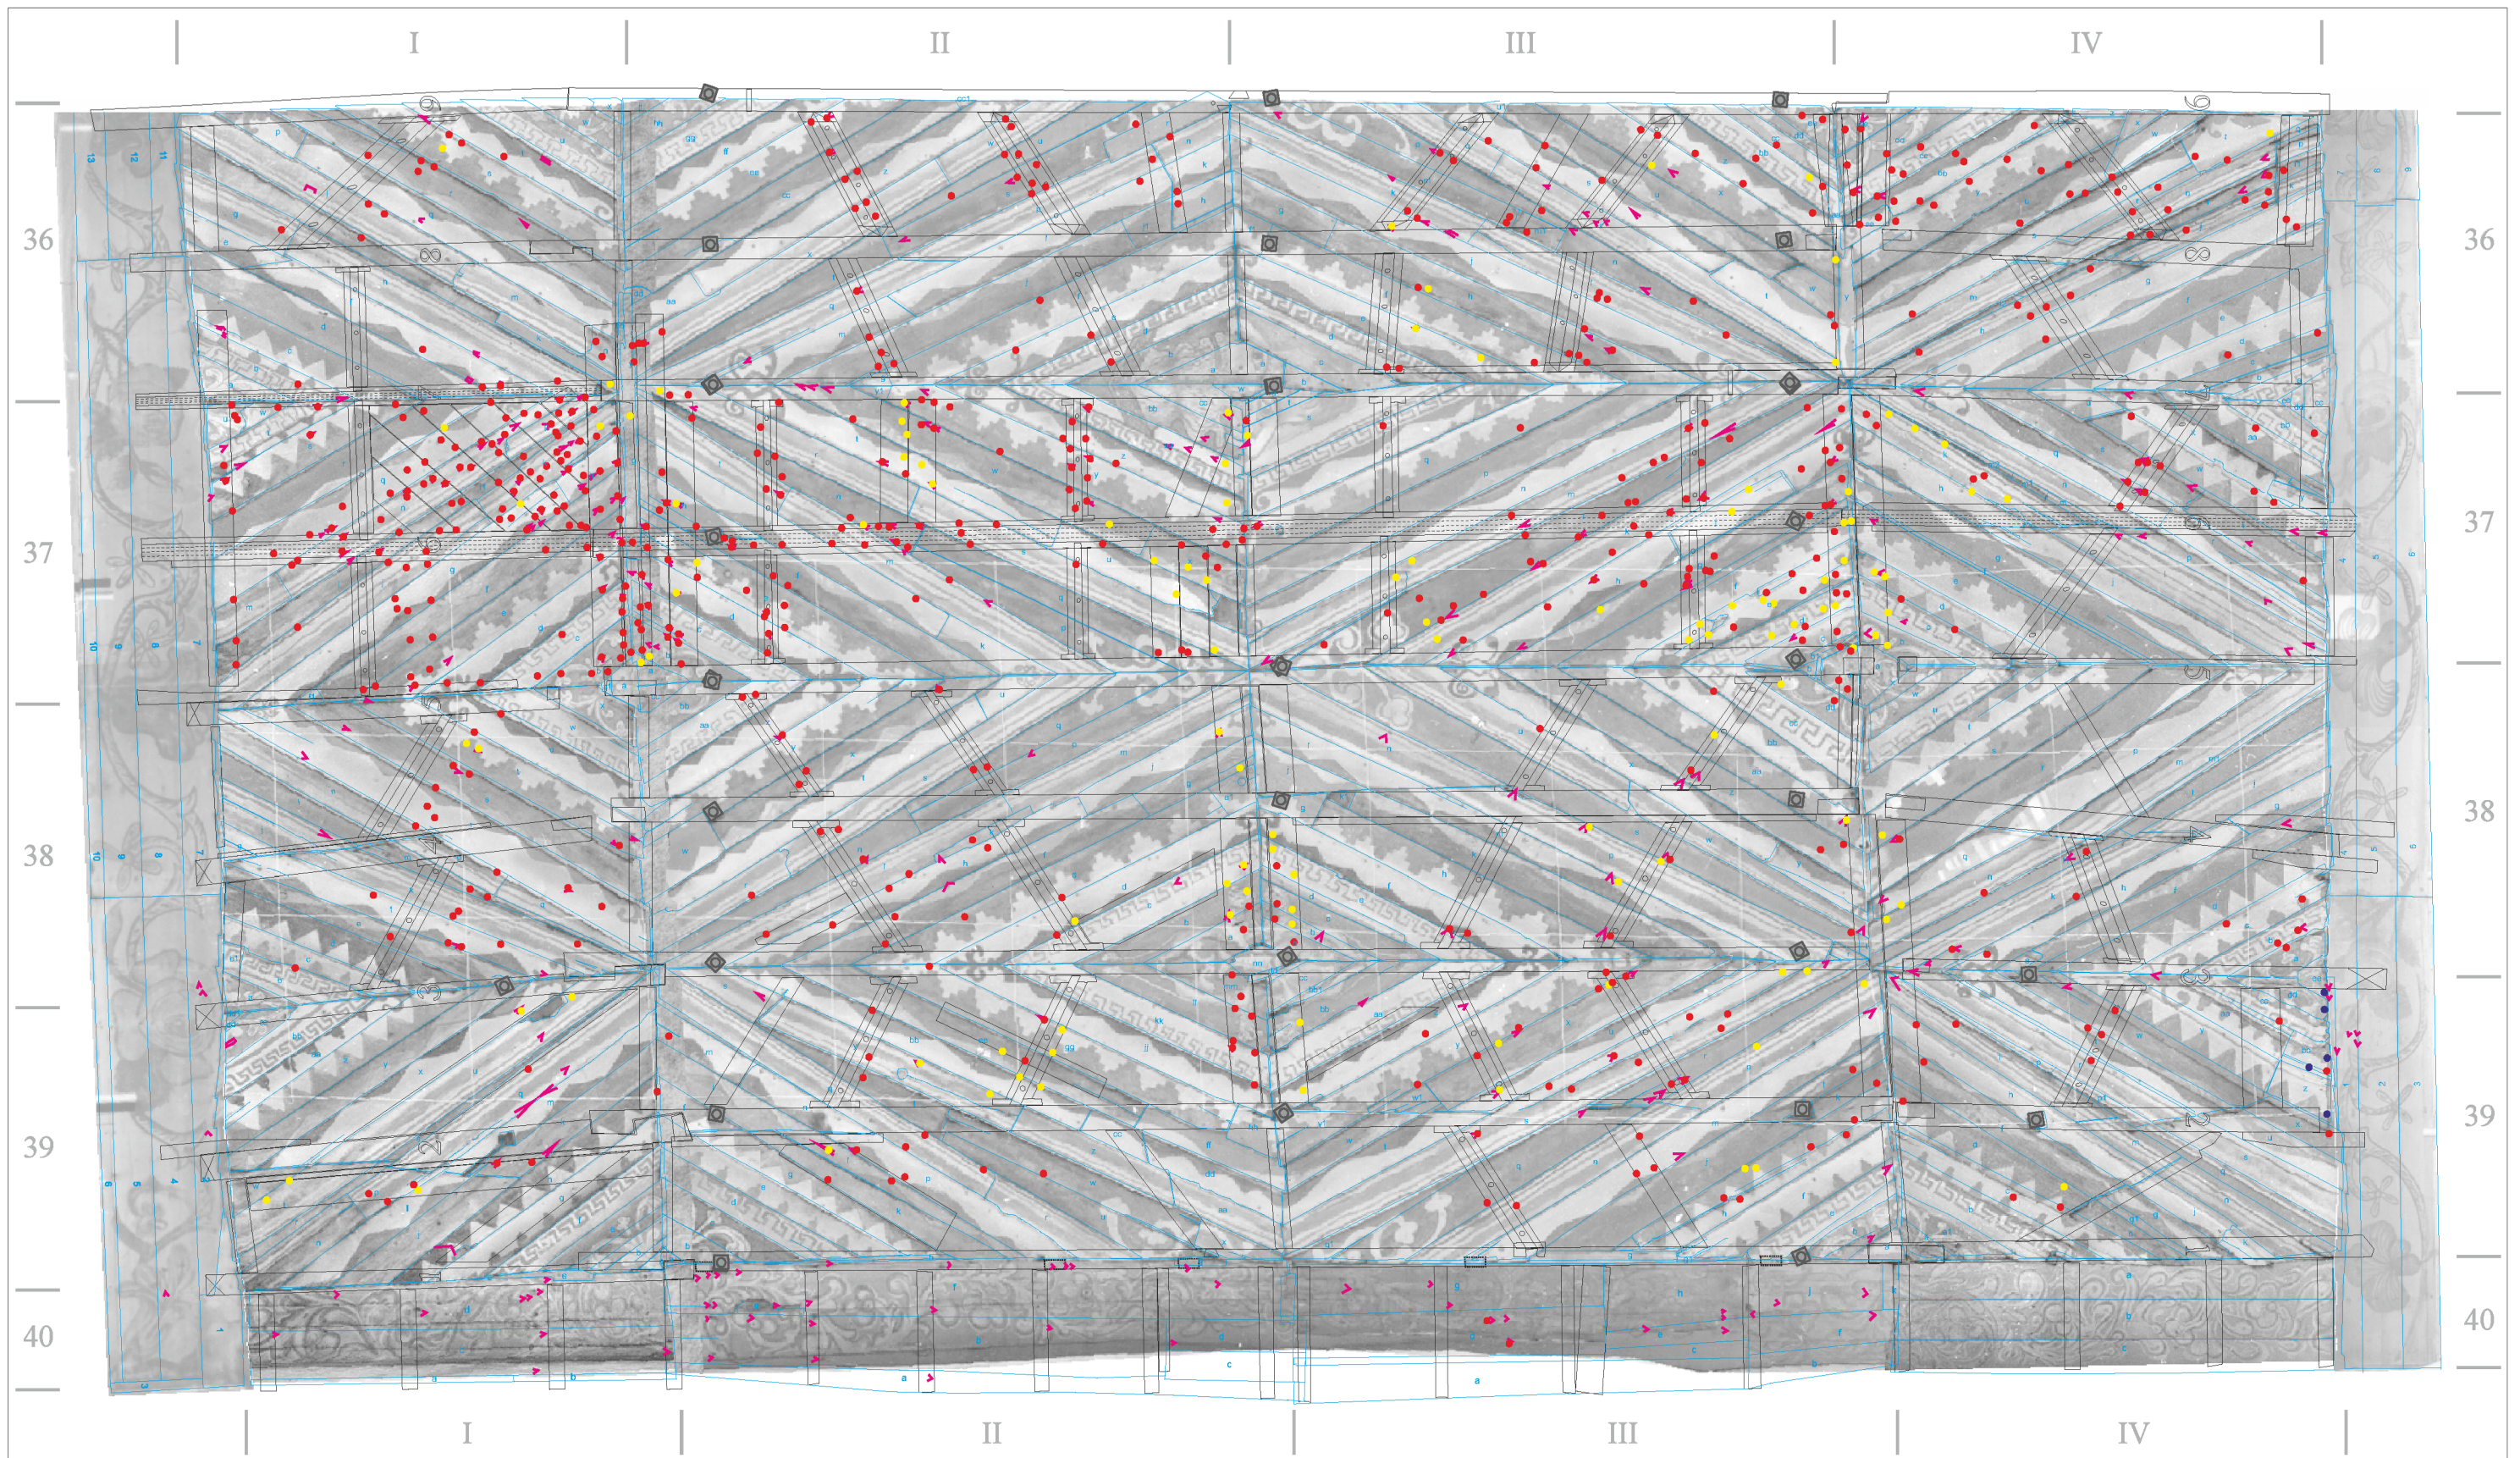
It can be seen that concentrations of screws relate to patches, noggins and composite joists.

There seems no apparent rationale for the choice of steel or galvanized screws. Neither is there for the occurrence of surface splintering.

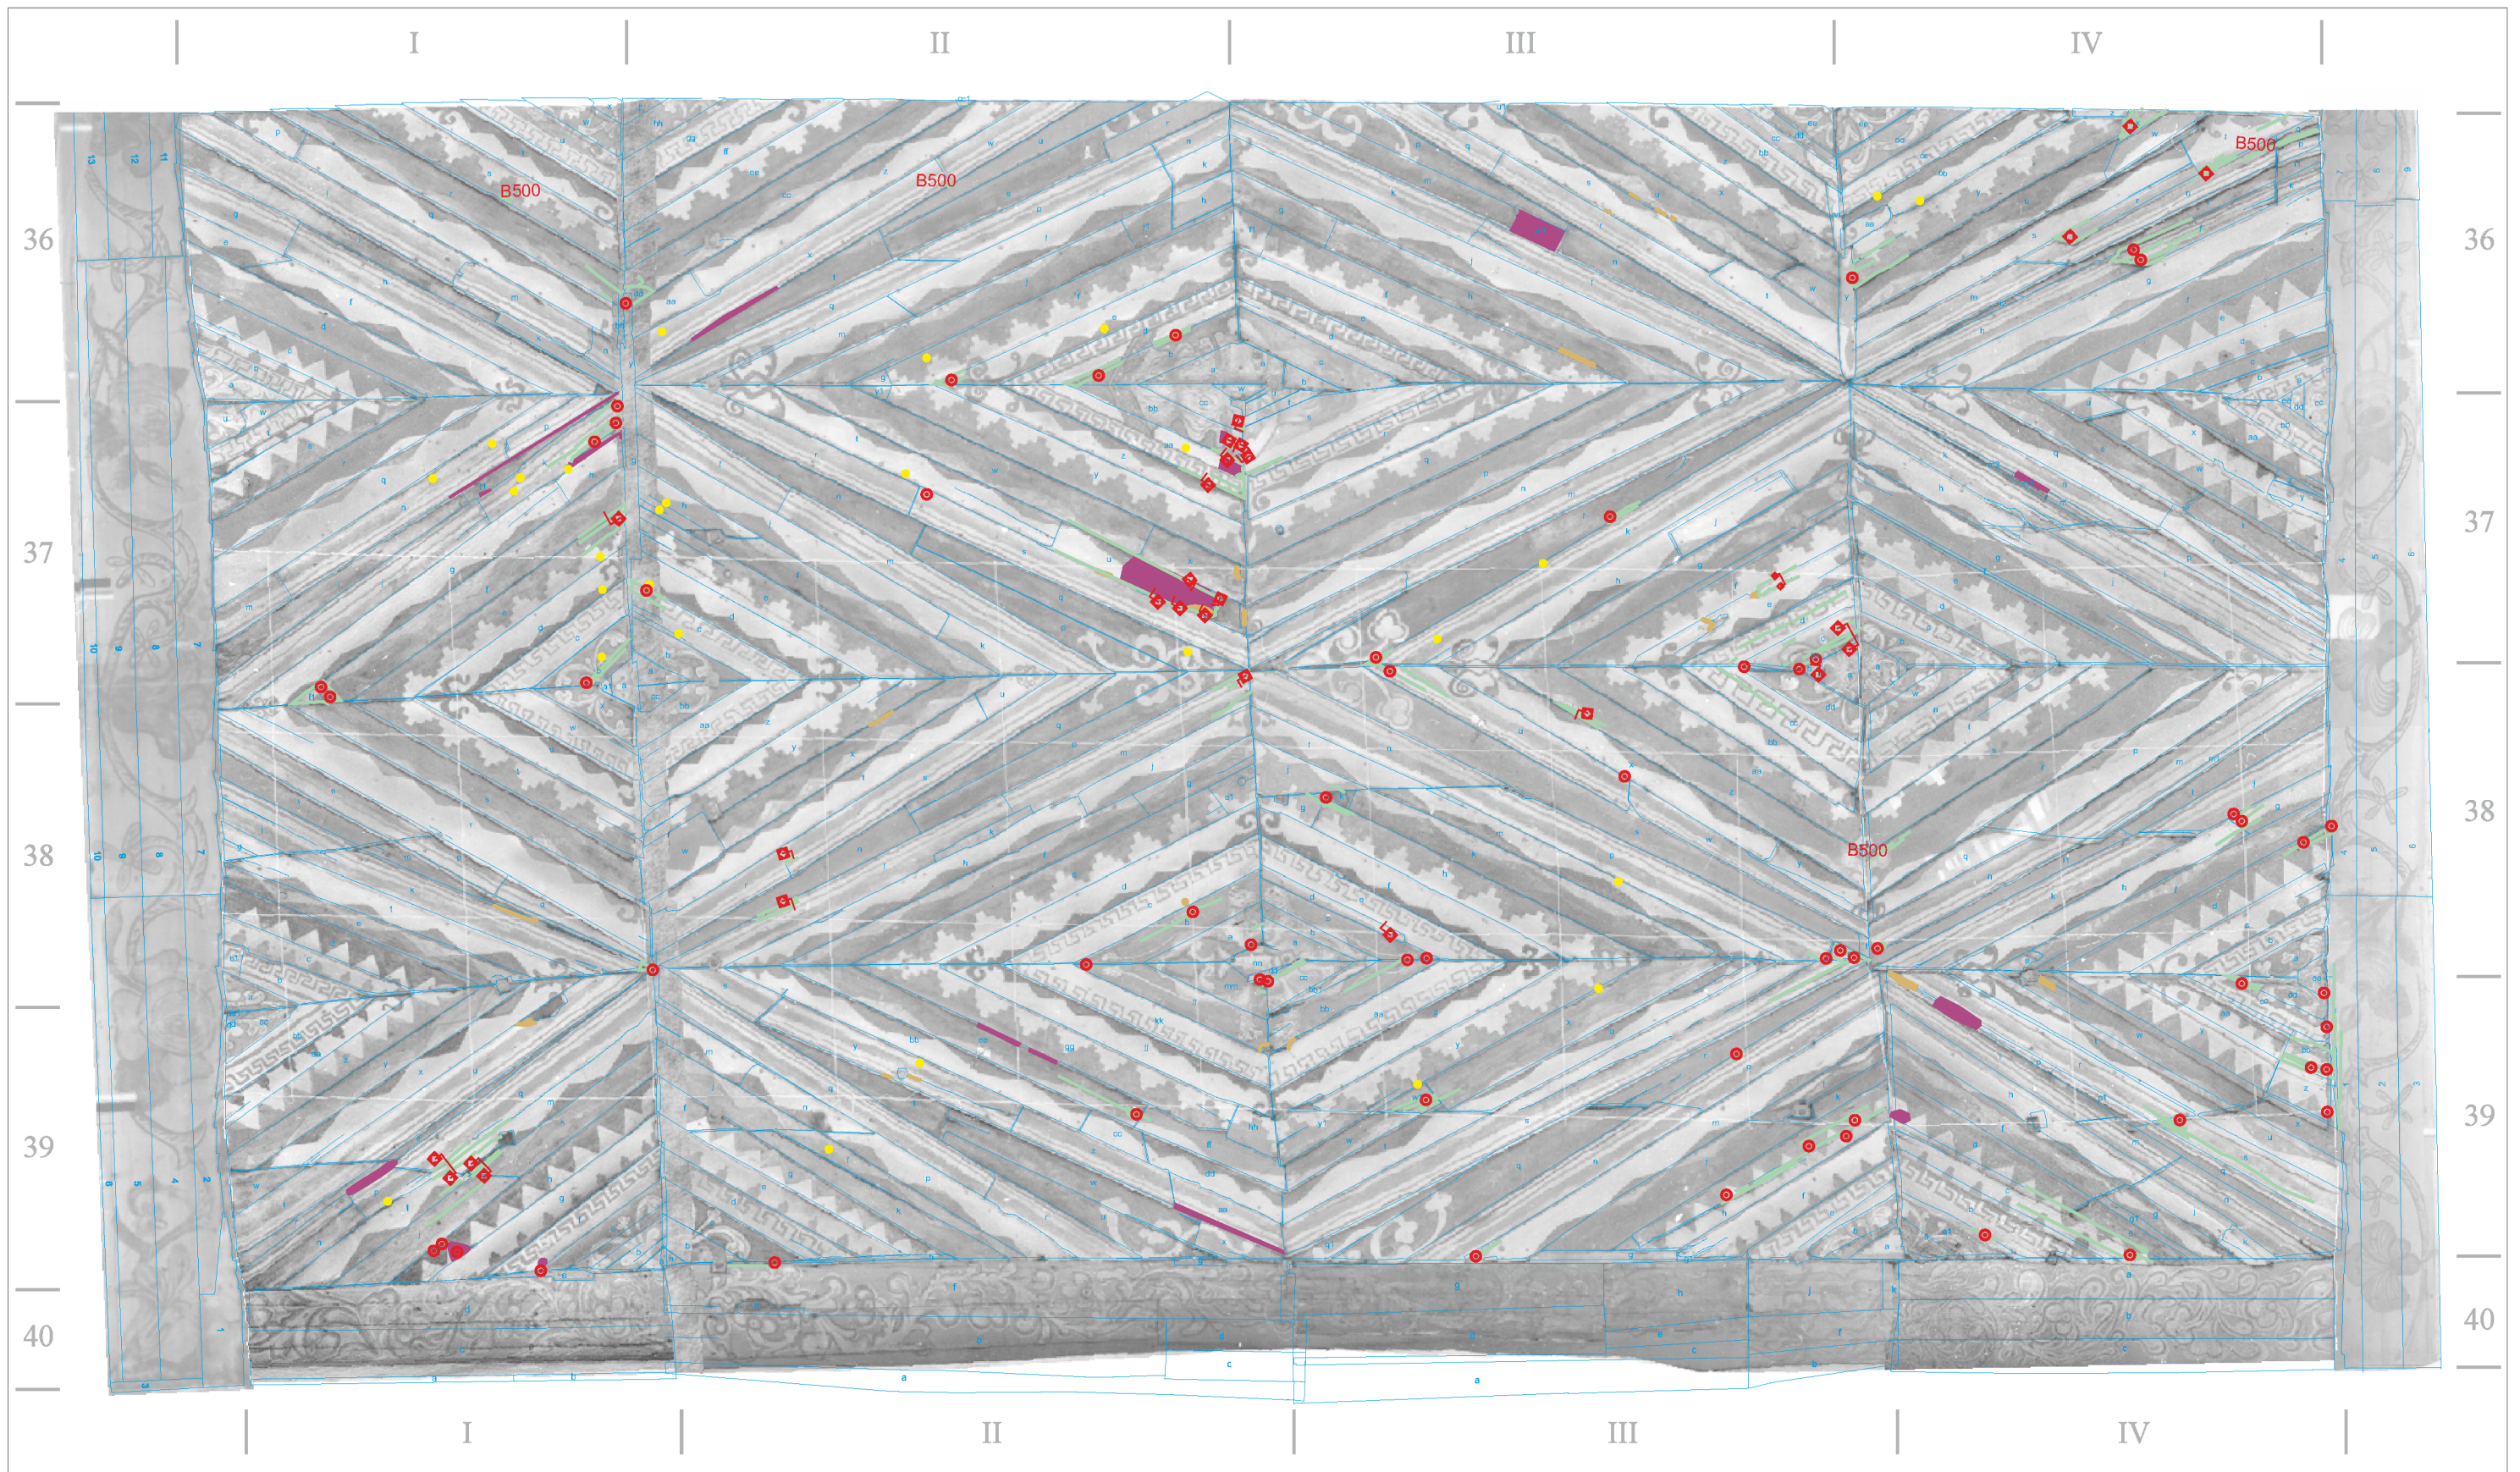
It is noticeable that consolidation by Paraloid B72 and fillings has been used in areas of insect damage and fungal decay.

Stainless steel fixings have been used to secure unstable splinters and fragments of the ceiling boards.

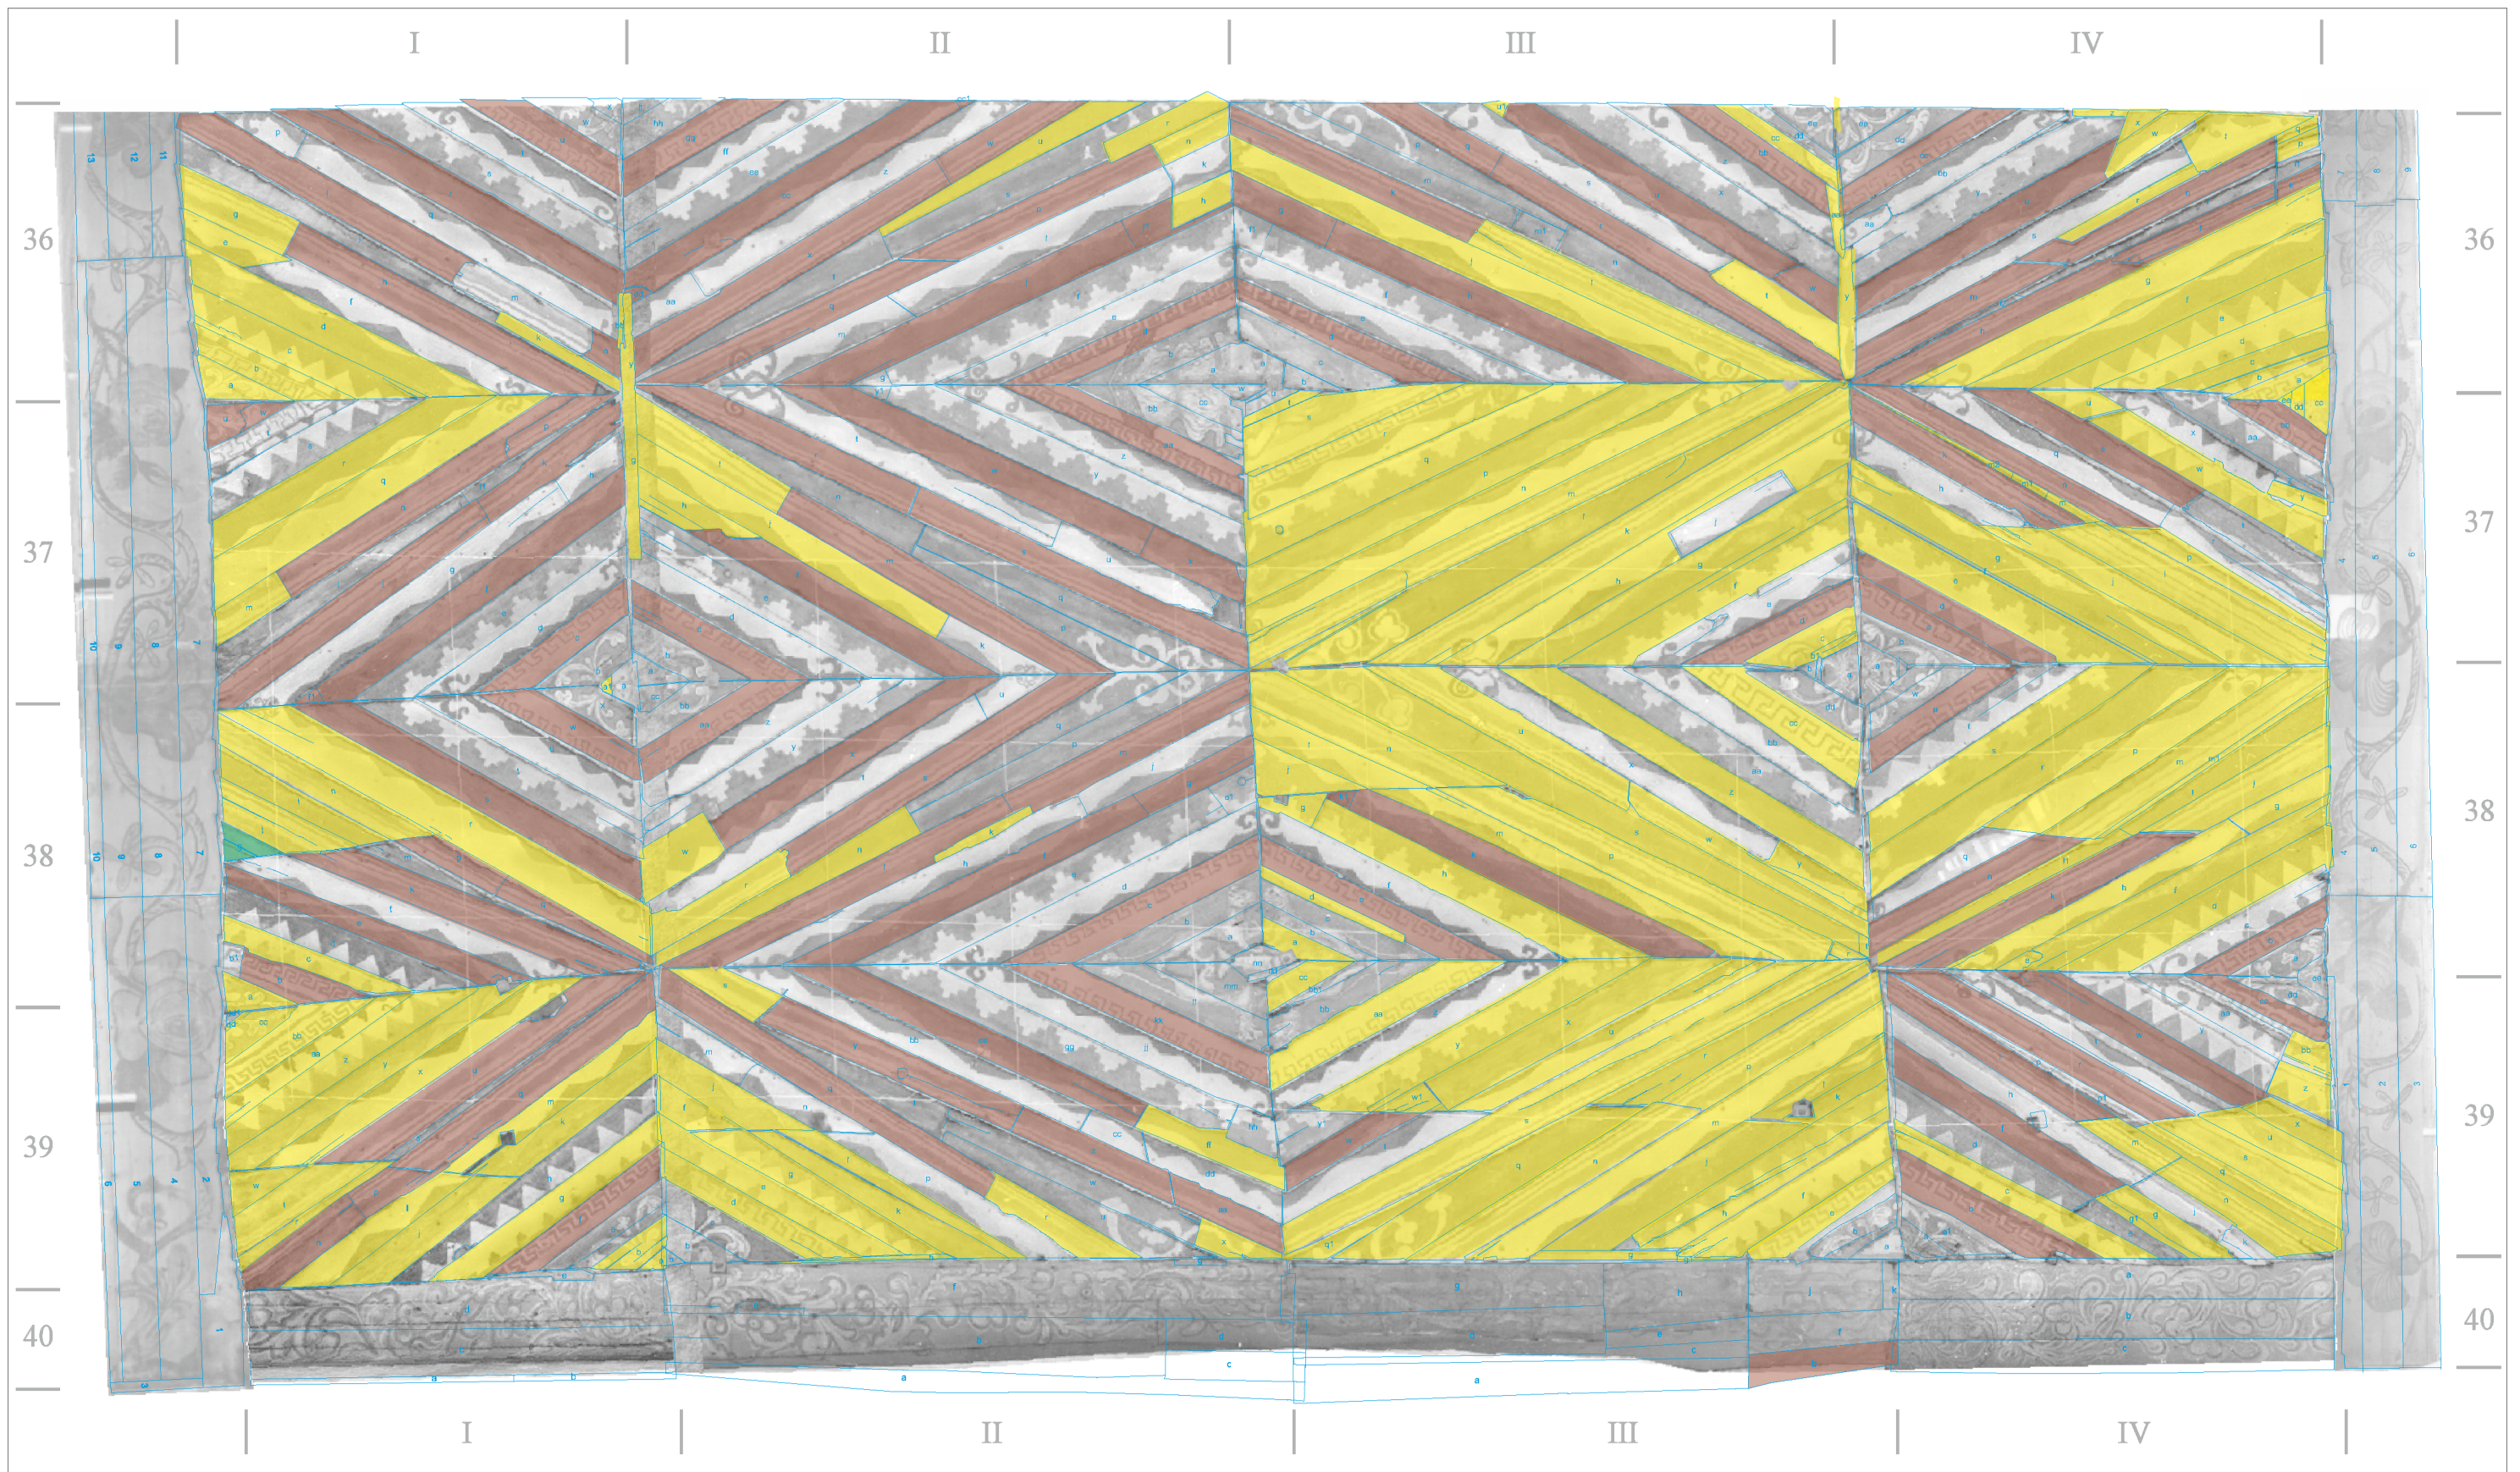
The disposition of boards with grooving is shown and the explanation for the fragmentary evidence is the substantial inclusion in the Ceiling of the softwood replacement boards. As the categorization of the eastern infill panels and Ashlar is unknown, they have not been shown specifically as replacement boards (except the one oak board in Panel 40 III).
