**PETERBOROUGH CATHEDRAL: THE NAVE CEILING**

**PHASE 1: ROWS 36 - 40**

**CONDITION SURVEY AND CONSERVATION TREATMENT**

**JANUARY - JUNE 1998**

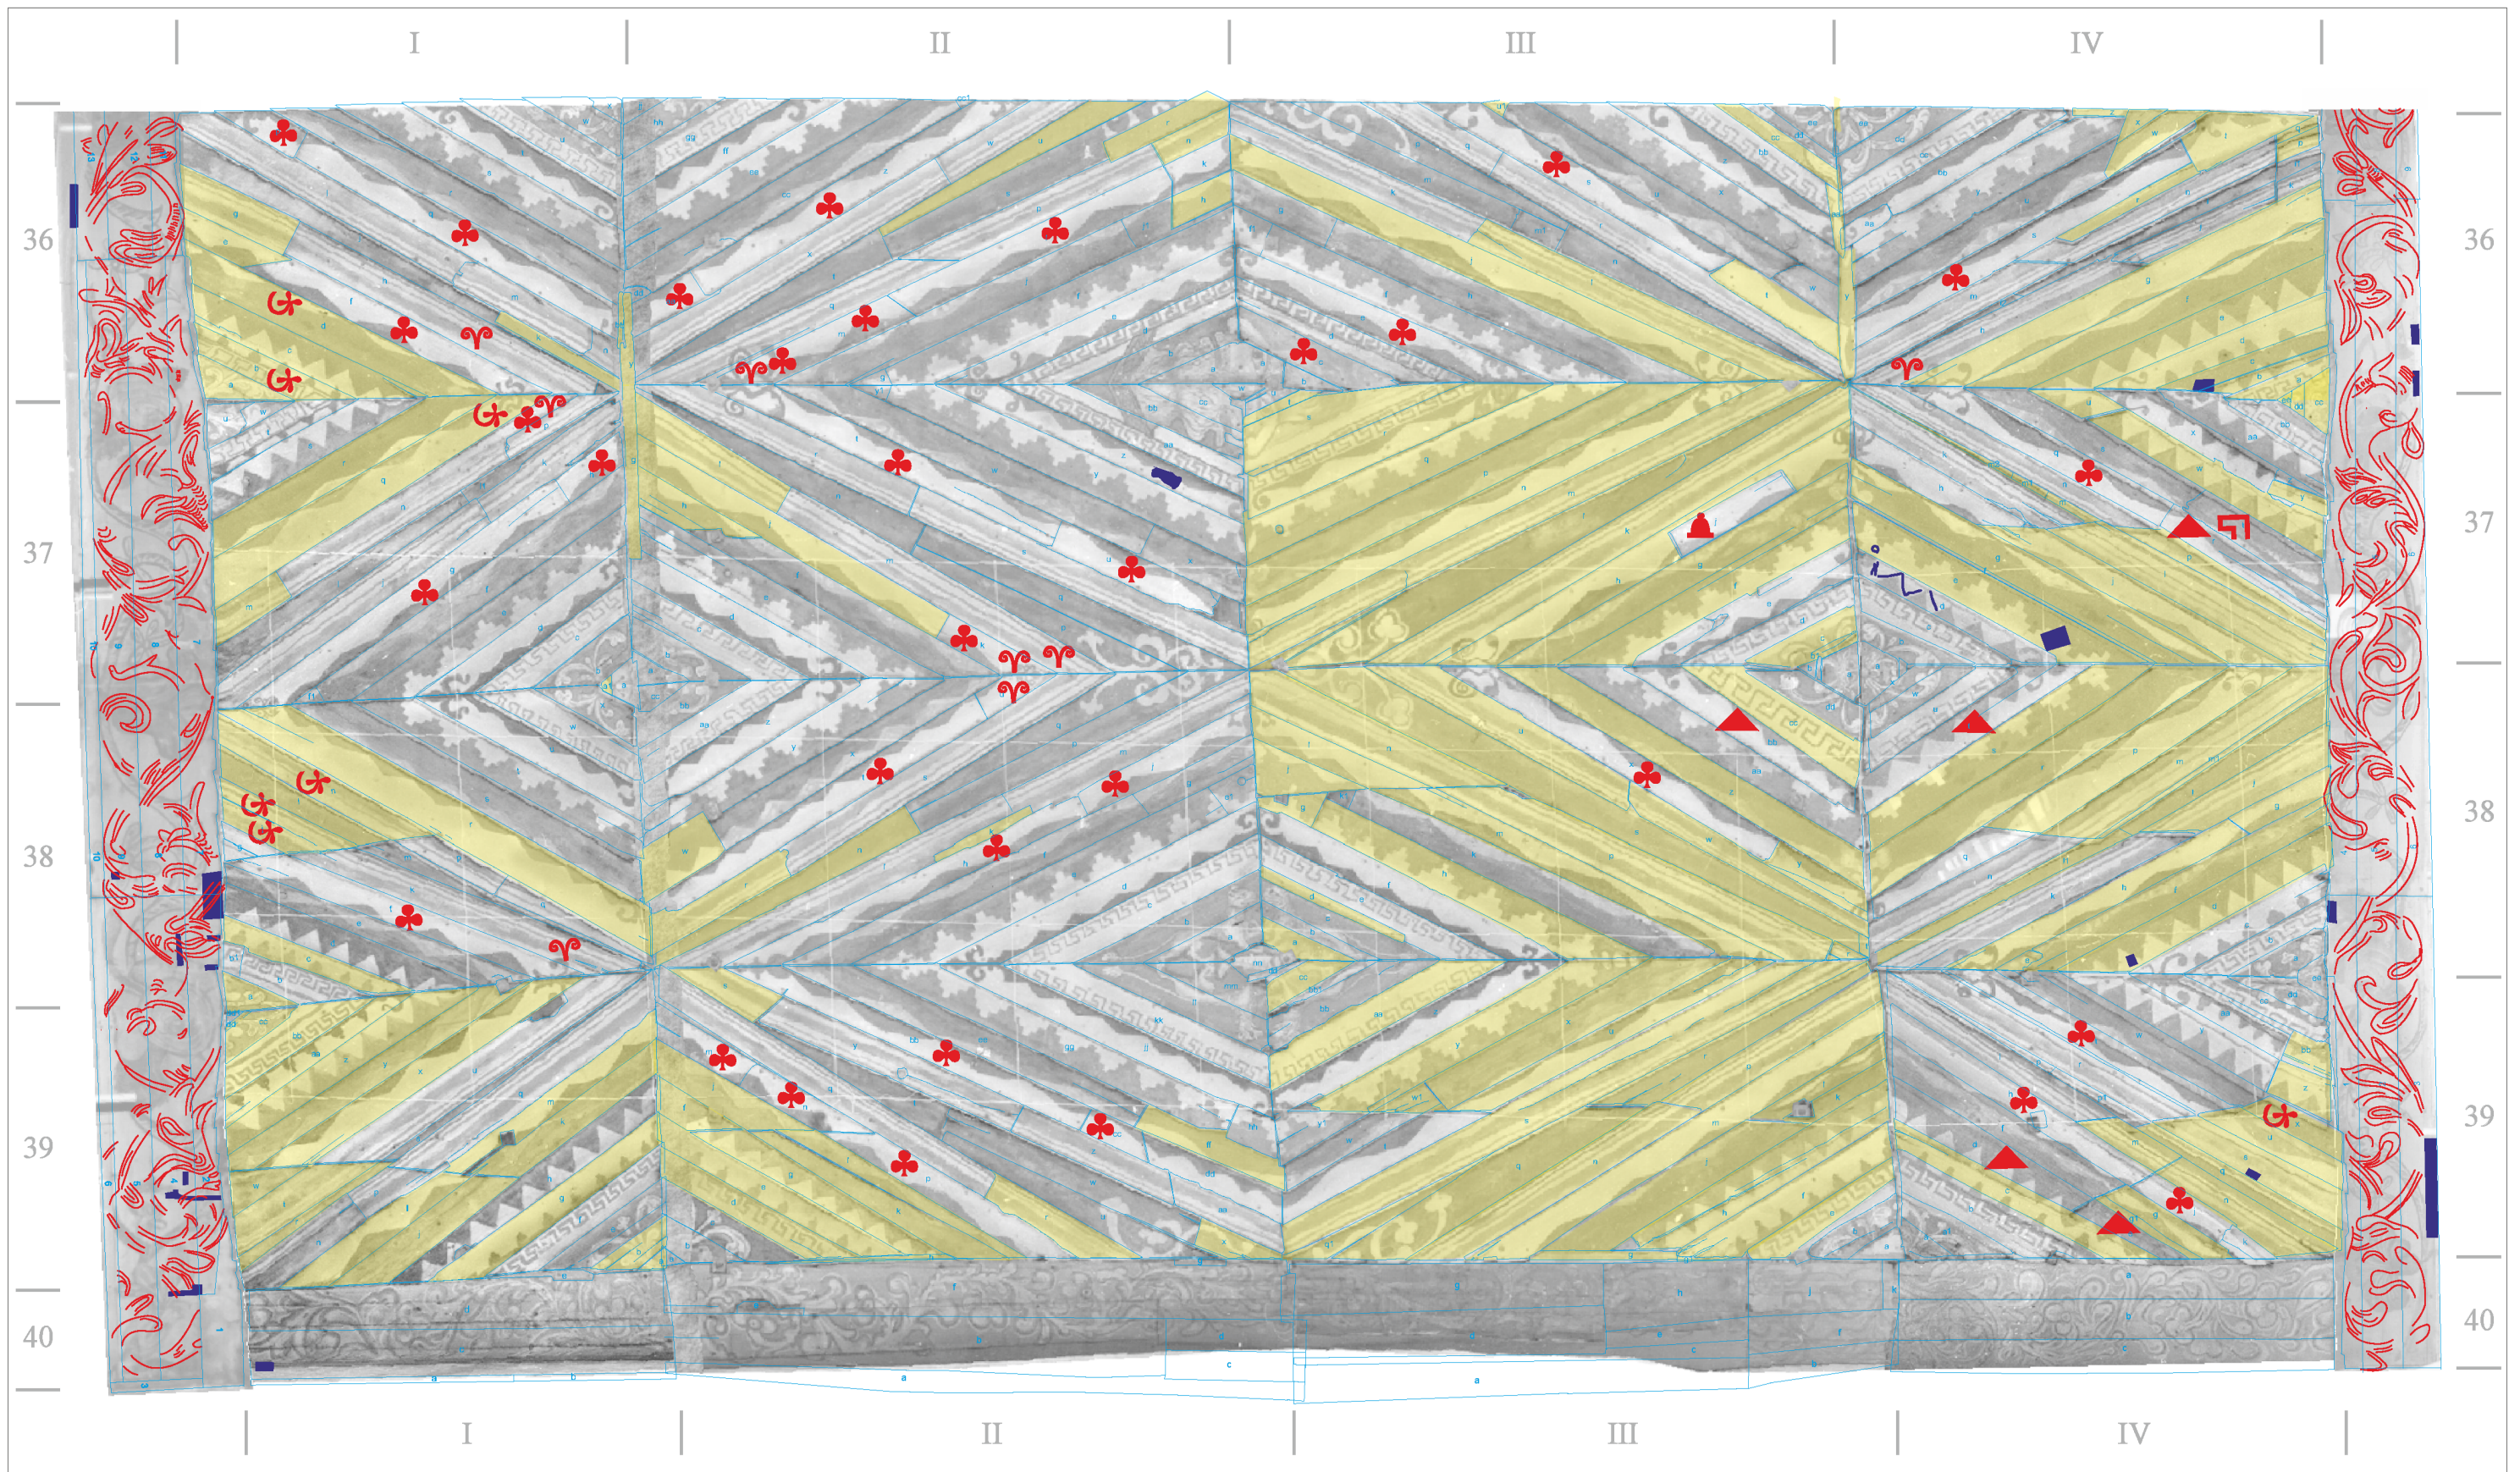
STAGE **PRELIMINARY CONDITION SURVEY**    DESCRIPTION **Paint & Surface Accretions**

*Visible Underpaint* - Many examples of the trefoil pattern and its end scroll design are visible in raking light beneath the extended chevron pattern on many original oak boards. Impasto outlines only of the stepped chevron and dog-tooth/chevron patterns are visible. There are only 7 ceiling boards with the frieze scheme as underpaint and one re-used, round-edged board with key pattern underpaint on its inside edge.

*Replacement Boards* - The majority of these boards appear to have been inserted during the 1830s restoration work; some in the 1740s; a number at the east end, within Panels 39/40, were replaced when the tower wall was rebuilt in the 1880s.

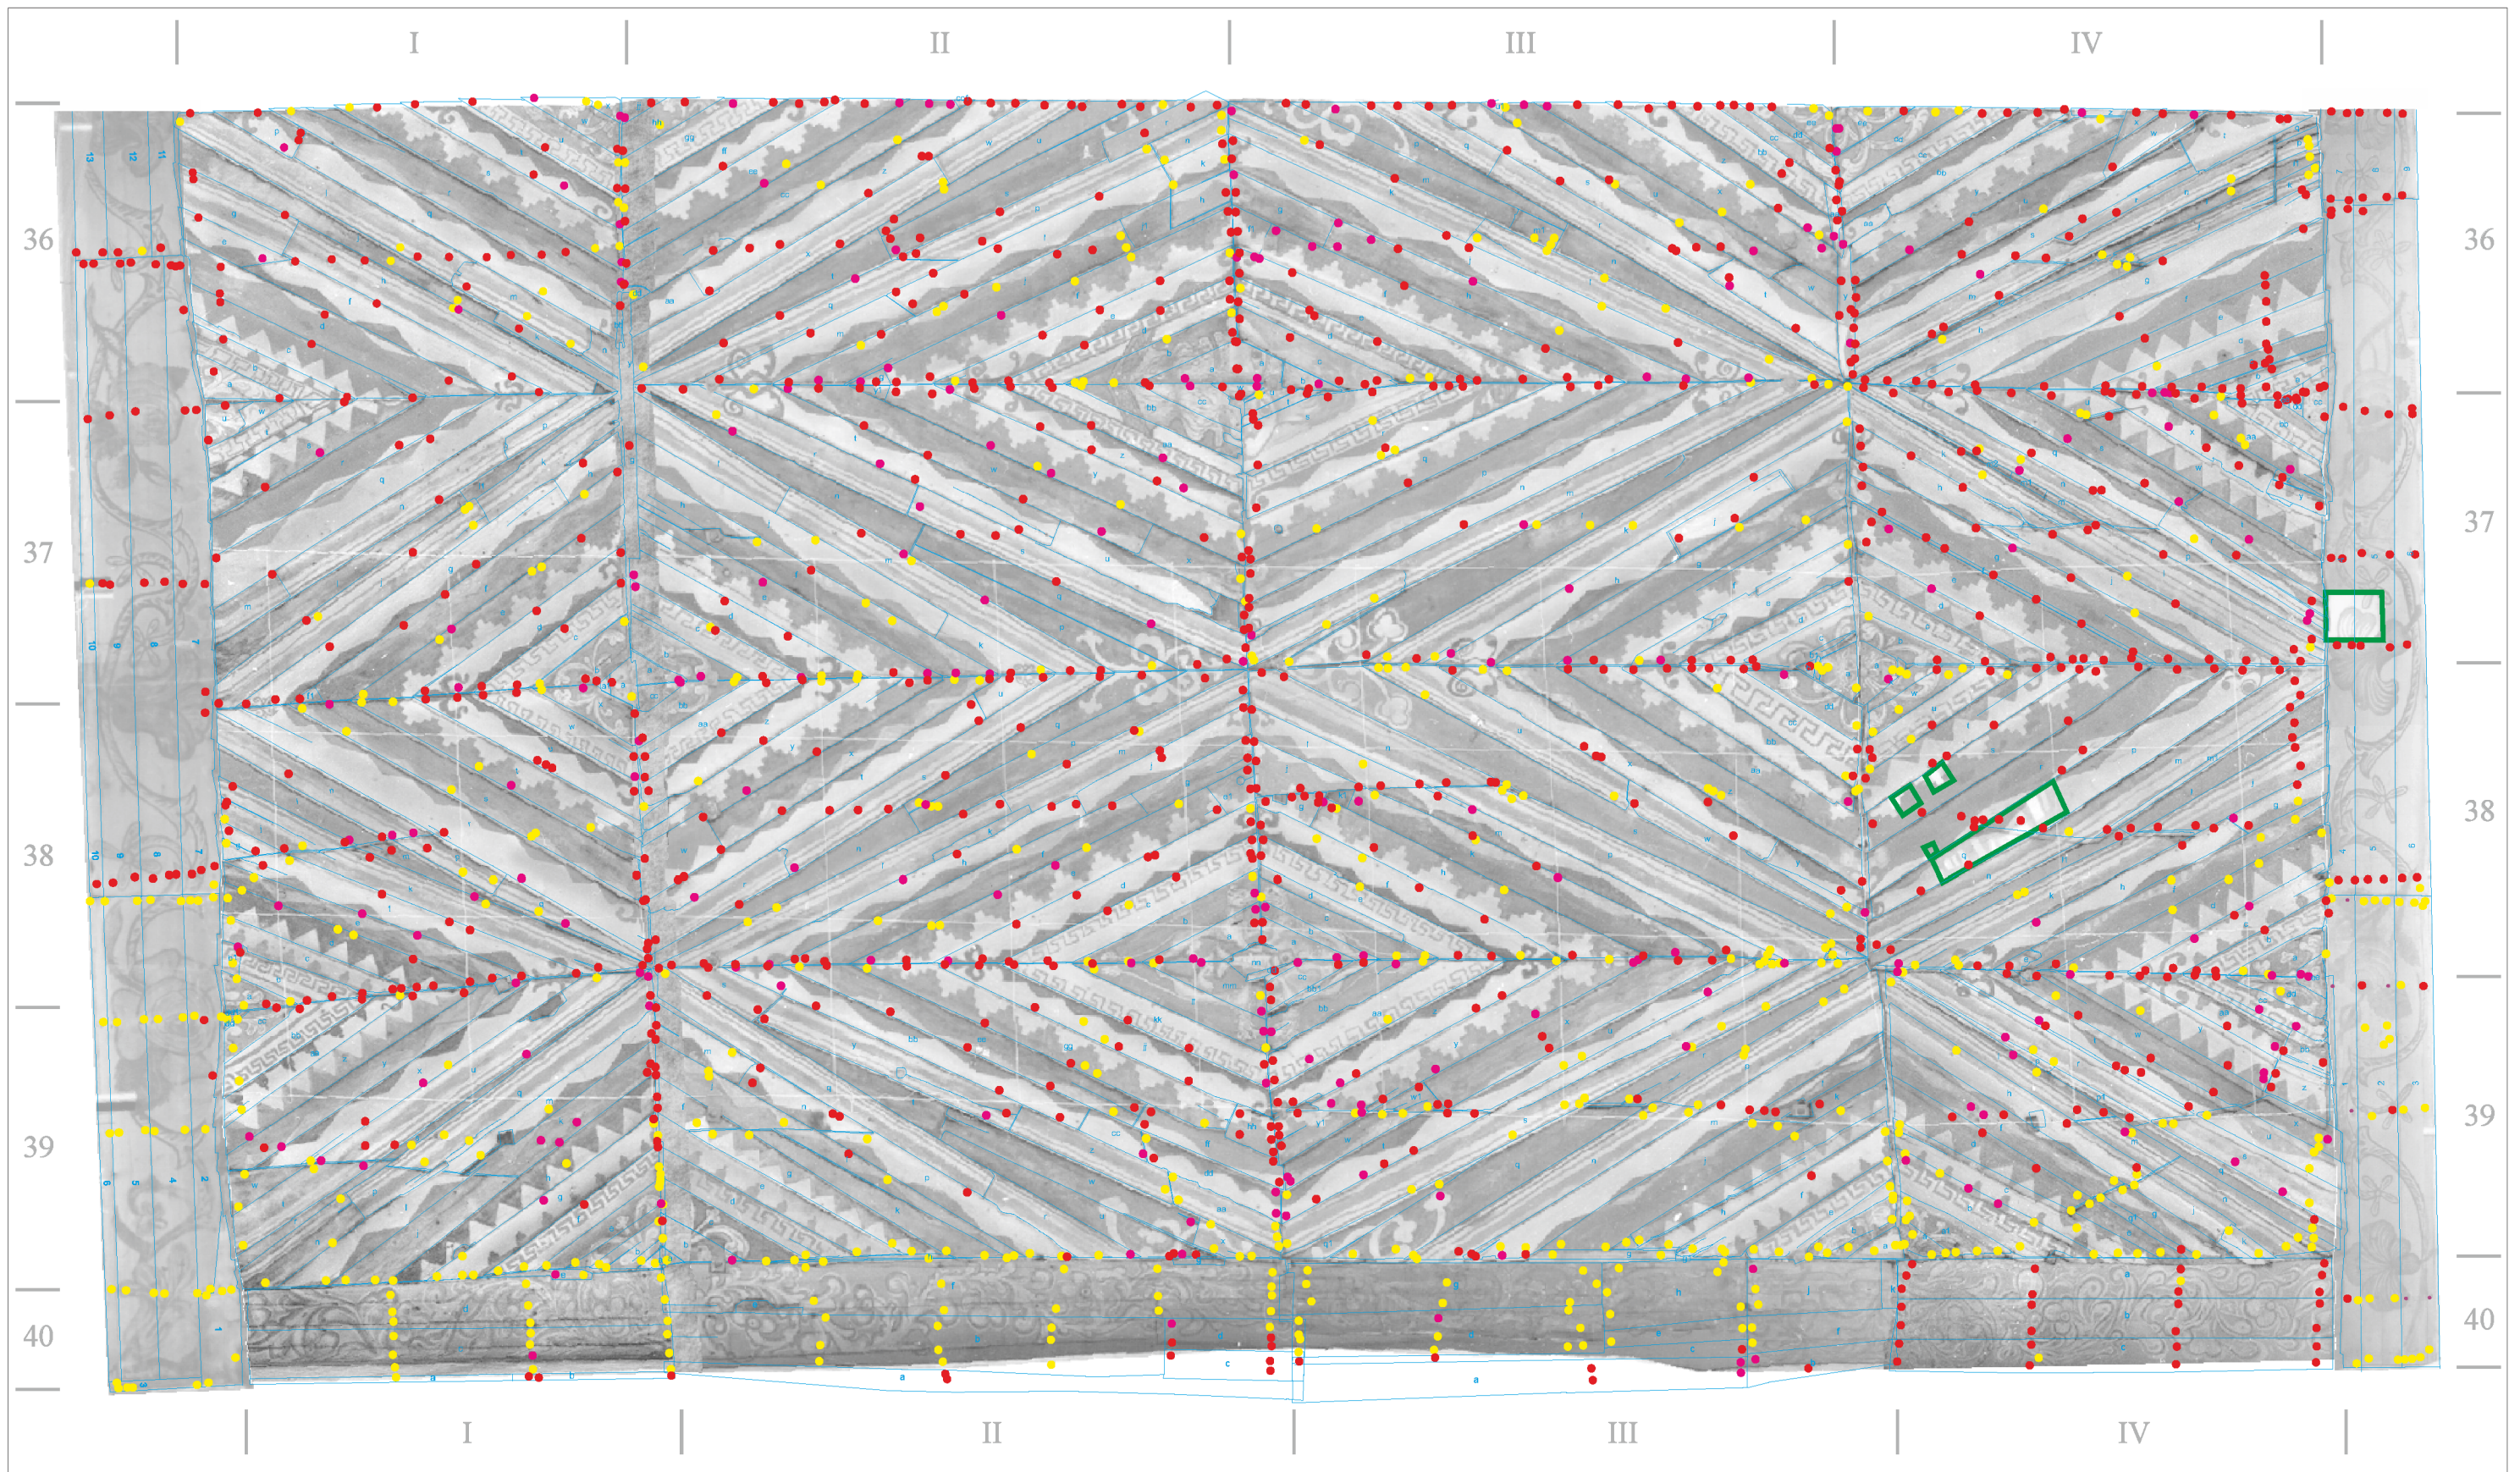
**Hirst Conservation Cleaning Tests** - Many of the cleaning tests carried out by Hirst Conservation in 1995, using a wide range of solvents, were still visible after surface cleaning with Wishab sponges. These cleaning tests were reintegrated using water-colour paints as part of Phase 1 treatment.

**Paint Surviving on Nail Heads** - The nail heads are shown here as oversized to aid visibility. The groupings signify the percentage of paint remaining on each nail but do not indicate whether the surviving paint was flaking. The same material in the same solution (Paraloid B72: 10% in acetone) was used both to re-attach flaking paint on nail heads and to coat exposed metal.

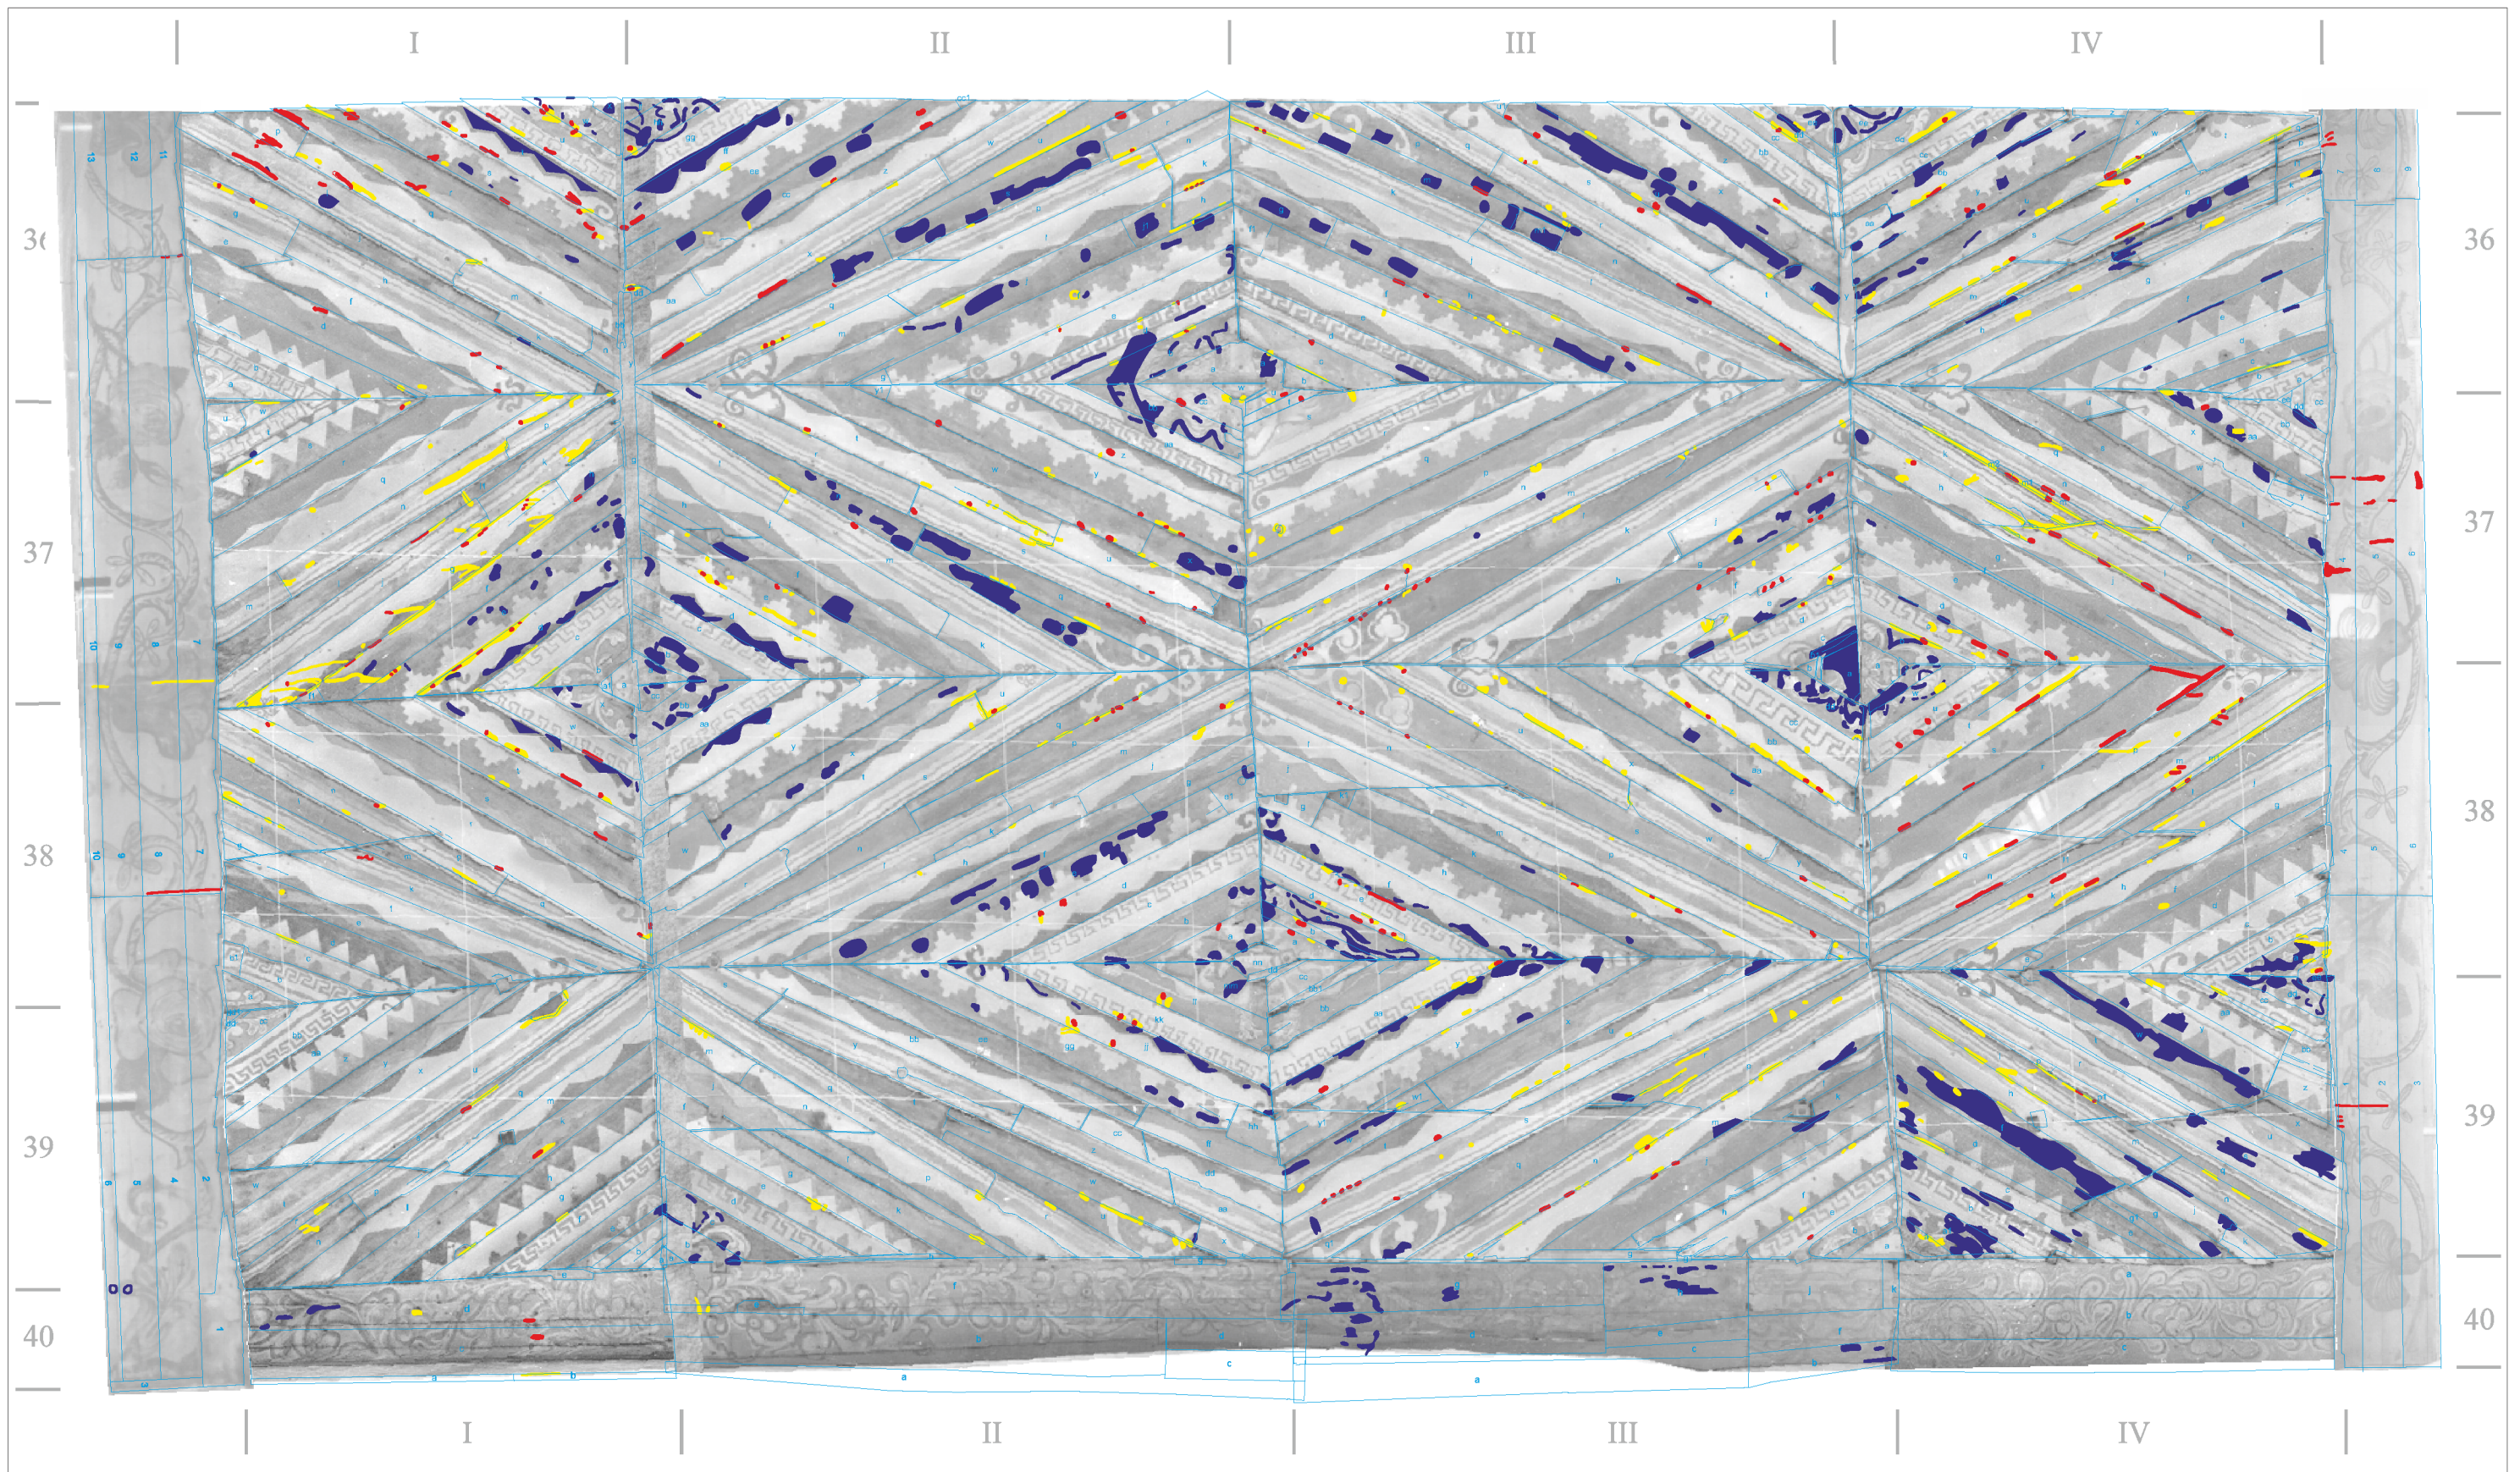
**Glue** - The extensive glue deposits on the edges of straight-edged boards cannot be shown here. As far as is possible all glue deposits on the paint surface were removed.

**Flaking & Glue** - In general, the glue caused paint flaking only where it had collected in thick droplets or runs. Glue deposits are less likely to cause flaking of the more robust white background paint.

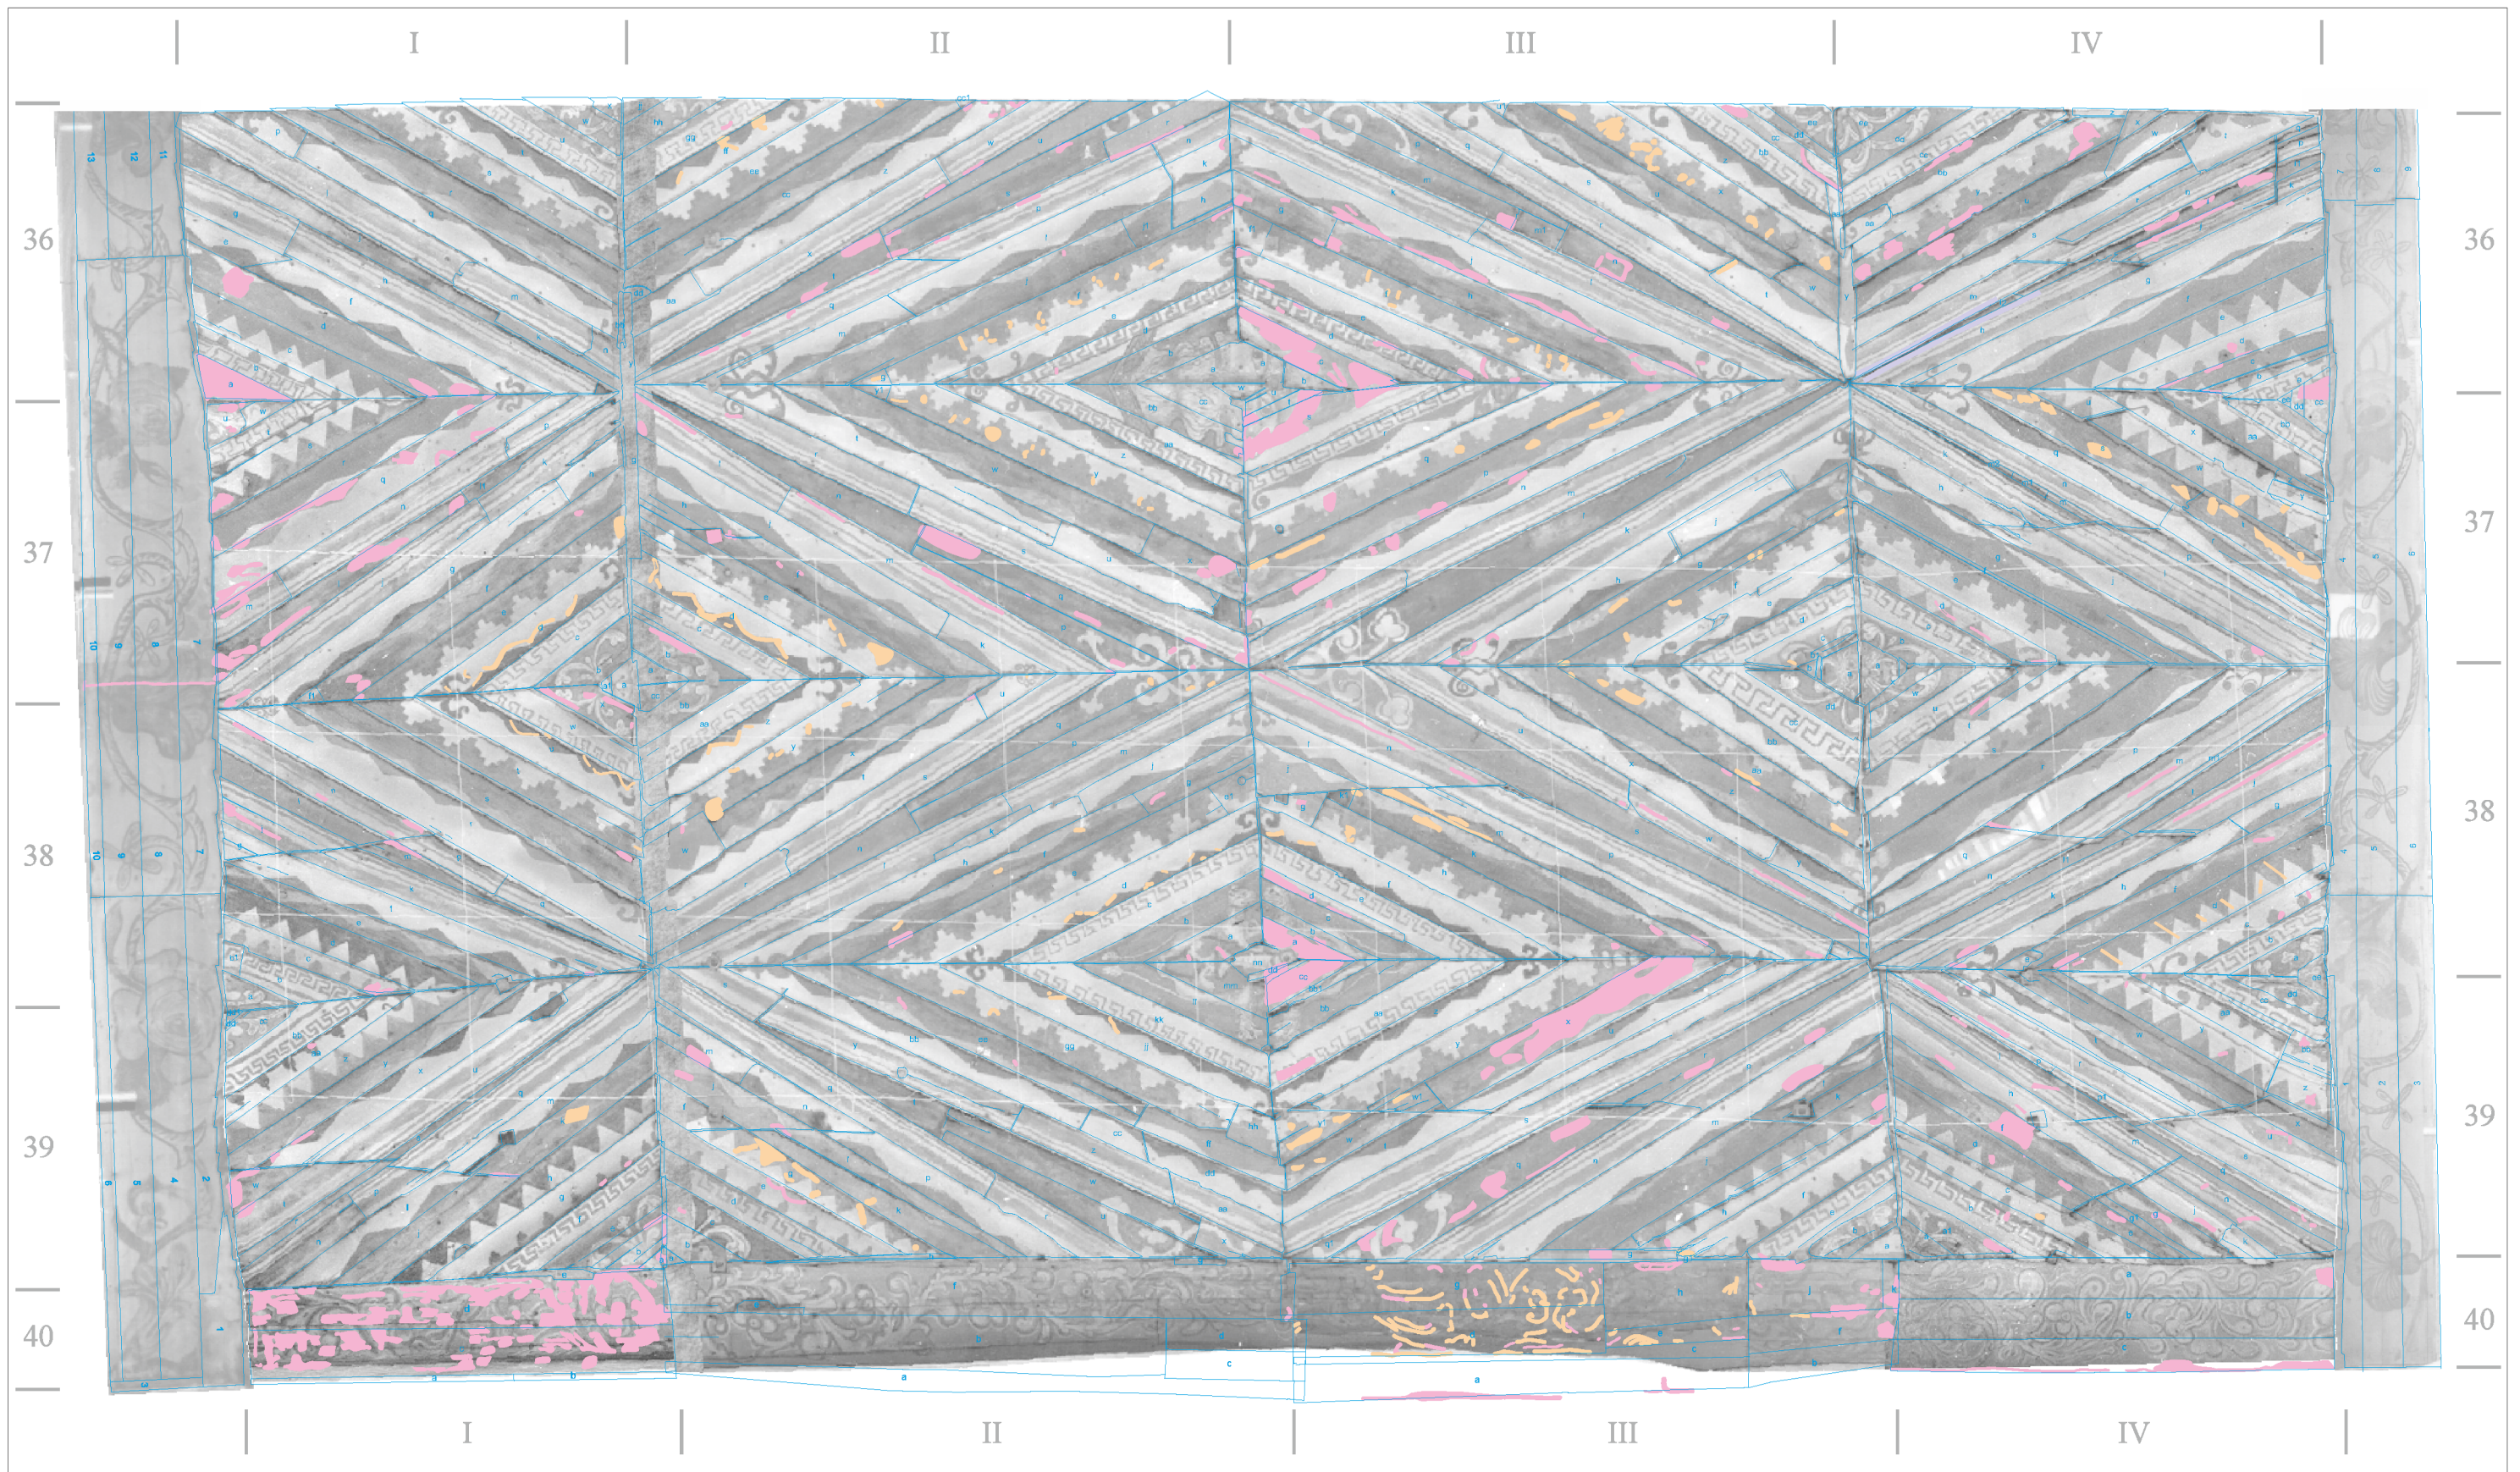
**Efflorescence** - There are varying examples but most characteristic is The 'white chalk line' on a number of original, wave pattern boards with the matte, saturated, black paint: at least two different salts are present, chloride and sulphate. Further analysis of the different forms of efflorescence will be carried out in Phase 2. All efflorescence was removed during surface cleaning.

**Surface Bloom** - Three forms of bloom are included: a whitish veil covering paint on some 1830s replacement boards (removed during surface cleaning); an opaque metallic sheen that occurs in patches on the shiny, 1830s black paint (not removed); a very noticeable unidentified surface coating over the black paint on an 1830s replacement board (not removed).

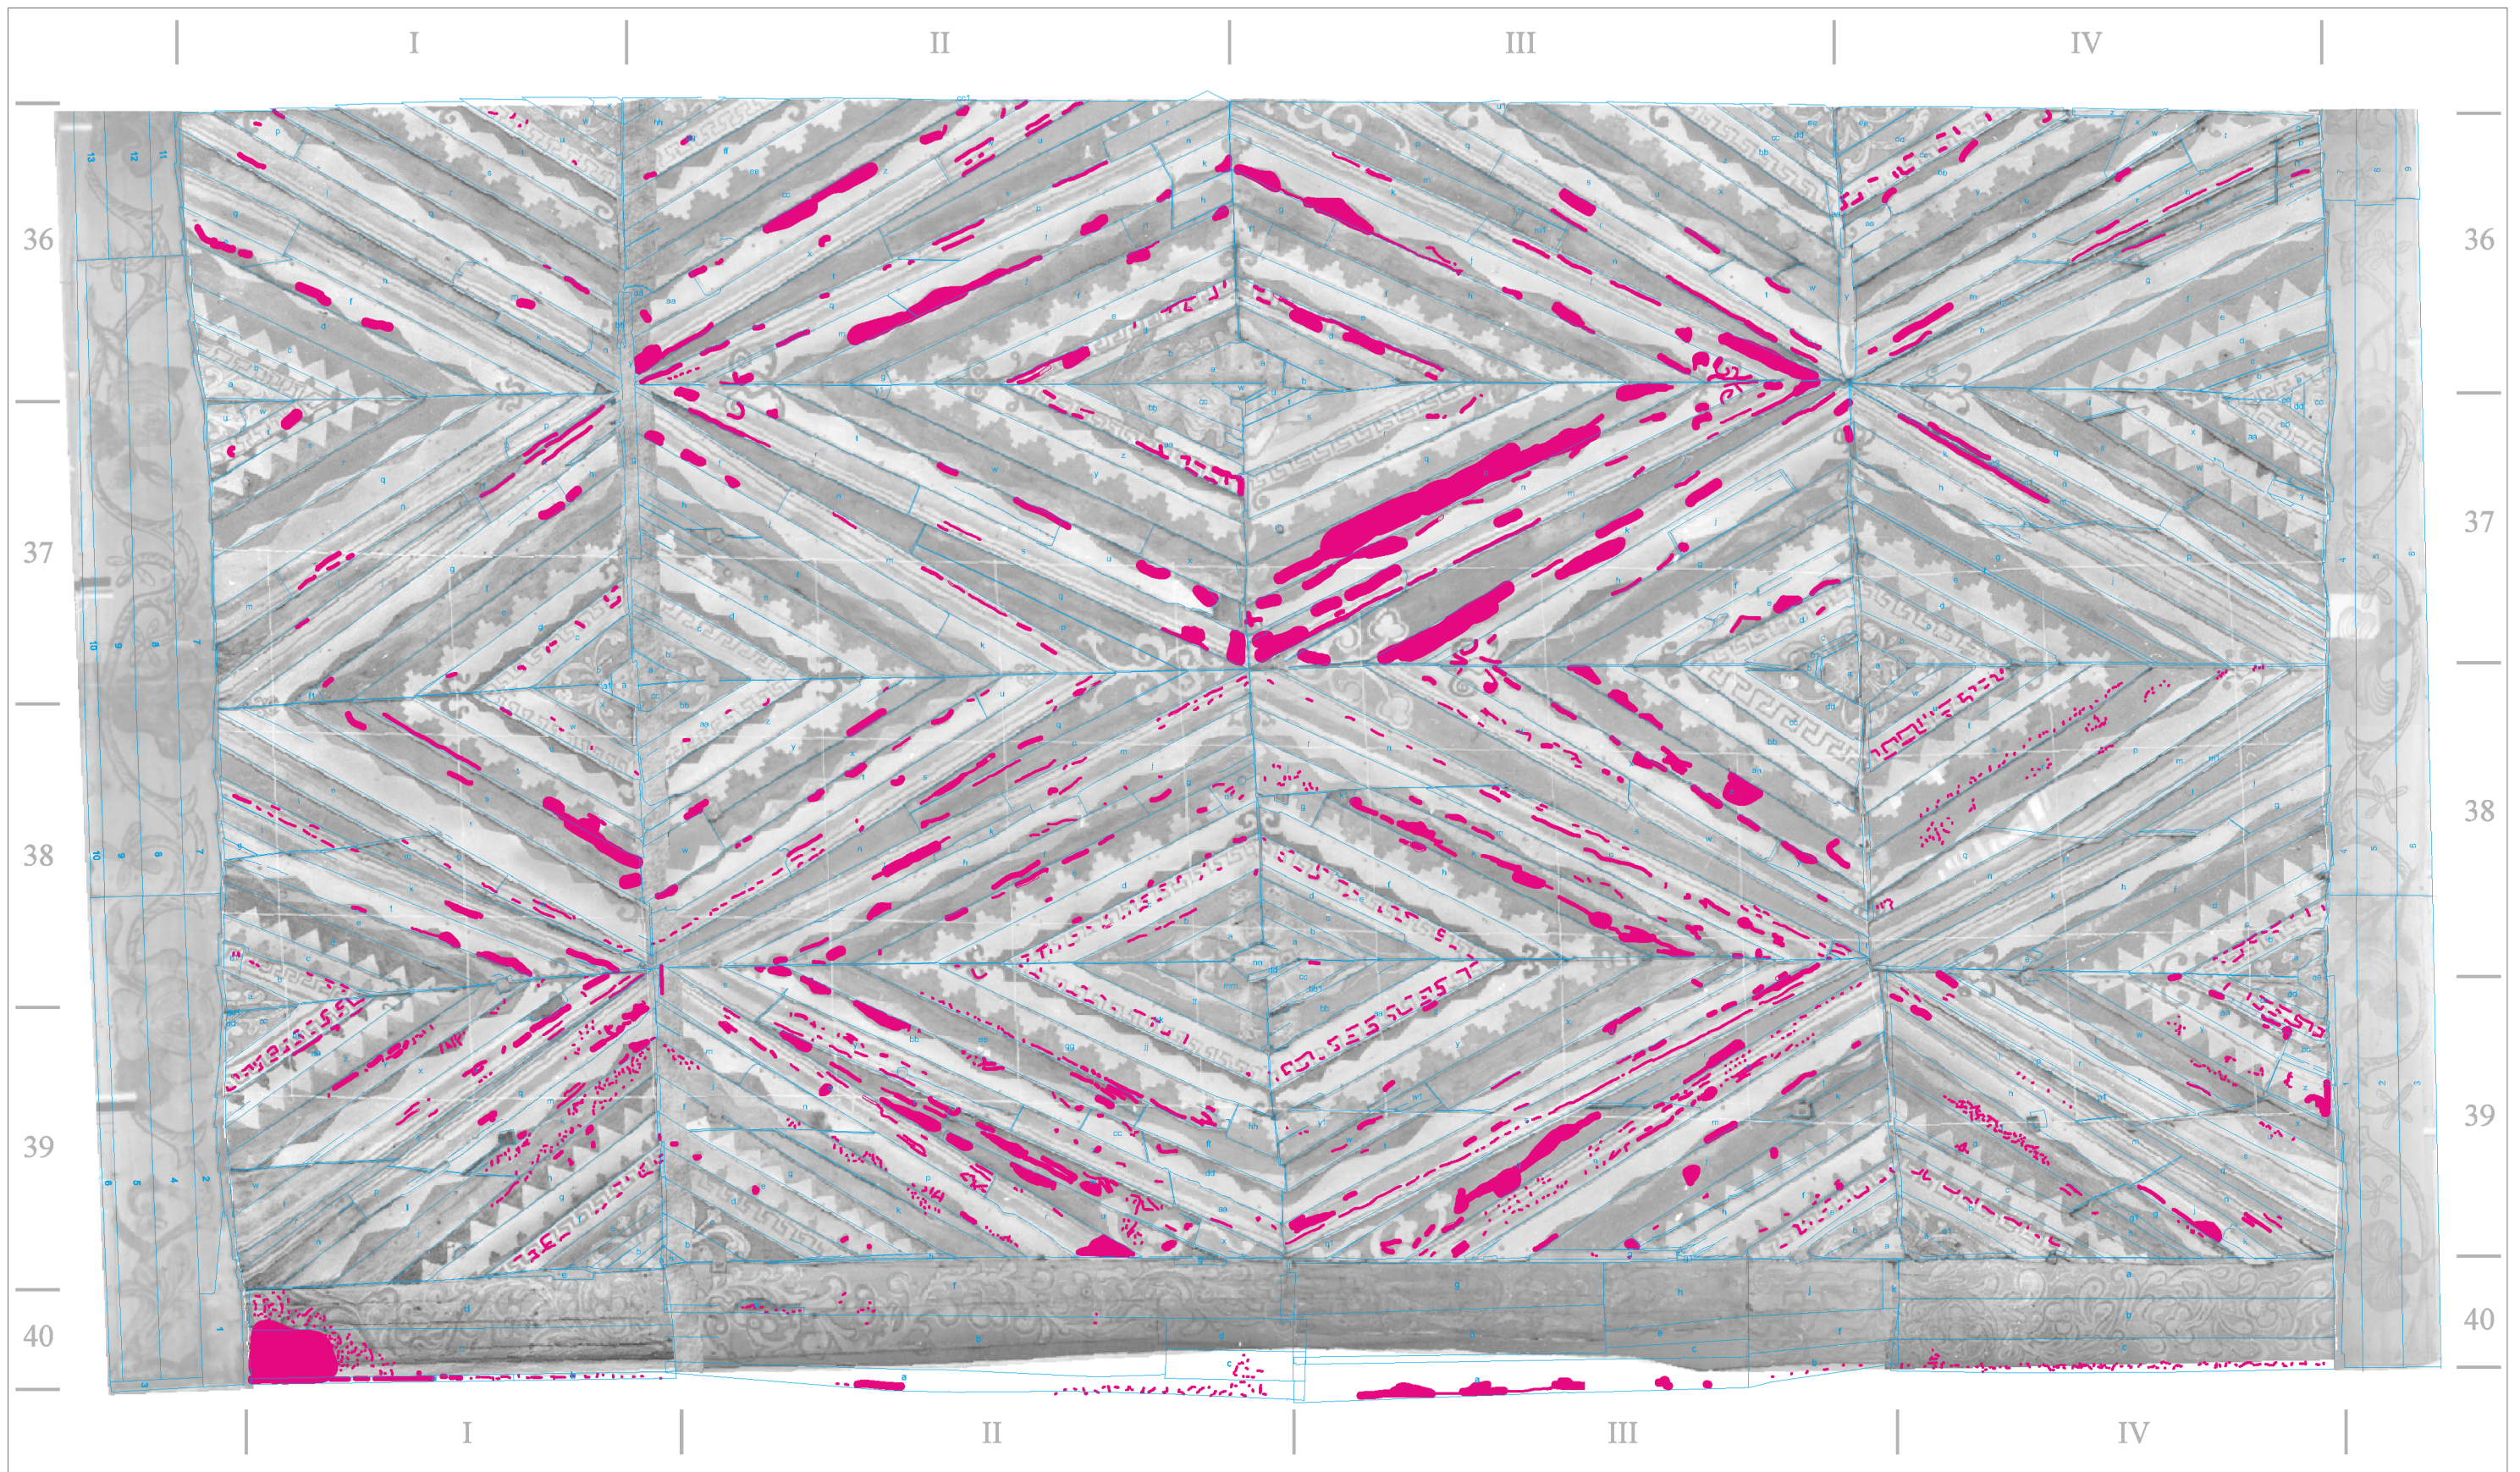
**Microbiological Growth** - Residues of what may be three forms of microbiological growth were found on the paint surface. These were removed as far as possible during the surface cleaning process. These residues are widespread across the Ceiling and will be analysed as part of the Phase 2 investigations. The three forms of residue are: a spattering of light brown powdery flecks ( faint traces of this remain after cleaning with a Wishab) sponge; a purplish powder residue; a white bloom or stain on the paint not removed by Wishab cleaning (the fine tendrils suggest this results from microbiological growth).
