**PETERBOROUGH CATHEDRAL: THE NAVE CEILING**

**PHASE 1: ROWS 36 - 40**

**CONDITION SURVEY AND CONSERVATION TREATMENT**

**VOLUME II PLATES**

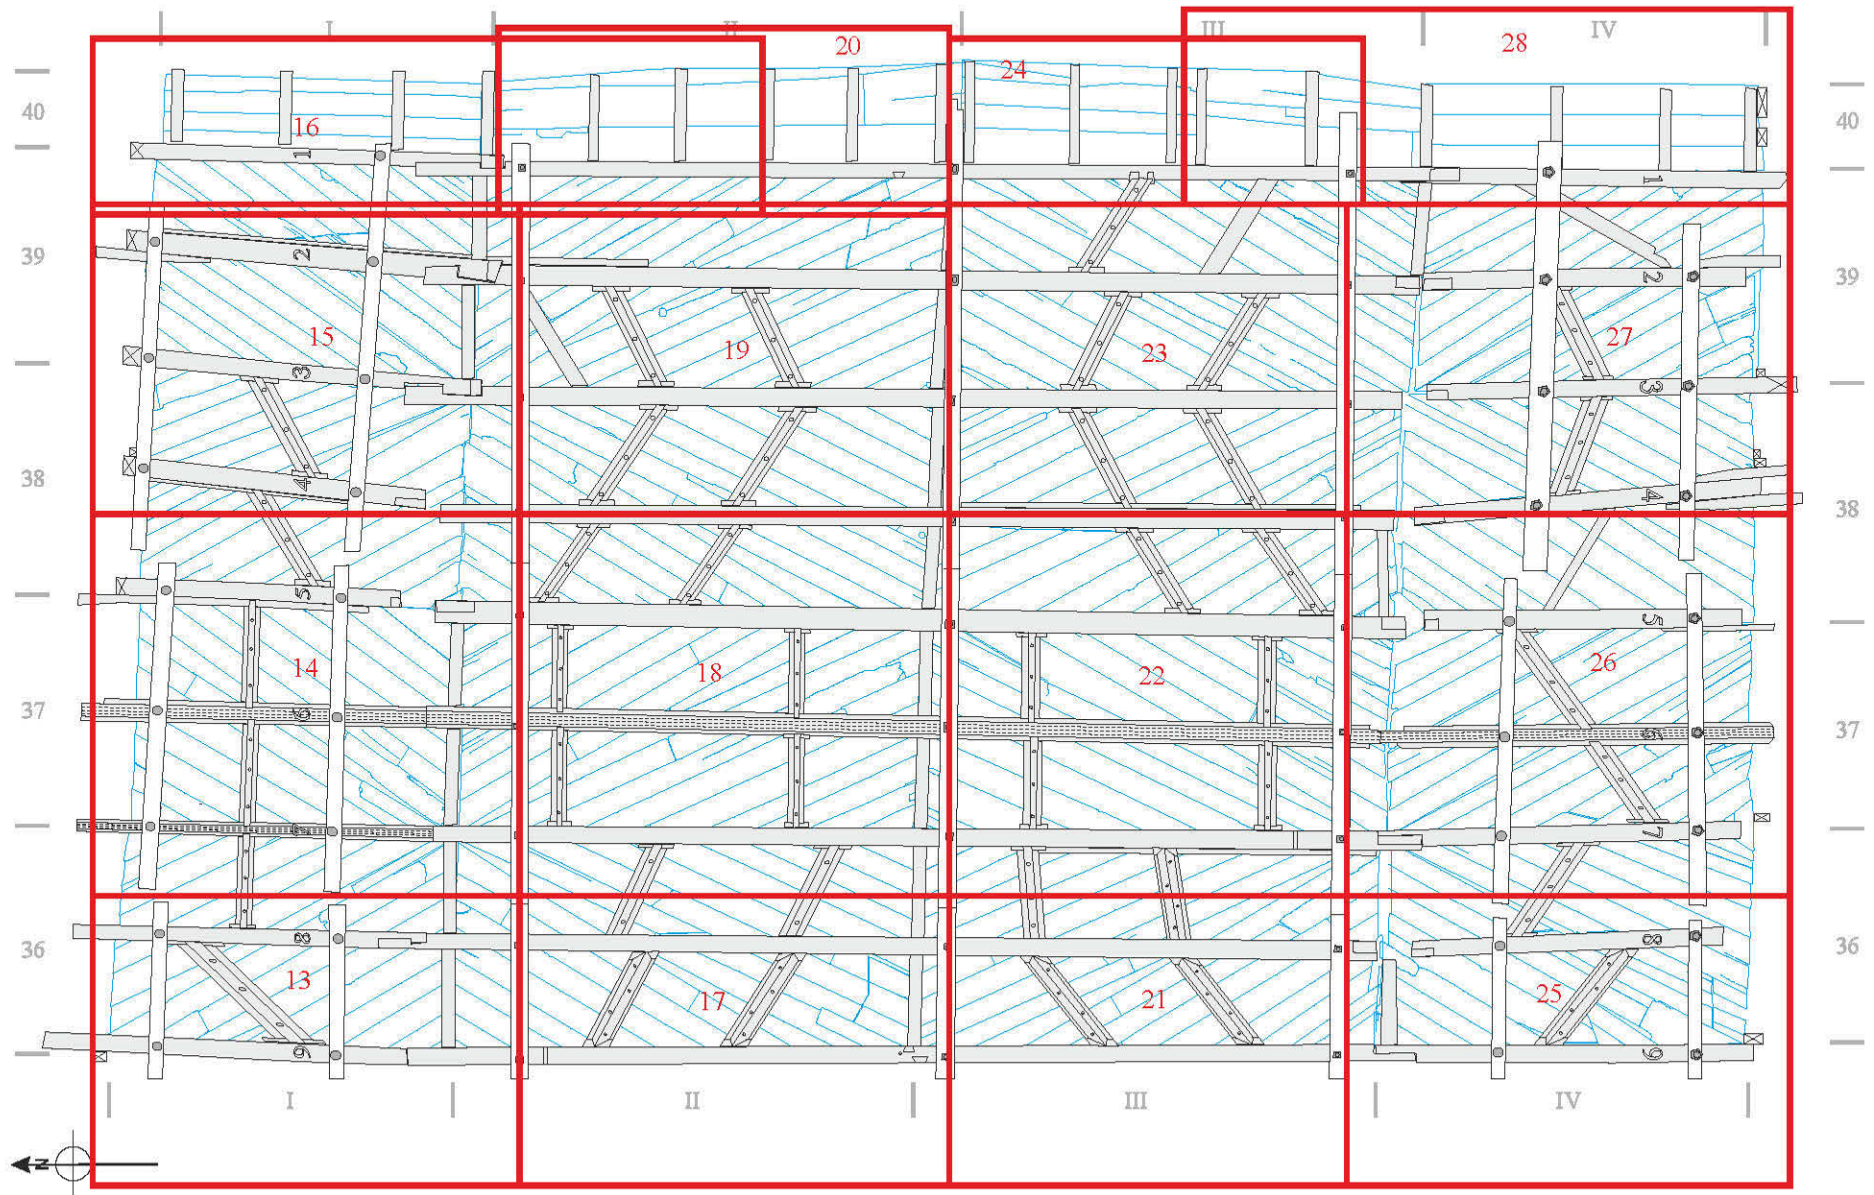
PETERBOROUGH CATHEDRAL, NAVE CEILING, PHASE 1  
PLATE REFERENCE SHEET NO: 1

Location of Plates 13 - 28 (Structure Upper Side)

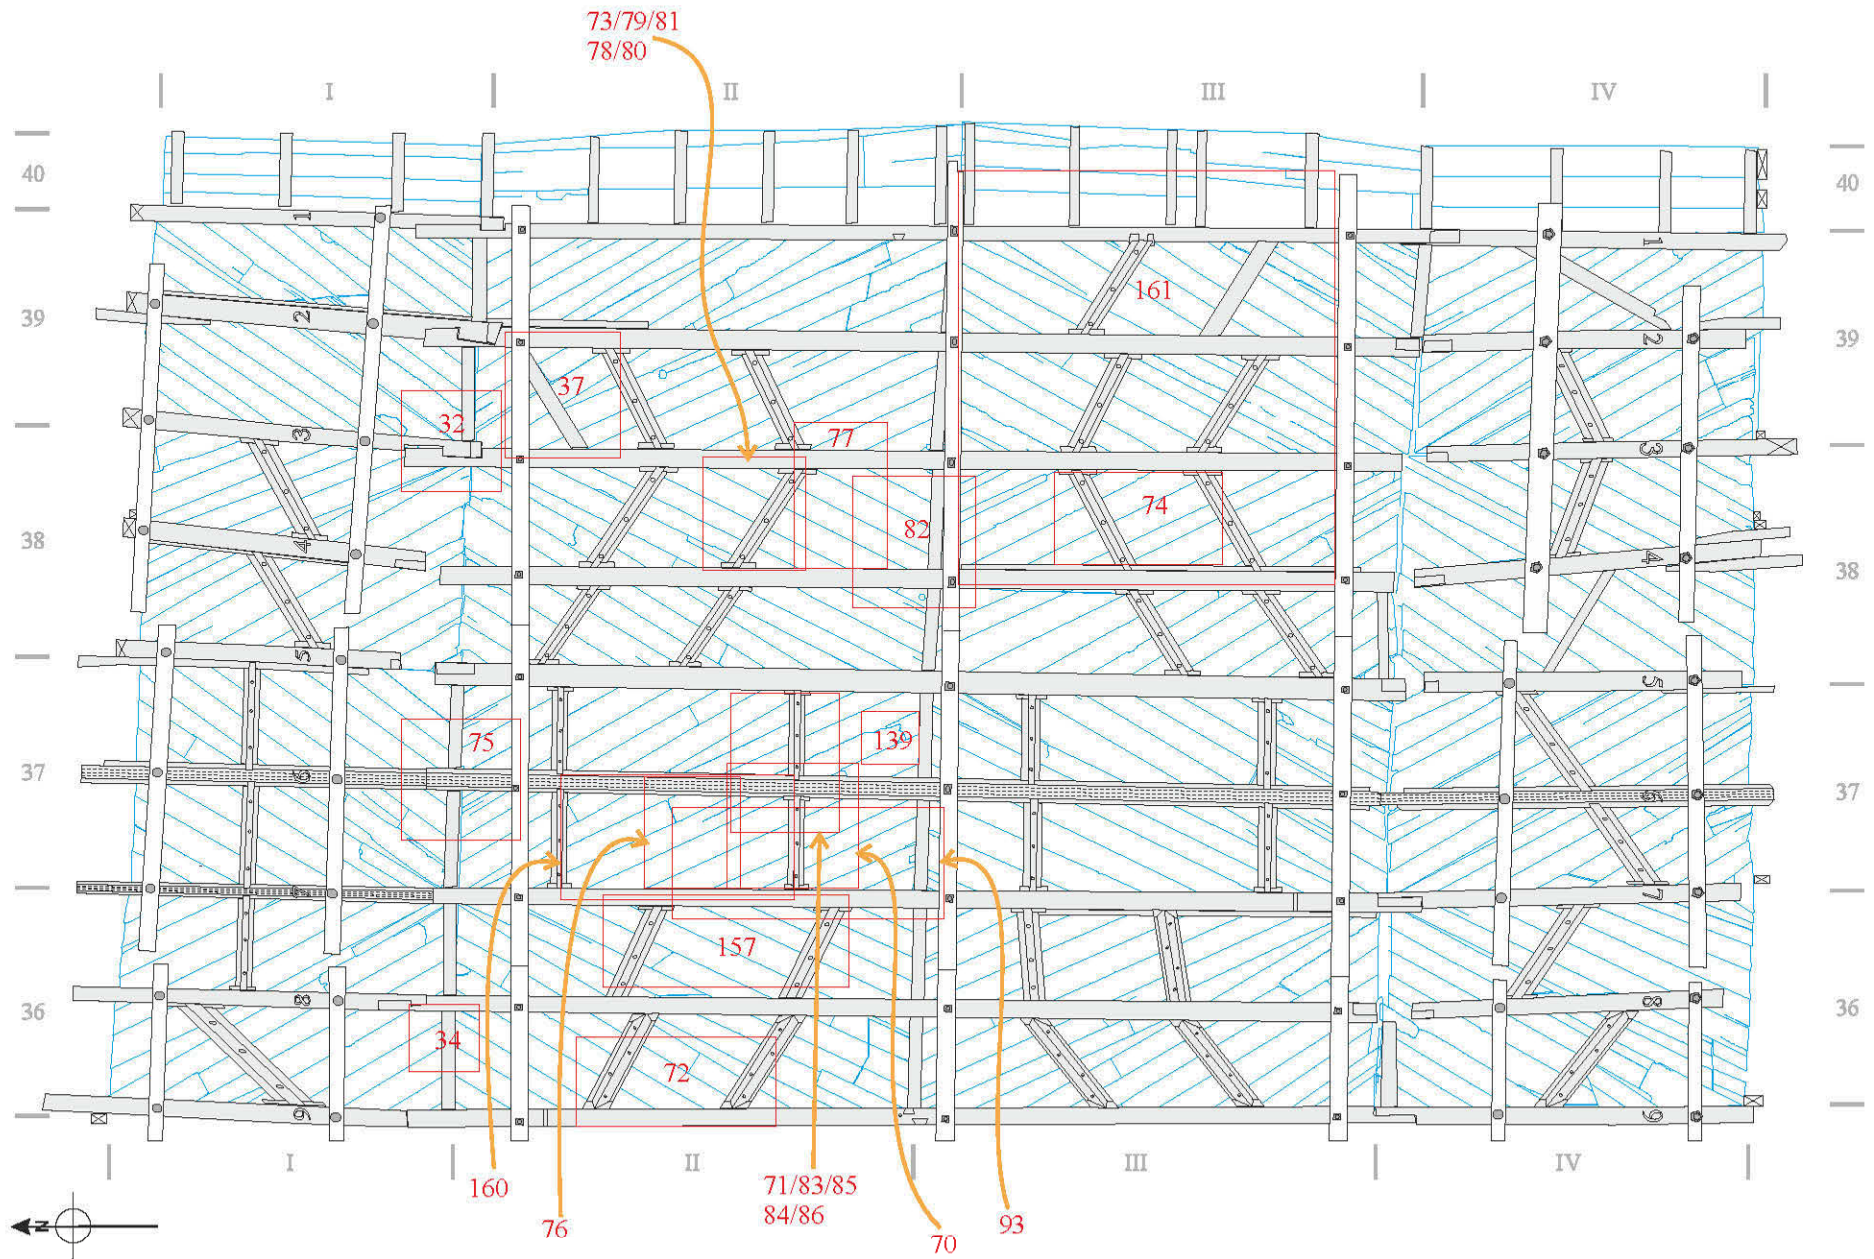
PLATE REFERENCE SHEET NO: 2

Location of Plates 32 - 161 (Structure Upper Side)

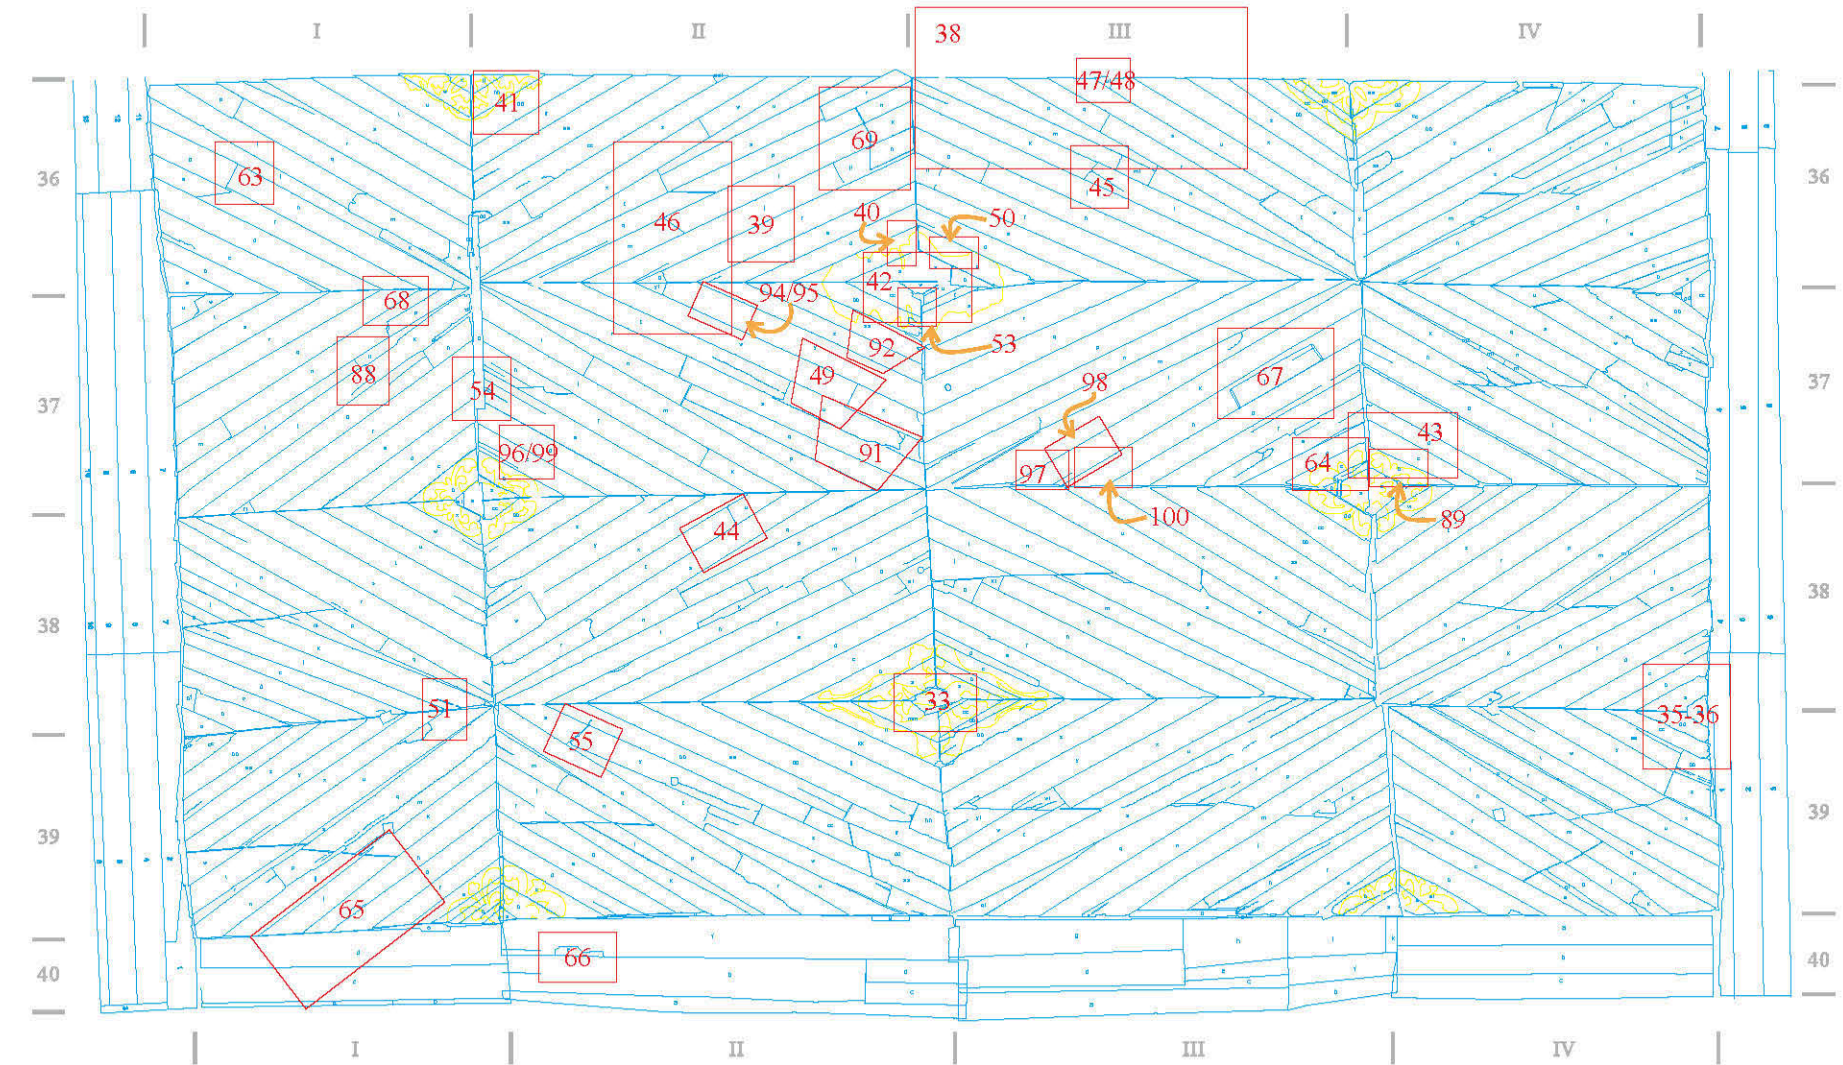
PETERBOROUGH CATHEDRAL, NAVE CEILING, PHASE 1  
PLATE REFERENCE SHEET NO: 3

Location of Plates 33 - 100 (Structure Lower Side)

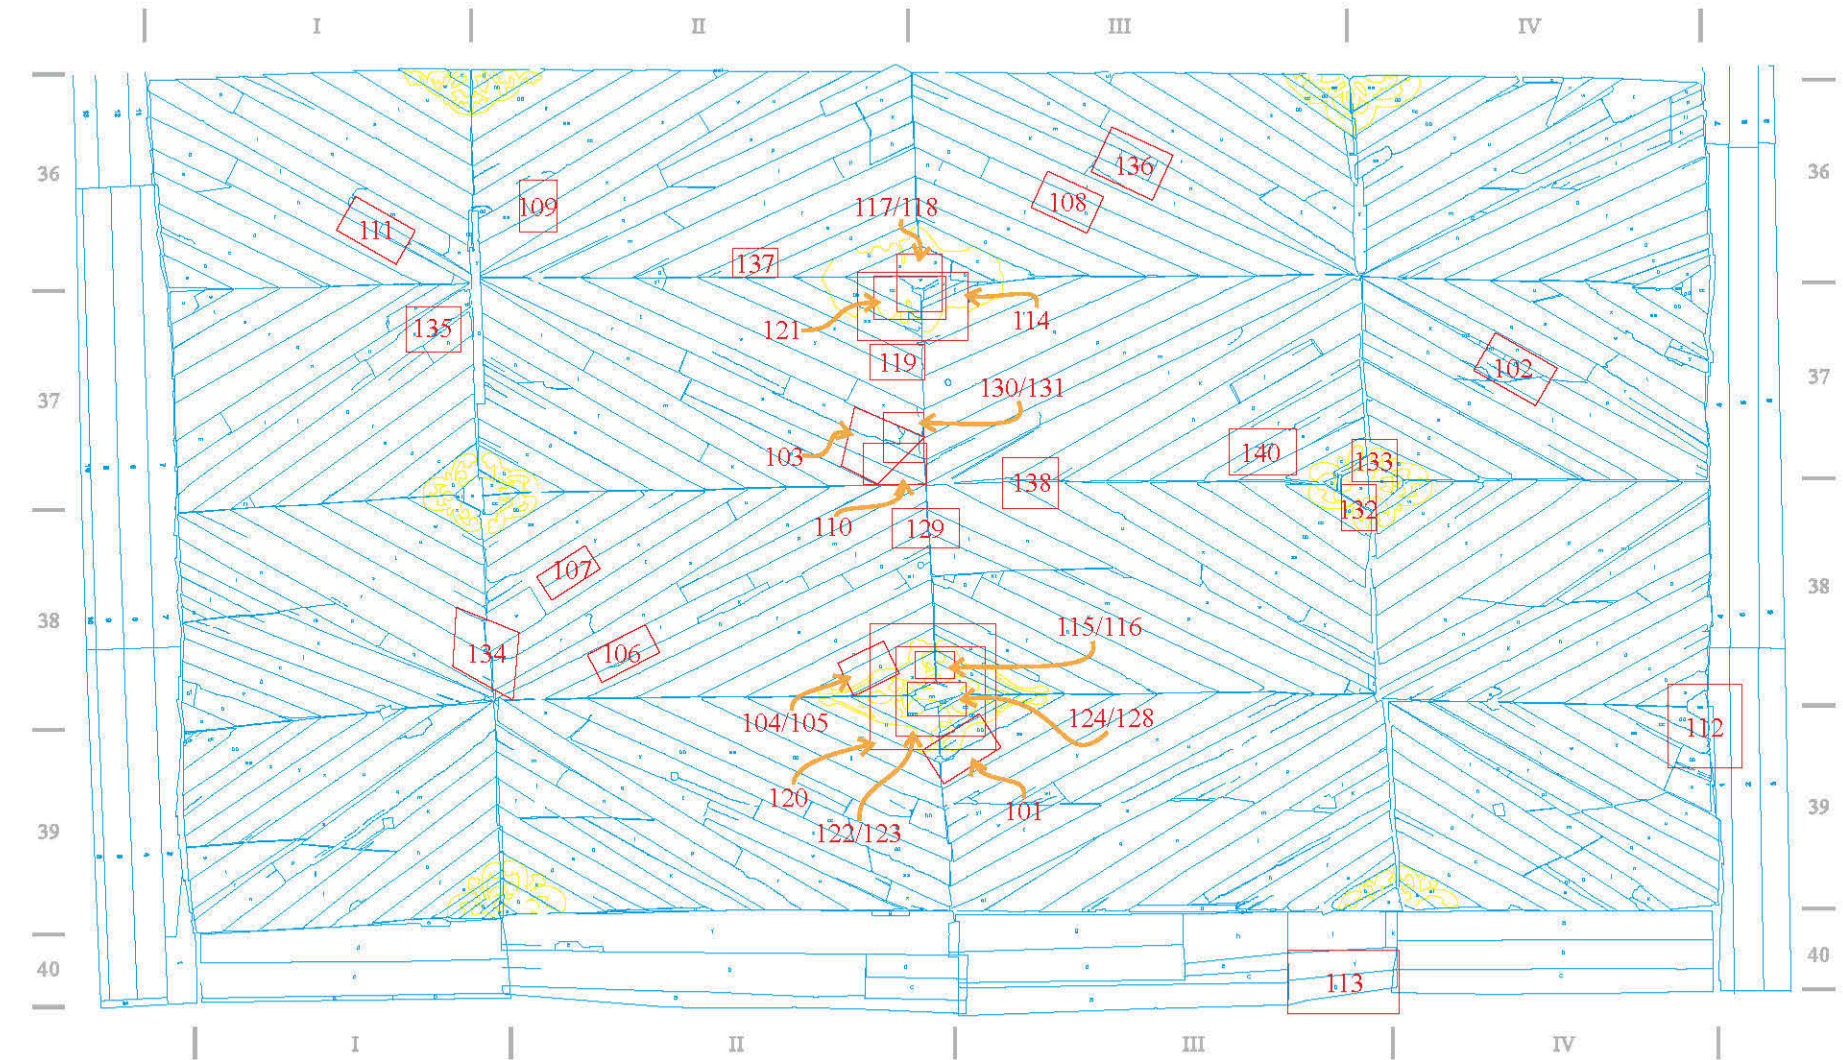
PLATE REFERENCE SHEET NO: 4

Location of Plates 101 - 140 (Structure Lower Side)

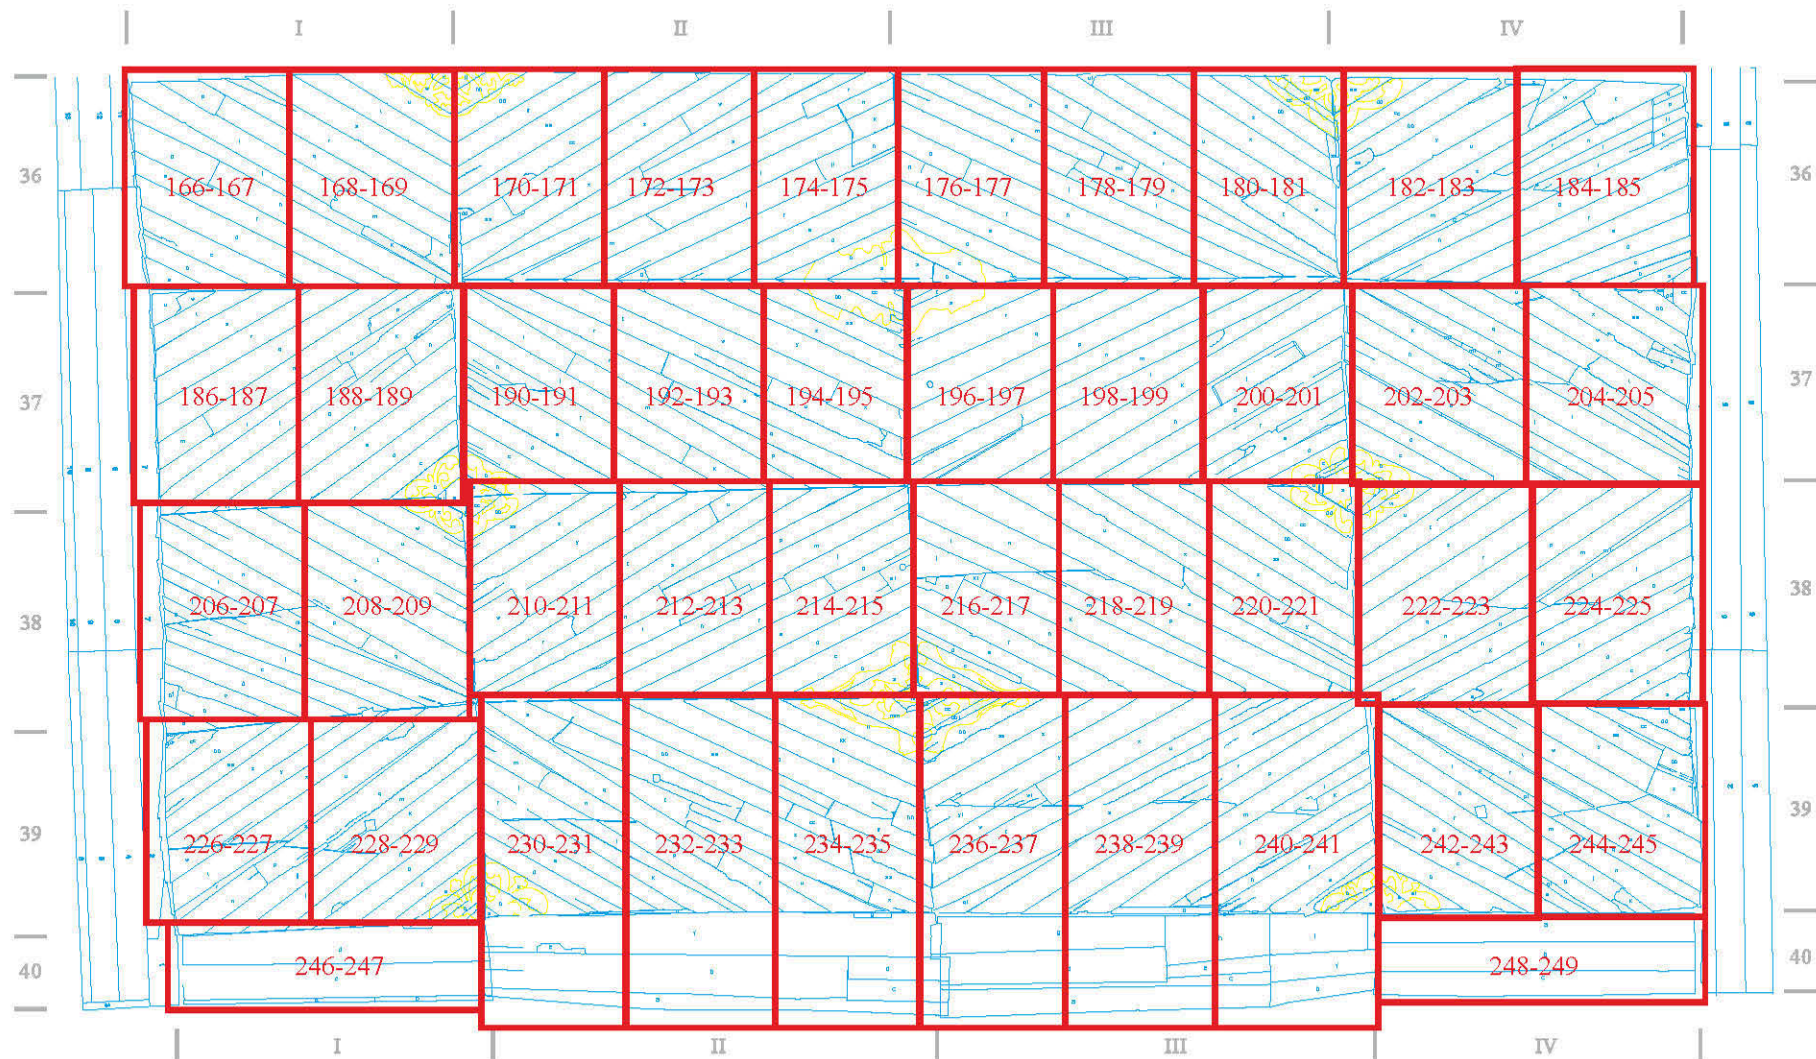
PETERBOROUGH CATHEDRAL, NAVE CEILING, PHASE 1  
PLATE REFERENCE SHEET NO: 5

Location of Plates 166 - 249

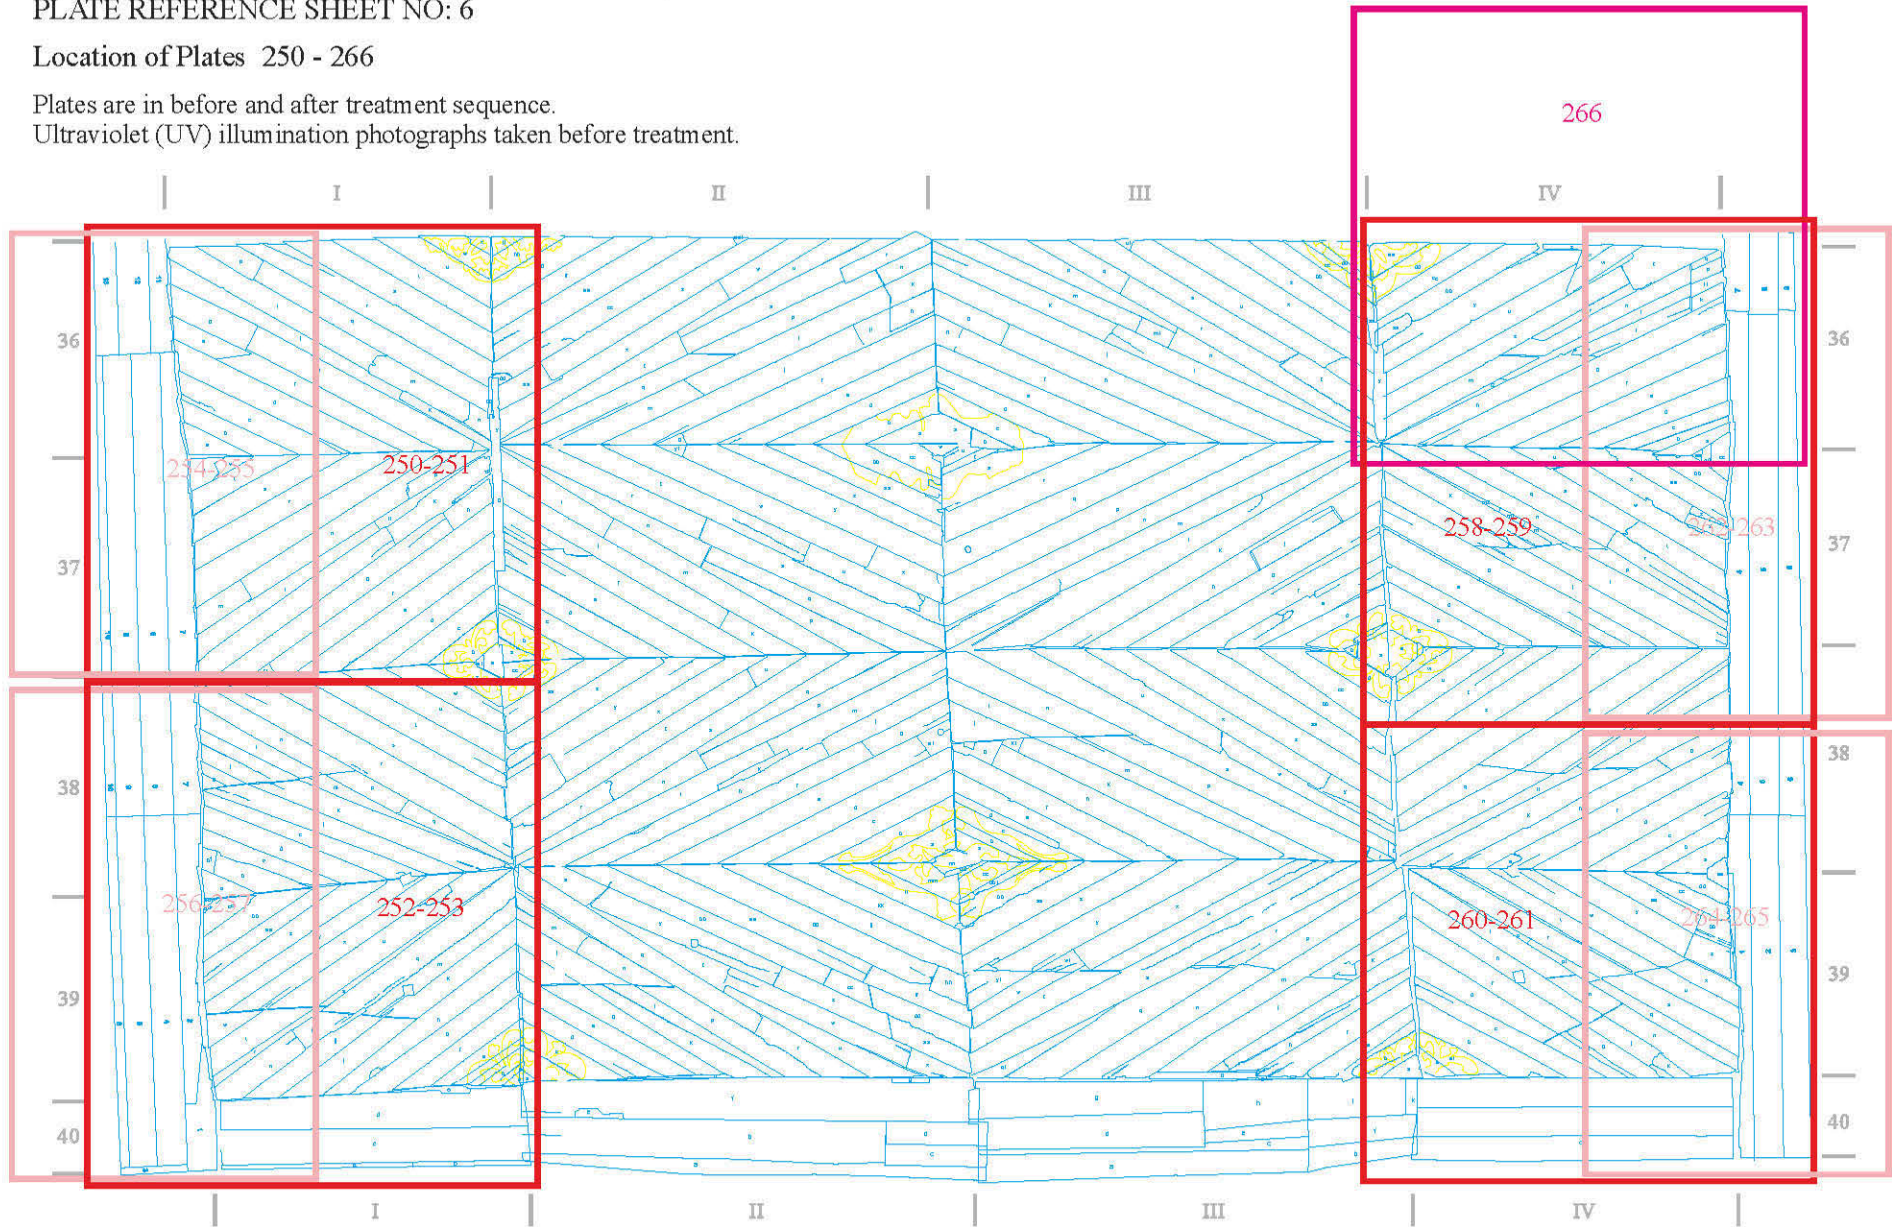
PETERBOROUGH CATHEDRAL, NAVE CEILING, PHASE 1  
PLATE REFERENCE SHEET NO: 6

Location of Plates 250 - 266

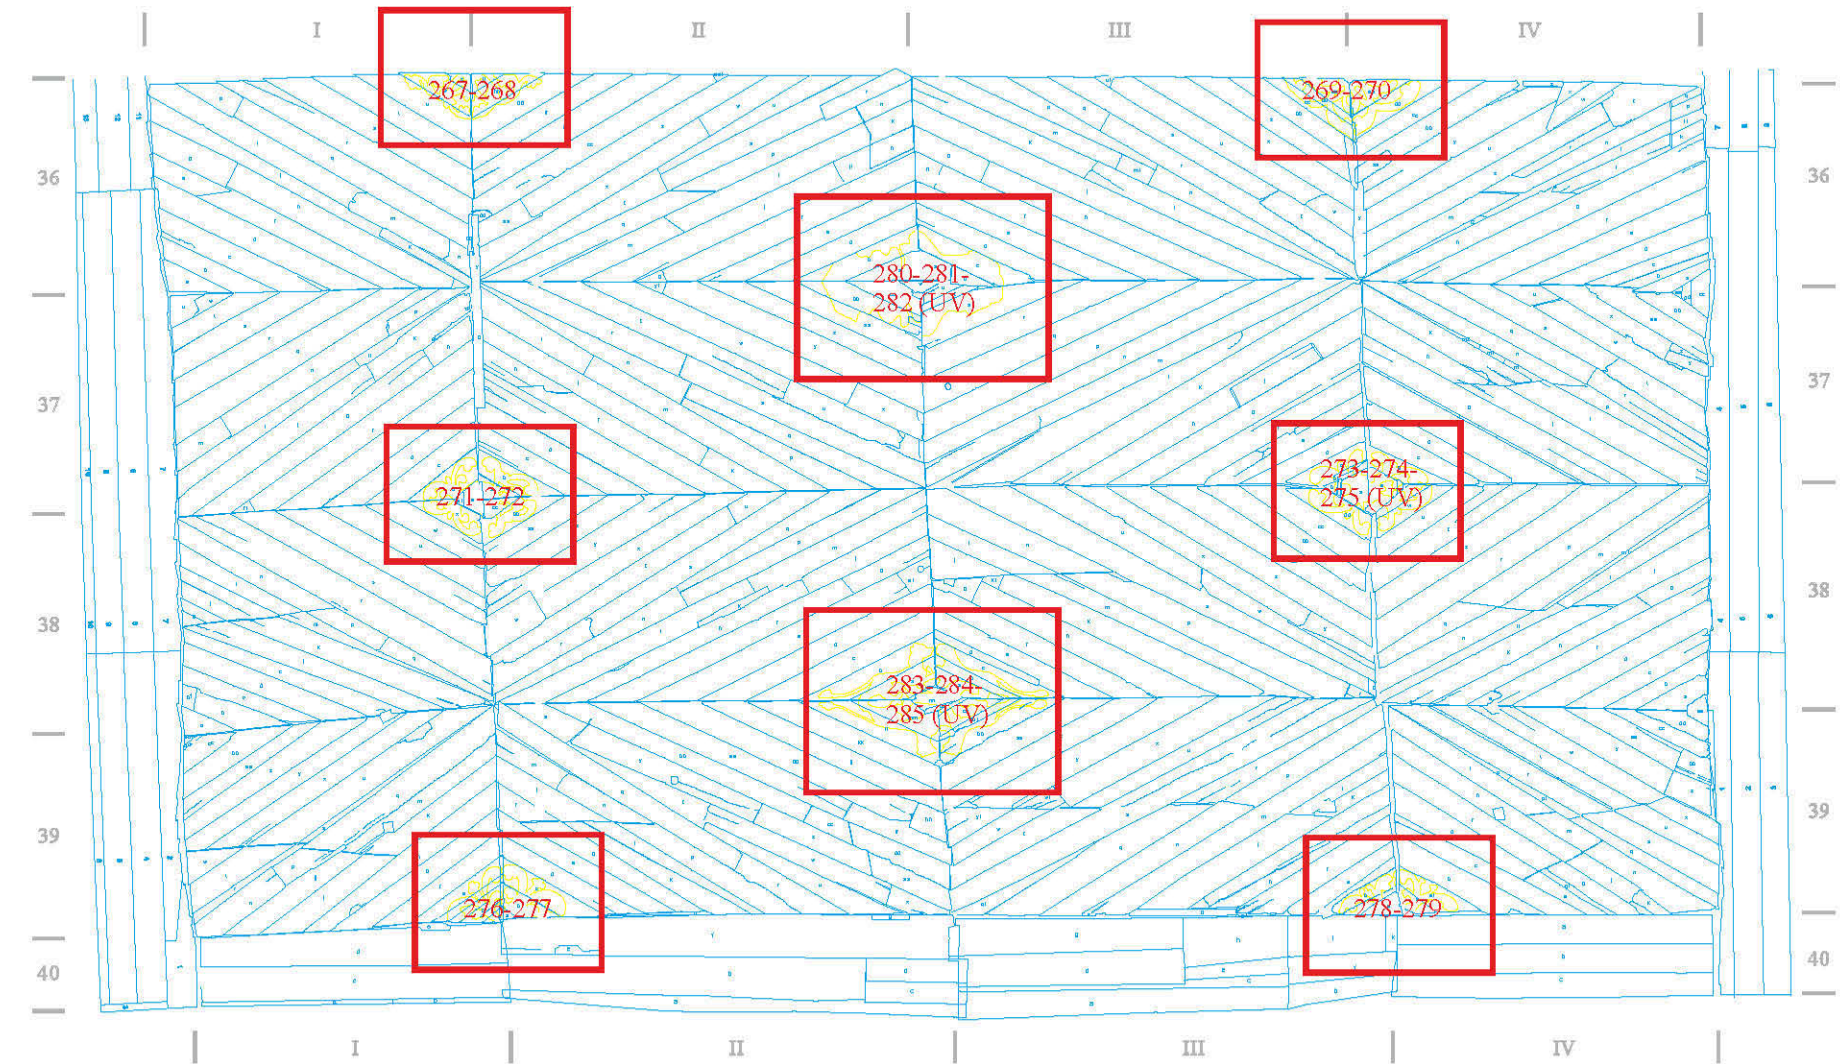
PETERBOROUGH CATHEDRAL, NAVE CEILING, PHASE 1  
PLATE REFERENCE SHEET NO: 7

Location of Plates 267 -285

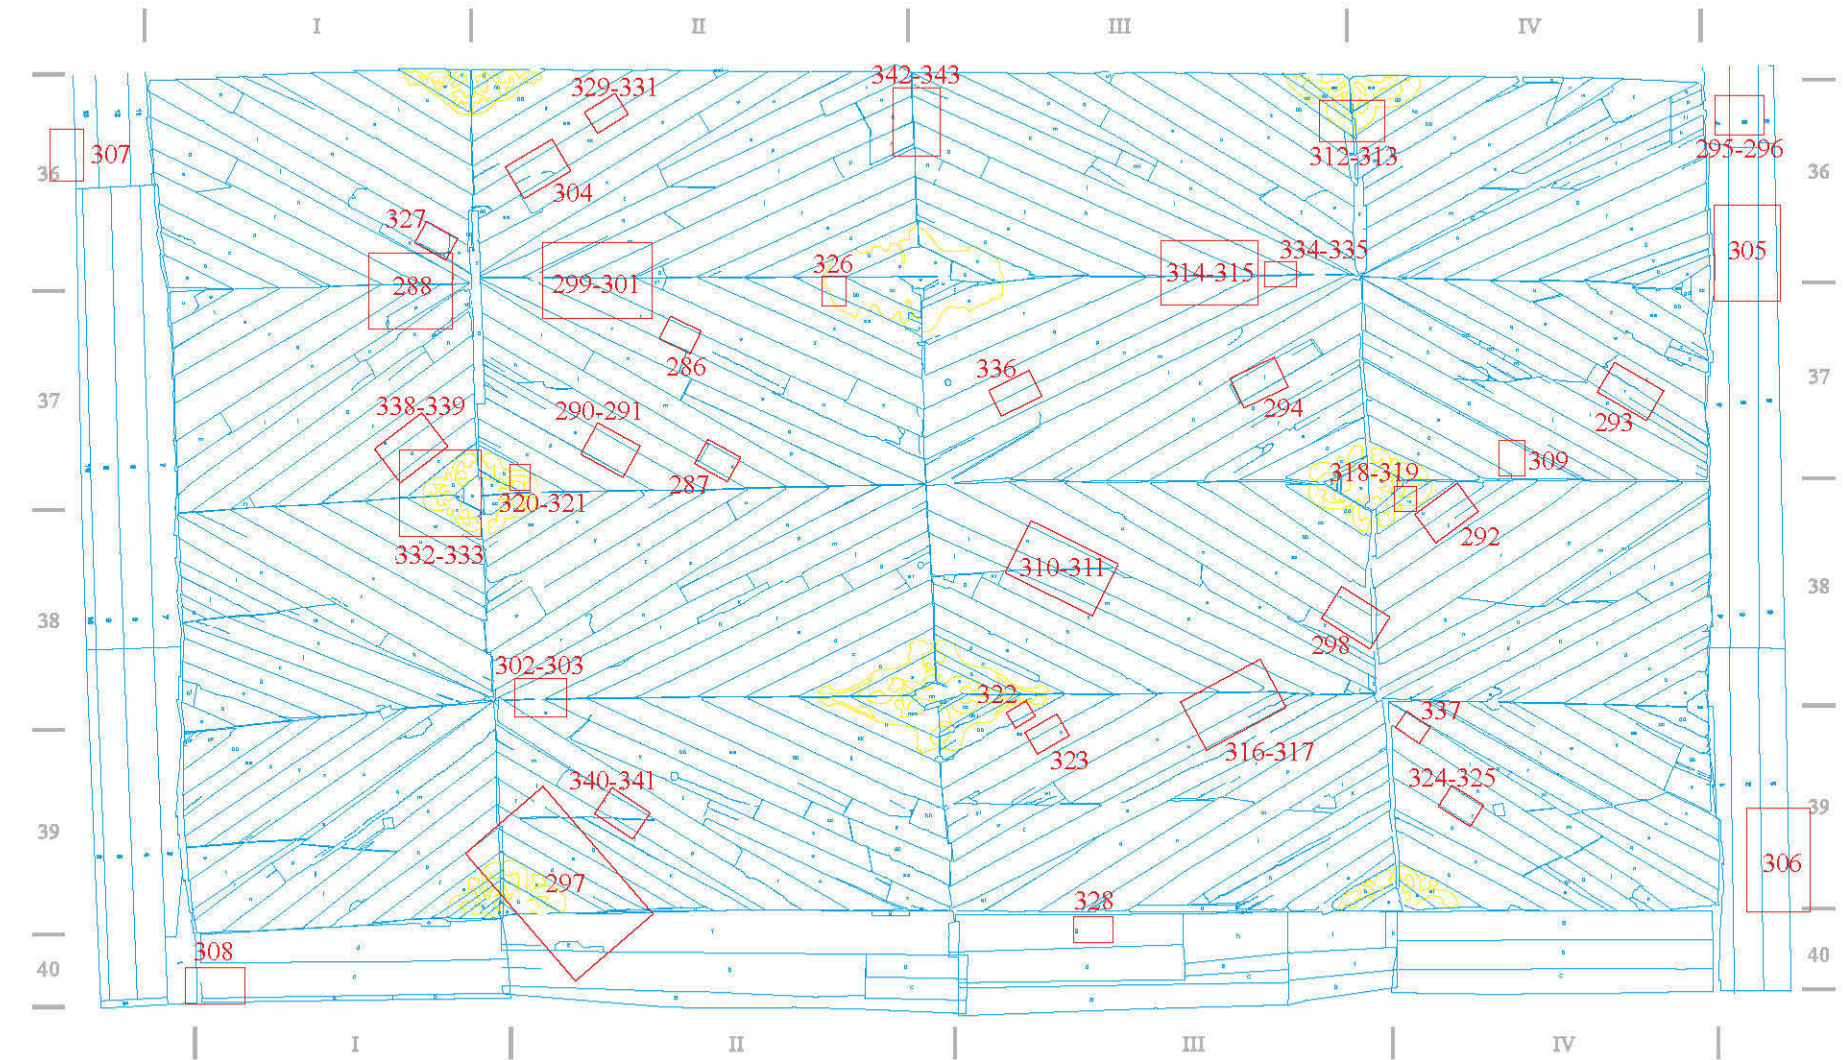
PETERBOROUGH CATHEDRAL, NAVE CEILING, PHASE 1  
PLATE REFERENCE SHEET NO: 8

Location of Plates 286 - 343

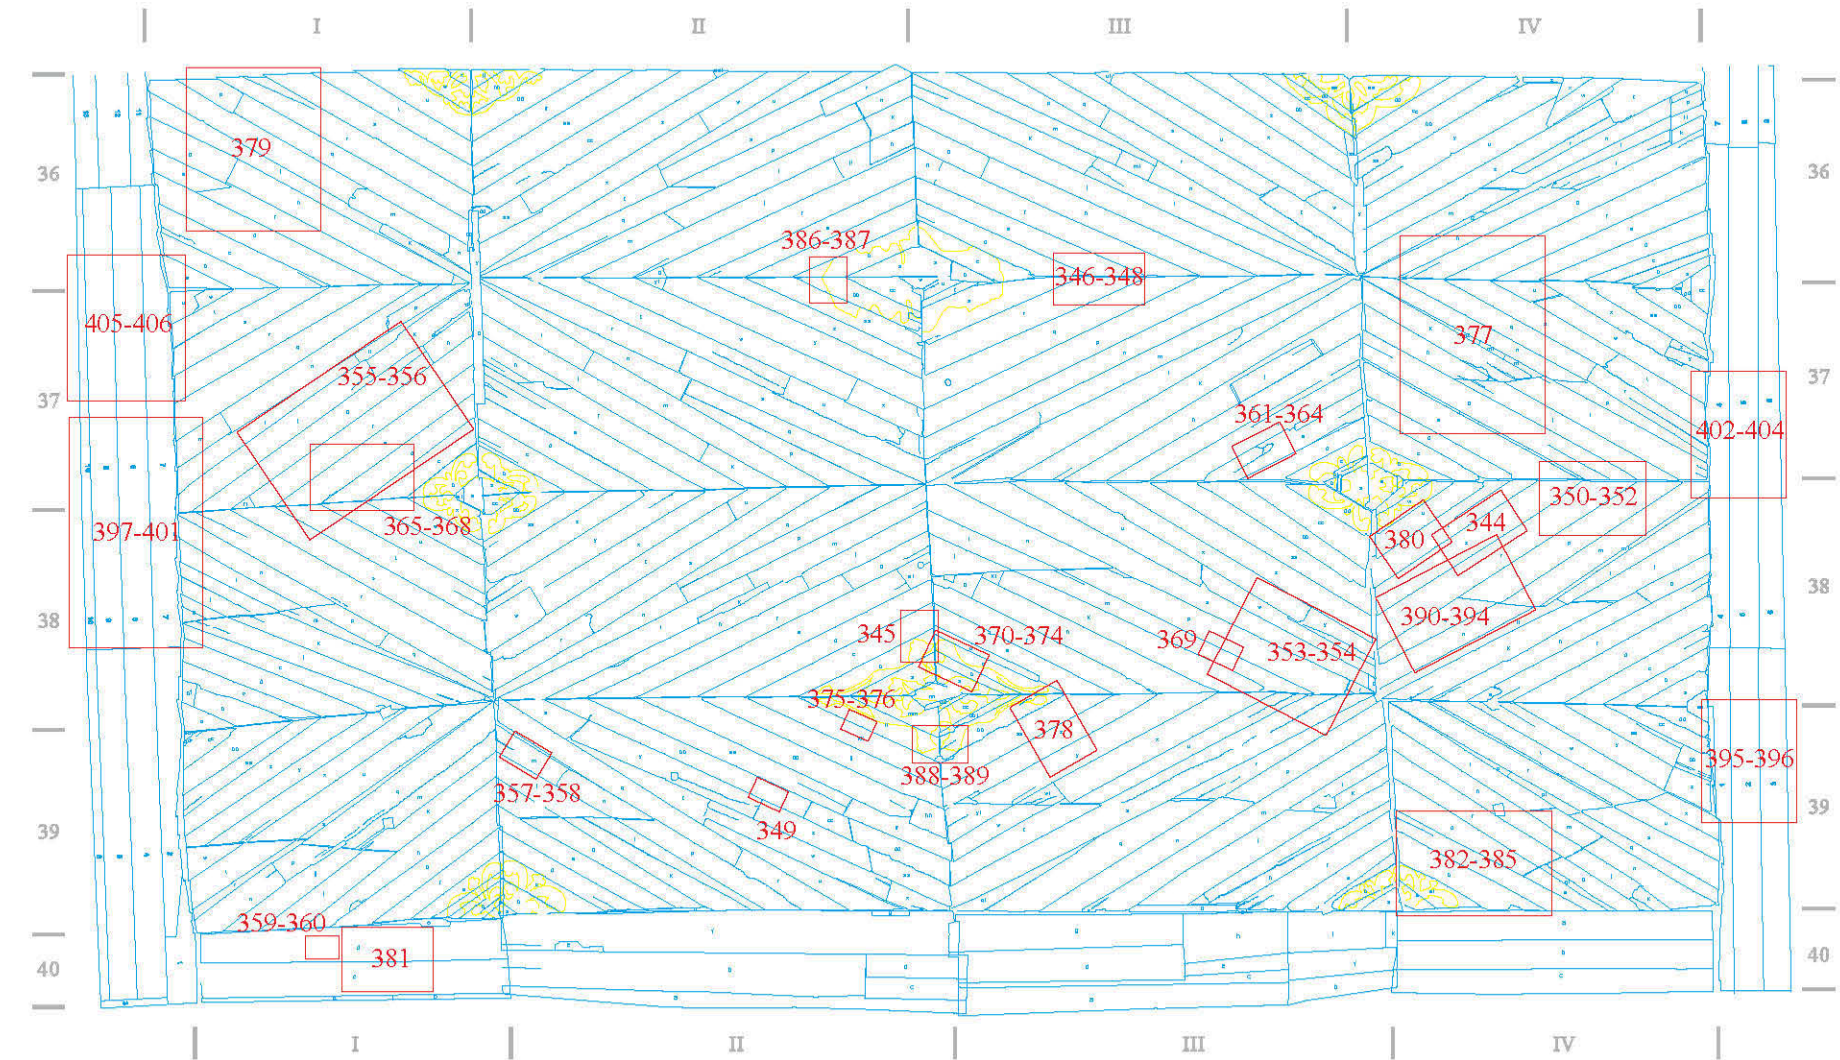
PETERBOROUGH CATHEDRAL, NAVE CEILING, PHASE 1  
PLATE REFERENCE SHEET NO: 9

Location of Plates 344 -406
