PETERBOROUGH CATHEDRAL: THE NAVE CEILING

PHASE 2: ROWS 28 - 35

CONDITION SURVEY AND CONSERVATION TREATMENT

MAY - JULY 1999

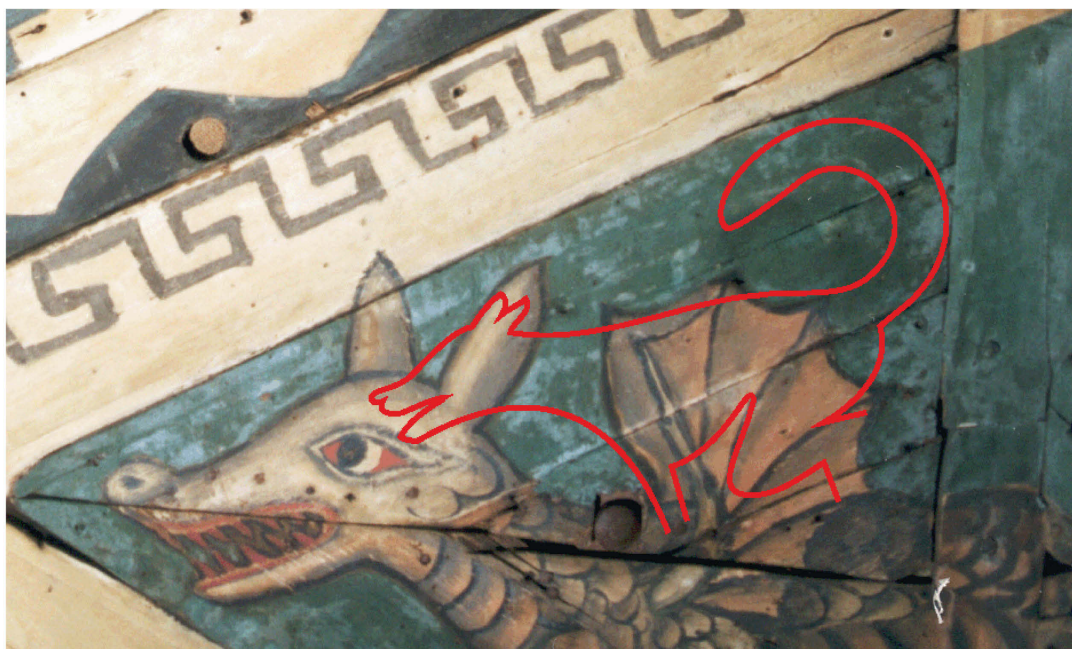
Figure 7. Underpaint visible in raking light indicates the original scheme had a Renard occupying only one quarter (33 III) of the lozenge: here shown outlined in red. Not enough low relief underpaint survives within the other three-quarters of this lozenge to suggest the original subject.

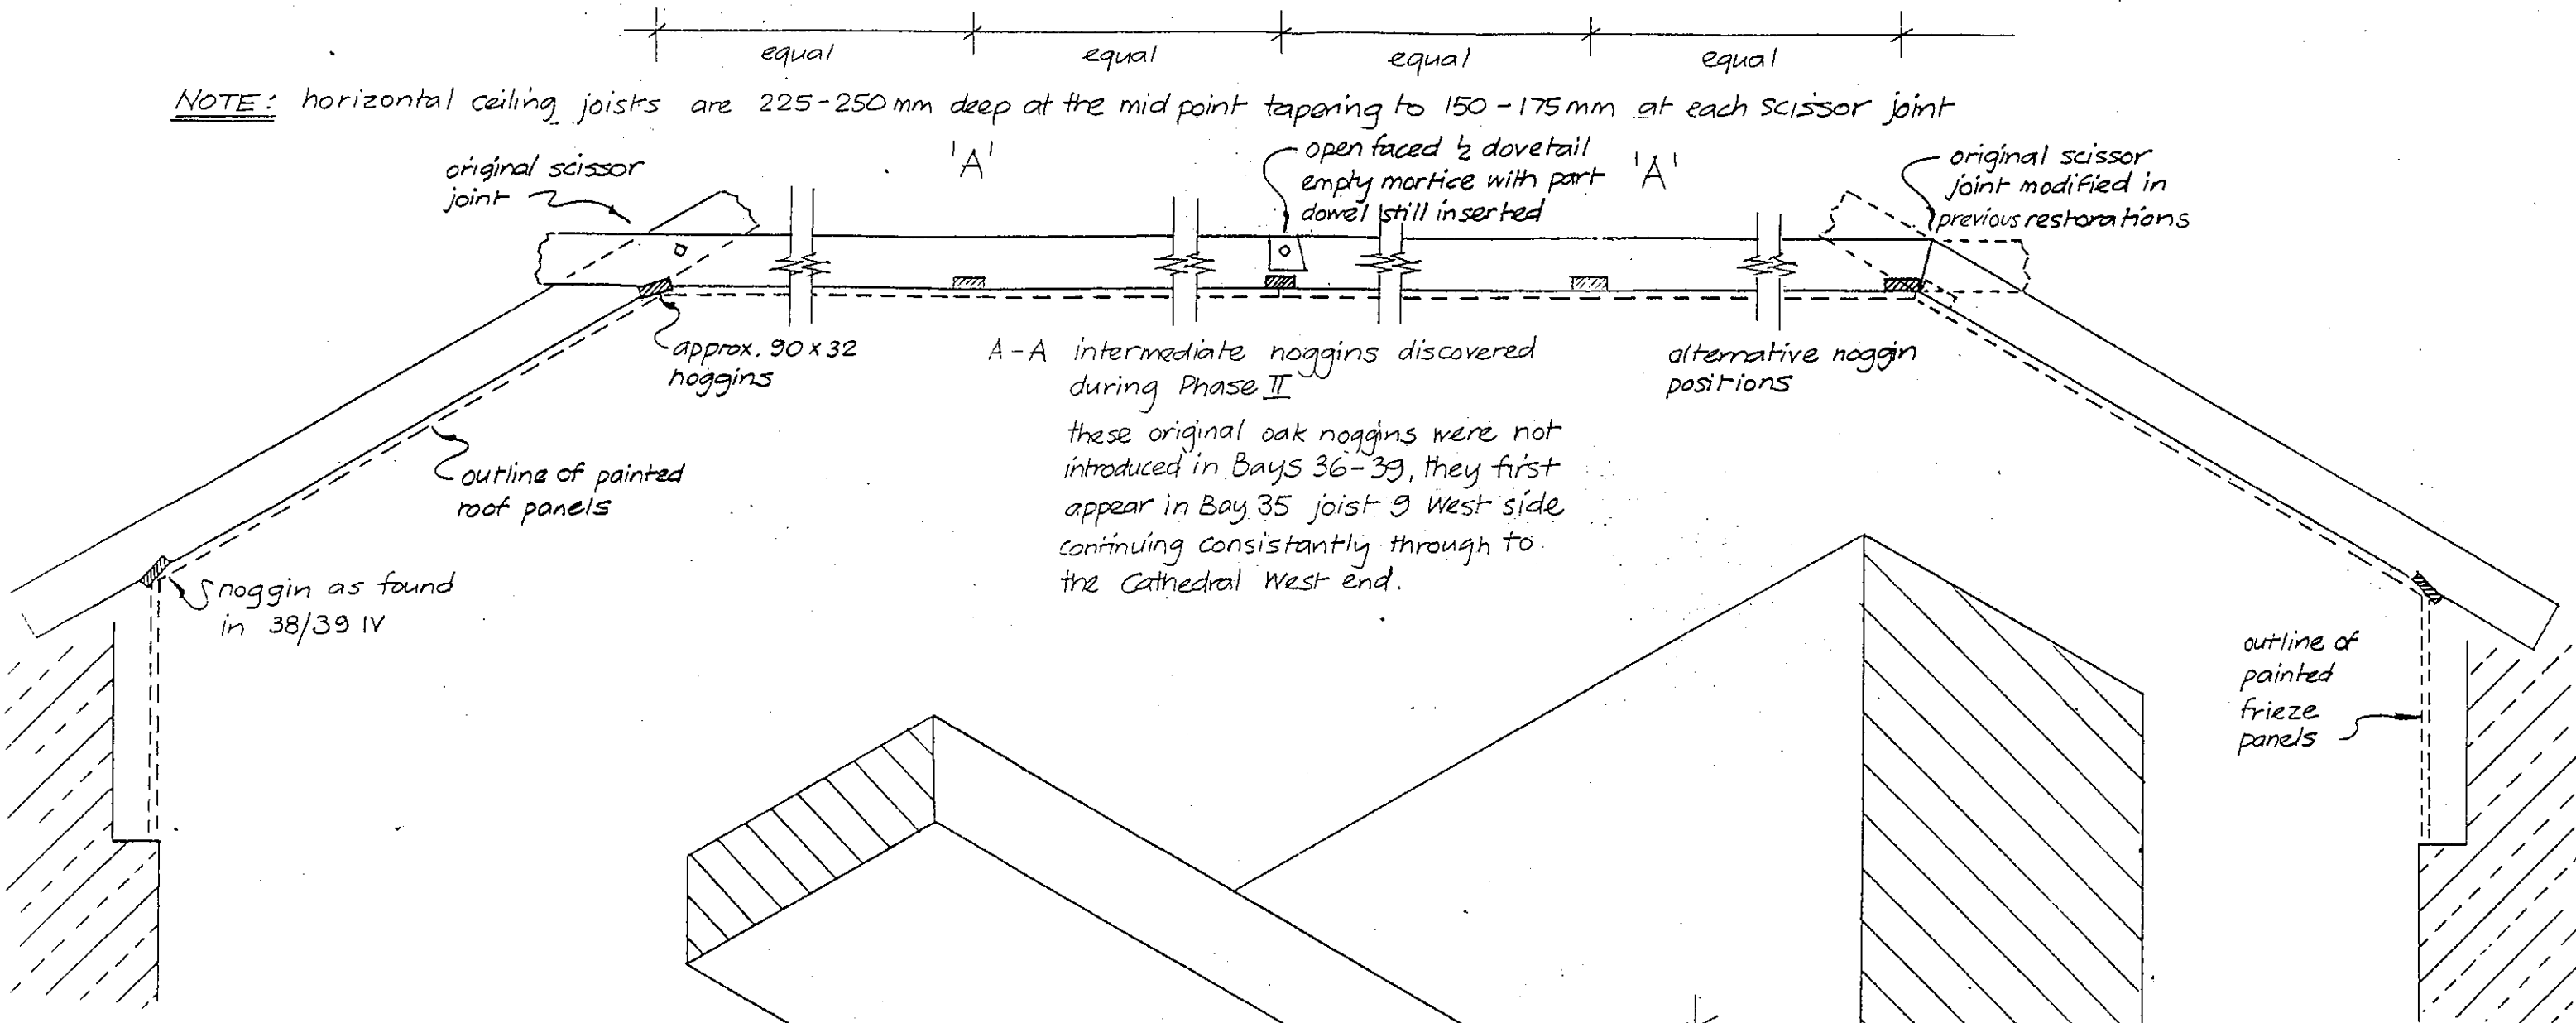
Typical Section Through Remaining Original Structure

A-A intermediate noggins discovered during Phase II
 these original oak noggins were not introduced in Bays 36-39, they first appear in Bay 35 joist 9 West side continuing consistently through to the Cathedral West end.

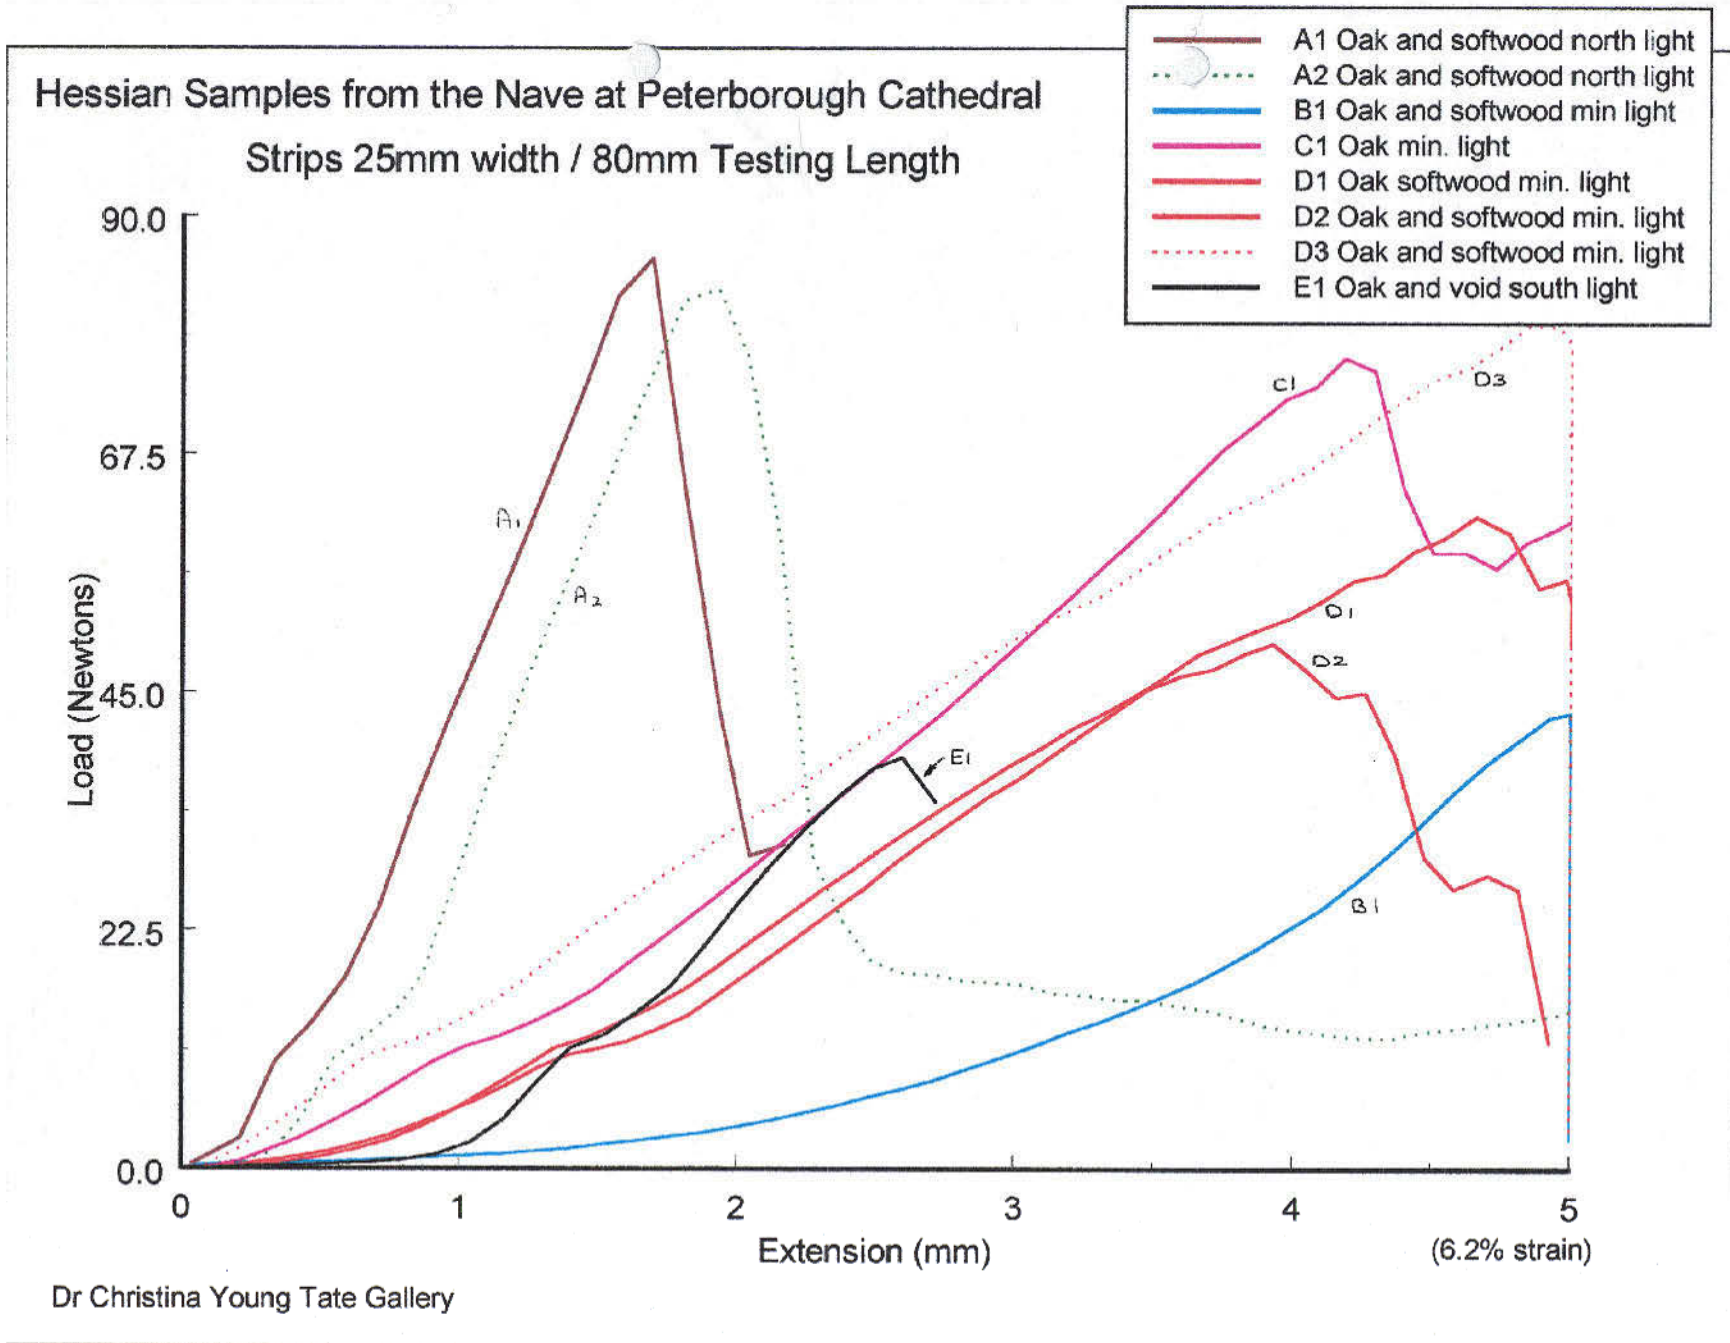
Figure 12. Hessian samples from the Nave at Peterborough Cathedral Dr Christina Young, Tate Gallery

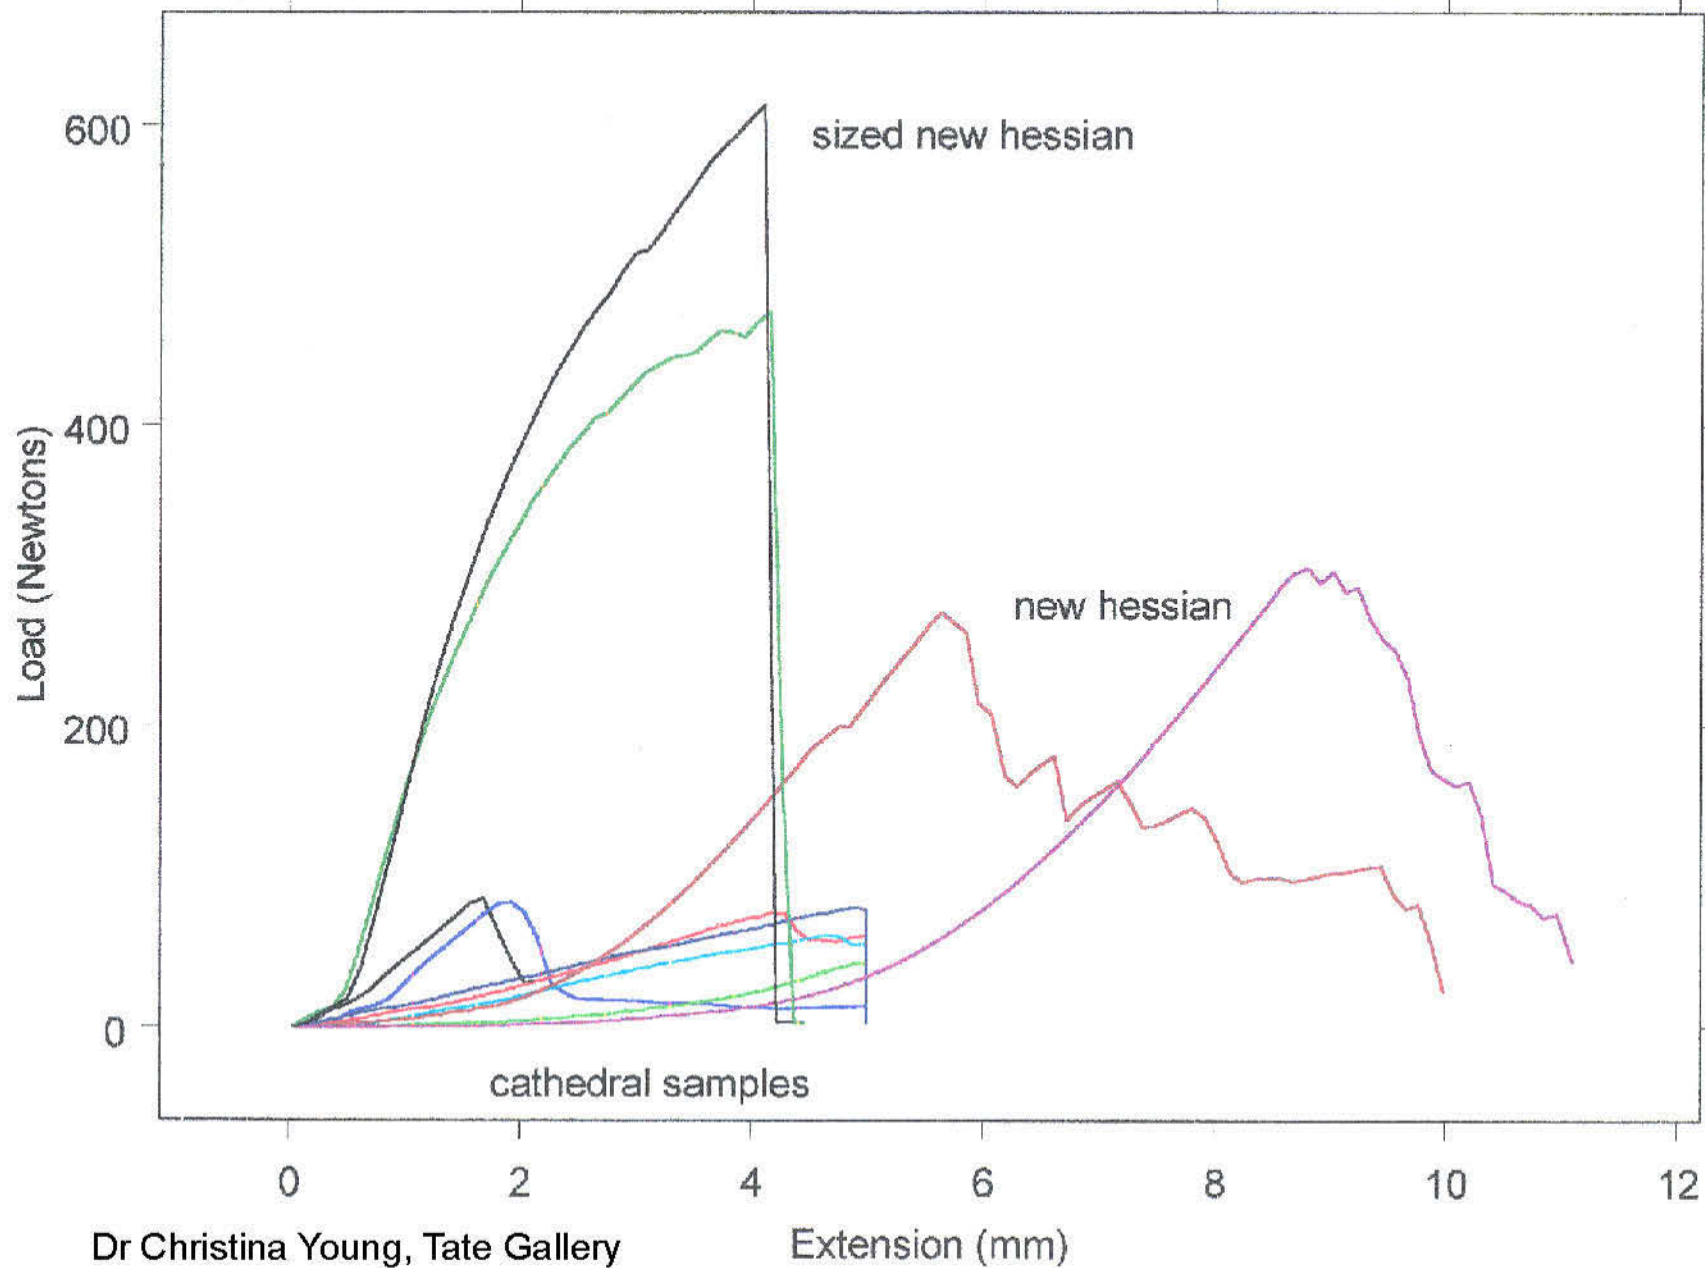
Figure 13. Ultimate tensile strength of hessian samples from the Nave at Peterborough Cathedral Dr Christina Young, Tate Gallery

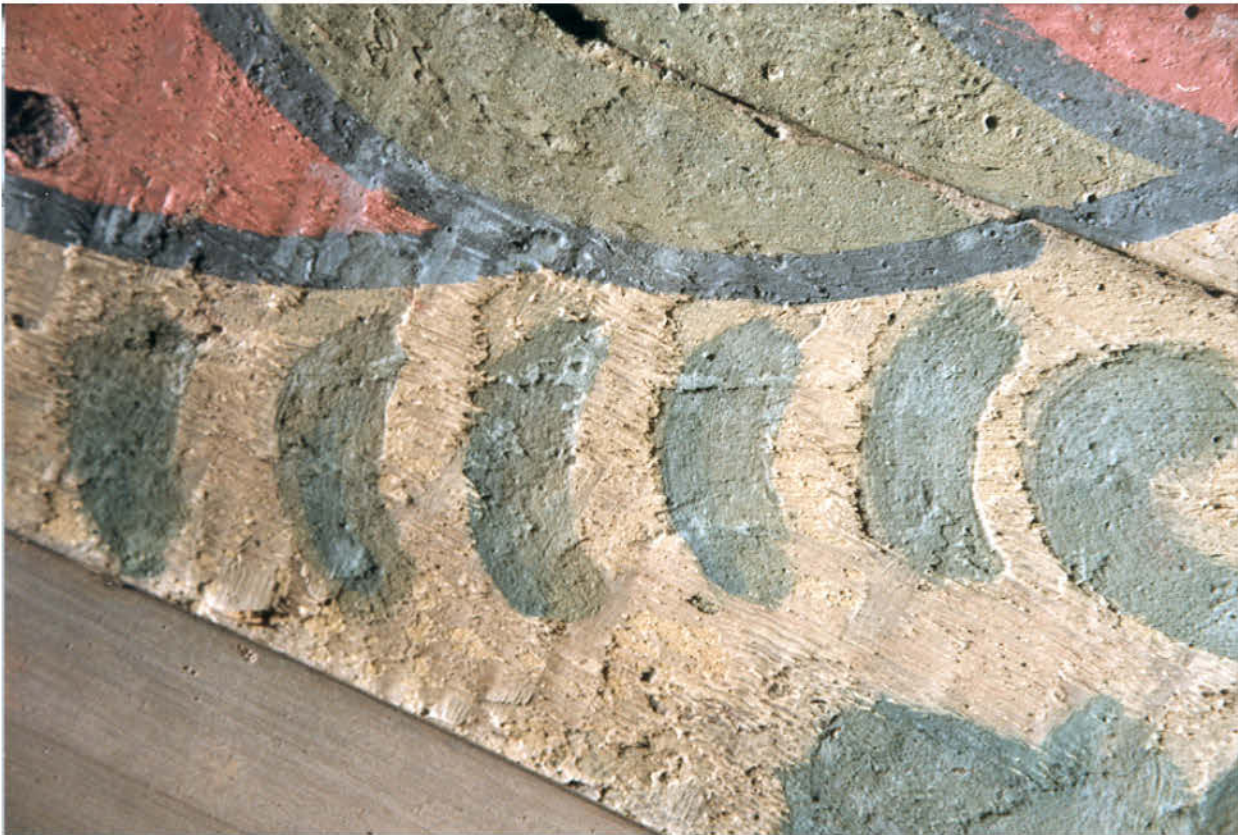
Figure 15. *St Albans Cathedral, C15th Choir Ceiling: Detail showing the apparently receded wood surface where original background paint had been lost. The same phenomenon has occurred on the nave ceiling at Peterborough Cathedral.*

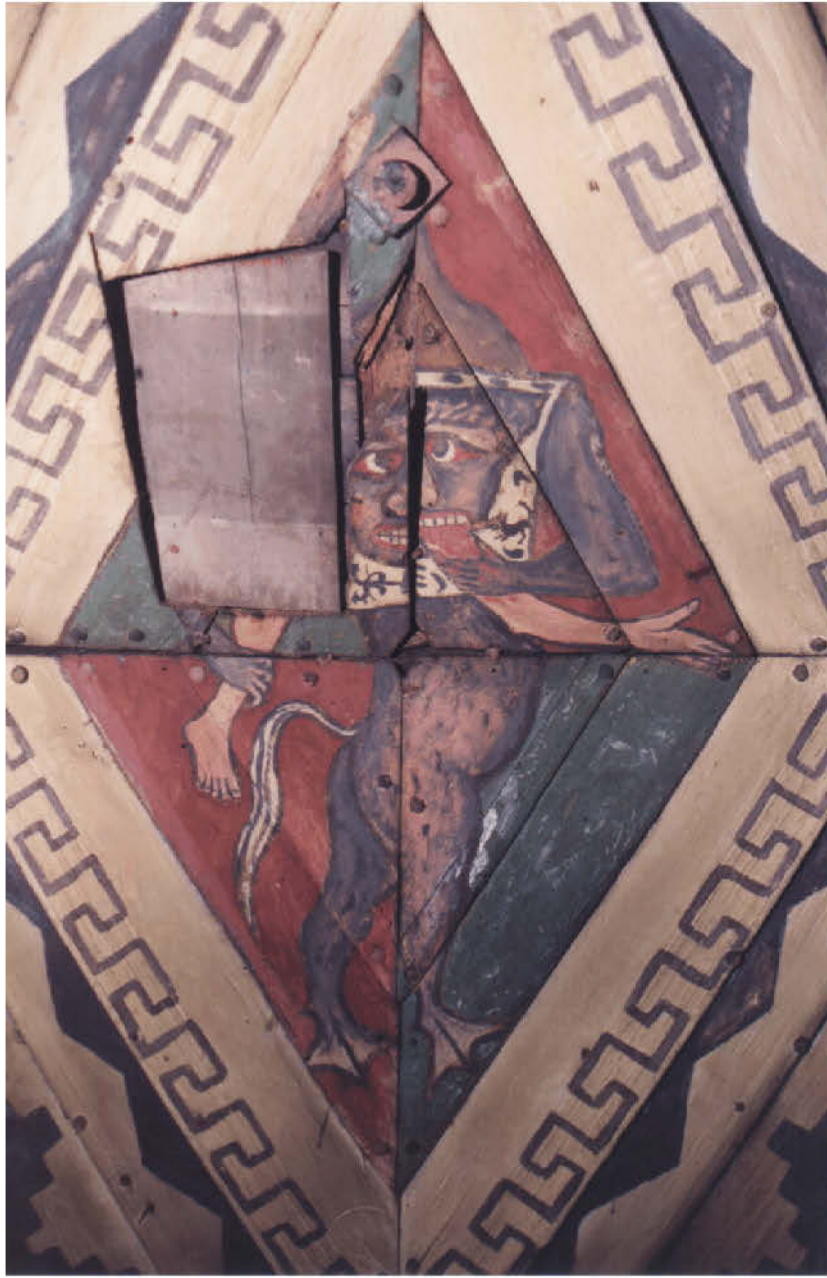
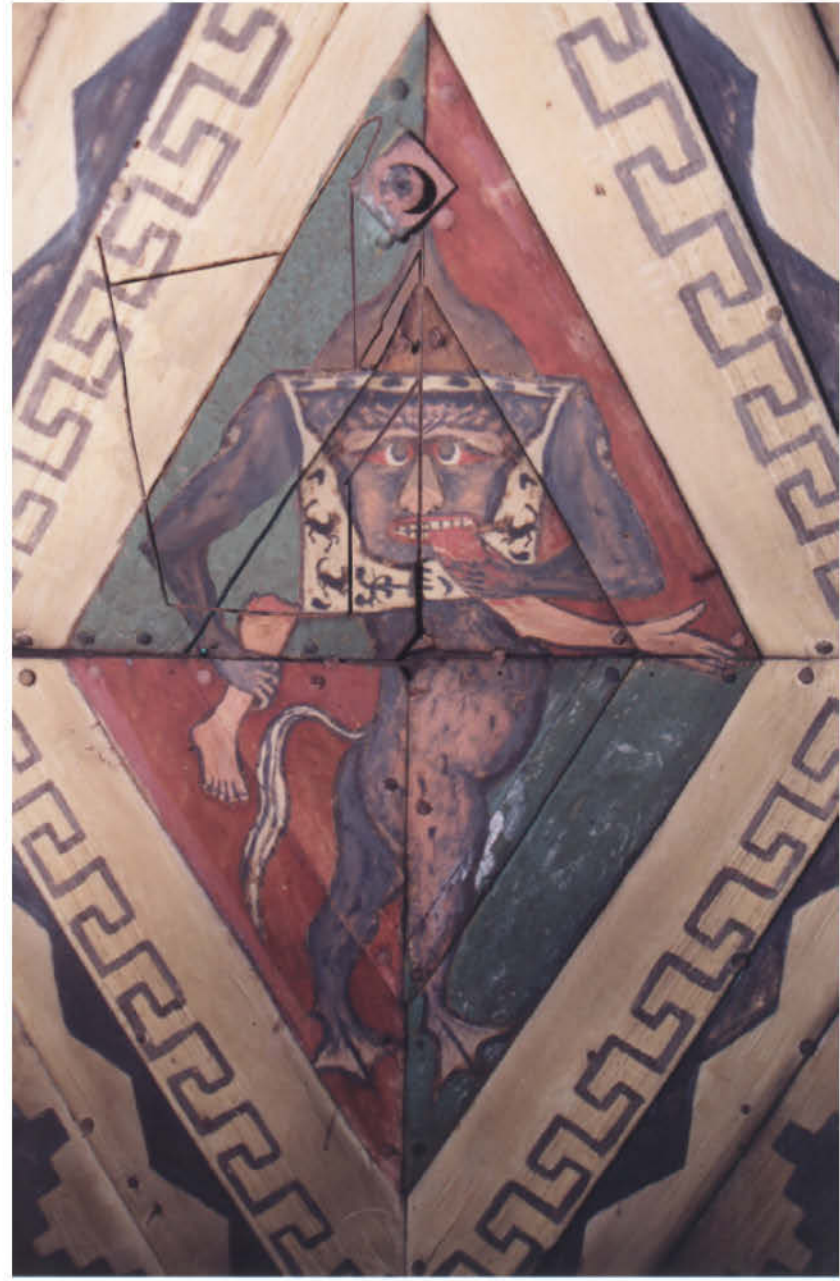
Figure 20. Anthropophagus (Lozenge 33/34/ I/II). Conjectural reconstruction of missing figurative detail. The background colours only were recreated on the replacement oak inserts.

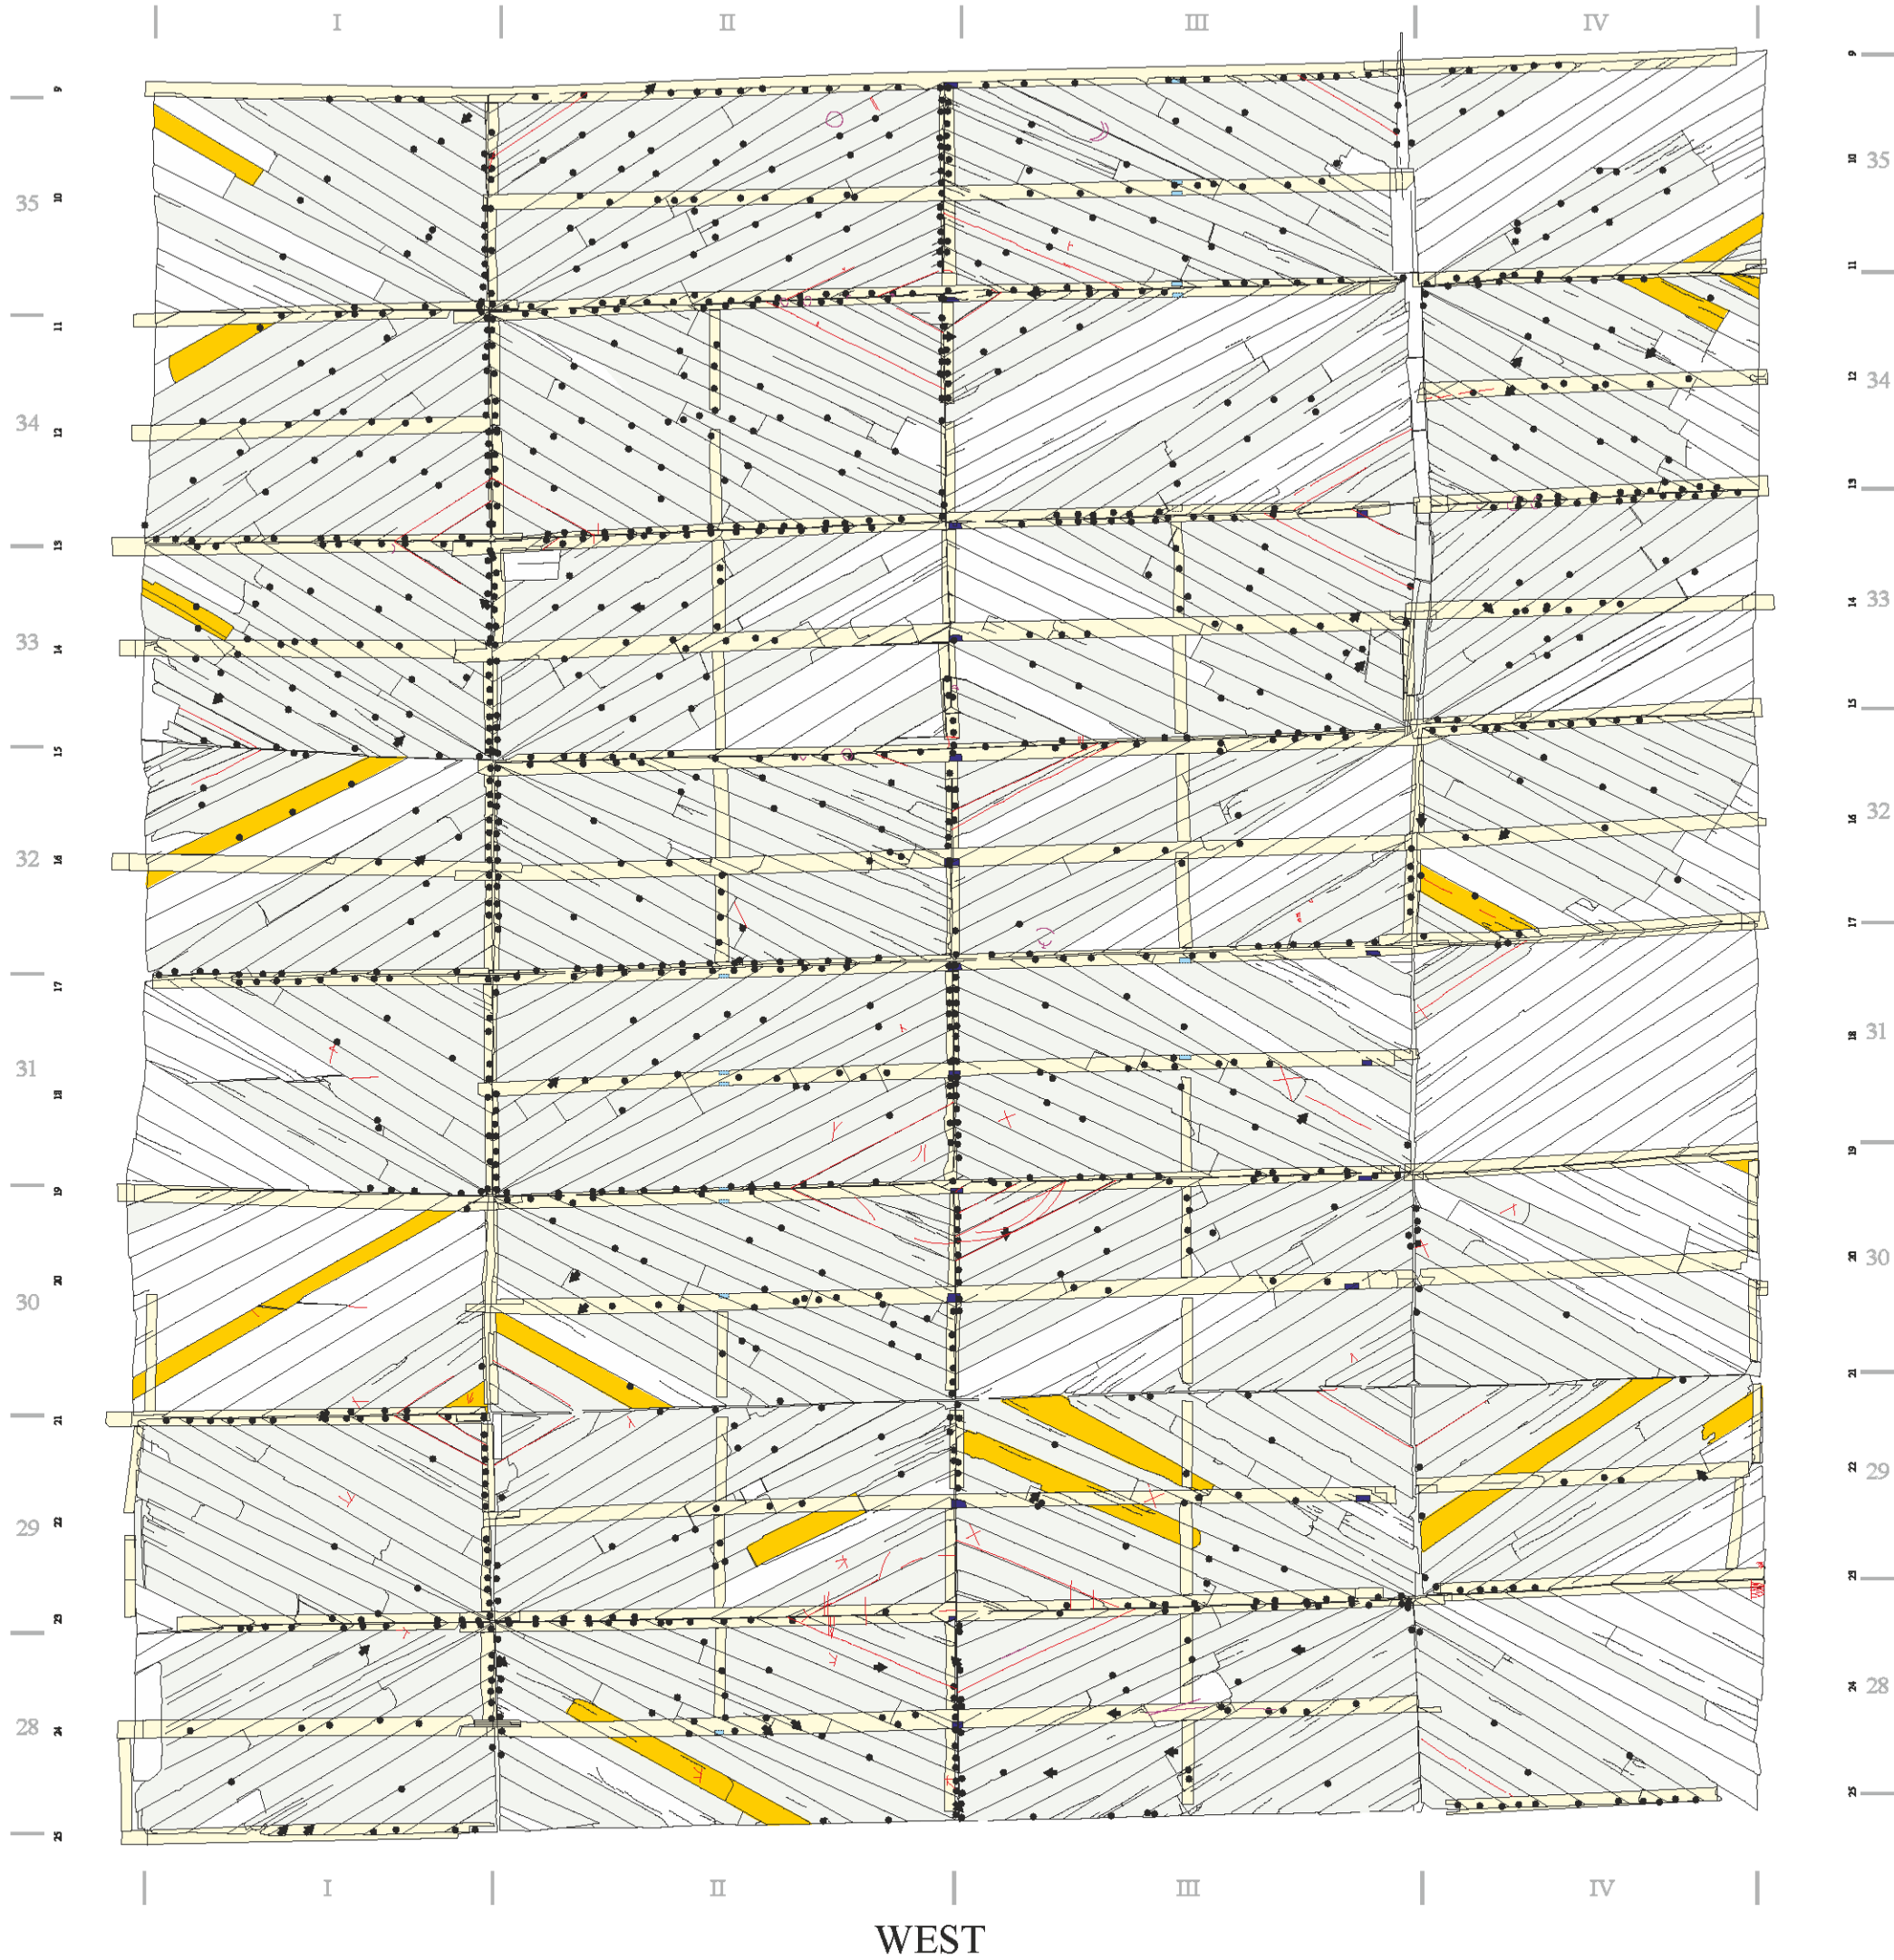
NOTES
 The major change to the structure in Phase 2 is the addition of noggins from Joist 9 between the centre noggin and those at the scissor joints. Note should also be taken of how few nails fix boards to these intermediate noggins, more probably existed at one time as can be seen from the nail holes shown on **Graphics 6A/B**. Note also the carpenter's marks, some of which seem to be for locating adjoining boards, and some, the painted design. Hessian was not removed above every noggin, so the categorisation of noggins as original or from a later intervention is not always precise.

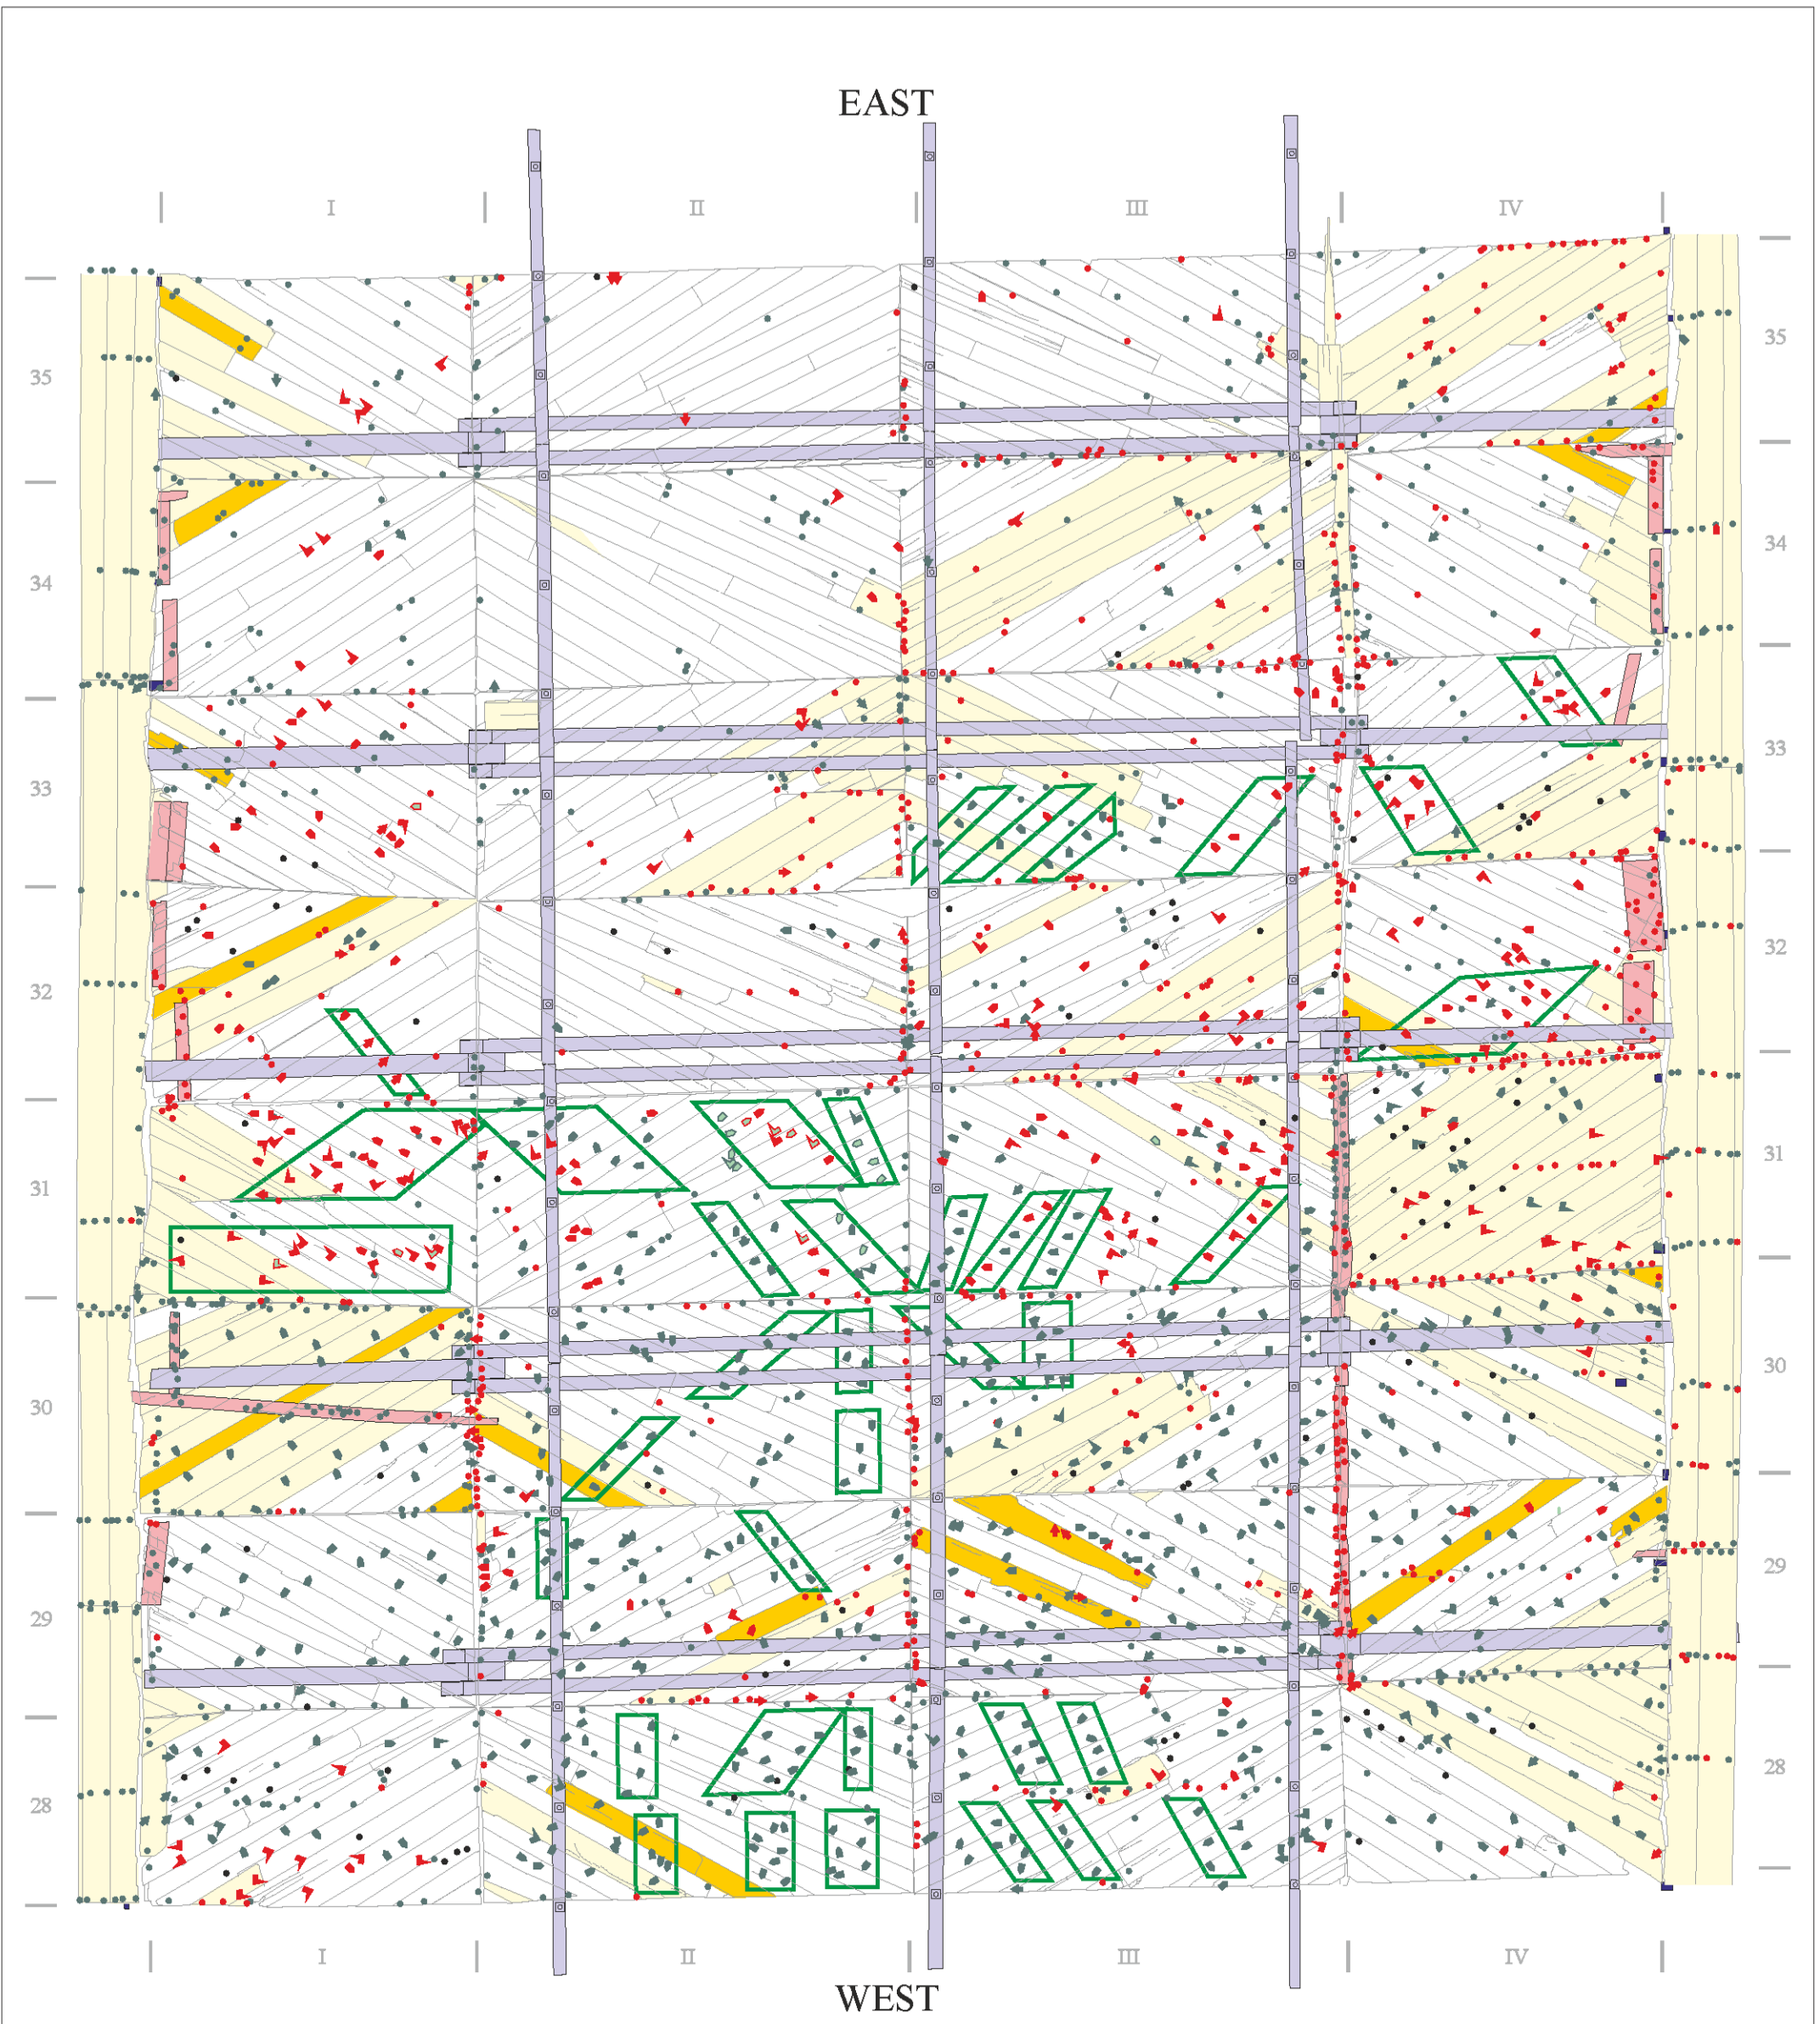
NOTES
 So far it has been impossible to apportion repairs to either the 1740s or 1830s restorations, so all the work attributed to both campaigns is shown on this Graphic. It is known that many repairs of this period were stripped out in the 1926 restoration (of which it is conjectured that many of the nails driven from above are evidence), so this Graphic should not be taken as a full picture of all work from this period. It is interesting to note the single replaced joist in *Panel 30 I*, the patches at the foot of the sloping panels, the reused original oak ceiling boards as well as the replaced noggins at the south scissor joint. The 1830s roof is shown from which the ceiling is now suspended by hanging bolts.

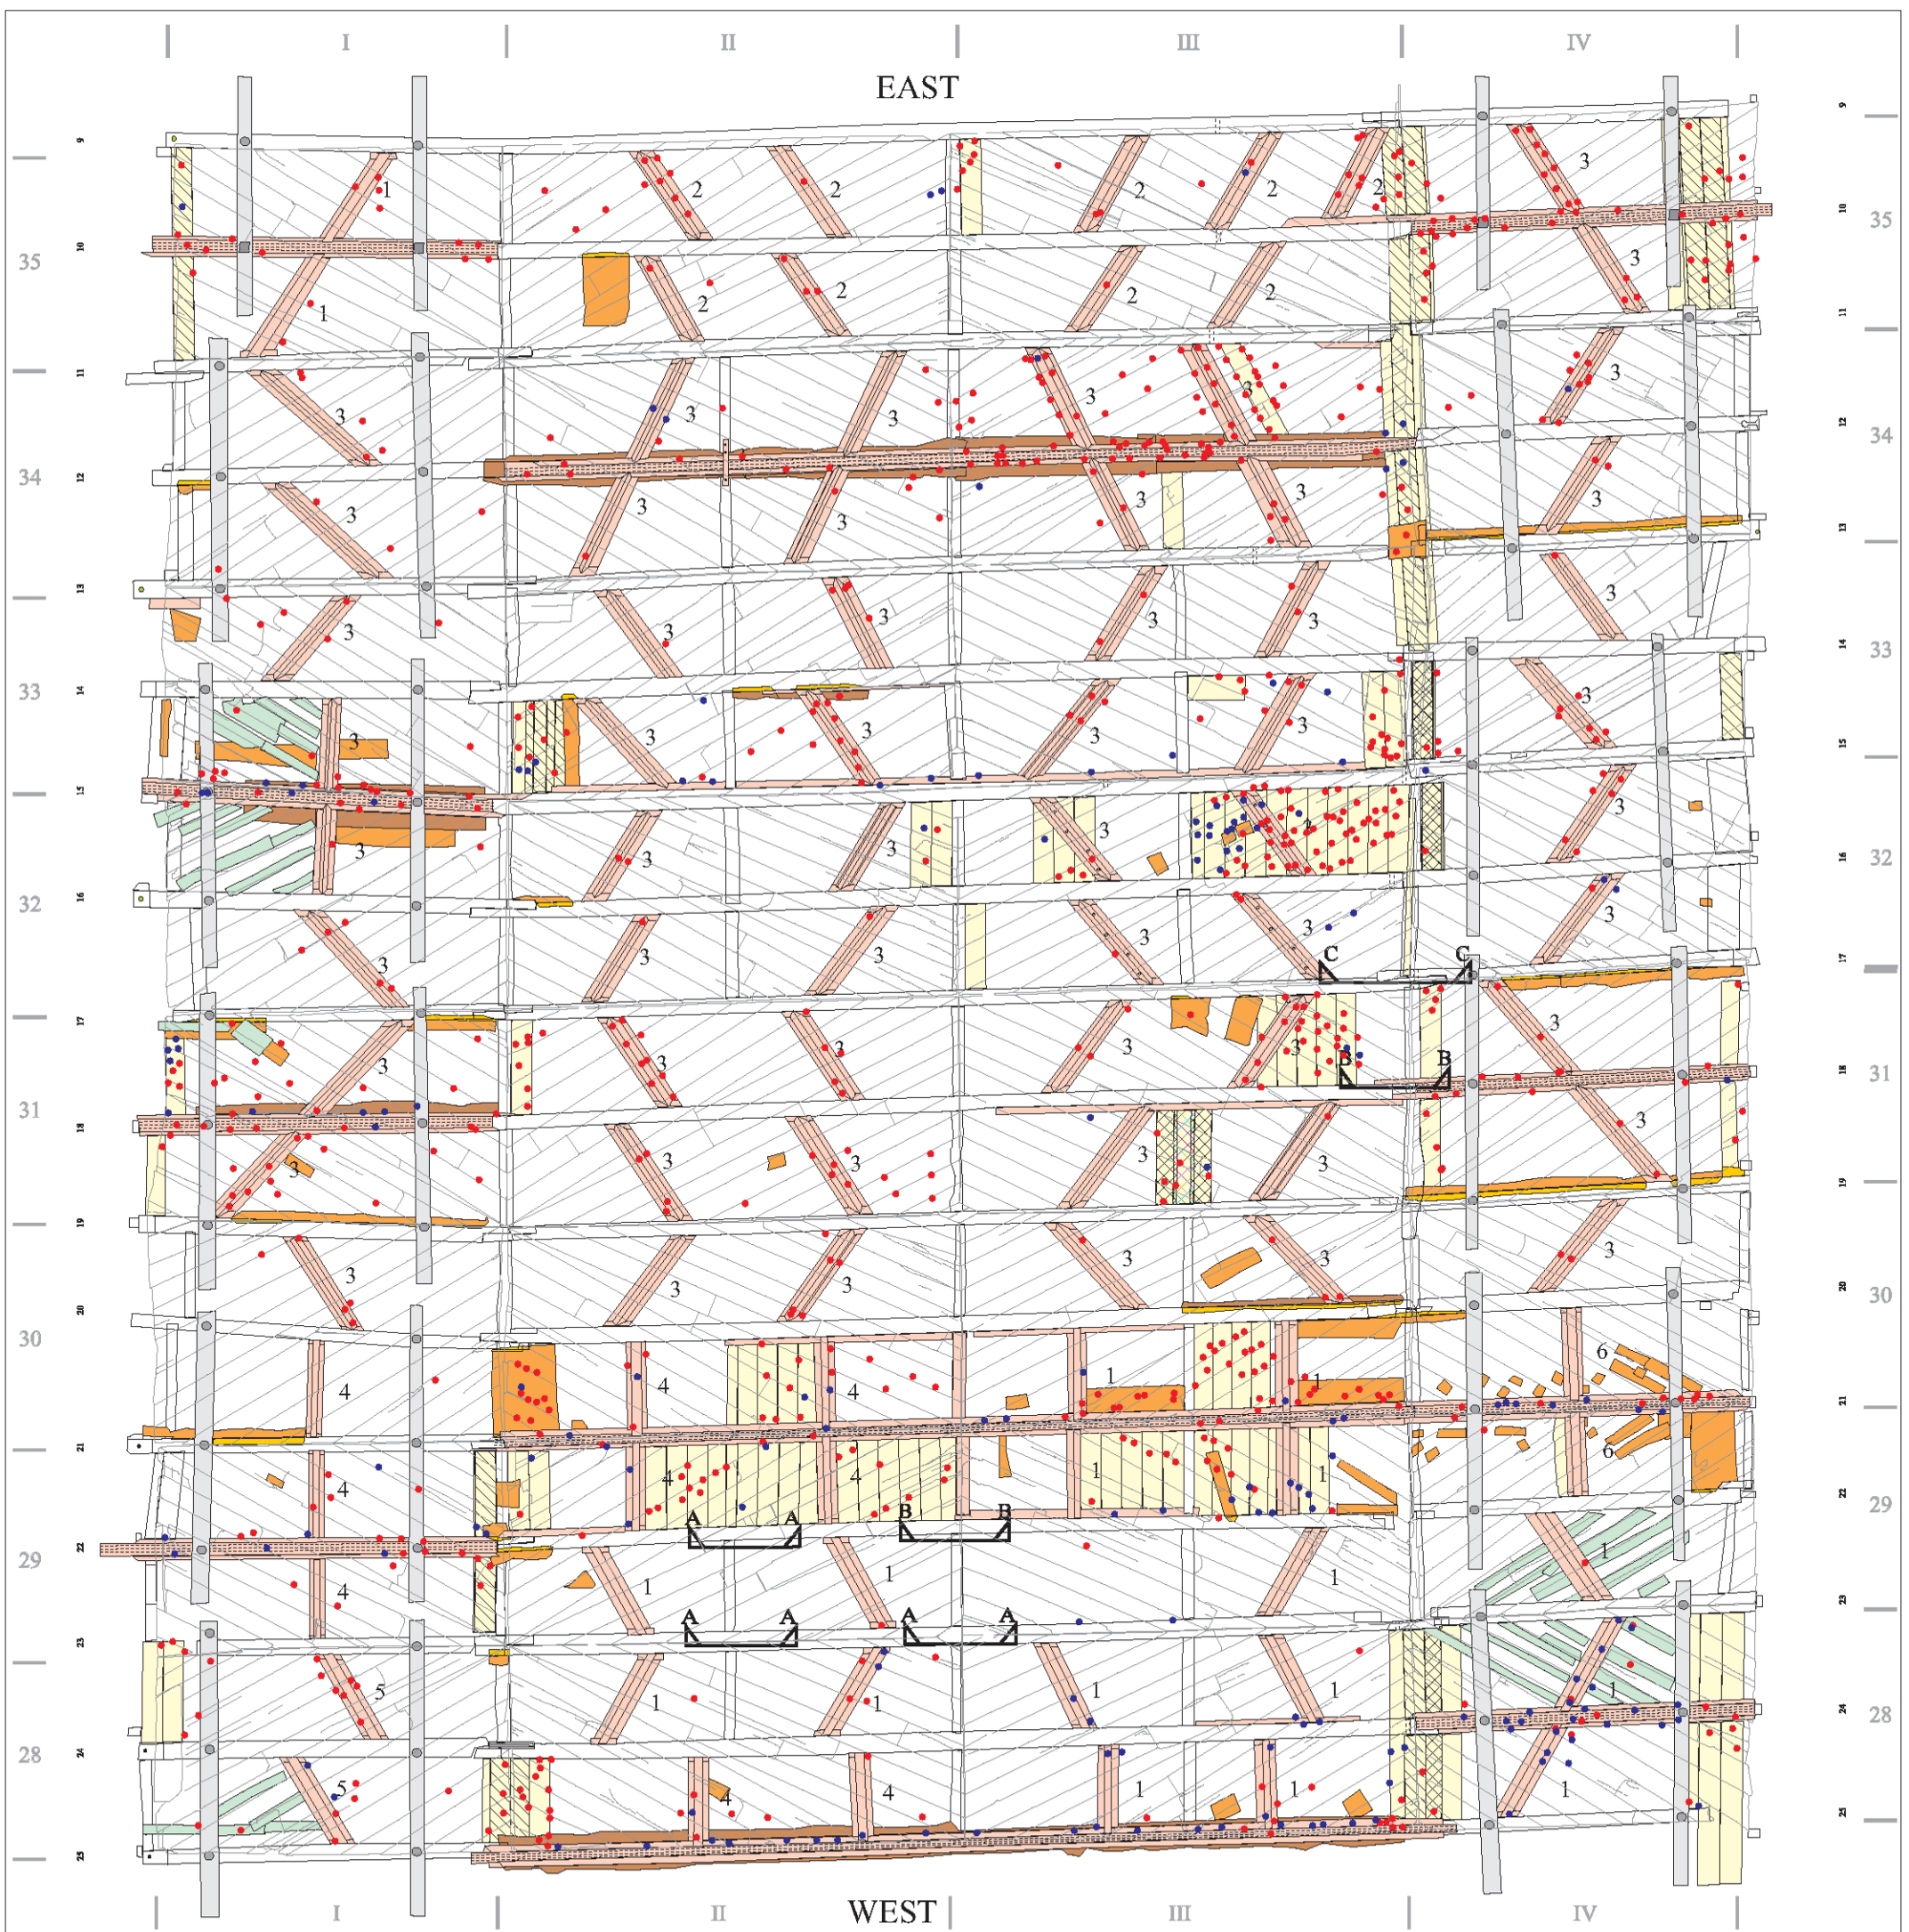
NOTES The 1926 restoration is characterised by the complete new system for supporting the ceiling using softwood noggins, patches, a number of laminated joists (all items mostly fixed with screws) and a complete layer of hessian. The work caused considerable damage to the face of the painted boards arose because there was no access below the ceiling to see what was happening. In addition, binders were installed to carry the sloping ceiling panels.
