PETERBOROUGH CATHEDRAL: THE NAVE CEILING

PHASE 2: ROWS 28 - 35

CONDITION SURVEY AND CONSERVATION TREATMENT

MAY - JULY 1999

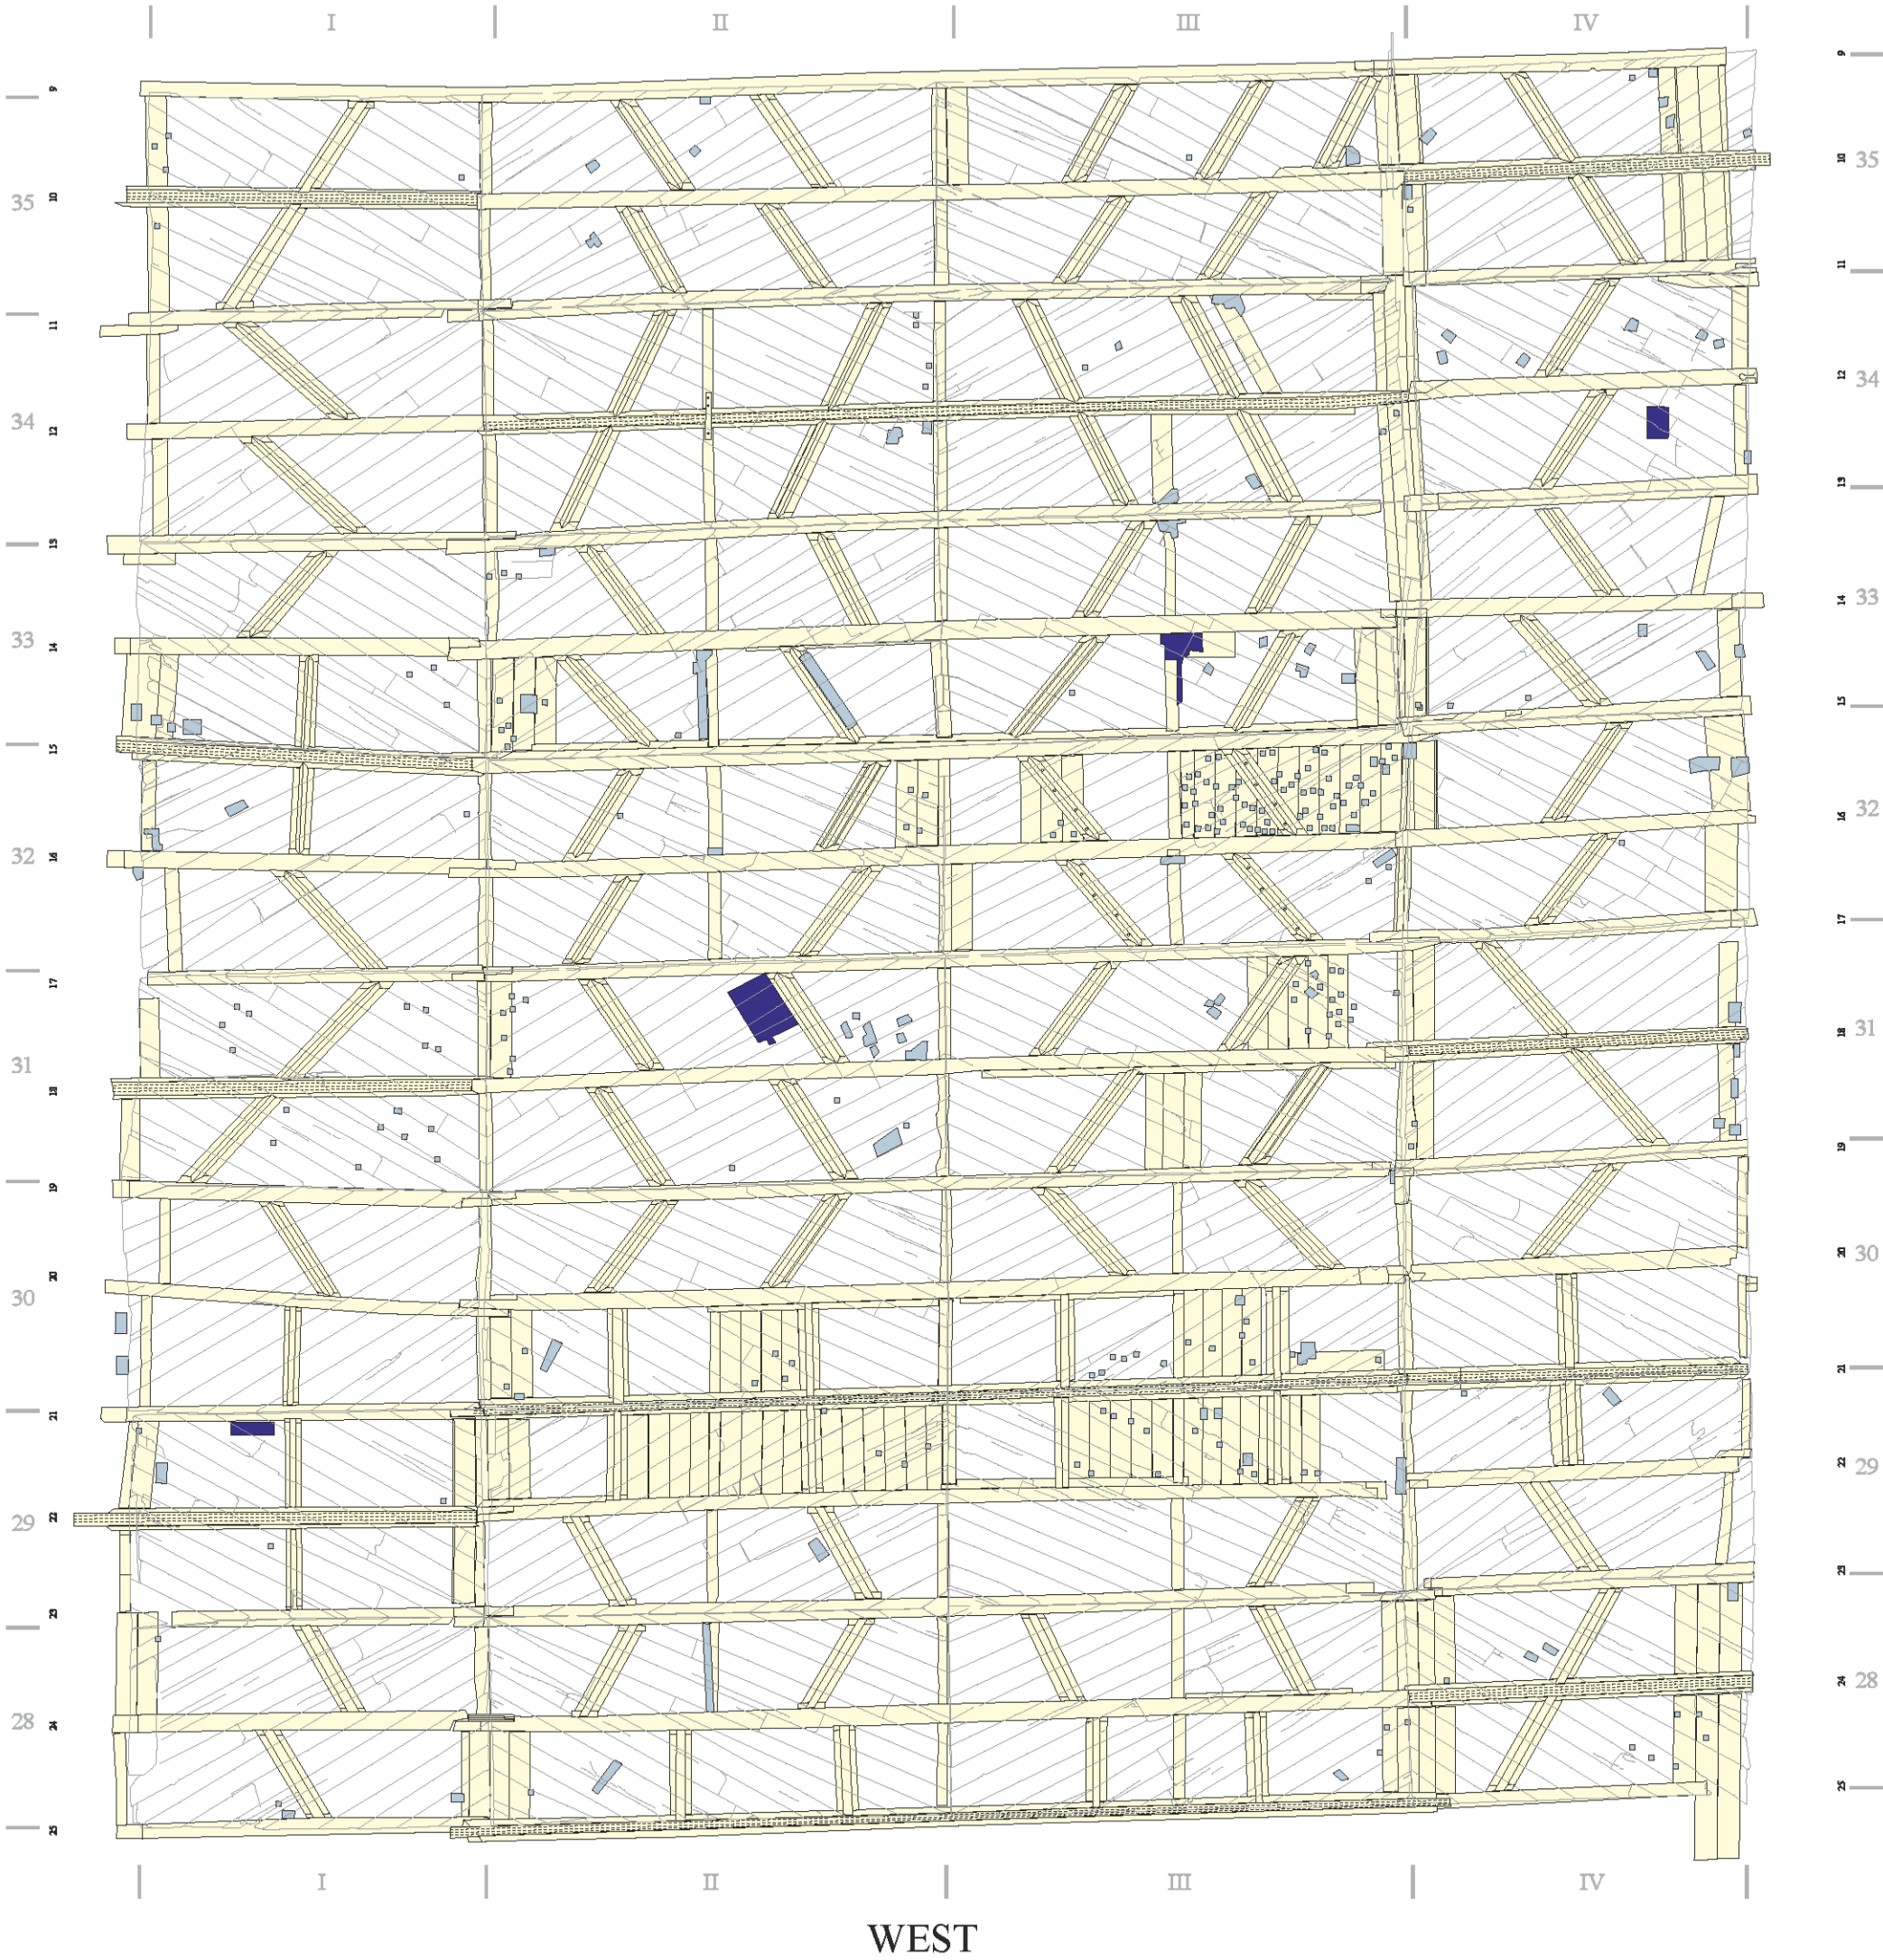
NOTES
All new sailcloth patches used in Phase 2 to repair the 1926 hessian layer are marked, also the positions of hessian samples which were removed and sent to the Tate Gallery for testing.

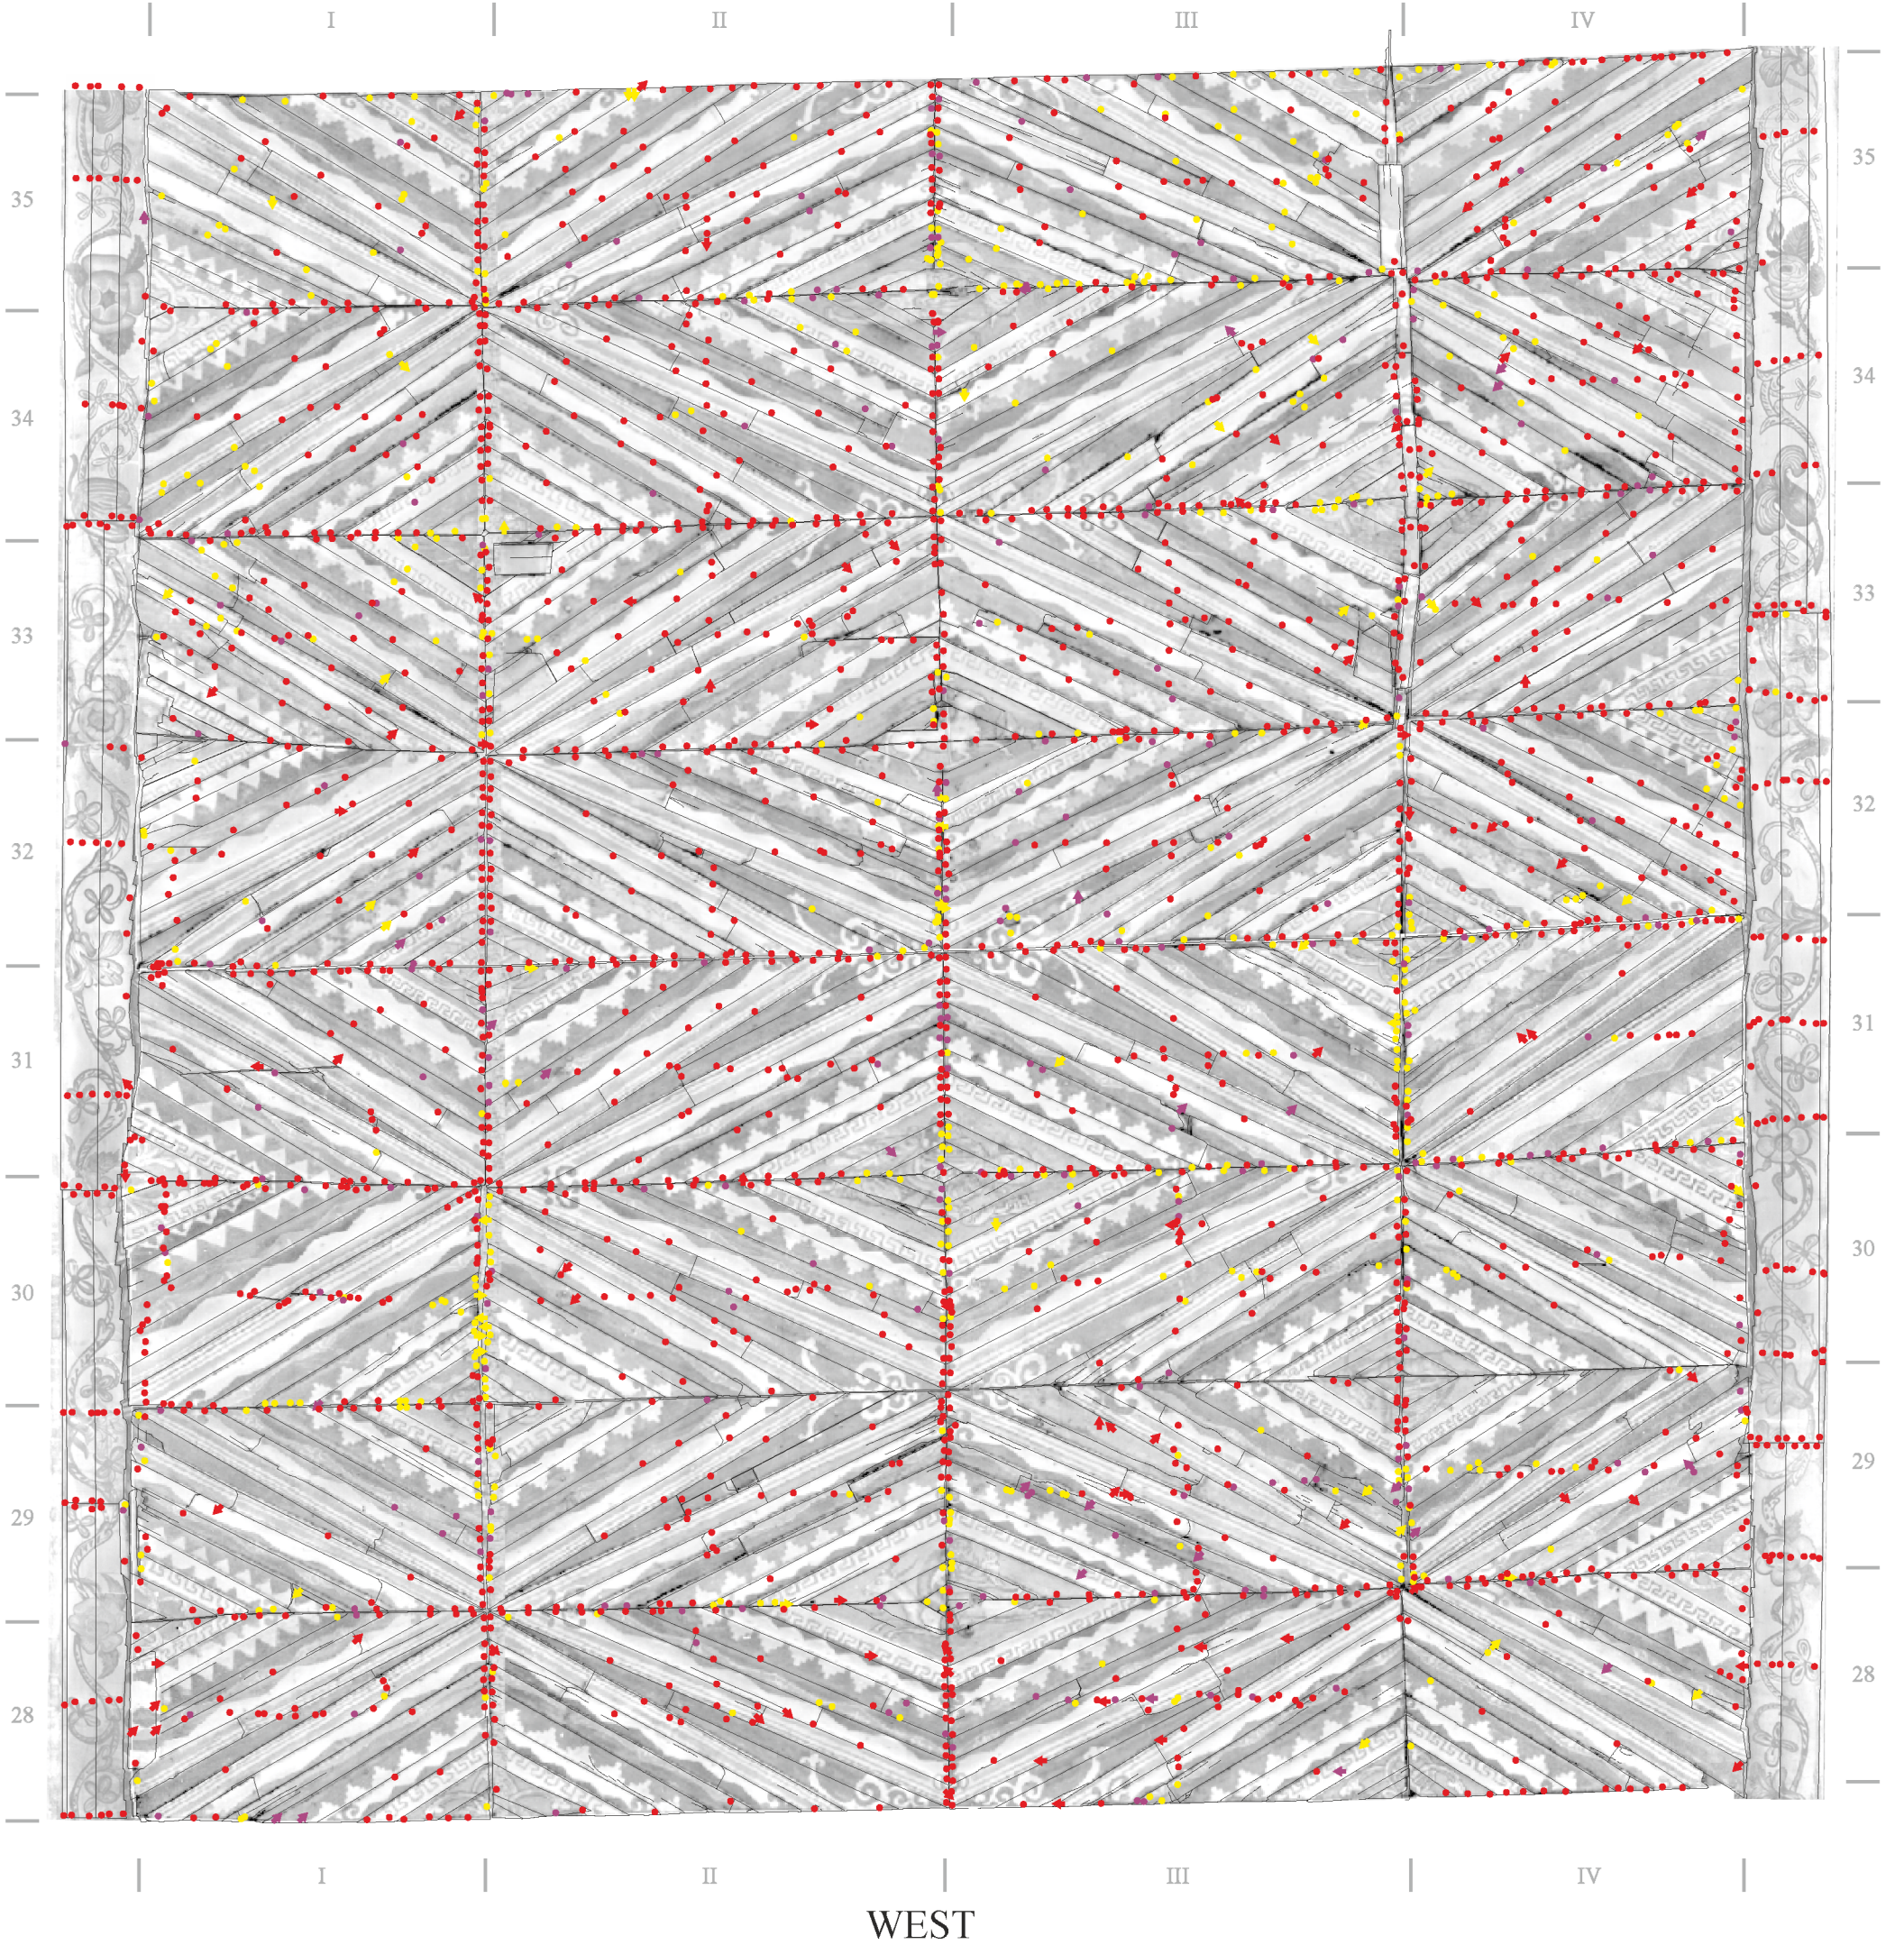
NOTES
Paint Surviving on Nail Heads - The nail heads are shown here as oversized to aid visibility. The groupings signify the percentage of paint remaining on each nail but do not indicate whether the surviving paint was flaking. The same material in the same solution (Paraloid B72: 10% in acetone) was used both to re-attach flaking paint on nail heads and to coat exposed metal.

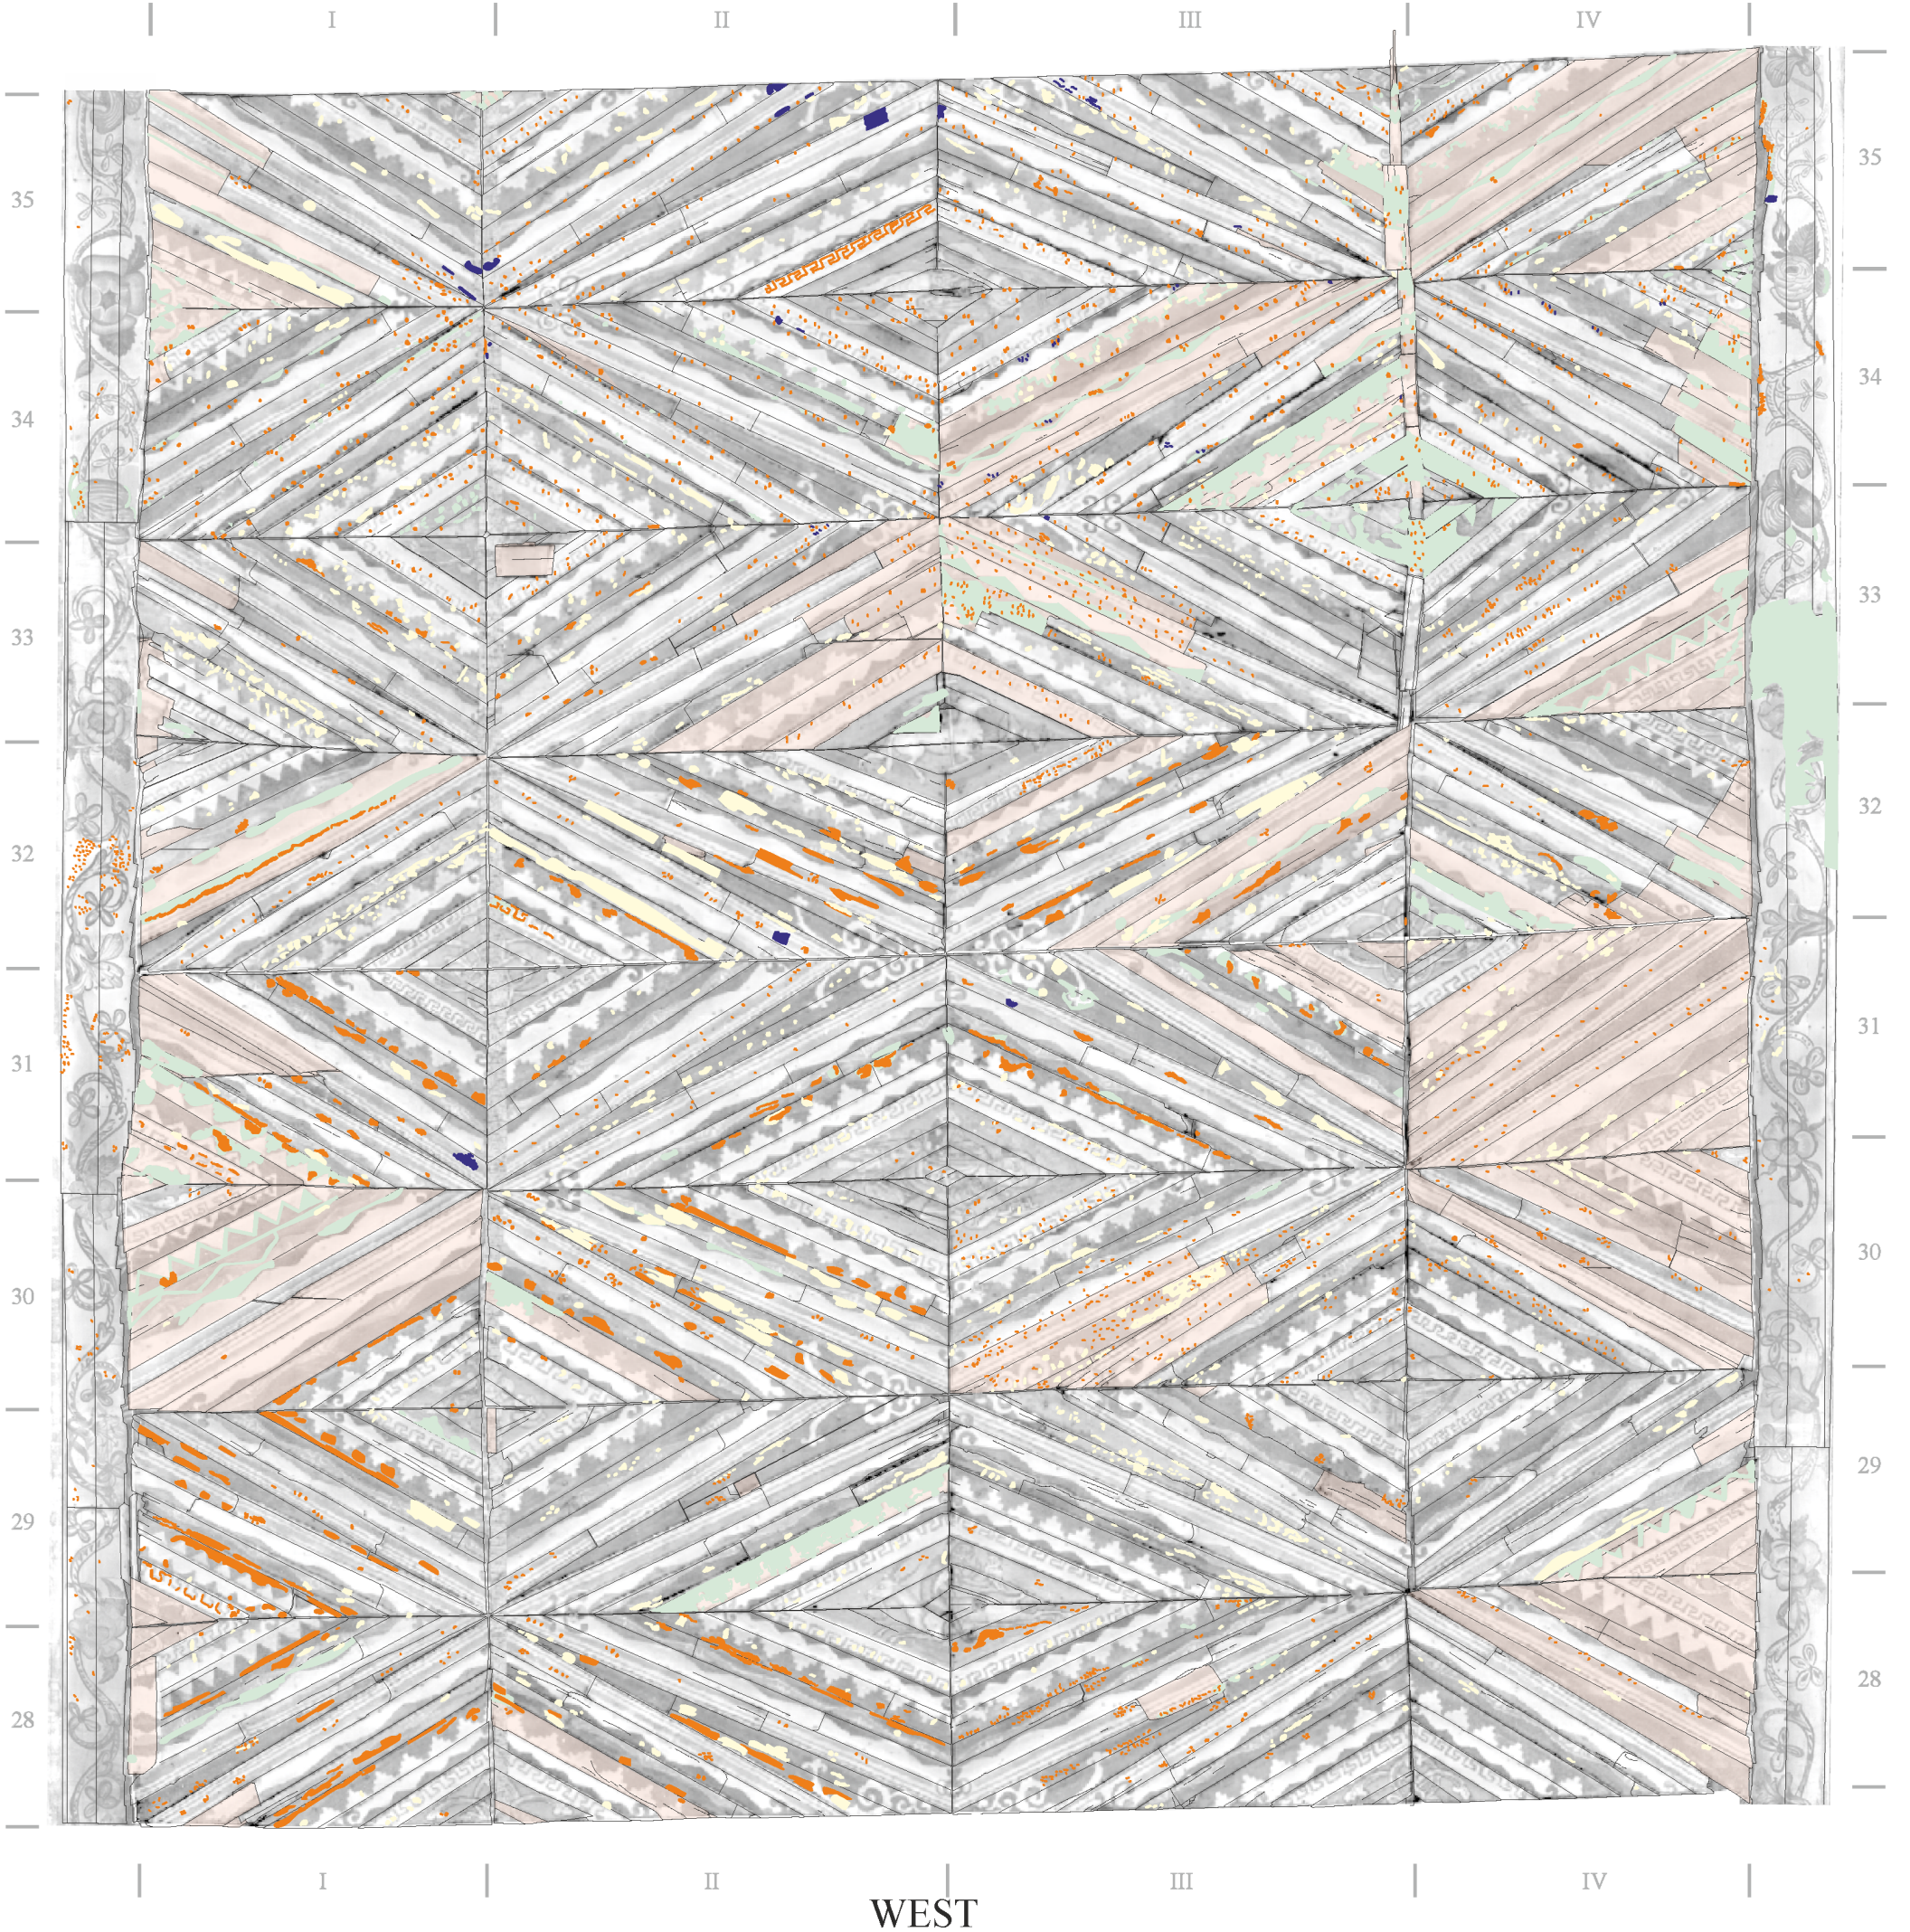
NOTES **Patchy white deposits** - Associated with the thick resinous 1830s black paint/coating remain unidentified. Analysis indicates they are accumulations of irregularly shaped, translucent, plate-like crystals. Further investigations are required to determine whether these crystalline deposits are the result of seepage from the paint layer or a reaction caused by adverse environmental conditions. **Tendril deposits** - These resemble miniature spider web, joining larger elements together. This type of deposit may have originated through microbiological action: analysis found some collapsed strand material. **Brown/white blotches** - Irregularly shaped, translucent granules. The spots are generally brown and at the centre there appears to be a dark brown particle, like a grain of sand, around it is a lighter brown or off-white halo with a fuzzy edge. **Surface Bloom** - Nearly all surface bloom recorded in Phase 2 occurs on 1830s softwood boards. The boards appear to have a coating of white dusty material.
