PETERBOROUGH CATHEDRAL: THE NAVE CEILING

PHASE 5: ROWS 0 - 7

MAY - OCTOBER 2003

CONDITION SURVEY AND CONSERVATION TREATMENT

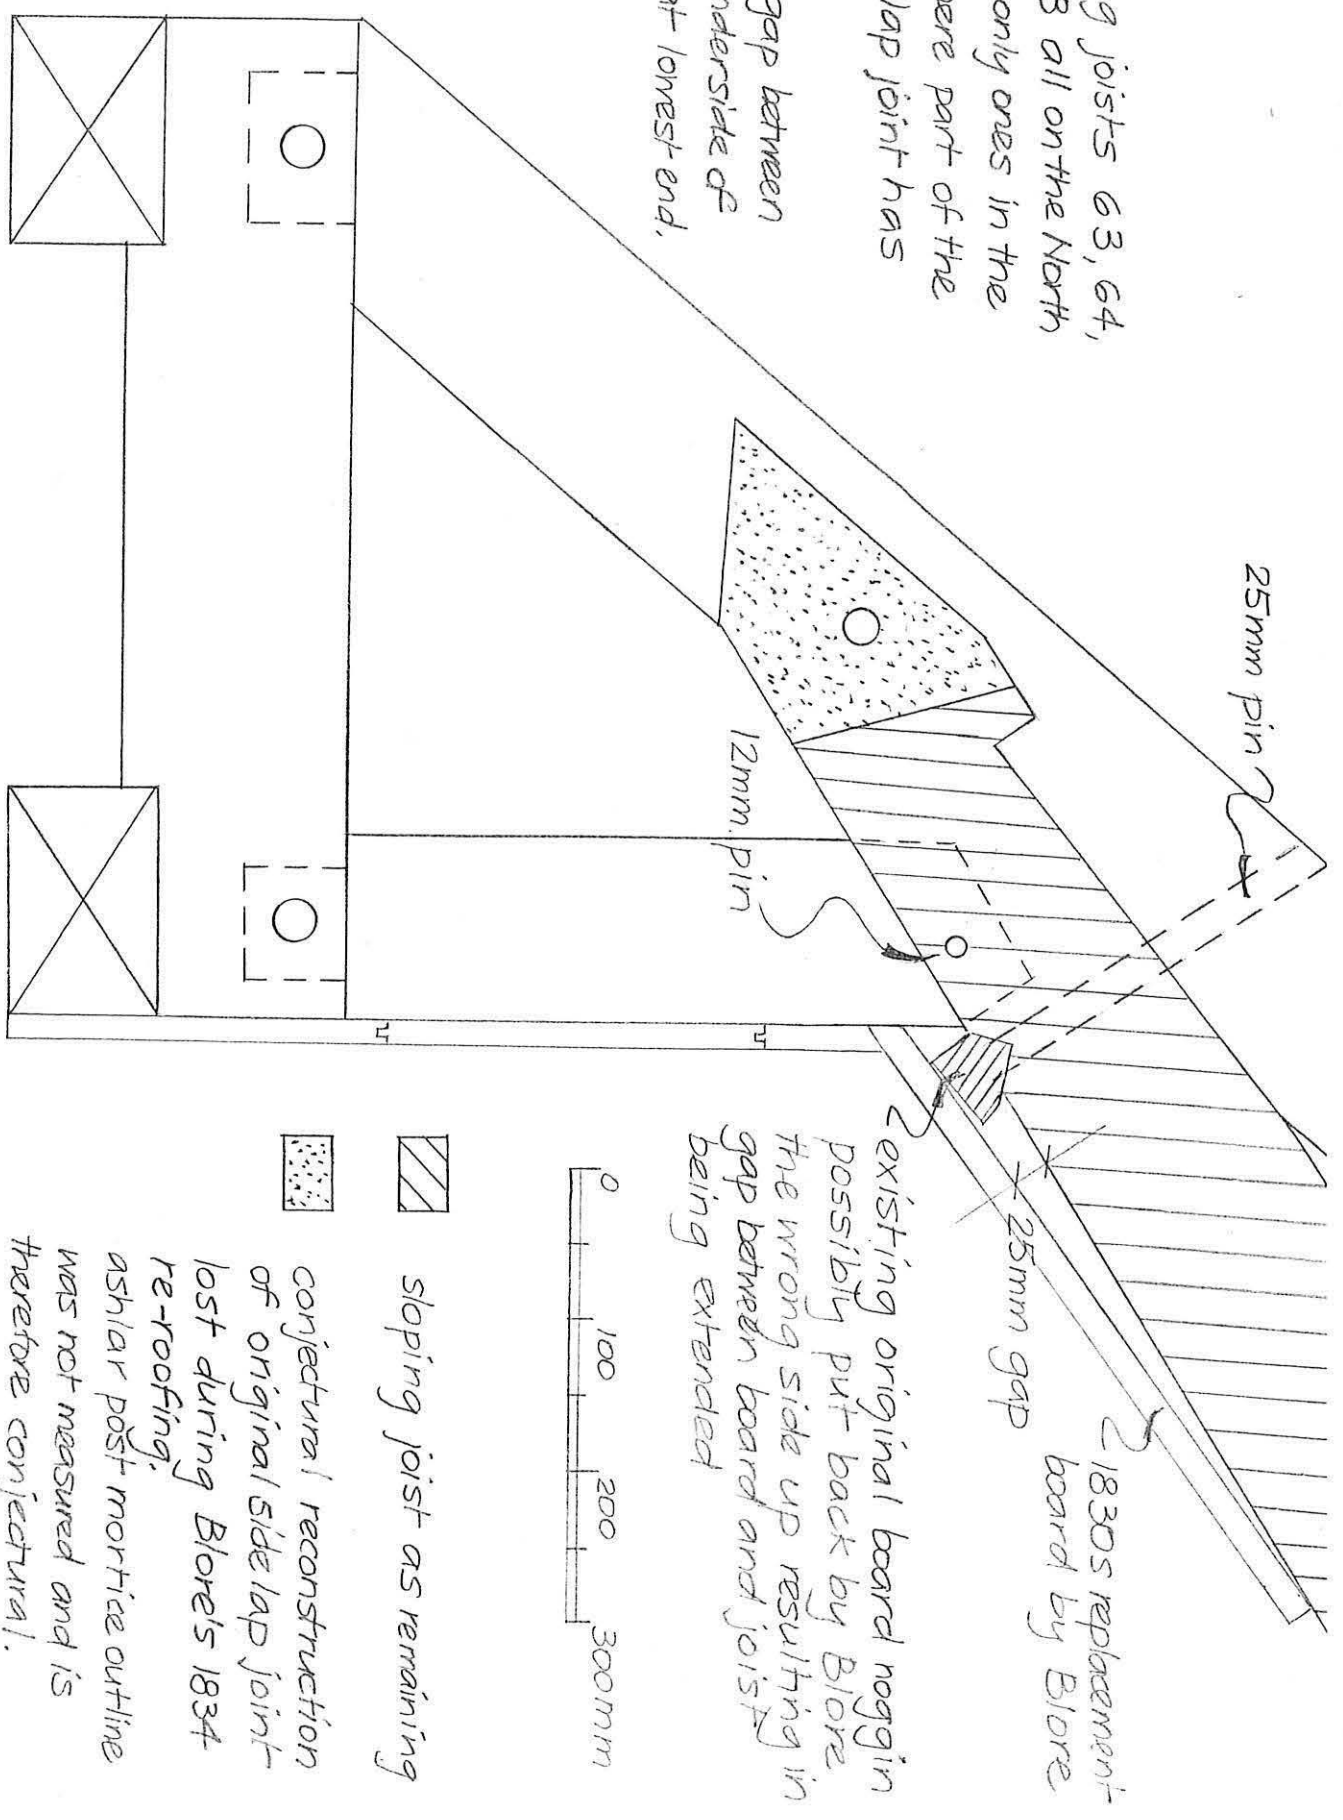
note 25mm gap between boards and underside of sloping joist at lowest end.

existing original board noggin possibly put back by Blore the wrong side up resulting in gap between board and joist being extended

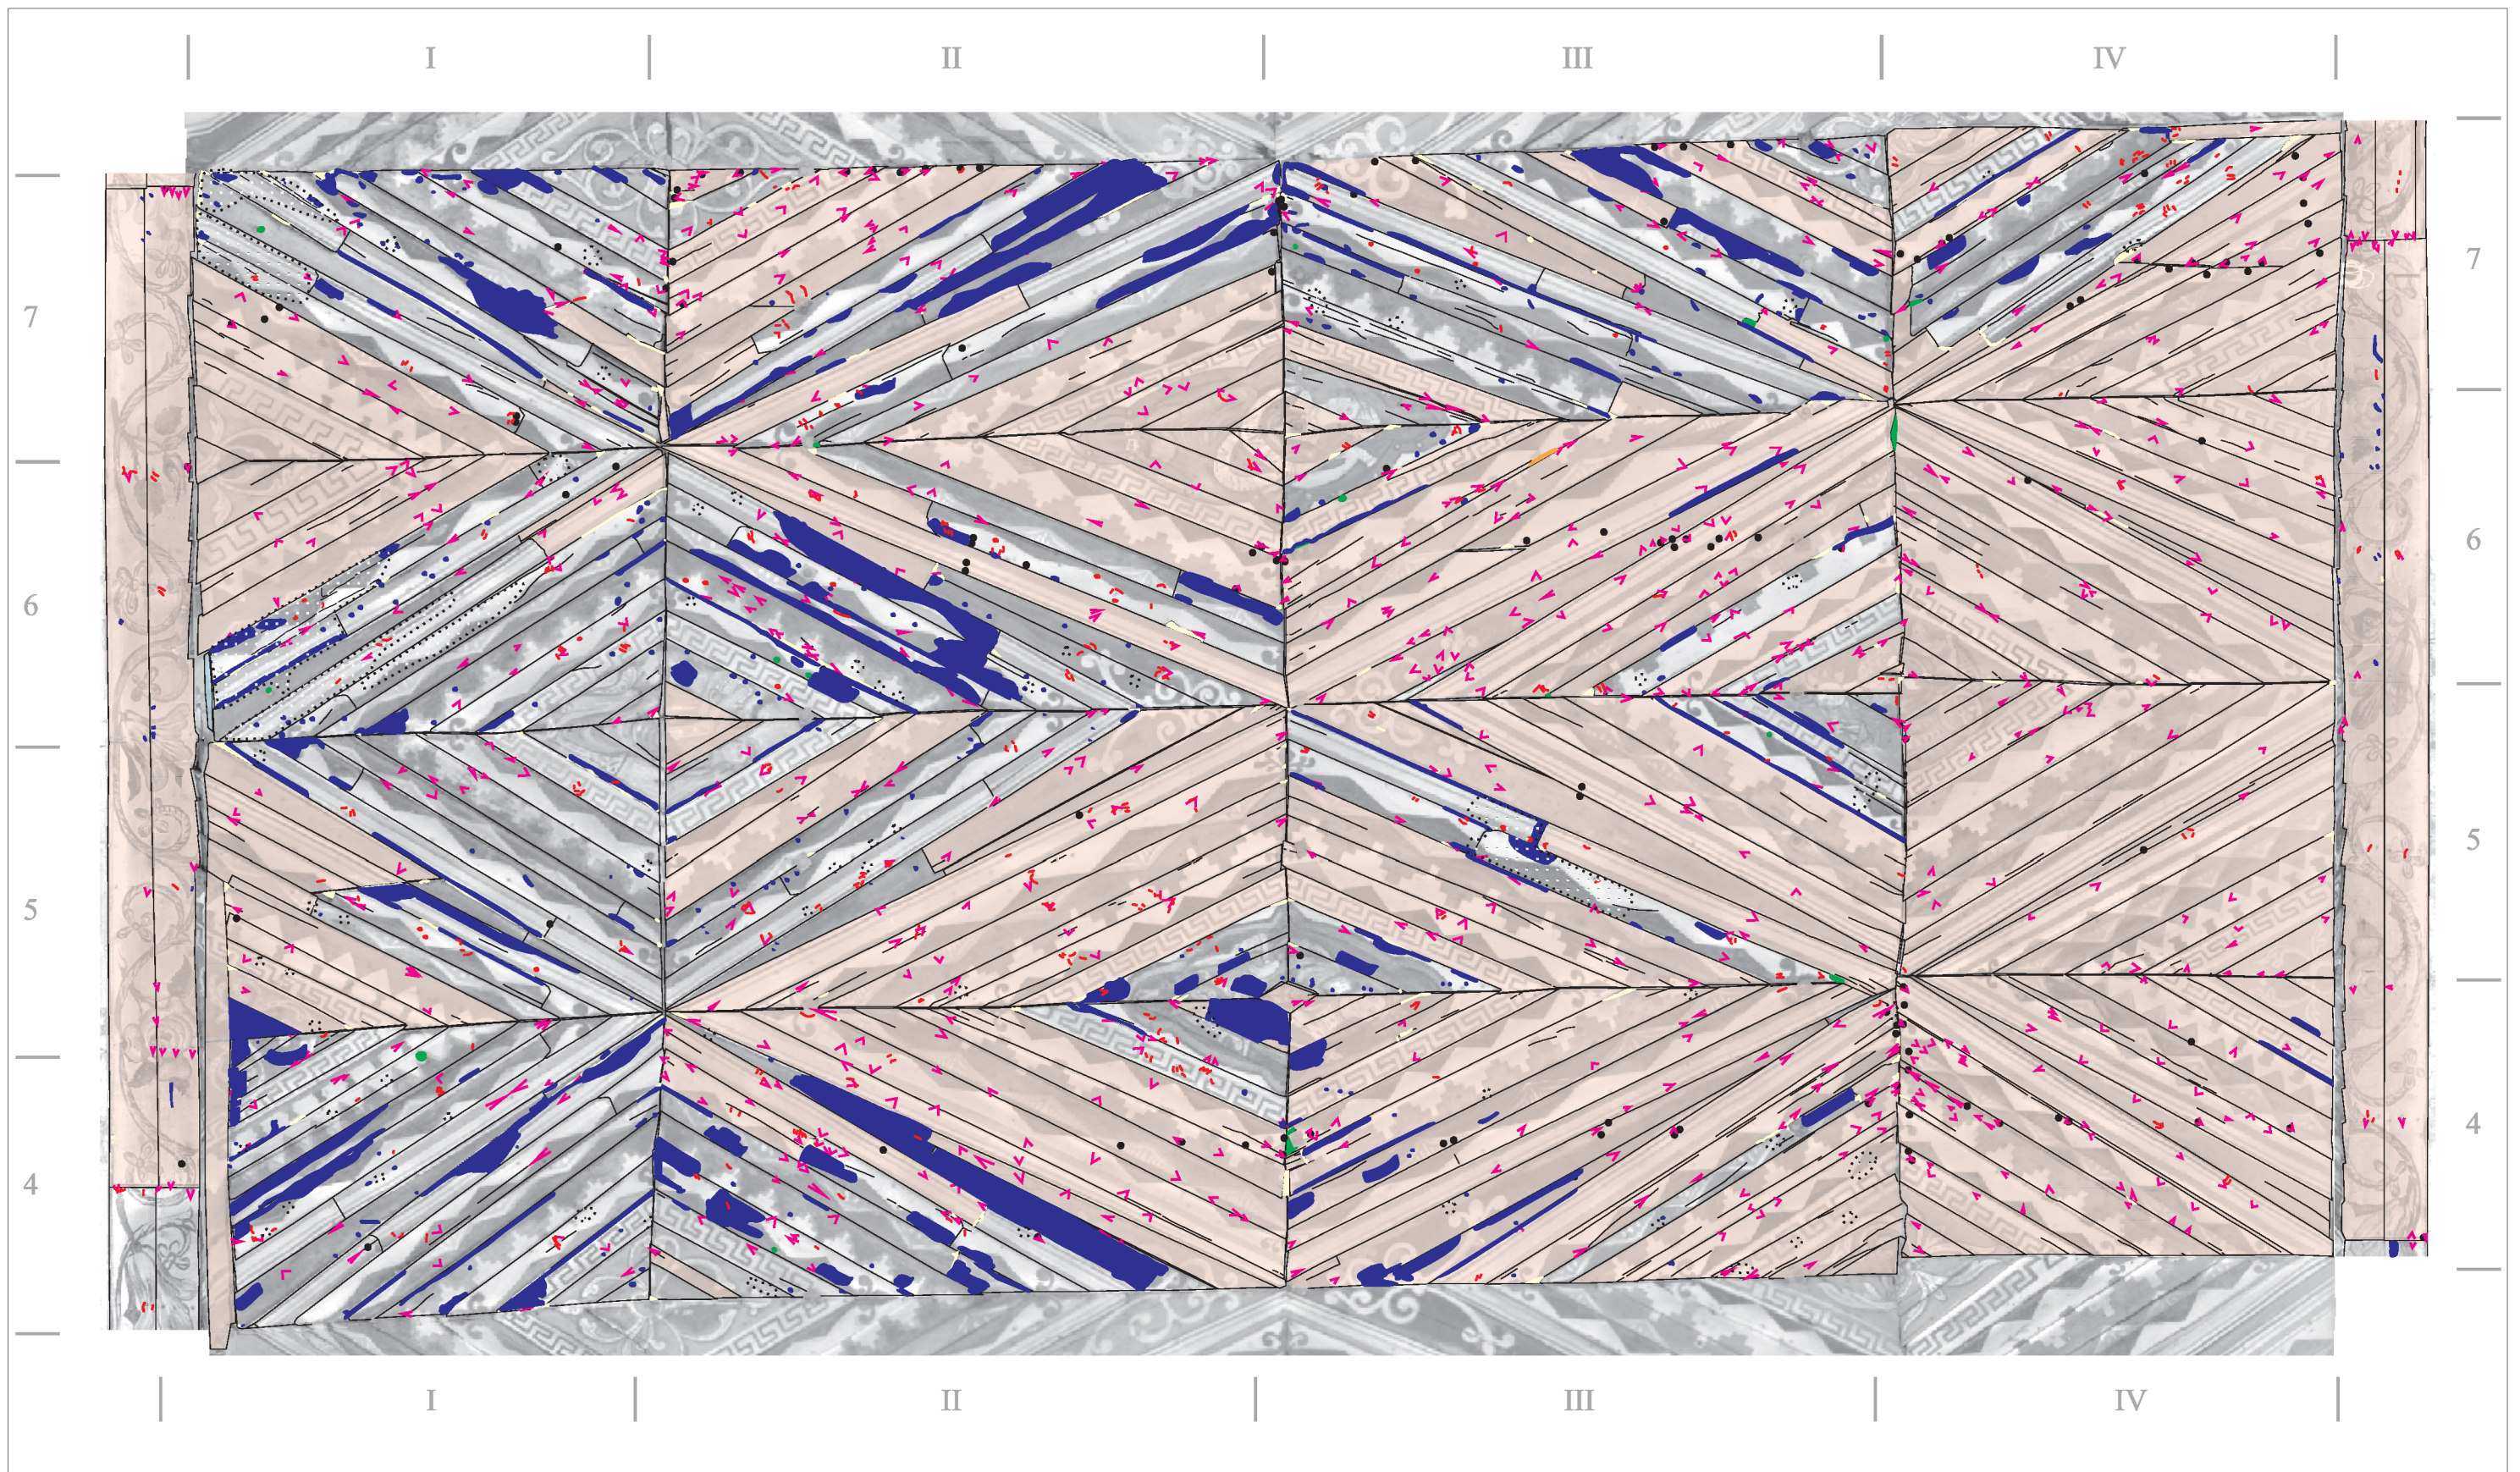
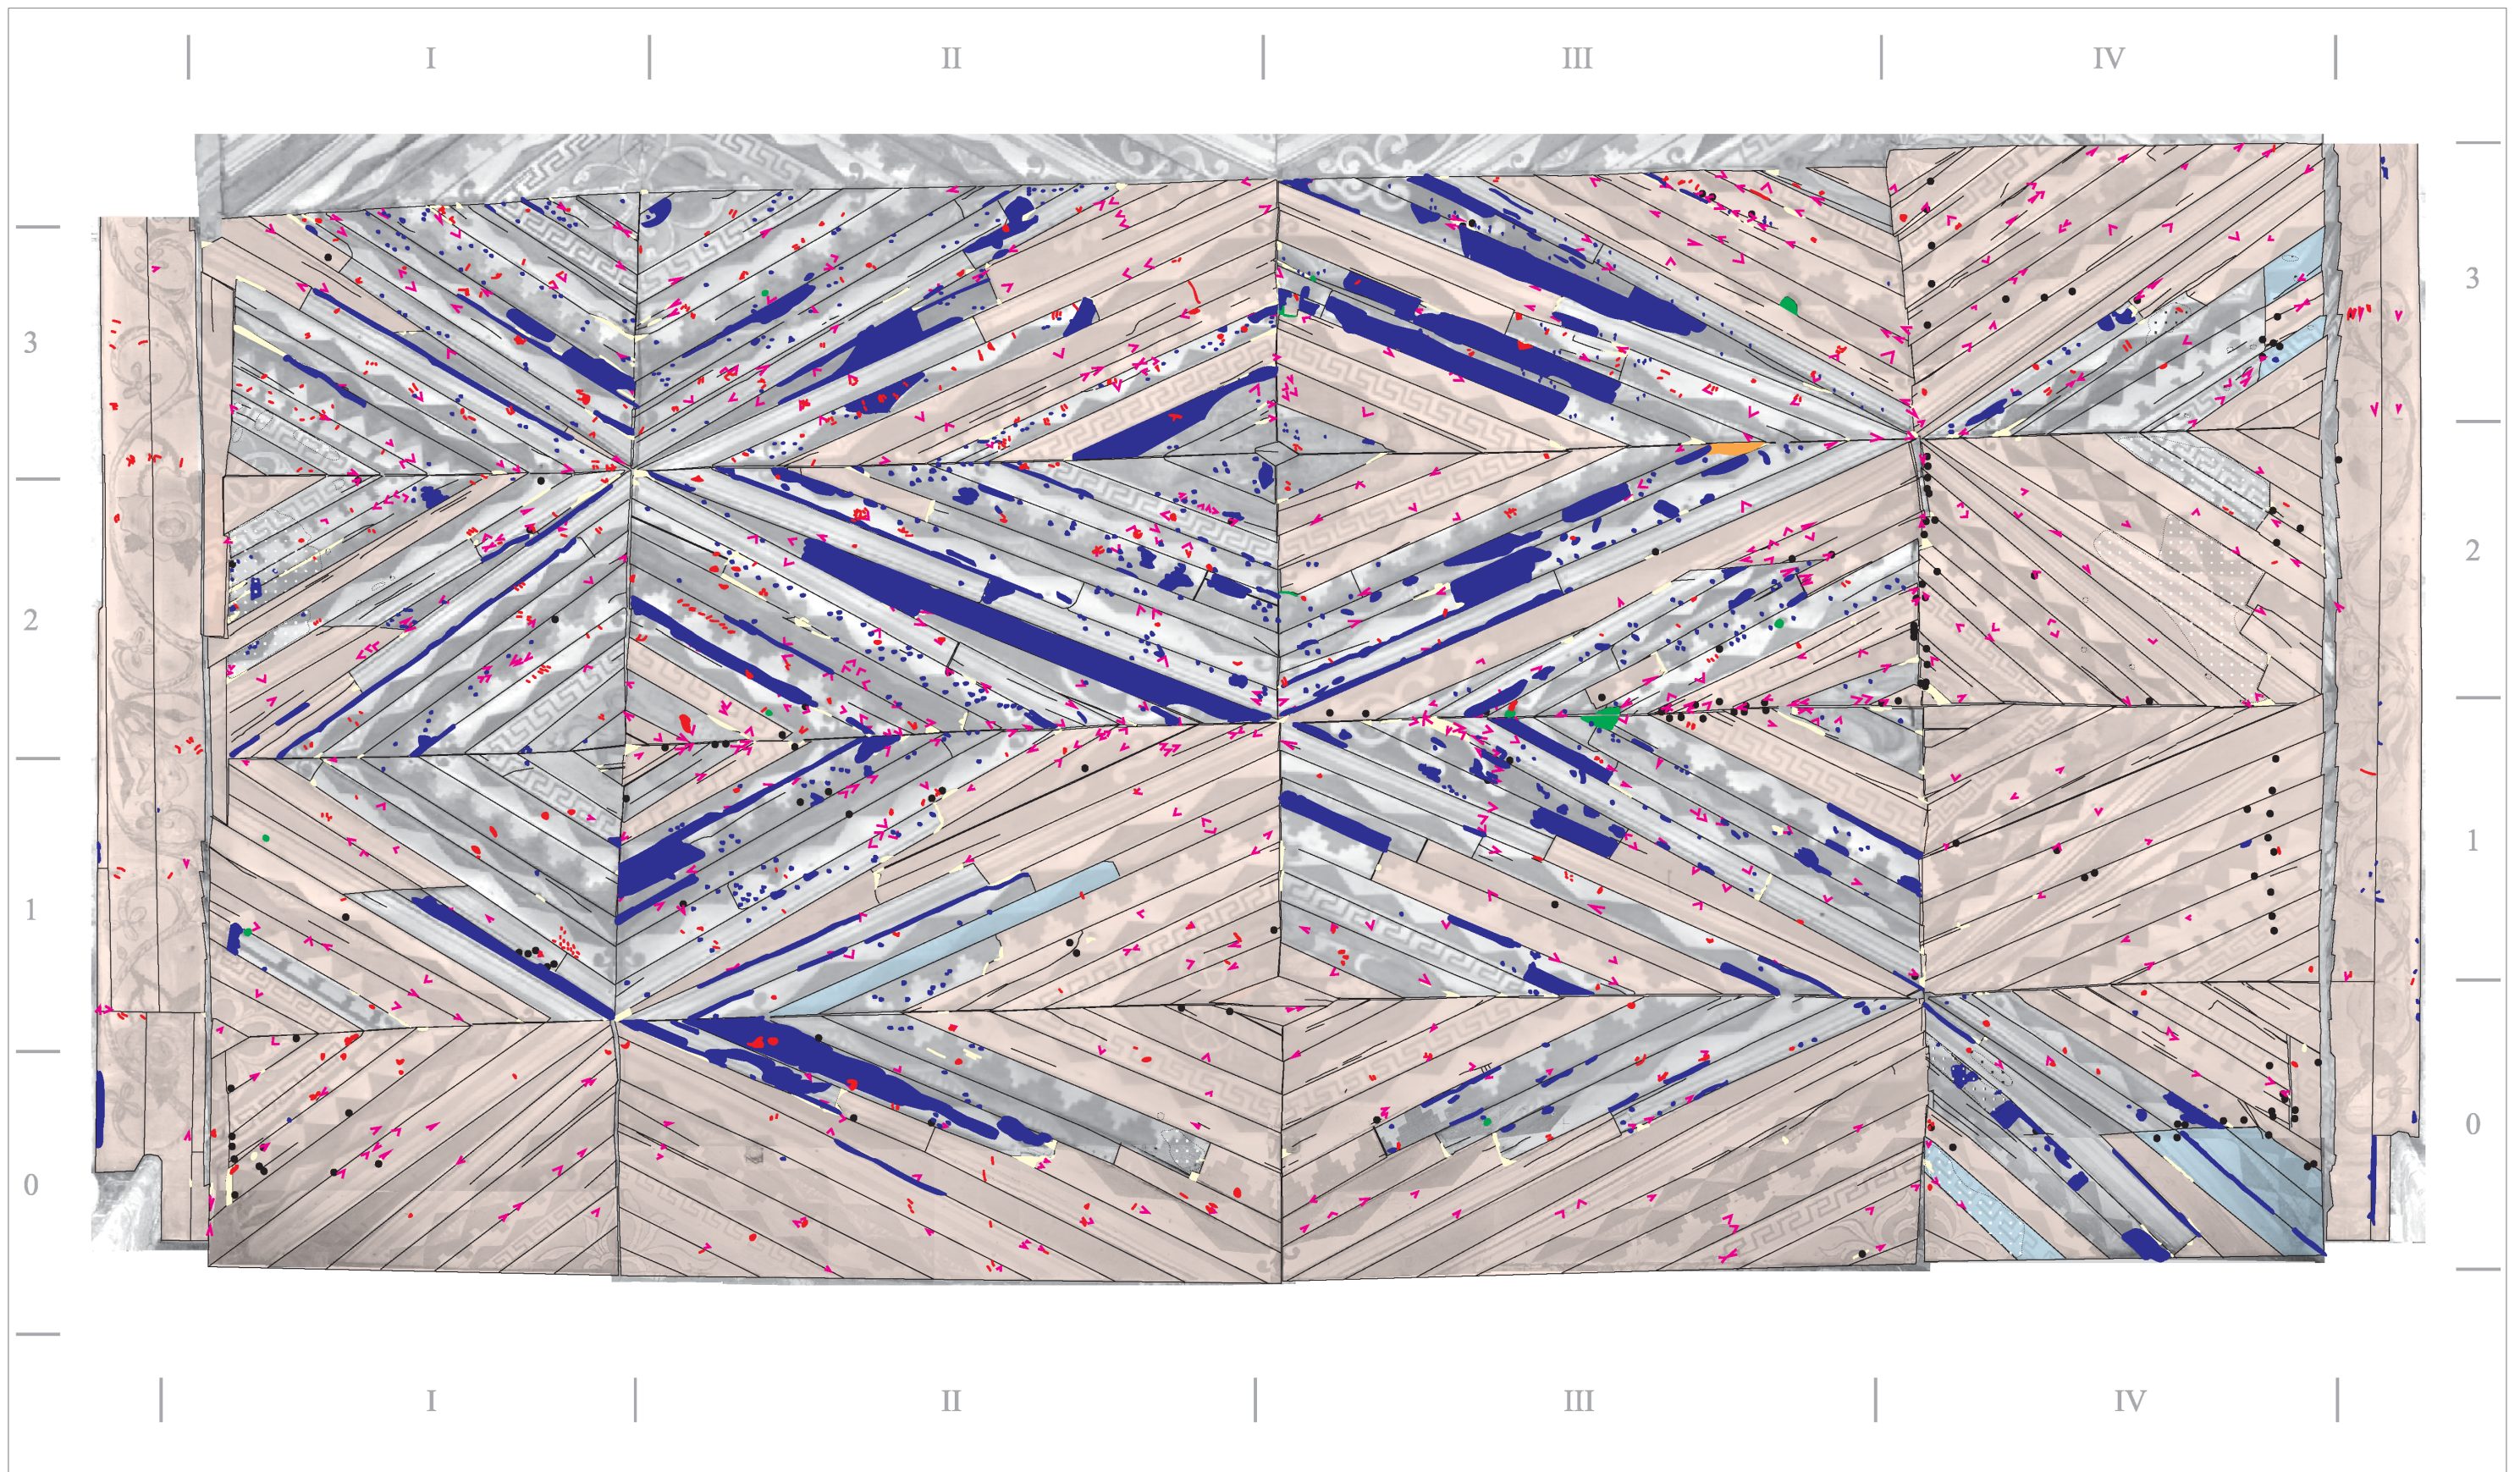
Repositioned oak boards - Not many of these boards are found in this phase.

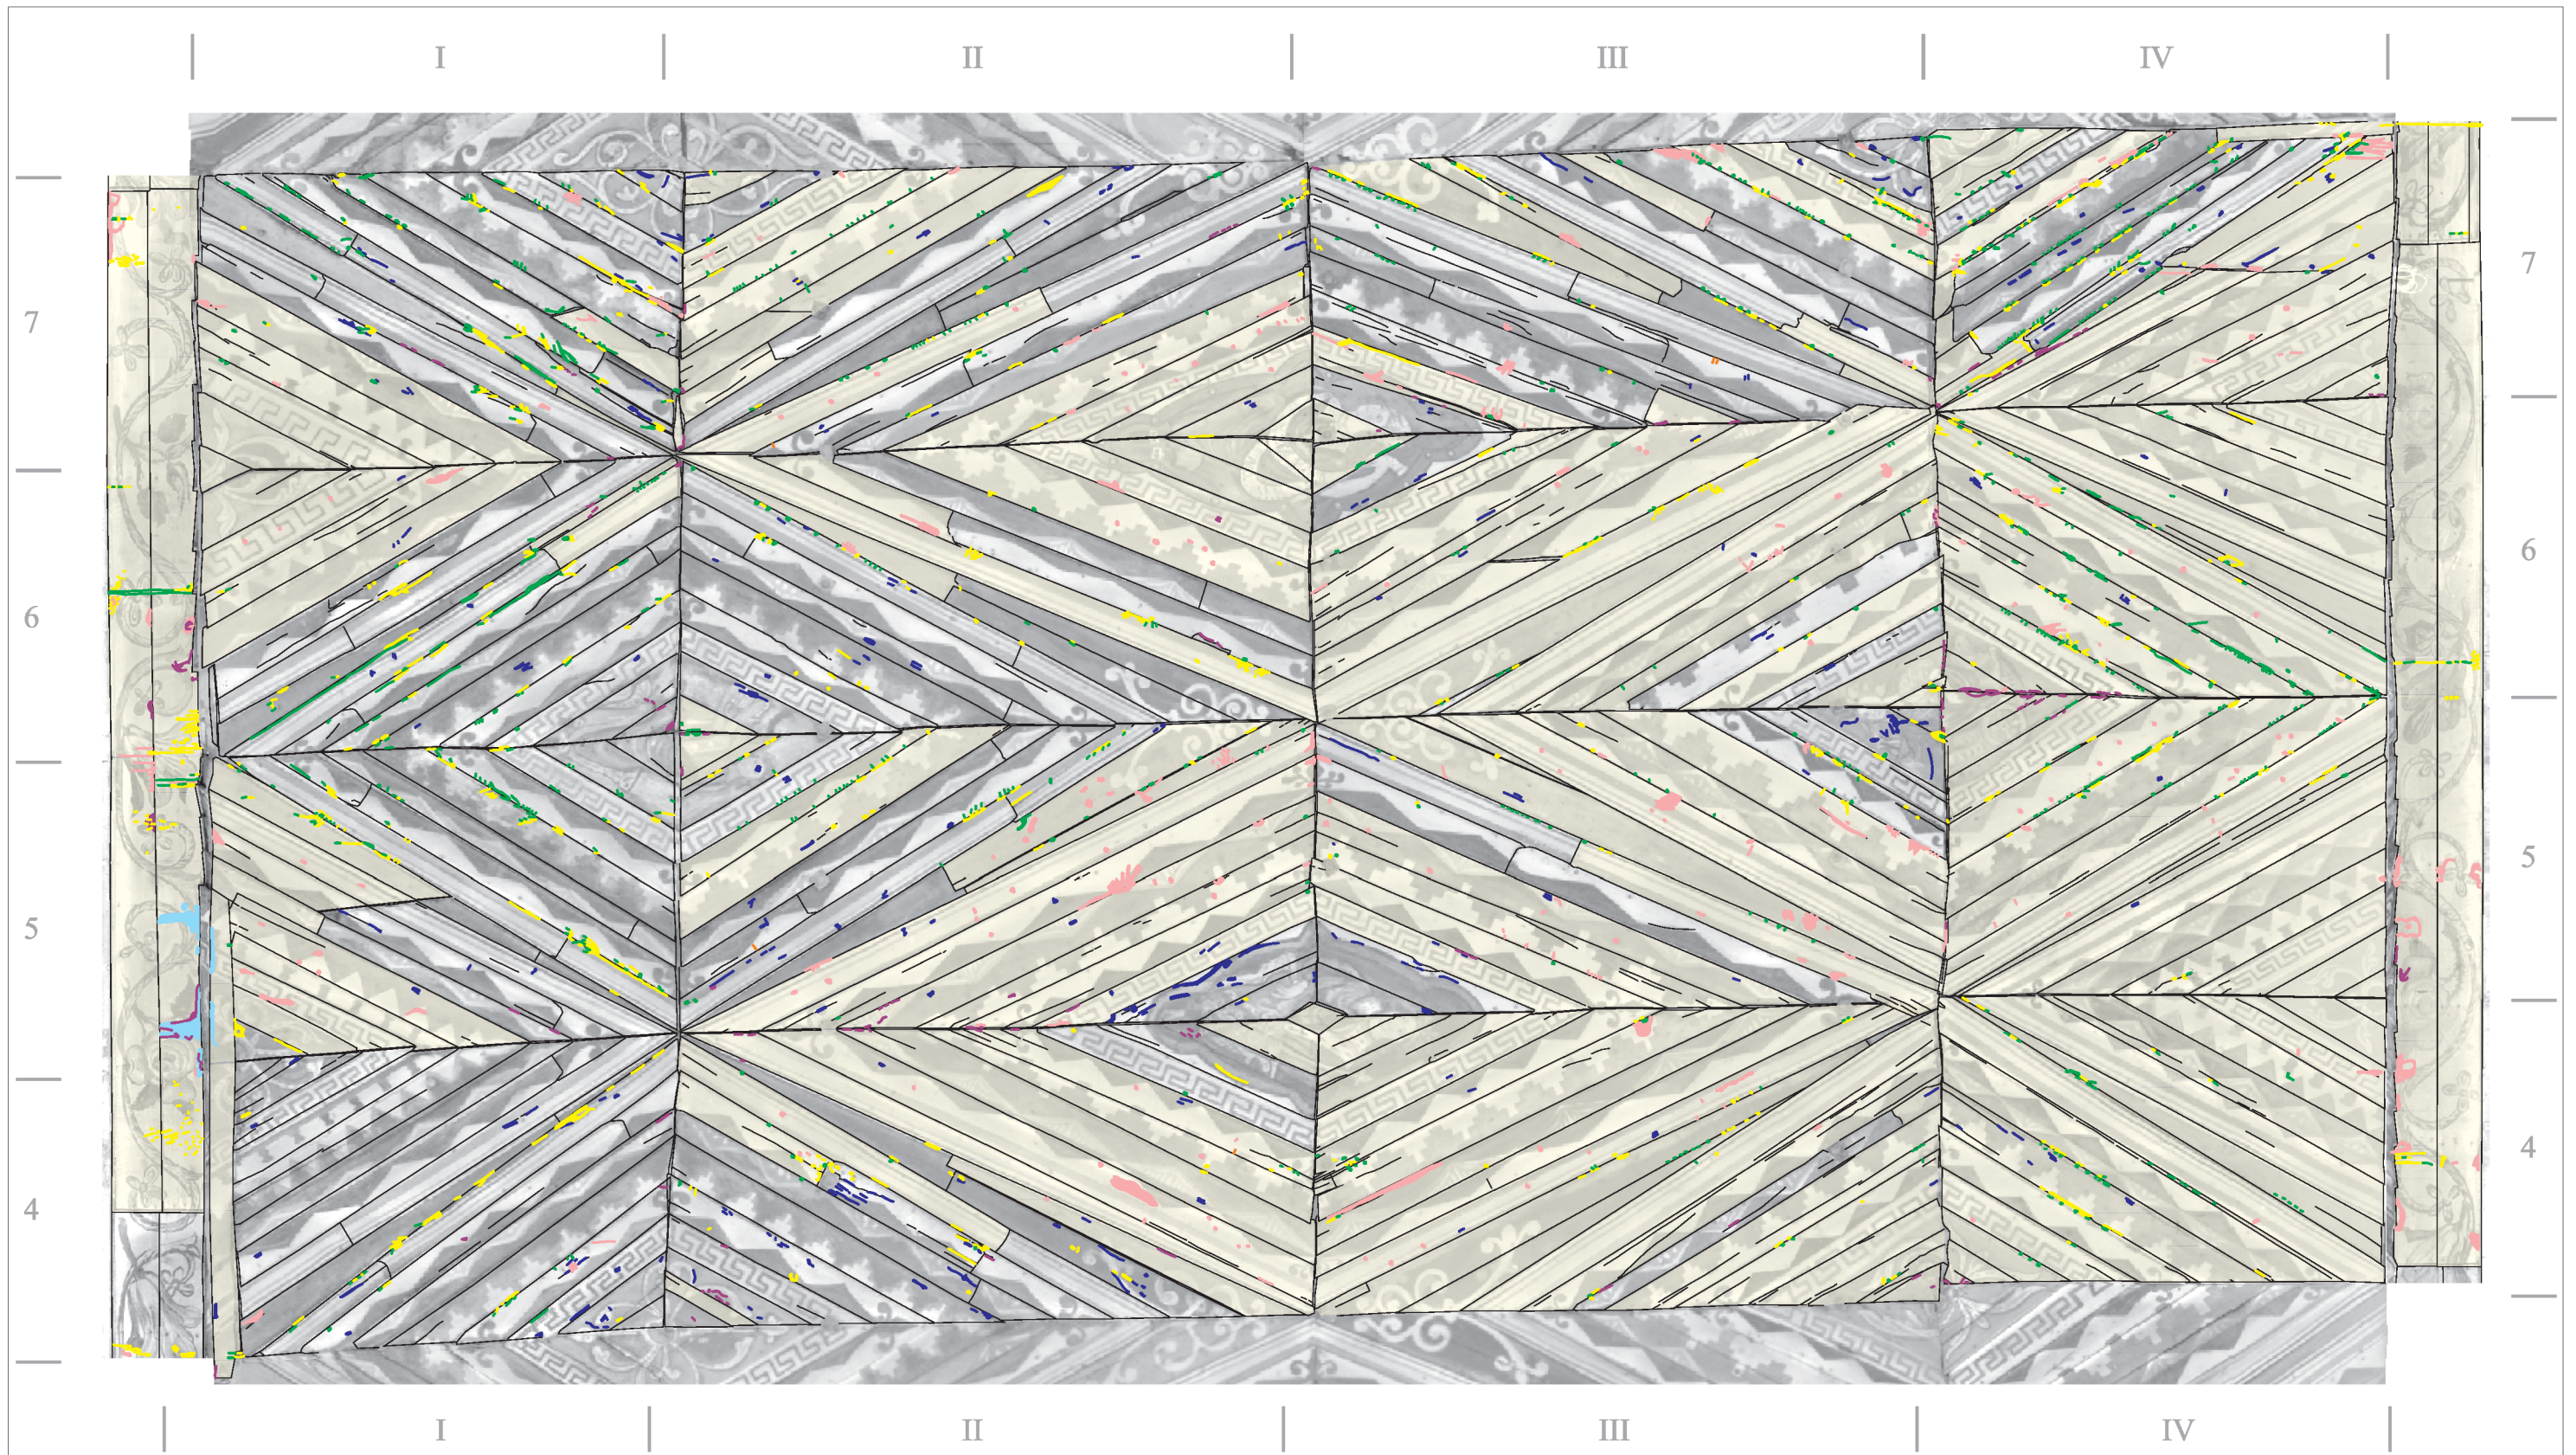
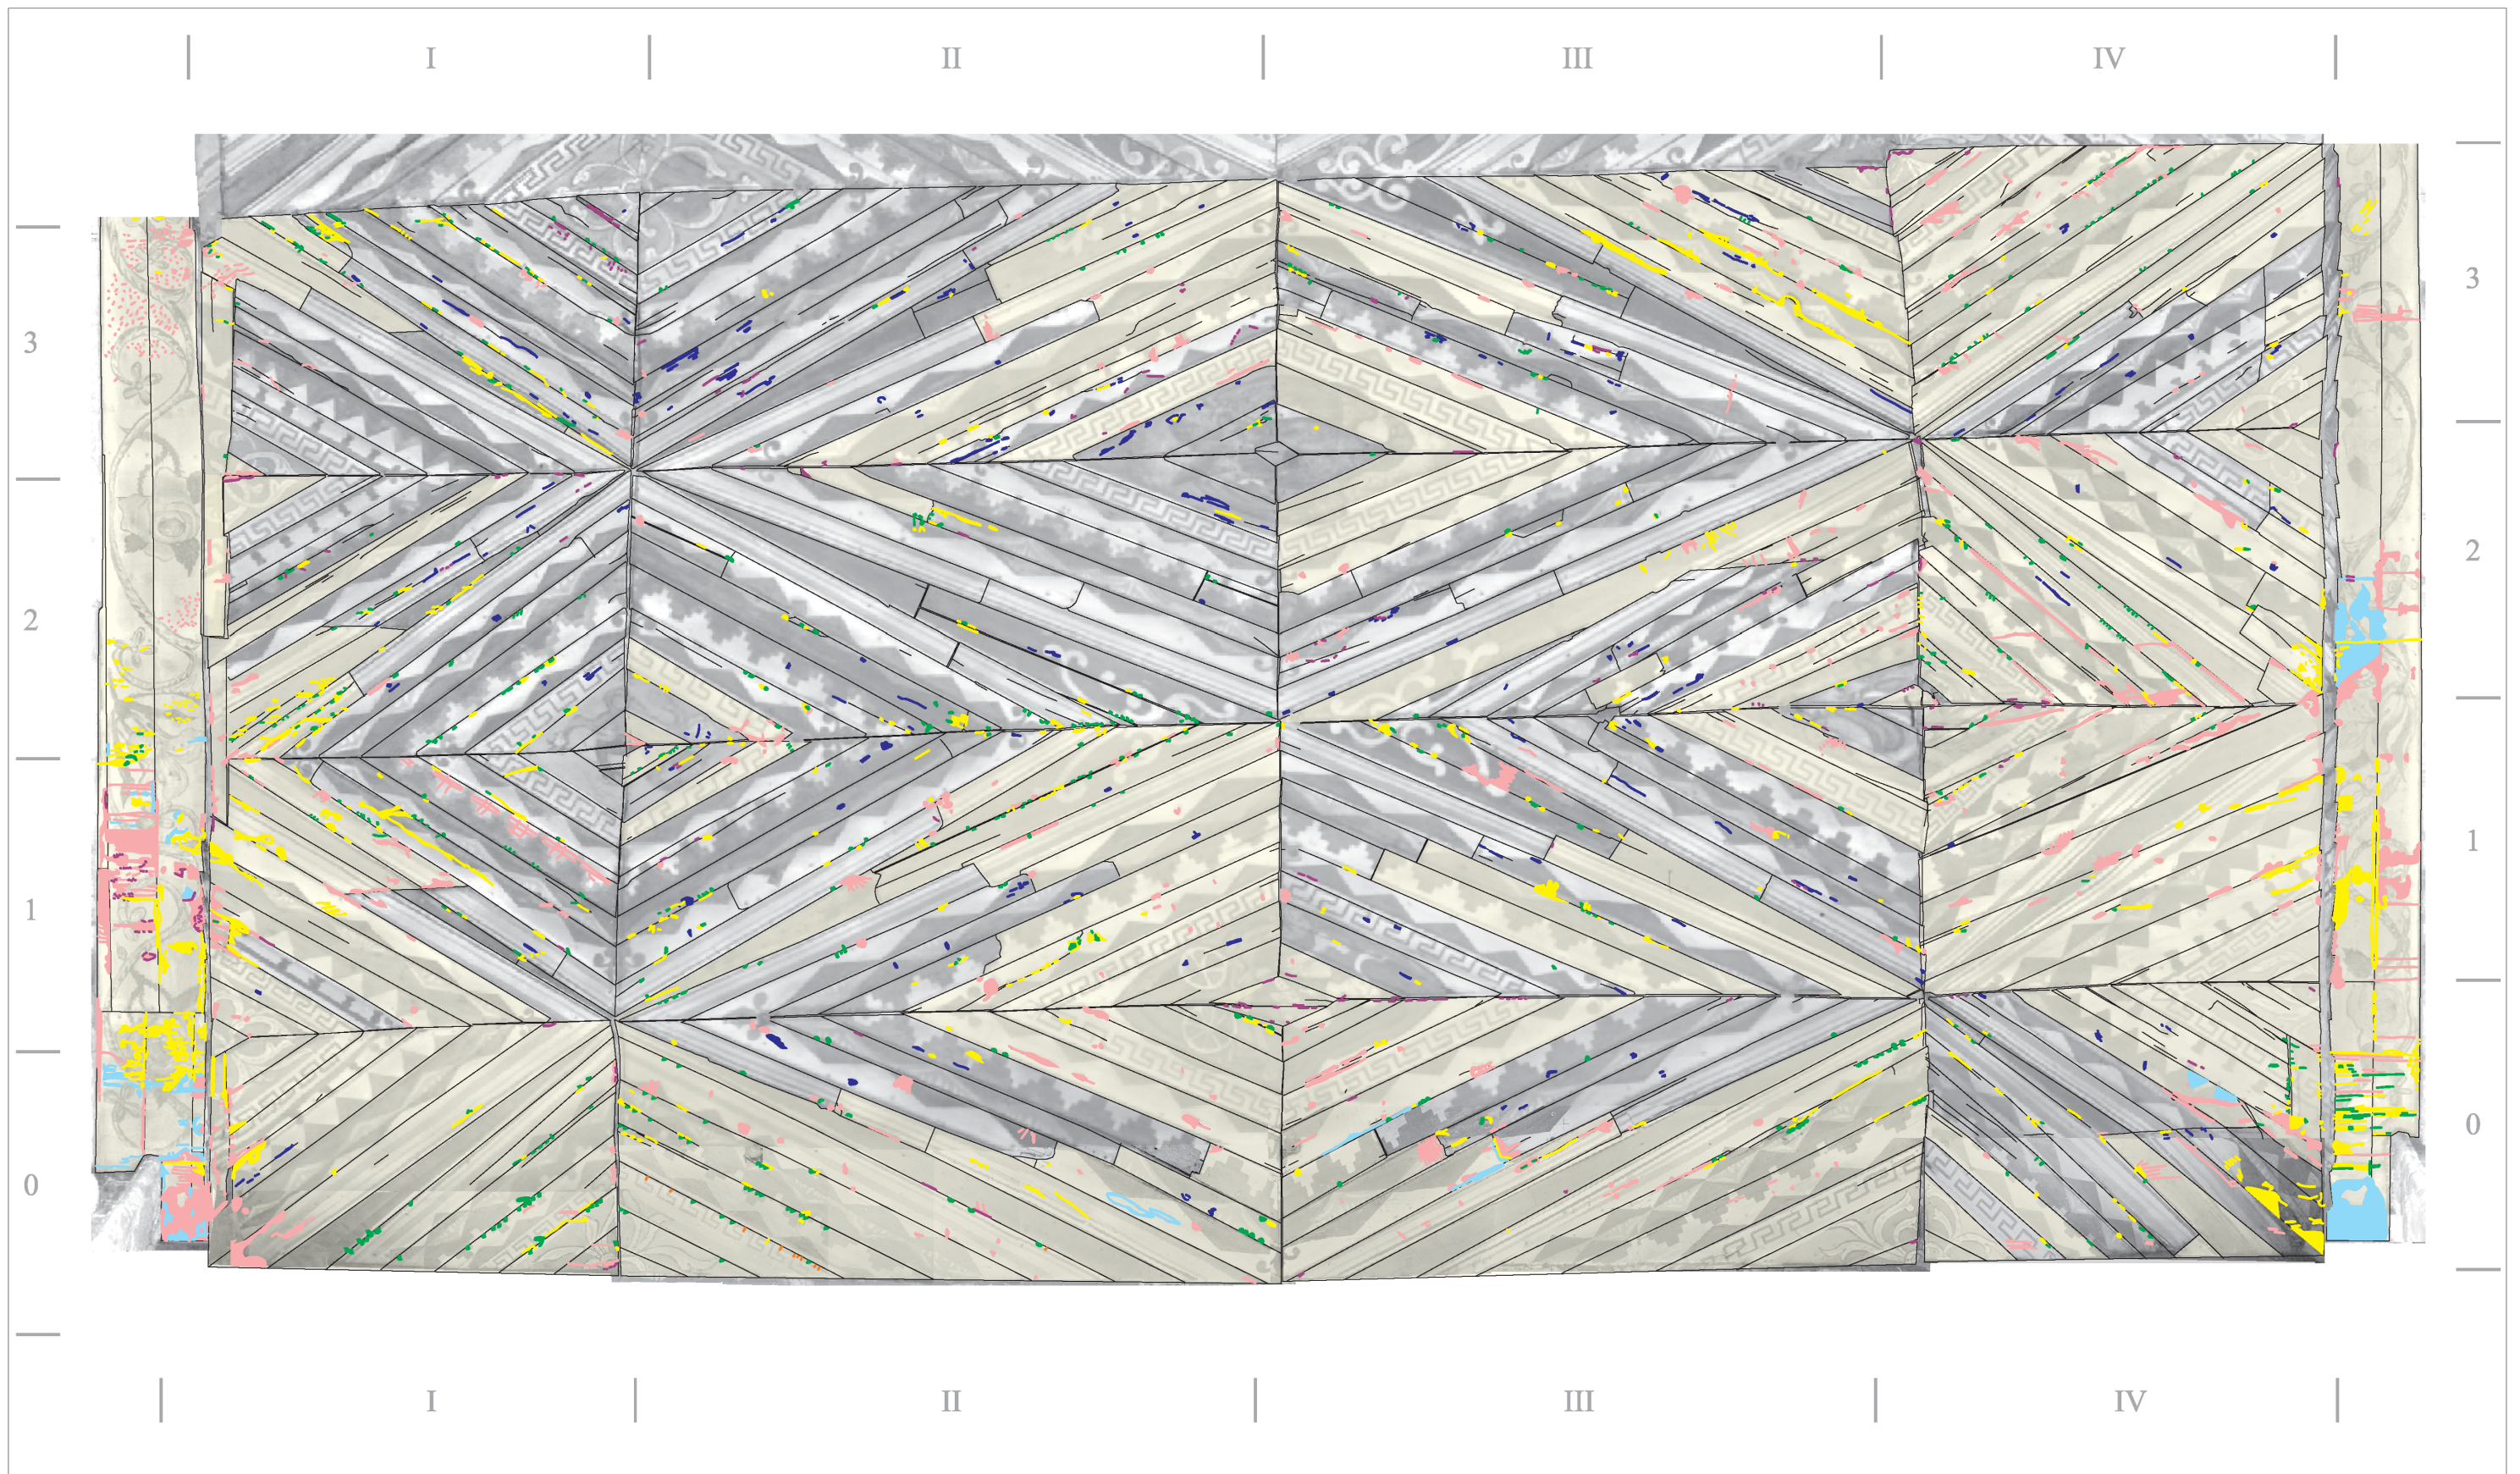
Efflorescence - In Bays 4-10 the 'white chalk line' efflorescence (in previous phases associated microflaking on the wave pattern boards) was found on other boards particularly around the edges of splits : at least two different salts are present, chloride and sulphate. All efflorescence was removed.

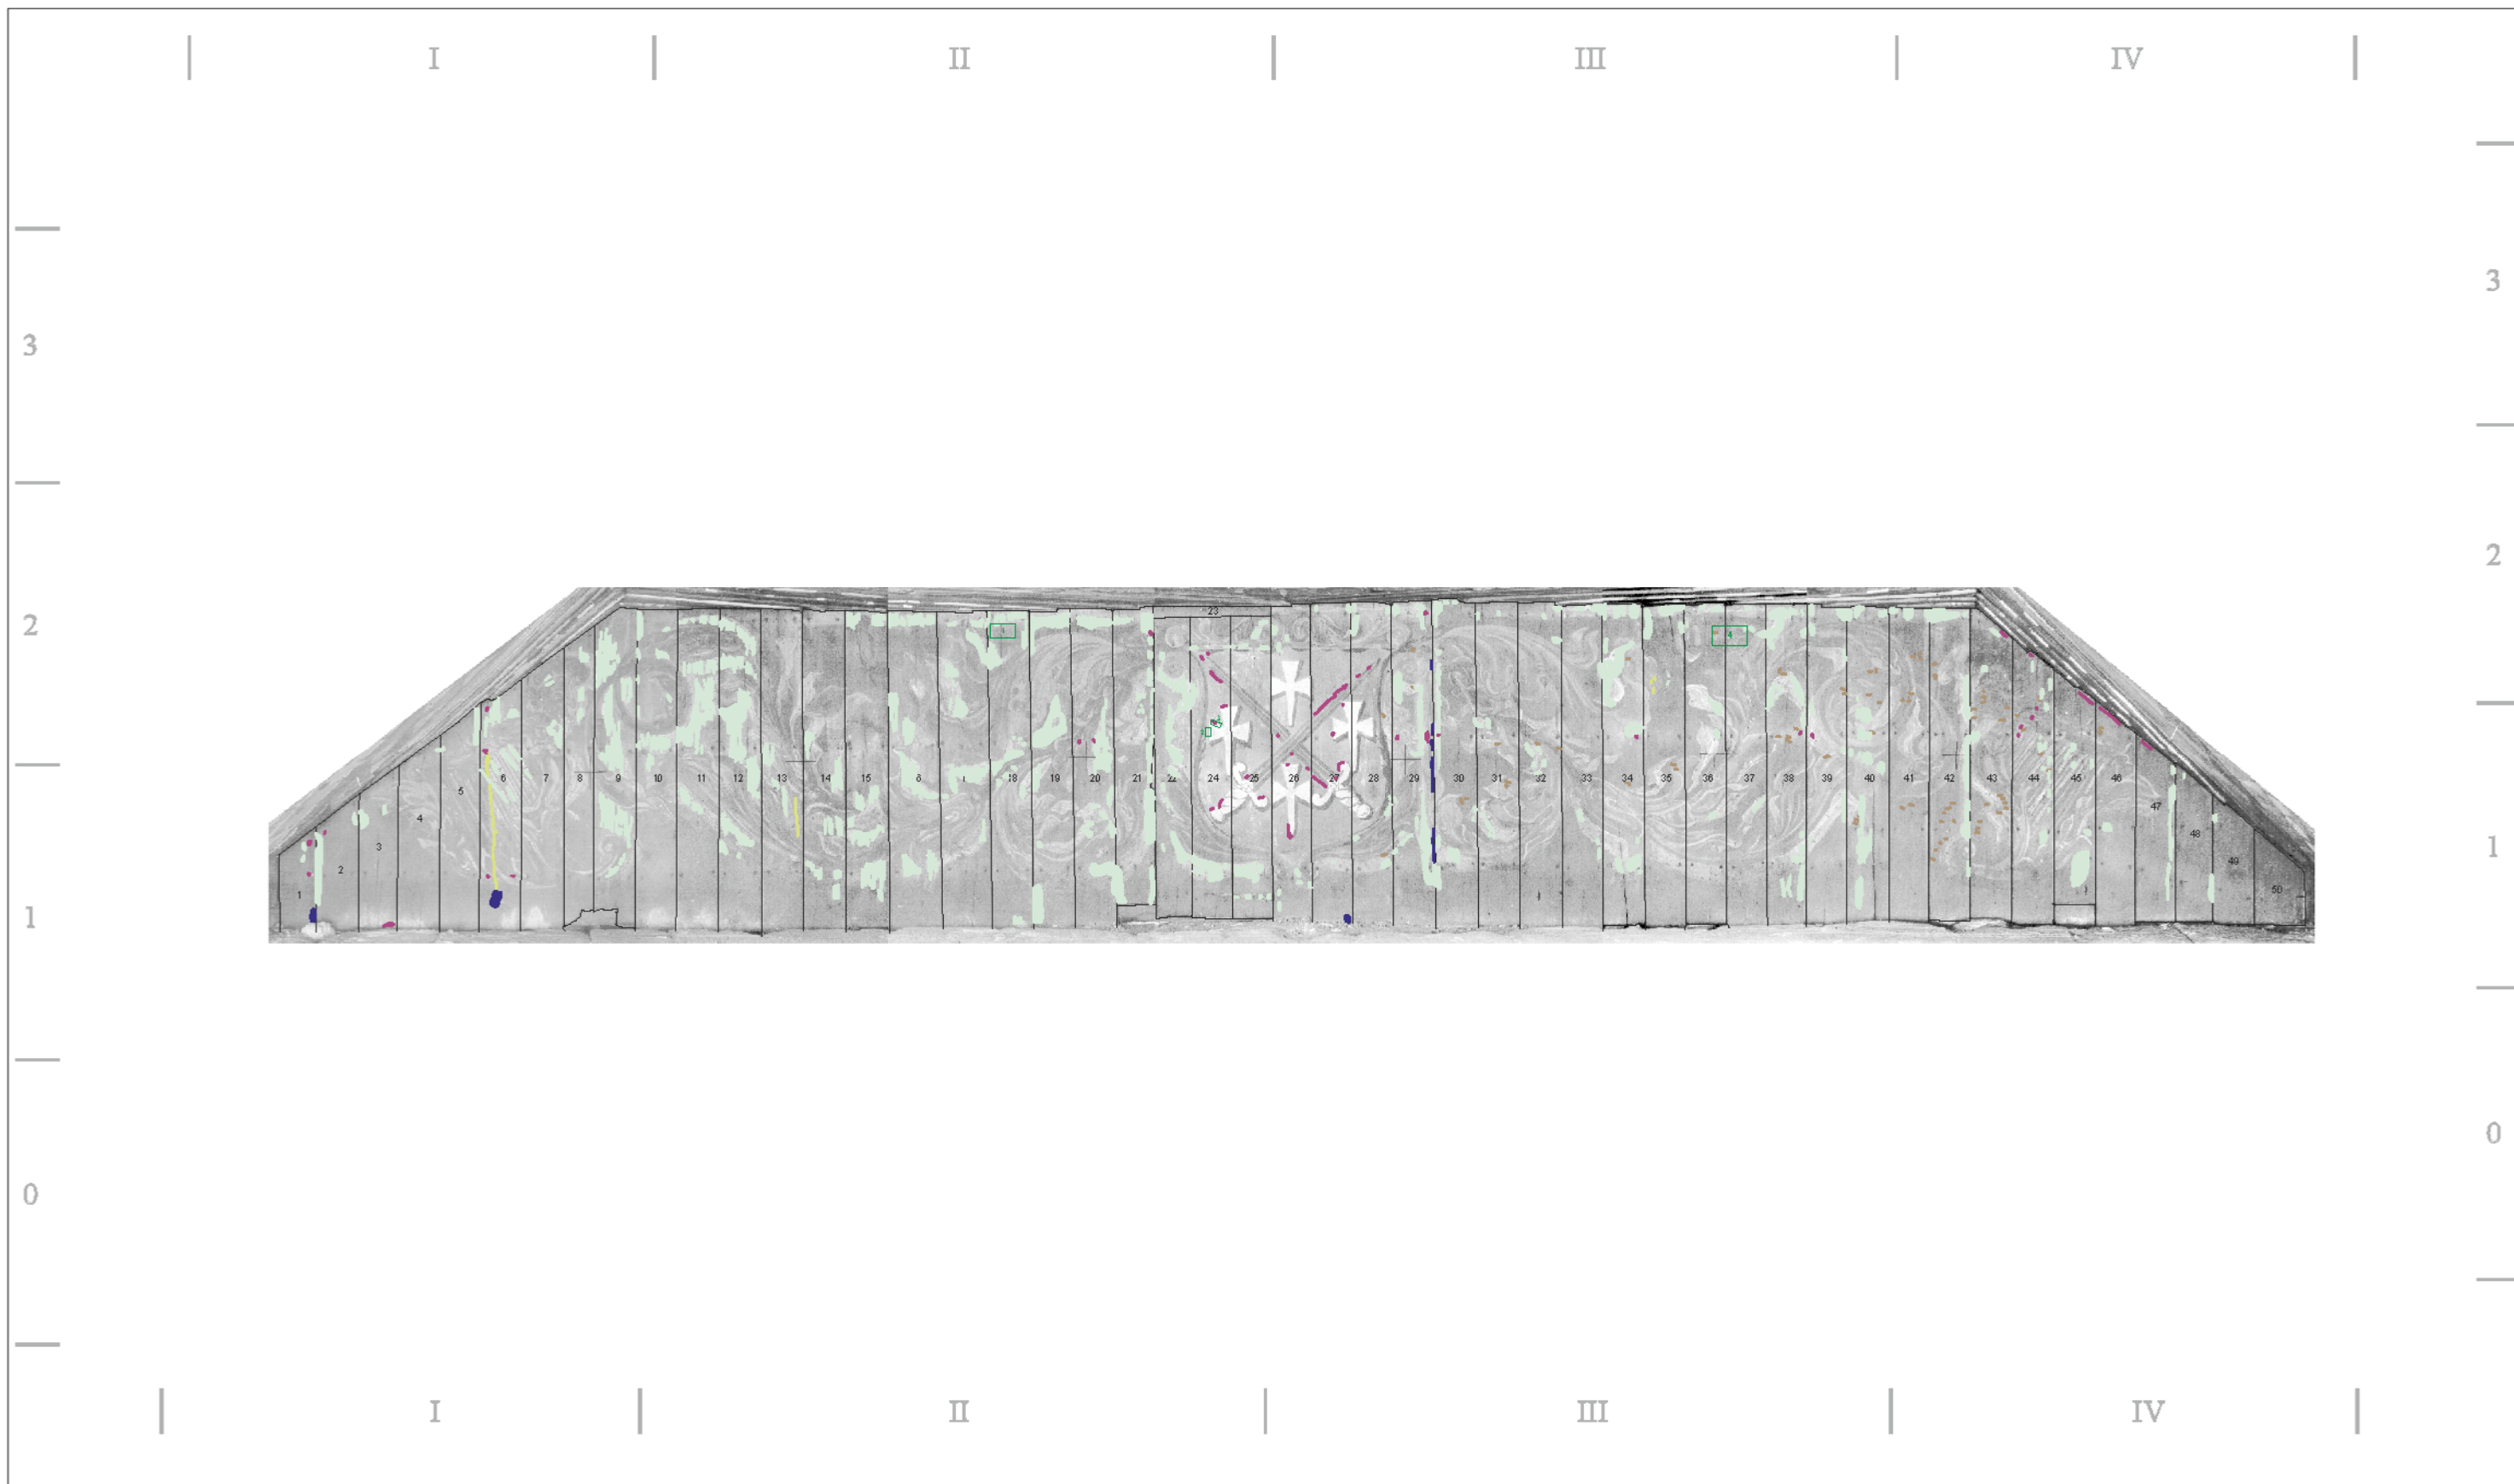
NOTES **Graffiti** - The most interesting graffiti on the West End Vertical boards is an indistinct white painted inscription "...Cobley Painter 1835" within a small foliate cartouche, also painted in white.
