PETERBOROUGH CATHEDRAL

ENVIRONMENTAL MONITORING OF THE NAVE CEILING

MARCH 1998 – MAY 2000

Report No: PTB01.1

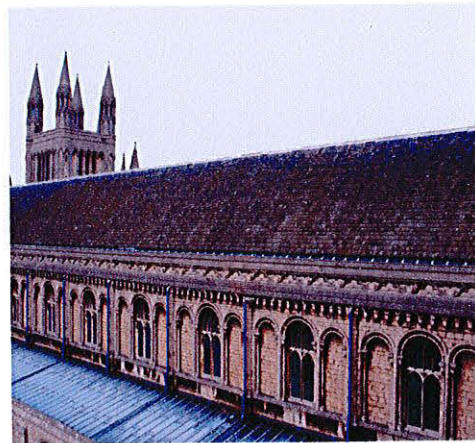
Figure 3. South side of the roof. (Photo: TCA 2000)

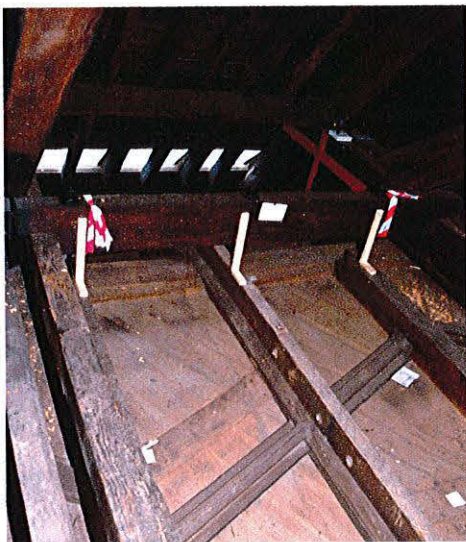
Figure 3. Detail of the back of the roof in bay 34 III. Note the windows at the base of the roof on the south side. (Photo: TCA 2000)

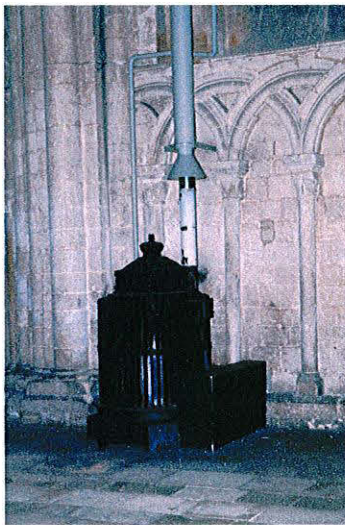
The stoves in the nave are situated in the north and south aisles at the east and west ends of the nave. Smoke stains can be seen directly above them on the aisle vaults and on the inner walls of the clerestory and triforium directly above, giving a clear illustration of the passage of hot air and combustion products.¹⁷

Figure 8. Stove in the north aisle.
(Photo: TCA 2000)

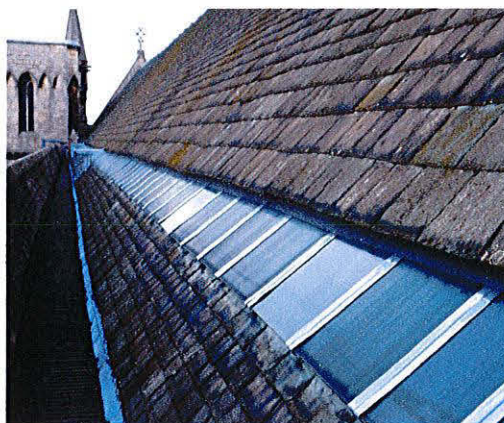
The principal sources of ventilation within the roof void, from the external environment, are the vents above and below the glass panels in the north and south sides, as well as those at the apex of the roof. Irregularities in the roof structure and the loosely fitting doors to the parapets would also provide minor sources of ventilation. Ventilation from the body of the cathedral can occur when the east access door is open and through irregularities and damage to the ceiling structure. However, ventilation from these sources is very limited in comparison to the external sources.

Figure 9. Windows on the south side of the nave roof.
(Photo: TCA 2000)

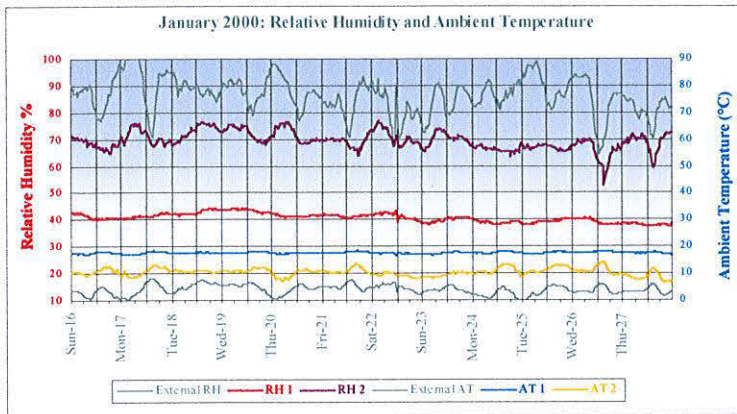
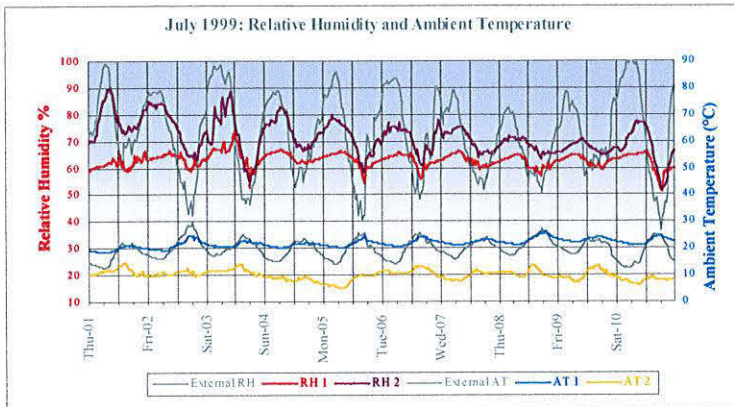
Analysis of the data showed a very clear humidity and temperature gradient between the upper and lower sides of the ceiling, throughout the year. This is most significant in the winter when there may be a variation of over 30% RH and 10°C . However in the summer, the conditions are closer, with variations generally of no more than 5% RH and 4°C . (Charts 1 & 2)

Charts 1 & 2: The charts show the variations in the pattern of internal relative humidity and ambient temperature at probes 1 and 2 during July 1999 and January 2000. The divergence in the conditions above and below the ceiling is apparent throughout the year but is particularly extreme in the winter. The stability evident in the conditions at probe 1 in January is due largely to the buffering effect of the closed building in conjunction with the high level of constant heating. The lack of buffering is very apparent at probe 2 during the same period.

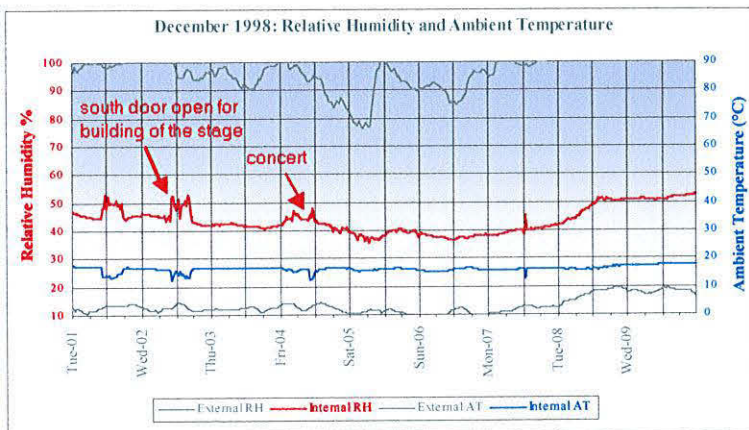
Sudden changes in ambient temperature, resulting from the doors being open, were clearly visible during winter, which had an immediate impact on the relative humidity and ambient temperature. In summer, the contrast between internal and external conditions were less significant and therefore sudden changes were smaller and less obvious. The ingress of external air usually caused a mild increase in the absolute humidity as the external level was generally higher than that inside. Irregularities such as this were short lived, and the AT and therefore RH returned to their previous levels within one or two hours of the incident. (Chart 3)
Interestingly the events recorded in the cathedral diary when the doors were open, did not always show on the environmental data. It is thought possible from anecdotal evidence that wind direction might have a significant impact on the level of air exchange, as well as occasions when both the west and the south doors are open at the same time, increasing the speed and level of air exchange.

Chart 3: Conditions at probe 1 during December 1998 showing the impact of the doors being open during the preparation for and presentation of, a concert in the nave. Note the sharp fall in ambient temperature causing a marked increase in the relative humidity.

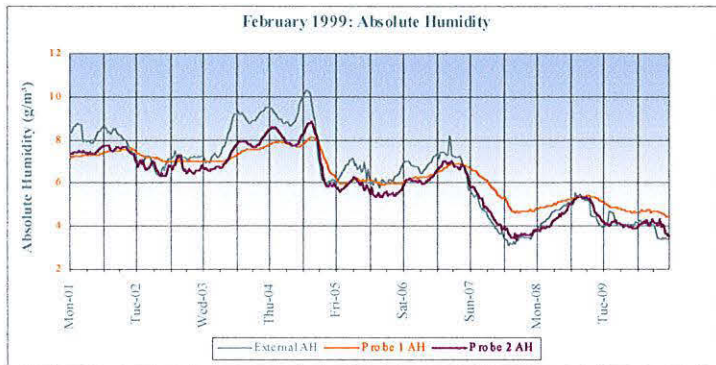
Chart 4: The absolute humidity at probe 2 follows the external values far more closely than that at probe 1, demonstrating the differing levels of buffering above and below the ceiling.

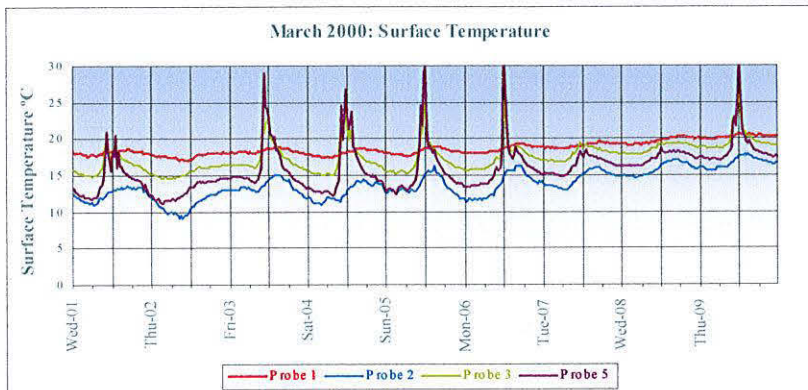
The data recorded in February 2000 showed that both ambient and surface temperature at probe 5 (on the upper side) rose more significantly than at probe 3. (Chart 5) However, by April, the rise in ambient temperature was similar and the rise in surface temperature was far greater at probe 3 (lower). The reason for this is not entirely clear although it may be associated with the changing angle of the sun at this time of year, falling preferentially on different sections of the panels.

Chart 5: Comparison of the surface temperatures in March 2000, clearly demonstrates the effect of direct sunlight on panel 33IV.
