PETERBOROUGH CATHEDRAL

ENVIRONMENTAL MONITORING OF THE NAVE CEILING

JUNE 2000 – MAY 2001

Report No: PTB01.2

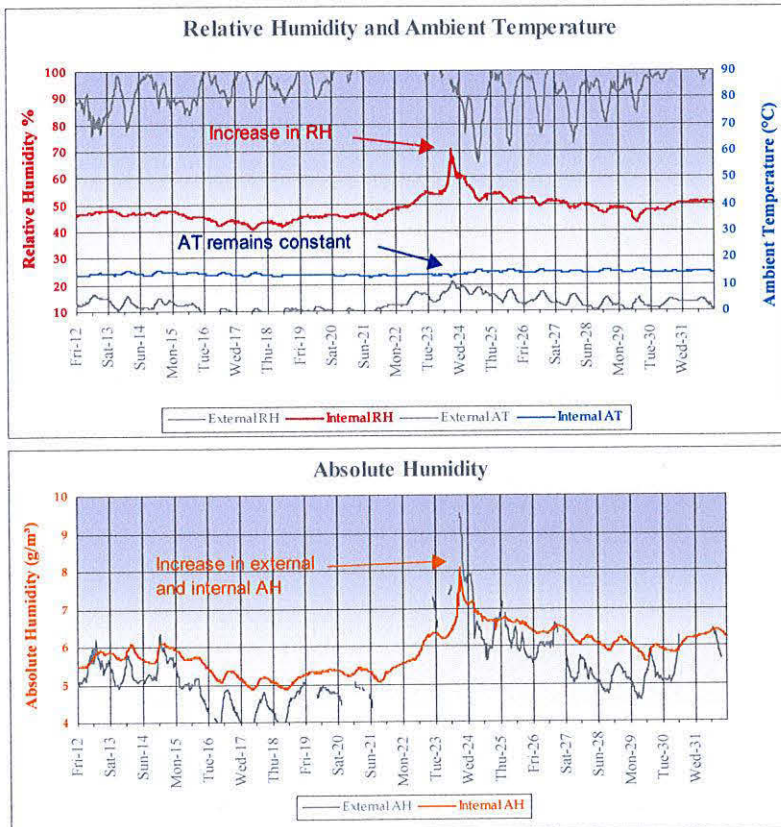
As was the case in previous years, there was a very large variation in the level of buffering between the external conditions and those in the body of the cathedral, and the external conditions and those in the roof space. In the cathedral itself, the influence of the external conditions was relatively low, in particular in the winter when air exchange (as a result of deliberate ventilation) was at its lowest, and the airspace was artificially heated on a twenty four hour basis by the Gurney stoves. During this period the diurnal fluctuations of the AT were extremely low at approximately 1.5°C. The influence of the AT on the RH was therefore very limited and for much of the period the RH remained very stable. However, on occasions, there were sharp variations in the RH resulting from significant fluctuations in the AH. In almost all cases, this was due to the influence of the external AH, which was itself subject to external temperature fluctuations. Therefore although the external AT had very little influence on the internal AT, it had an indirect but very significant influence on the internal AH and therefore the RH.

Charts 1 & 2. Conditions at probe 1 in January 2001. The increase in external absolute humidity causes an increase in internal absolute humidity resulting in a sharp increase in internal relative humidity, despite the fact that the internal temperature remains fairly constant throughout.

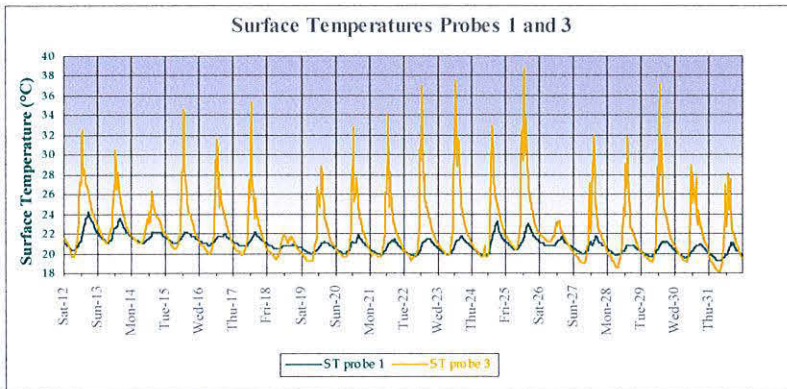
As was the case in the previous year, the effects of direct sunlight on the back of the panels was extremely dramatic, with sharp increase in ST and AT with consequent, and equally sharp, decreases in RH. It was interesting to note that in August 2000, although increases in surface temperature of up to 18°C were seen at probe 3 on the lower side of the ceiling, increases of only 8°C were seen on the upper side of the ceiling. However, by late September the temperature increases were similar. This appears to be due to the fact that the probes are not directly above each other and the angle of the sun is such that probe 5 is not subjected to direct noon sunlight until some weeks after probe 3. In September and October when both probes were receiving sunlight, the peak temperatures at approximately noon were almost identical. However, during the night, the surface temperature in the roof space dropped to several degrees below the temperature on the under side of the boards, presumably as a result of the ventilation with cool external air. During the periods of greatest solar heating, surface temperatures of up to 38°C were reached in the roof space with a diurnal fluctuation of up to 22°C. In these periods the RH dropped to as low as 25% with a diurnal fluctuation of up to 50%.

Chart 3. Surface temperatures at probes 1 and 3 in August 2000. The effect of direct solar radiation on the back of the panels above probe 3 is clearly illustrated by the immense rise in surface temperature compared to that at probe 1.

Although it appears that the effects of direct sunlight on the back of the panels are not causing significant movement, they are likely to have a deleterious effect on the hessian backing as well as any other photosensitive materials. As the primary reason for the insertion of the windows (the disruption of the reproductive cycle of the deathwatch beetle) has now been shown to be invalid, it has been decided that the windows are to be covered over. It is understood that this is likely to take place later this year.

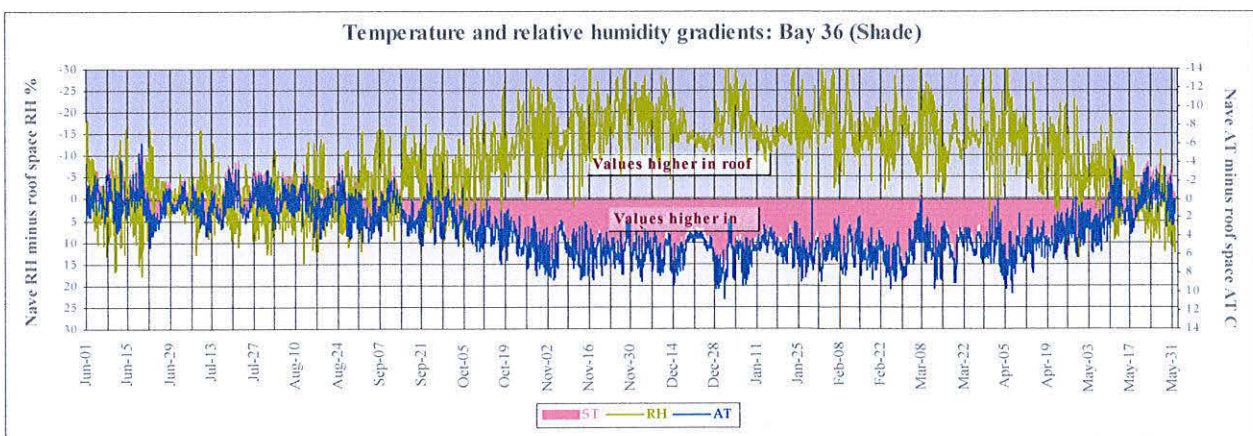
In order to examine the effect that the temperature and humidity gradients between the upper and lower sides of the ceiling may have, the data for the two most recent years was re-processed and charted to show the differences between the upper and lower values over the whole of the year. This clearly shows that during the period May – September, while there were short term variations in particular parameters, the gradients above and below the ceiling tended to cancel each other out. However, during the period October to April, there was a very significant divergence of conditions with the RH in the roof space remaining significantly and constantly above that in the cathedral. During the same period the ambient and surface temperatures in the roof space were constantly lower than in the body of the cathedral. A comparison of the data in the 1999-2000 programme and the 2000-2001 programme showed precisely the same pattern.

Chart 4. Chart showing the gradients for relative humidity, ambient temperature and surface temperature between probes 1 and two, below and above the ceiling boards. (Full gradient charts for probe 1, 2, 3 and 5 can be found in section 5 of the report)
 A comparison was then made between the conditions in the shade (probes 1 and 2 in bay 36) and in areas subjected to direct sunlight (probes 3 and 5 in bay 33). This showed that although the general pattern was the same the level of variation was greatly reduced. (The effects of periods of direct sunlight creates a slightly more complex image, but the general patterns are clear). The reason for the difference between the areas of sun and shade appears likely to be due to ventilation rather than sunlight. In order to avoid direct sunlight probes 1 and 2 were placed higher in the bay, away from the windows and therefore away from the window vents. As a

result, in addition to avoiding direct sunlight, they would also have avoided the level of external air exchange (and consequent cooling) which occurred at probes 3 and 5 during the winter months.

What this discrepancy shows us is not that the conditions differ between bays 33 and 36, but that the conditions between the upper and lower part of row III (and presumably the upper and lower part of row IV) vary due to the levels of ventilation as well as the direct solar heating. The existence of these types of very localised microclimates may well cause variations in the pattern of deterioration across the ceiling as a whole.
