PETERBOROUGH CATHEDRAL

ENVIRONMENTAL MONITORING OF THE NAVE CEILING

JUNE 2001 – MAY 2002

Report No: PTB01.2

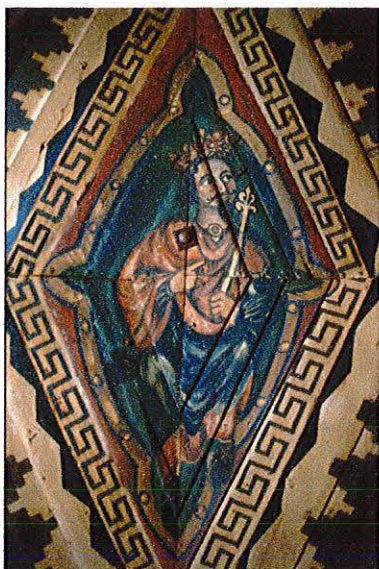
Figure 2. Detail of an area of the roof treated in Phase IV of the programme (Photo: PLP 2001).

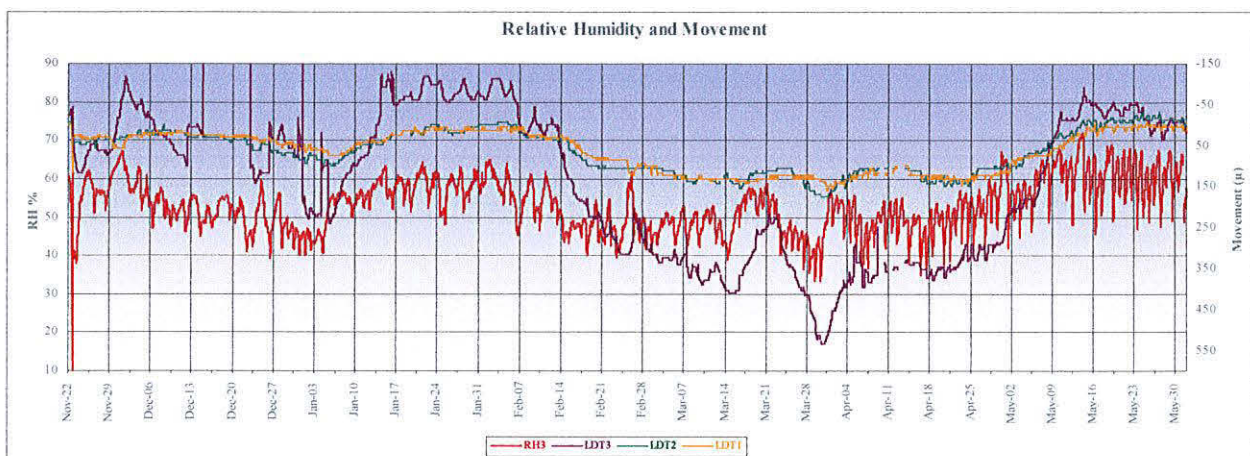
Chart 1: LDT data (from their installation in November 2001, until May 2002) plotted against RH data from probe 3 (in an area below the ceiling effected by sunlight). In order to show the correlation more clearly, the movement scale has been reversed. Therefore, when the LDT chart rises, the board is contracting and vice versa

The variations between the above and below ceiling conditions often result in extreme hygro-thermal gradients across the boards, raising concerns about their dimensional response and the implication for the paint layer. It was in order to measure their *actual* movement that Linear Displacement Transducers were installed on three separate boards (two original oak and one later pine). The data showed that in all three cases, movement took place in response to changes in Relative Humidity.

The pattern of movement indicated that when the RH increased, the surface of the board contracted, and when the RH decreased, the surface of the board expanded. During these long slow periods of movement, the RH in the roof space remained consistently above that below the ceiling, possibly suggesting that an increase in volume on the top of the board was causing a mild concave compression on its under side. This may have been exacerbated by the fact that the upper side is covered with only hessian and glue, while the lower face is covered with a non porous layer of oil paint.

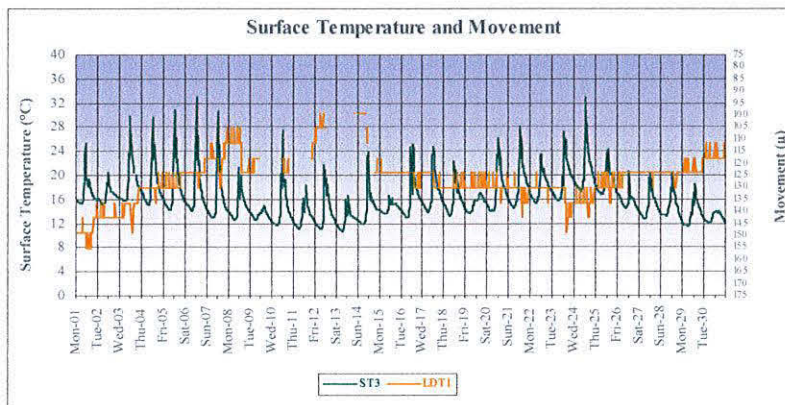
However, the level of movement was extremely limited and took place over long periods of time. In general, diurnal fluctuations in hygro-thermal parameters had no observable influence on the dimensional response of the boards. The only exception to this was the sudden heating of the boards as a result of solar gain, which appeared to have a very marginal effect, although it was inconstant and irregular.

Chart 2. Detail of the surface temperature at probe 3 in April 2002, plotted against the movement of the LDT. Although there is a very minor response following extreme heating, it is irregular and inconsistent.

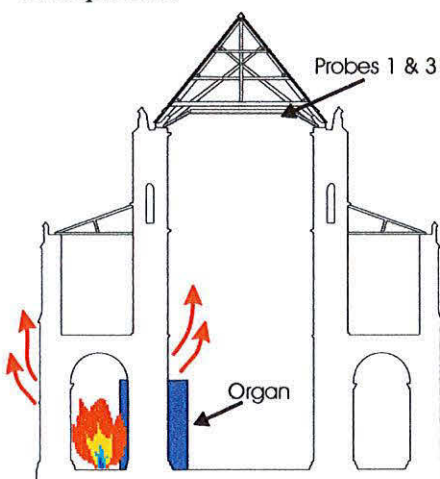
Figure 5: diagram showing the location of the fire relative to the ceiling

On 22nd November 2002, a fire broke out at the west end of the north aisle, immediately behind the organ. Although it was swiftly brought under control, structural damage to the masonry and the organ was very severe and a veil of soot was deposited over much of the interior of the cathedral.

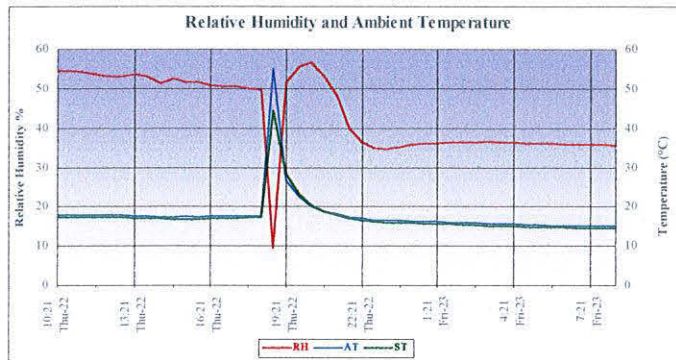
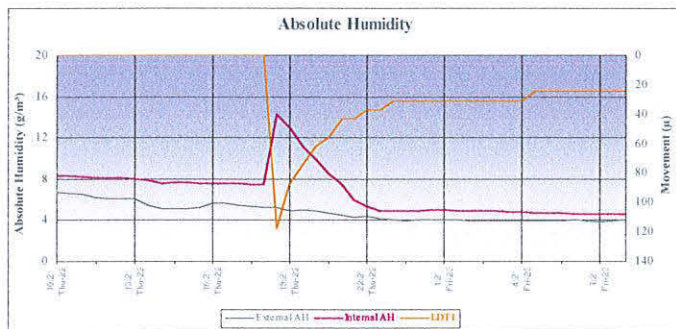
The sharp increase in air temperature (17°C at 18:21 and 55°C at 18:51) is reflected in the decrease in RH to just over 9%. It is interesting to note that the ST remained below the AT, as a result of the cooling effect of the conditions in the roof space. The increase in temperature caused a high level of desorption or evaporation of

moisture from the surface of the wood, resulting in a sharp increase in AH. It is understood that a relatively limited amount of water was used to control the fire and this may well have caused an additional increase in the AH.

Charts 3 & 4. The conditions on the evening of 22nd November 2002 during the fire. Note the increase in AH as a response to the increase in temperature. LDT1, situated some distance to the west, also shows a considerable level of movement.

The more gentle decrease in the AT which followed the fire being brought under control was immediately reflected in an increase in RH, which, because of the increase in AH, rose above the level where it stood before the fire began. Following the reduction of the AT to its normal level, the RH decreased in accordance with the prevailing AH.¹¹ At the height of the fire, the LDT's, which are located approximately 45m from the source of the fire, recorded an increase of up to 120µ. However, it is possible that the change in dimensions was caused by the effect of the heat on the mountings rather than on the board itself.
