## PETERBOROUGH CATHEDRAL

### ENVIRONMENTAL MONITORING OF THE NAVE CEILING

*JUNE 2002 – OCTOBER 2003*

**Report No:** PTB01.2

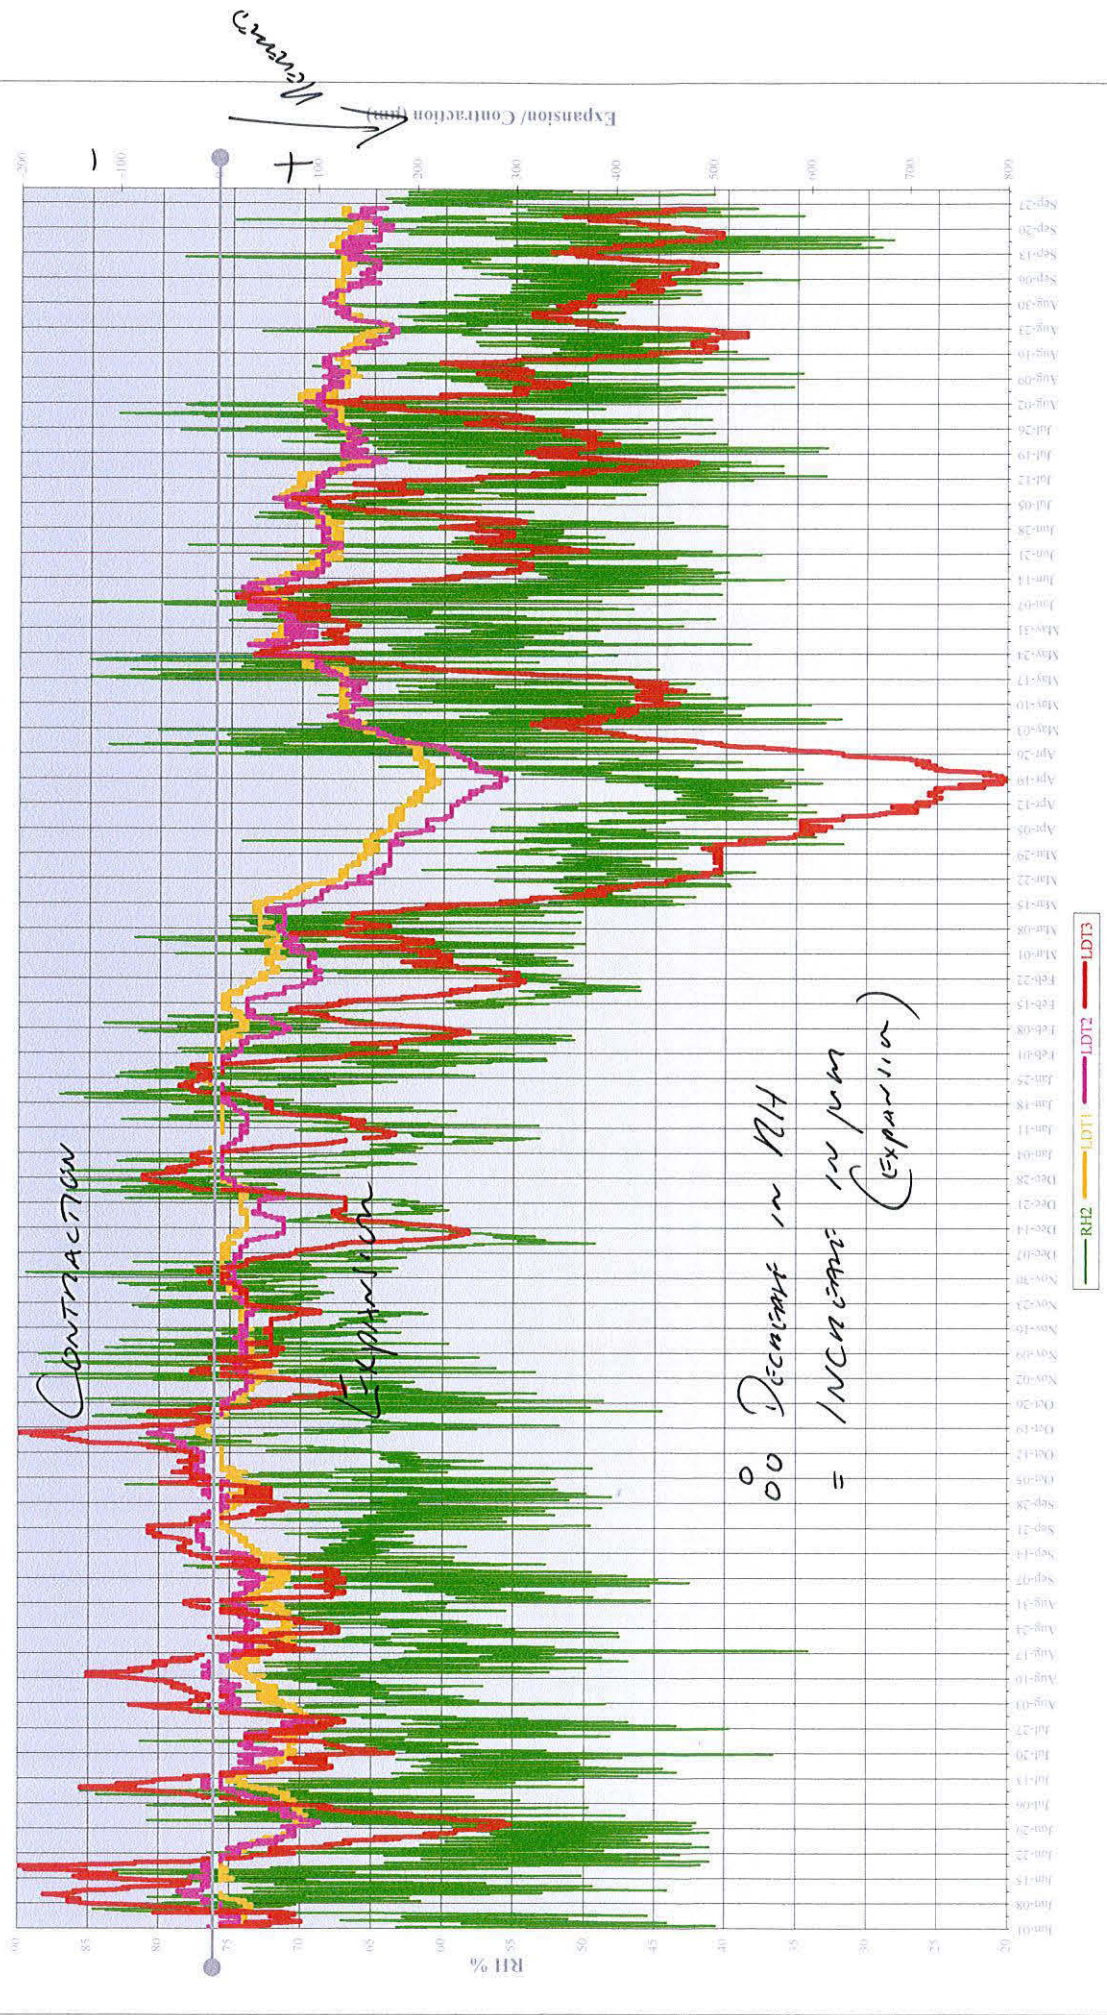
Relative Humidity and LDT Movement

As had been demonstrated in 2001/2002, the movement was proportionate and opposite to the change in RH. In other words, when the RH decreased, the boards expanded, and when it increased they contracted. This was far clearer in the current period than in the previous year. While the RH above and below the ceiling varies in level and short term patterns, the longer term patterns are similar. The upper, unpainted, sides of the boards, with their hessian and glue backing, are also far more porous and hygroscopic than the lower painted side. It is possible therefore that an increase in RH disproportionately effects the upper sides of the boards, causing a greater level of expansion as the RH increases, and thus creating a concave deformation on the lower sides. This may also be exacerbated by the methods of fixing from above.

**Chart 3.** Movement in the boards plotted (in reverse) against the relative humidity in the roof space. A decrease in relative humidity can be seen to induce expansion in the boards.

As had been seen in the previous year, the level of movement in probes 1 and 2 (mounted on a pine and an oak board, respectively) were very similar, with a movement range of <300µm. Although the pattern of movement for probe 3 (mounted on an oak board), was similar, the range was far higher at <1000µm. No obvious difference between the two oak boards was observed and so it appears probable that the variation in movement levels is associated with the methods in which the boards are fixed.

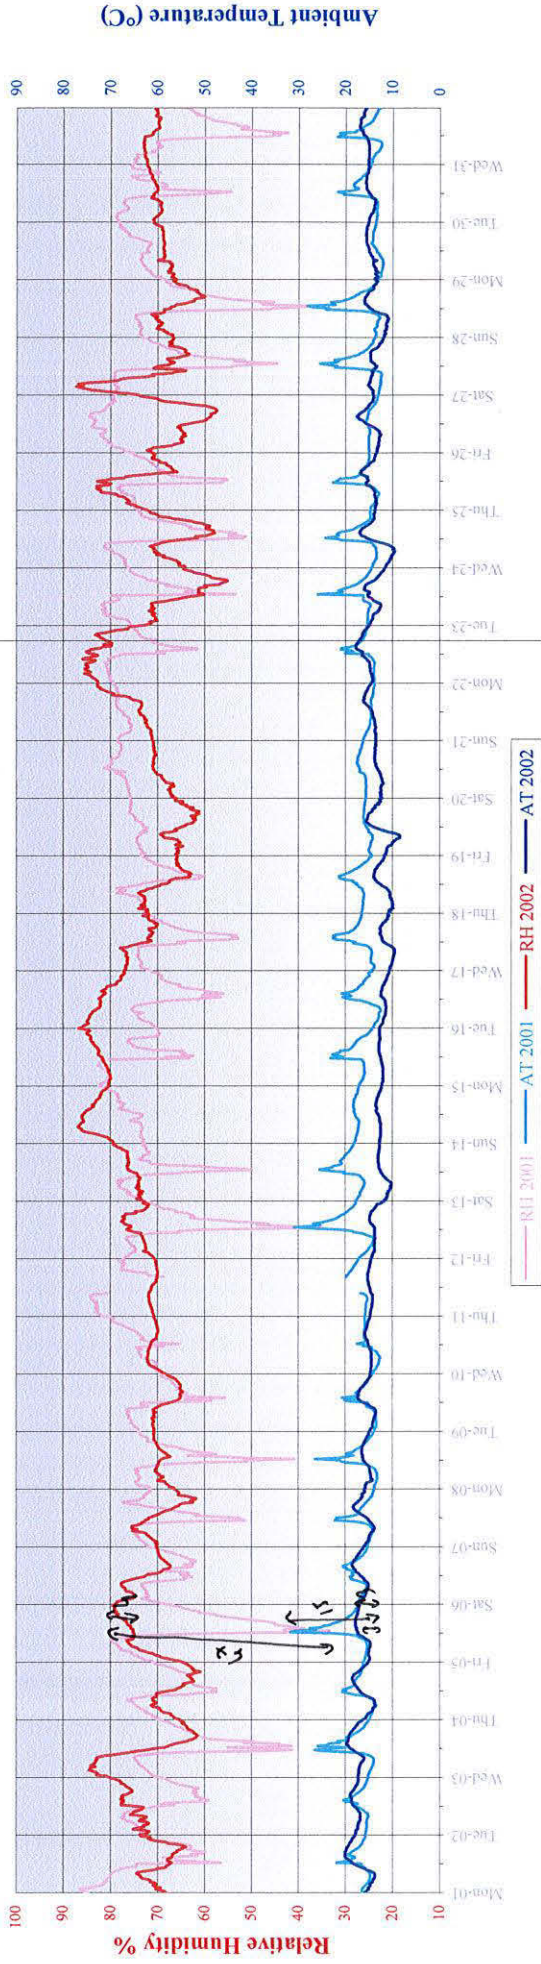
Relative Humidity and Ambient Temperature

In previous years, the effect of sunlight from the glass panels on the south side of the roof, has been to cause sudden fluctuations in temperature, sometimes up to 38°C, with consequent fluctuations in the relative humidity. In order to prevent this, wooden panels were inserted across the windows in 2002 and 2003. The effect has been to entirely eliminate these sharp fluctuations, creating a microclimate which is almost identical to areas of the ceiling which have always been in shade. The ventilation grills were not covered, so the hygrothermal buffering between internal and external conditions remains low, and as a consequence, the background microclimate remains unstable.
