PETERBOROUGH CATHEDRAL

ENVIRONMENTAL MONITORING OF THE NAVE CEILING

OCTOBER 2003- OCTOBER 2005

Report No: PTB01.3

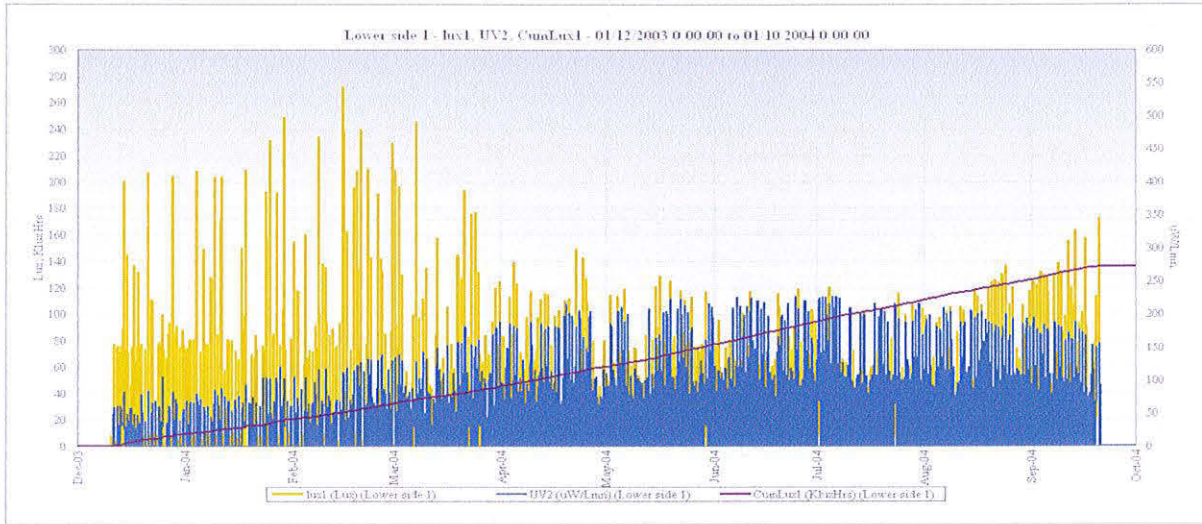
Chart 1. Lux, cumulative lux and UV conditions between December 2003 and October 2004

During 2004, when the halogen lamps were in place, the average daytime peak lux level was approximately 80, with occasional peaks over 200. This was similar to the data recorded in 2003. The proportion of UV radiation during this period rose from approximately $60\mu\text{w}/\text{lm}$ in the winter to just over $200\mu\text{w}/\text{lm}$ in the summer. The halogen lamps are known to produce between $49\text{--}127\mu\text{w}/\text{lumen}$ of UV radiation,⁶ although cover glass of the fittings may well suppress this. However, daylight, even through standard glass, contains a far higher proportion of UV radiation, possibly up to 6 times as much radiation, as tungsten lighting.⁷ Therefore it is likely that a significant part of the UV recorded is due to indirect daylight from the large clerestory windows, rather than from the lamps.

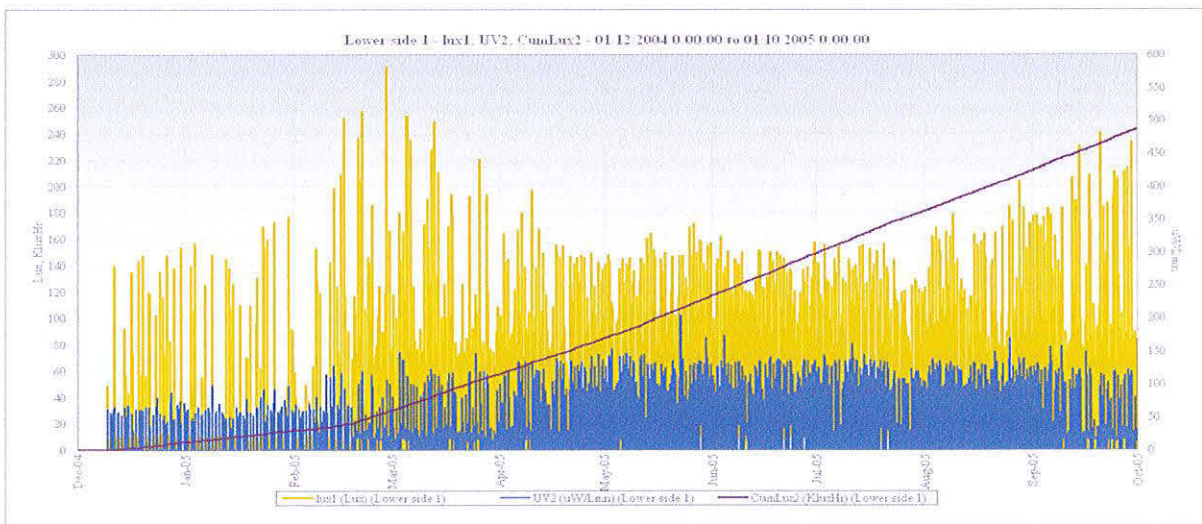
Chart 2. Lux, cumulative lux and UV conditions between December 2004 and October 2005

In 2005, when the new metal halide lamps were installed, the average peak lux level was approximately 120, with occasional peaks over 220. However, the proportion of UV radiation was lower with winter levels of approximately $60\mu\text{w}/\text{lm}$ rising to $120\mu\text{w}/\text{lm}$ in the summer. The Osram lamps used are mounted in UV filtering quartz envelopes, and it is likely that the cover glass in the lamp fittings would further reduce UV levels, albeit by a small amount.⁸ Therefore it appears that, as in the previous year, a significant proportion of the recorded UV is due to indirect daylight. However, the spectra for the metal halide lamps suggests that (depending on the filtering) they may contribute more UV by proportion than the previous lamps.

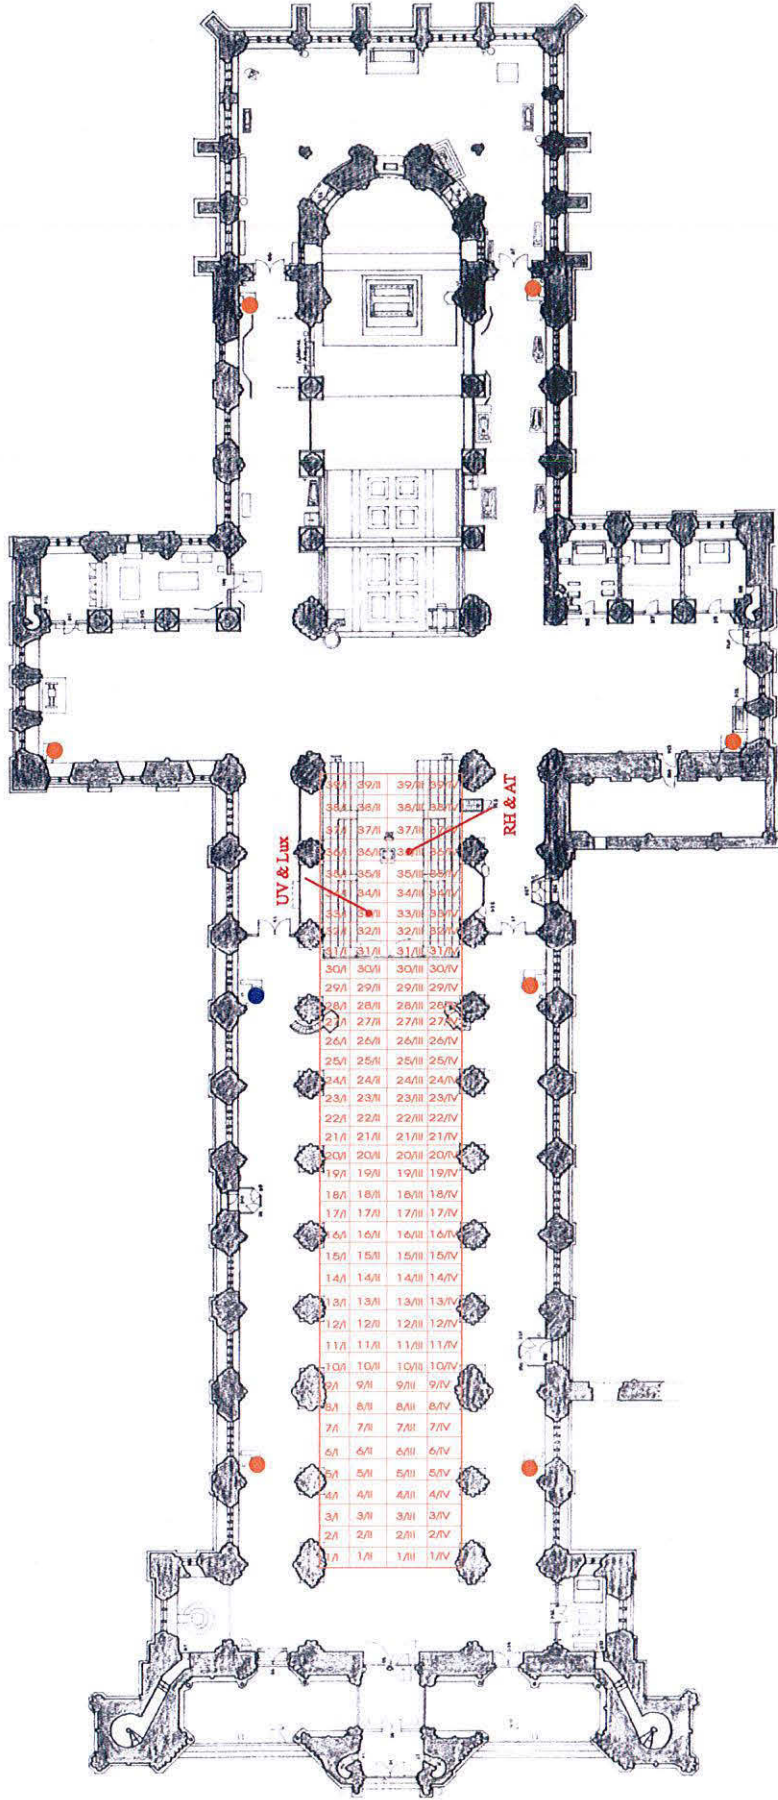
Diagram 1

Relative humidity (RH) and ambient temperature (AT) were recorded above and below bay 36 III, while UV and lux were recorded in bay 33 II. An external probe was situated on the north side of the nave roof in order to provide RH and AT control data. (*Diagram 1*) Data was logged on all channels at 30 minute intervals. Internal RH/AT probes were suspended in front of the ceiling surface from available fixing points. The UV/lux probe was inserted in a small hole in the ceiling so that the sensors were exposed to the light on the underside (painted side) of the ceiling. The external RH/AT probe was protected by a Stevenson screen.
