Architectural Paint Research

PETERBOROUGH CATHEDRAL, NAVE CEILING

PHASE 3 INVESTIGATION OF PAINTING MATERIALS AND TECHNIQUES

October 2001

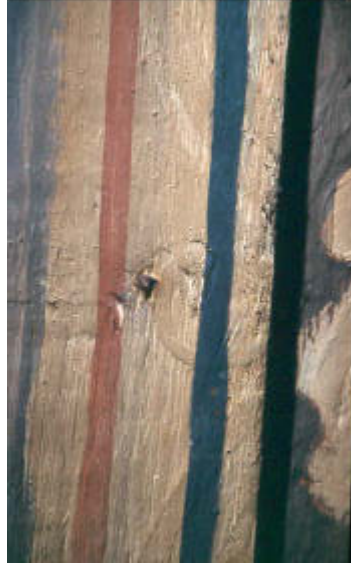
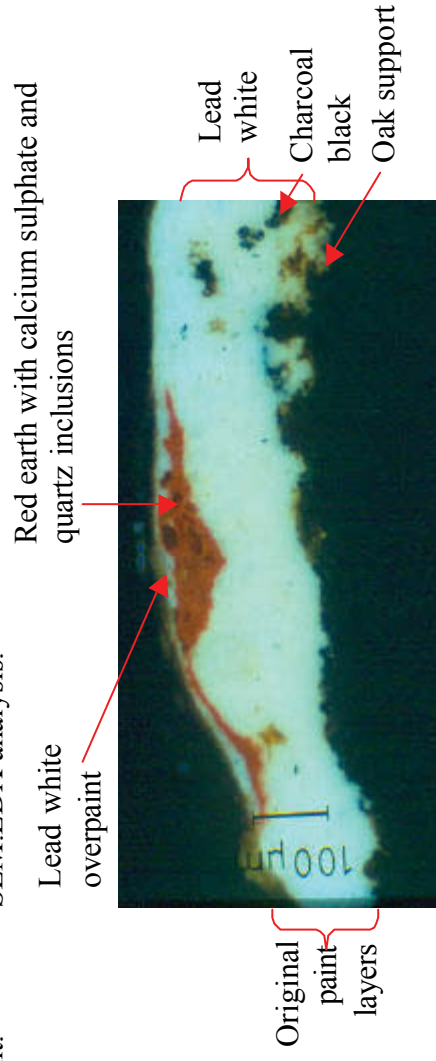
Sample 1 (2989)

Sample 1 was taken from the original frieze decoration on an oak replacement board (22 III o), where it was suspected that original ashlar decoration was present, as a design was visible in relief on two repositioned oak ceiling boards. A sample of paint was taken from trefoil design in order to identify the original paint if present.

The sample appears to show the original paint layers and a thin lead white overpaint. The original layers comprise the surface bright red trefoil design (red earth with calcium sulphate and quartz inclusions) on a lead white ground and charcoal black underpaint on the oak substrate. The overpaint is lead white, surface dirt is present on the upper surface of the overpaint. No barytes was identified using SEM.EDX analysis.

Sample 1 photographed in cross-section under reflected light at 220x magnification (on slide). (Printed magnification not calculated).

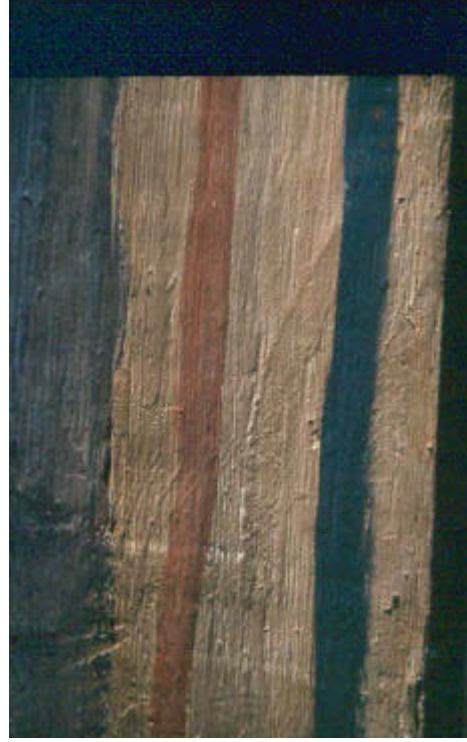
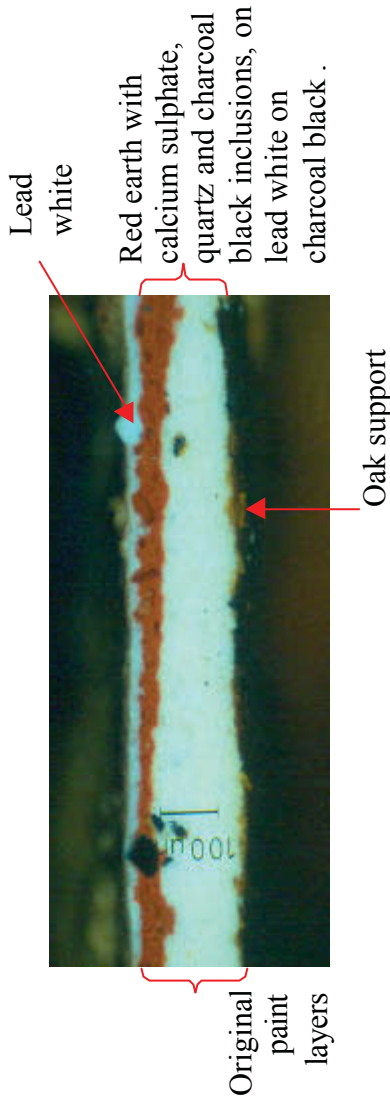
Sample 2 (2990)

Sample 2 was taken from the original frieze decoration on oak replacement board (22 III o), where it was suspected that original ashlar decoration was present, as a design was visible in relief on two repositioned oak ceiling boards. A sample of paint was taken from the tendril design in order to identify the original paint if present.

The sample shows the original paint layers and a thin lead white overpaint. The original layers comprise the surface bright red trefoil design (red earth with calcium sulphate, charcoal black and quartz inclusions) on a lead white ground and charcoal black underpaint on the oak substrate. The overpaint is lead white, surface dirt is present on the upper surface of the overpaint. No barytes was identified using SEM.EDX analysis.

Sample 2 photographed in cross-section under reflected light at x 148 magnification. (Printed magnification not calculated).

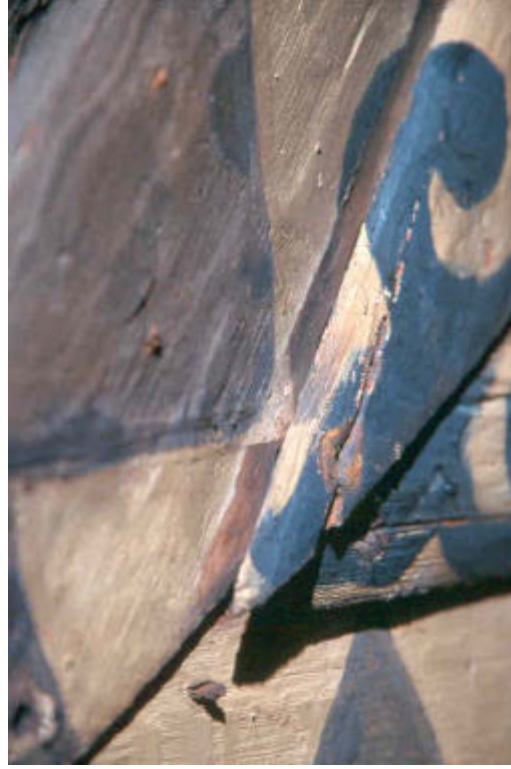
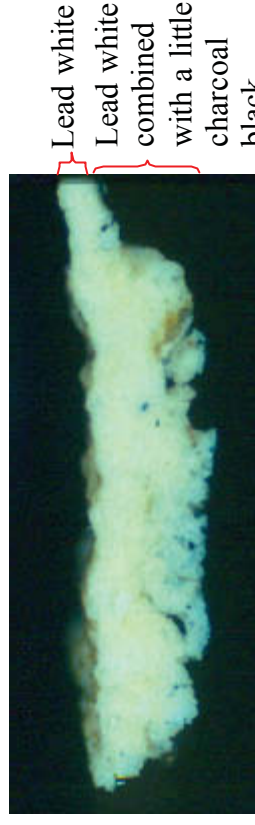
Sample 3 (2991)

The sample was taken from an area of apparently original linear white dogtooth pattern (22 IV e), which had been revealed by previous restoration but not overpainted. It was hoped that the sample could be confirmed as original paint and that it might further knowledge of the original preparatory technique.

The sample shows only two paint layers: a surface lead white (the upper boundary of which is marked with surface dirt), and a lower paint consisting of lead white combined with a little charcoal black. The timber substrate (and possibly lower paint layers) are absent.

Sample 3 photographed in cross-section under reflected light at x 185 magnification. (Printed magnification not calculated).

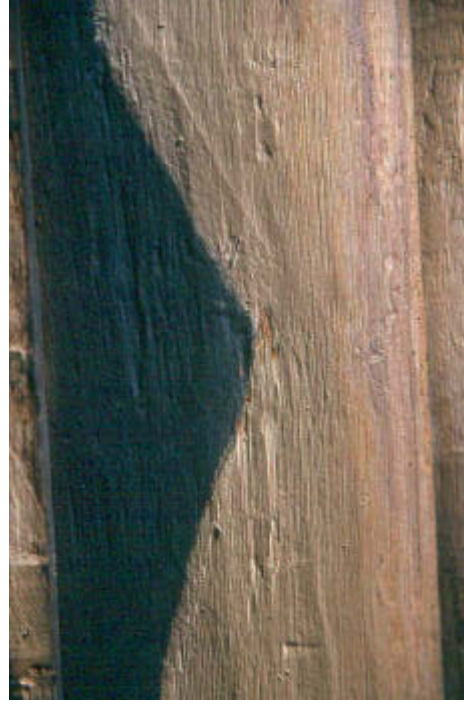
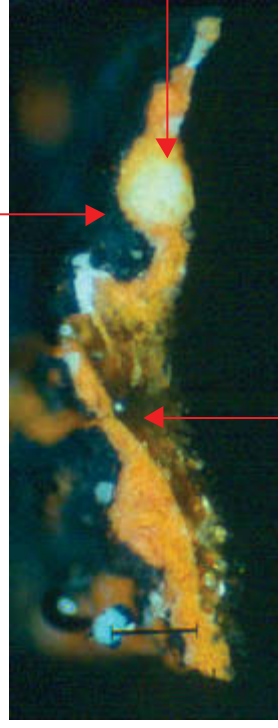
Sample 4 (2992)

Sample 4 was taken from the linear wave pattern where red paint was visible under edge of black wave pattern (22 I r). The sample was taken to confirm Kakoulli's findings in 1999 (sample 18) and to identify the original scheme if it was present.

Kakoulli (1999) identified a lead white and barytes paint overlying lead white and red lead paints on sample 18. She interpreted these

layers as later overpaint (2 layers lead white and barytes) on a red lead layer belonging to an earlier phase.⁸

This sample shows a finely divided black pigment combined with lead white. This is interpreted as later overpaint. Below this is a layer of red lead, combined with lead white and some inclusions, directly on the timber substrate.

Sample 4 photographed in cross-section under reflected light at 210x magnification. (Printed magnification not calculated).

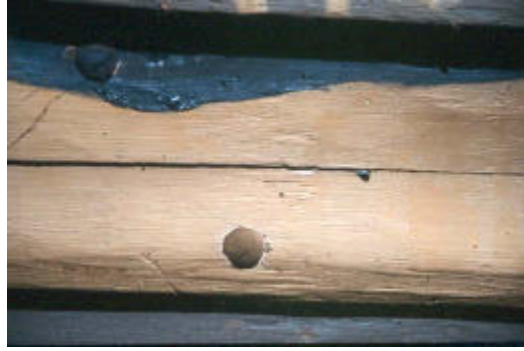
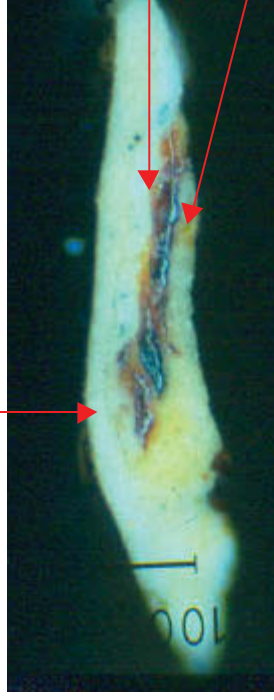
Sample 5 (2993)

Sample 5 represents paint on original nail heads and the sample was taken from original non-corroded nail head (overpainted in 1740s and 1830s with white background paint.) from the extended chevron (24 IV r). The aim of sampling was to identify the original scheme if present and to suggest whether the nails were painted to match the unpainted background.

The sample shows an early lead white paint with a little earth pigment. Over this is a lead white layer containing a little carbon black, apparently contaminated with an organic 'glue'.

Later overpaint comprised of lead white with a little red lead (?) and carbon black pigments. The surface of the sample is marked by dirt accumulation.

Sample 5 photographed in cross-section under reflected light at 250x magnification. (Printed magnification not calculated).

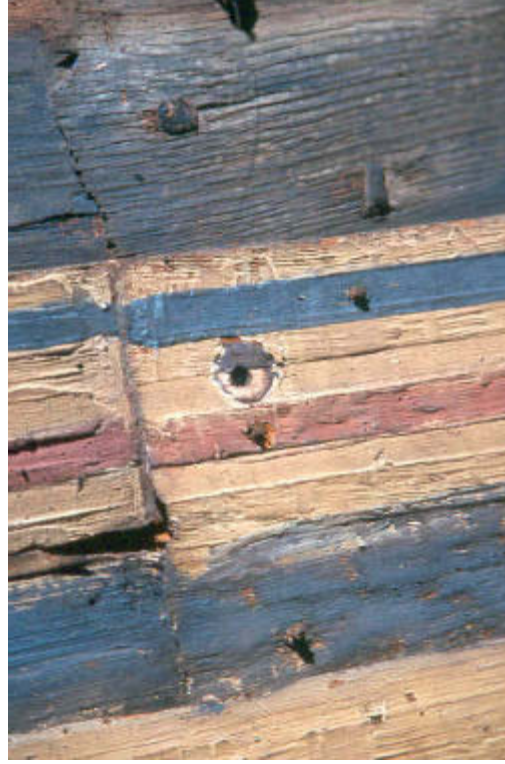
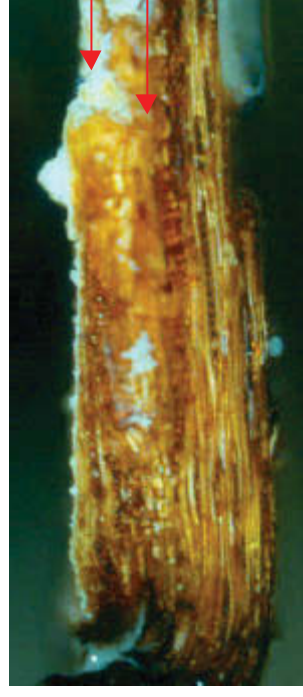
Sample 6 (2994)

Sample was taken from paint under an original nail head — now missing (21 I o Coloured bands). The sample was of a thin layer of white paint or preparation layer from within a groove. The intention of sampling was to identify the original paint, if present, and to compare the sample with Kakoulli, 1999 (sample 57).

Kakoulli (1999) identified a black consisting of charcoal black particles mixed with lead white and dispersed ferric hydroxide particles, which is understood to date to the 1740s repainting.⁹

The sample shows only a very thin layer of lead white paint, directly on the timber substrate.

Sample 6 photographed in cross-section under reflected light at 90x magnification. (Printed magnification not calculated).

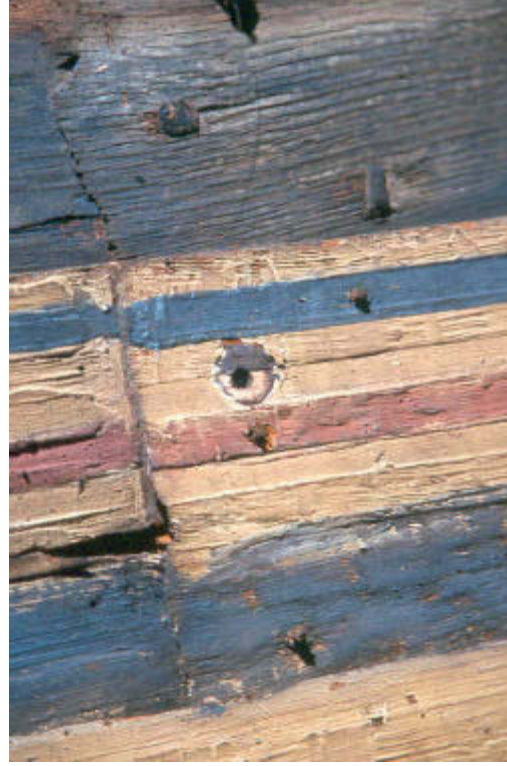
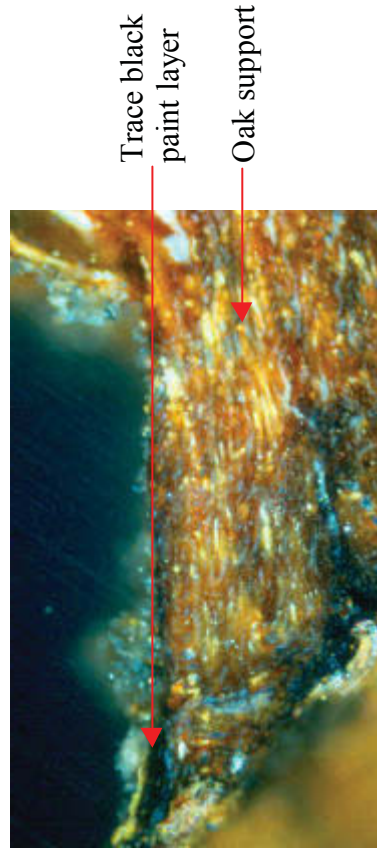
Sample was taken from paint under an original nail head — now missing (21 I o Coloured bands). The sample was of a thin layer of black paint on a raised area between grooves. The intention of sampling was to identify the original paint, if present.

The sample shows only a very thin layer of black paint, directly on the timber substrate.

Sample 7 photographed in cross-section under reflected light at 180x magnification. (Printed magnification not calculated).

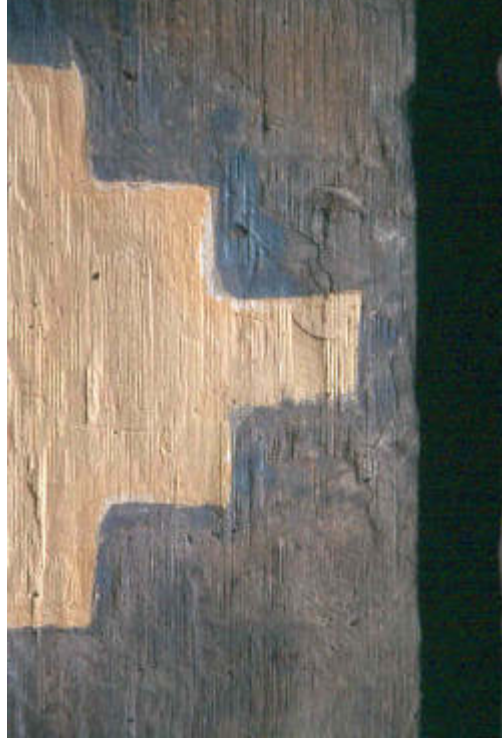
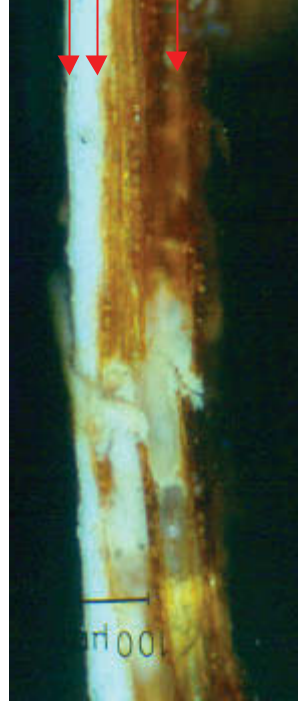
Sample 8 (2996)

The sample shows a layer of lead white paint, directly on the timber substrate. Over this is a very thin lead white paint layer, the surface of which is marked with dirt accumulation.

Sample 8 photographed in cross-section under reflected light at 169x magnification. (Printed magnification not calculated).

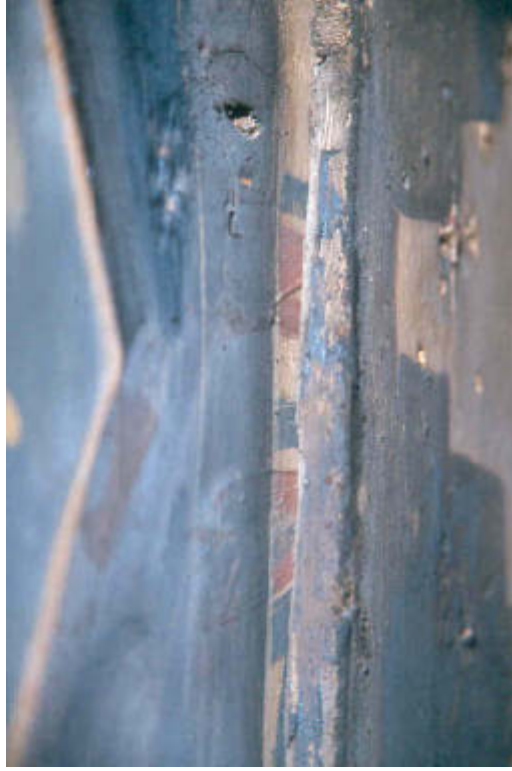
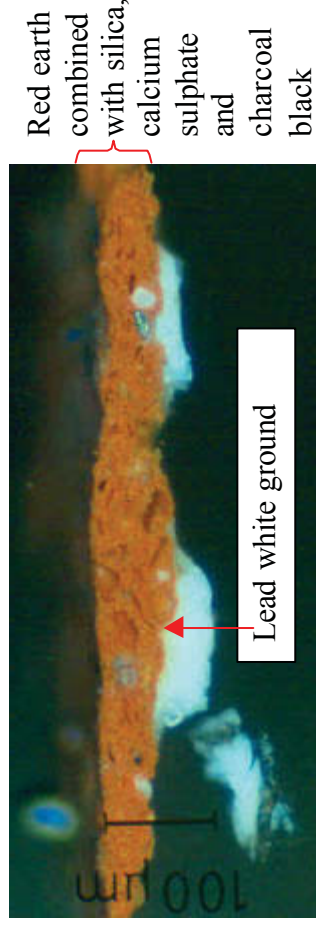
Sample 9 (2997)

Red paint from frieze decoration underpaint on replacement softwood boards (27 II s Grey chevron). It was hoped that identification of the paint layers might assist in dating of the boards.

The sample shows a layer of red paint, comprised of red earth combined with silica, calcium sulphate and charcoal black. This was applied over a lead white ground.

Sample 9 photographed in cross-section under reflected light at 250x magnification. (Printed magnification not calculated).

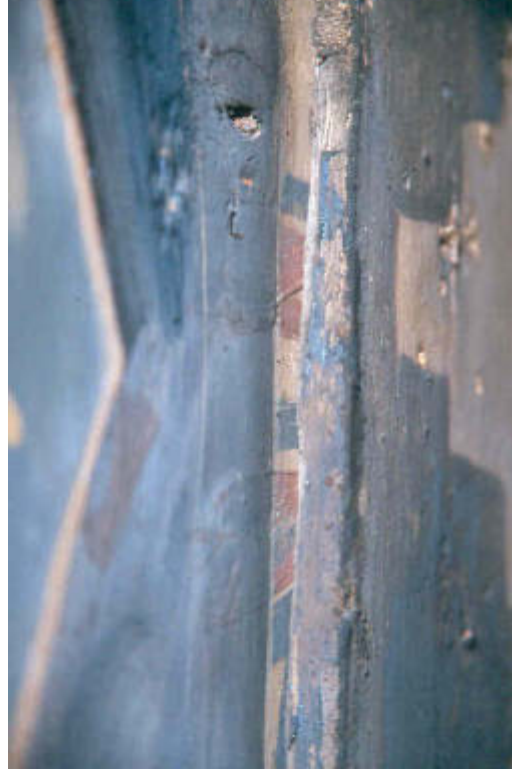
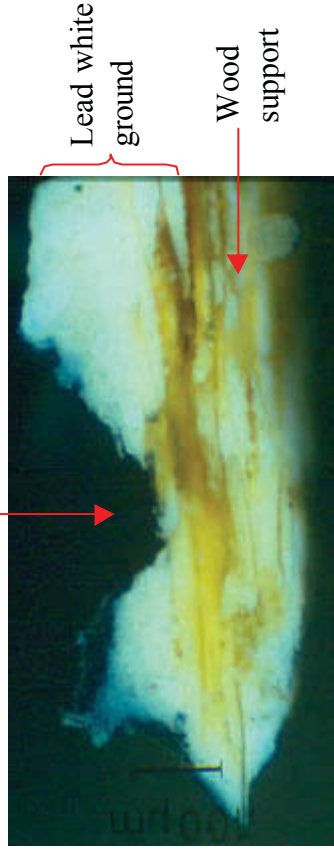
Sample 10 (2998)

Black paint from frieze decoration underpaint on replacement softwood boards (27 II s Grey chevron). It was hoped that identification of the paint layers might assist in dating of the boards.

The sample shows a finely divided black pigment together with some red inclusions, which was applied over a lead white ground, to the timber support.

Sample 10 photographed in cross-section under reflected light at 248x magnification. (Printed magnification not calculated).

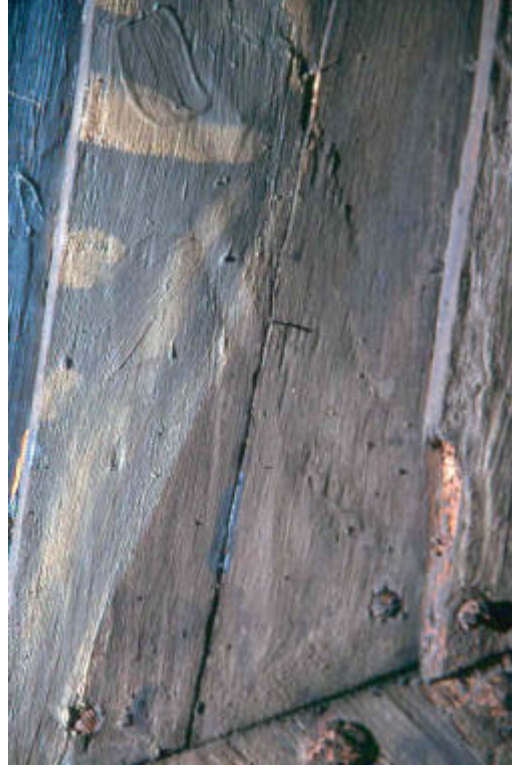
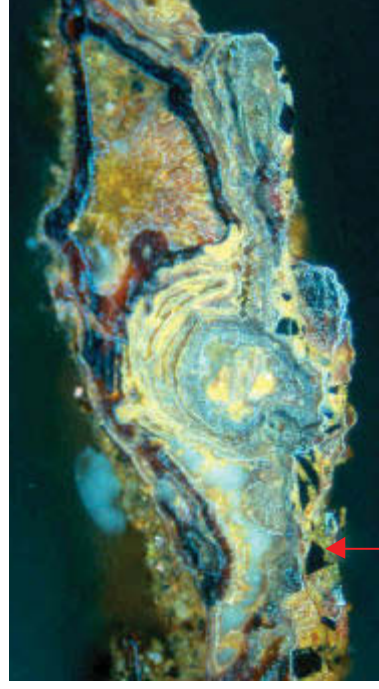
Sample 11 (2999)

The sample shows a thick build up of paint, distorted during application and also, it is likely, by the formation of corrosion products from the metal substrate.

The surface paint comprises a dark paint layer with black, yellow, red and brown inclusions. Under dark-field reflected light this

appears similar to the dark paint attributed to the 1740s by Kakoulli (1999) (sample 57). Corrosion products and possibly also an organic ‘glue’ are present. The lower paint layer contains charcoal black in a yellow earth matrix. The appearance of the charcoal is consistent with charcoal identified on other areas believed to date to the 1740s.

- Dark paint layer with black, yellow, red and brown inclusions
- Corrosion products
- Organic residue ‘glue’ ?

Charcoal black in a yellow earth matrix (c. 1740s)

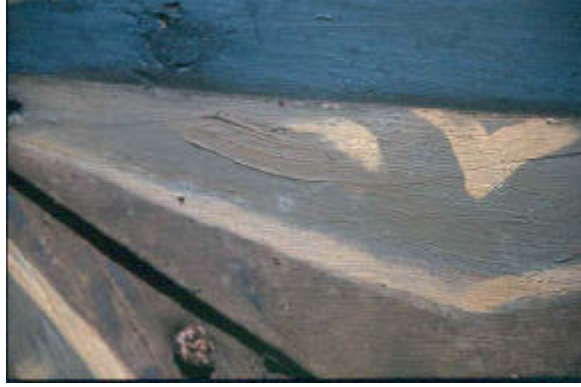
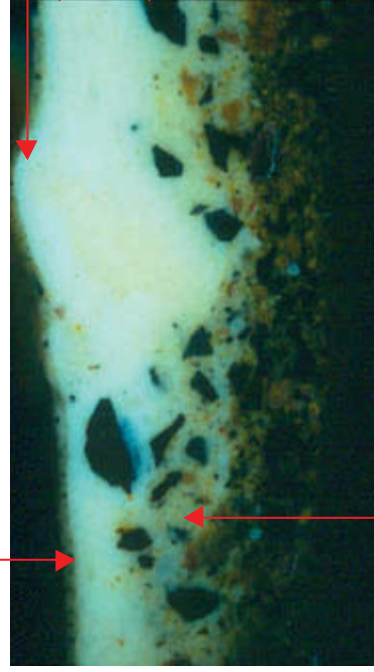
Paint on suspected 1740s softwood replacement board — sampled to confirm presence of 1740s paint below 1830s paint (23 I r Grey chevron).

The sample shows a build up of four paint layers: the surface paint comprises a thin grey layer of black particles in a white matrix. This lies over a fairly pure lead white layer, which in turn covers a layer of lead white combined with charcoal black and yellow earth. The lowest paint layer consists of charcoal black in yellow earth matrix.

The charcoal present in the lower two layers appears to be of the type identified within 1740s paint layers. For example, Kakoulli (1999) samples 13, 34, 47 and 52, which show similar large charcoal particles.¹⁰

Thin grey layer of black particles in a white matrix

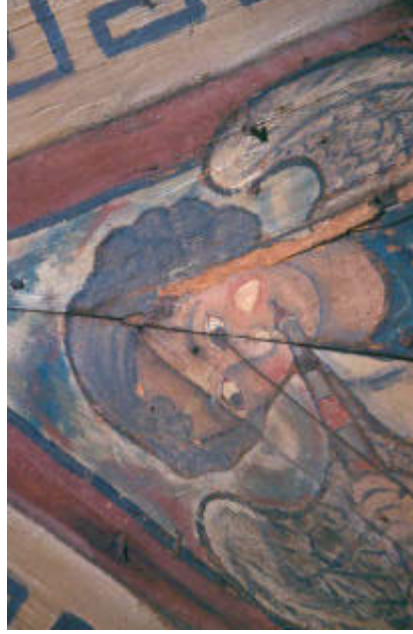
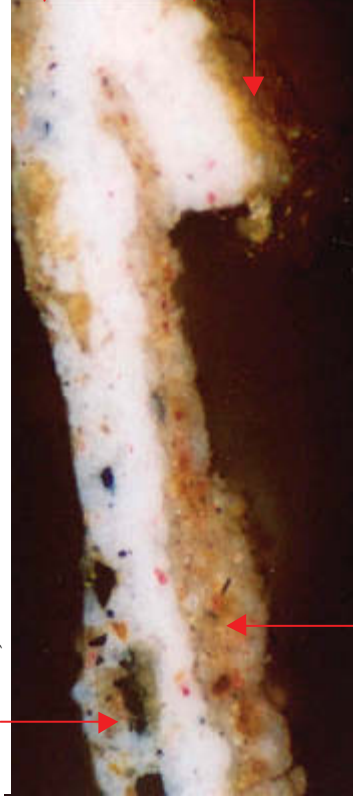
The sample has a heterogeneous surface paint layer containing lead white, iron oxides, vermilion and charcoal black. The upper surface of the layer is marked by accumulations of dirt. The layer has a slightly transparent appearance under reflected light and this may be

due to the inclusion of calcium carbonate. Calcium was detected by SEM.EDX, together with carbon and oxygen, but not sulphur.

Heterogeneous layer including iron oxides, white lead, vermilion, charcoal black and calcium carbonate.

Translucent paint containing some lead white and vermilion

Sample 13 photographed in cross-section under reflected light at 200x magnification. (Printed magnification not calculated).

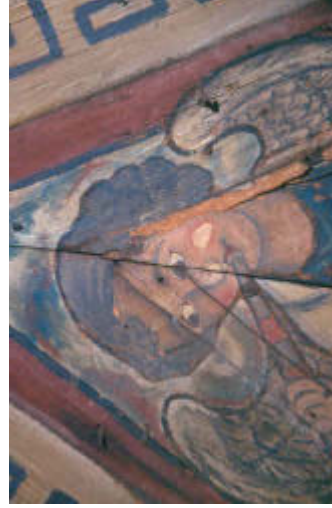
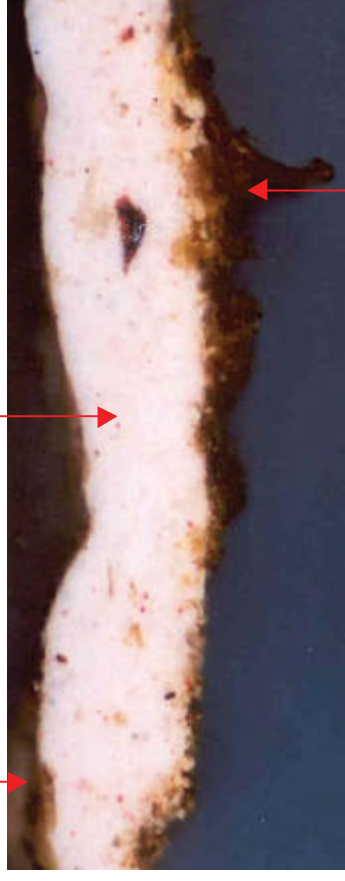
The sample shows a single thickly applied pink paint layer directly on the timber substrate. The pink paint is comprised mainly of lead white coloured with both iron red and vermilion. SEM.EDX indicates the presence of Sn (tin) with the iron red pigment, however the reason for this is not yet clear. No barytes is present. The layer may be original.

Thick layer of pink paint
comprised of lead white,
coloured with iron oxide and
vermilion pigments

Sample 14 photographed in cross-section under reflected light at 100x magnification. (Printed magnification not calculated).

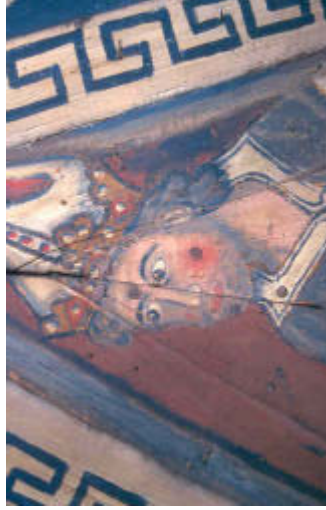
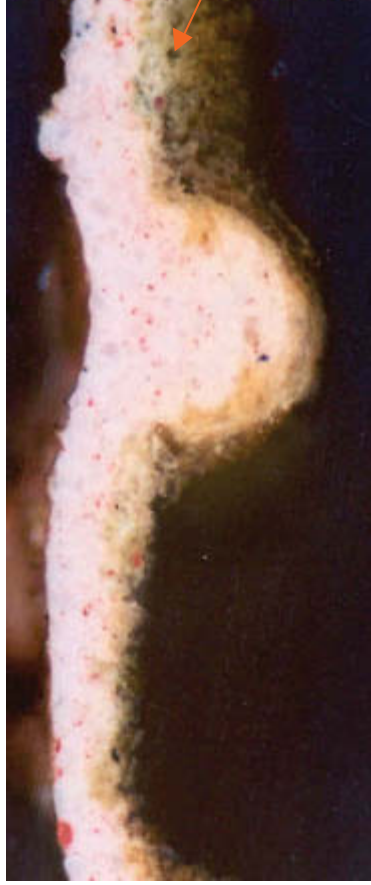
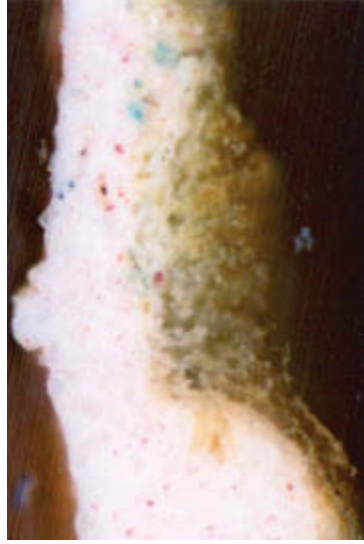
The sample shows a surface pink paint comprised mainly of lead white coloured with iron oxide red and vermilion pigments. Below this is a semi-translucent layer of copper green pigments mixed with barium sulphate and silicates. At the base of the sample is the timber substrate. The presence of barium sulphate at low level in the sample suggests the paint is of nineteenth century date.

Sample photographed in cross-section under reflected light at 200x magnification. (Printed magnification not calculated).

- Pink paint comprised mainly of lead white coloured with iron oxide red and vermilion pigments
- Semi-translucent layer of copper green pigments mixed with barium sulphate and silicates
- Timber substrate

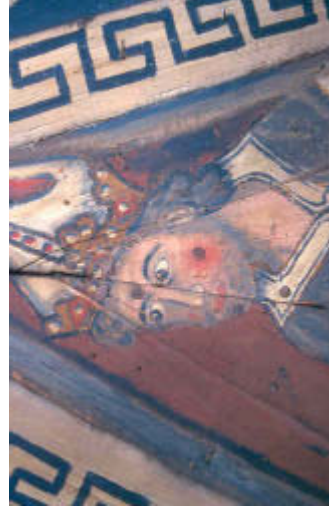
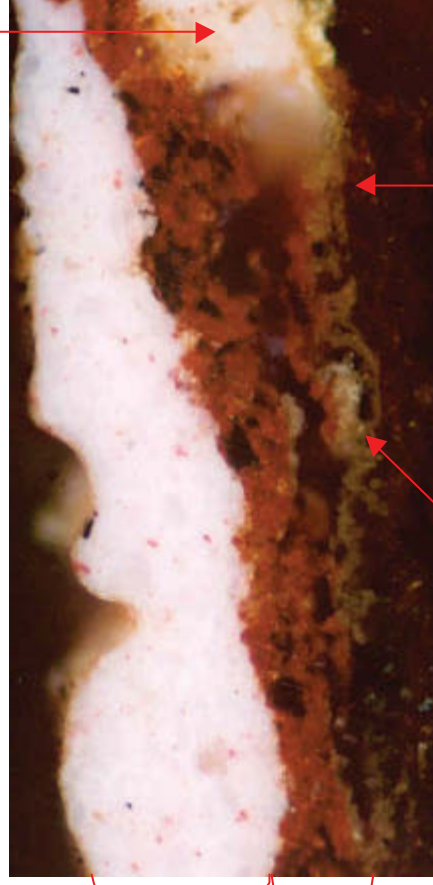
Sample 16 (3063)

Pink paint composed mainly of lead white coloured with vermilion and red iron oxide

Red iron oxide (probably from a naturally occurring source as it contains aluminium and silicate impurities) and charcoal black, with traces of lead white

Lead white with a little iron oxide red

Carbon black underdrawing

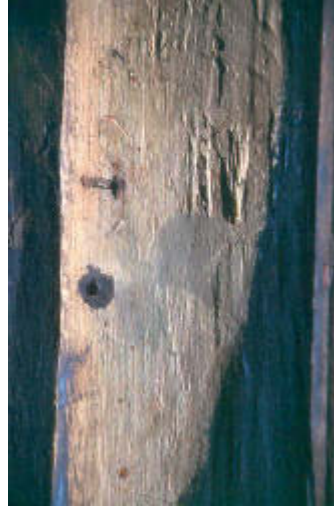
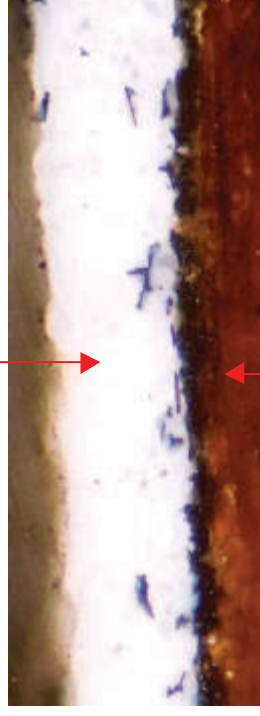
The sample shows white lead paint overlying a charcoal black paint, which lies directly on the timber substrate. The lead white paint contains some charcoal black particles, these appear to be of the same type as comprise the underlying black layer. However it may be that loose particles were mixed into the wet paint as it was applied rather than suggesting the two paint layers are co-eval.

Lead white layer containing charcoal black inclusions, possibly from underlying layer

Sample 17 photographed in cross-section under reflected light at 220x magnification. (Printed magnification not calculated).

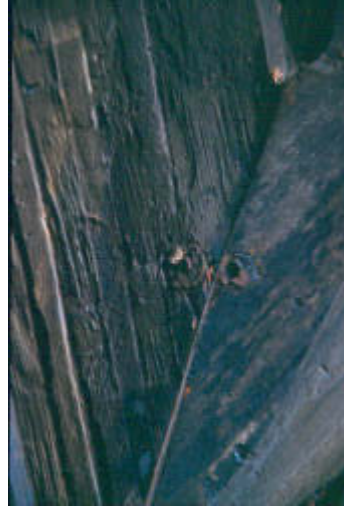
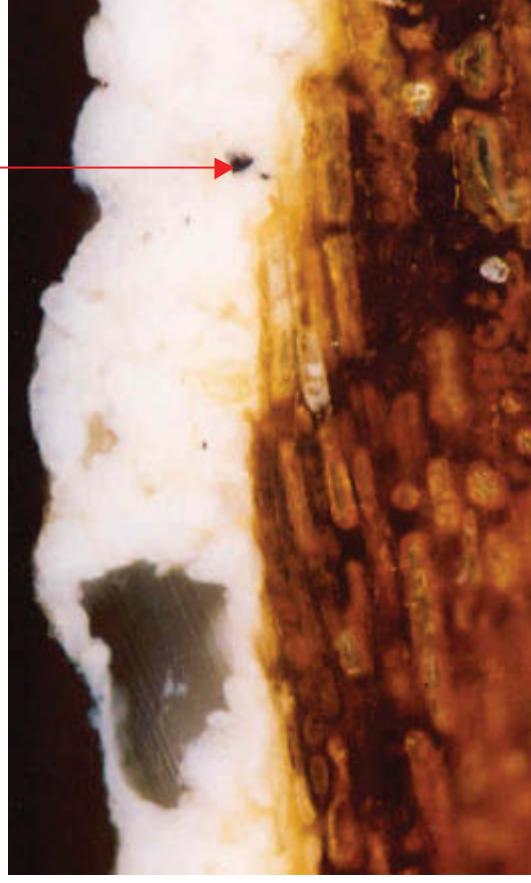
The sample shows a single thin layer of lead white with a tiny amount of carbon black. SEM.EDX also detected some calcium, towards the boundary of the paint and timber substrate. This may possibly be suggestive of the presence of a very thin calcium-based ground as identified in previous studies. No sulphate was detected and previous studies have identified calcium sulphate within ground layers, although possibly as an alteration product. This suggests the sample is probably original paint.

Single layer of lead white, containing a tiny amount of carbon black.

Sample 18 photographed in cross-section under reflected light at 200x magnification. (Printed magnification not calculated).

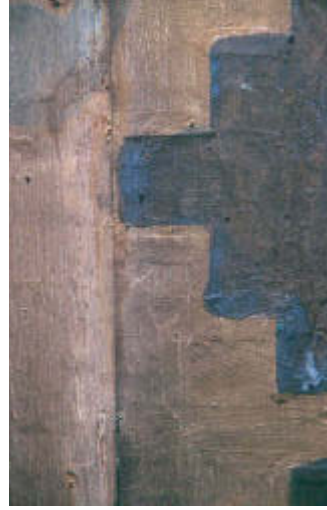
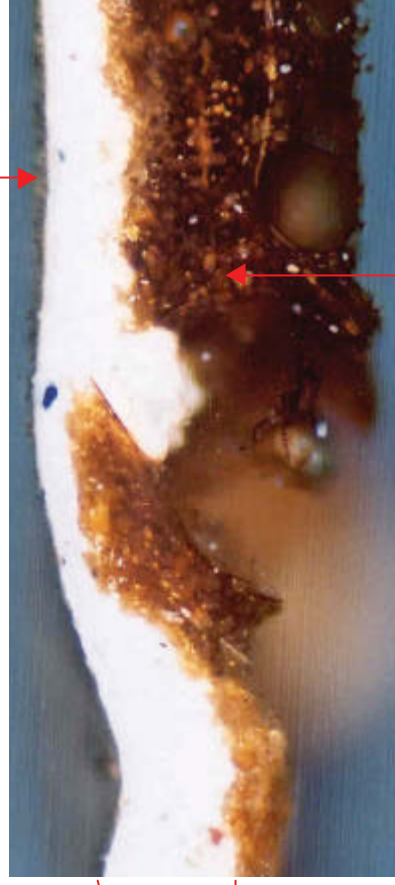
Sample 19 (3066)

Lead white paint with carbon black (and iron oxide yellow) inclusions

is a thin translucent material. SEM.EDX of two separate sites within this material both produce similar spectra: the layer contains sulphur (sulphates?) and potassium. At the base of the sample the timber substrate is present.

Surface greyish white layer

Sample 19 photographed in cross-section under reflected light at 100x magnification. (Printed magnification not calculated).

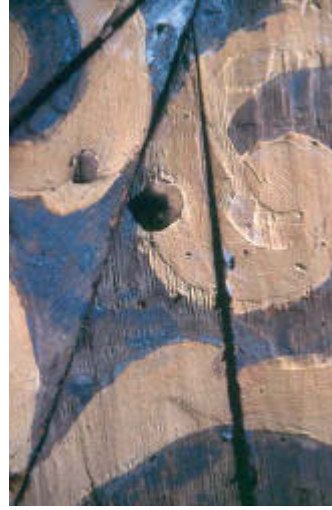
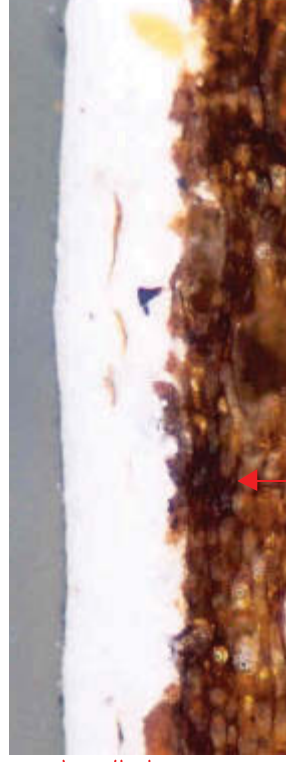
Upper white
lead paint layer
Lower white lead
paint layer,
containing carbon
black and iron
oxide yellow
inclusions

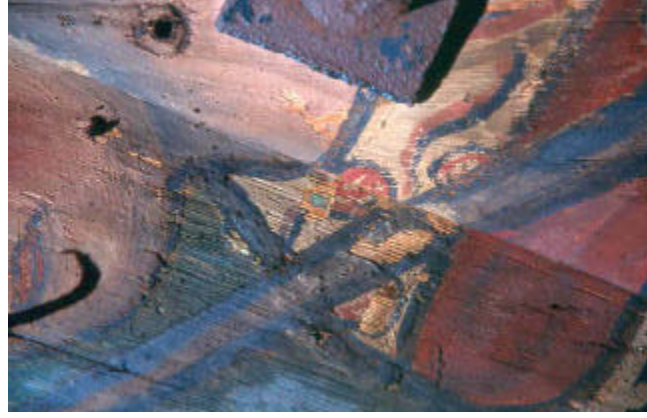
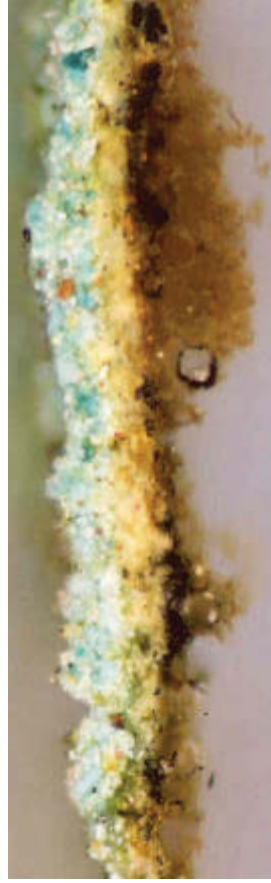
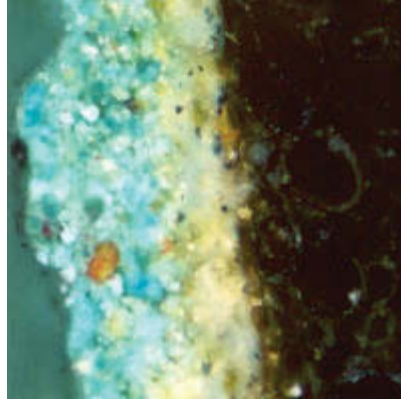
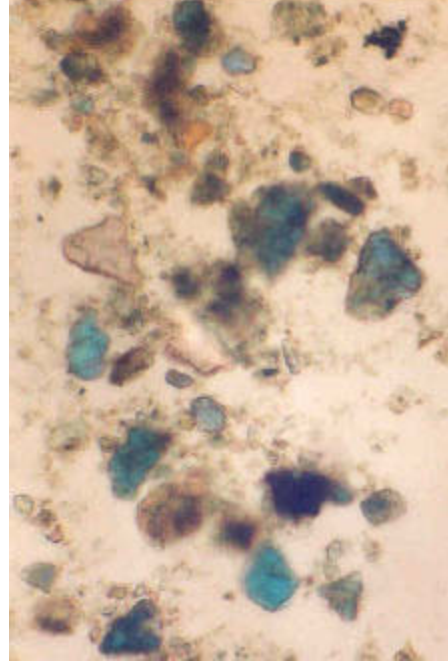
In dispersion particles of yellow ochre, calcium carbonate and a blue copper pigment can be seen. In section, the blue copper pigment looks like azurite, and the red-brown particles of cuprite confirm this identification. In dispersion some particles do resemble azurite, but the majority has undergone change to other copper salts.¹²

Sample 21 photographed in cross-section under reflected light at 100x magnification. (Printed magnification not calculated.)

Sample photographed in cross-section under reflected light at 200x magnification. (Printed magnification not calculated).

Paint dispersion from the green layer in sample 21 photographed in transmitted light at 200x magnification. (Printed magnification not calculated.)

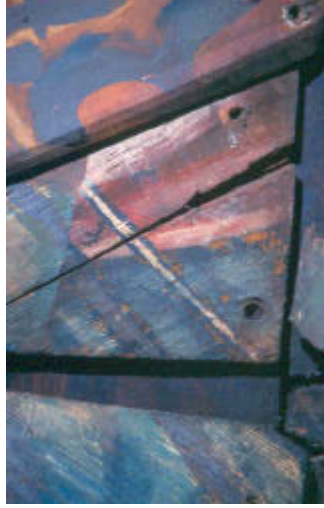
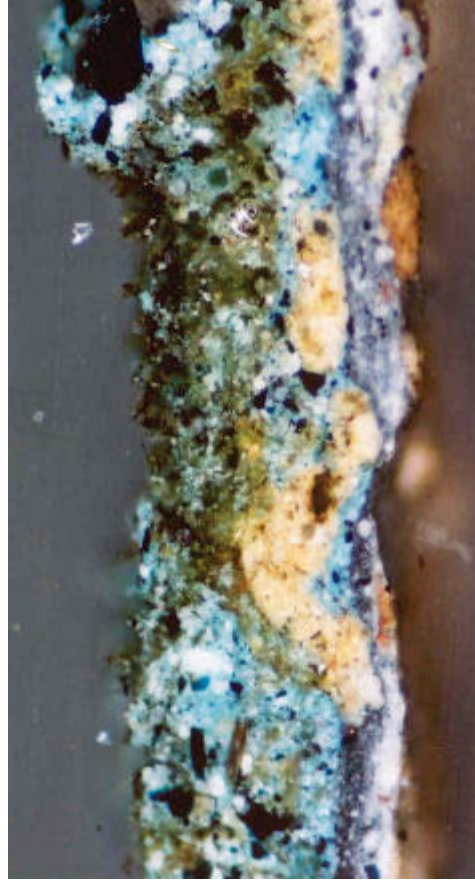
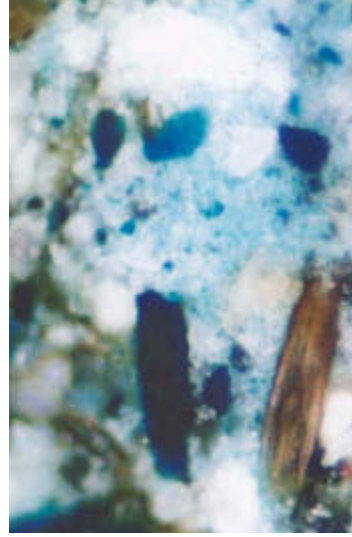
Sample 22 (3069)

The sample shows a complex build up of paint layers. The surface layer contains large blue particles which have been identified as Prussian blue. The presence of aluminium, potassium and sulphur (detected by SEM.EDX) together with iron is strongly suggestive of the use of alum (potassium aluminium sulphate) in the production of the pigment. This historic production method has been associated with relatively large particle size and may be considered typical of

Sample 22 photographed in cross-section under reflected light at 100x magnification. (Printed magnification not calculated.)

Area shown as detail is visible to the upper left of 100x image.
