JANE DAVIES CONSERVATION

PETERBOROUGH CATHEDRAL, NAVE CEILING ROOF SPACE

INVESTIGATION OF PAINT MATERIALS AND TECHNIQUES

May 2003

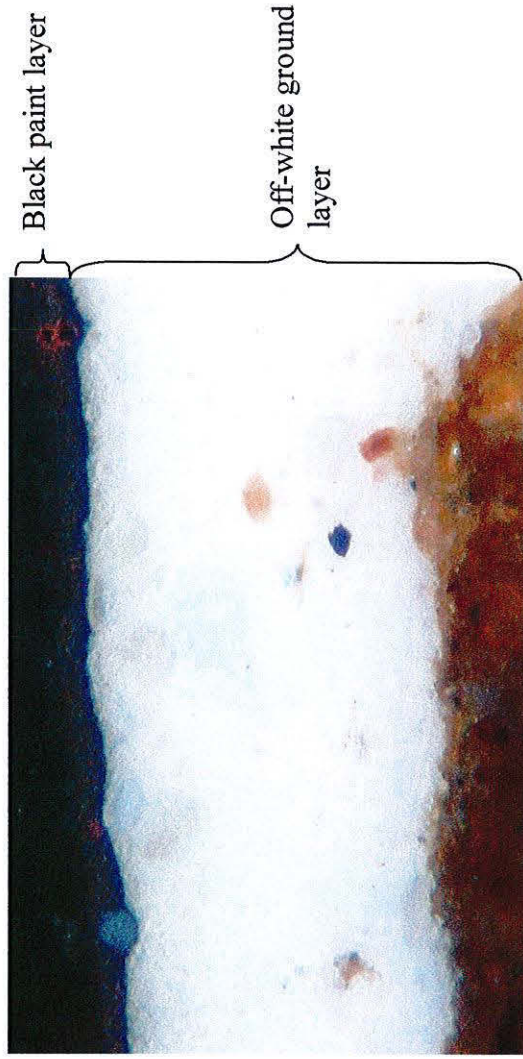
Sample 32 (3101, P4a:1) photographed in cross-section under reflected light at 200 x magnification. (Printed magnification not calculated).

The sample shows a simple layer structure, with an off white ground and a relatively thin upper dark paint layer. The white ground is composed largely of lead white, with a few iron oxide articles and some carbon black. The black layer contains a carbon black pigment together with some iron oxide — an orange iron oxide particle is visible on the cross-section photomicrograph. Calcium is also

present in the black paint. No phosphorous was detected by SEM.EDX therefore the possibility of the black being Bone black pigment has been ruled out. The calcium presumably originates from an inert calcium based filler — occasional transparent white particles are visible.

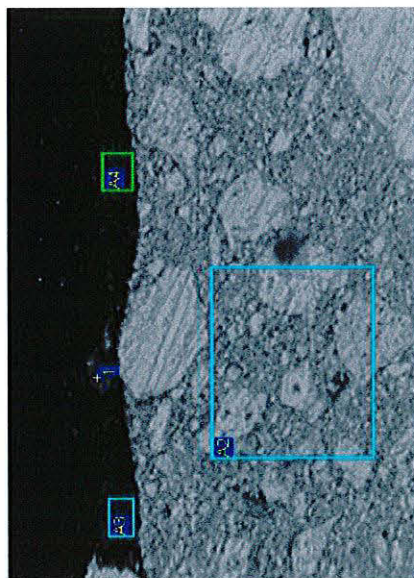
SEM.EDX backscattered images of sample 32 (3101, P4a:1) showing the location of SEM.EDX spectra.

Spectra 1 (orange particle) showed major peaks for iron (Fe). This suggests the orange coloured particles in the black layer are an iron oxide pigment.

Spectra A3 and A4 (black paint) show peaks for carbon (C), calcium (Ca), iron and lead (Pb). The lead probably arises from the white ground below. The iron from the iron oxide pigment present in the layer. No phosphorous was detected, ruling out the presence of Bone black pigment. The calcium presumably originates from an inert filler, such as calcium carbonate.

Spectra A2 shows peaks for lead, confirming its identity as lead white.

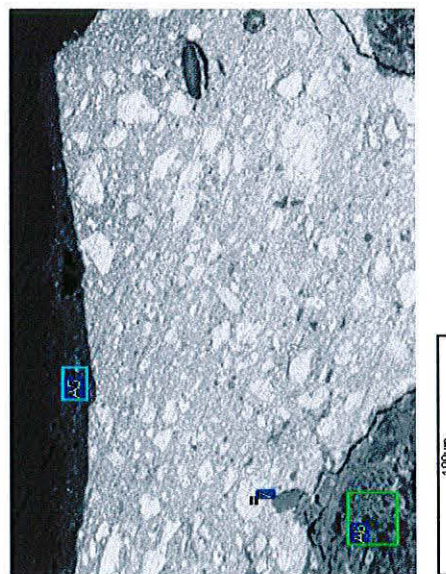
Spectra A5 (black paint) again shows major peaks for carbon, calcium and lead.

Spectra A6 (timber substrate) shows peaks for lead and traces of iron and carbon. These probably arise from the adjacent off-white ground layer.

Spectra 7 (white particle) shows peaks for lead. The particle is lead white.

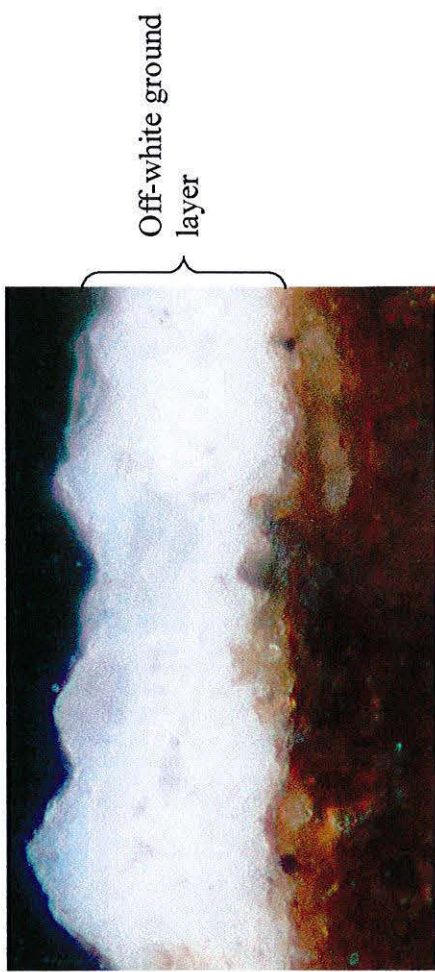
Sample 33 (3102, P4a:2) photographed in cross-section under reflected light at 200 x magnification. (Printed magnification not calculated).

This sample shows the off-white ground layer. No surface paint layer is present on the sample. No SEM.EDX was undertaken on this sample.

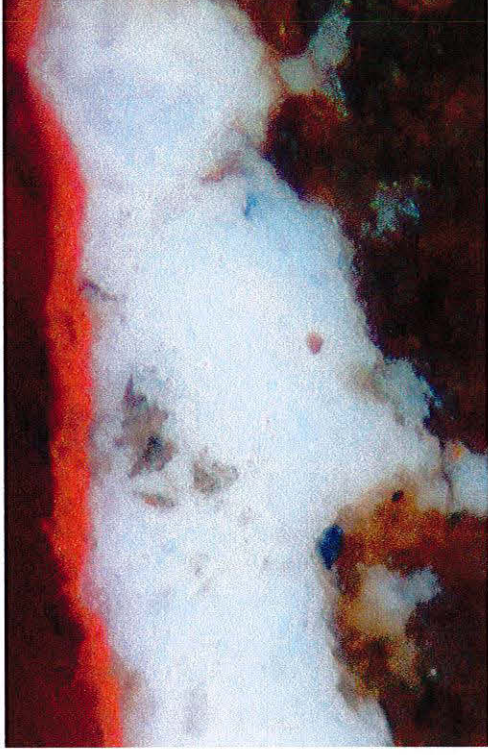
Sample 34 (3103, P4a:3) photographed in cross-section under reflected light at 200 x magnification. (Printed magnification not calculated).

The sample shows the timber substrate, white ground and upper red paint layer. The off-white lead white ground contains a few transparent white calcium containing particles as well as a very few black and brown pigment particles. The red paint layer also contains transparent particles, also calcium based. The red layer has a microscopic appearance consistent with an iron oxide red pigment. The red layer produces SEM.EDX spectra with

peaks for lead, iron and calcium. The lead present is attributed to the underlying white lead ground.

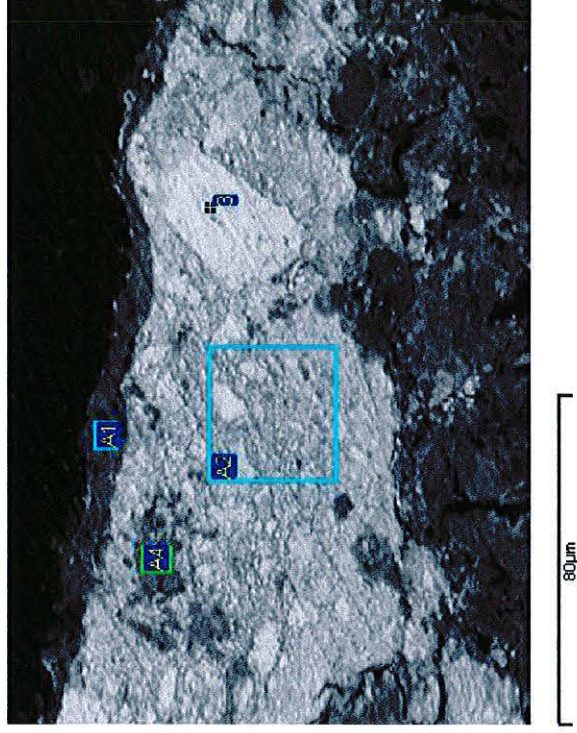
Image above right: SEM.EDX backscattered image of the sample showing points at which EDX spectra were made.

Spectra A1 shows peaks for lead, iron and calcium.

Spectra A2 shows peaks for lead.

Spectra point 3 shows peaks for lead.

Spectra A4 shows peaks for lead and a trace of calcium.

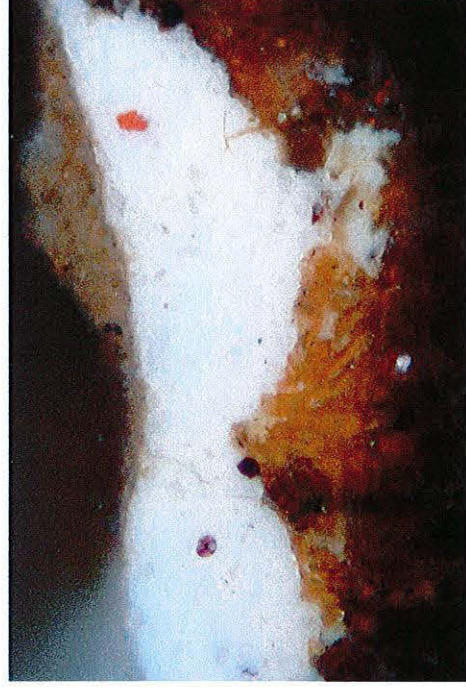
Sample 35 (3104, P4a:4) photographed in cross-section under reflected light at 200 x magnification. (Printed magnification not calculated).

The sample shows a single layer of lead white, with a few coloured iron oxide, carbon black and white transparent particles. Noticeable on the sample is the translucent brownish layer on its surface. As similar material is also present at the substrate/paint interface. The presence of silica and aluminium, suggestive of a clay rich material, in this substance was confirmed by SEM.EDX. Previous research (Howard 1997) identified calcium sulphate and a

clay-rich material at the wood/paint interface which was attributed to previous conservation treatment of the ceiling. Given the proximity of the sample location to areas of hessian and glue applied during previous conservation it appears likely that the clay-rich material may not be original to the painting, but a later introduction.

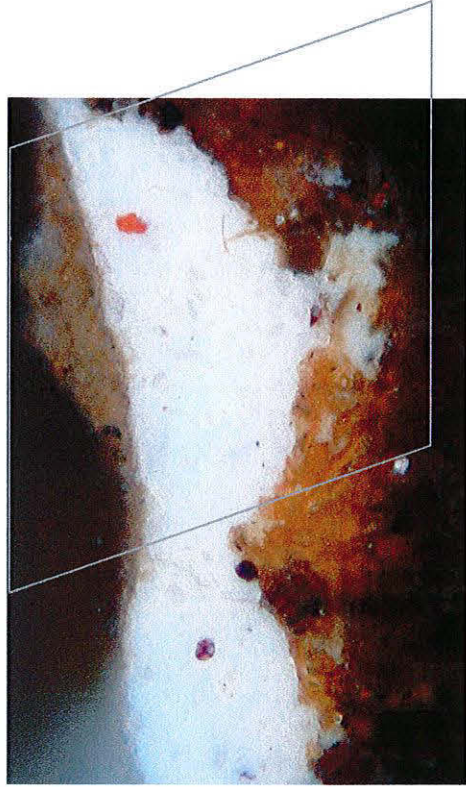
Image right: SEM.EDX backscattered image of the sample showing points at which EDX spectra were made.

interface and on the surface of the sample. Previous research (Howard 1997) identified calcium sulphate and a clay-rich material at the wood/paint interface which was attributed to previous conservation treatment of the ceiling. Given the proximity of the sample location to areas of hessian and glue applied during previous conservation it appears likely that the clay-rich material may not be original to the painting, but a later introduction.

Spectra A2 and Spectra point 4 both show peaks for lead, carbon and oxygen.

Spectra A1 (brown layer) shows peaks for lead, silica (Si), sulphur (S) and calcium. Aluminium (Al), iron, oxygen, carbon and phosphorous. The lead reading probably originates from the white lead ground. The spectra from point 3 also shows peaks for silica and aluminium, together with potassium (K), oxygen and a trace of sodium (Na). The presence of silica and aluminium is suggestive of a clay rich material, present at the substrate paint
