PETERBOROUGH CATHEDRAL
ENVIRONMENTAL MONITORING DATA
5th APRIL TO 13th JUNE 1995.

PETERBOROUGH CATHEDRAL
ENVIRONMENTAL MONITORING
SECOND PERIOD
5th APRIL TO 13th JUNE 1995

PETERBOROUGH CATHEDRAL

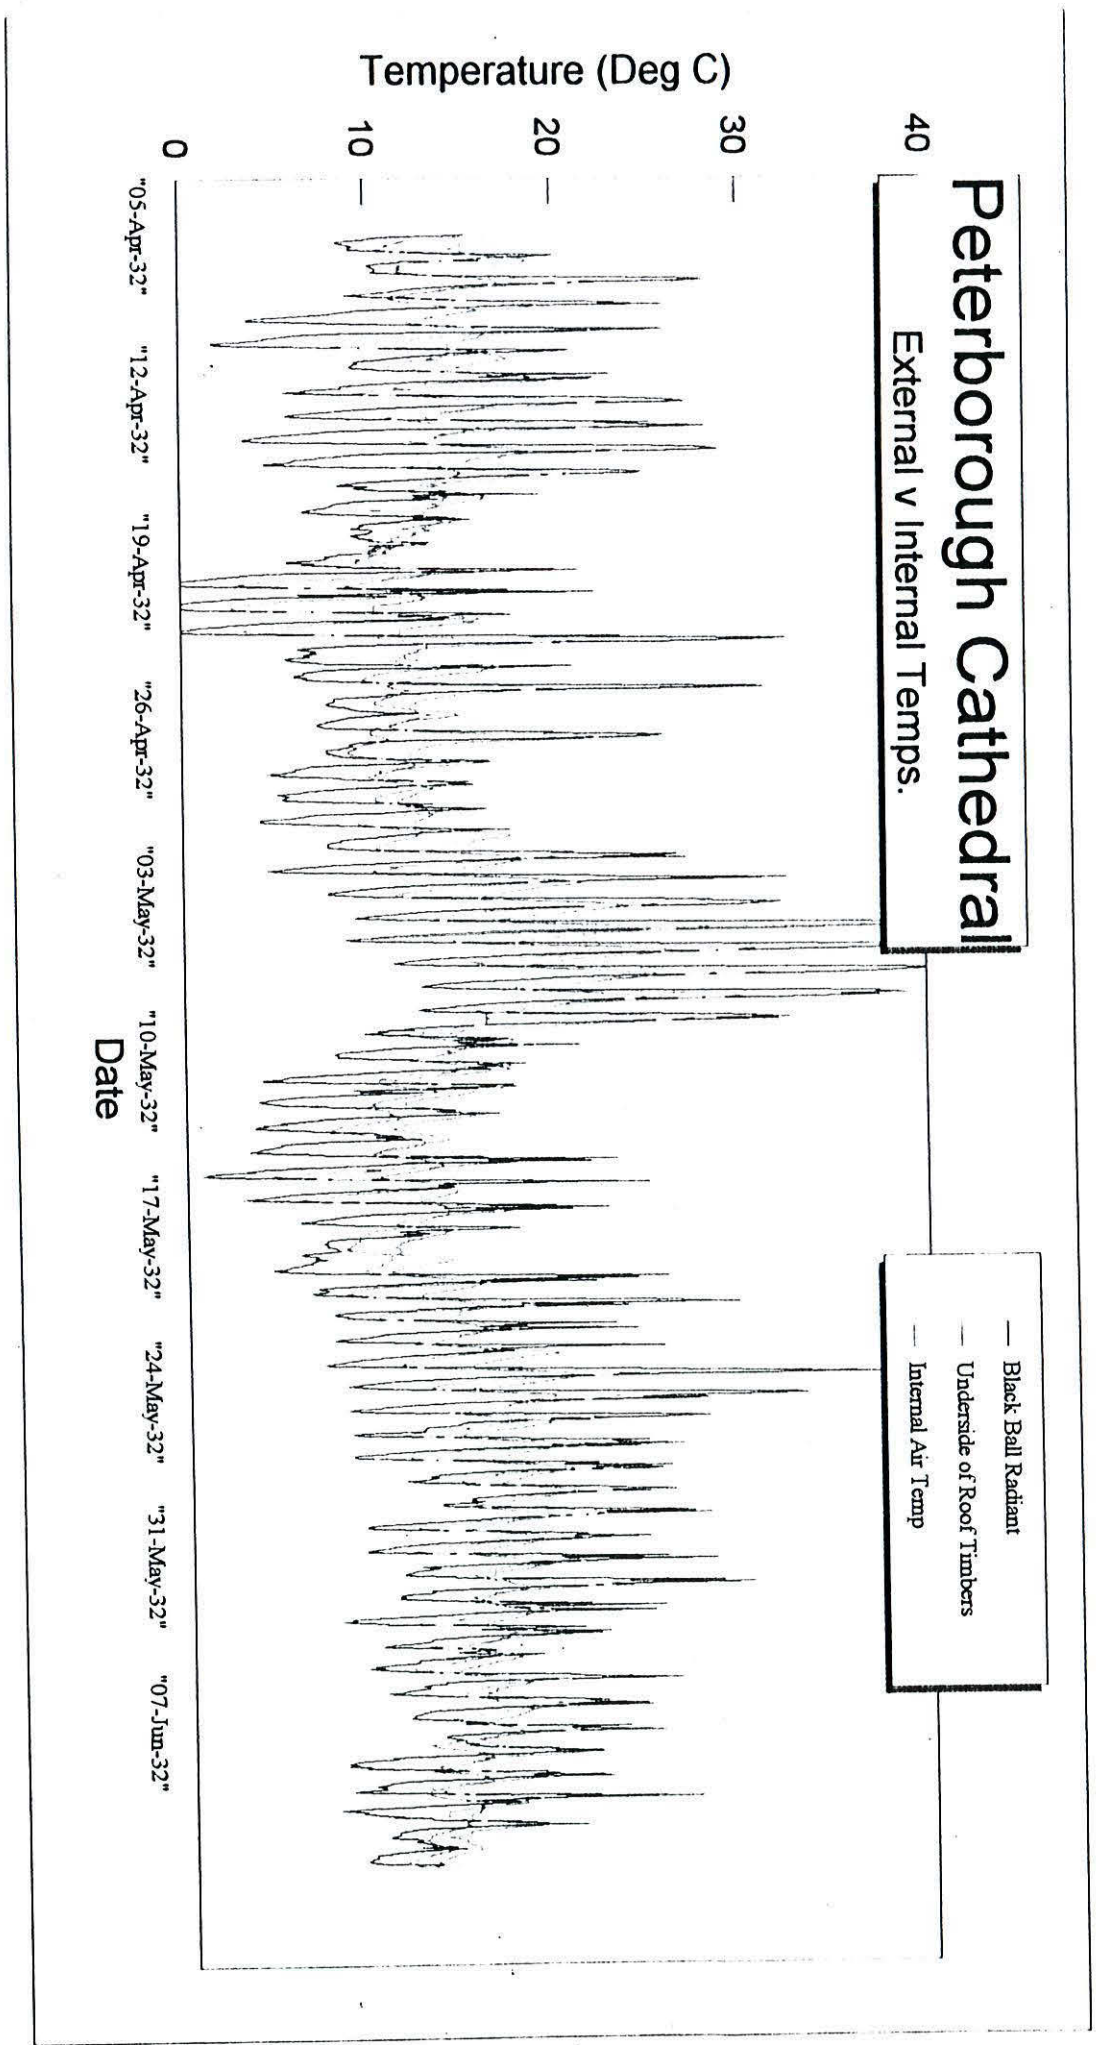
GRAPH 1.

During this monitoring period a "black ball" sensor was installed to record radiant temperatures. These varied between -2°C and 40°C whilst the shade temperatures ranged from 0°C to 30°C . The relative humidity fluctuated from 100% to 30%. Graph 1 clearly shows the daily variations of temperature and humidity and indicates a general levelling in temperature towards the end of the period.

Additional sensors were installed to give high level temperature and humidity and also the temperature of the roof boarding on the south side of the building. Graph 1 shows the relationship between the three temperatures for the complete monitoring period. Graphs 2 and 3 are an expanded portion of the data and have the external ambient temperature included. Daily variations of temperature can be clearly seen and it can also be seen how the roof boarding follows the external temperature. The internal air temperature shows distinct daily variations but these are smoothed out showing how the building fabric helps remove extremes of "peaks and troughs".

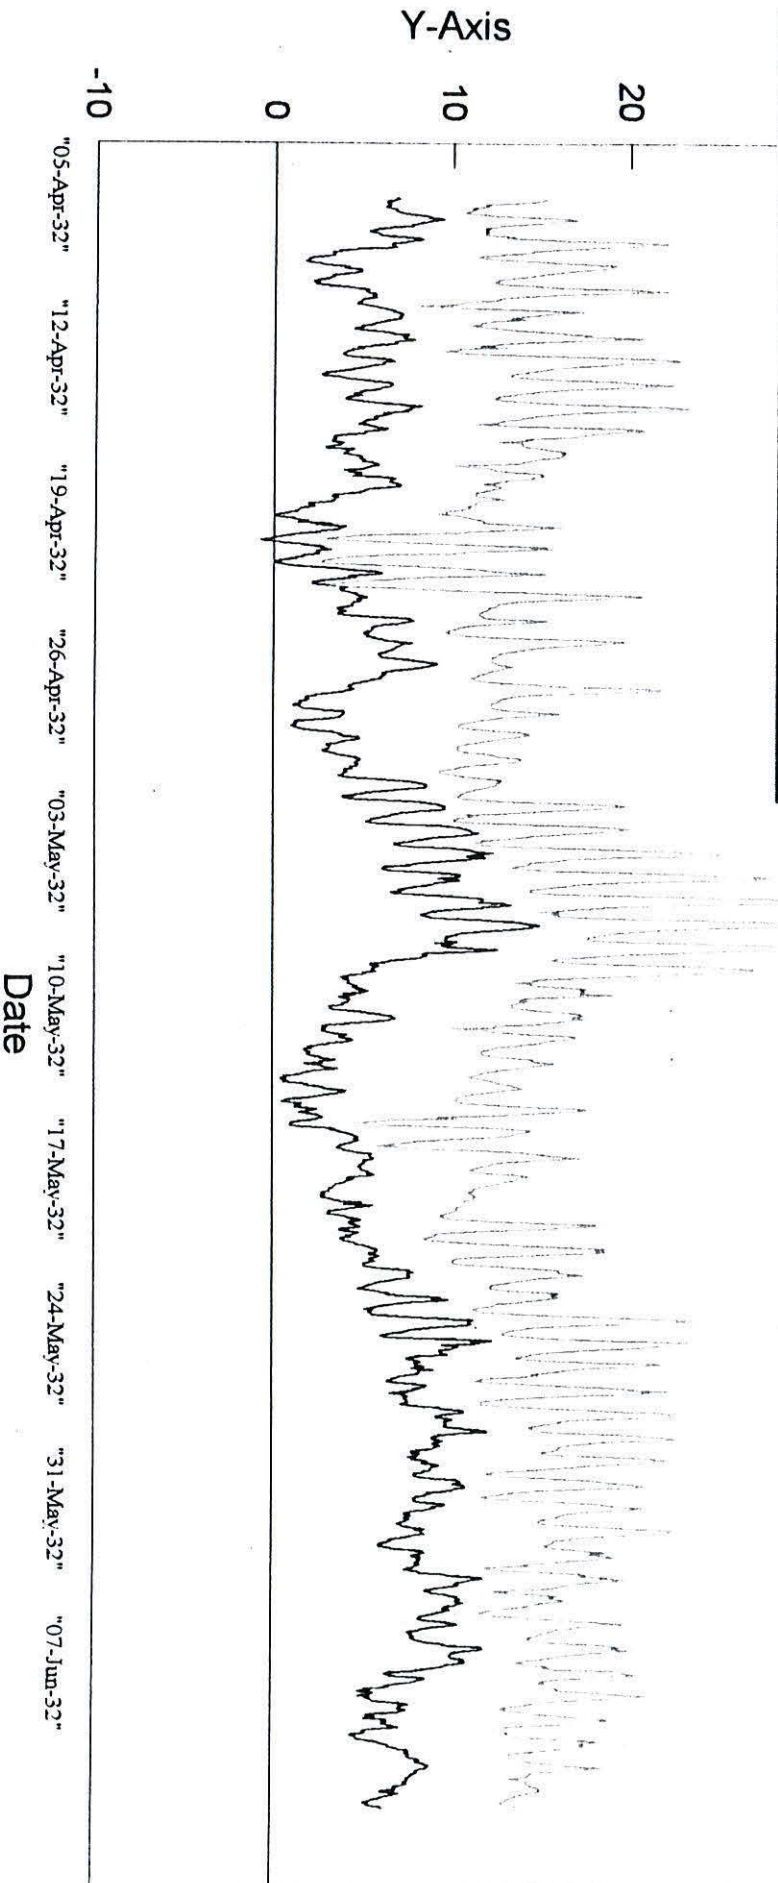
GRAPH 4.

Graph 4 shows the dew point and surface temperatures of the roof boarding, as there is no clear crossover point it is very unlikely that any surface condensation formed on the inside of the roof during this monitoring period. Graph 5 shows the internal and external vapour pressures. The graph clearly indicates that the trend of moisture movement is from outside to inside but can move in either direction depending on the temperature and humidity at any given time. The moisture movement through the roof structure caused by the vapour pressure difference will be absolutely minimal due to the vapour resistance of the bitumen felt under the roof tiles.

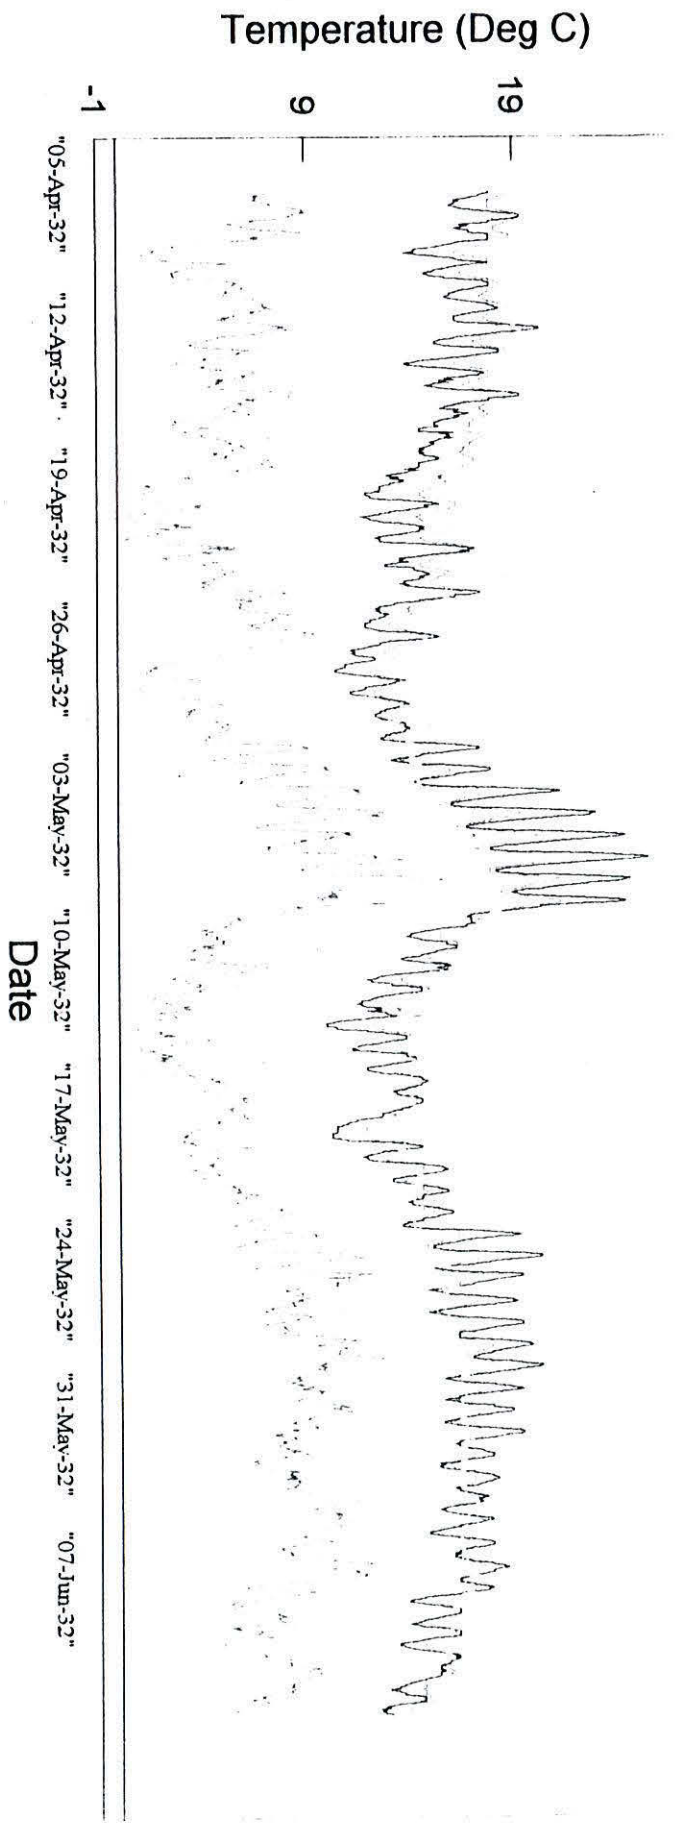
Graph 6 shows the temperatures on either side of the painted ceiling as well as the dew point temperatures. It shows that, as the surface and dewpoint temperatures are well separated, there was no likelihood of surface condensation on the ceiling during this monitoring period. Graph 7 shows the vapour pressure either side of the ceiling and it can be seen that moisture is moving in either direction. As the ceiling is of a relatively light construction, the moisture should pass through with little effect on the wood.

Unlike the previous monitoring period when the underside of the painted ceiling was always warmer than the topside, the temperature varied on either side of the ceiling. This effect can be seen in Graph 6 where the topside temperature is obviously being affected by the external conditions.

Visual inspection of the ceiling should continue to check whether the condition of the wooden panels has stabilised or if the fastenings are continuing to become dislodged.

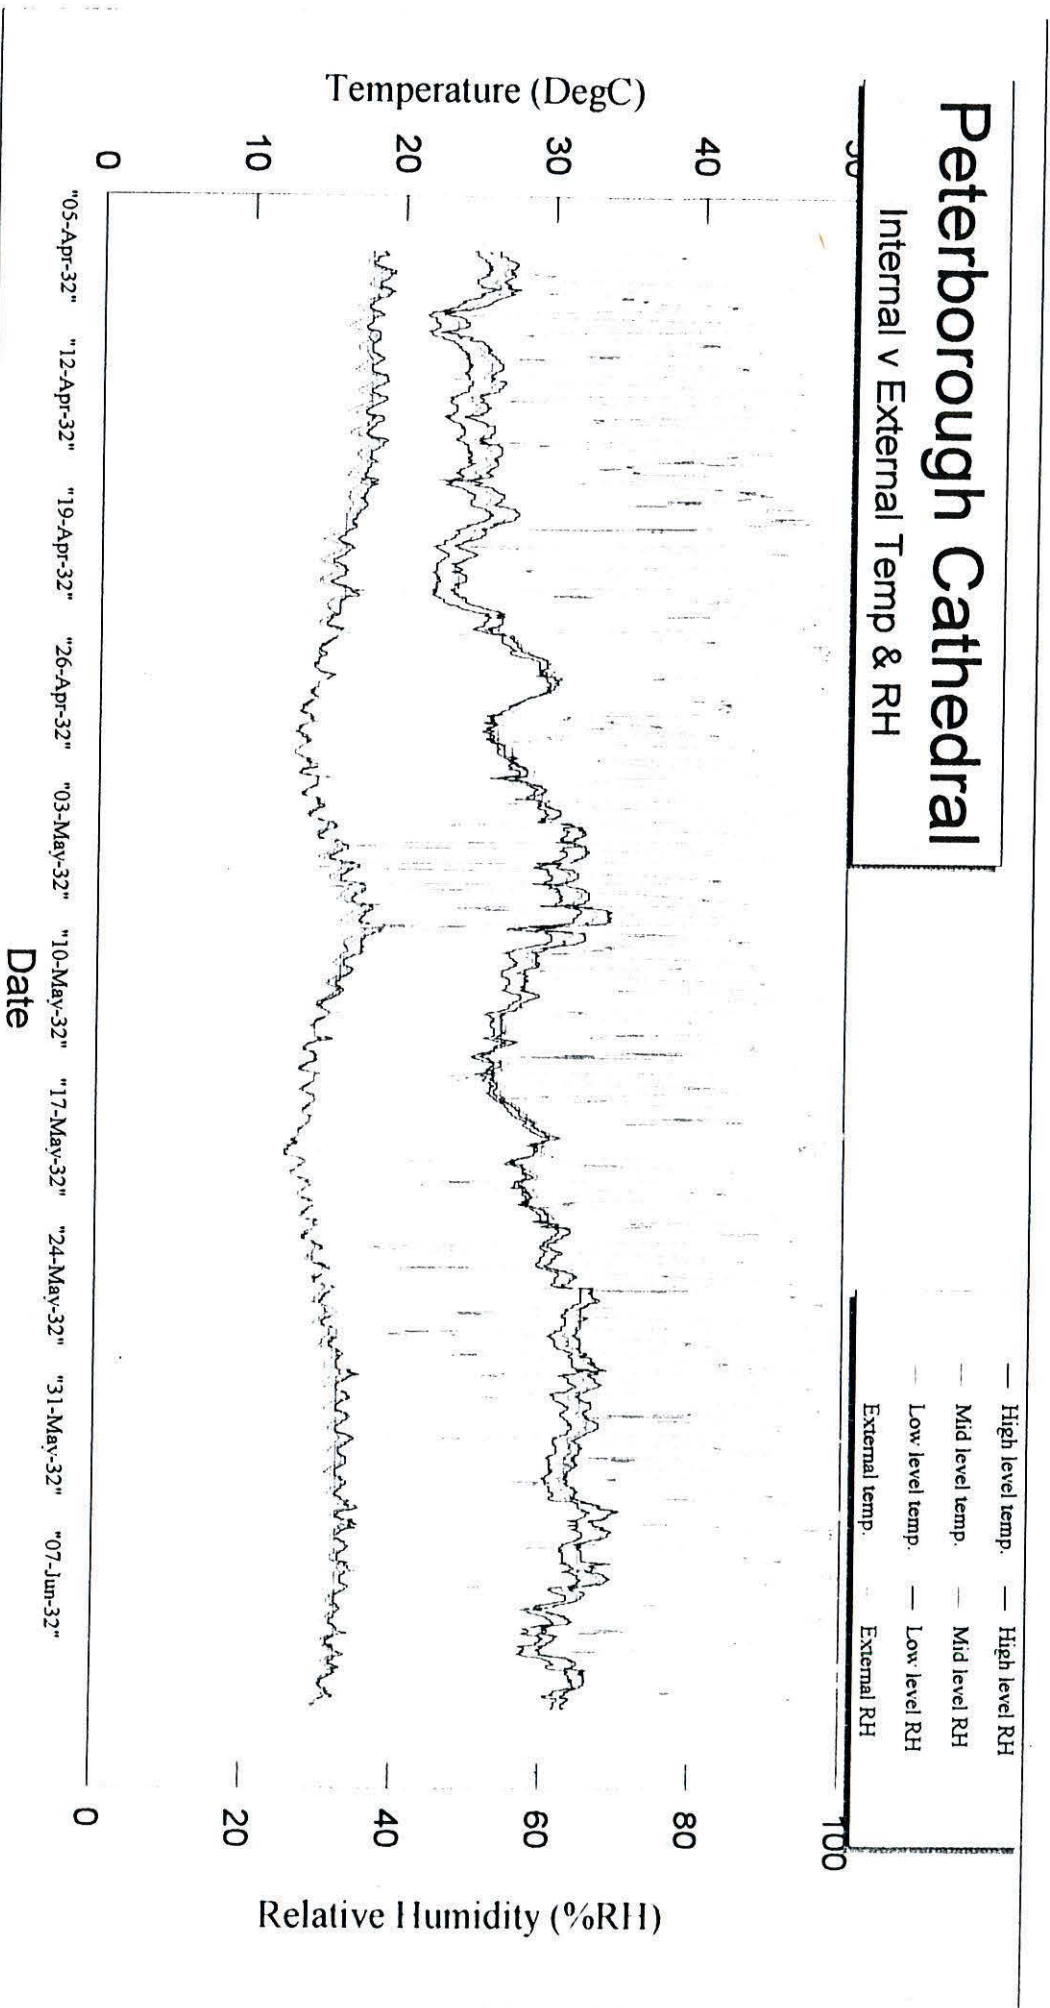
GRAPH 8.

The sensors in a vertical stack in the main body of the cathedral indicate a very stable environment. Graph 8 shows the three internal readings plus the external, it shows clearly that whilst the external conditions are varying by a very wide margin, the internal readings are "buffered" by the building fabric.

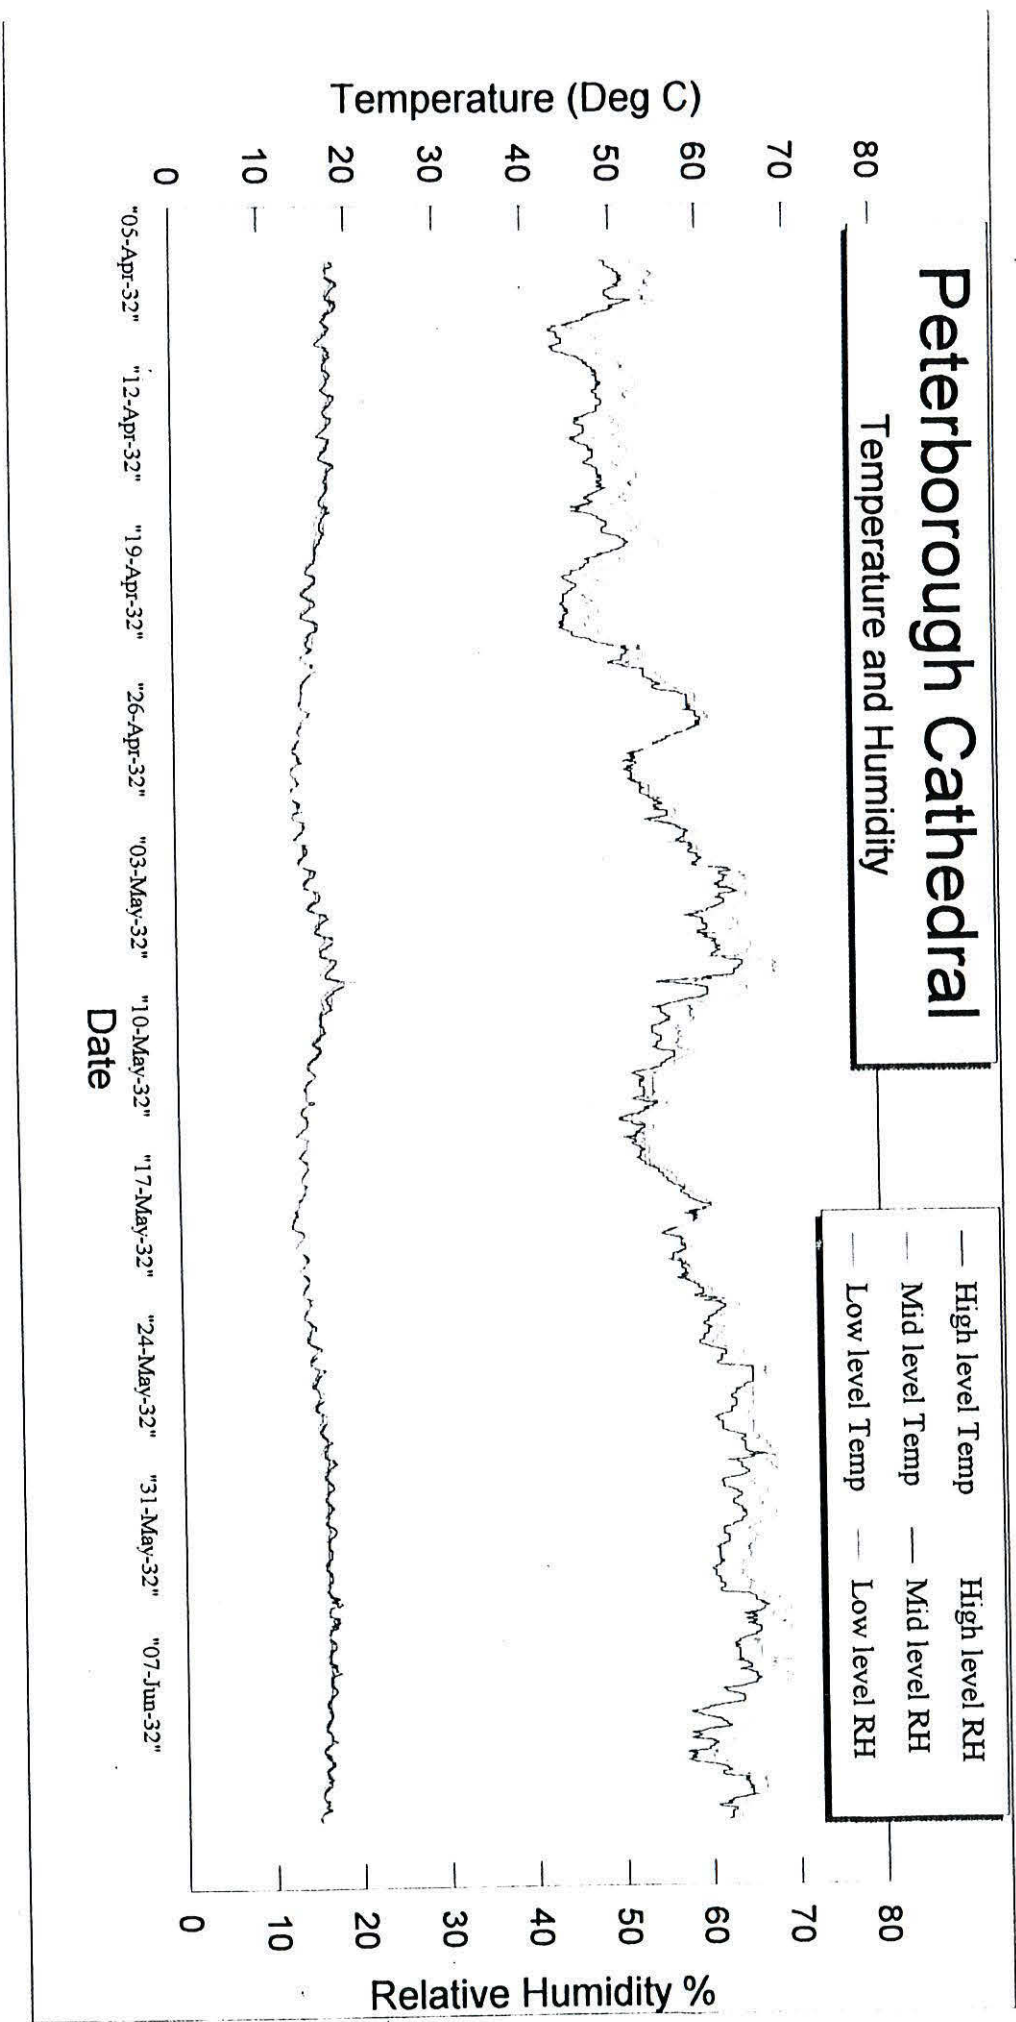
GRAPH 9.

Graph 9 comprises the readings from the internal sensors only, it can be seen that three temperature graphs are almost identical giving, as for the previous period, an almost total lack of temperature gradient. This is probably helped by there being a draught lobby preventing ingress of air every time the main doors are opened. Graph 10 is an expanded portion of the data indicating the stability of the internal environment whilst the external conditions are fluctuating over a wide range.
