PETERBOROUGH CATHEDRAL
ENVIRONMENTAL MONITORING
FOURTH PERIOD
20th SEPTEMBER TO 1st NOVEMBER 1995

Monitoring is continuing to establish the environmental conditions within the cathedral so that an assessment can be made as to whether the medieval painted ceiling is being adversely affected by the heating system.

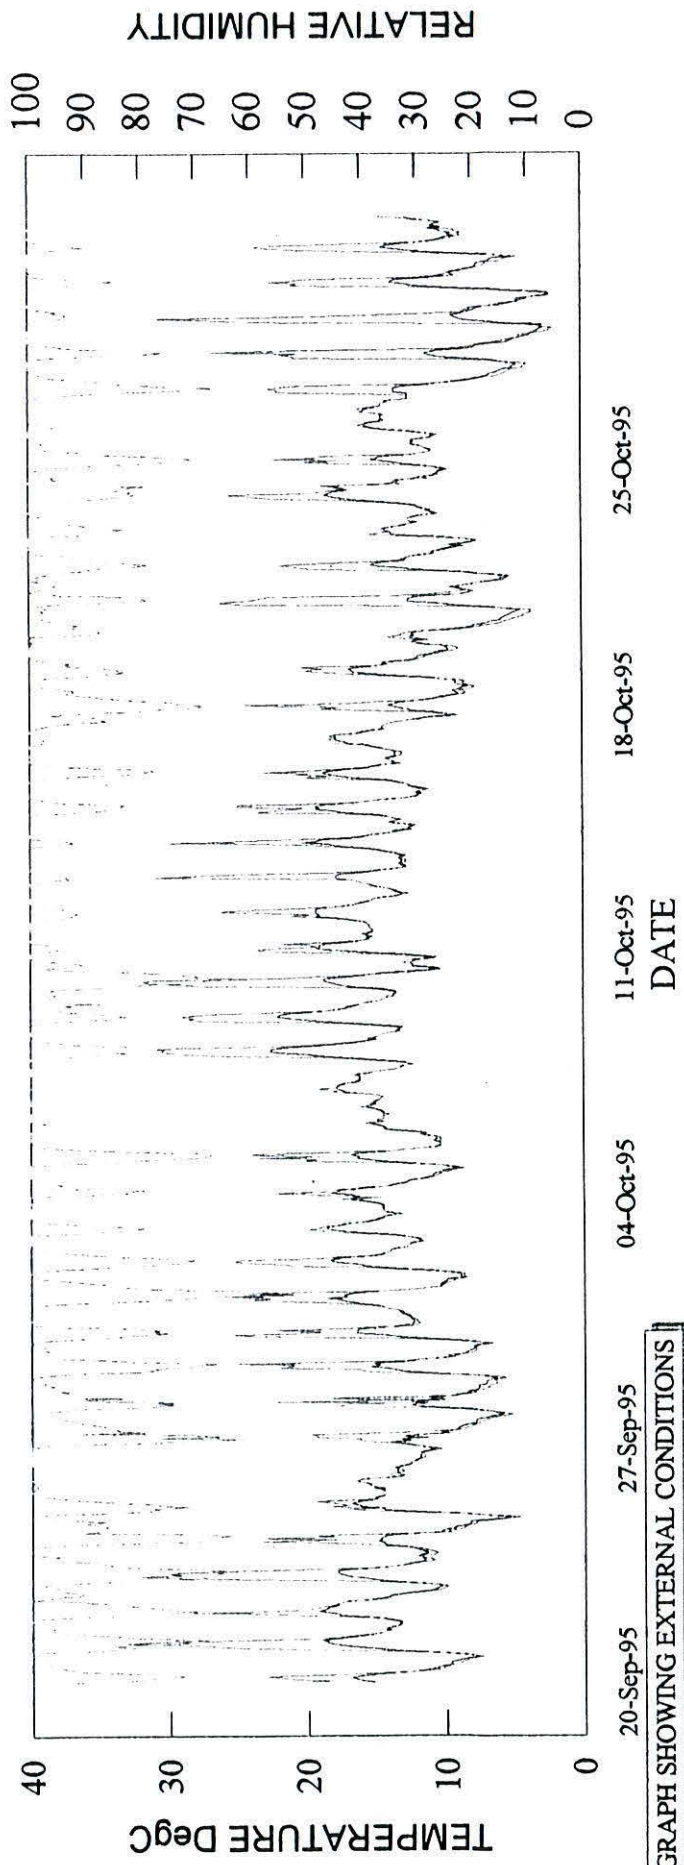
GRAPH SHOWING EXTERNAL CONDITIONS

During this monitoring period radiant temperatures varied between 2°C and 39°C whilst the shade temperatures ranged from 2°C to 33°C. The relative humidity fluctuated from 100% to 30%. Appendix A shows the daily variations of temperature and humidity and indicates a gradual decline in the external temperature towards the end of the period.

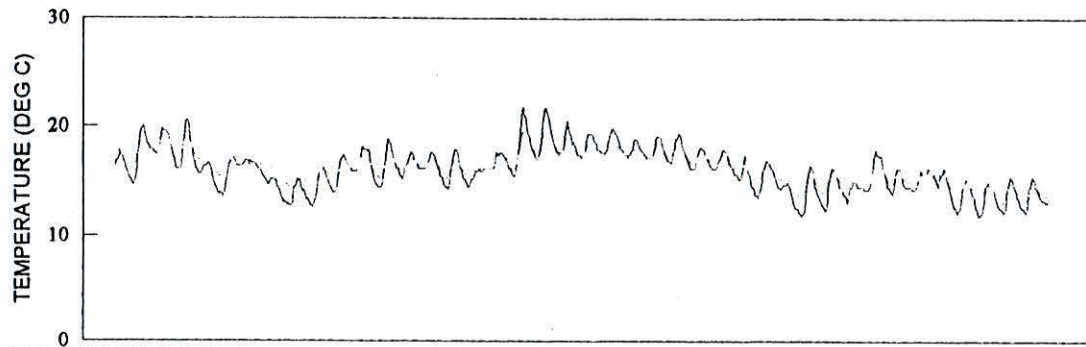
SURFACE TEMPERATURES EITHER SIDE OF PAINTED CEILING
GRAPH 1

Appendix C, Graph 1 shows the relationship between the topside and the underside ceiling surface temperatures. The underside surface temperature generally showed a greater variation than the high level air temperature, this was due to it as being affected by the topside ceiling surface temperature. There were only minor differences between the high level (scaffolding level) temperature and that adjacent to the ceiling.

Conditions within the roof void varied by a greater amount than those in the cathedral, appendix C, graph 1 shows how the ceiling surface temperatures varied and graph 3 shows the temperature difference across the ceiling. It is inevitable that with an unheated roof space, there will be some temperature differential across the ceiling. Graph 2 shows an expanded portion of the data and indicates a maximum difference of 2 degrees. Given the heavyweight building structure, any flexing due to this deviation should be minimal.

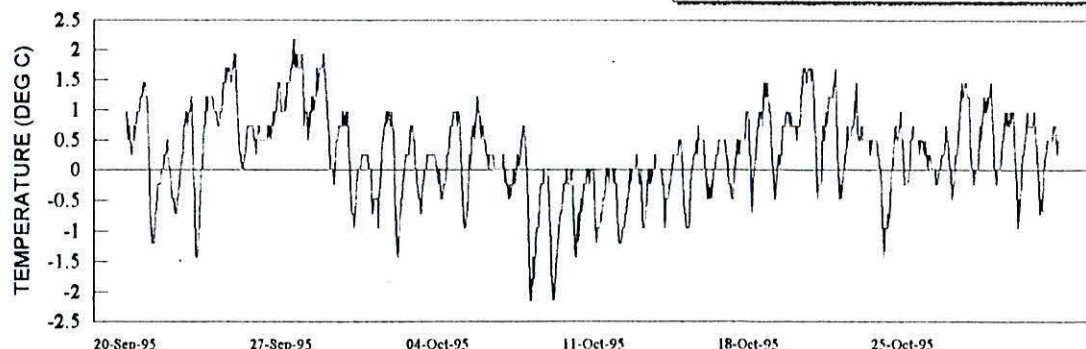
GRAPH 3

Results for this monitoring period show relatively stable conditions for the painted ceiling. There is no excess temperature variation across the ceiling, therefore any flexing or movement of the structure should be minimal.

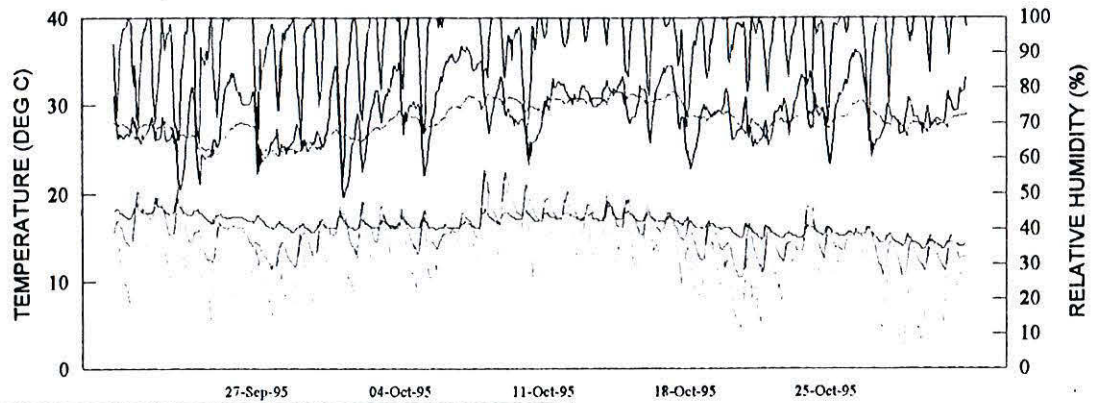
COMPARISON OF CONDITIONS IN CATHEDRAL, ROOF SPACE AND EXTERNAL. GRAPH 1

The conditions in the Cathedral are shown in Appendix B, Graph 1. The relative humidity is very stable averaging at 70%, difference between the three levels is between 2 and 3%. Temperatures at each level are virtually identical, major discrepancies occur between the 6th and 18th of October, even at this time the maximum variations are less than 1°C, this is shown in Graph 2. As for previous monitoring periods, there is an almost total absence of temperature gradient.

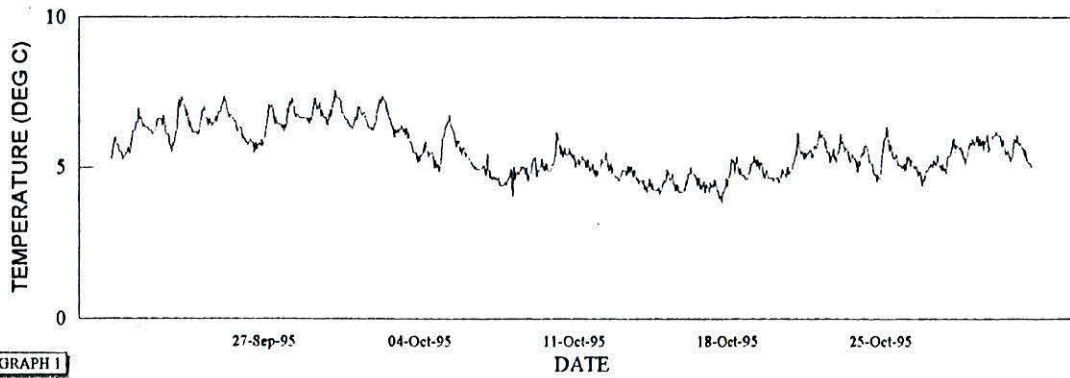
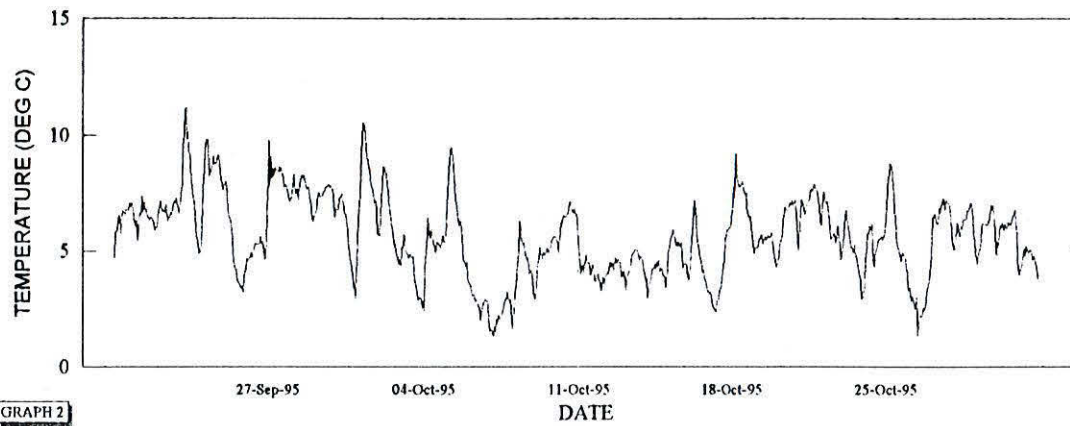
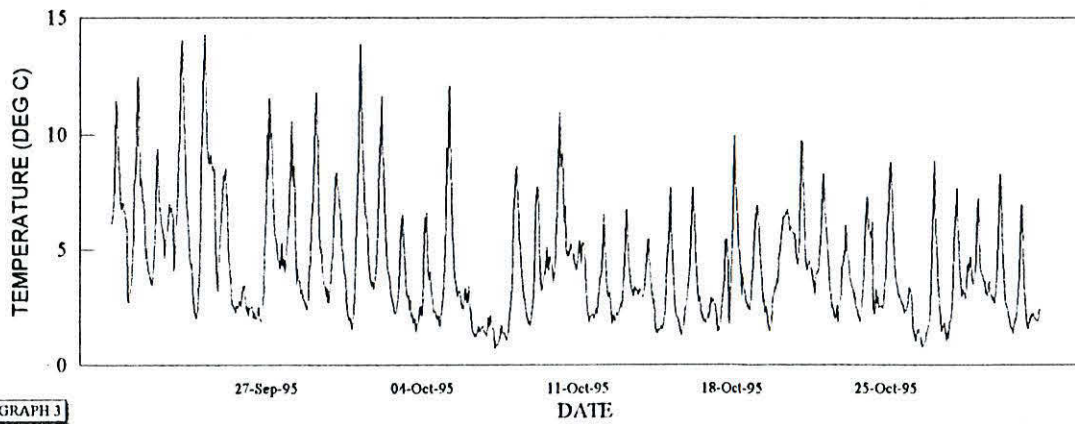
Graphs in appendices D,E,F and G show dew point temperatures, vapour pressures and moisture contents. Dew point temperatures for the ceiling indicate that there was no condensation formed on either surface and that the roof boarding was also free from any problems during this monitoring period.

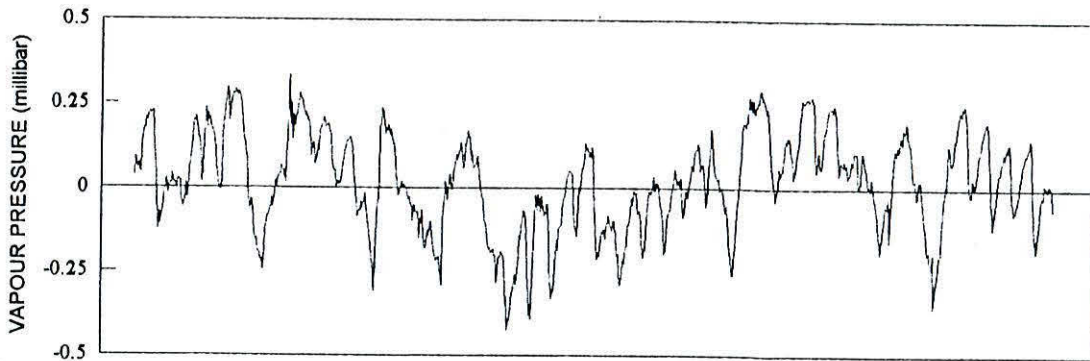
POSITIVE INDICATES MOVEMENT CATHEDRAL TO ROOF SPACE
GRAPH 3

The vapour pressure graphs show that the moisture movement is predominantly from outside to inside but the conditions across the painted ceiling are relatively stable (see graph 3 of appendix F). The moisture content graphs also show that the conditions across the ceiling are

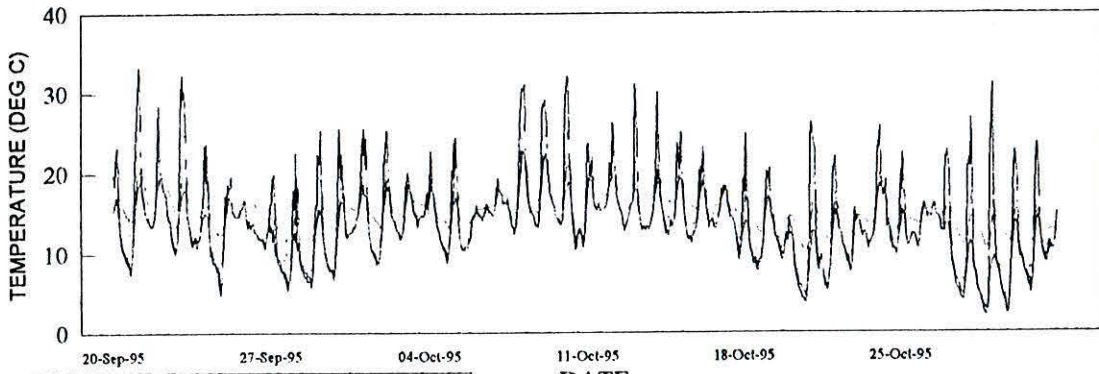
COMPARISON OF TEMPERATURES - EXTERNAL AND ROOF SPACE
 GRAPH 1

Appendix H shows the graphs comparing internal and external conditions, it can be seen that the roof boards are directly influenced by the sun as their temperatures follow the black ball radiant figures. Internal surface temperatures are higher than the external ambient which are recorded in the shade.

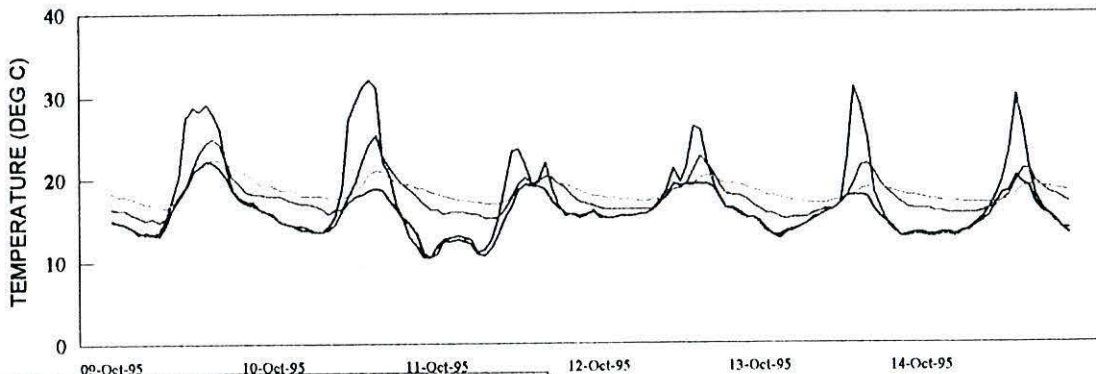
EXPANDED GRAPH SHOWING BUFFERING EFFECT OF THE BUILDING FABRIC
 GRAPH 2

Daily variations of external temperature are between 10 and 15°C. The roof space temperatures only vary by around 5°C which shows the considerable "buffering" effect of the building fabric.
