**PETERBOROUGH CATHEDRAL  
ENVIRONMENTAL MONITORING  
2nd NOV 1995 TO 31st JAN 1996.**

**PETERBOROUGH CATHEDRAL  
ENVIRONMENTAL MONITORING  
FIFTH PERIOD  
2nd NOVEMBER 1995 TO 31st JANUARY 1996**

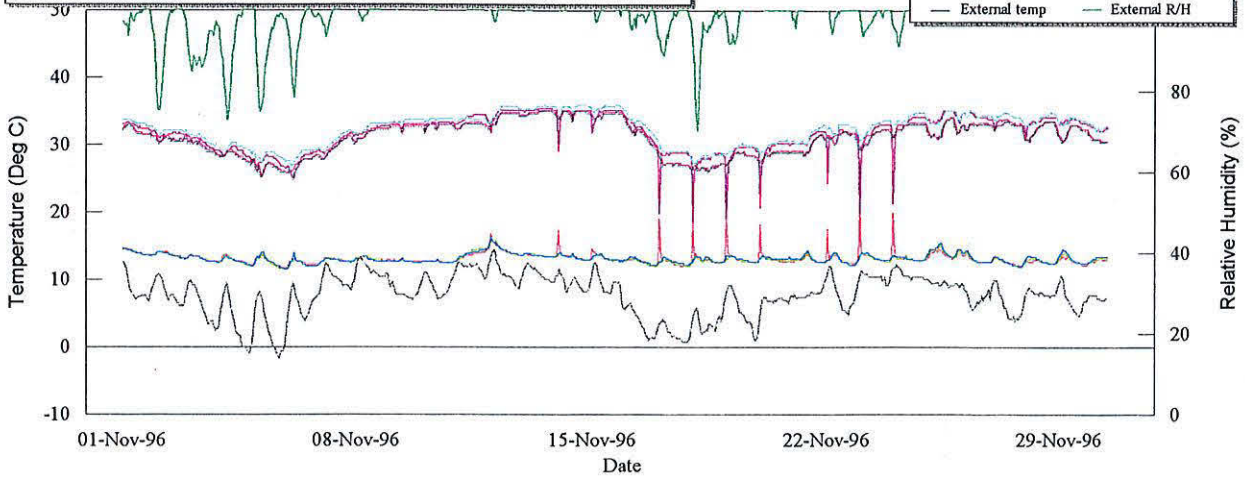
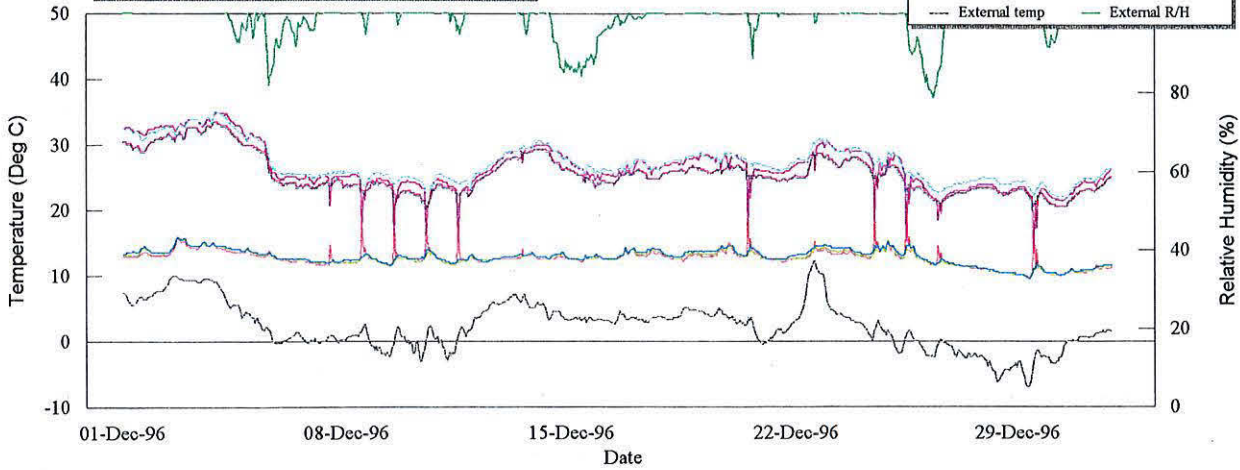
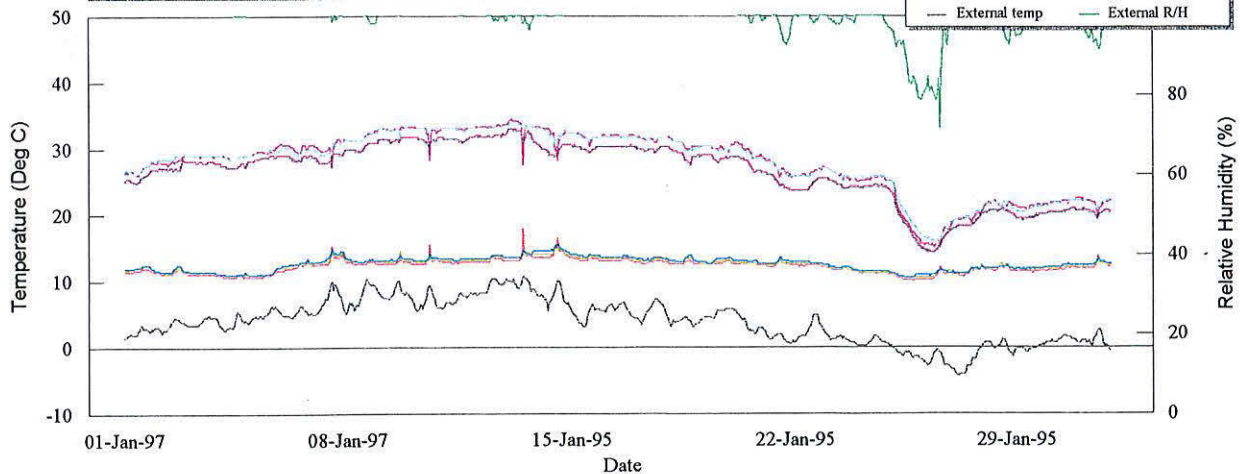
Relative humidities remained high for the entire period, temperatures reached a low in December and showed a steady rise towards the end of January. External readings can be seen in graphs 1 - 3.

Internal conditions can be seen in graphs 1 - 3, as in previous periods there is virtually no temperature gradient. Average temperatures for high, mid and low levels are 12.8, 12.7 and 12.6°C respectively. The relative humidity was reasonably constant but showed a drop at the beginning of December. It is possible that the fall in relative humidity would have been greater if the water had not been added to the Gurney stoves. The reason for the RH falling is that as the outside air cools it has a reduced capacity to hold moisture. Air within the building is constantly changing and will enter through doors, windows and other openings. As this "dry" air is introduced into the Cathedral, its temperature will rise and with no moisture added its relative humidity falls, resulting in lowered readings within the building.

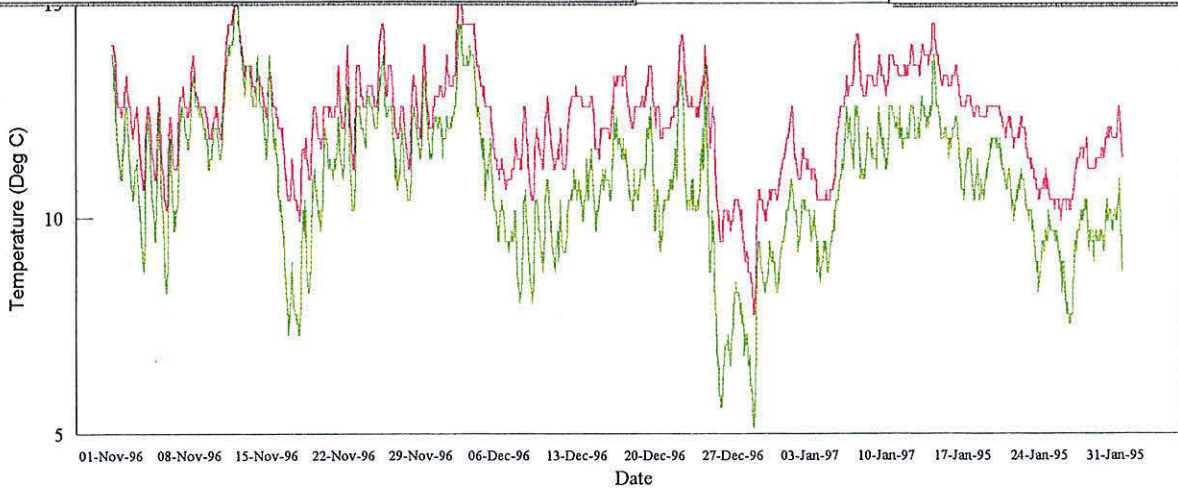
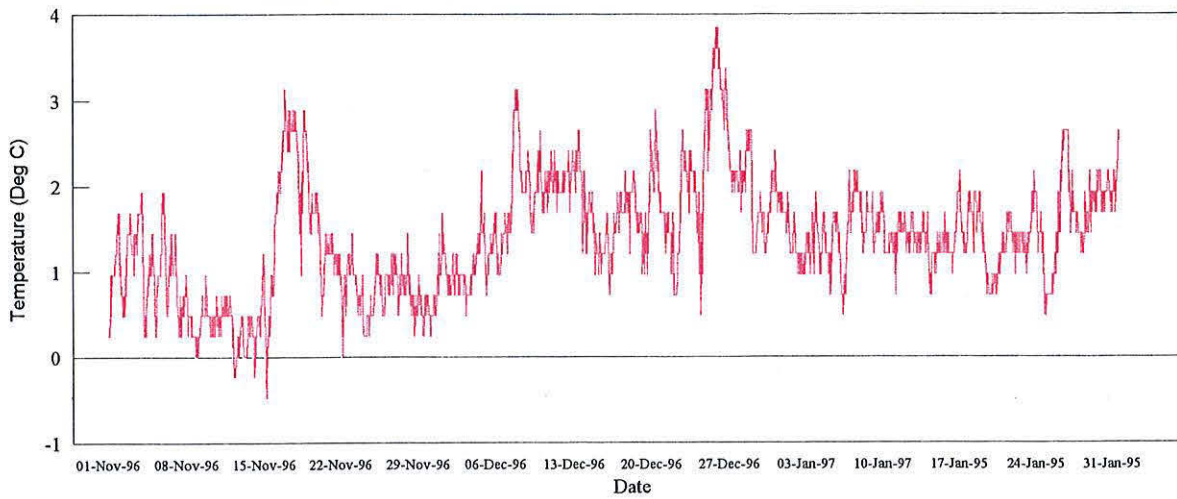
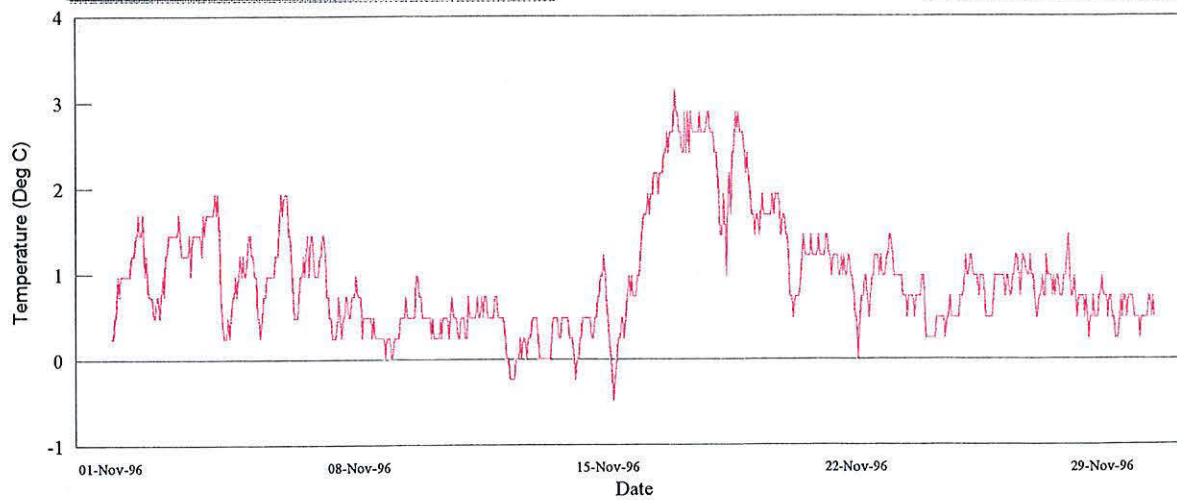
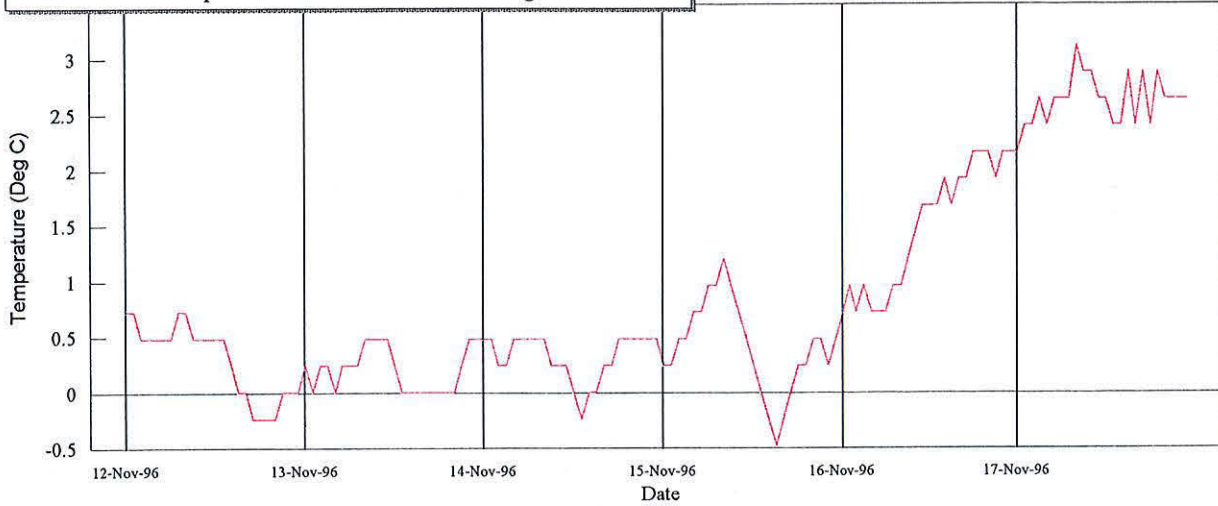
Temperatures either side of the ceiling are shown in graphs 4 to 7, in general the underside of the ceiling was warmer than the topside. The exception is shown in graph 7 when there were three occasions when the reverse occurred. This probably coincided with a sudden drop in outside temperatures and it took a couple of days for the building fabric to stabilise. The maximum temperature difference across the ceiling was 4°C, this is not considered to be a

sufficiently large differential to cause problems by warping.

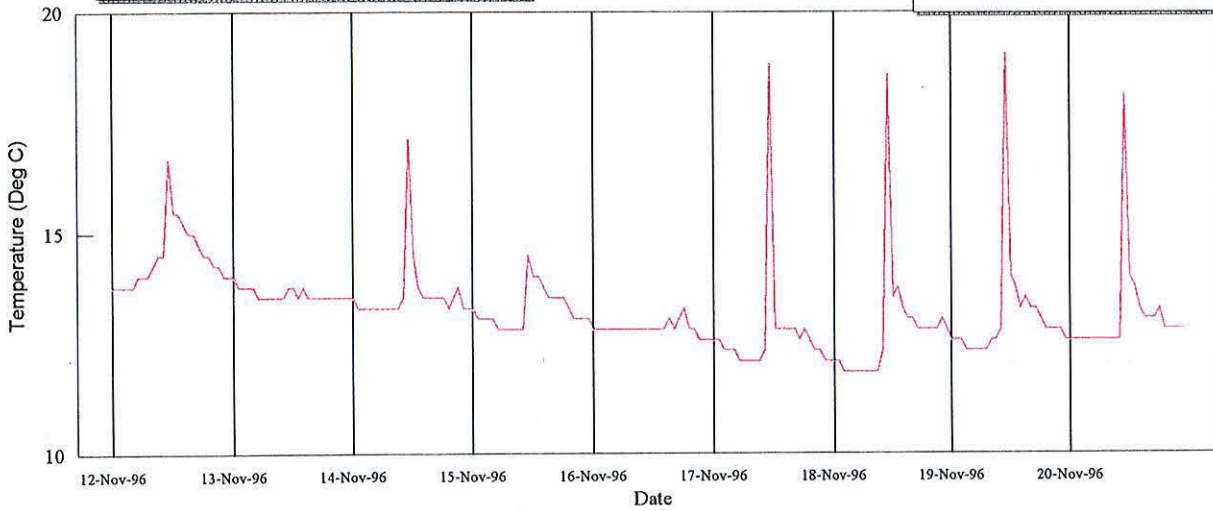
low level (pulpit) temperature

It can be seen from graphs 1 and 2 that the low level temperature increased on a number of occasions. An expanded view of these peaks is shown on graph 8, as they are of relatively short duration they are unlikely to cause problems. Each incident occurred at 1100, as the sensor is located in the pulpit it would be interesting to check whether the person giving the sermon is "cheating" and has his/her own heater.

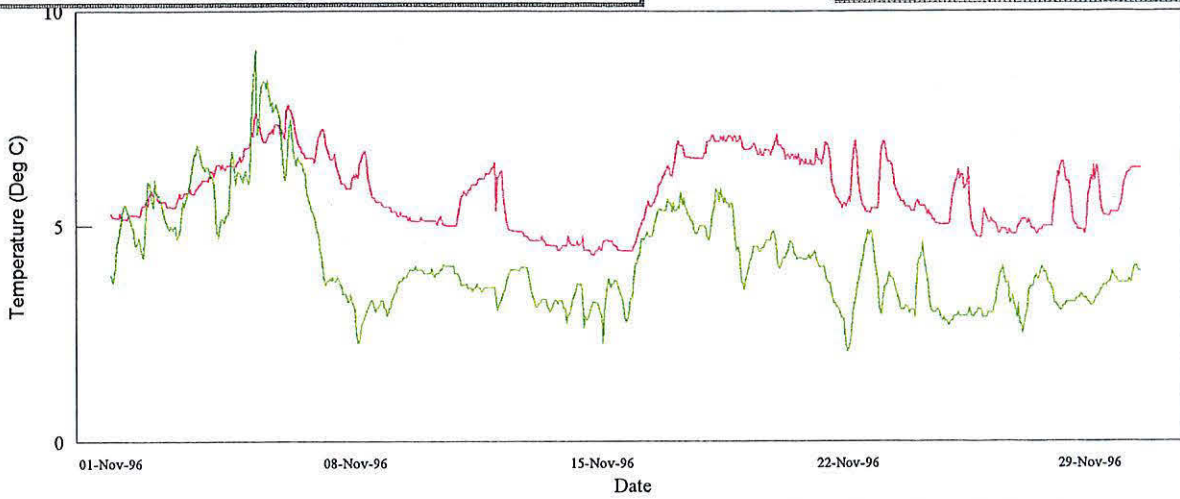
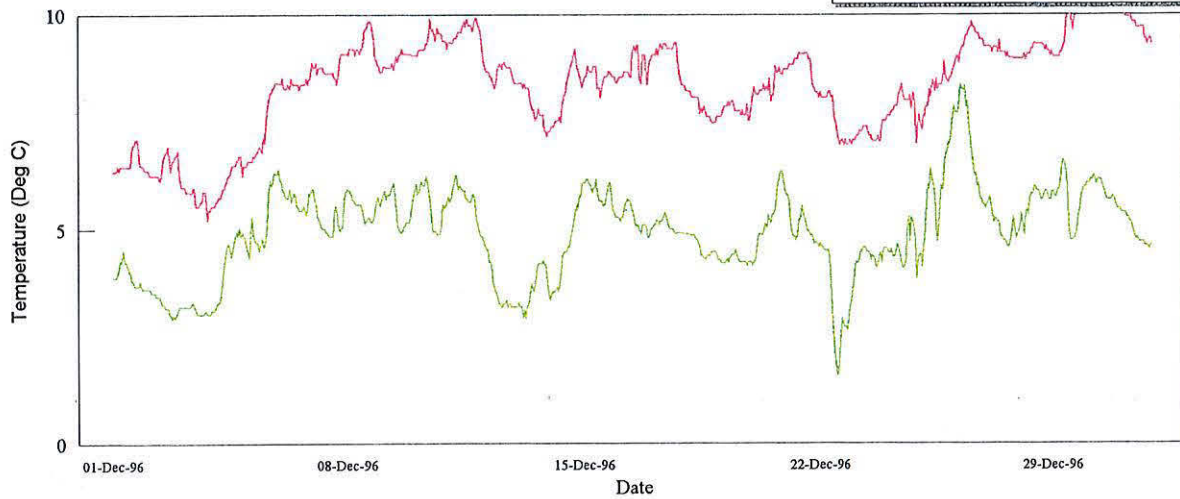
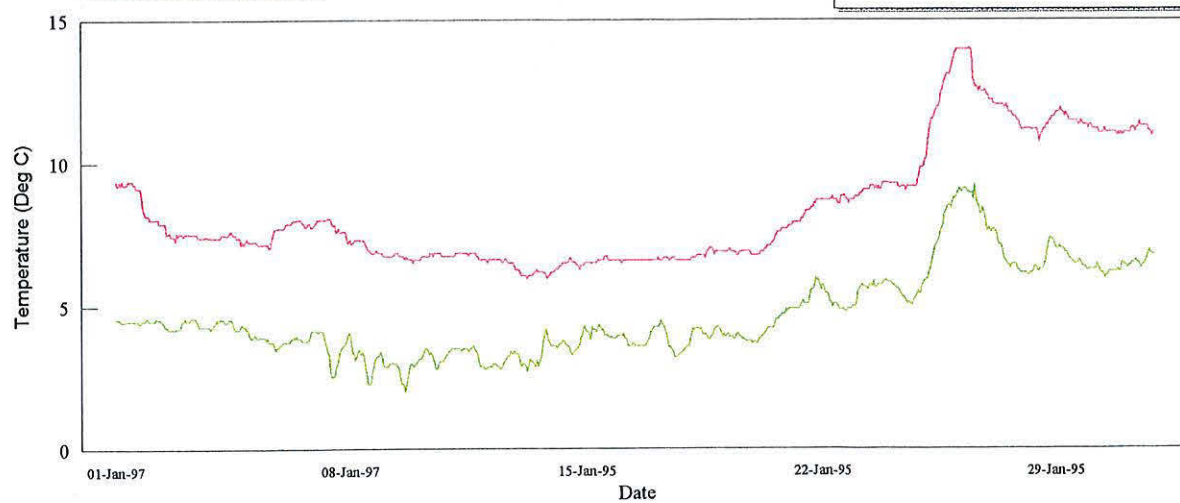
Dewpoint temperatures for the ceiling are shown in graphs 9 - 11, there were no occasions when the surface temperature dropped below the dewpoint. Monitoring has now been in operation for a complete year and calculations have indicated that there will be no condensation problems on either of the ceiling surfaces.

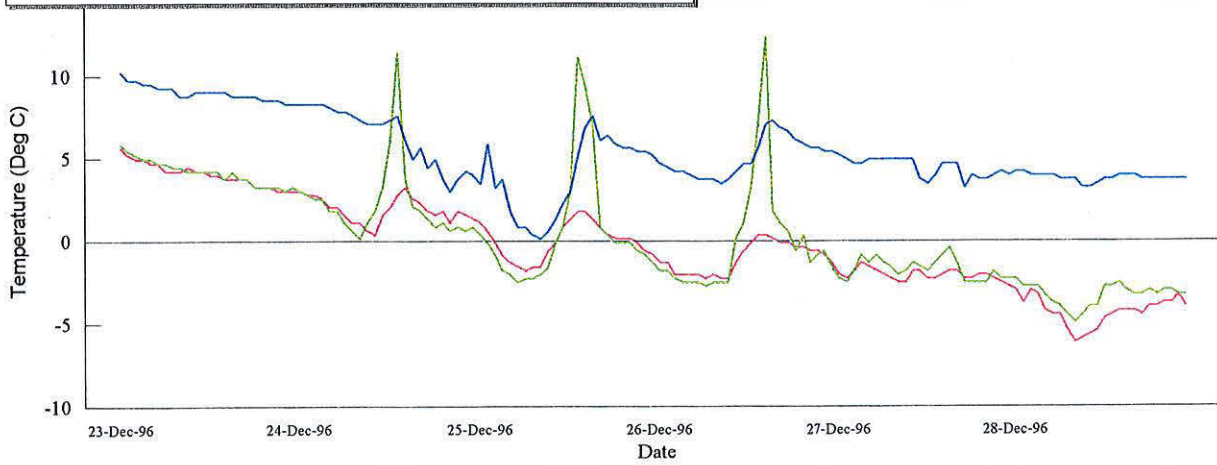
GRAPH 33

Comparisons of “black ball”, external temperature and inside roof timber temperatures are shown in graphs 30 - 33. The inside is generally well buffered from the external conditions, the only time the roof boards approached the external is shown in graph 33 and coincided with a sharp drop in external temperature. Calculations show that condensation will have occurred on the outside between the tiles and the roofing felt on a number of occasions, predictions indicate that there is a small possibility of condensation occurring on the inside between the felt and the boarding. A visual inspection of the roof boarding shows some staining but there is no evidence of moisture falling onto the top of the ceiling.
