**PETERBOROUGH CATHEDRAL
ENVIRONMENTAL MONITORING
1st FEBUARY TO 26th JUNE 1996.**

This report covers 5 months bridging winter/spring/summer. An analysis of temperatures across the painted ceiling has been included to assess the effects of solar gains in the roof space. The mid level temperature and humidity sensor had been disturbed around April 8th and humidity readings from that sensor are unreliable.

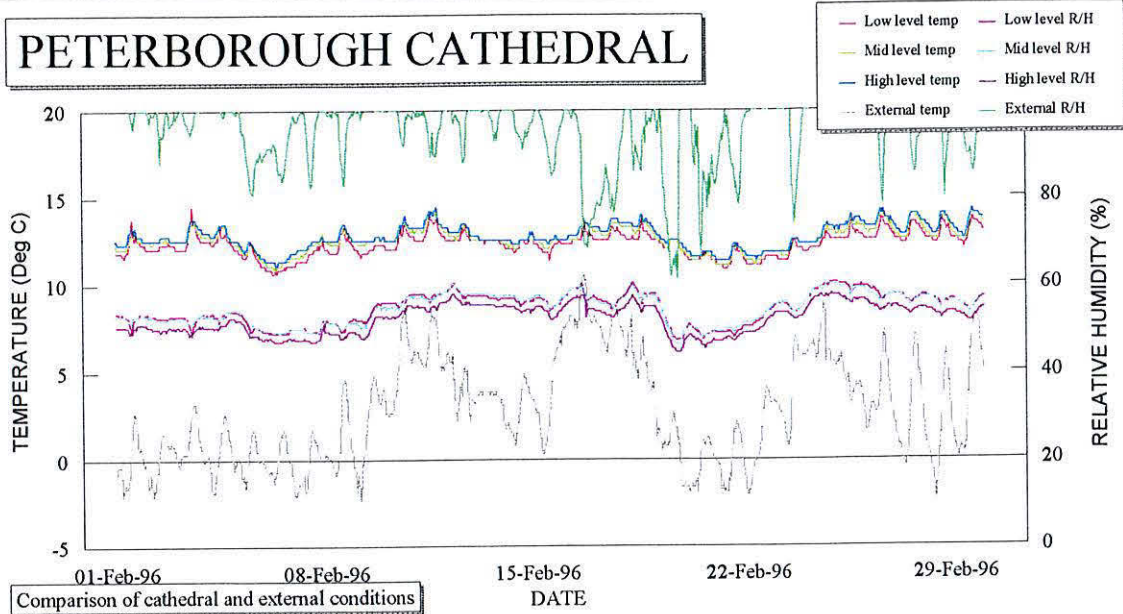
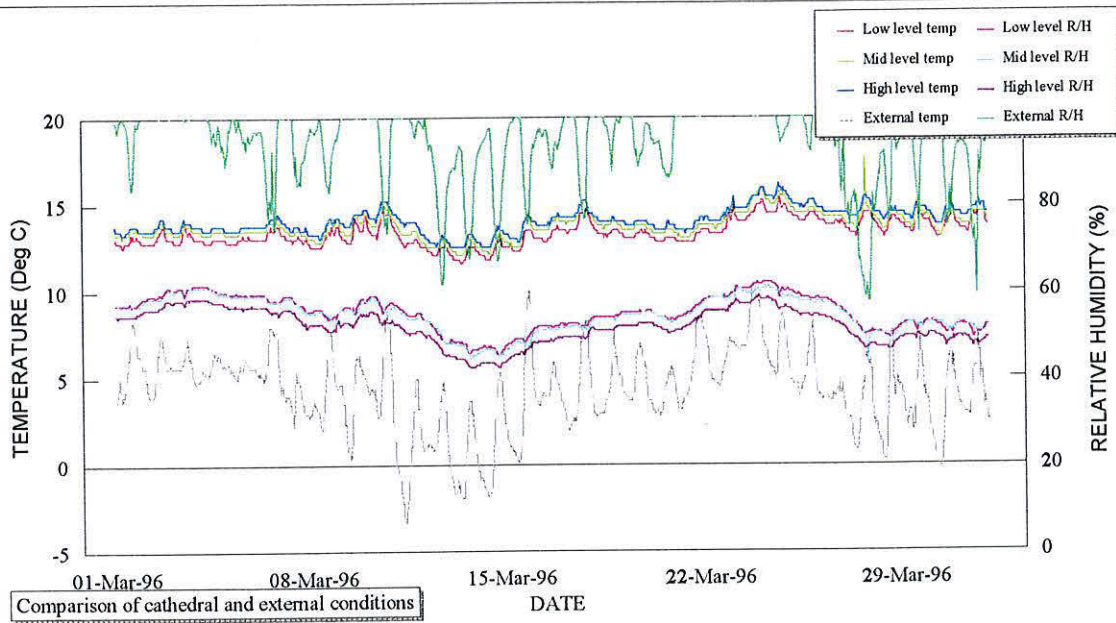
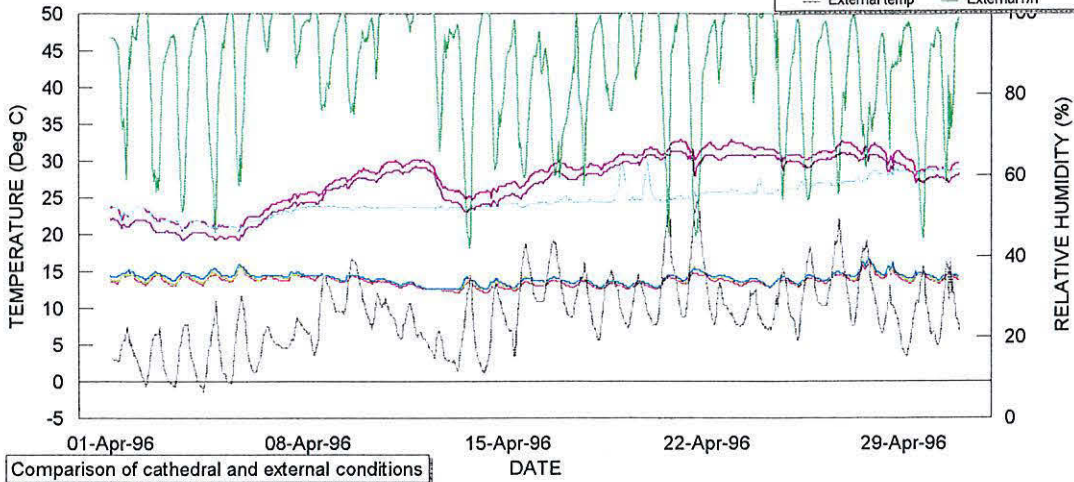
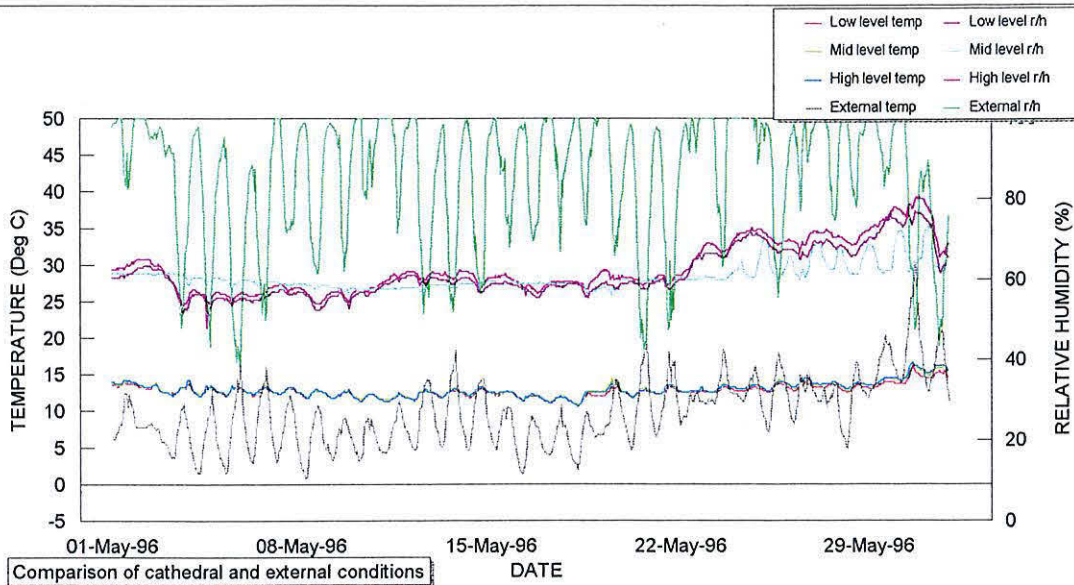
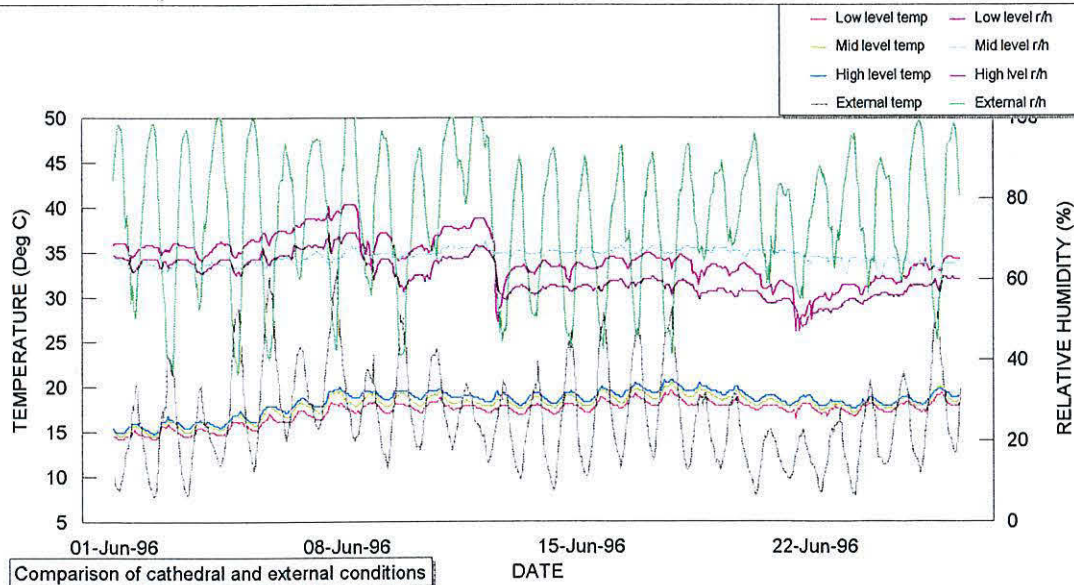
Relative humidities remained high for the entire period, temperatures reached a low in December and showed a steady rise towards the end of June. External readings can be seen in graphs 1 - 5.

Internal conditions can be seen in graphs 1 - 5, as in previous periods there is virtually no temperature gradient whilst the heating is in operation. Once the heating was turned off (April 8/9th?), there was a very small gradient of around 2°C. The relative humidity was fairly constant at around 60%, with occasional dips coinciding with changes in external conditions.

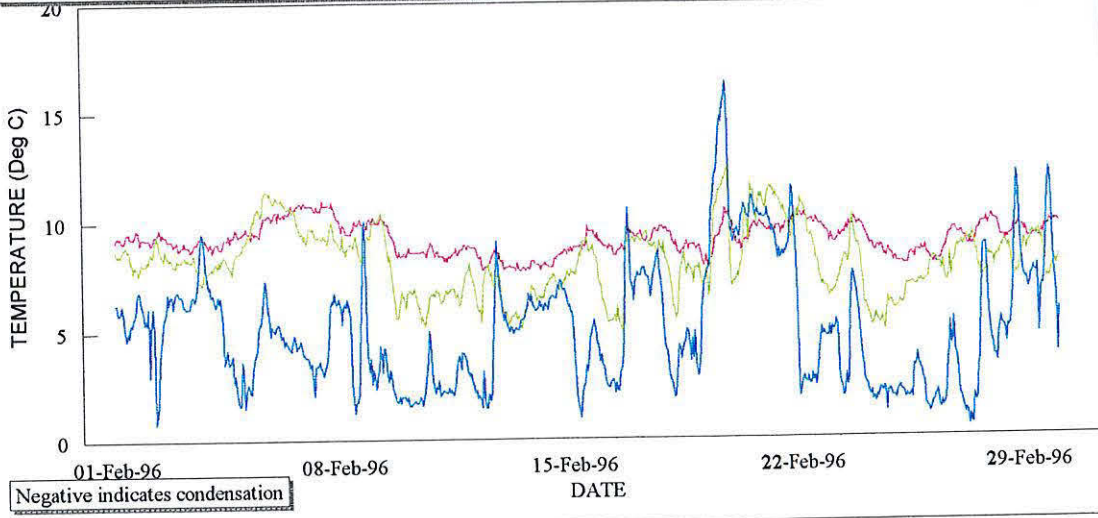
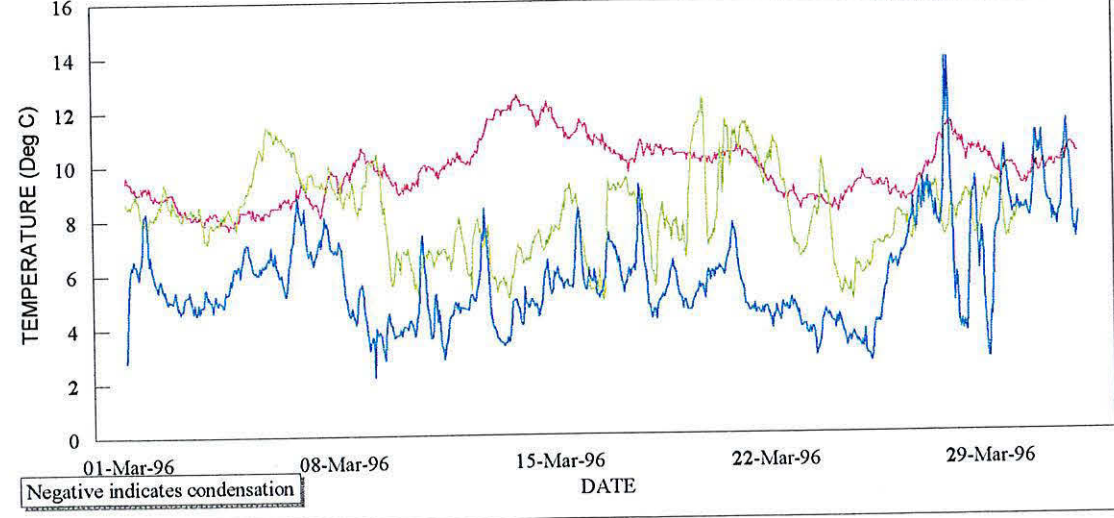
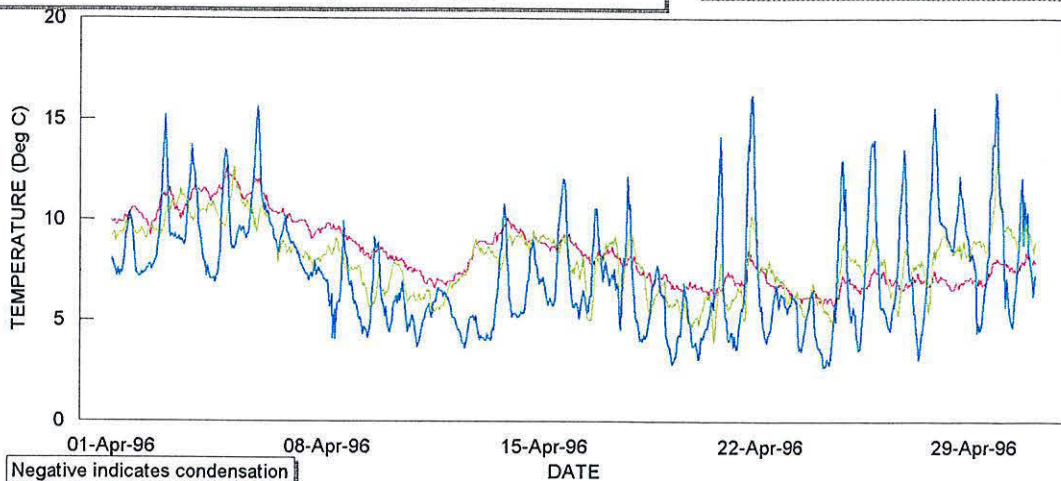
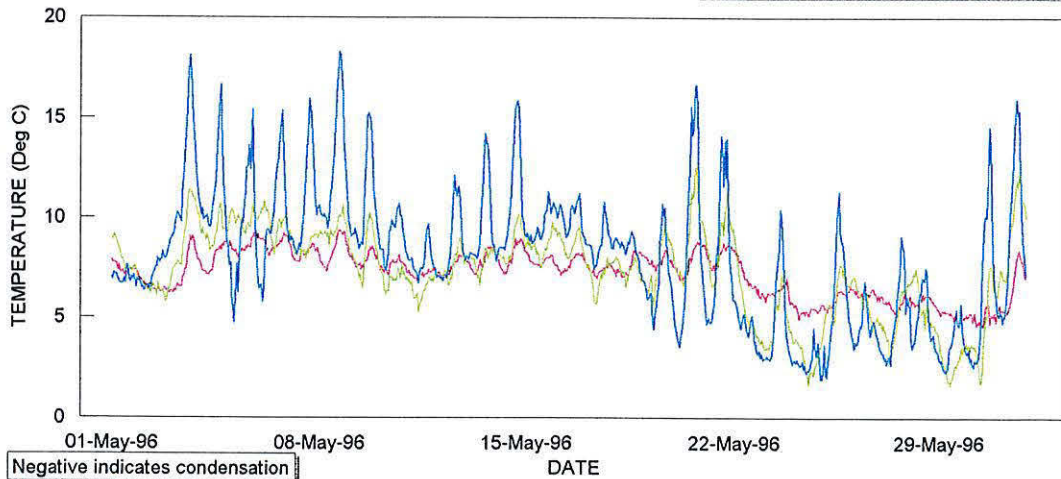
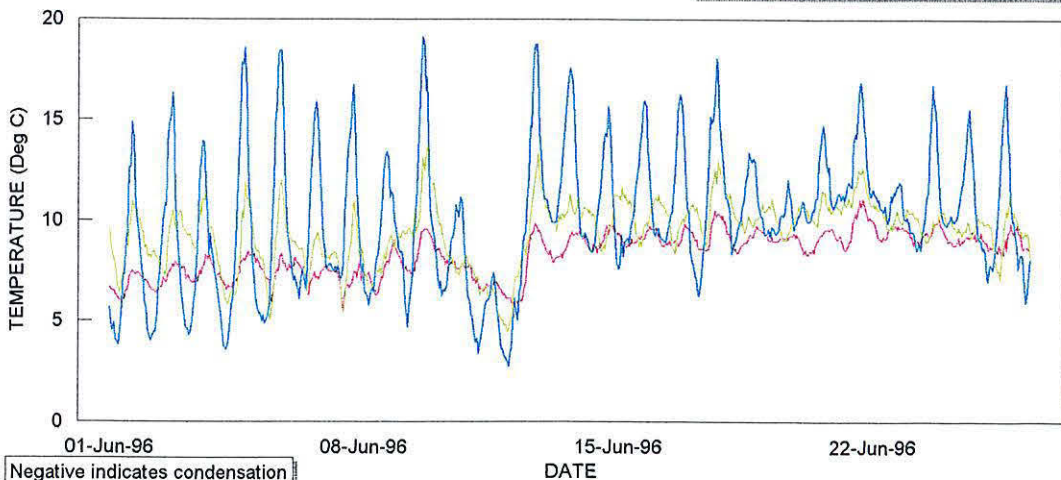
Dewpoint temperatures for the ceiling are shown in graphs 6 to 10, there were no occasions when the surface temperature dropped below the dewpoint. It is therefore safe to assume that the ceiling will remain condensation free for the whole year.

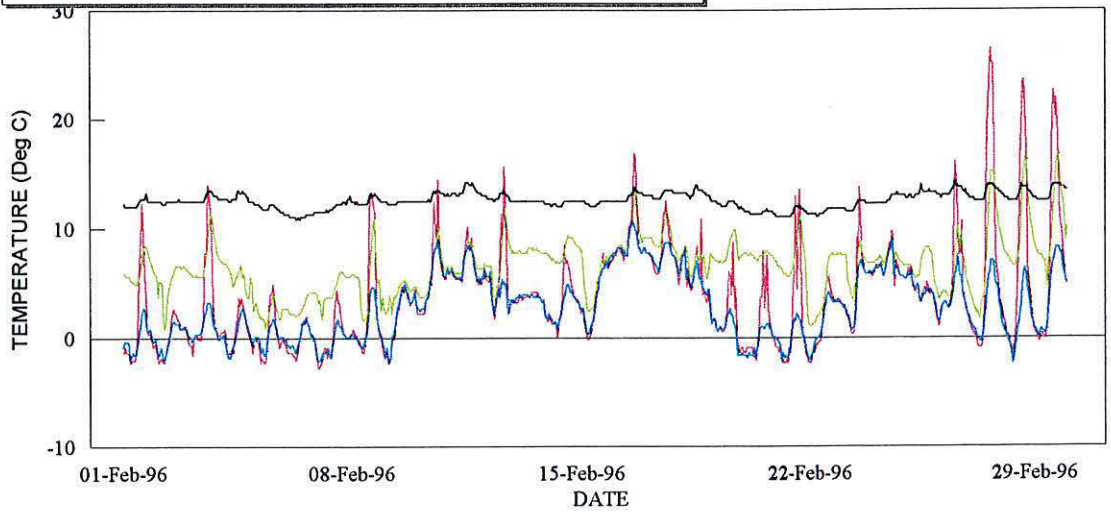
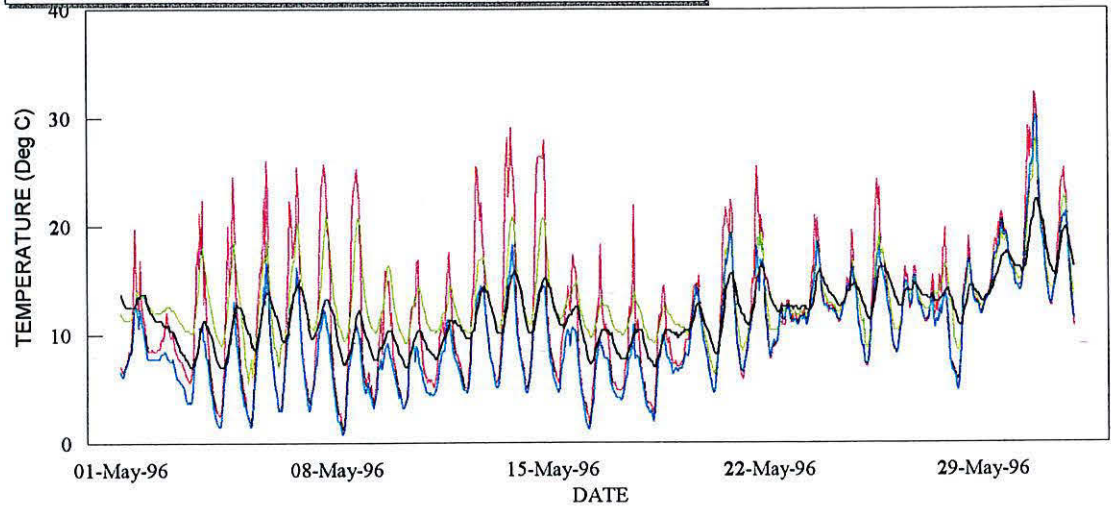
GRAPHS 21 - 22 SHOWING EFFECT OF HEATING ON ROOF SPACE TEMP

Comparisons of "black ball", external temperature and inside roof timber temperatures are shown in graphs 21 - 22. Graph 21 shows the roof space temperature (black line) as fairly constant at around 12°C with the heating in operation in February. Graph 22 shows the roof space temperature in May with no heating. It can be seen that the internal temperature is being

influenced directly by the external conditions.

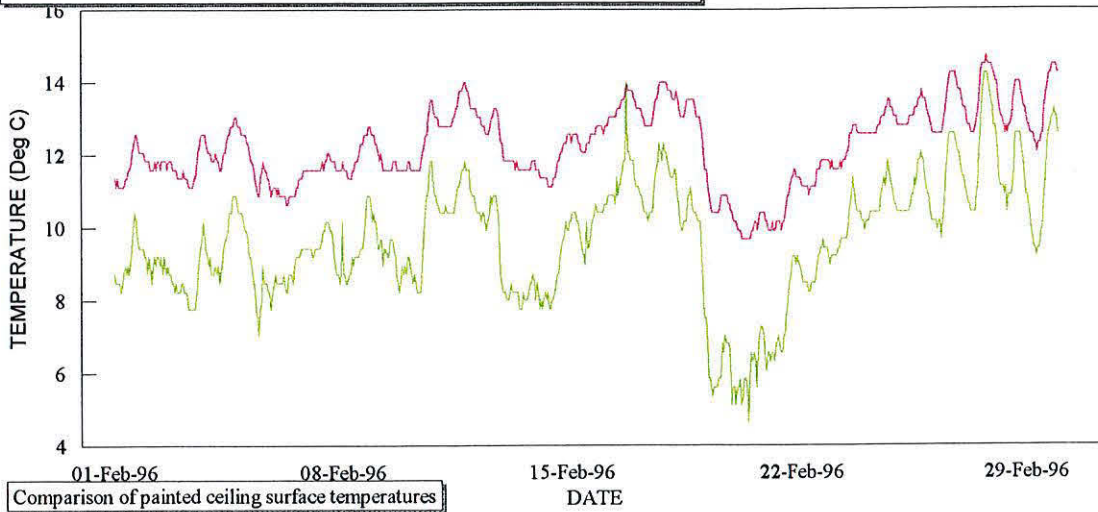
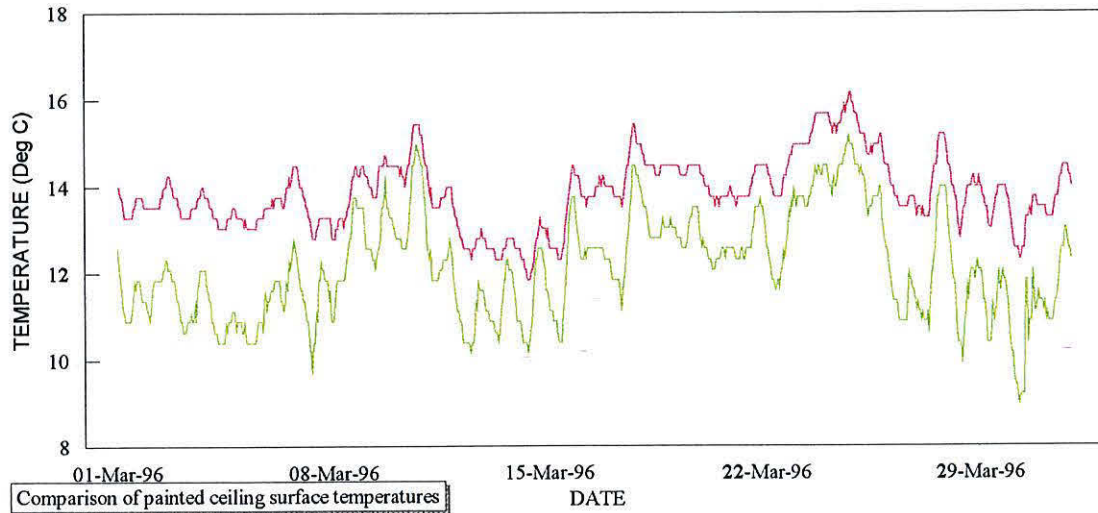
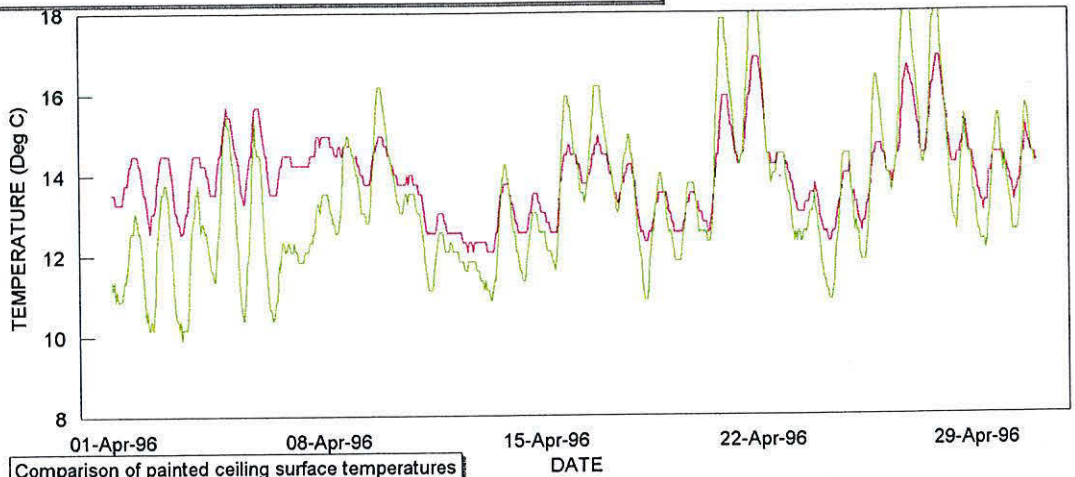
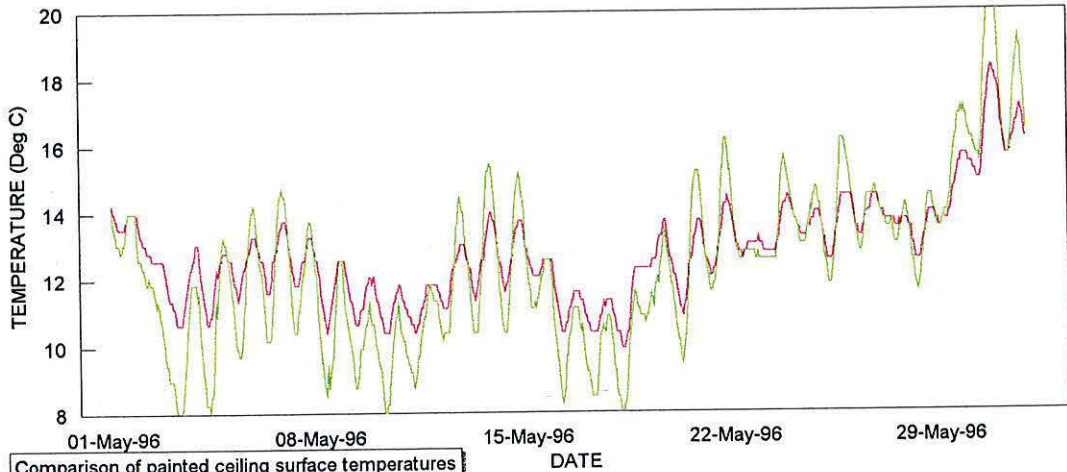
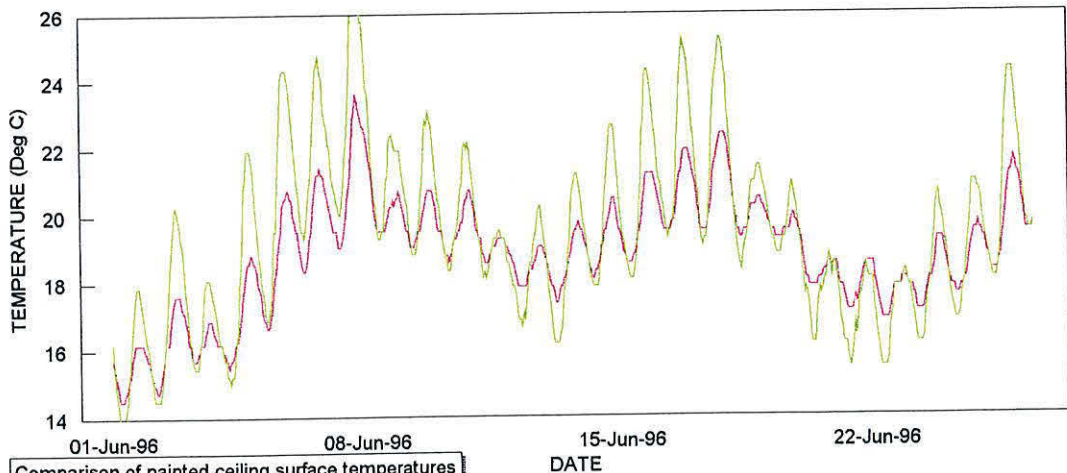
Temperatures either side of the ceiling are shown in graphs 23 to 27. When the heating is operating, the underside of the ceiling is generally warmer than the topside. After April the 8th/9th (graph 25), when the heating had been turned off, it can be seen that the temperature of the topside is generally higher than the underside. This action is caused by solar gains in the roof space. As the temperature is fluctuating across the ceiling it is more likely that movement of the timber will occur in the summer than the winter. Graphs 25 - 27 show the effects on the ceiling of a heated and unheated cathedral.

The heating season appears to offer the most stable environment for the painted ceiling. Once the heating is turned off the ceiling is subject to the variations of the external conditions, although the extremes are buffered by the building fabric.

As already mentioned in previous reports, the ceiling does not appear to be in any immediate danger. Any deterioration (as indicated by loose nails etc) is likely to have coincided with the previous upgrade of the heating system. For the next heating season, the temperature should be kept as low as possible. The settings used for 1995/96 gave good results, by limiting the temperature the relative is kept to reasonable figures. If the temperature is too high the tendency is for the relative humidity to fall. This will create unacceptable differences of both temperature and vapour pressure on either side of the ceiling.
