**WOLFGANG GÄRTNER, Conservator**  
Director Canterbury Cathedral Wallpaintings Workshop

PETERBOROUGH CATHEDRAL - PAINTED CEILING - NAVE

INSPECTION REPORT:

Date: 17 + 18 May 1988

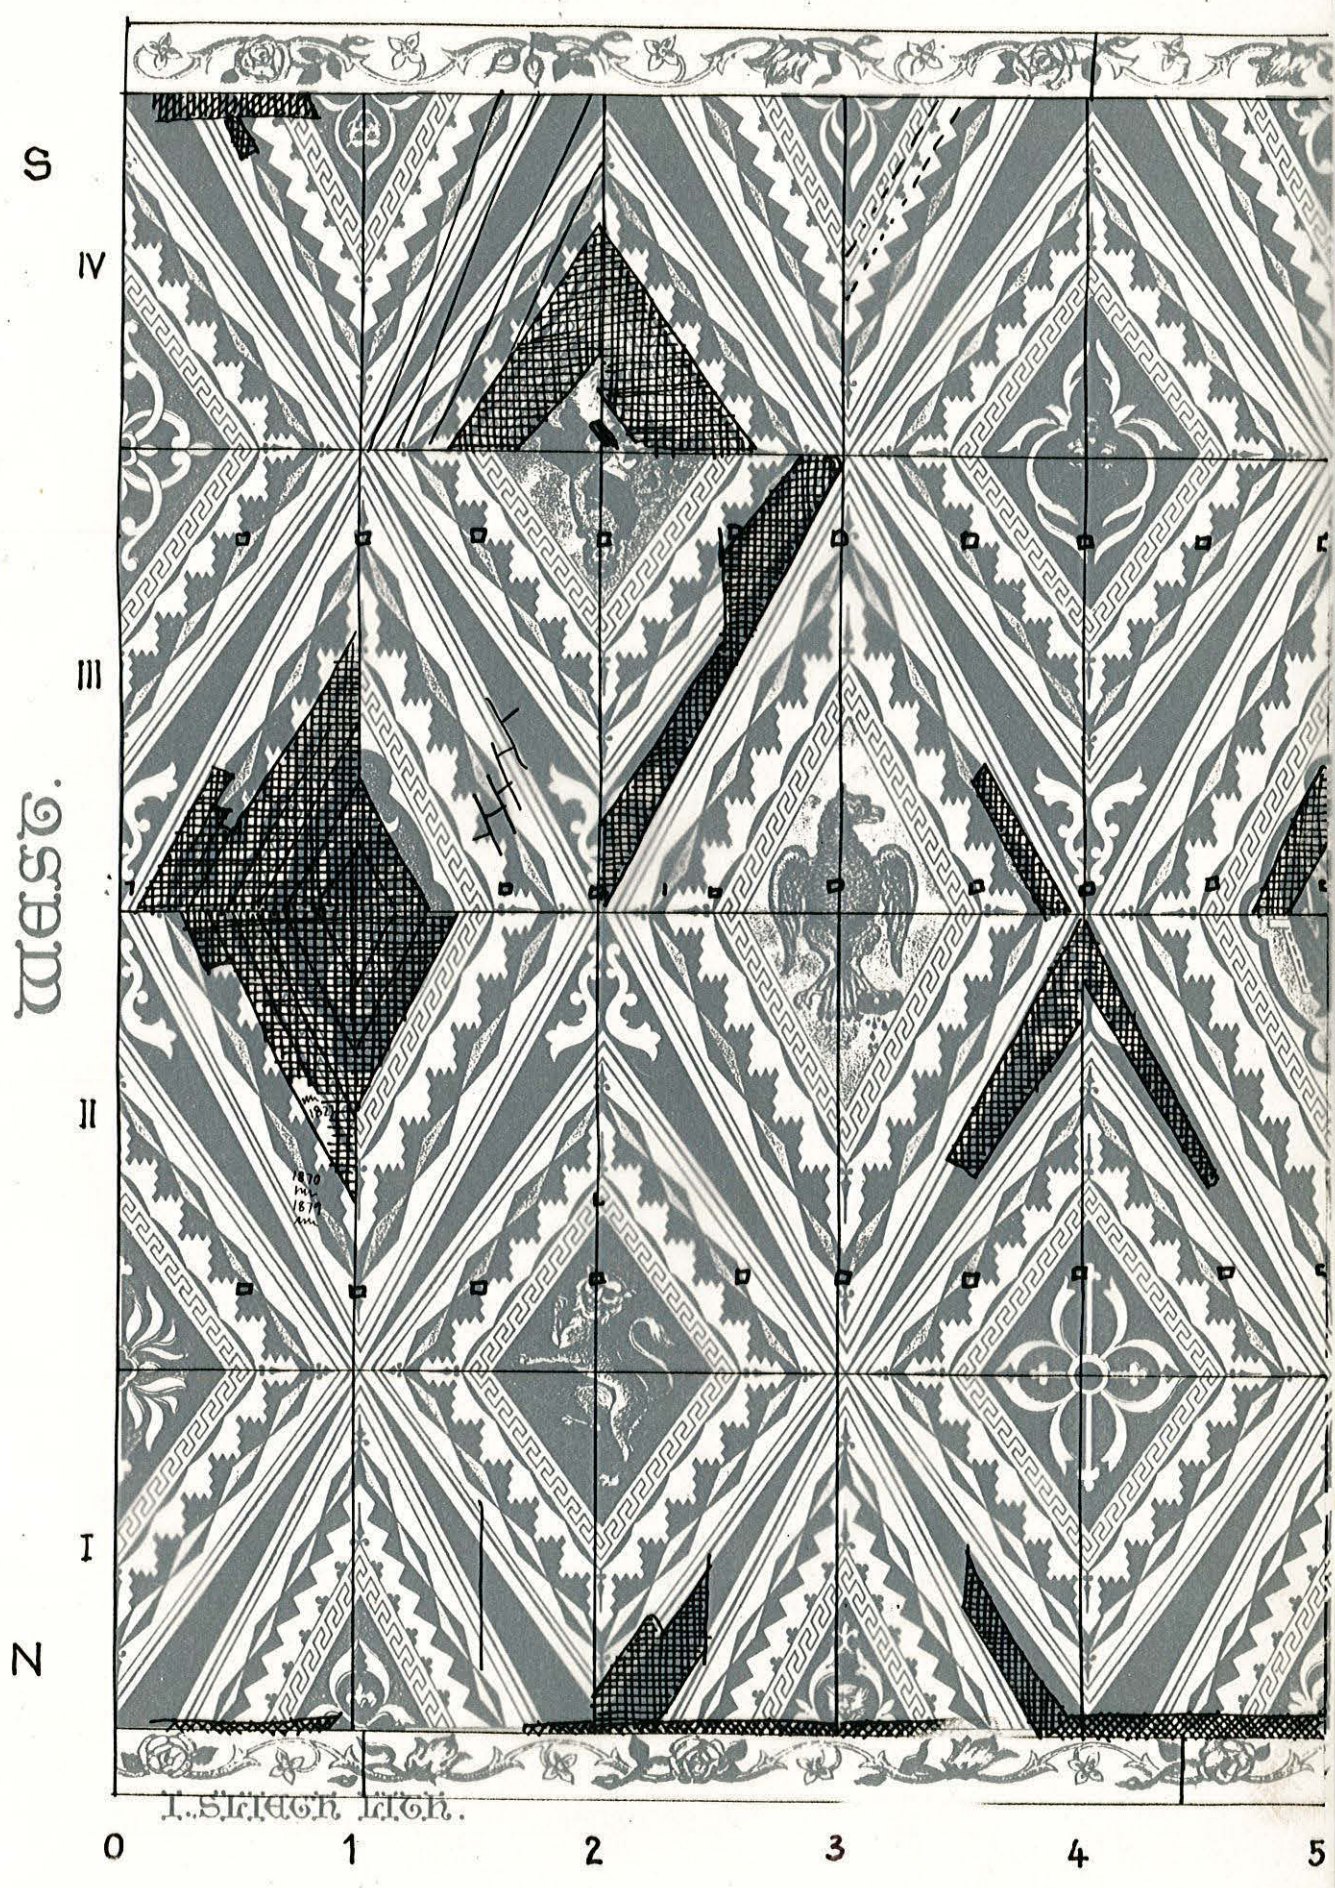
How many of the original boards had been replaced and when, is more difficult to establish. One example: At the west end, south side panels 0-5, Row IV, the boarding does not correspond to the design as elsewhere, and there are clear marks in red chalk or pencil on the white ground to construct and outline the decorative pattern. In how far the figurative painting is affected by overpainting can only be assumed where the boards are clearly renewed, otherwise it would need a close inspection.

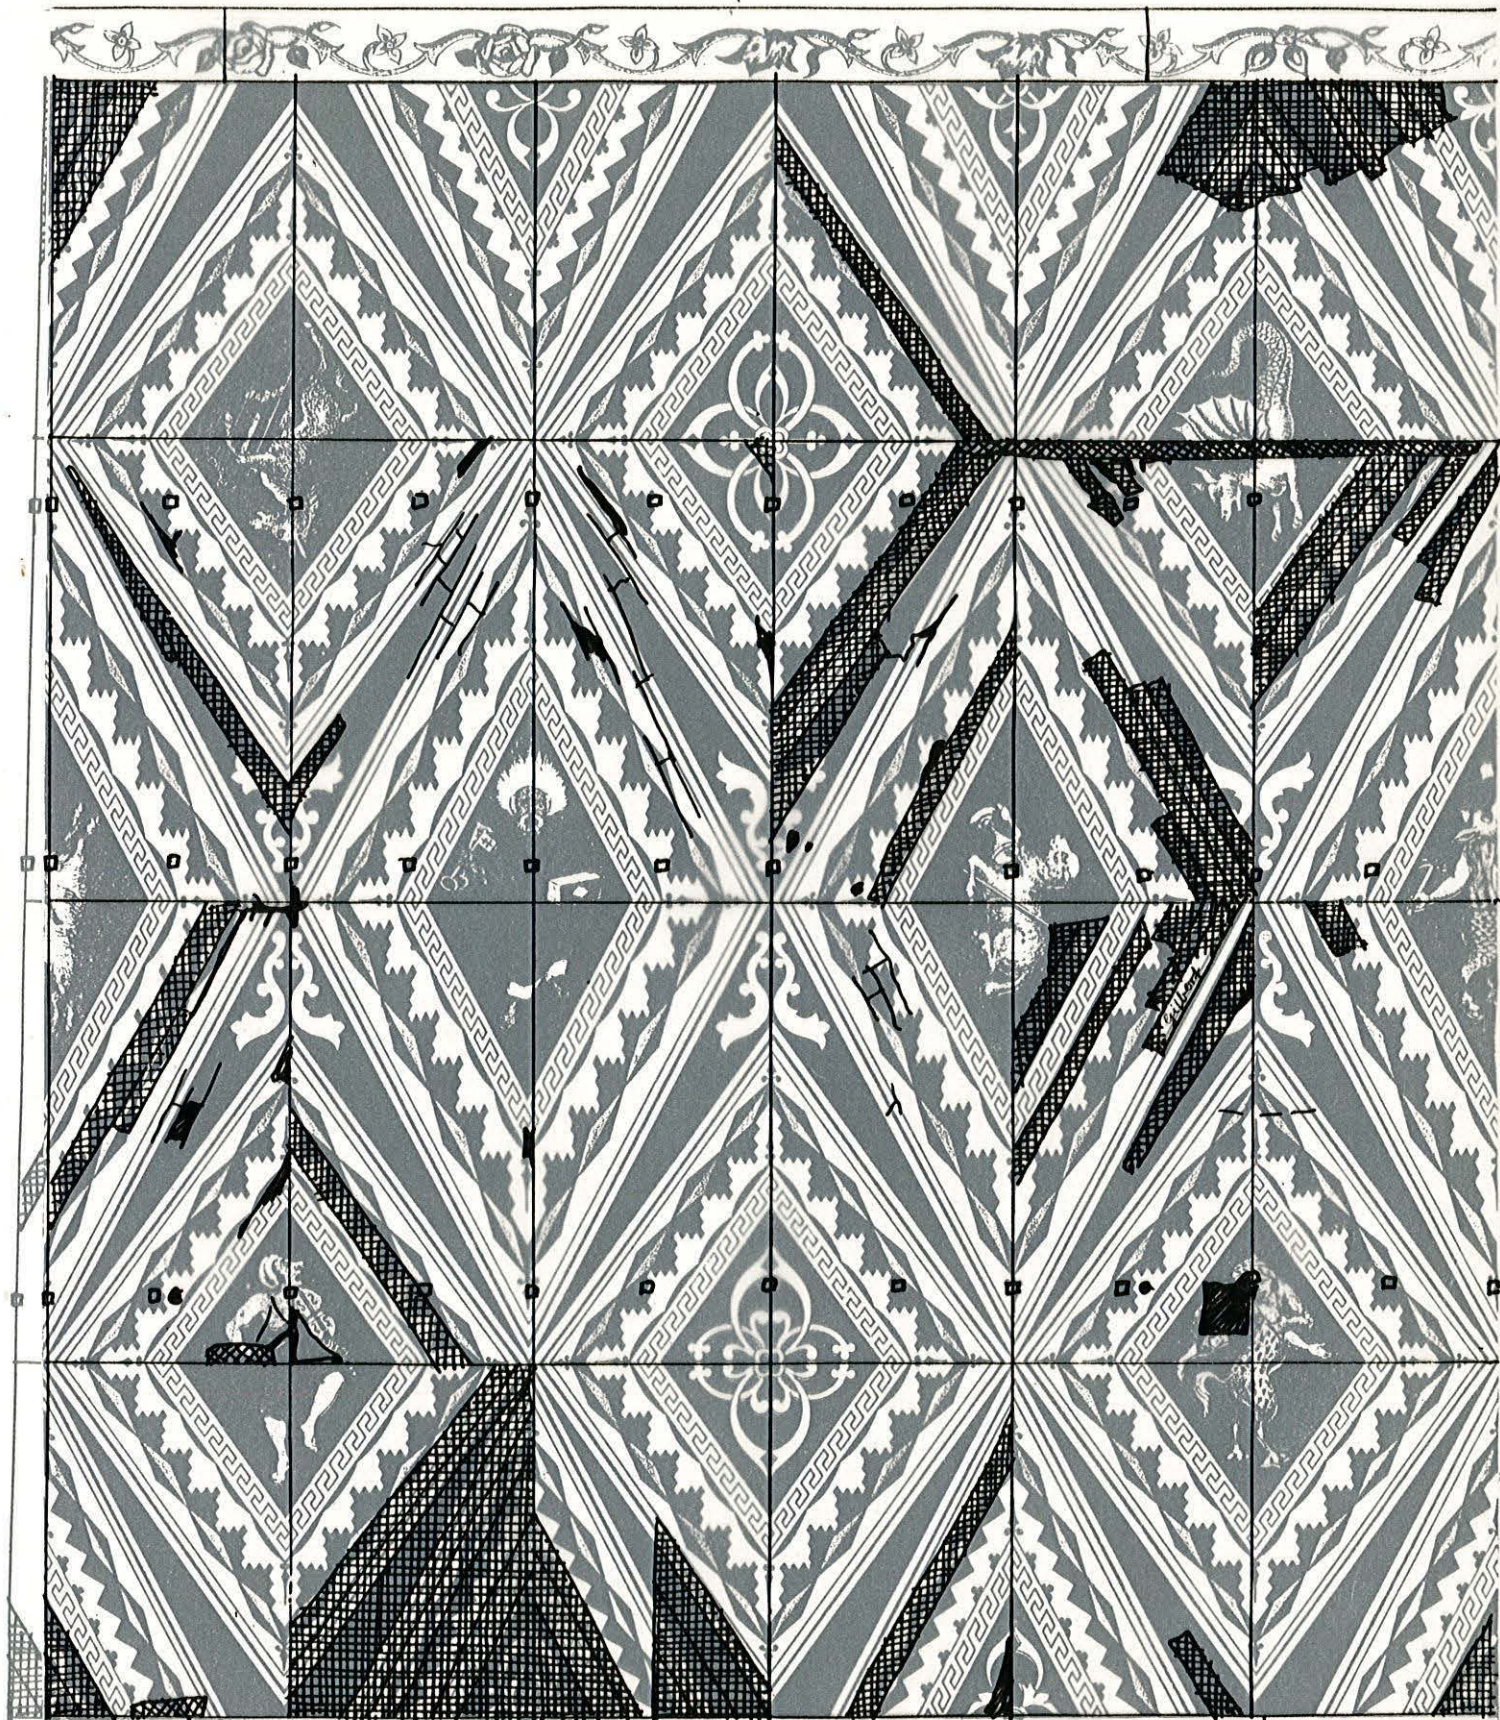
22 S, 30 N, 39
