HIRST
Conservation

**PETERBOROUGH
CATHEDRAL
NAVE CEILING
PHOTOGRAPHS**

APPENDIX A: PHOTOGRAPHS

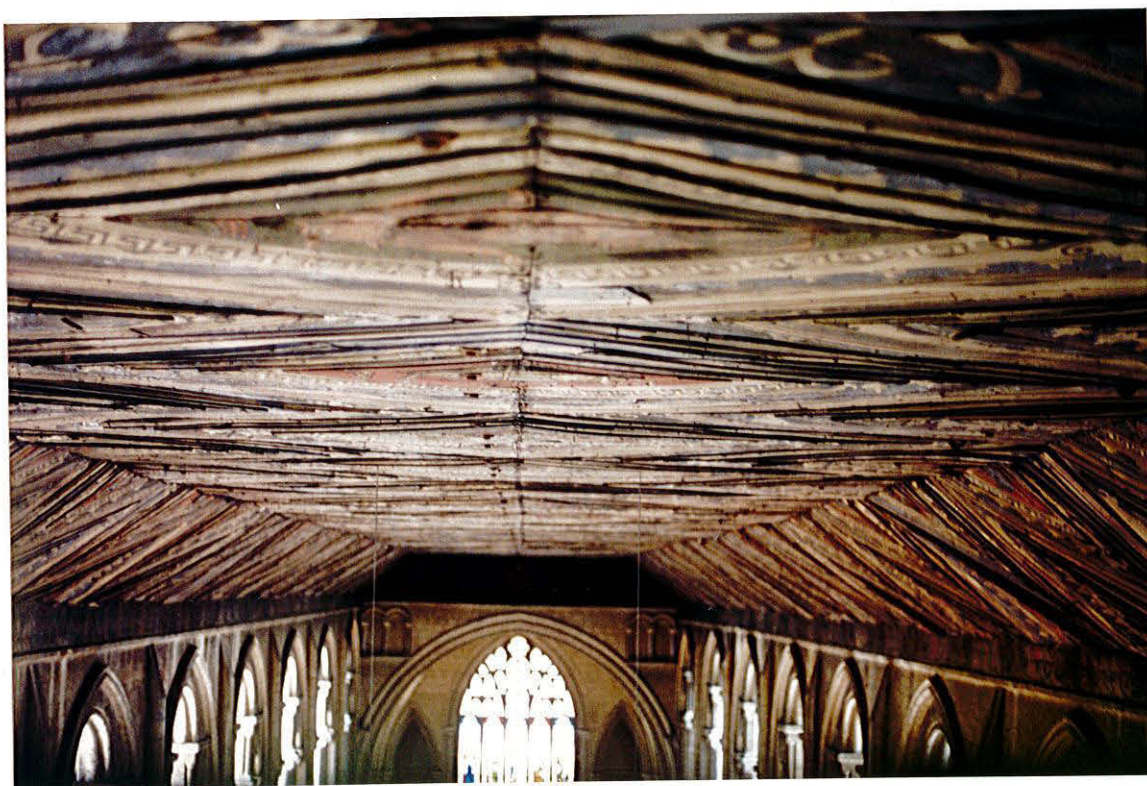
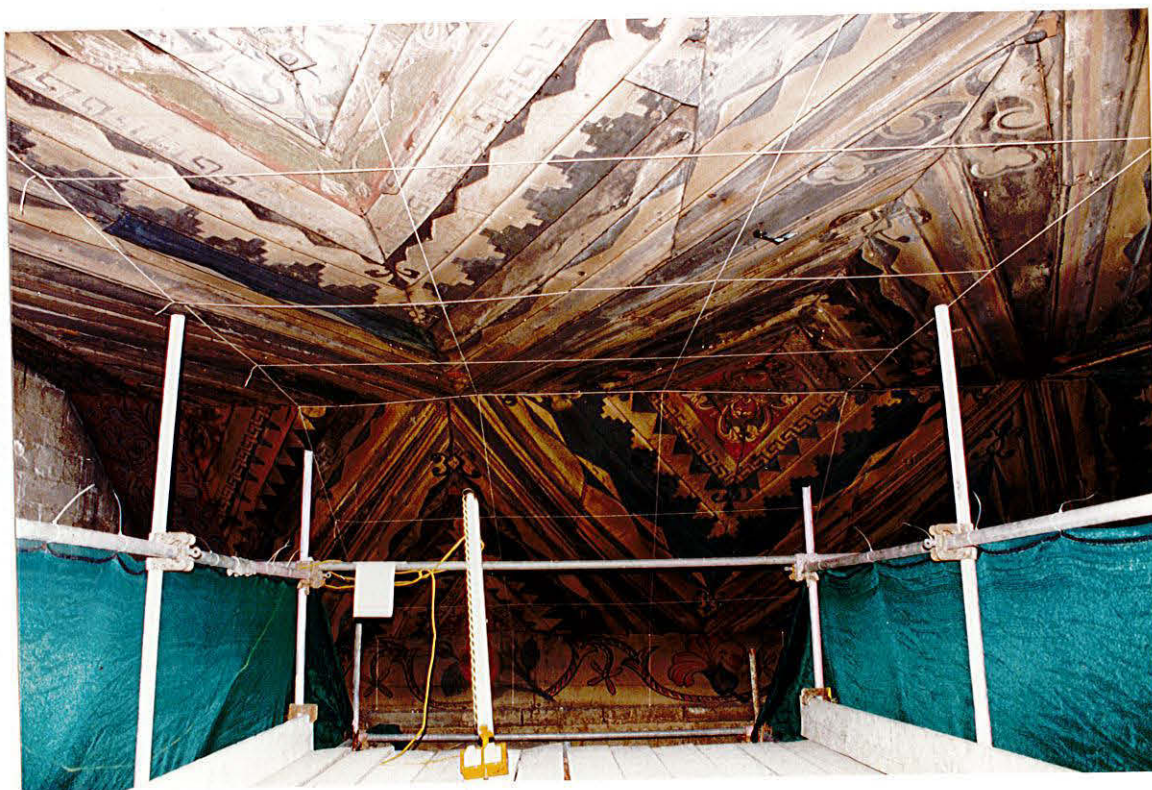
Plate I

- a View of the nave ceiling from the scaffolding.
- b View of the nave ceiling from the scaffolding.

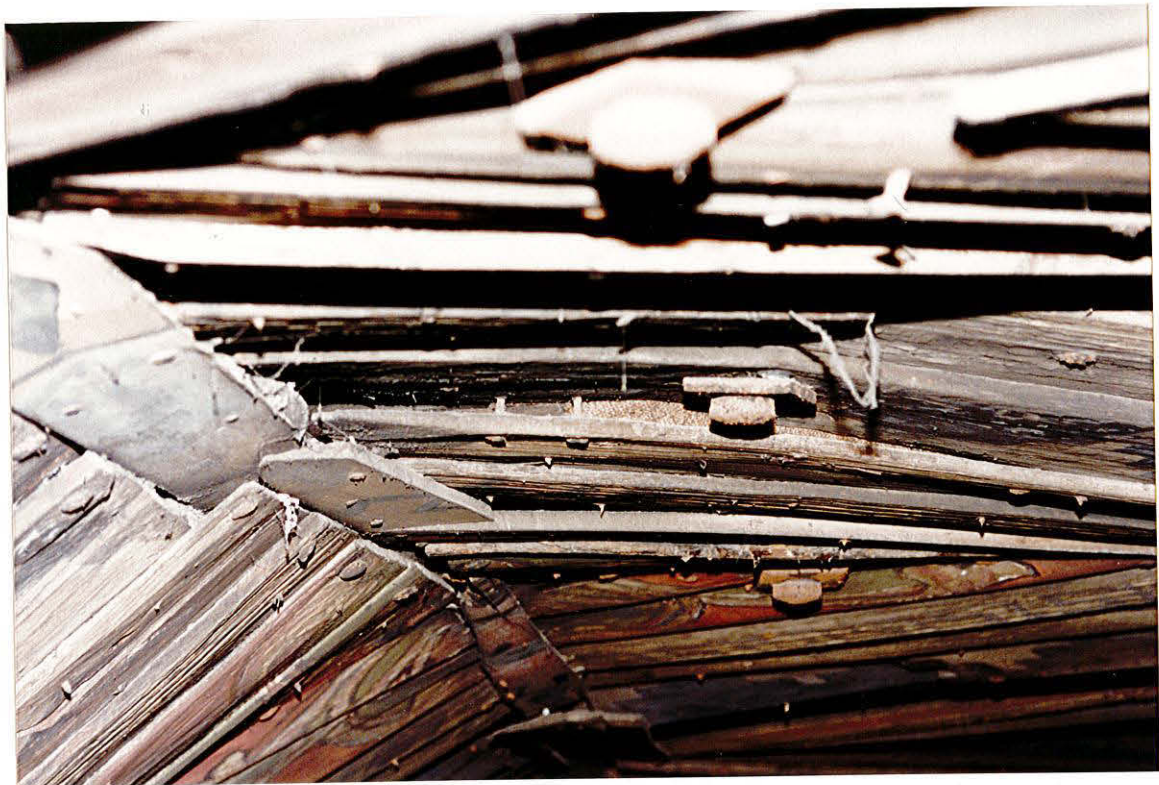
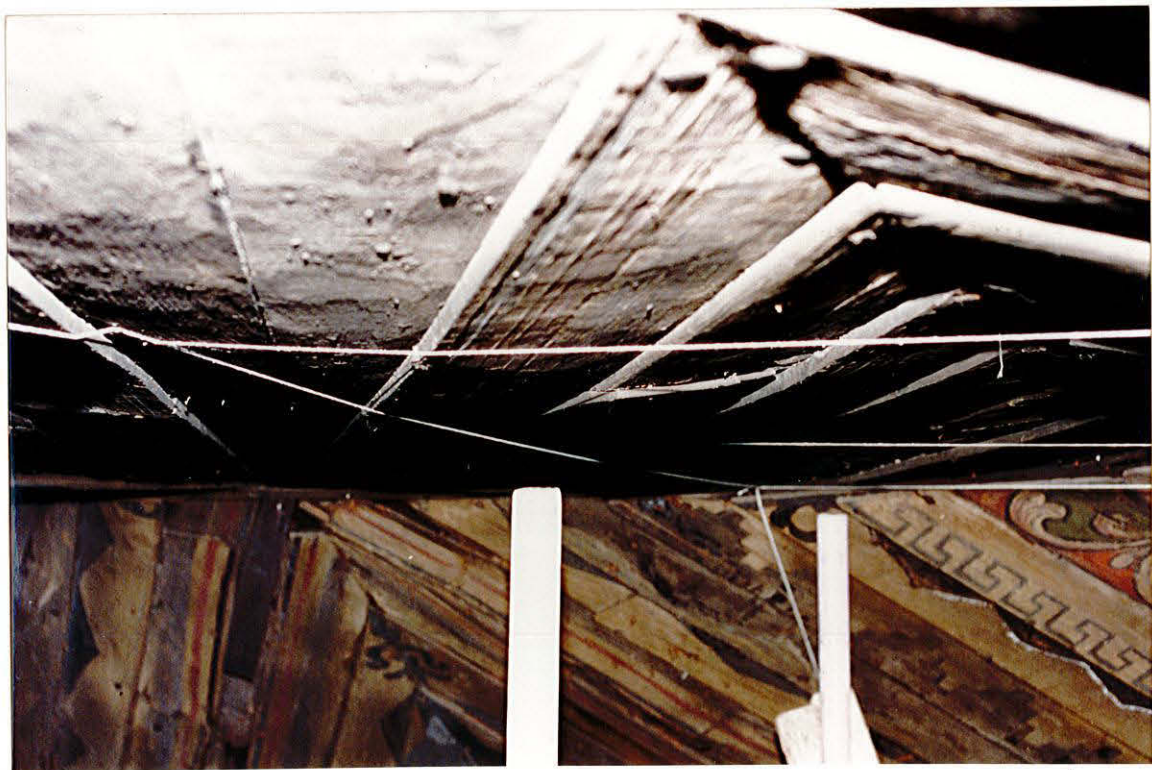
Plate II

- a Detail of ceiling boards and fixings in raking light.
- b Detail of ceiling boards and fixings in raking light.

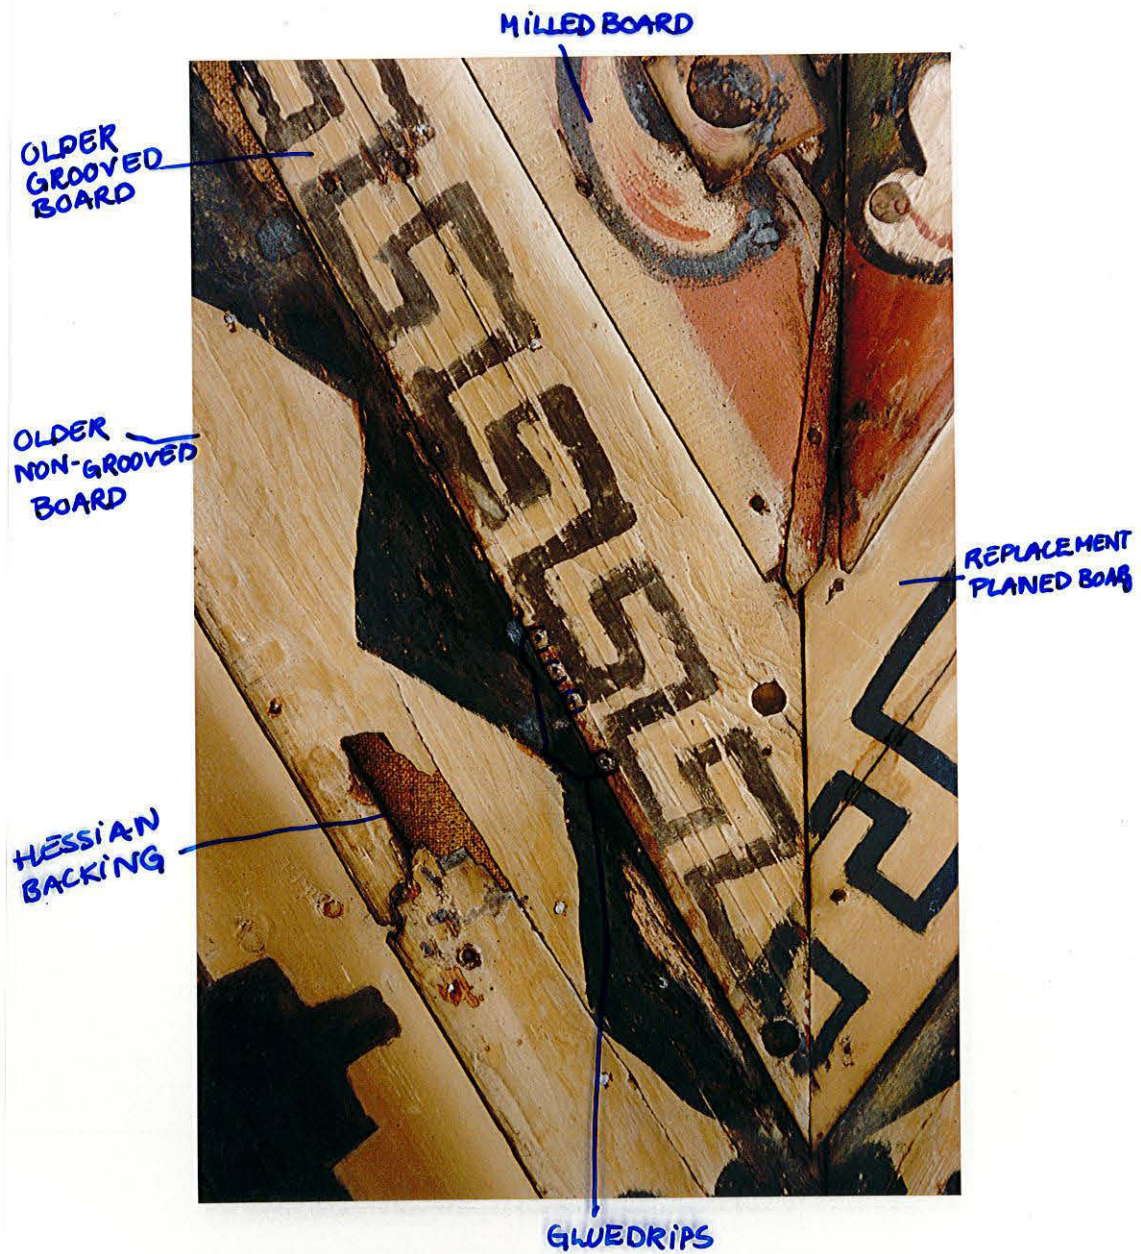
Plate IV Typical area showing bolts, nails, etc. (overlay).

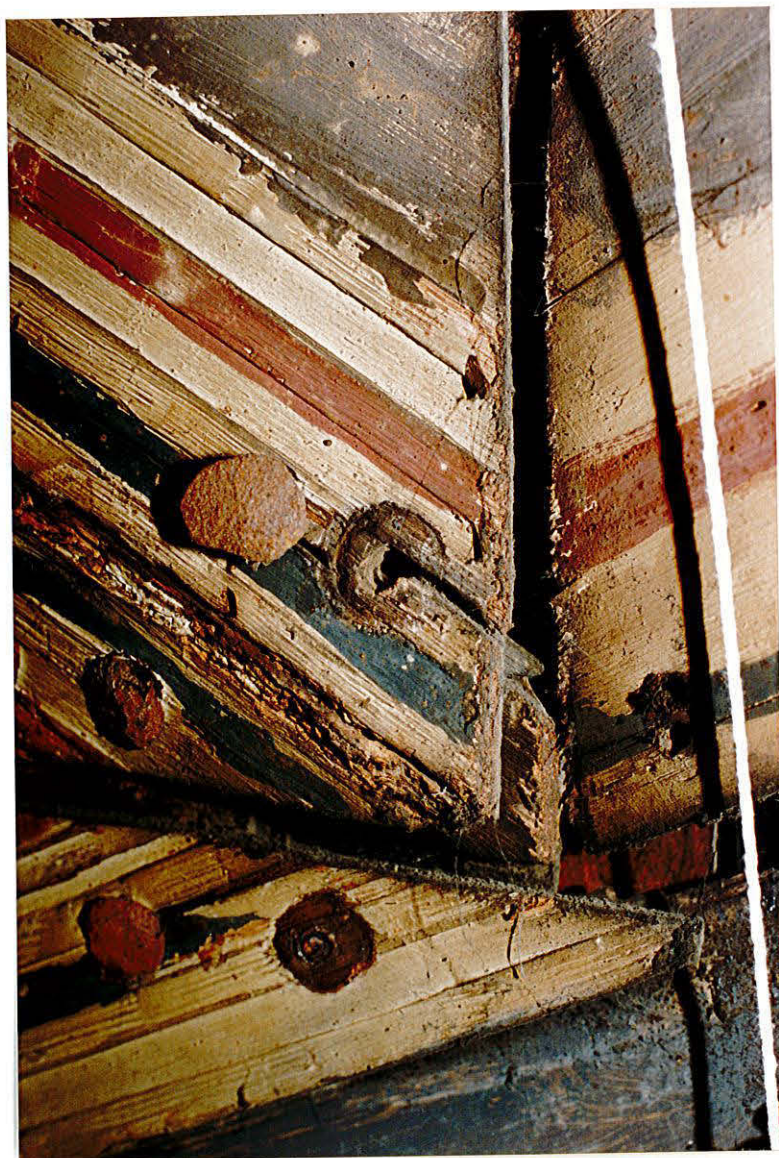
Plate V

Detail of early nails (one fell out in 1995, hole to centre).

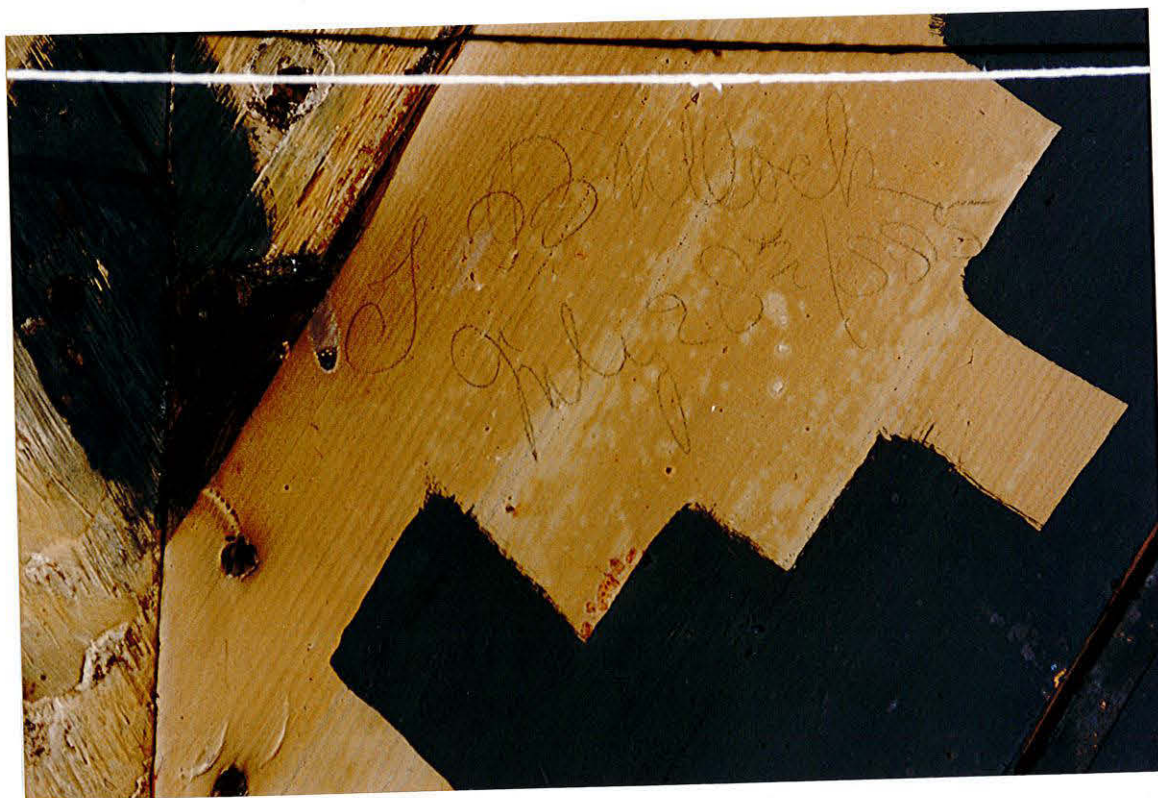
Plate VI Detail of pencil inscription from 1885 (during tower works).

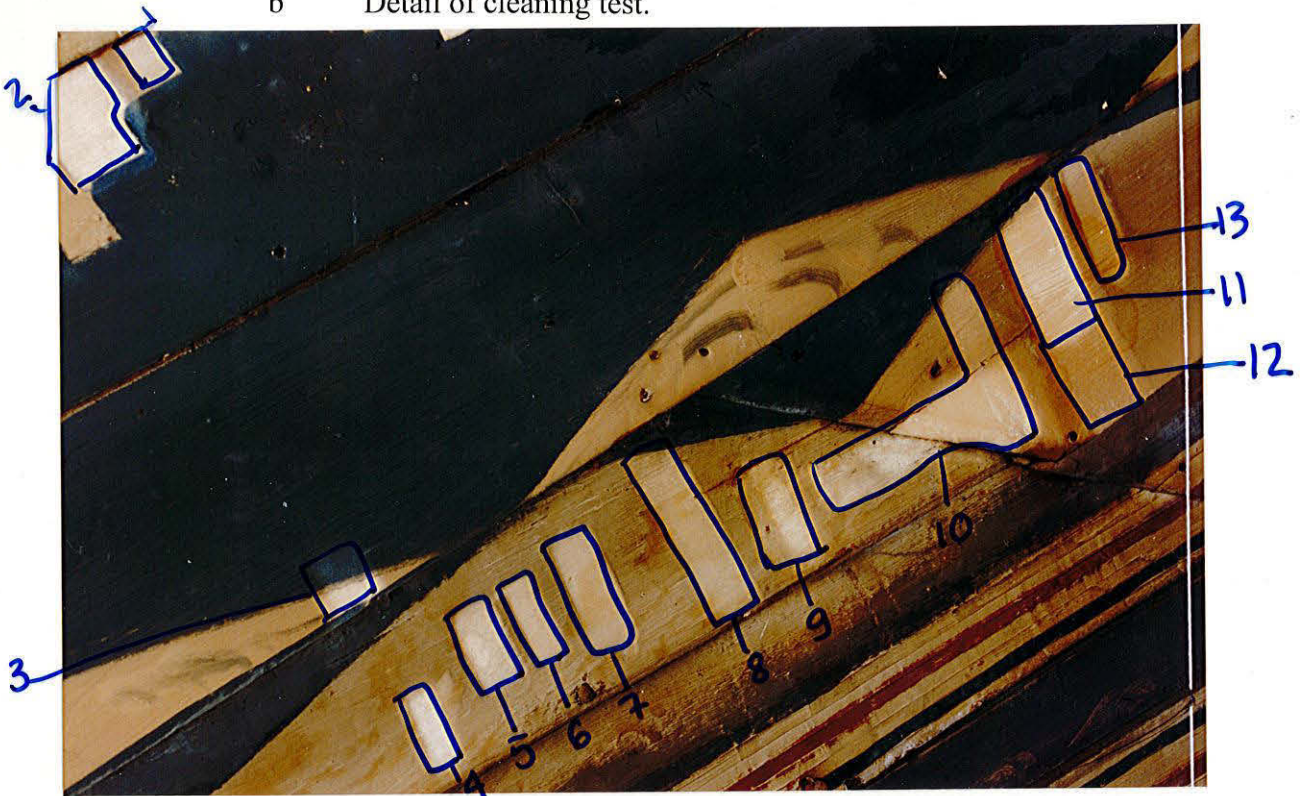
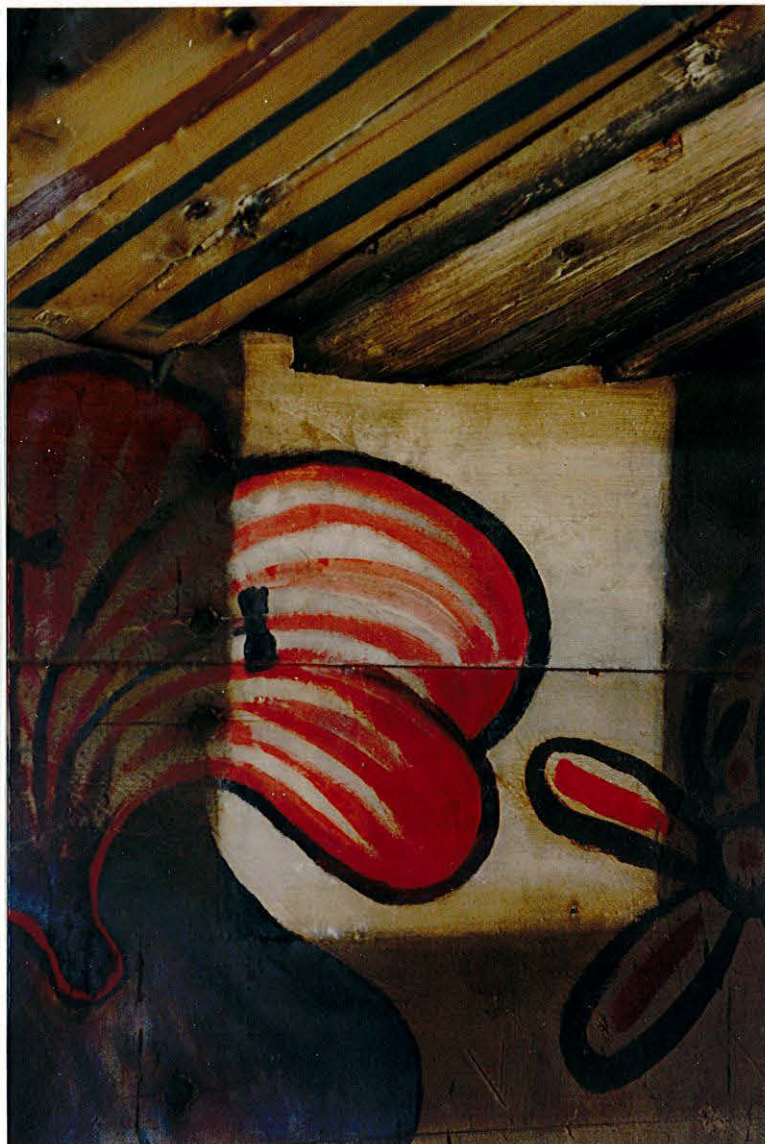
Plate VII

- a Details of cleaning tests.
- b Detail of cleaning test.

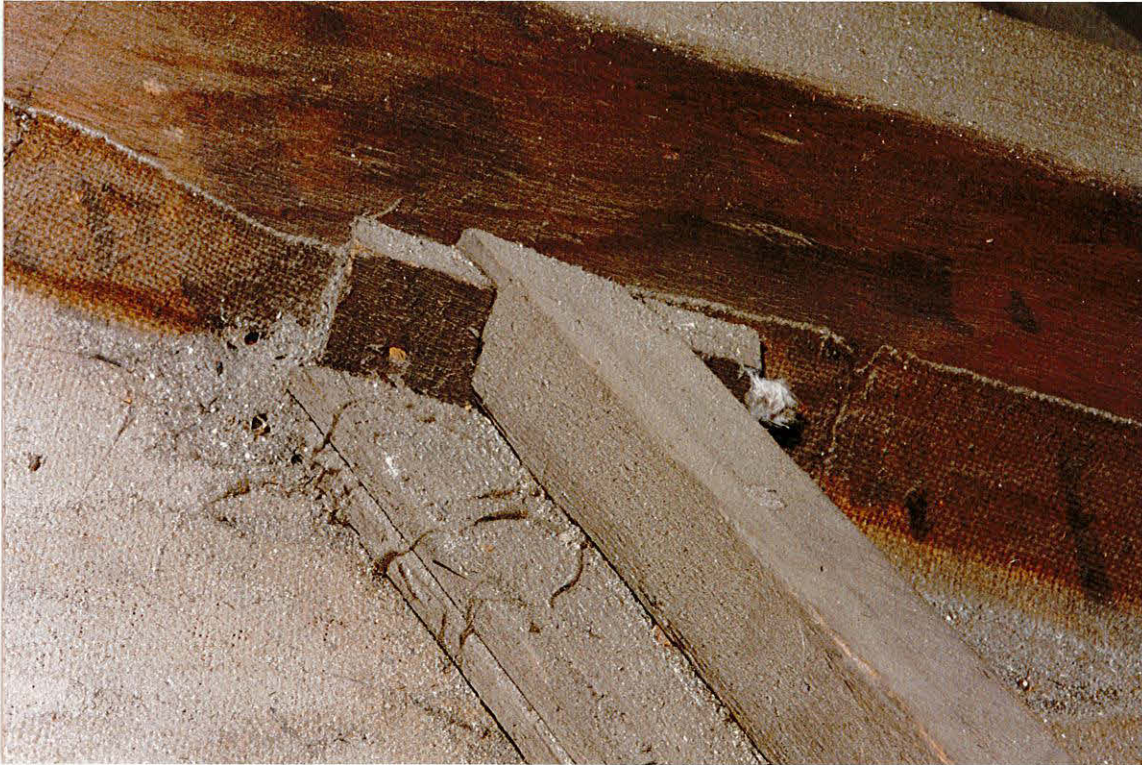
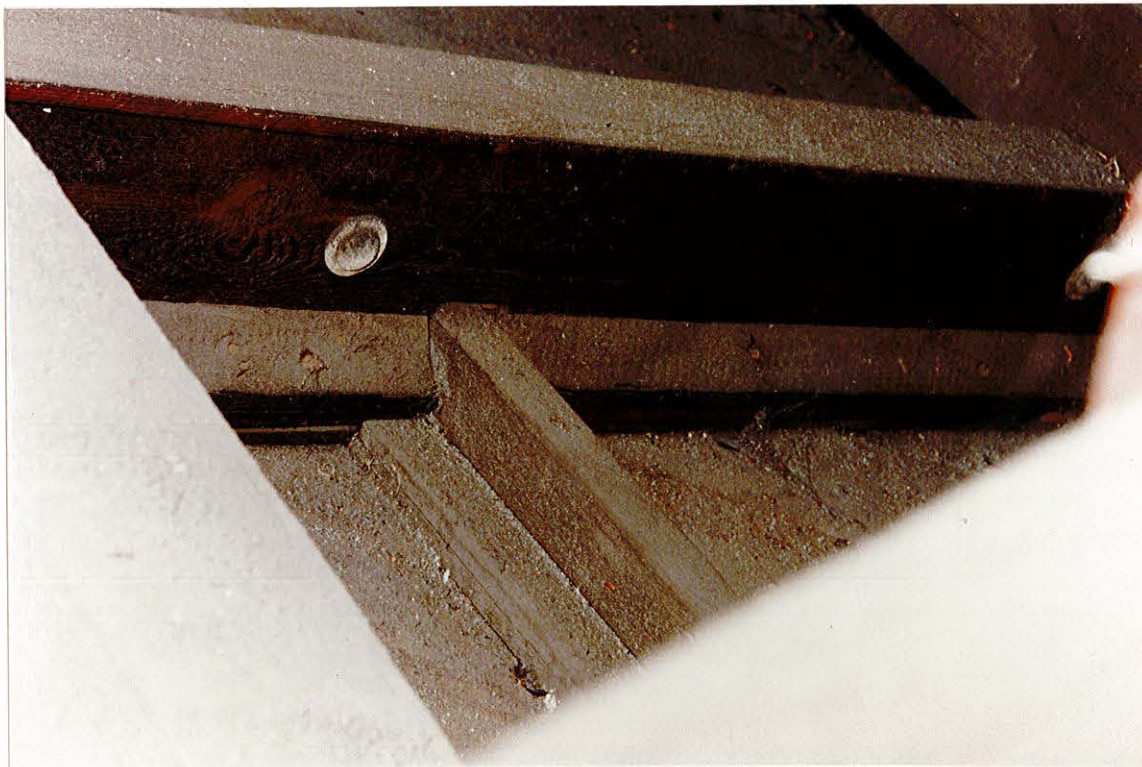
- Plate VIII a Detail of nogging, bay 2 - north side.
 b Detail of nogging and built up joist, bay 2 - north side. The
 nogging appears to run through the built up joist.

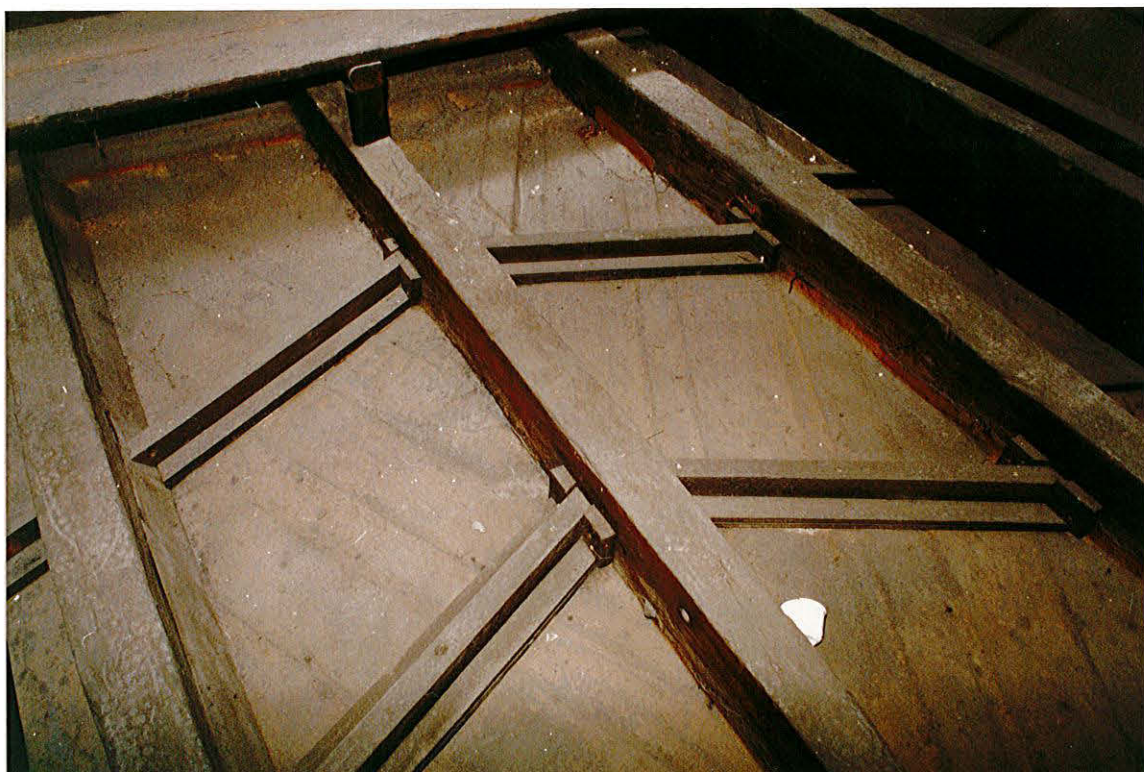
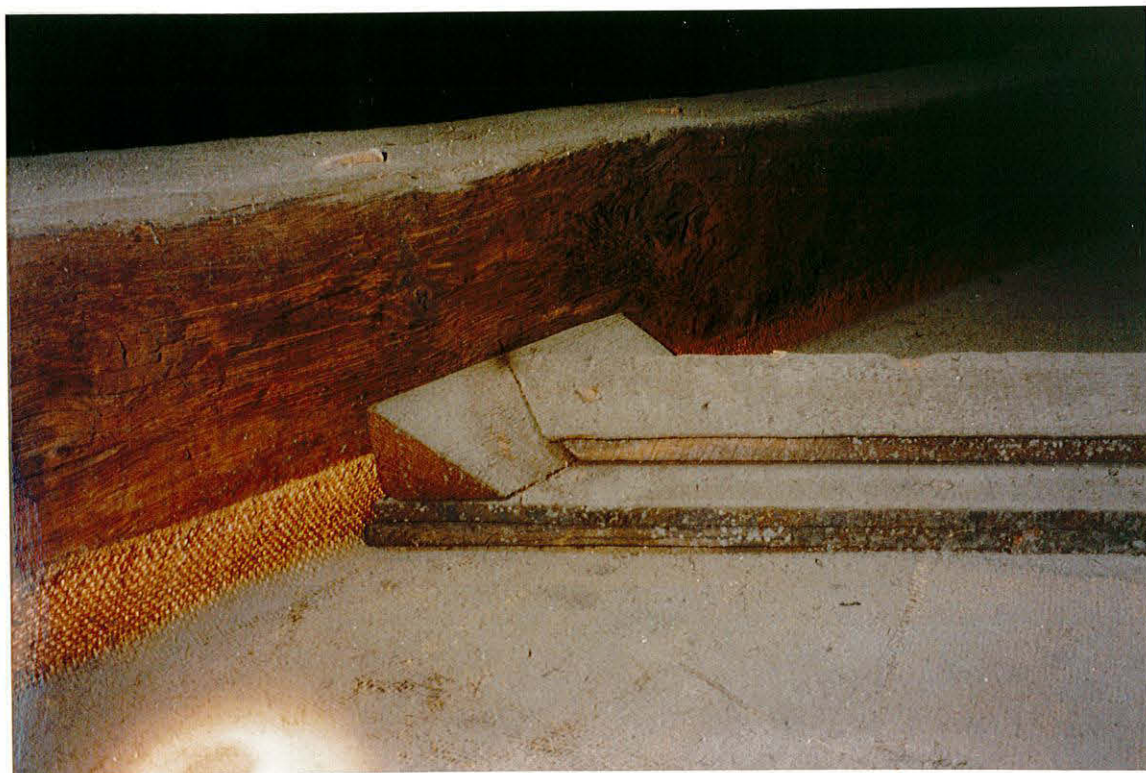
Plate IX

- a Detail of layout of noggings, bay 2 - north side.
- b Detail of typical nogging.

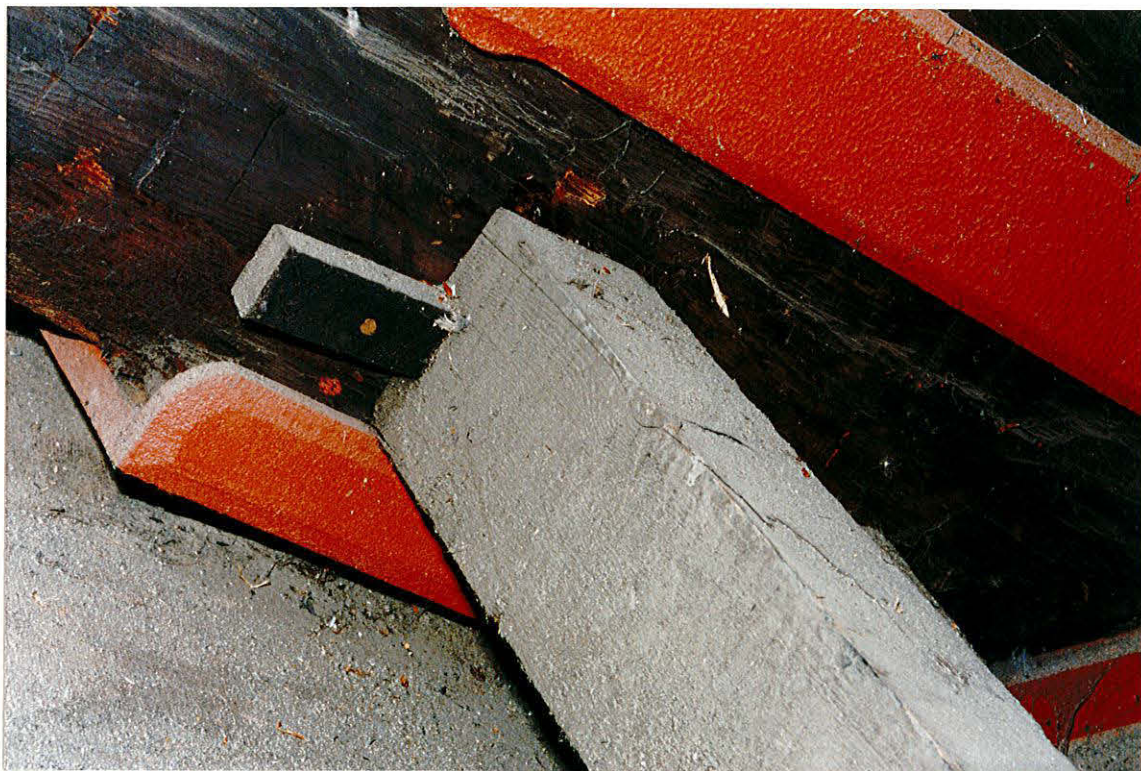
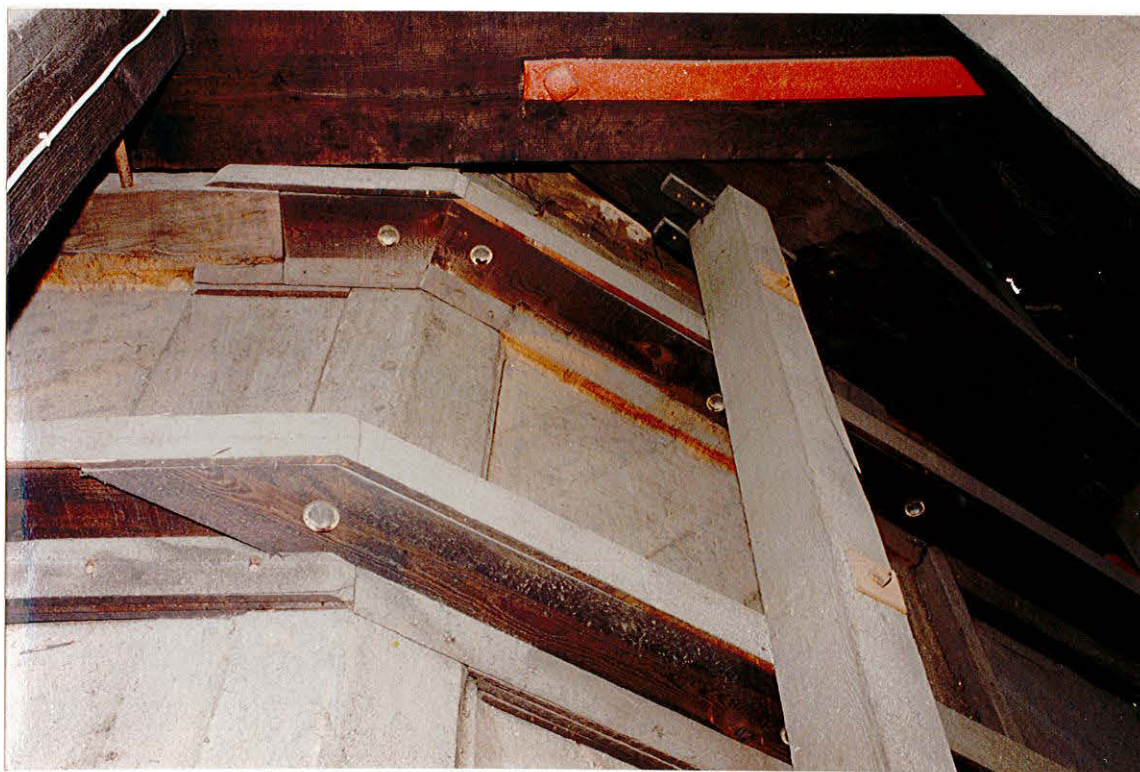
Plate X

- a Detail of binder/truss joint, 2nd truss, north side.
- b Built up joist and packer detail, bay 2 - north side.

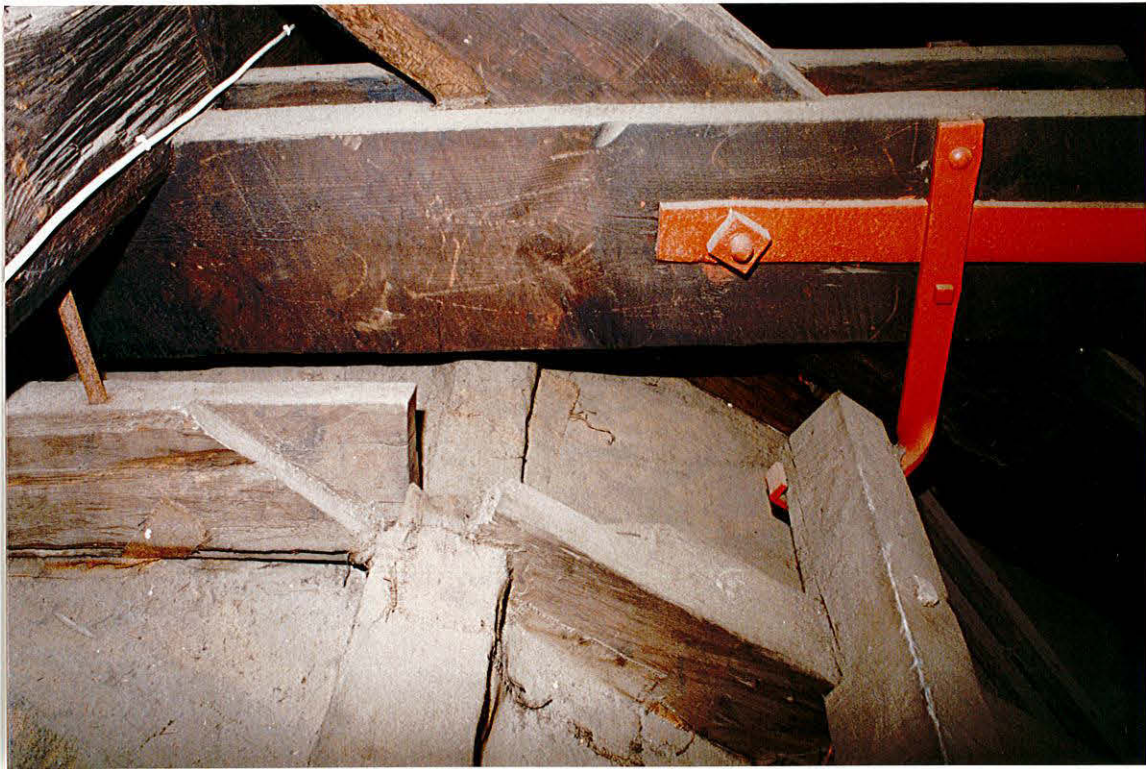
Plate XI View of bay 1, including detail of steel strapwork.

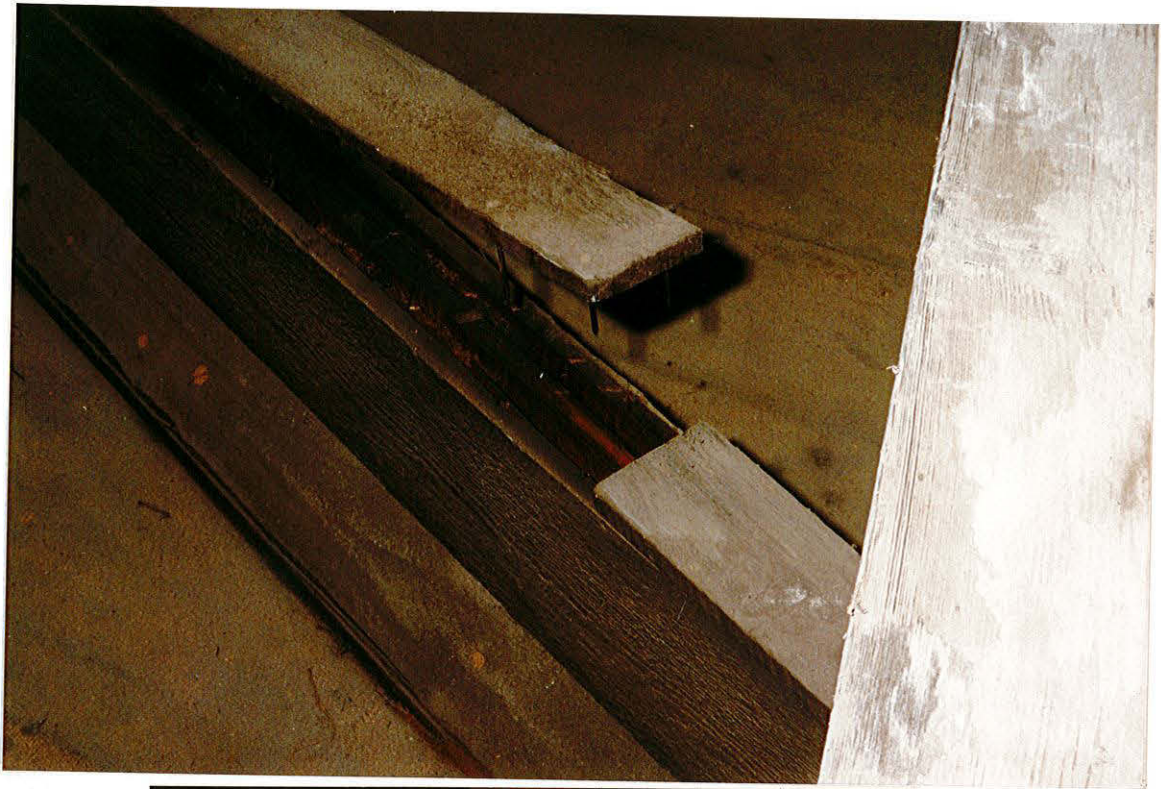
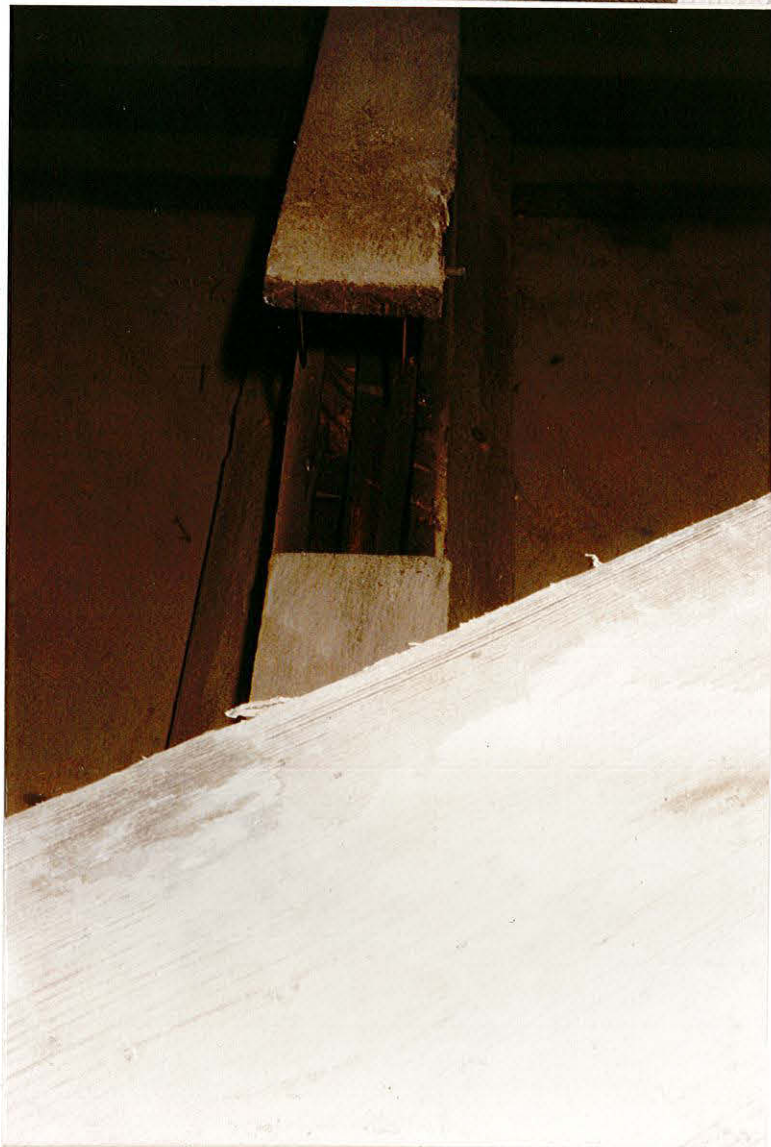
Plate XII

- a Detail of built up joist.
- b Detail of built up joist.

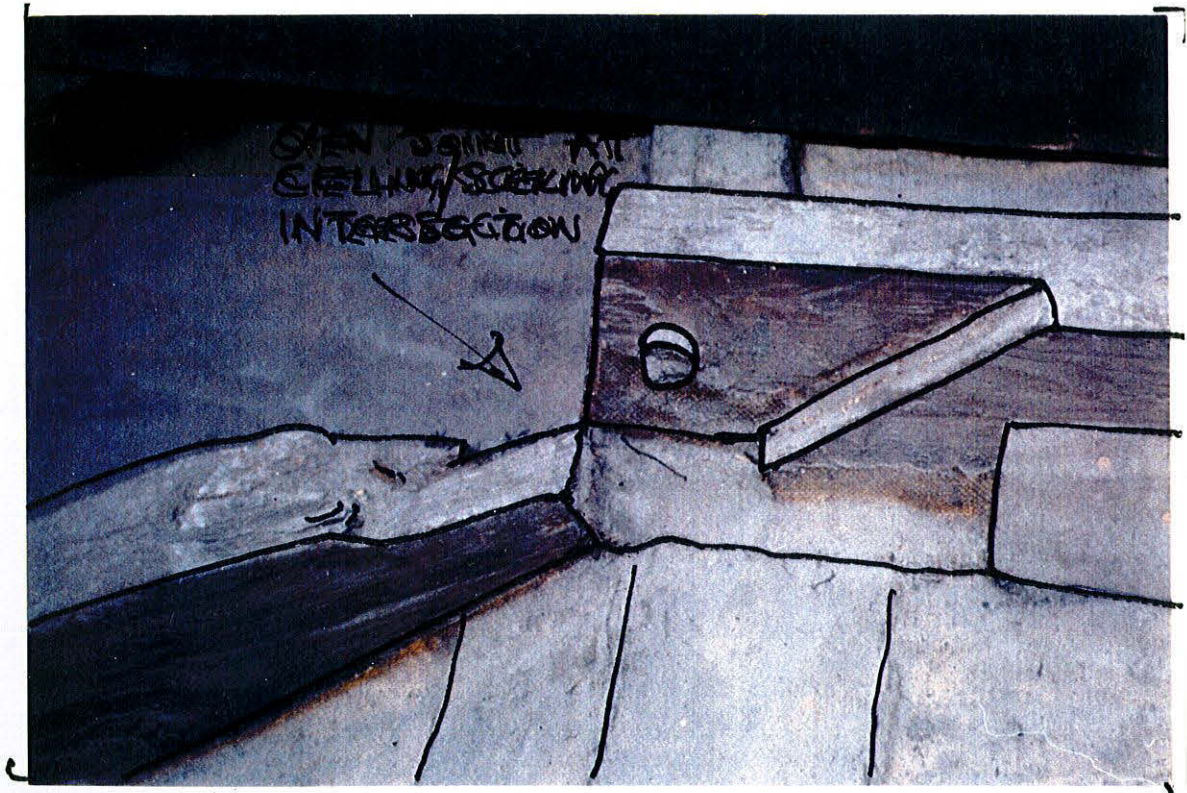
Plate XIII Detail of open ceiling joint at ceiling/ceiling intersection. note how the original joint has been cut and released.
