PETERBOROUGH CATHEDRAL

AN ARCHAEOLOGICAL ASSESSMENT OF THE ROOF OF THE NAVE AND THE PAINTED CEILING

Nave Roof and Ceiling: recommendations concerning further research

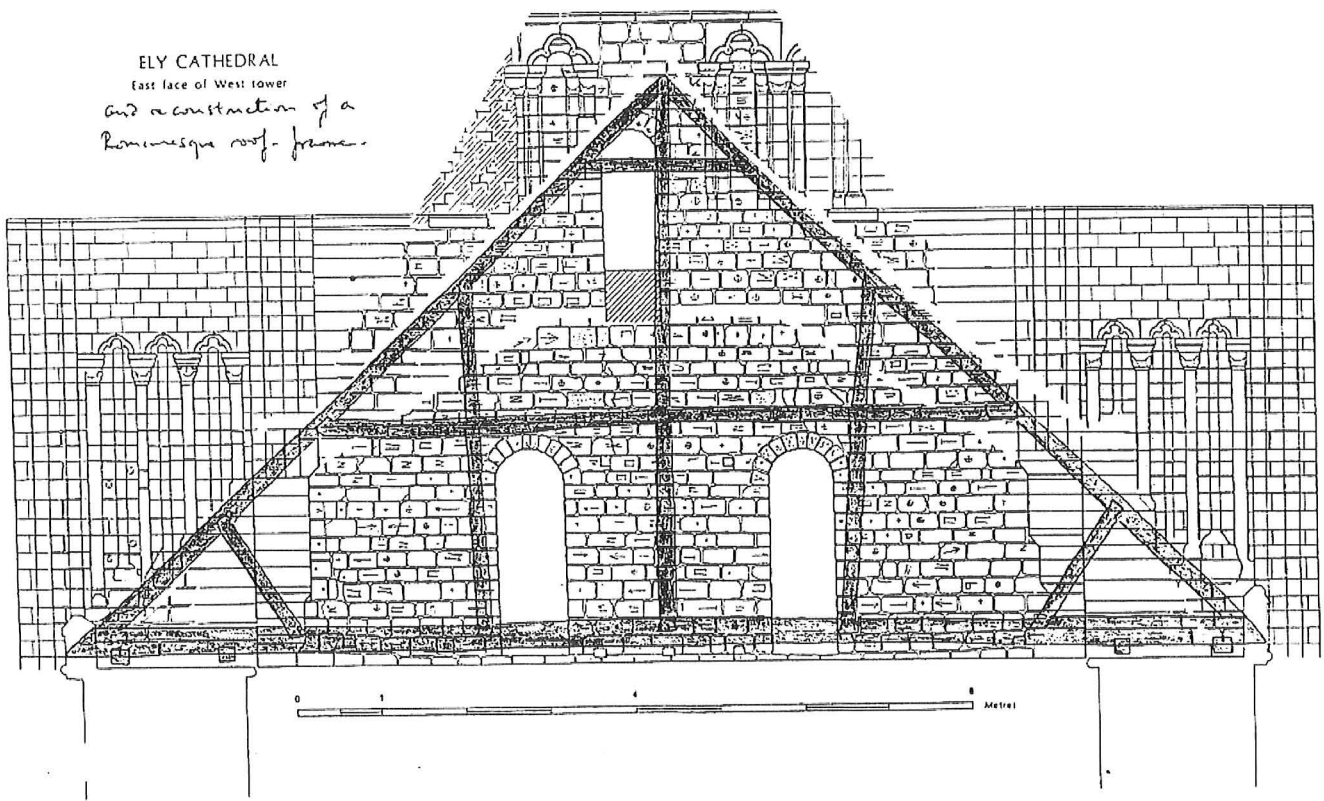
Fig. 1 Reconstruction of one of the original Norman roof trusses over the nave of Ely Cathedral. It has been dated by dendrochronology to c.1120.

The nave of the cathedral was probably built during the third quarter of the 12th century (Pevsner and Metcalf, 1985). It was therefore completed rather more than half a century after the nave of nearby Ely cathedral. That, we know, had a low-pitched roof made up of a series of tie-beam trusses which carried central, king-struts and shorter, raking-struts supporting the rafters. These rose from the ends of the massive 46ft (14m) long tie-beams, which spanned the tops of the walls, so that the roof had no gutters or parapets (fig. 1).

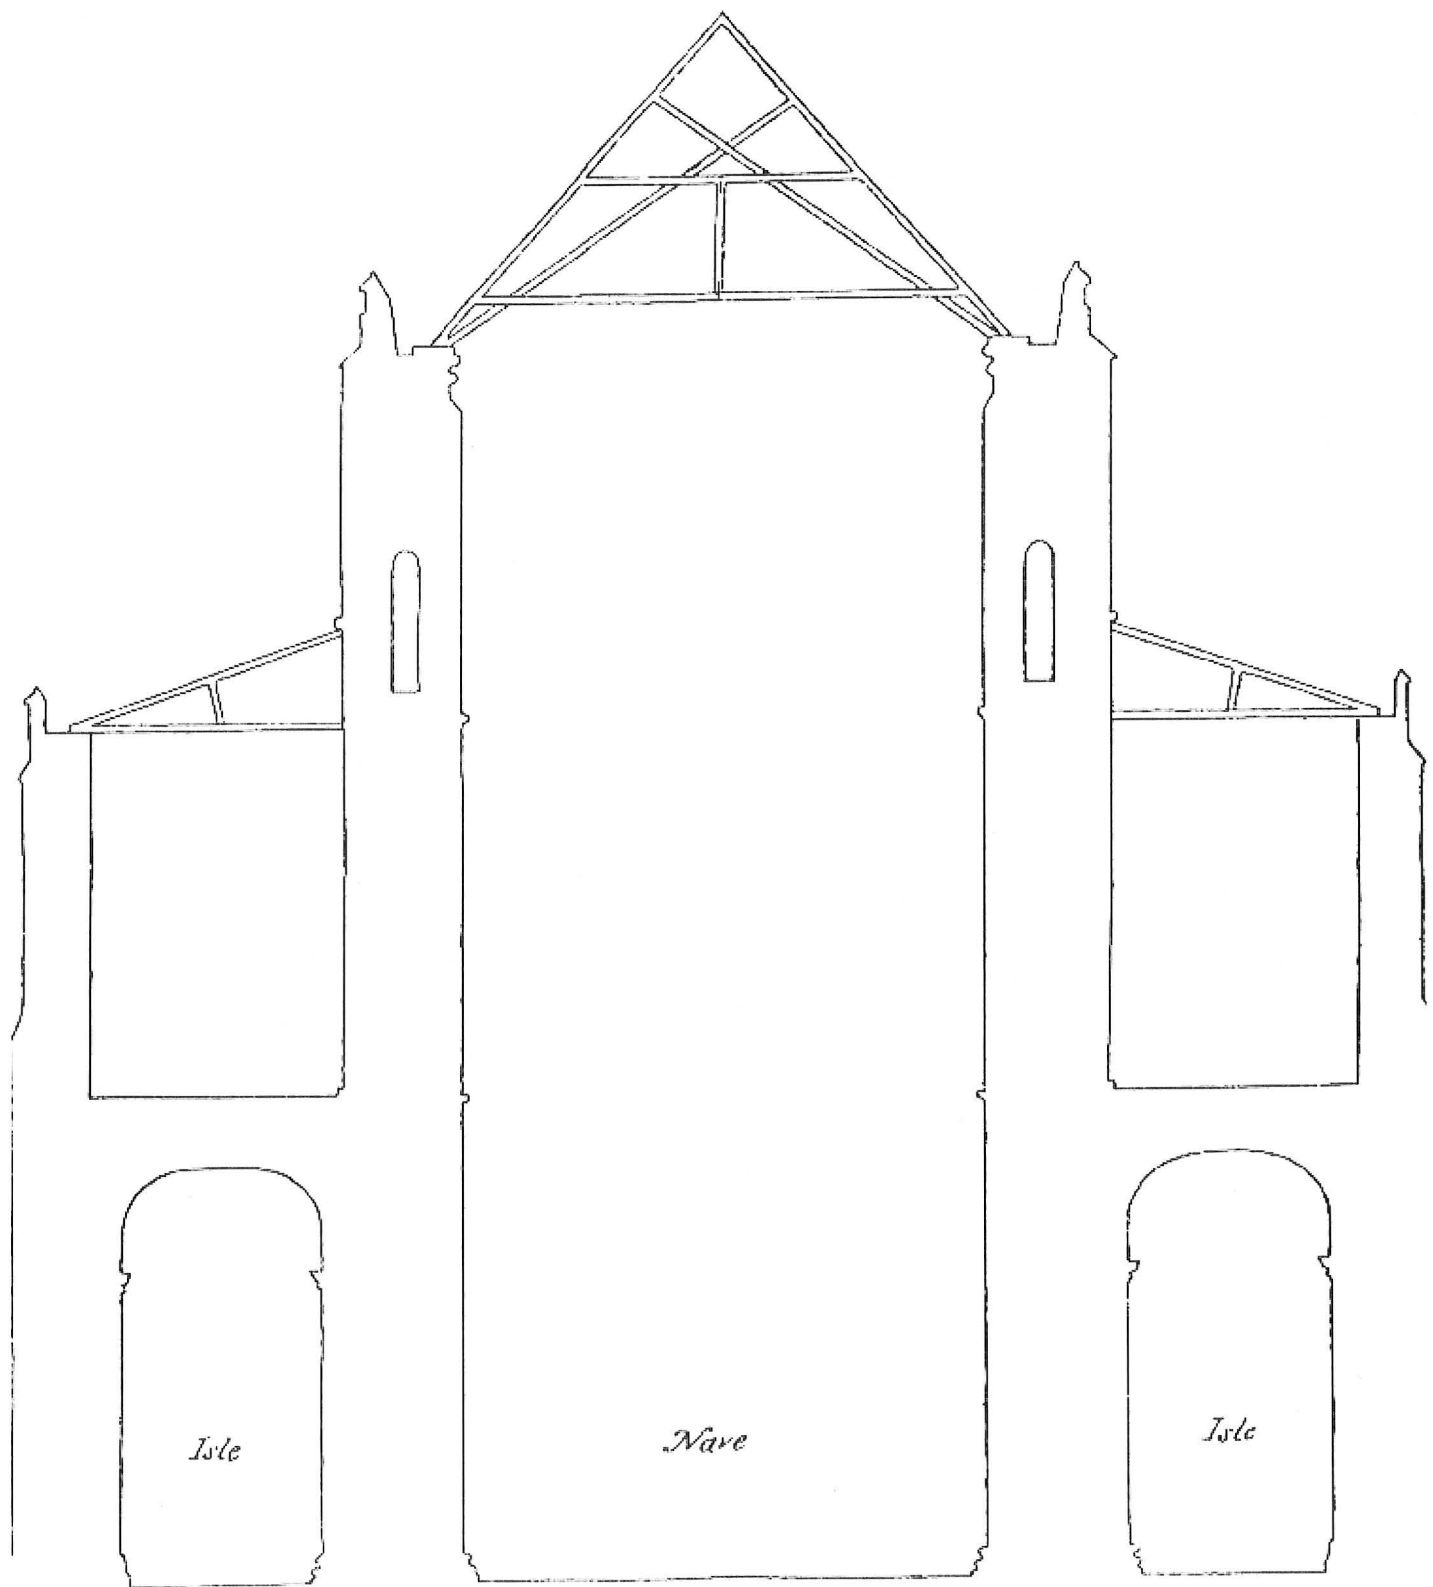
Fig. 2 Cross-section of the nave of Peterborough Cathedral drawn by Samuel Ware c.1805.

Since my first visit to the cathedral's roofs in 1988 a cross-section of the nave drawn in the early years of the 19th. century has come to light (Ware, 1809, Pl. 18 - see Fig 2). This shows the form of the medieval roof to which the painted ceiling was fastened before the present roof of imported pine was built by Edward Blore c1830 (Winkle, 1838, II, 77). My own attempt (Simpson, 1989) to reconstruct the design of the medieval roof from the little evidence that still survives has proved to be invalid and it can now be seen that Blore followed the medieval design quite closely. The only published illustration of his roof is that of Ruprich-Robert (1881- see Fig.3).

Unfortunately neither of these 19th. century drawings are accurate in all particulars. Ruprich-Robert's section does not show the gutters and parapet walls but otherwise seems to be substantially correct. This was presumably a careless omission made because the drawing was intended to illustrate the timber framing of the roof rather than structural details of the masonry. Ware's drawing shows the gutters and the parapets correctly but the feet of the rafters are set right on the inner edges of the walls, the feet of the scissor arms which carry the sides of the ceiling are too short and the internal wall faces immediately below have mouldings which do not exist. In making his survey Ware would have had access to the parapets and gutters of the roof and would have been able to take external measurements, however, the internal structure would have been completely dark and possibly dangerous to enter. It would anyway have been impossible to measure the width across the base of the roof and his observations were probably largely confined to what he could see from the doors into the roof at either end. The ceiling and profile of the lower part of the roof are therefore shown foreshortened, much as appears to anyone standing on the floor of the nave.

Ware's drawing shows a scissor-braced roof with a pitch of about 50%.

The arms of the scissors would have been half-lapped across the two collar beams which were linked by a short post. It is surprising that this did not extend as a king-strut up to the apex of the rafters but it has parallels elsewhere, for example, the late 12th. century high roof of the nave of Wells cathedral (Hewett, 1985, 11). A unique feature of the roof was the relative positions of the feet of the scissor arms and the rafters, the former just in front of the latter (on sole pieces presumably) at the tops of the wall. Usually the feet of the scissor arms are joined to the rafters at a height of 4-5ft (1-2m). This feature and the lack of any evidence that the roof ever had tie-beams indicate that the roof was designed for the present ceiling.

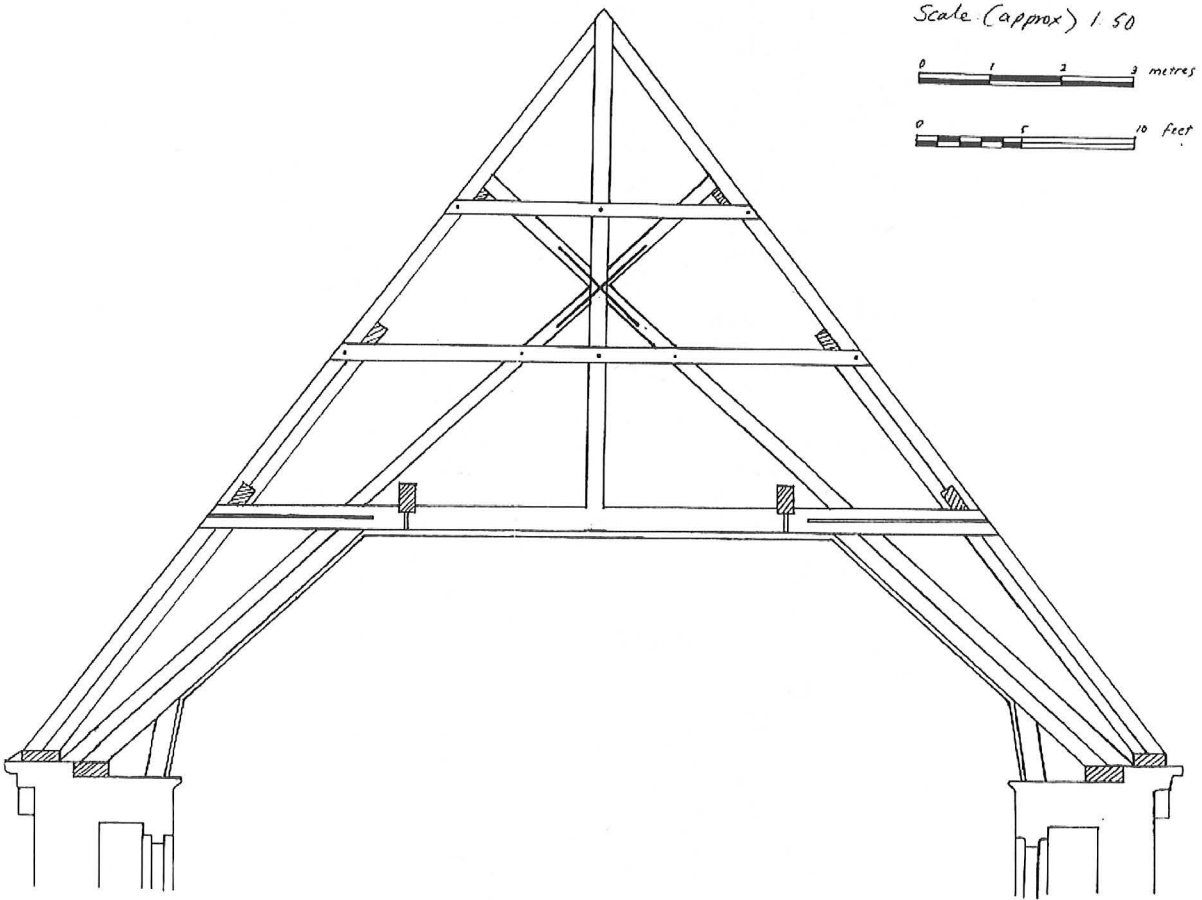
Fig. 3 Drawing of one of the principal trusses of the present roof of the nave, Peterborough Cathedral built by Edward Blore c.1830. (After V. Ruprich-Robert, 1881).

The present roof of the nave is much as depicted by Ruprich-Robert (1881 - see Fig. 3). The presence of clasped purlins on all three of its collars is a wise precaution against racking (ie twisting or tilting) of the trusses which was often a problem in medieval roofs of the kind formerly at Peterborough. Iron straps reinforce the joints of the lower collar beams with the rafters and the intersection of the scissor arms and the king-strut. The ceiling is suspended from the roof by bolts through the old collar beams and such additional timbers as were subsequently inserted for the purpose (Moore, 1923). Moore completely recovered the roof in 1926 and also treated it with preservative, constructed a new gangway and improved the lighting by the introduction of electricity and by the addition of windows above the eaves. He also covered all the extrados of the ceiling with canvas which is glued to the boards to maintain their cohesion.

The Ruprich-Robert drawing of one of Blore's pine roof trusses is inaccurate in various ways. A new, accurate scale drawing of a typical truss should be made.

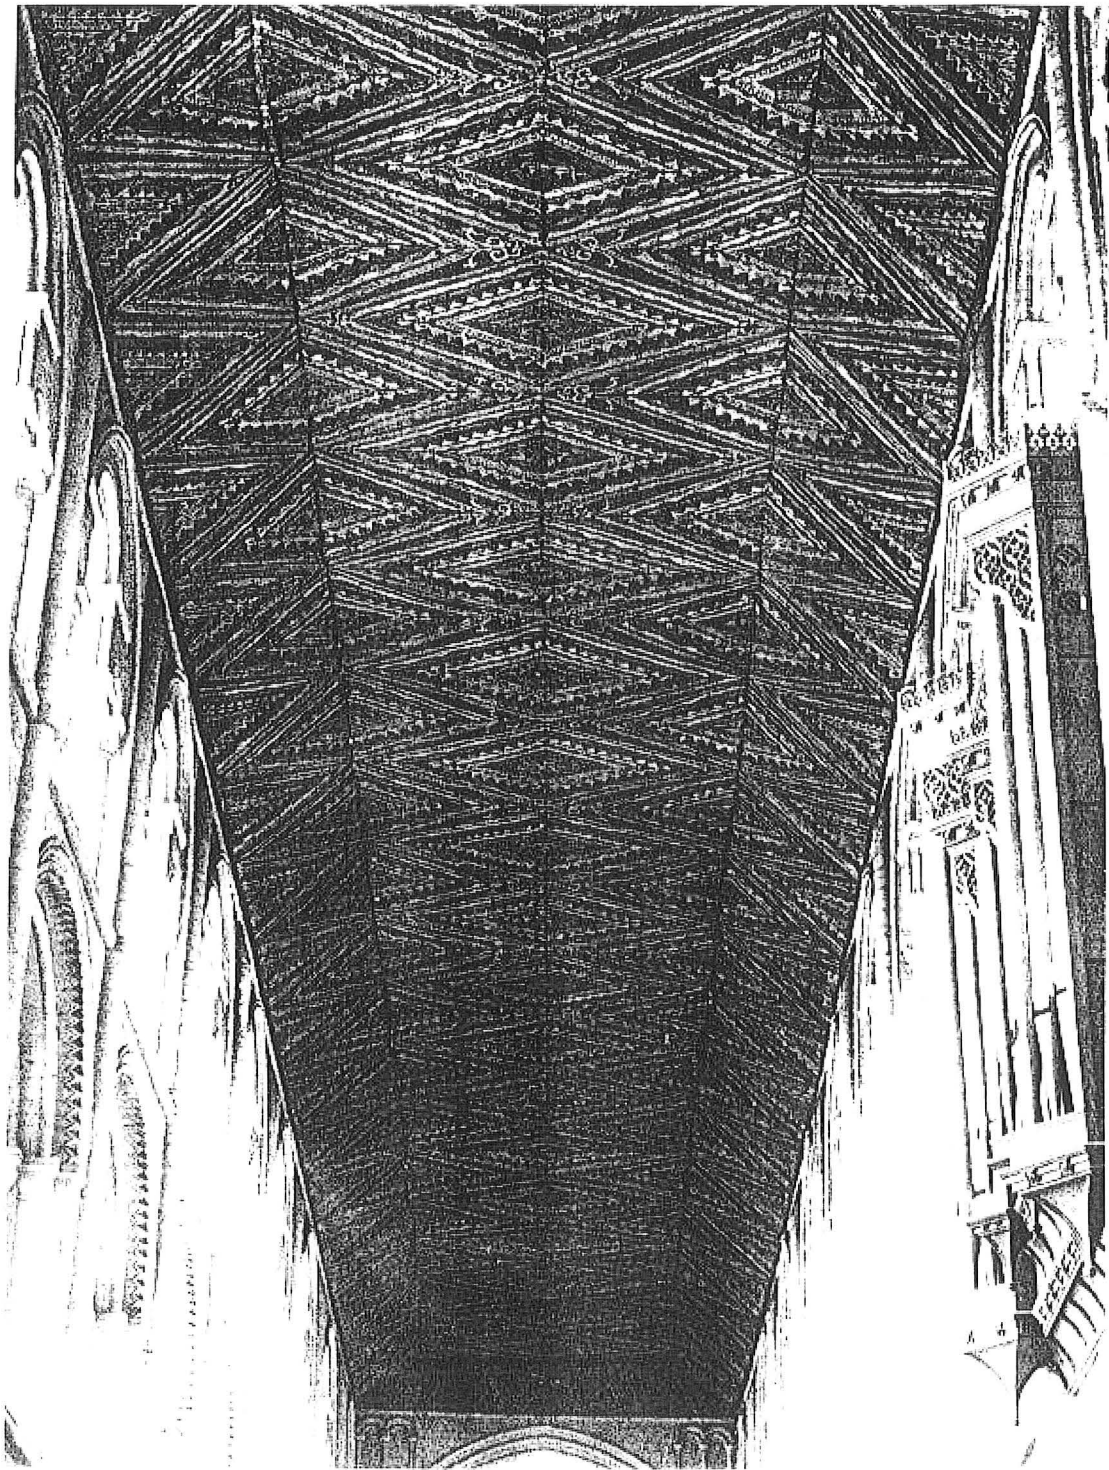
Fig. 4 Three views of the nave, Peterborough Cathedral, looking west showing the vacant space above the end wall between the cornice and the ceiling.

Dendrochronology has shown that the original Norman roof of Ely cathedral was replaced by a new scissor-braced roof 120 years later. Possibly much the same happened at Peterborough, but the apparently shorter time interval makes it less likely. The unique form of the roof with the feet of the scissor arms on top of the walls, in front of the feet of the rafters suggests that it was indeed designed specially to take the painted ceiling. It has been suggested (Cave and Borenius, 1937; Cartwright, 1969) that the ceiling was originally flat and was later raised up to its present canted form when the east and west arches of the tower were altered from round, Romanesque to pointed, Gothic c.1325. A flat ceiling would have been quite in keeping with the former but would have truncated the apex of the latter. This idea has not been generally accepted for, it is argued, it would have been necessary to increase the width of the ceiling and there is no evidence of that. Certainly, if it has been moved or changed from its original form some archaeological evidence of it should still be apparent. The fact that the parapets of the roof and the axial arches of the former tower are very close in date otherwise makes this an attractive theory. It should also be noted that the west wall of the nave over the arch rises no higher than a level cornice as would be appropriate for a flat ceiling (Pevsner and Metcalf, 1985, 277 - see Fig. 4).

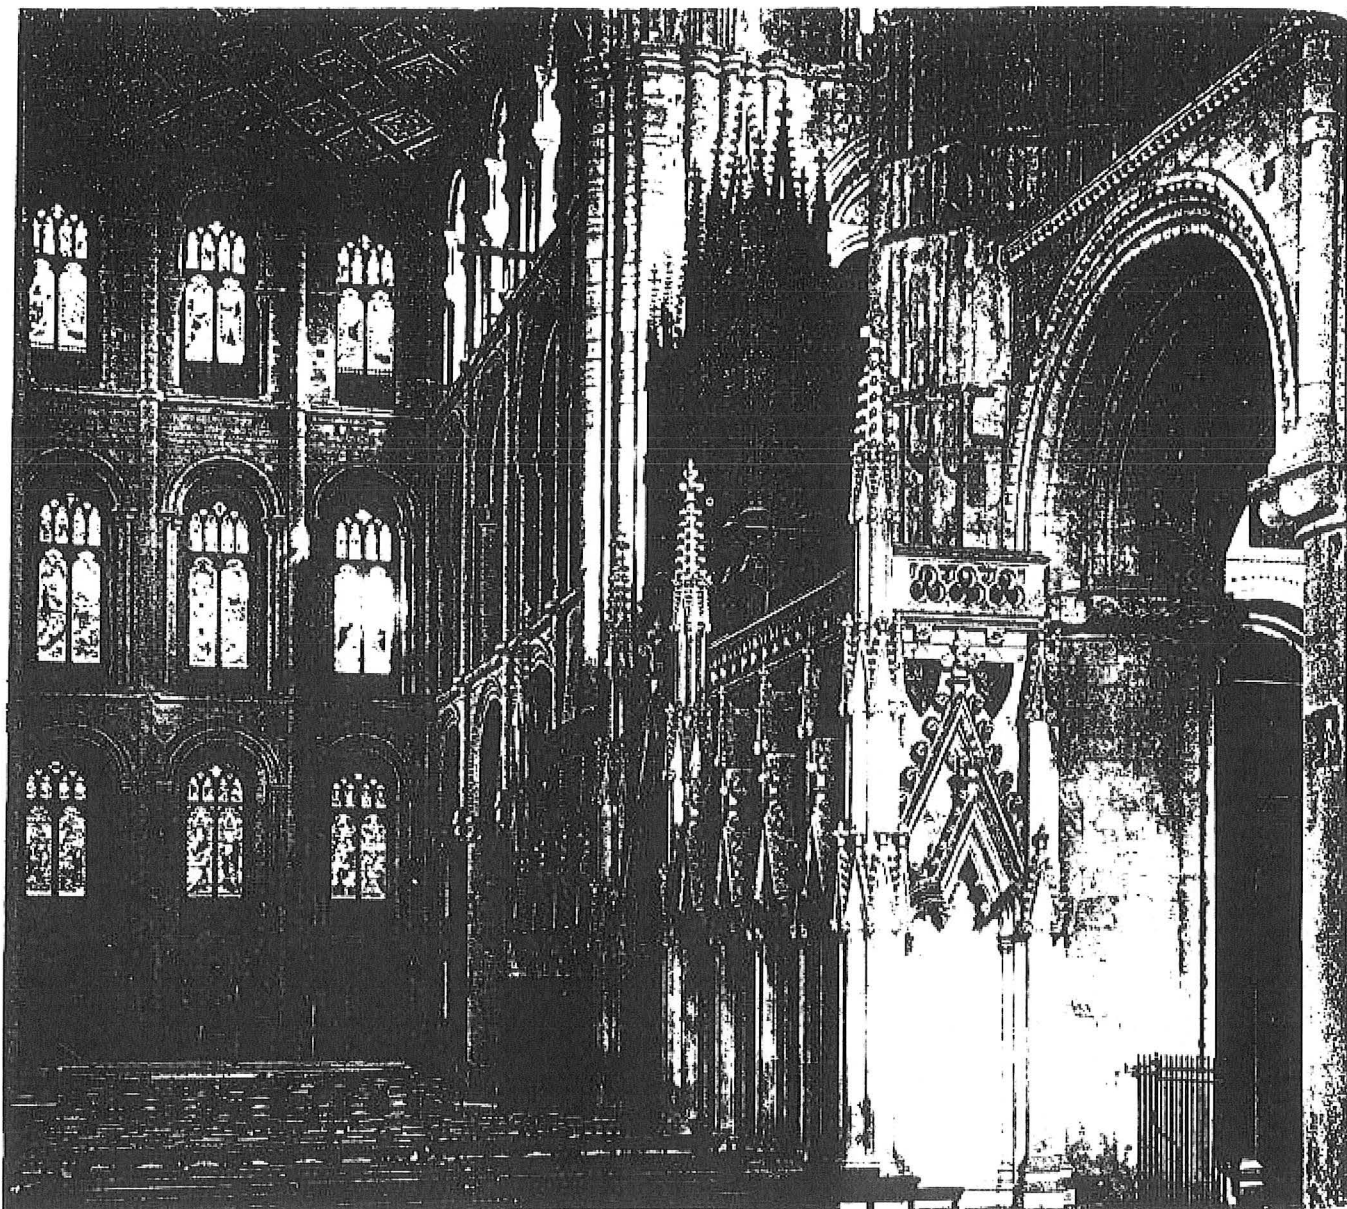
Fig. 5 Photograph of the north transept, Peterborough Cathedral, taken before Pearson's rebuilding of the tower (1882-85), showing part of its original painted ceiling.

Finally, it only remains to draw attention to the similarities which are apparent between the nave and transept ceilings. Both are composed of boards arranged in diamond patterns which are further accentuated by their painted decoration (fig. 5). How the boards of the transept ceilings are/were fitted together is not entirely clear but I have only come across the 'clinker' construction of the nave roof before in the 13th century nave ceiling of Warmington, Hunts., parish church. It is possibly an earlier panelling technique than the tongue and groove technique which may only appear with the importation of large quantities of riven oak boards from the Baltic from the later 13th. century.

158. The crossing from the south transept, some time between 1873 and 1884. The nearest pier is the one strengthened with iron clamps.
