Building Record

18 Thames Street, Windsor

On behalf of Byron Hamburgers Ltd

October 2016

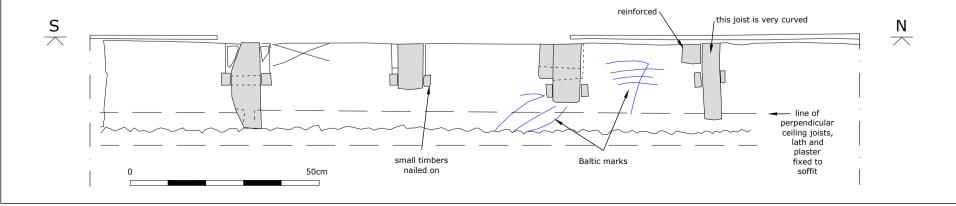
Appendix 2.8 - Area C, Sectional Elevation of side of principal joist showing Baltic timber marks Room S5- 1:10

- 3.26 The lath and plaster ceiling was visible fixed to a smaller series of ceiling joists tenoned into taller floor joists.
- 3.27 The eastern face of the principal floor beam featured a series of long inscribed Baltic timber marks (see appendix 2.8). Baltic Timber marks do not relate to the construction of the floor but instead reflect marks applied to baulks of timber at the timber yard or port and relate to the quality and or quantity of the timber in the baulk. They are almost always partial when observed in buildings as the large timbers on which they are inscribed originally are cut down later to form smaller timbers for use within a building. They are most usually found on late 18th and 19th century timbers after the increase in timber from the Baltic states.

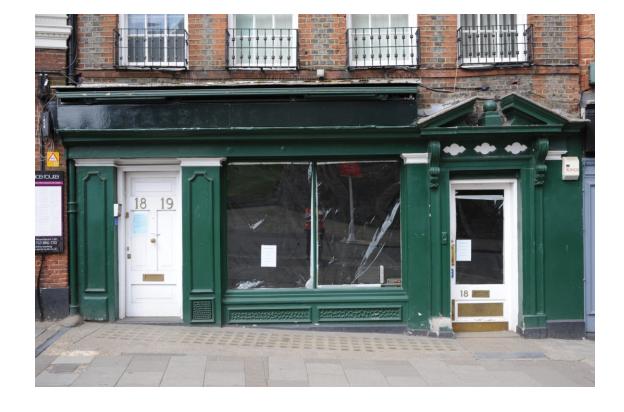
- 3.2 The front elevation (Appendix 3.1) was four bay's wide with a timber ground floor shop front incorporating a plain door between wide pilasters and two windows all beneath a continuous fascia on the left hand side and, in the right hand bay an entrance beneath an open pediment with ball ornament. The door had a bolection architrave and curved consoles supported the pediment.

Appendix 3.1: Front elevation to Thames Street with, below, a detail of the PREZZC shop front. W

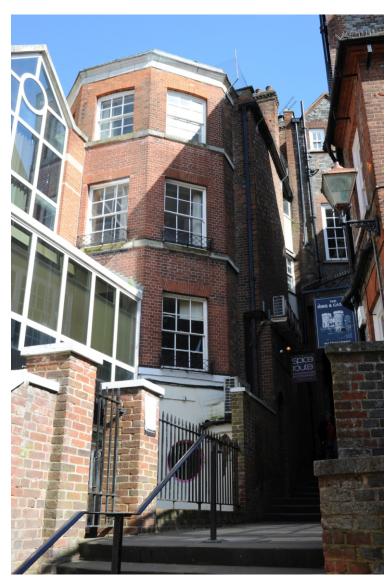
Appendix 3.2 (left): Rear elevation with canted bay representing the primary historic fabric. The late 20th century Cavendish House with glazed link is visible abutting the historic structure on the left of the picture.

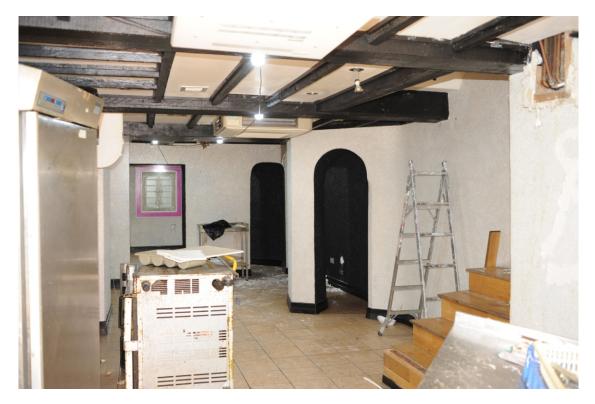
Appendix 3.3 (below):

Basement/Lower ground room 1 looking towards the street, arched opening on right of image is in former angled stack and suggests a possible early partition. E

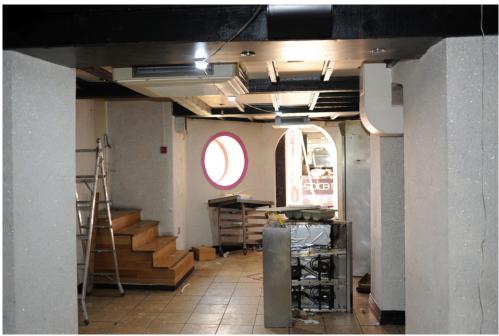
Appendix 3.4: Basement/Lower ground floor room1 looking towards the rear of the property. Steps on left lead to the alley S of the building. W

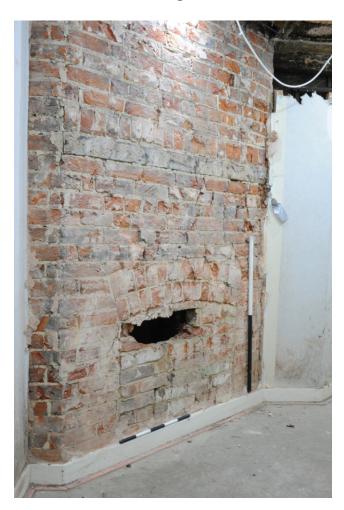
Appendix 3.5 (above left): Former fireplace, bricked up, in G2 entry passagee. Note raised floor level. W

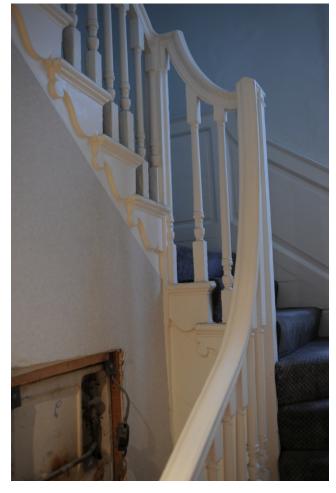
Appendix 3.6 (above right): stair detail in G2 showing tread end decoration, balusters and swept balustrade. S

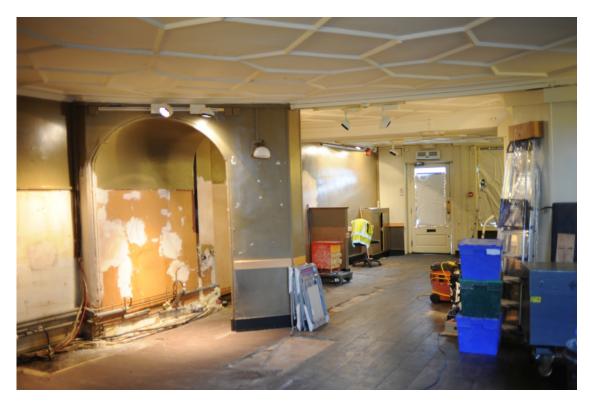
Appendix 3.7: Room G1 looking towards the front of the building. Arch on left in former angled stack, note decorated ceiling. E

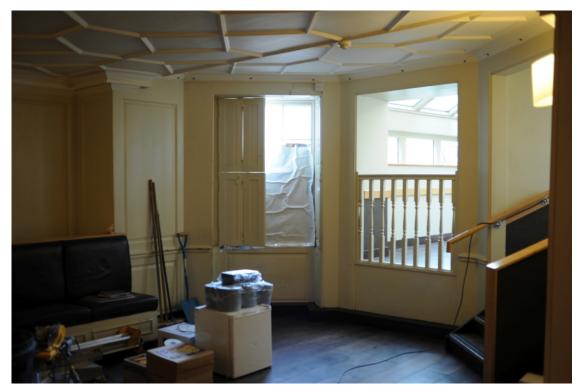
Appendix 3.8: Room G1 looking towards rear bay with extant shutters. SW

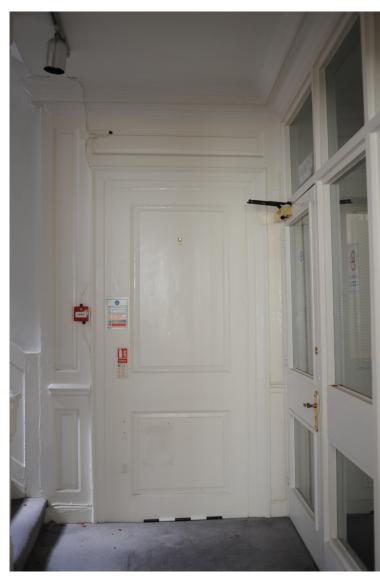
Appendix 3.9 (left): F1, blocked doorway formerly from stair into F5. Within F5 this doorway is panelled over. W

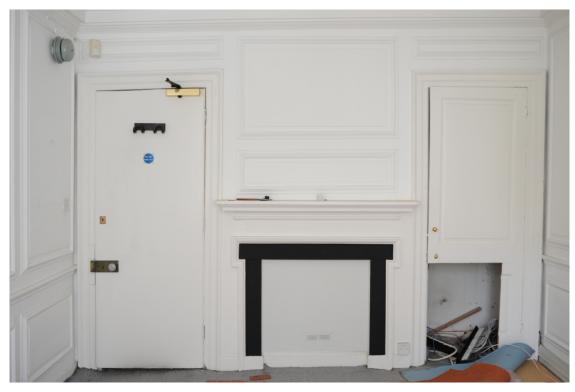
Appendix 3.10 (below): F3 blocked fireplace, door to right into cupboard. W

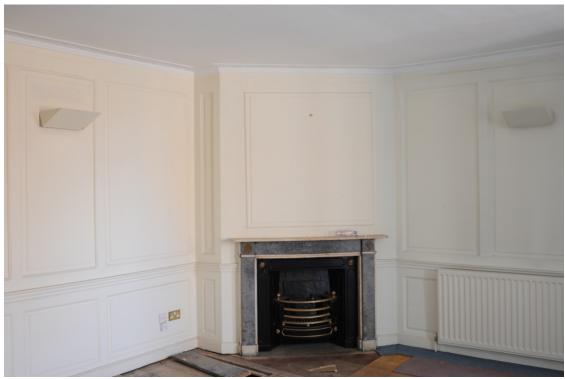
Appendix 3.11: Room F5 angle set fireplace with marbled surround, note panelling to the left of the fp obscuring former doorway. SE

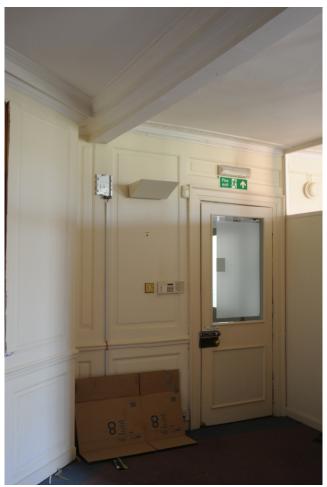
Appendix 3.12 (left): F5 small area divided from main room with modern partition. Note downstand in ceiling representing possible earlier partition at corner of second stack, different cornices to either side. SE

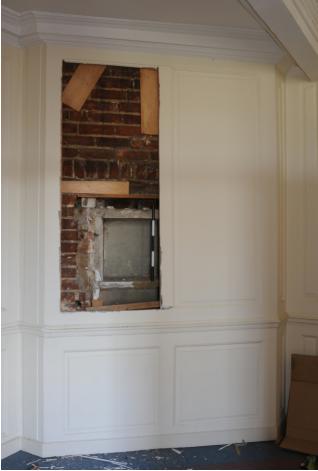
3.16 The removal of one of the panels from the northern angled corner in room F5 revealed part of a hidden feature which appeared to be a set of stone shelves set into a former fire place recess. Only part of this feature was ever exposed so its full form and extent was never revealed to enable a closer understanding of its original form or development (Appendix 3.13).

Appendix 3.13 (right): Removed panel on angled stack in F5 revealing stone shelving feature within former fireplace. E

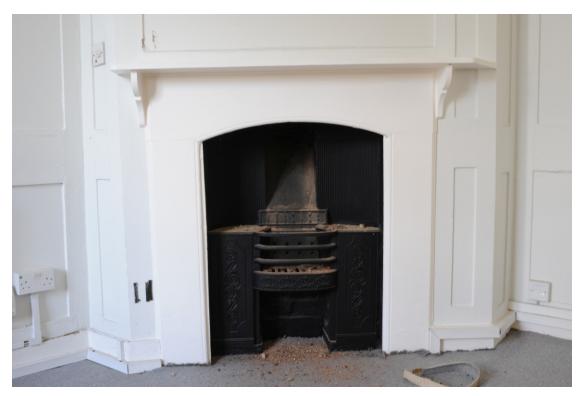
Appendix 3.14: Room S5, angled stack with grate. SE

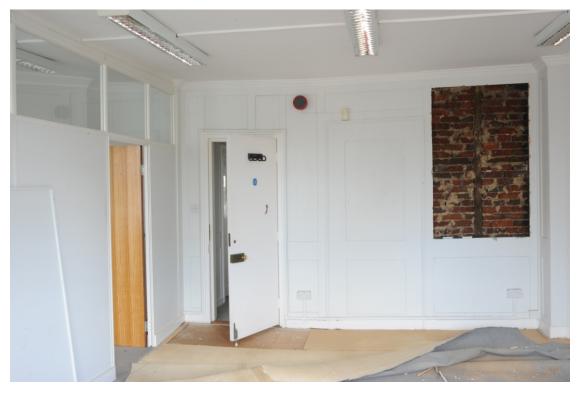
Appendix 3.15: Room S5, wall with exposed fabric, blocked doorway embedded within the panelling left of the opening. E

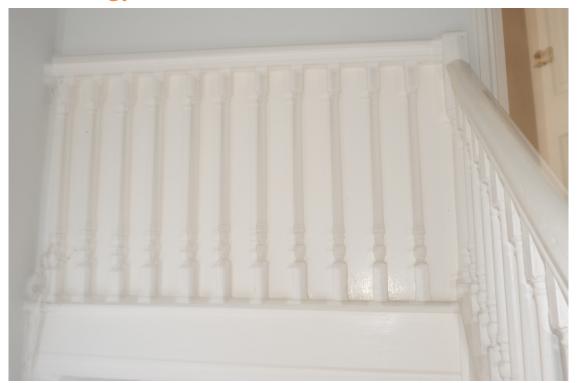
Appendix 3.16: Stair balustrade embedded within later fire partition. Th1. N

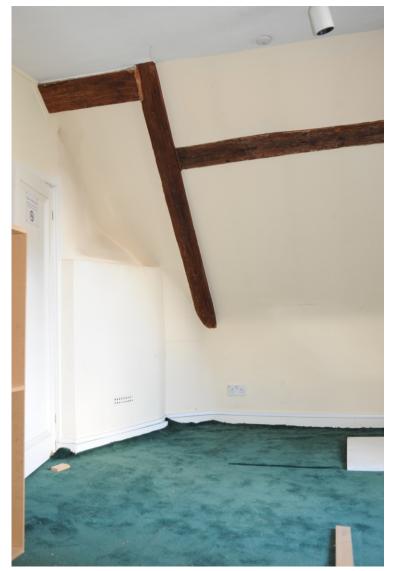
Appendix 3.17: Room Th 2, blocked fireplace in angled stack, exposed principal rafters and staggered purlins. N

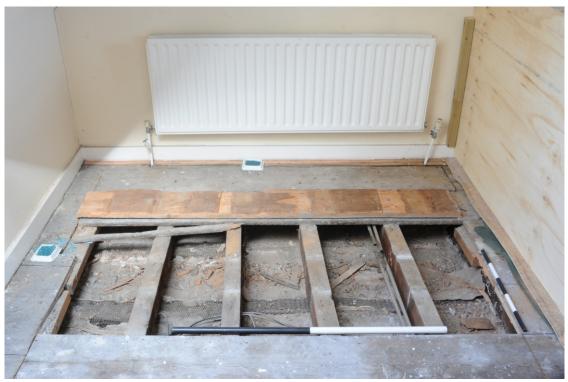
Appendix 3.18: Room Th 4, Area A.W

- 3.20 This area was a narrow rectangular area in the rear of the third floor (See Appendix 2.?, Appendix 3.18, 3.19). It revealed a series of common floor joists running east to west supporting the floor boards, which in this room ranged from 9-11 inches wide. Beneath the floor joists was a second set of joists running perpendicular to the floor joists. Between these joists the spaces over the mesh was filled with a plaster type material which appears to have provided support to underlying lath and plaster. The precise relationship of the steel mesh to any historic lath and plaster beneath was not clear. No joints between common or principal joists in this area was visible.
- 3.21 The floor joists were well squared regularly sized soft wood timbers. The wide oak floor boards had been re-laid at some time and showed multiple sets of nail holes.

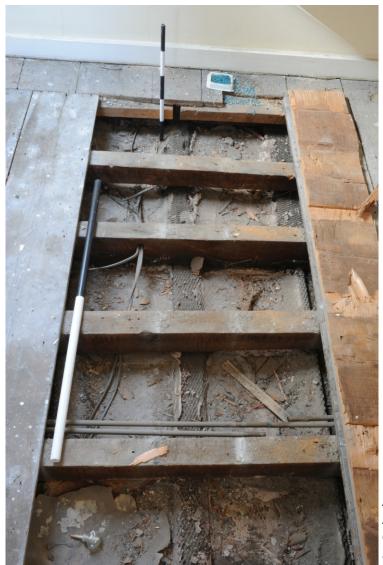
Appendix 3.19: Room Th4, Area A. Note perpendicular ceiling joists obscured by expanded steel mesh and ceiling plaster reinforcement. S

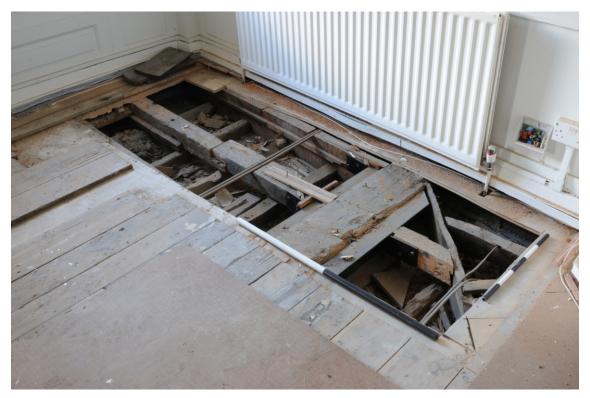
Appendix 3.20: Room S5, Area B. NW

3.22 Area B was located against the northern wall of Room S5. It revealed a single large principal joist running north to south with secondary floor joists running east to west. The principal joist was flanked with 'C' shaped steel sides, and fixed to this were steel cradles supporting the feet of the common floor joists. The steel arrangements obscured the timber joint between principal and common joists though peg holes were visible in the top of the principal joist (see appendix 3.20, 3.21).

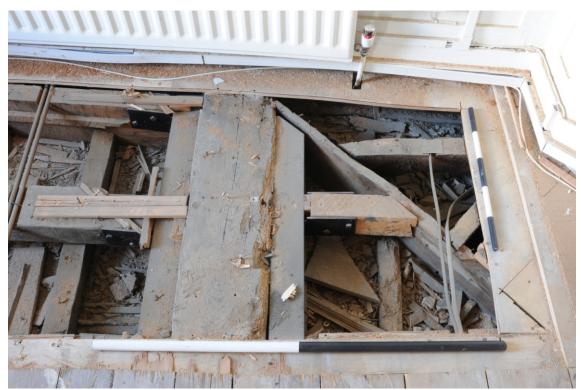
Appendix 3.21: Room S5, Area B, eastern end of open area showing principal floor beam, angled trimmer for the fireplace and steel reinforcements to main beam and joist on left hand side. N

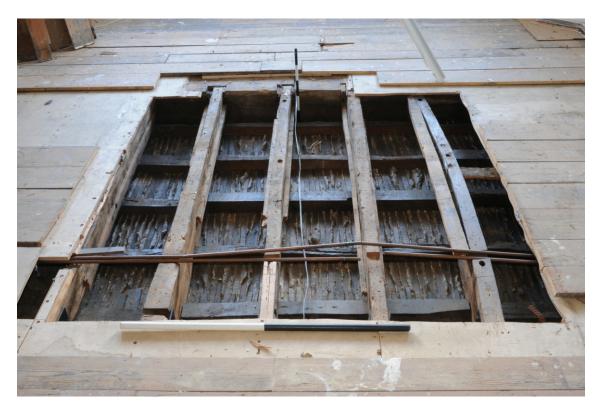
Appendix 3.22: Room S5, Area C. W

- 3.25 This area was a larger square opening in the centre of room S5 measuring approximately 2m by 2m (Appendix 3.22 And 3.23). It exposed a large principal beam aligned with the rear wall/bay window on the western side of the building. Smaller floor joists were jointed into this large principal with tenons with sloped, or diminished, haunches above and single pegs. The exposed joints at the principal beam showed wider mortices than the joists within them suggesting that the joists were perhaps replacements of wider earlier examples.

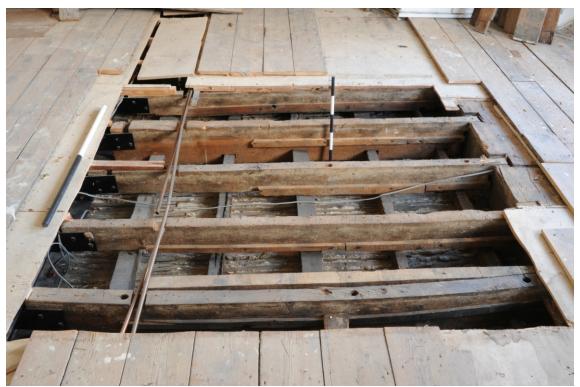
Appendix 3.23: Room S5, Area C. note perpendicular floor and ceiling joists, extant lath and plaster, steel cradles for floor joists on left hand side, surviving historic joints on right hand side into beam at the front of the rear bay. S

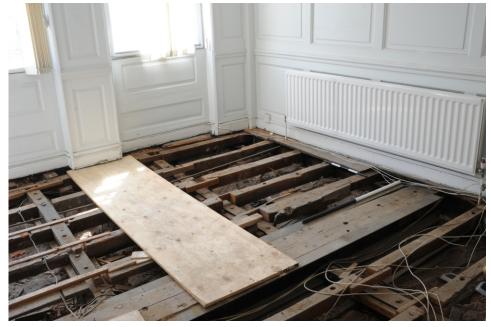
Appendix 3.24: Room F2 after removal of floor boards revealing primary floor beam with steel reinforcement, altered floor joists. SE

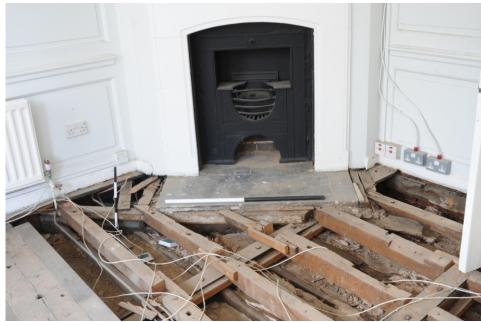
Appendix 3.25:Room F2 after removal of floor boards revealing structure around fireplace. SW

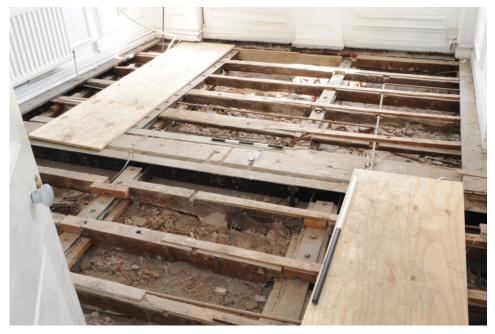
Appendix 3.26: Room F3 after removal of floor boards revealing floor structure, main floor beam continues from that in F2. E

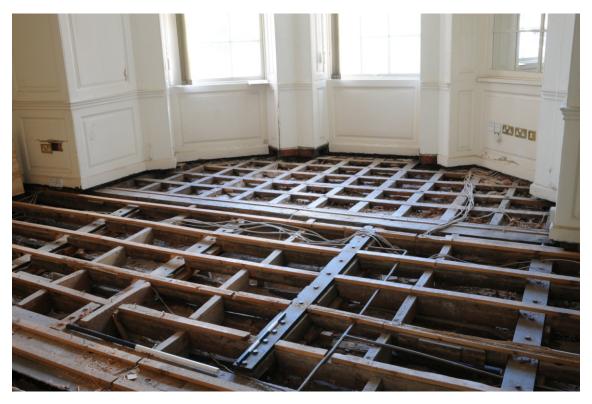
Appendix 3.27: Room F5, looking towards rear canted bay after removal of floor boards. SW

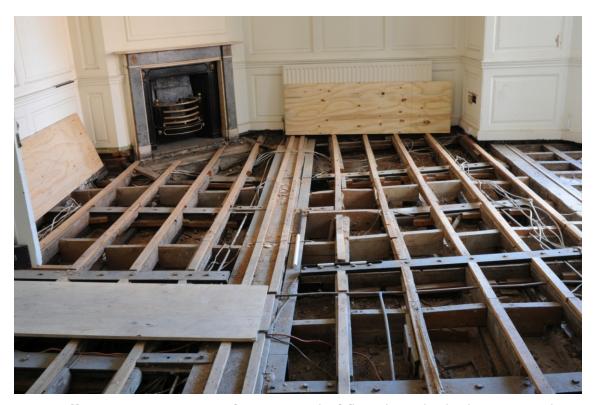
Appendix 3.28: Room F5 after removal of floor boards, looking towards the southern part of the room. S

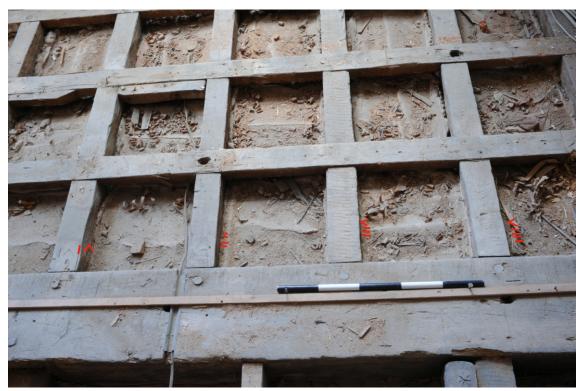
The bay window floor was constructed of a series of square timbers (80 x 80mm) running at approximately 300mm intervals east to west and supported by the brick walls of the bay (and timbers embedded in the walls) and on a large beam spanning the opening into the bay with flatter timbers (80 x 40mm) crossing these creating a lattice (See Appendix 3.27 and 3.29). A series of regularly cut carpenters' marks were seen on the square joists rising from numeral I at the southern end of the bay to XII on the northern-most joist (See Appendix 3.29).

Appendix 3.29: Room F5, detail of beam between main room and rear canted bay showing alternate grid floor joists and position of carpenter's marks. Tracings of the chisel cut marks in red to right of the joists. E

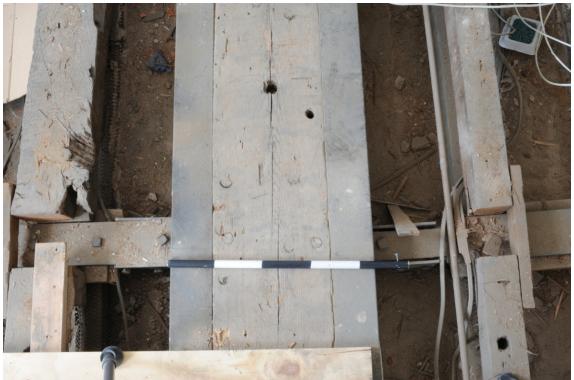
Appendix 3.30: Room F2 detail of main spine beam showing the steel cradles each side of the beam and smaller steels supporting floor joists, cut ends of secondary floor joists and peg holes within the main beam indicating original location of joists. S
