A Report prepared for Mr. R. Bailey

HISTORIC BUILDING RECORDING AT DETACHED COACH-HOUSE , THE
OLD RECTORY, CHURCH ROAD, WADDINGHAM, GAINSBOROUGH,
LINCOLNSHIRE (Grade 2 Listed Building)

BBS Report No. : BBS/HBR/RB 1/17.

DETACHED COACH-HOUSE AT THE OLD RECTORY,
CHURCH ROAD, WADDINGHAM, GAINSBOROUGH, LINCOLNSHIRE.

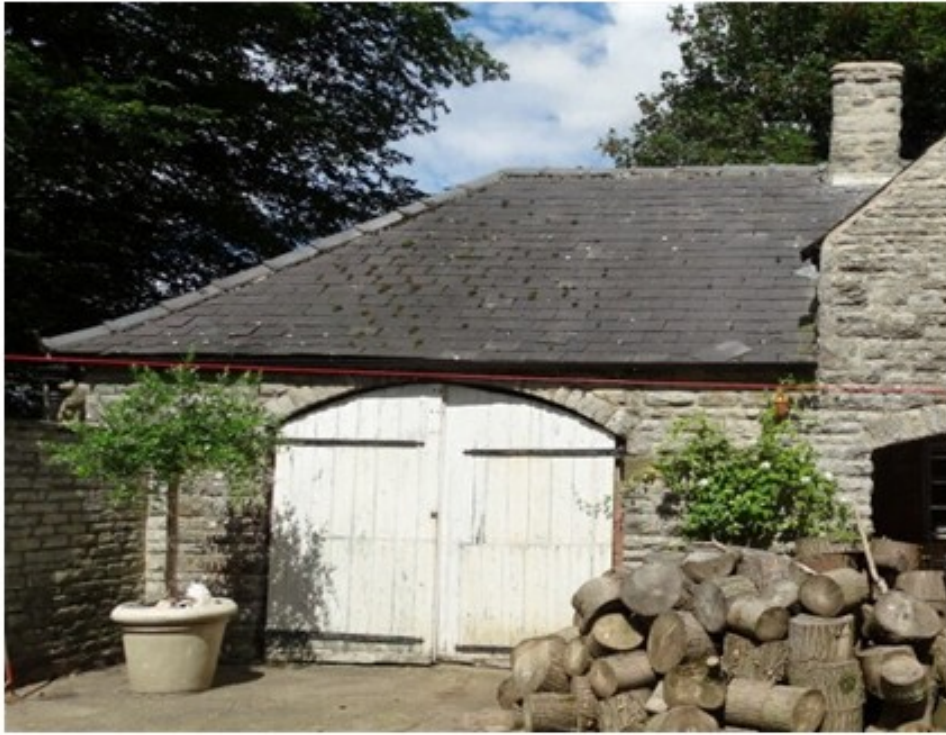
Plate 1 : Coach House : South Side...01.08.16.

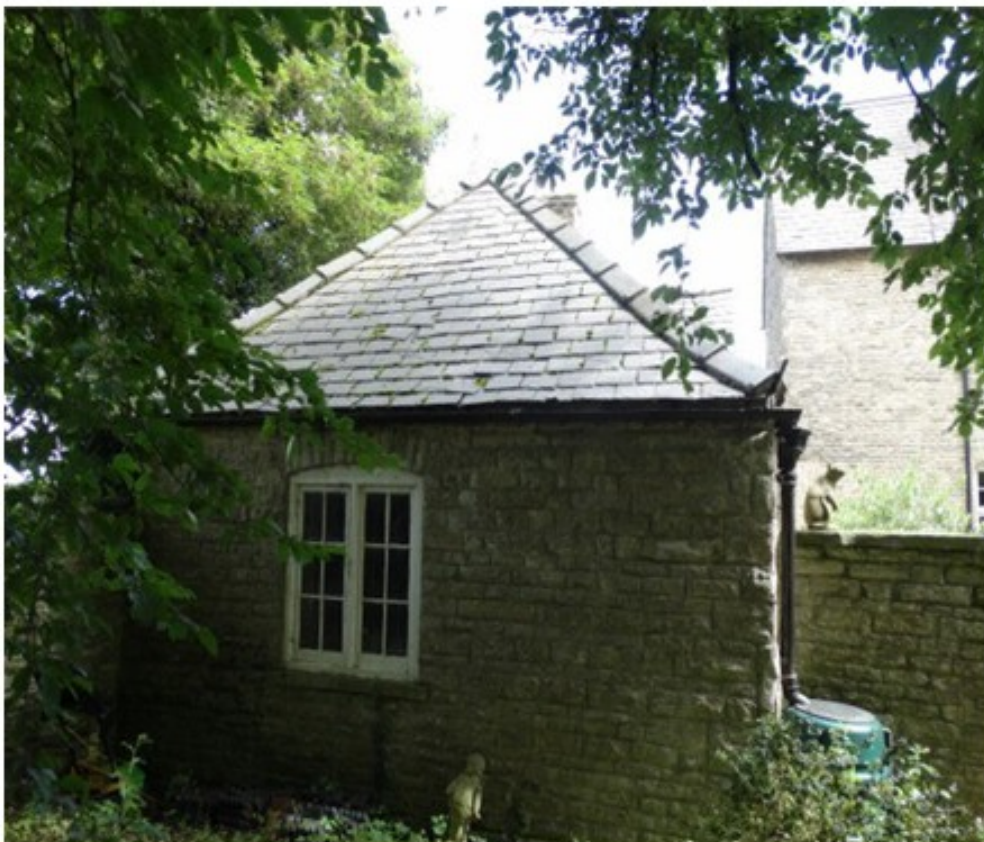
Plate 2 : Coach House : West Side...01.08.16.

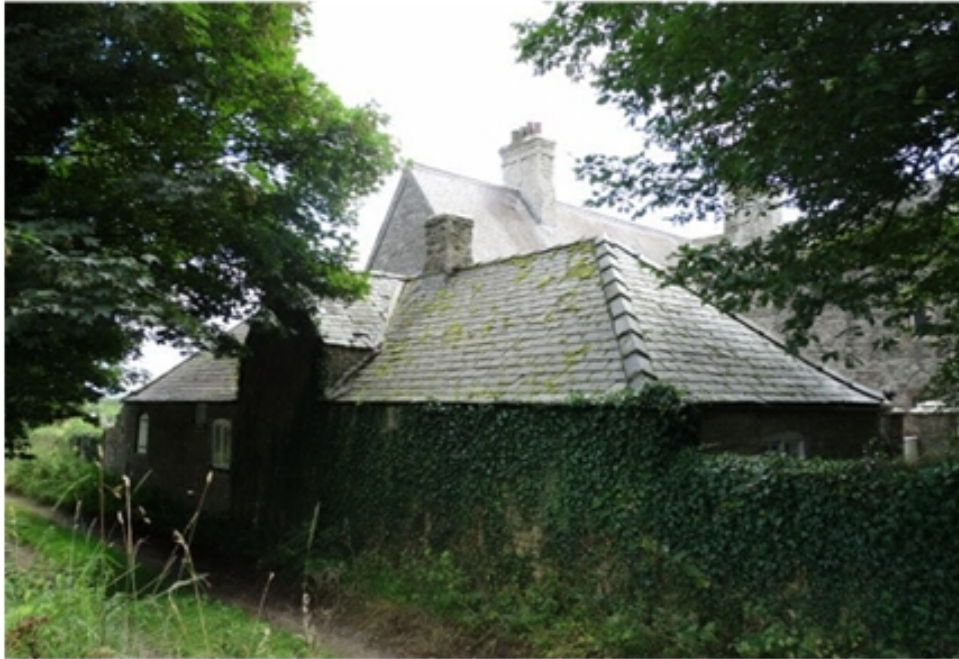
Plate 3 : Coach House North Side : 01.08.16.

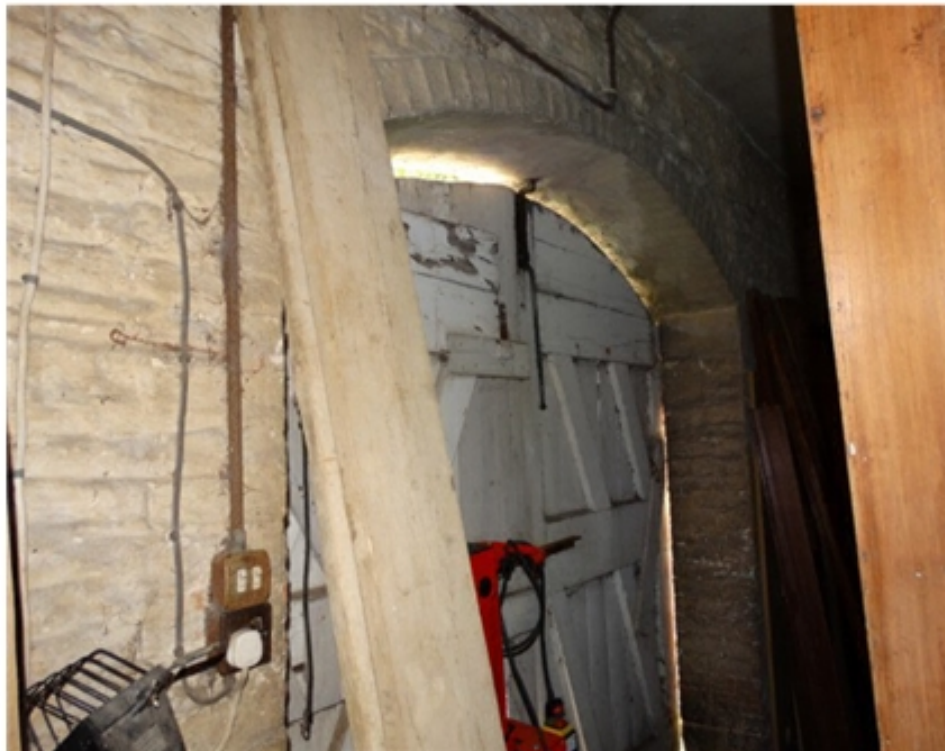
Plate 4 : Inside Coach House Double Doors (south wall) : 01.08.16.

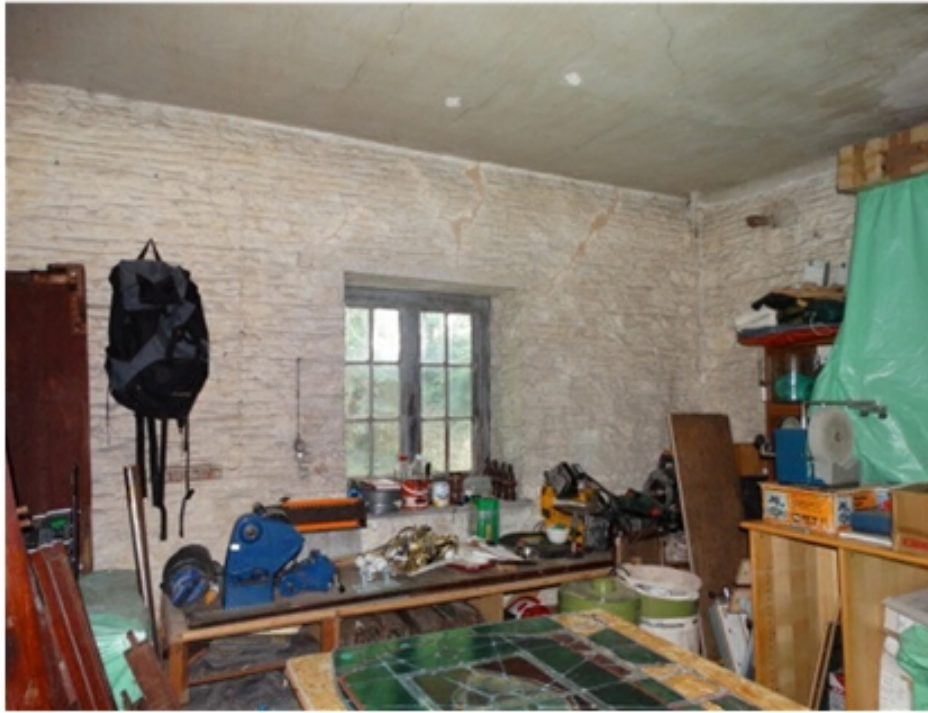
Plate 5 : Inside the Coach House : west wall window...01.08.16.

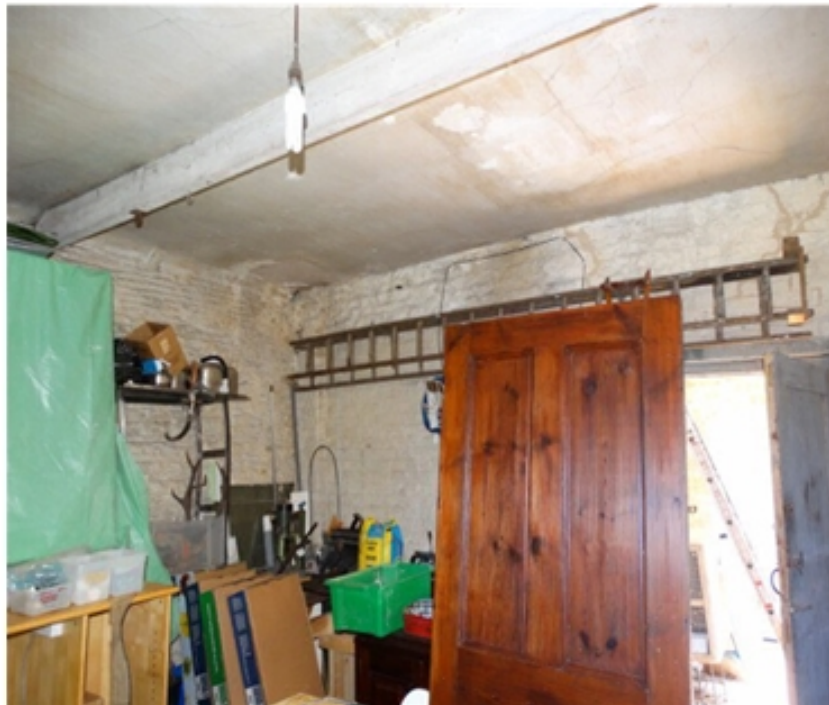
Plate 6 : Inside the Coach House : east wall hand door and roof beam...01.08.16.

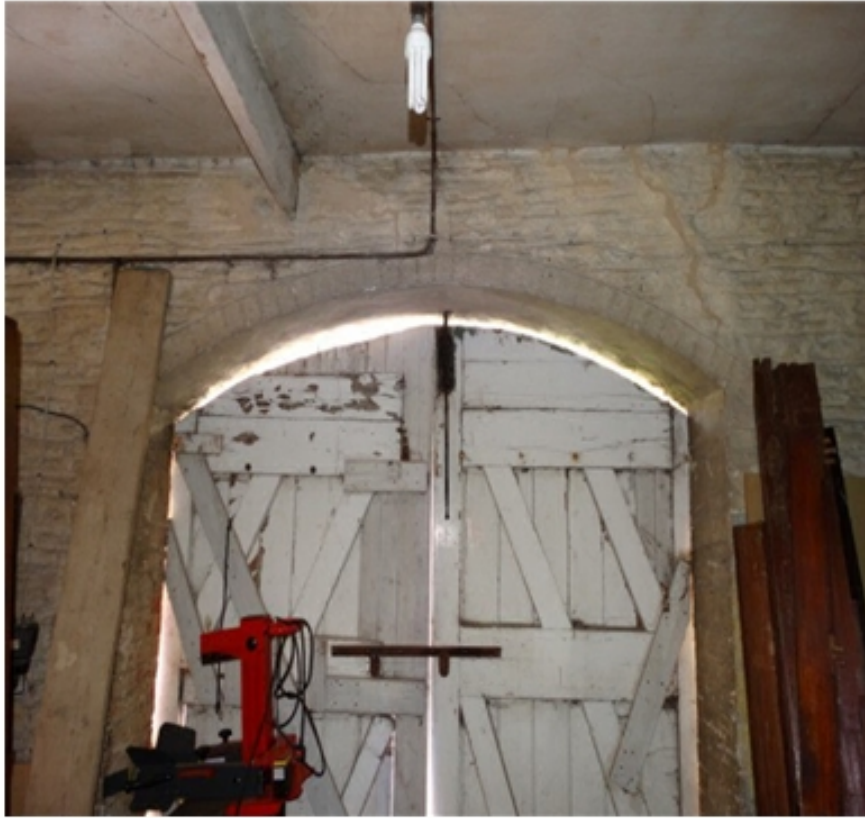
Plate 7 : Inside the Coach House : Double Doors...01.08.16.

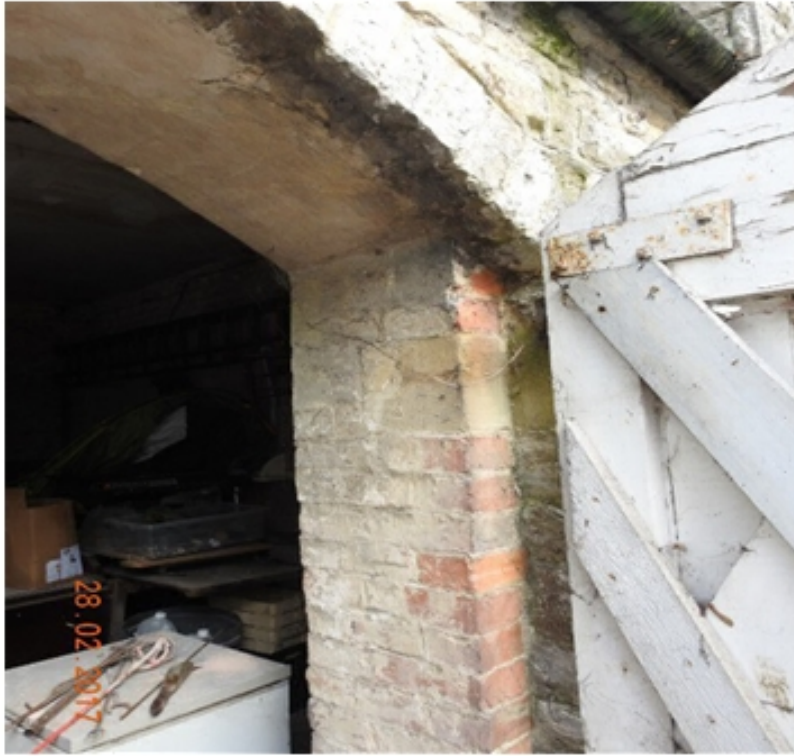
Plate 9 : Outside the Coach House double doors r.h. side rebate...28.02.17.

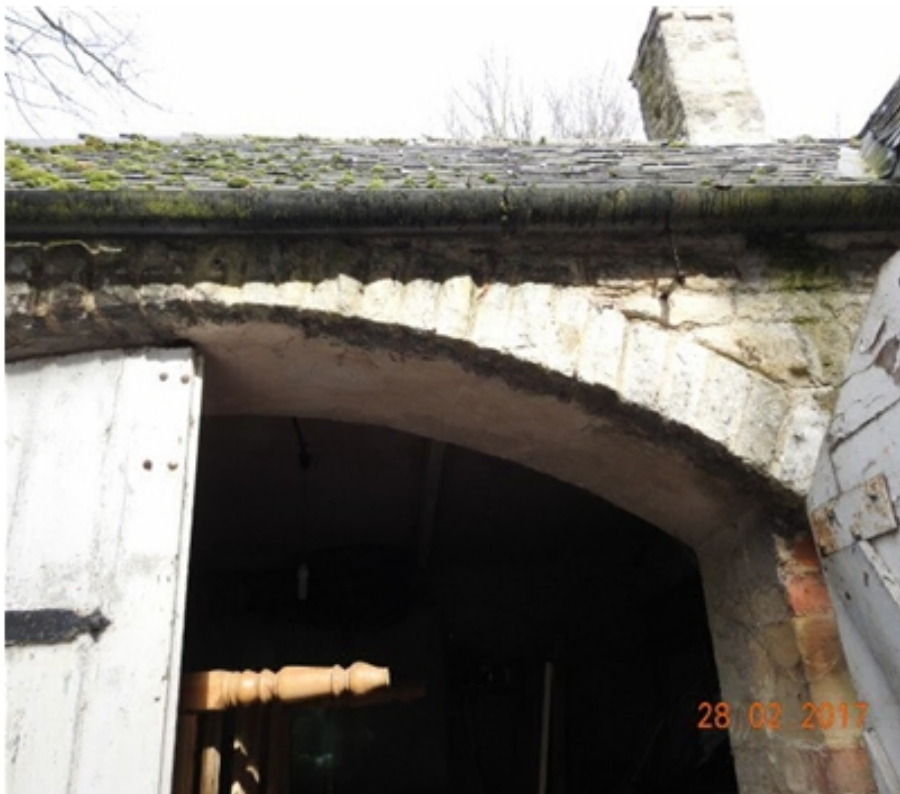
Plate10 : Outside the Coach House Double Doors r.h. Leaf...28.02.17.

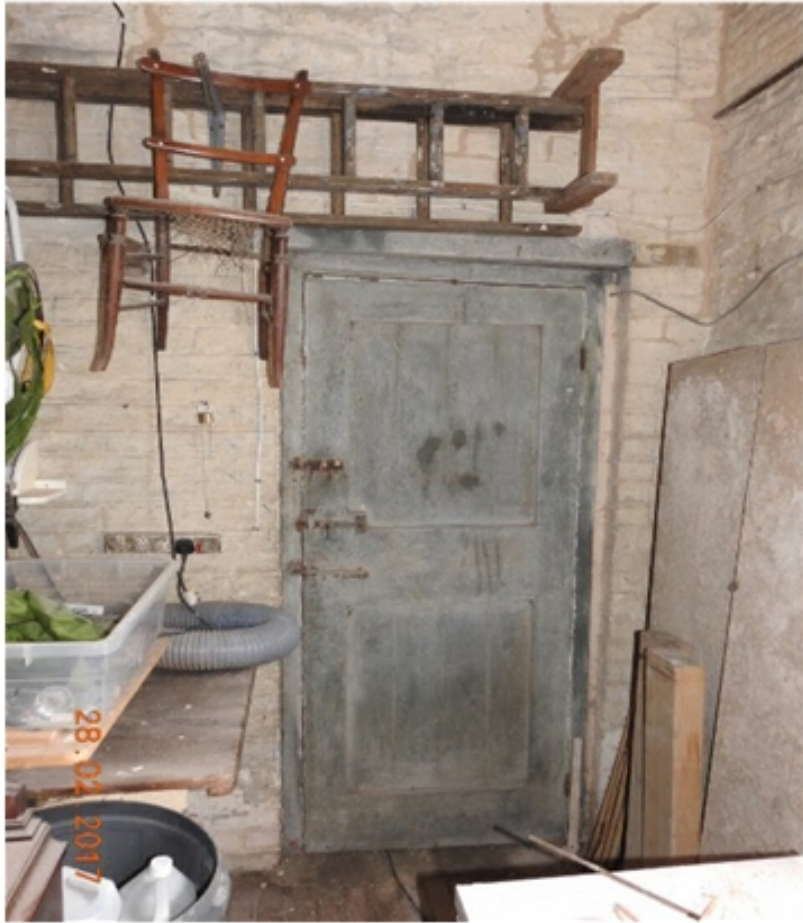
Plate 11 : Coach House inside east wall : hand door...28.02.17.

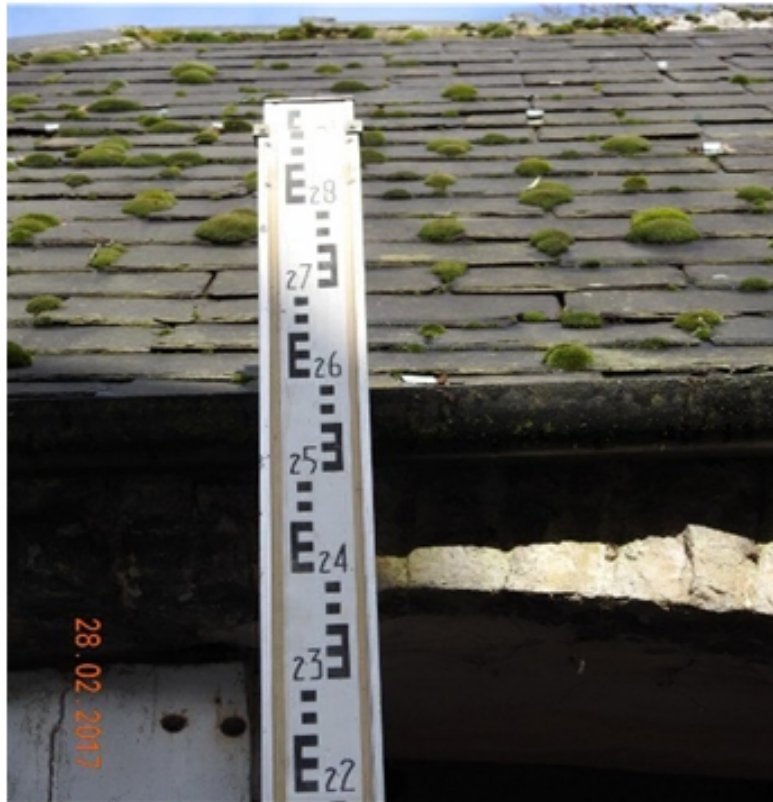
Plate 13 : Coach House eaves height on centre-line of double doors : 2.6 metres...28.02.17.

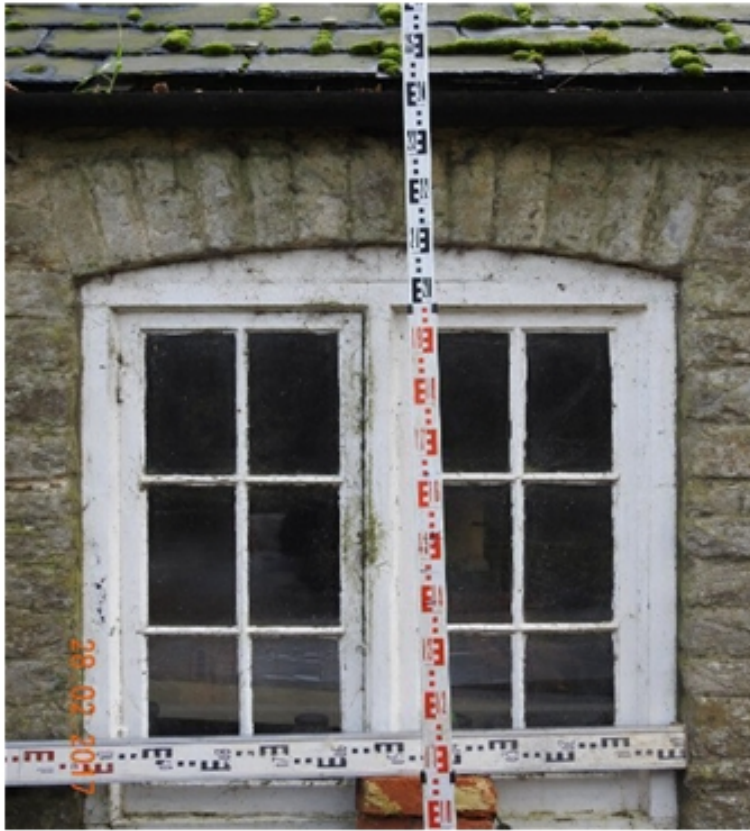
Plate 15 : Outside the Coach House west window.....28.02.17.

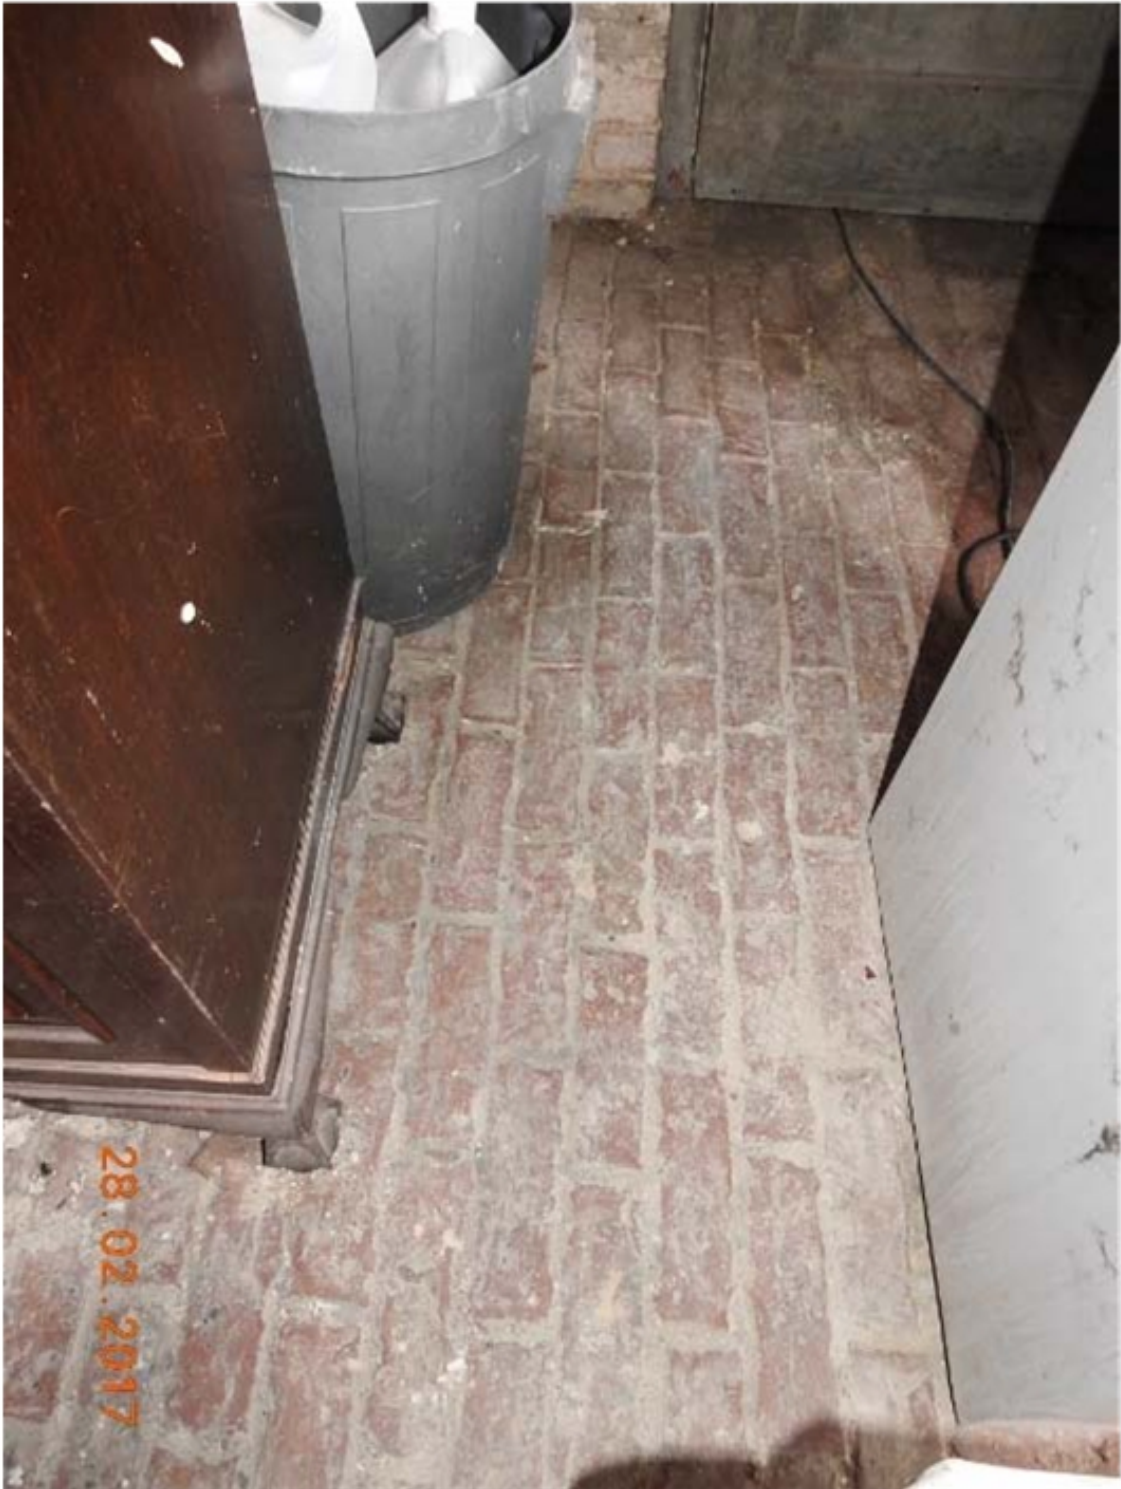
Plate 17: Coach House Floor

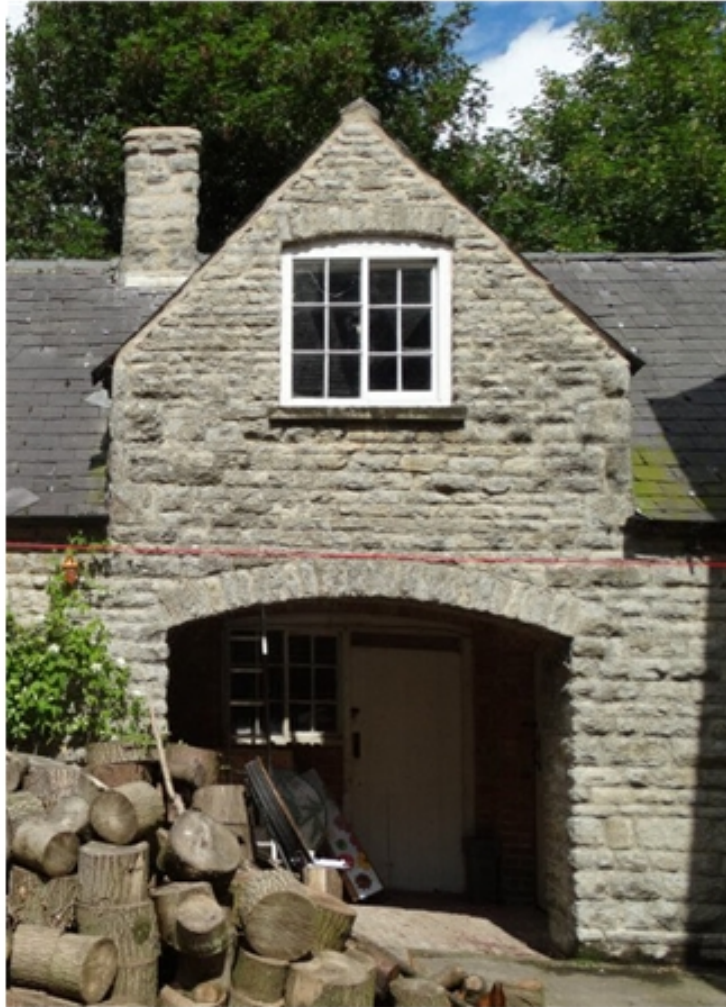
Plate 18 : Saddlery entrance and lobby : south side under Hayloft...01.08.16.

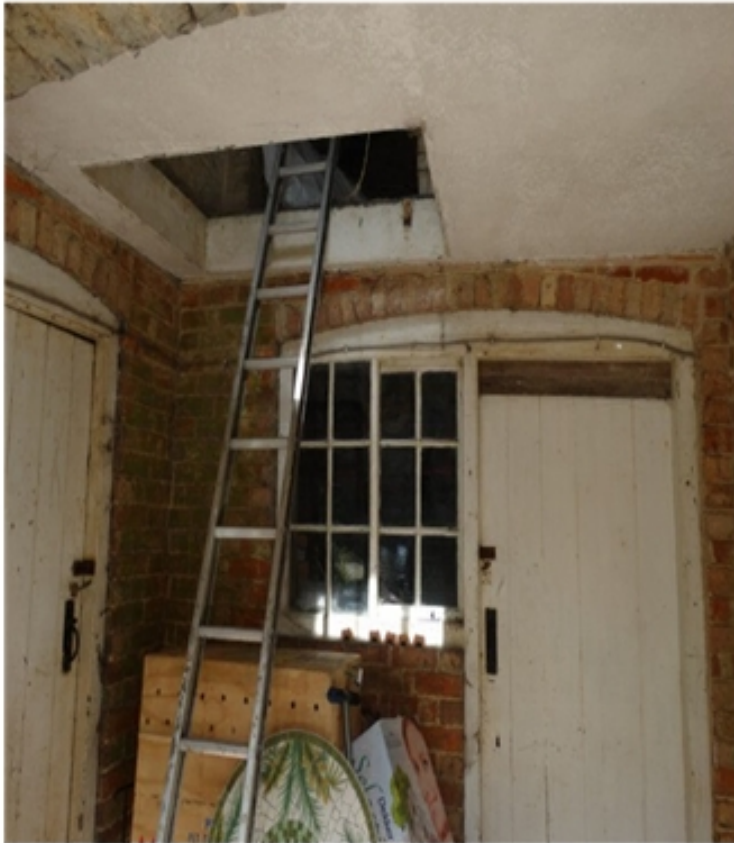
Plate 20 : Outside the south -facing Saddlery entrance screen...01.08.16.

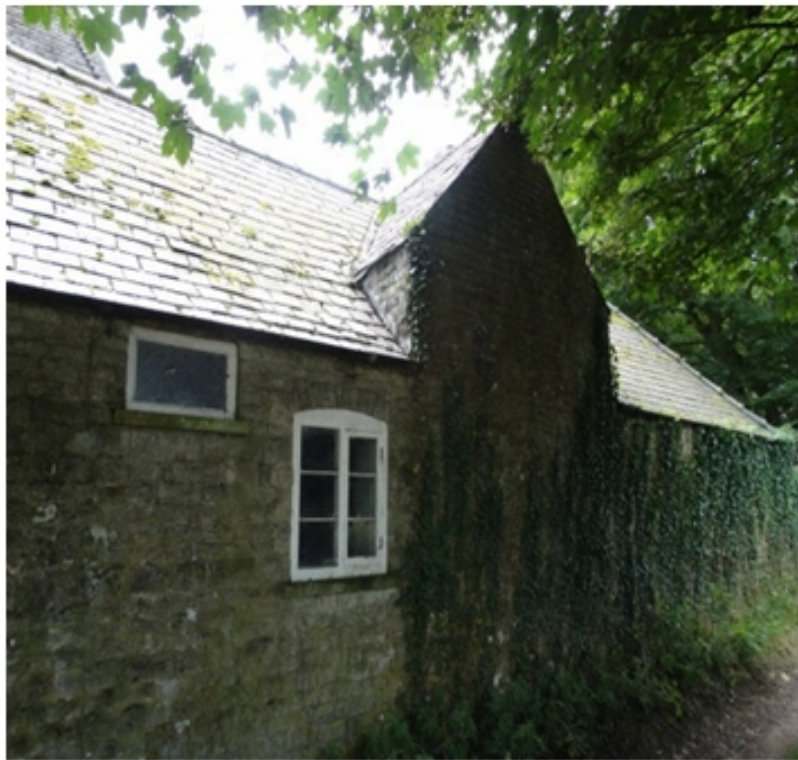
Plate 21 : Outside the Saddlery north-facing wall...01.08.16.

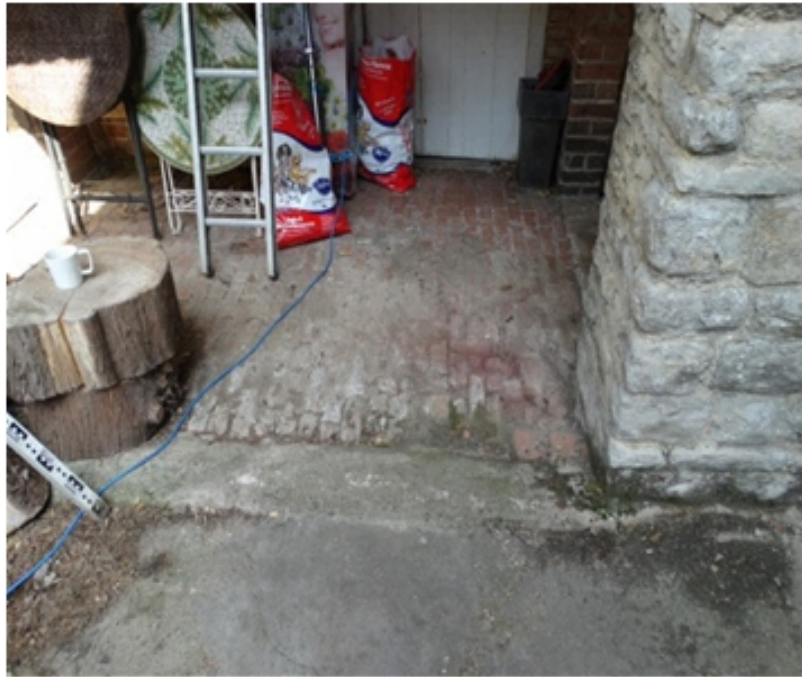
Plate 22 : Lobby/Entrance to Saddlery : outside south side : 24.08.16.

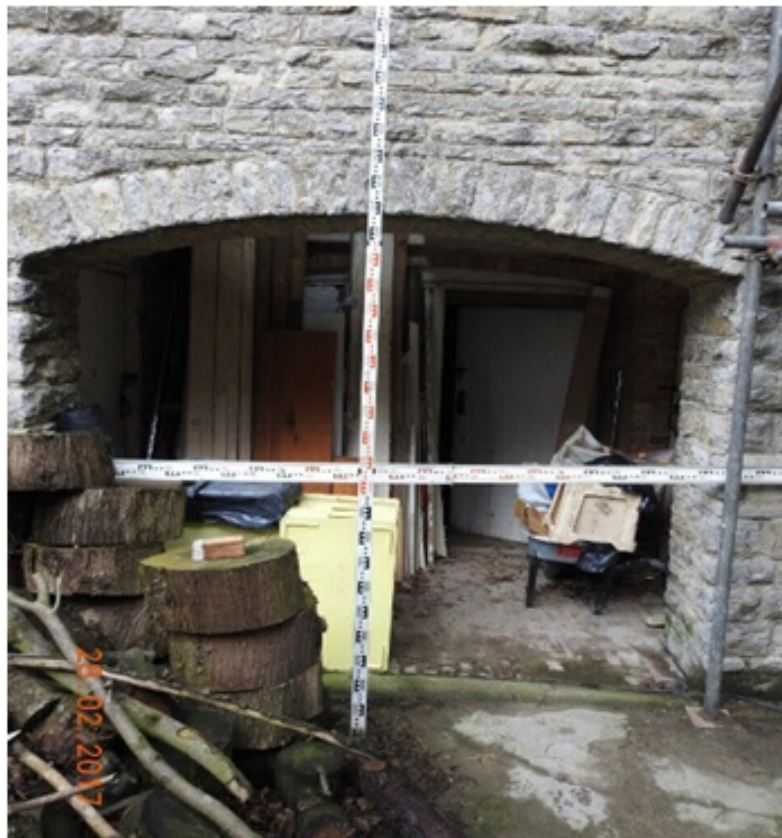
Plate 23 : Outside the Saddlery Entrance Lobby : 28.02.17.

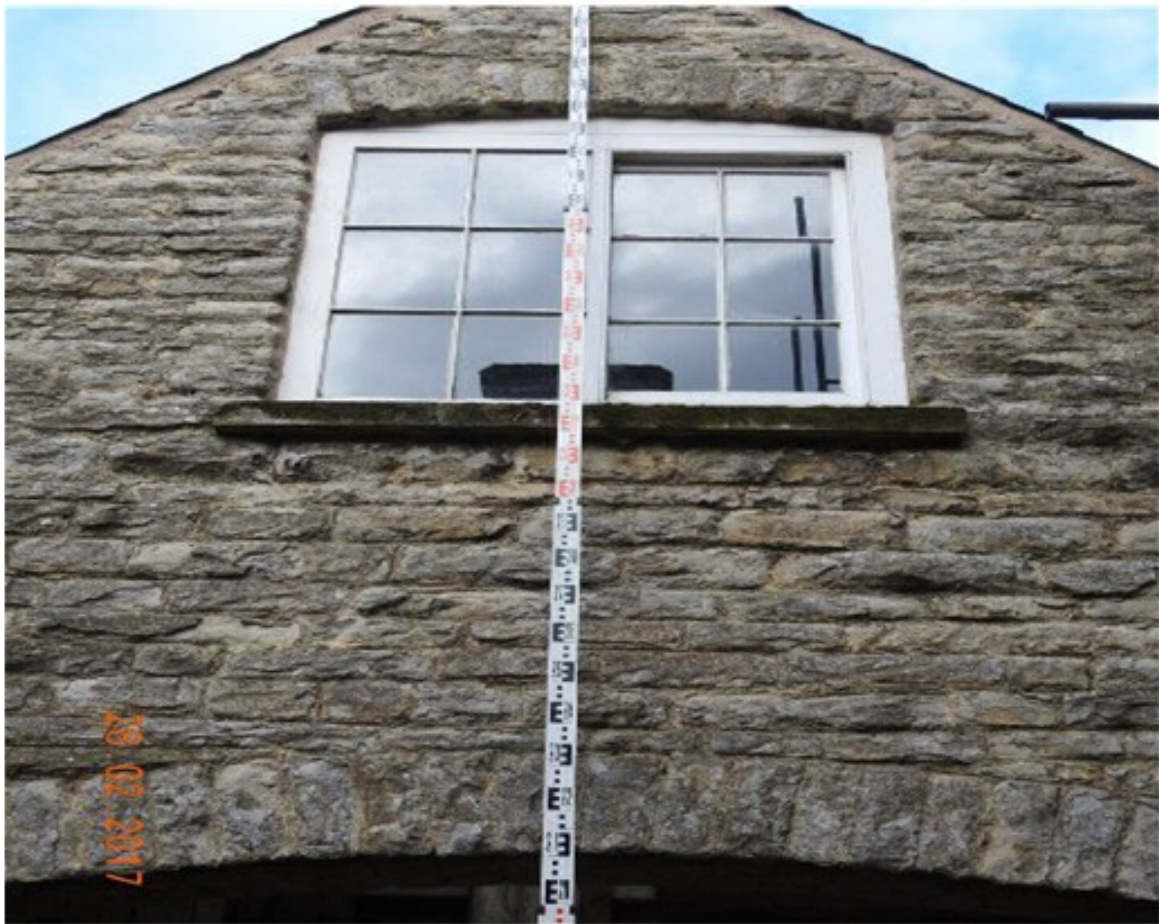
Plate 24 : Outside height of entrance lobby opening to Saddlery south side : 28.02.17. (2.1 m.)

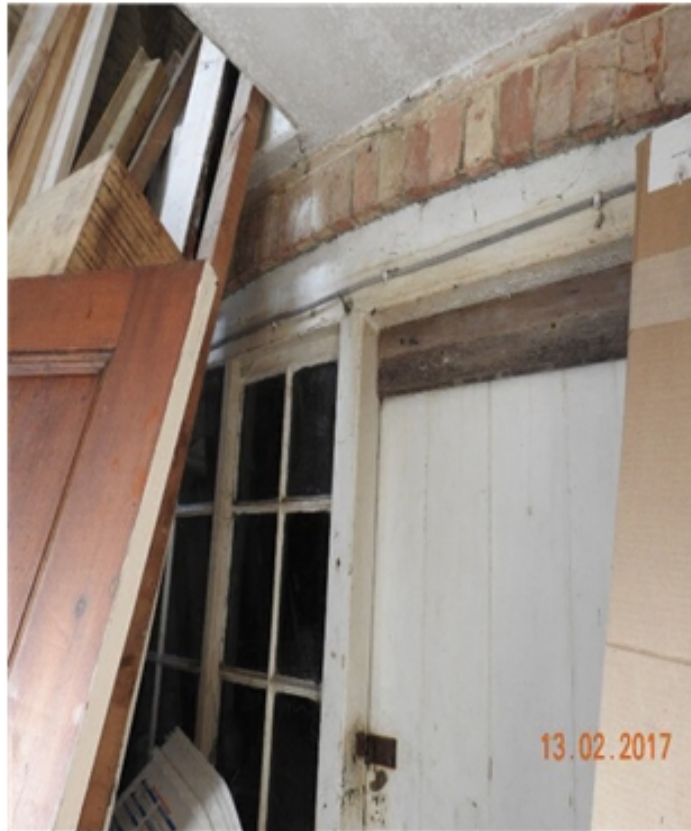
Plate 26 : Outside the saddlery screen (south side) :13.02.17.

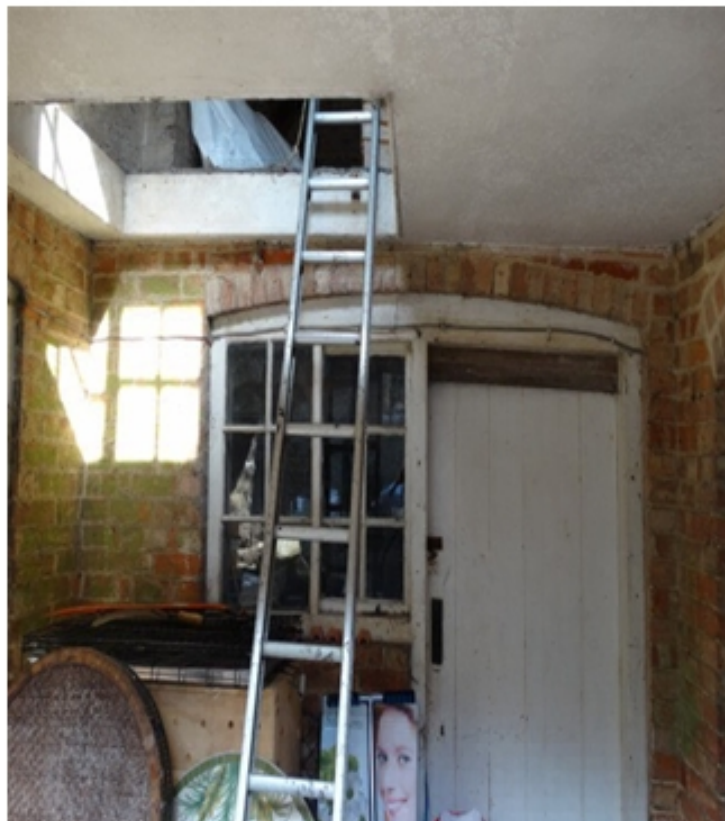
Plate 27 : Outside the south side of the Saddlery Entrance screen : 24.08.16.

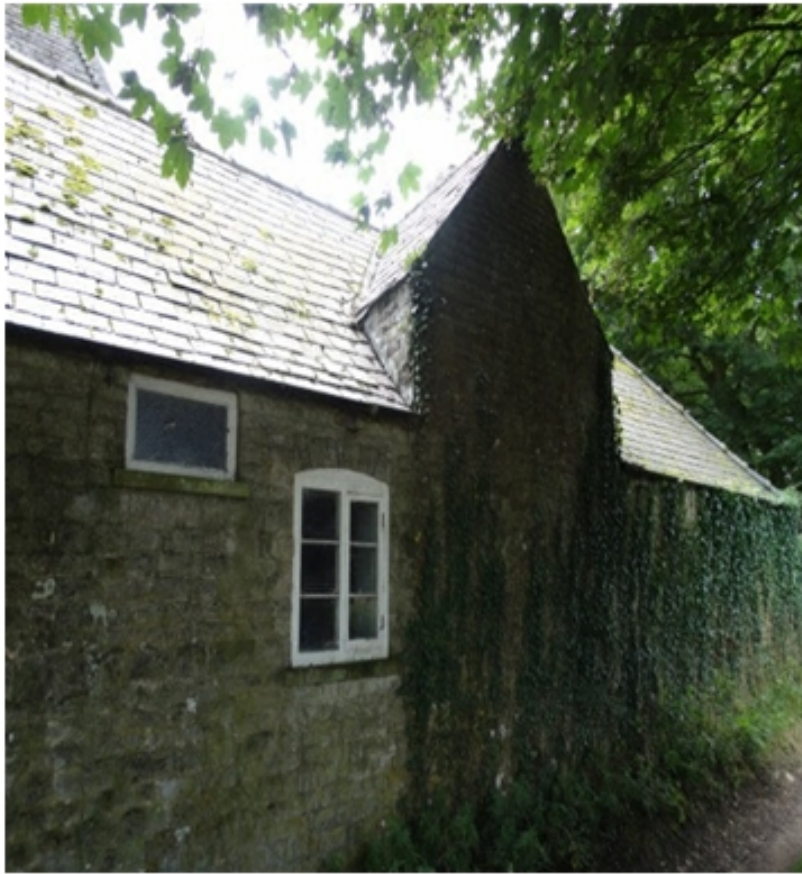
Plate 30 : Outside the North side of the Hayloft : 01.08.16.

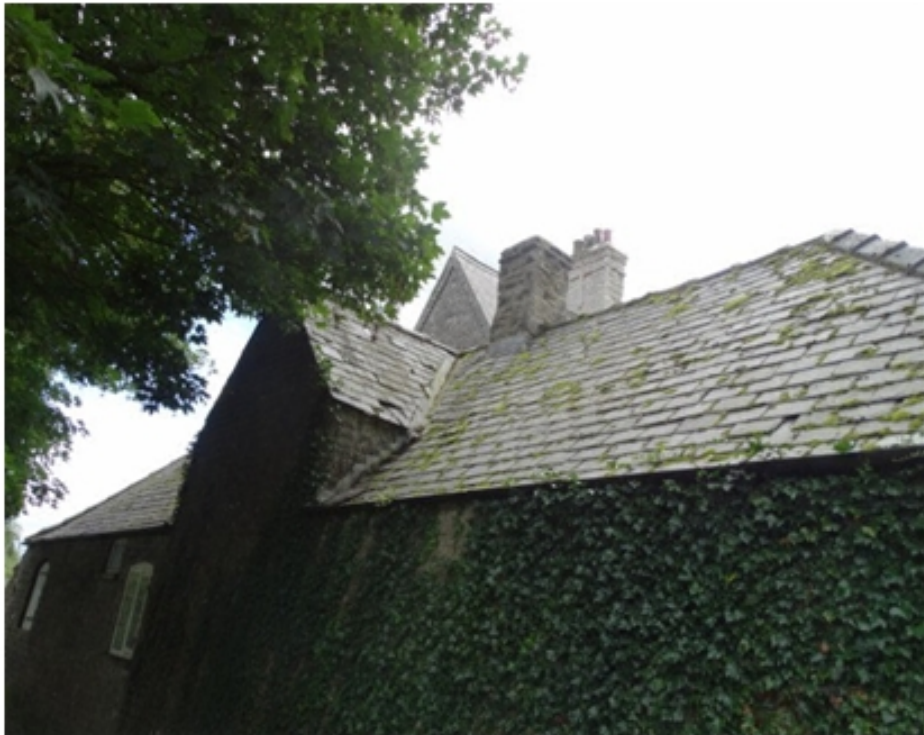
Plate 31 : outside the north facing side of the Hayloft : 01.08.16.

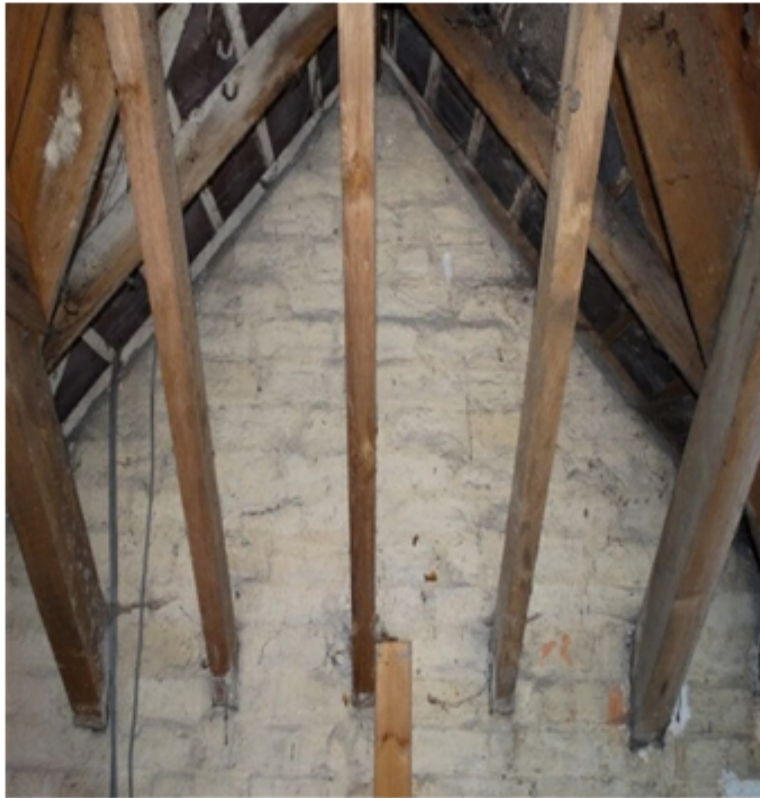
Plate 32 : Inside the Hayloft : west facing wall roof timbers : 24.08.16.

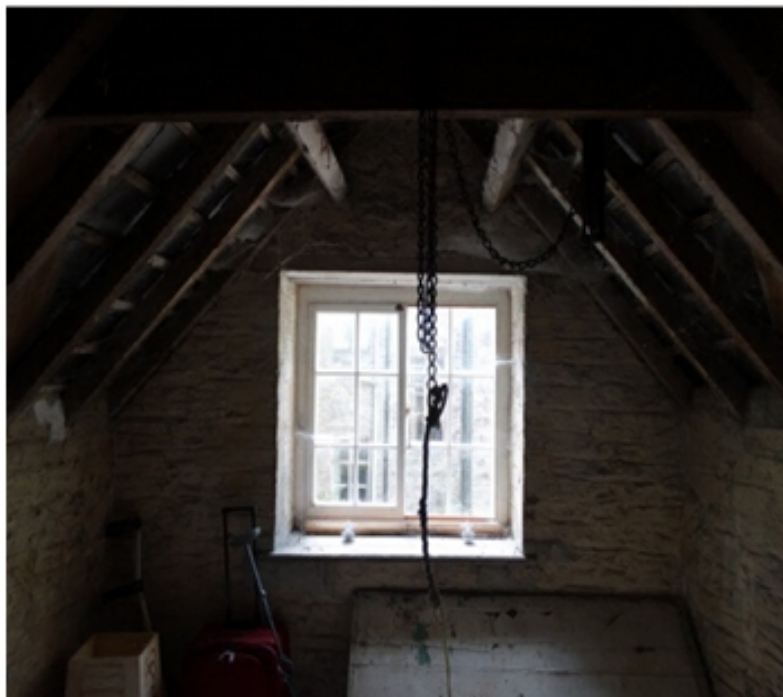
Plate 33 : inside the hayloft looking at the south facing wall window.

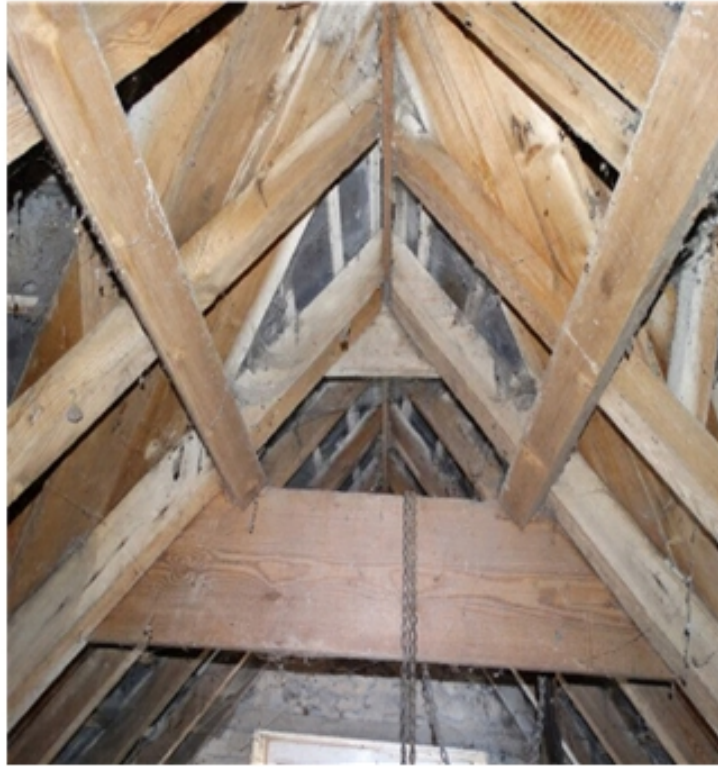
Plate 34 : Inside the Hayloft looking south, showing the valley boards and main ties : 24.08.16.

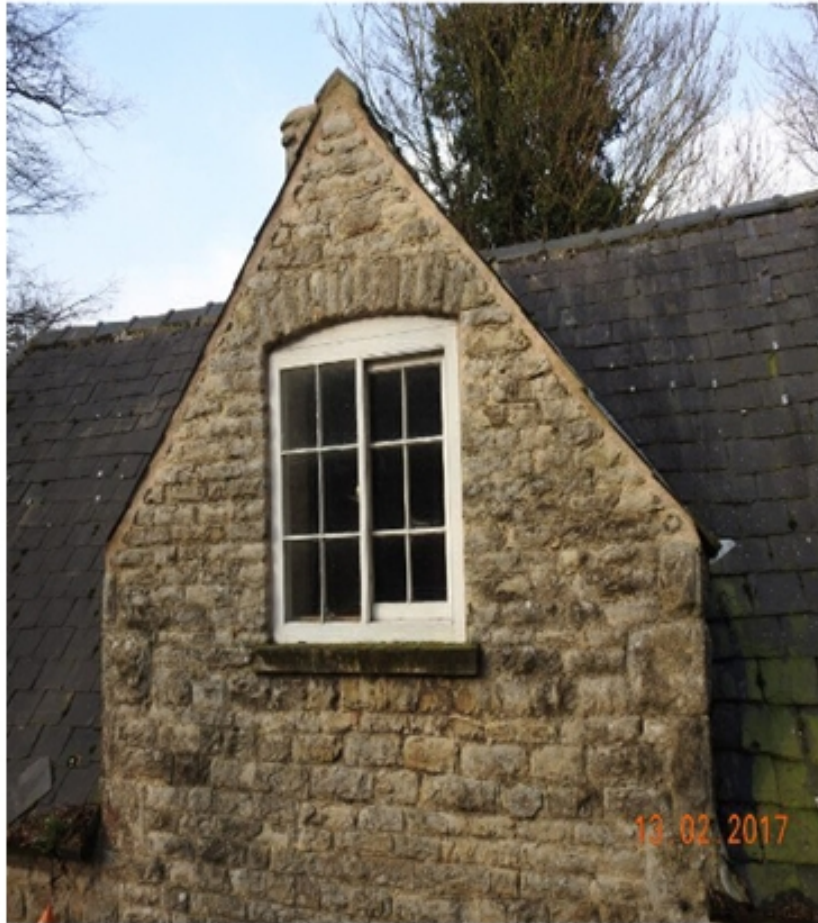
Plate 36 : Hayloft South Side window : 13.02.17.

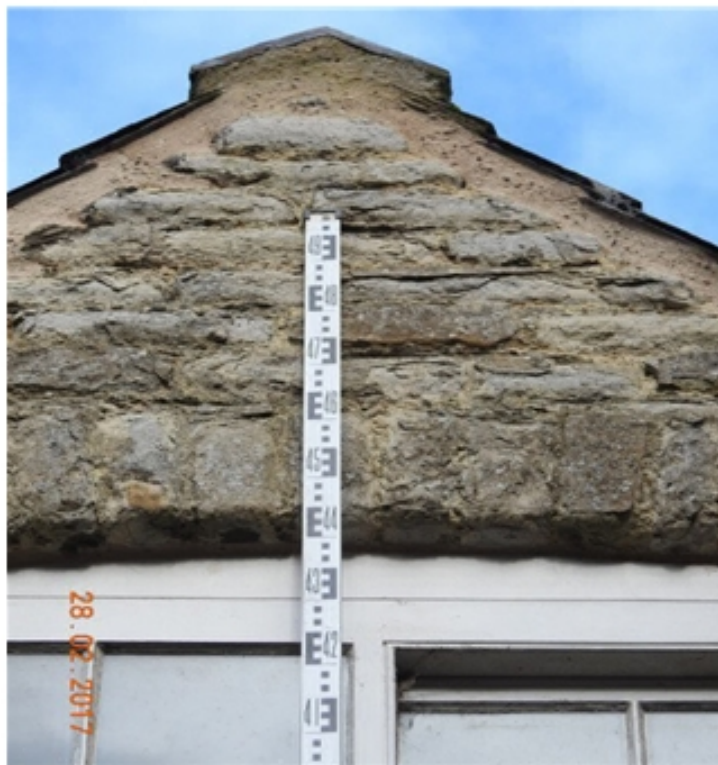
Plate 39 :Height of Hayloft south - facing window above ground level = 4.45 metres : 28.02.17

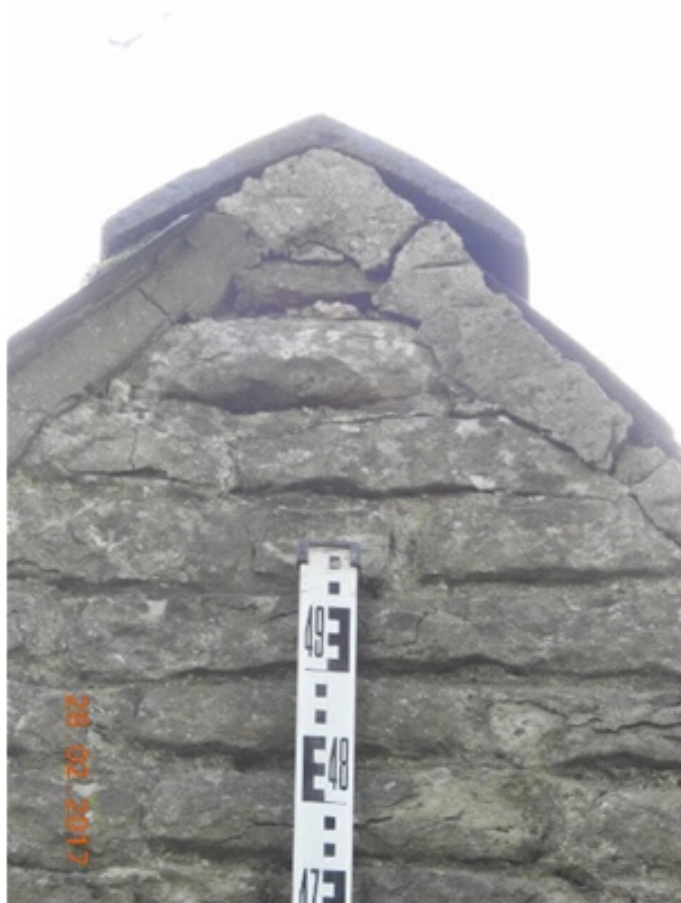
Plate 40 : Height of Hayloft on north facing outside wall =5.4 metres above ground level :
28.02.17.

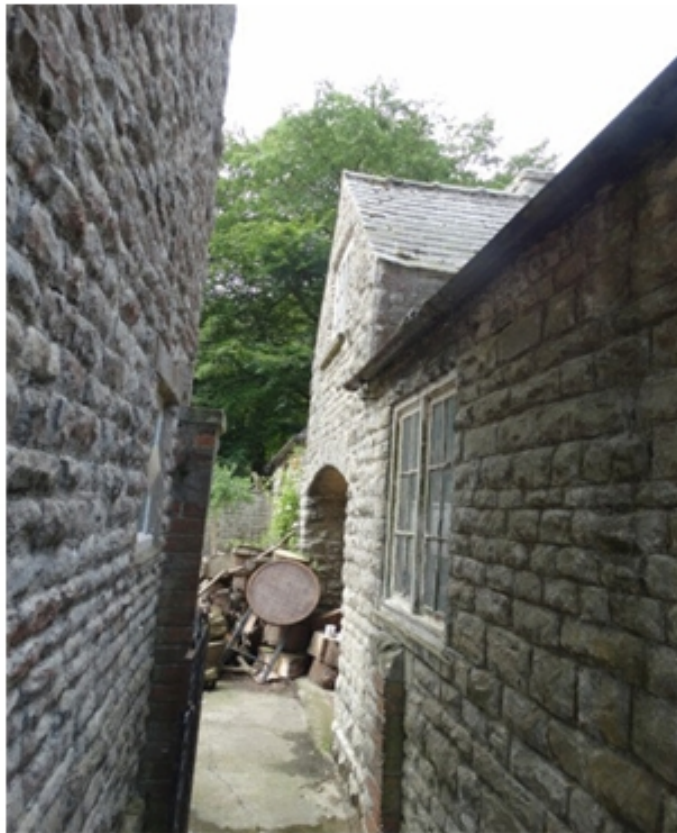
Plate 42 showing south wall of Stables looking west at window...01.08.16.

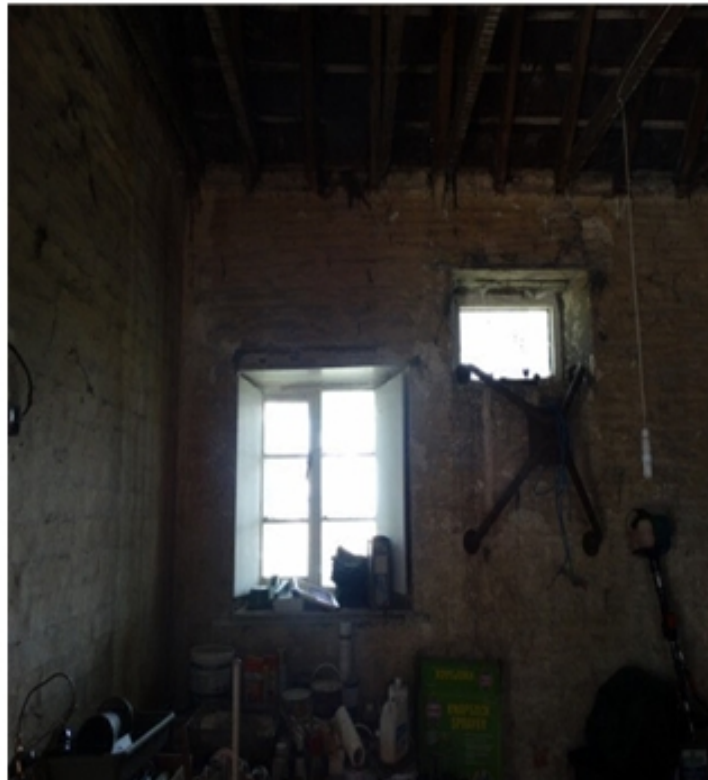
Plate 44 inside the Stables looking north showing the windows : 01.08.16.

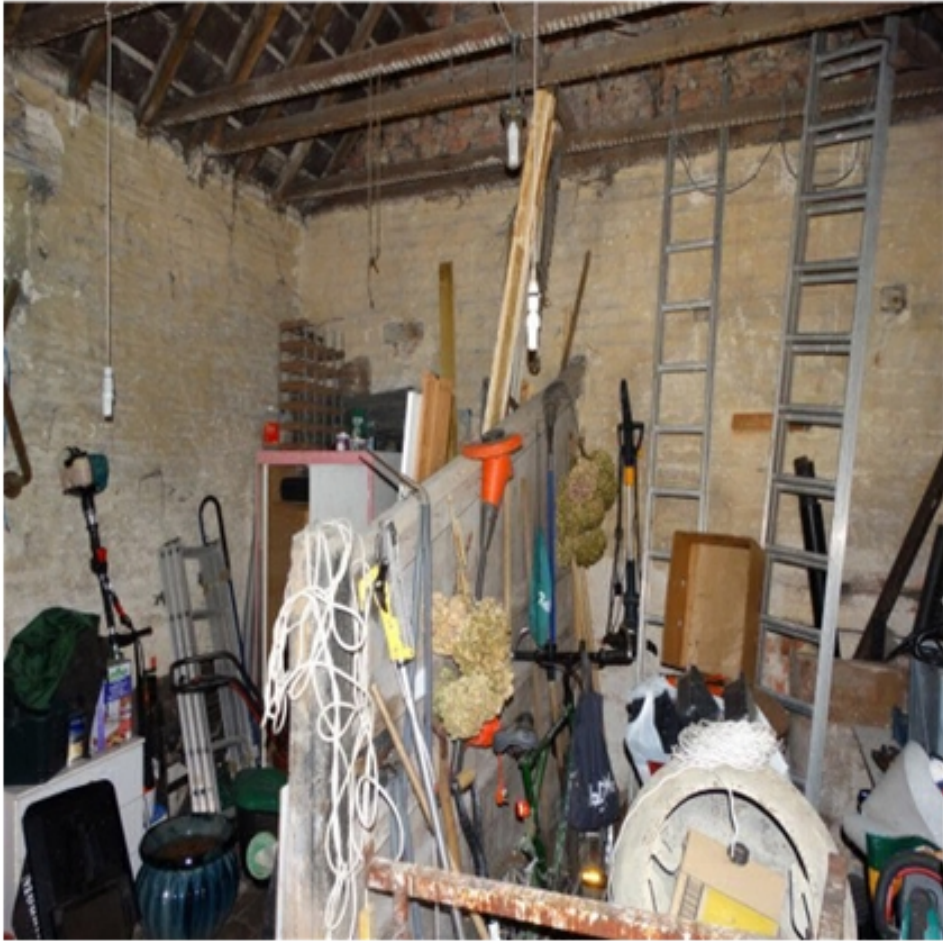
Plate 45 : inside the Stables looking east showing the stall divider : 01.08.16
