A Report prepared for Mr. R. Bailey

HISTORIC BUILDING RECORDING AT DETACHED COACH-HOUSE , THE
OLD RECTORY, CHURCH ROAD, WADDINGHAM, GAINSBOROUGH,
LINCOLNSHIRE (Grade 2 Listed Building)

BBS Report No. : BBS/HBR/RB 1/17.

DETACHED COACH-HOUSE AT THE OLD RECTORY,
CHURCH ROAD, WADDINGHAM, GAINSBOROUGH, LINCOLNSHIRE.

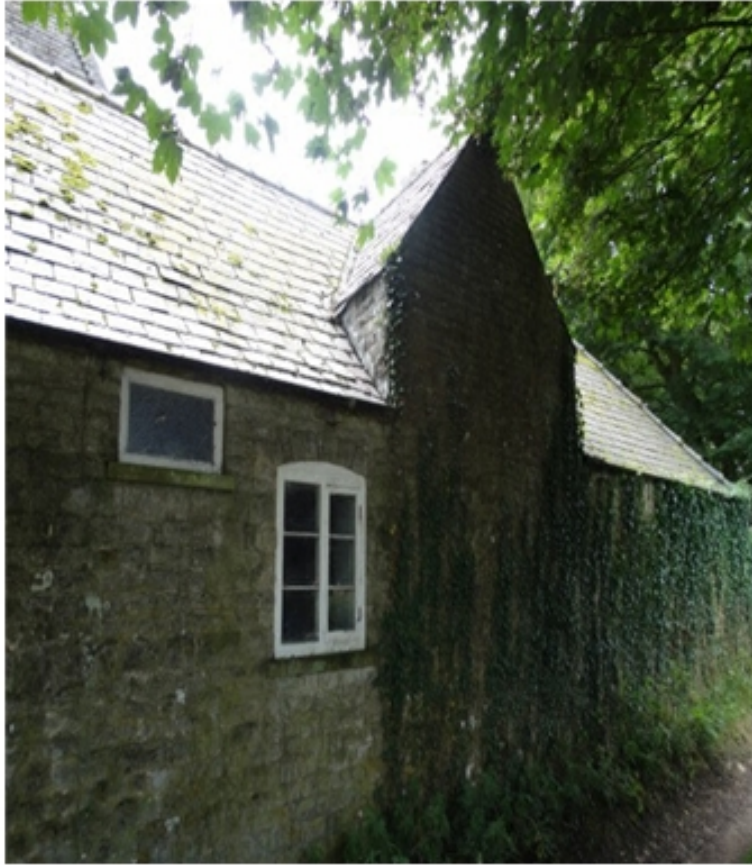
Plate 47 outside the Stable north side showing the 2 windows : 01.08.16.

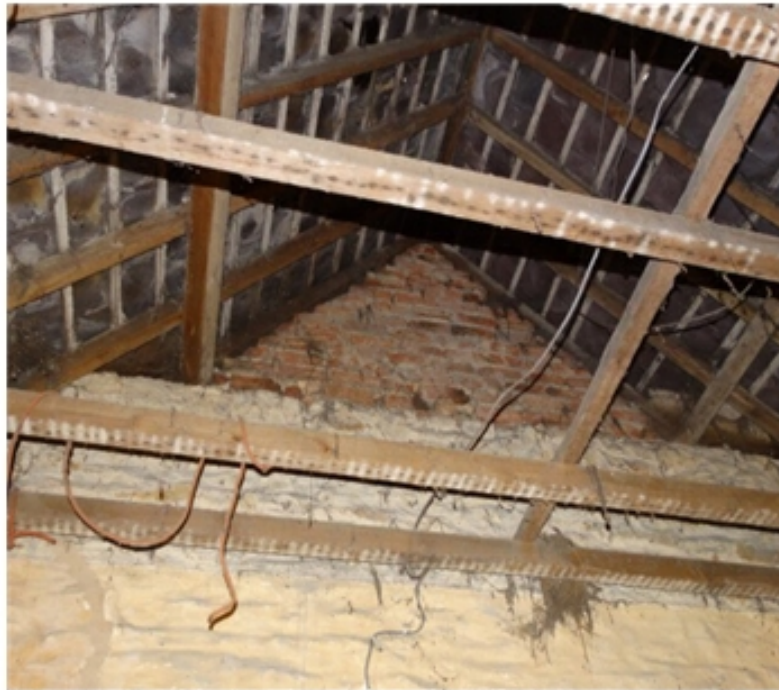
Plate 48 inside the Stables showing the east internal dividing wall and roof timbers looking towards the hayloft

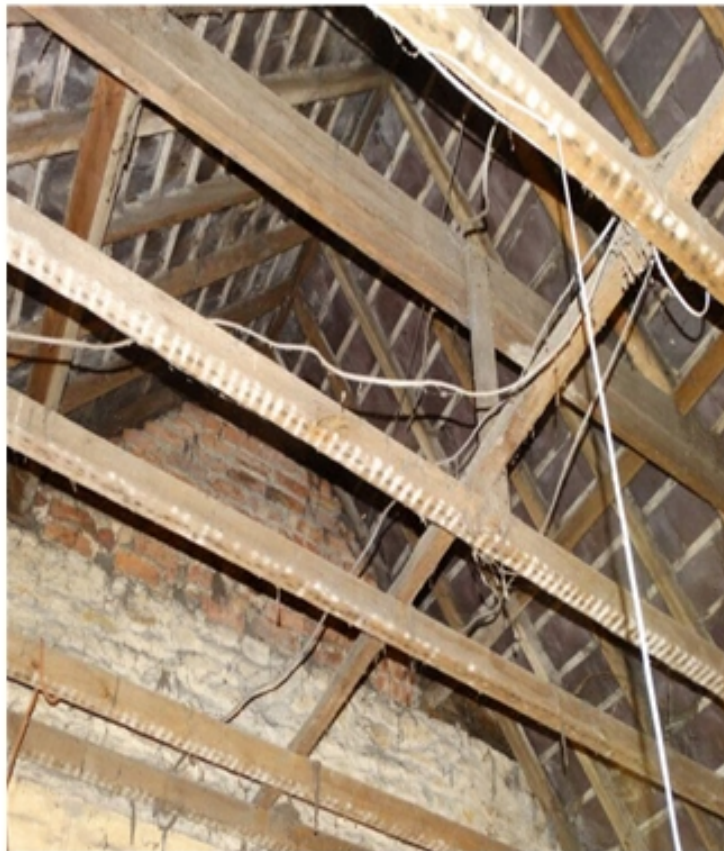
Plate 50 inside the Stables looking at the roof timbers and west side division wall..24.08.16.

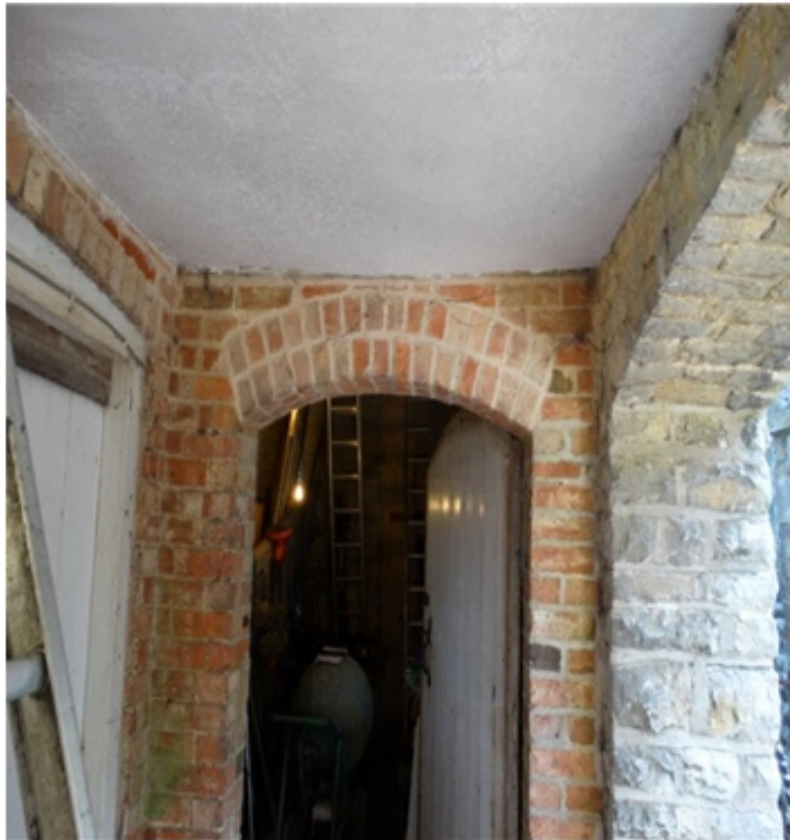
Plate 51 showing the entrance door to the Stables from the lobby...24.08.16.

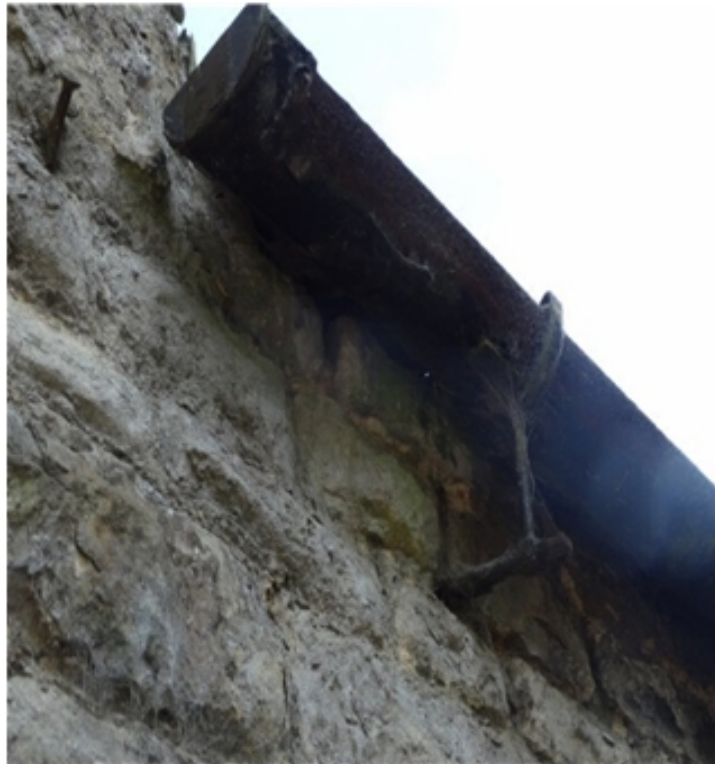
Plate 53 outside the south wall of the Stables showing the cast-iron gutter and brackets...24.08.16.

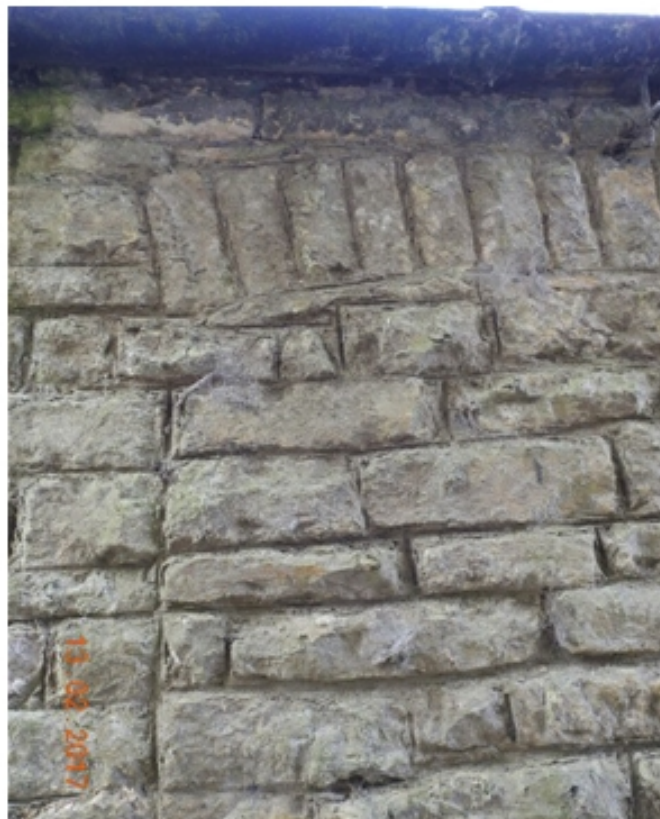
Plate 54 outside Stables south wall showing former window opening and arched lintel...13.02.17.

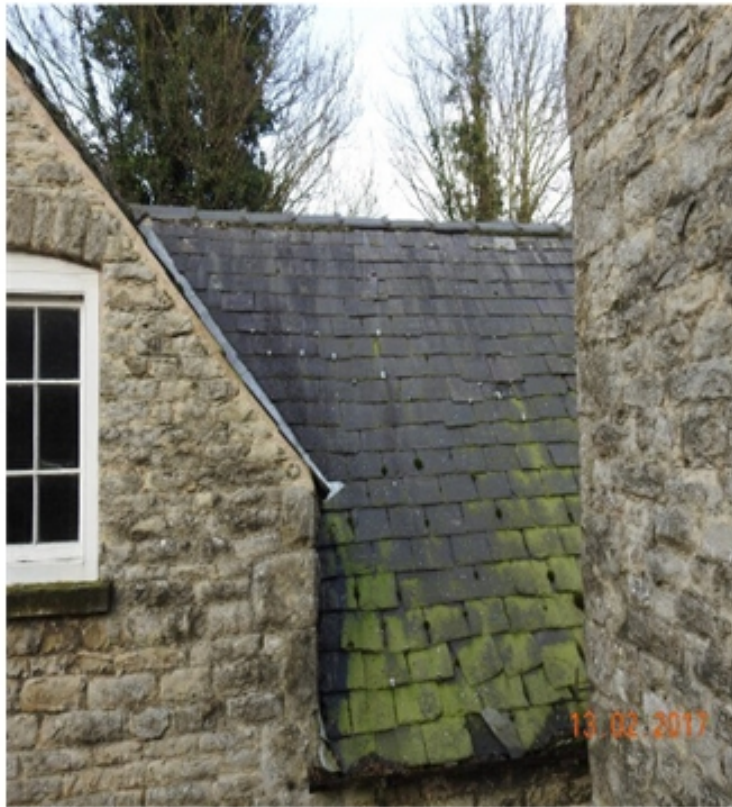
Plate 57 : Stables Roof at junction with Hayloft.....13.02.17

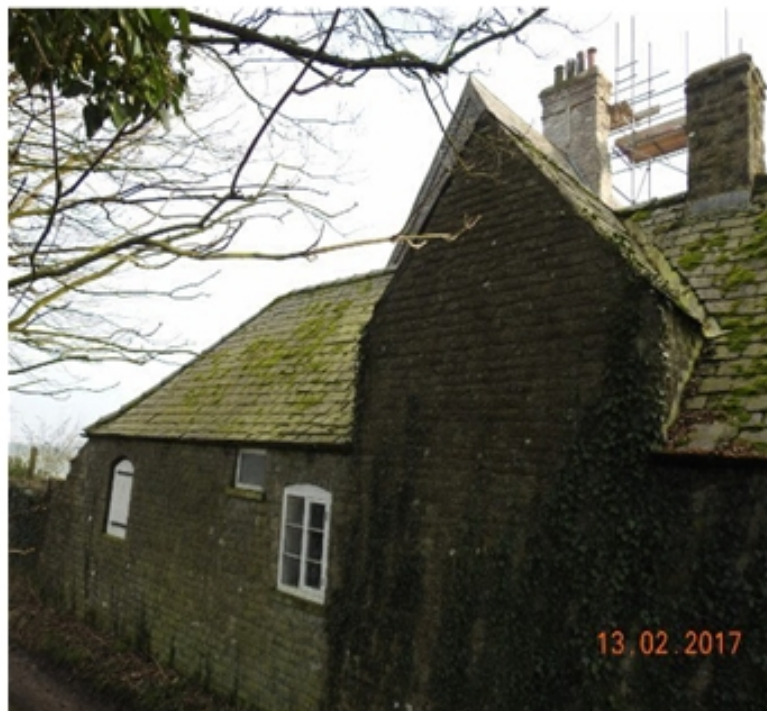
Plate 58 : Stables north facing roof from Carr Lane....13.02.17.

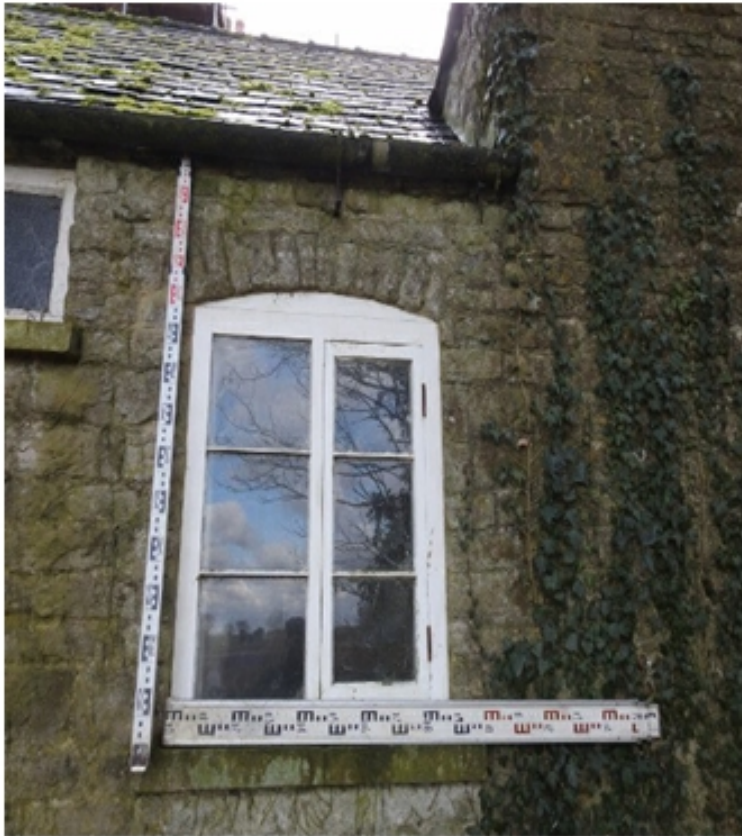
Plate 59 : Outside the north side of the Stables showing the main window....28.02.17.

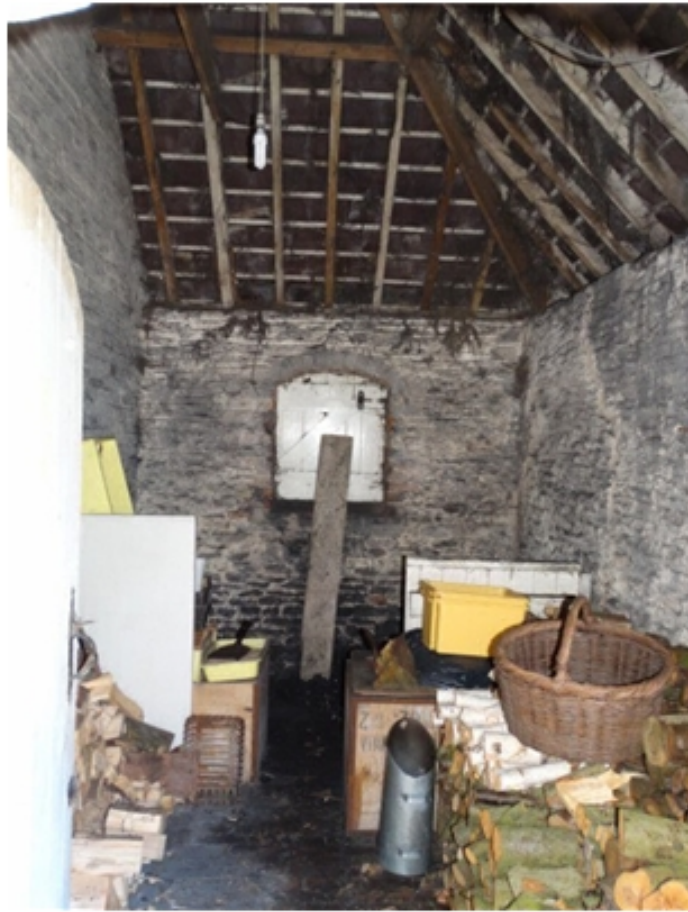
Plate 62 :Inside the Coal House looking at the north facing wall

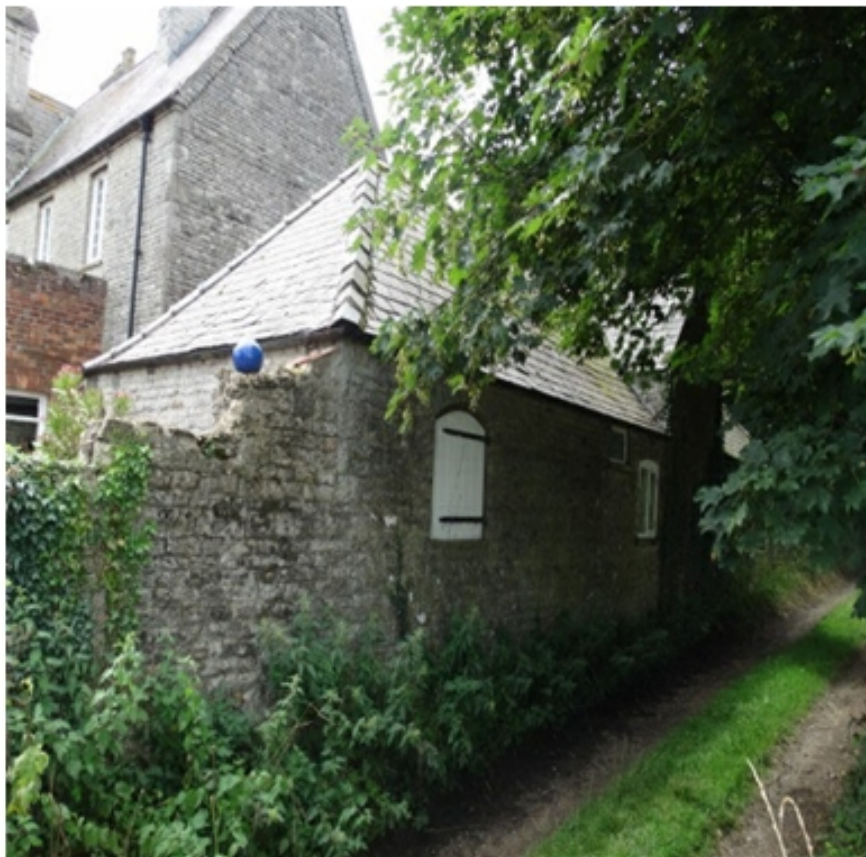
Plate 65 : north east corner of the Coal House adjacent to Carr Lane...01.08.16.

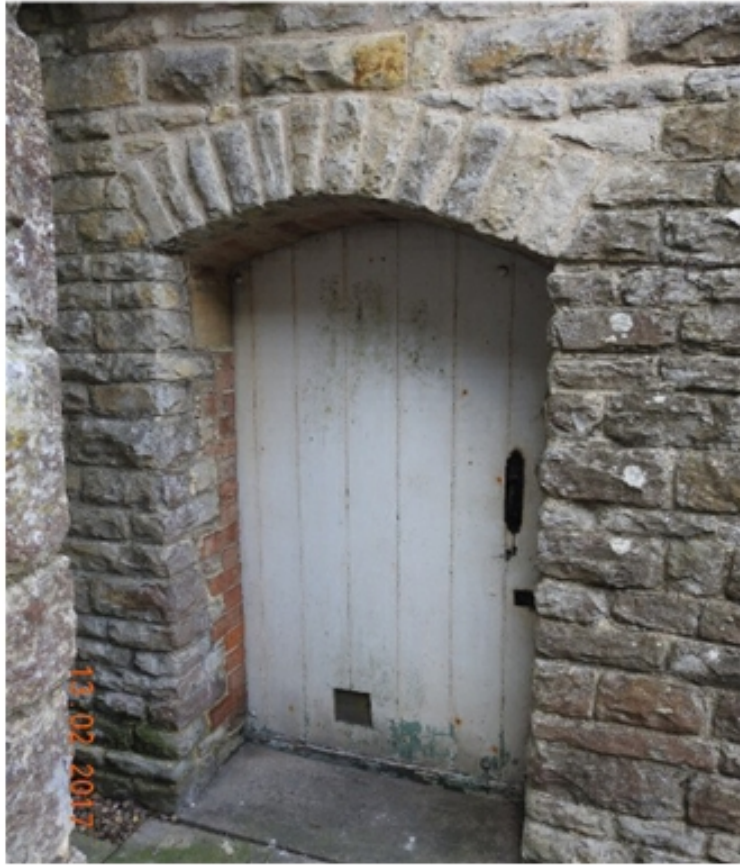
Plate 66 : outside the Coalhouse Entrance door (south wall)...13.02.17.

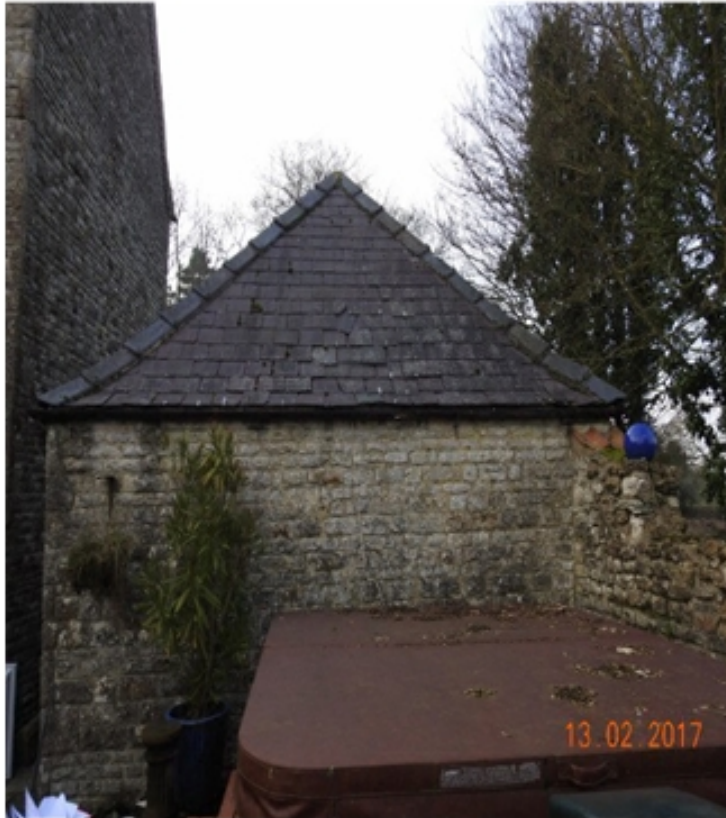
Plate 68 :East end of the Coalhouse...13.02.17.

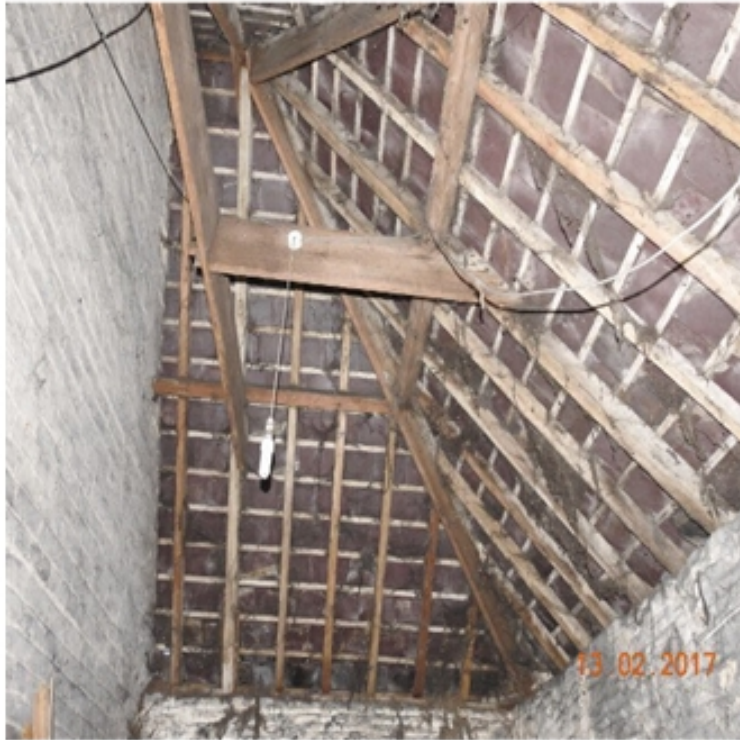
Plate 70 :inside the Coalhouse looking at the roof hipped end timbers....13.02.17.

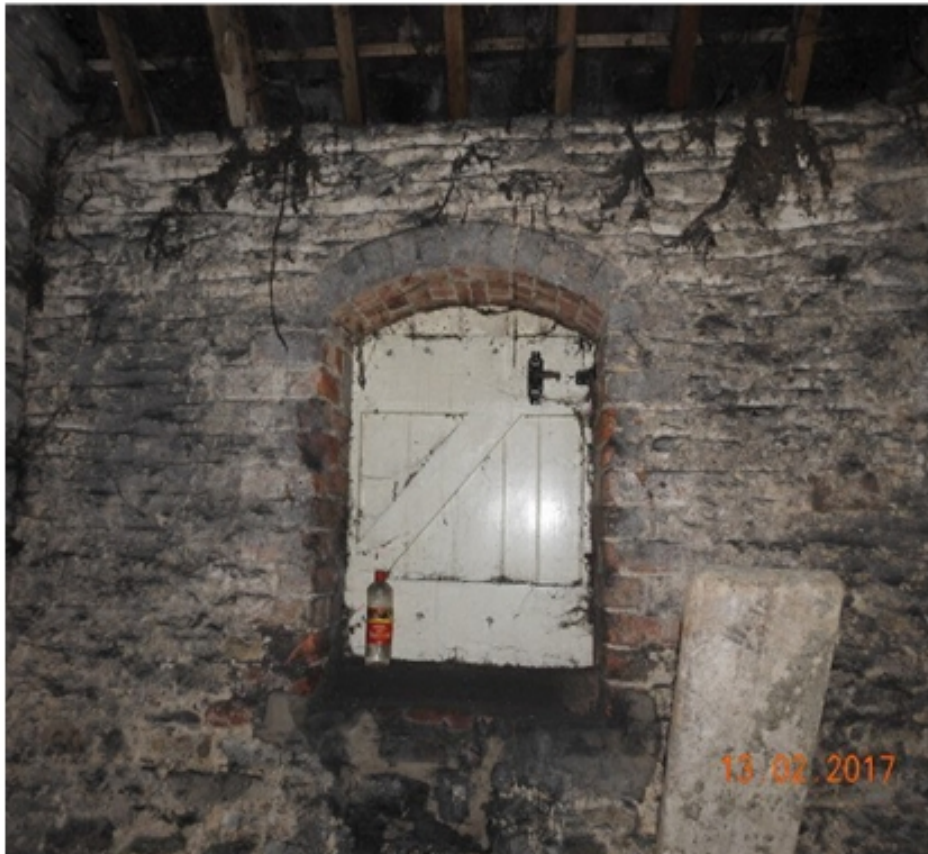
Plate 72 inside the Coalhouse looking north at the loading flap...13.02.17.

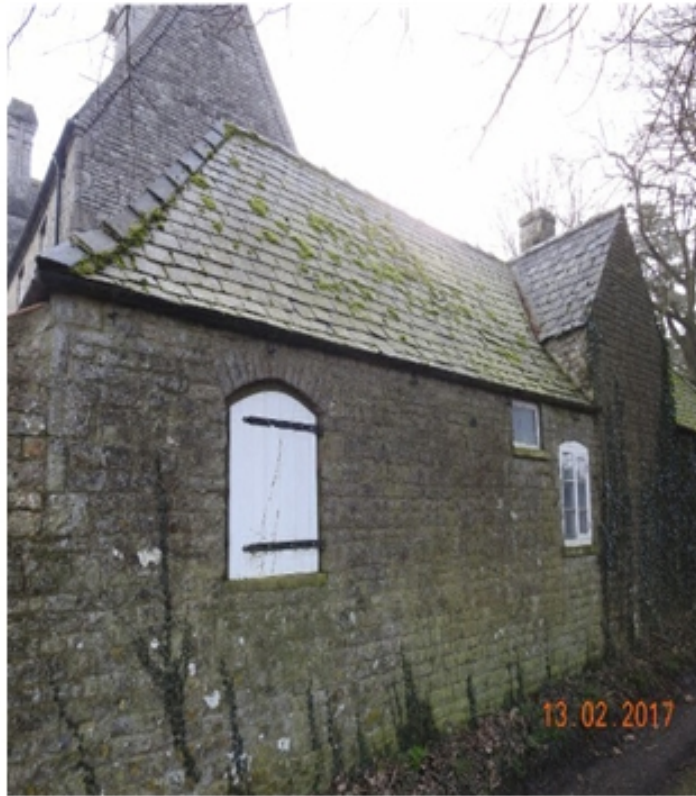
Plate 74 showing the north side adjacent to Carr lane loading flap door... 13.02.17.

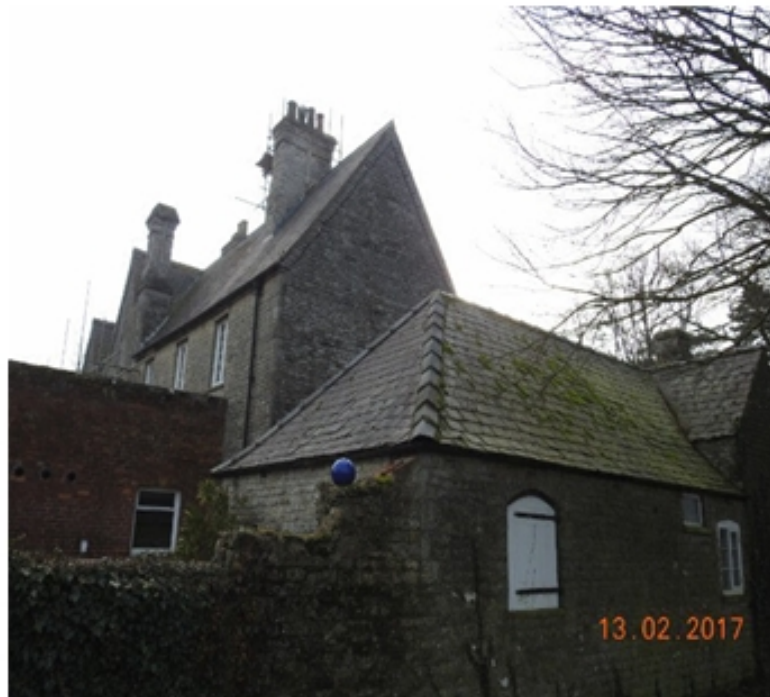
Plate 75 : north east corner of the Coalhouse adjacent to Carr Lane..13.02.17.

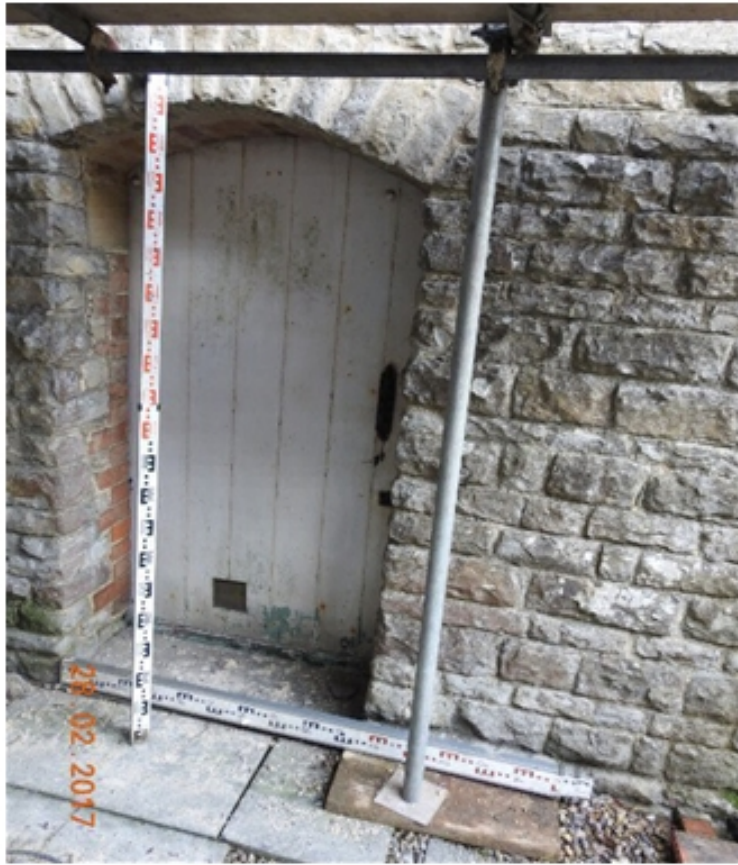
Plate 76 : Entrance to Coalhouse showing height and width (metric staffs)..02.03.17
