**Archaeological building recording and  
evaluation at Manor Farm Barn**

**7 Dychurch Lane, Bozeat, Northamptonshire**

Iain Soden BA MIfA

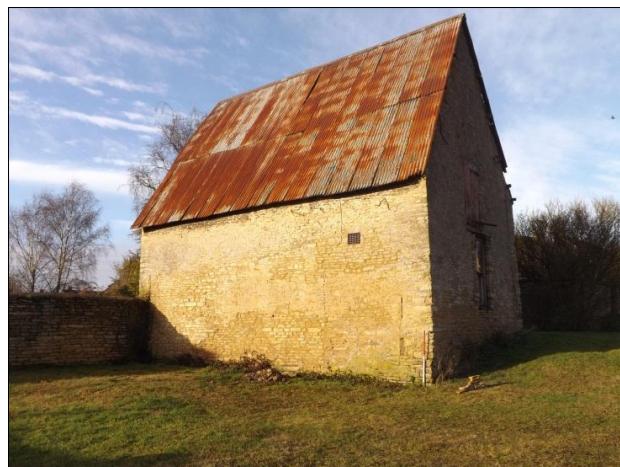
Fig 2: The bare and featureless south wall of the barn; scale 1m

The building began life as a crop barn, a single storage space open to the roof, which was and is supported on a single truss and principal rafter dividing it into two bays. This identification derives from the almost window-less south face (Fig 2). Such almost un-pierced walls were designed to stop the grain inside from being lit and warmed by the sun (which caused stored grain to sprout) and this configuration can be seen on barns and crop warehouses throughout the 17<sup>th</sup>- to the 20<sup>th</sup>-centuries (such as the just pre-World War I Southbridge rail depot warehouse, Northampton). Such buildings deliberately face away from the sunshine.

The only opening on the south is a tiny, inaccessible window under the eaves, which may have been an owl-hole. It has since been blocked in limestone although the blocking could not be inspected closely as the current first floor is unsafe.

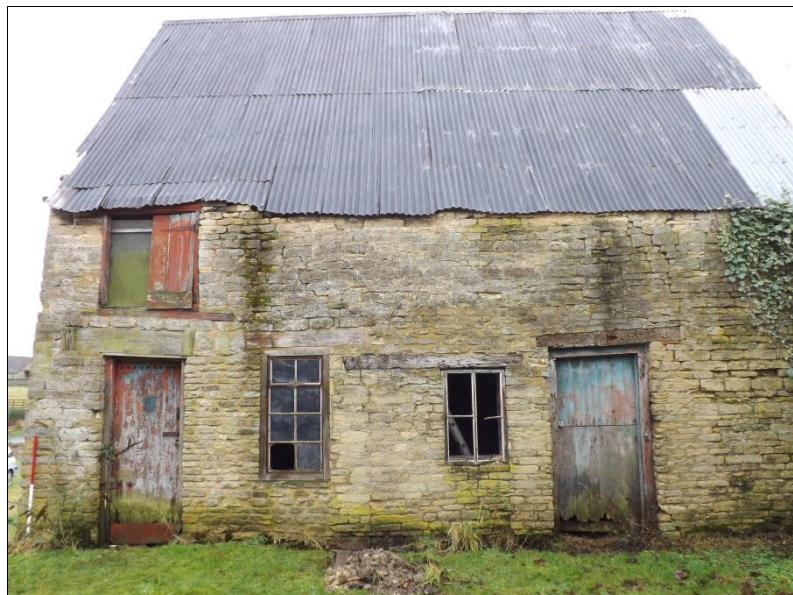
In the north wall stood the original entrance, a relatively low central doorway but wide enough to push a barrow or carry a sack through. This has since been blocked and today has a window in its blocking. The lintel remains in place but which has probably been shortened at the west due to later alteration and the insertion of a higher door to the right.

Fig 4: the barn, north wall

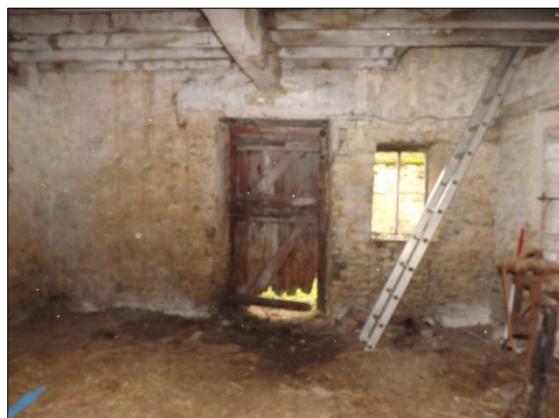
The stable was provided with windows in the west gable, and bars to prevent the horses putting their noses through the glass. A split stable door was put into the north wall. The gently-sloping floor was made of pebbles and water-worn cobbles and a drain-grille was incorporated into the foot of the new dividing wall, believed to connect to a soak-away outside (see The Excavations, below).

Fig 5: The northern stable door and blocking

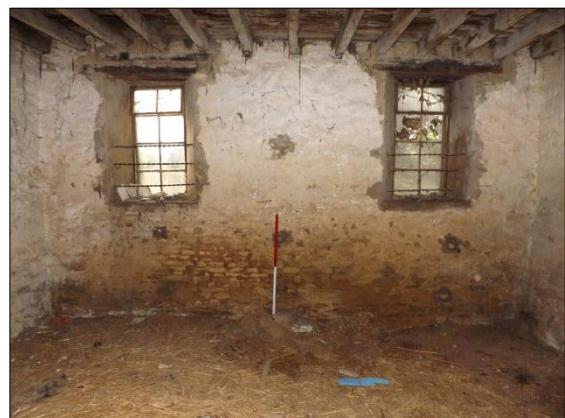
Fig 6: West gable windows and trough-marks

The stable probably supported two stalls for two or four horses in total. The mortices in the wall survive where both the feeding trough survived along the west wall was fixed, together with those for the travises which lined one stall on the south side and divided the two stalls, above the feeding trough. There is no evidence of former fixings for separate hay-baskets.

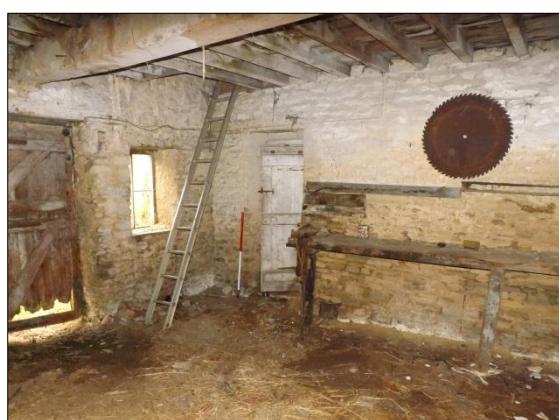
Fig 7: Dividing wall with drain at its foot

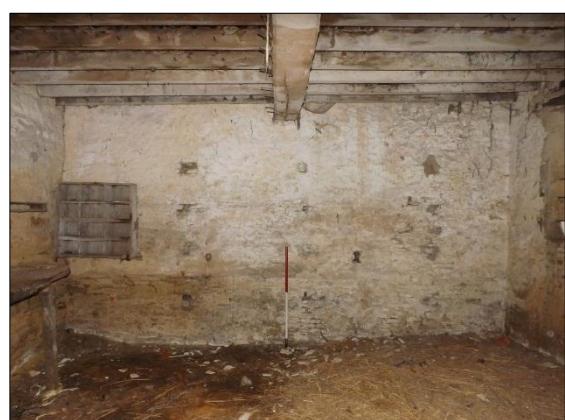
Fig 8: South wall, former travis-fixings

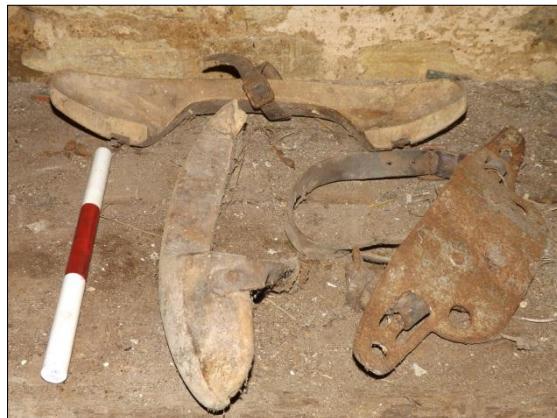
Fig 9: Yoke and harness parts in the stable; scale 300mm

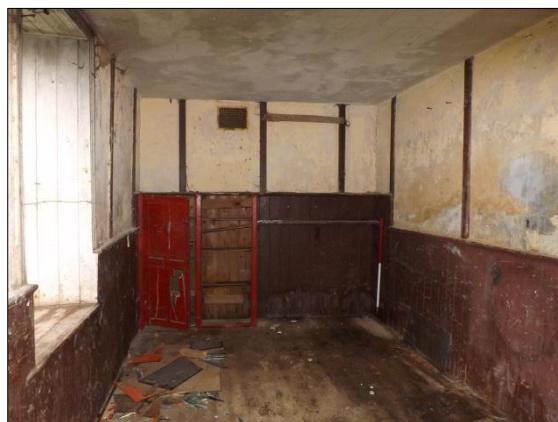
Fig 10: Office/tack-room, view south; scale 1m

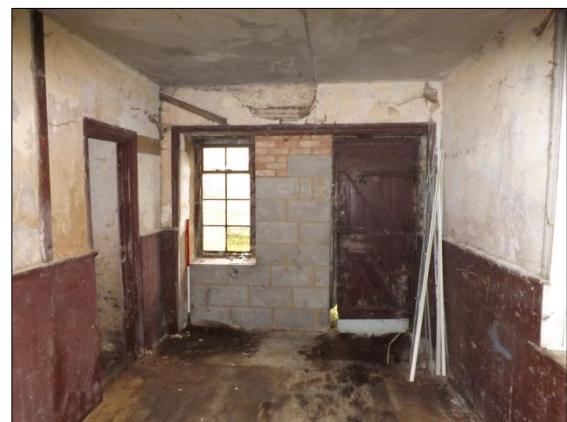
Fig 11: Office/tack-room, view north; scale 1m

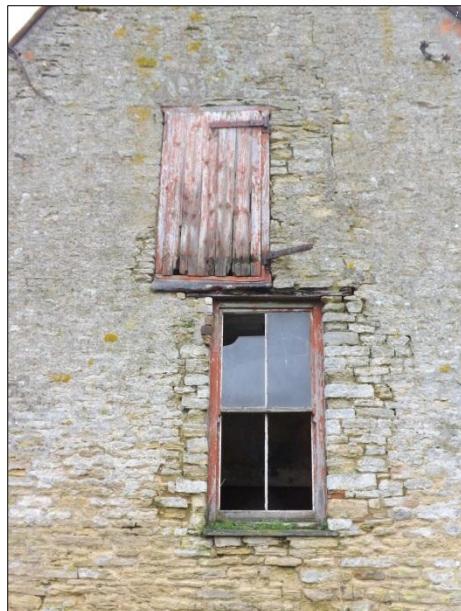
Fig 12: the inserted east gable window

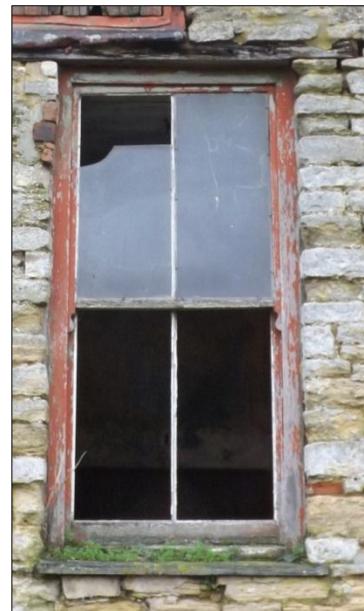
Fig 13: window close-up to show sash

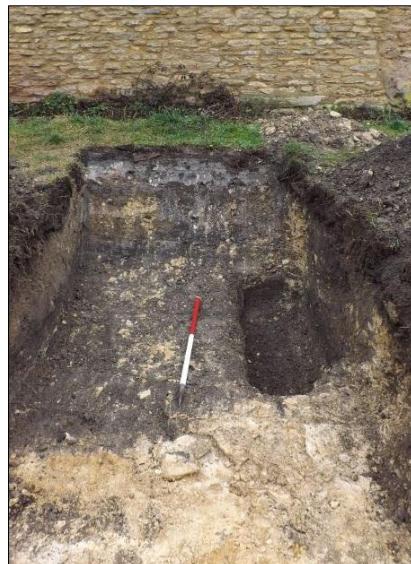
Fig 15: Soak-away pit [3] with the south wall of the barn behind; scale 1m. Looking north

At the north end of the trench a large, deep pit [3] had been dug into the natural limestone. The sides were vertical to steep-sided (but raggedly-cut) and the fill comprised numerous limestone chippings in a matrix of well-drained, stony black soil. The pit extended north toward the barn and west, in both directions beyond the trench. Pieces of brick (not retained) from the pit date it to the 19<sup>th</sup>-century and its location suggests it is a soak-away for a drain at the base of the stone cross wall, put in when half the ground floor of the barn interior was converted to the stable (see above).

The large and raggedly-cut pit in Trench 1 is consistent with a soak-away and coincides with a drain location within the building and the slope of the land. The drain was probably put in when the stable was created within the former barn, probably in the 19<sup>th</sup> century and, by stratigraphic association, before the cart-shed was added on before 1885.

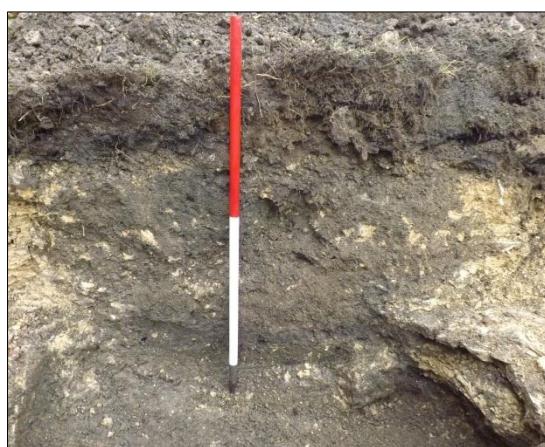
Fig 16: the same pit, showing depth and shelf under 1m scale; looking east

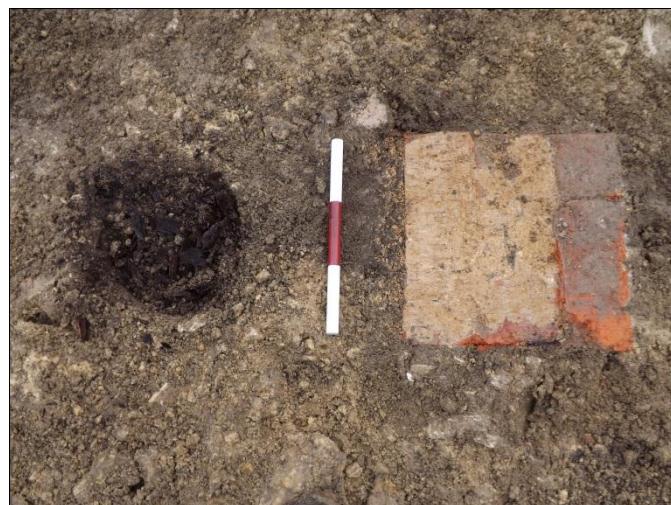
Trench 2 measured c6m x 1.6m and was aligned east-west. The topsoil was slightly shallower than in Trench 1 and like that trench it lay immediately on top of the natural geology, which hereabouts possessed a dirty, much-fragmented stone surface. Along the south edge of the trench was a strip of disturbance from which came three Victorian or early 20<sup>th</sup>-century bricks [8]. In the centre of the trench was a setting of similar bricks forming a square and neatly lime-mortared together [5]. One course was removed by machine and another lay mortared below. Adjacent to this was the sawn-off and half-decomposed remains of a cylindrical post. In conversation, Mr Brown, the last of the farming family to live at Manor Farm, noted that a telegraph pole had stood about here, and that at the back of the barn had stood a tractor shed. These remains are in keeping with both these assertions, the tractor shed probably beginning life as a Victorian, open-fronted cart-shed, its eaves supported on brick pillars. It is depicted on the 1<sup>st</sup> Edition Ordnance Survey map of 1885.

Fig 17: the eaves-supporting pillar base of the cart-shed and telegraph pole; scale 300mm.  
North is at the foot of the photograph.

The relatively flat ground to the south of the barn is notable on what is otherwise a sloping plot of land. The remains found include a square brick pillar base which looks like the footing for a pillar supporting the eaves of an open-fronted cart shed, noted by the former farmer, Mr Brown and plotted in early Ordnance Survey maps. The ground preparation needed for the construction of this cart shed probably entailed flattening the ground and this process removed any earlier material, if there had ever been any.
