A Heritage Asset Survey of Miller's Barn, Spratton, Northamptonshire

A Heritage Asset Survey of Miller's Barns, Spratton was carried out on Friday 20 March 2015. The small group of agricultural buildings lies on the west side of the A5199 road between the villages of Church Brampton to the south and Spratton to the north (NGR: SP 7190 6850; Fig 1). The purpose of the work was to record the barns group as they stood prior to any potential alteration and determine, if possible, their origin and development and assess if they have any historical significance.

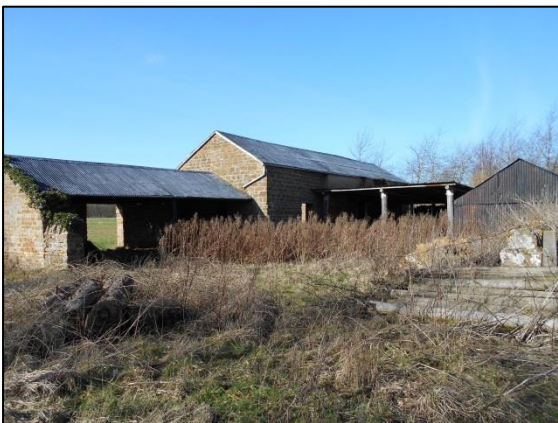
The buildings are aligned north-south and display the use of a number of materials, principally Northamptonshire Sand with Ironstone, the principal local building material. Brick has been used in a number of repairs and alterations, while cement blockwork has also been introduced where modern rebuilding has been extensive. Two areas of much older cob-walling survive on the inside, a once locally-favoured cheap building material, found as a survival in a number of villages in the district and sub-region (Seaborne 1964). The roofs are of modern corrugated metal sheeting (Figs 5 & 6).

Fig 5: The barn, viewed from the south-east

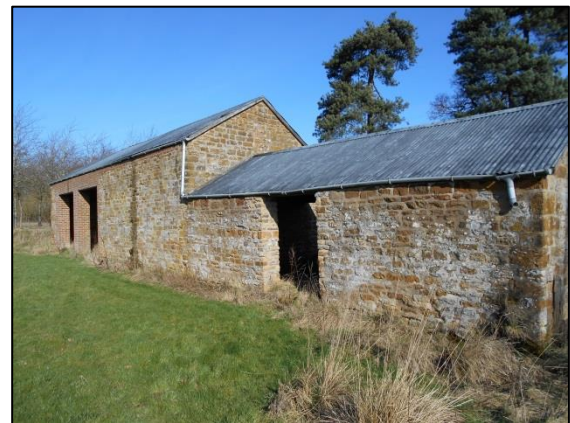
Fig 6: The barn viewed from the south-west

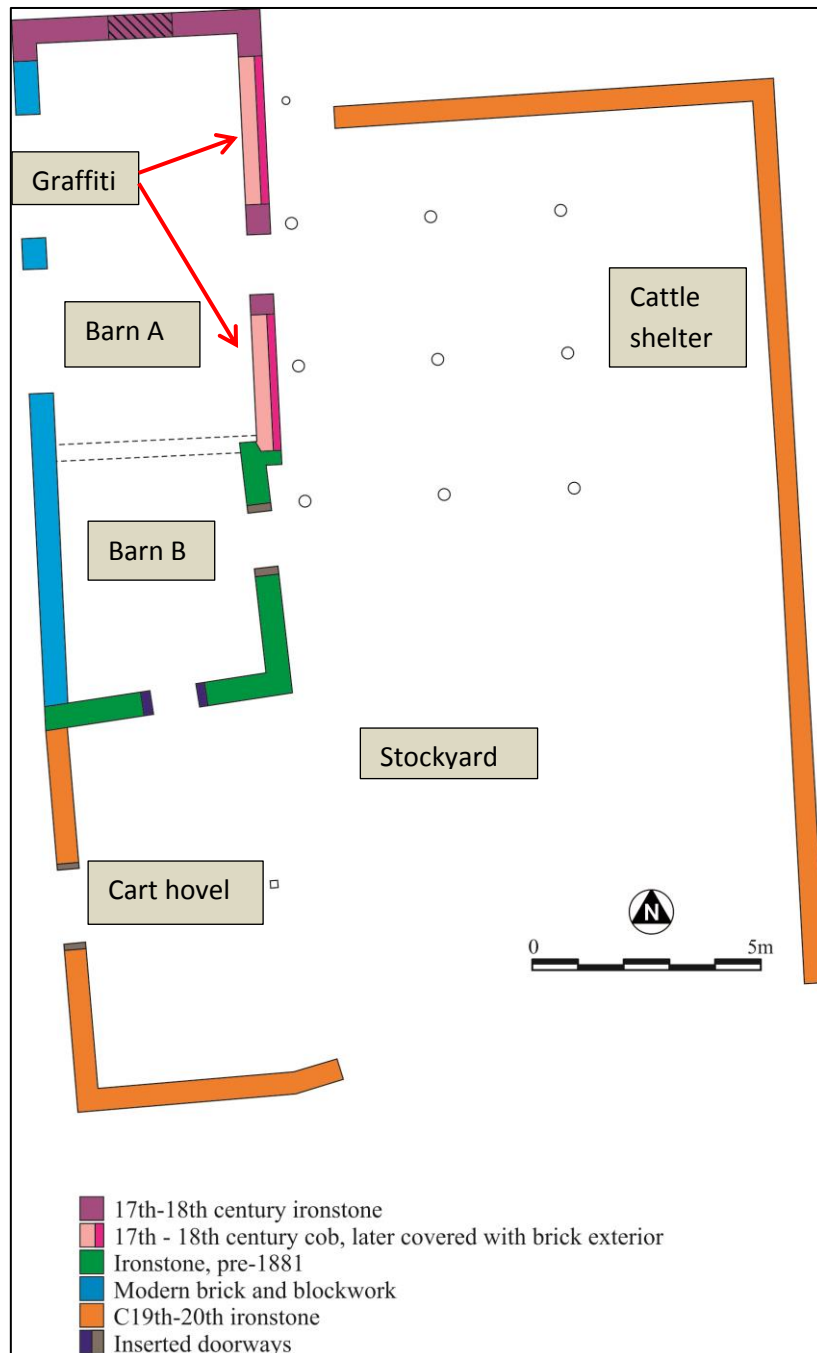
Fig 7: The barns phased, and where possible, dated

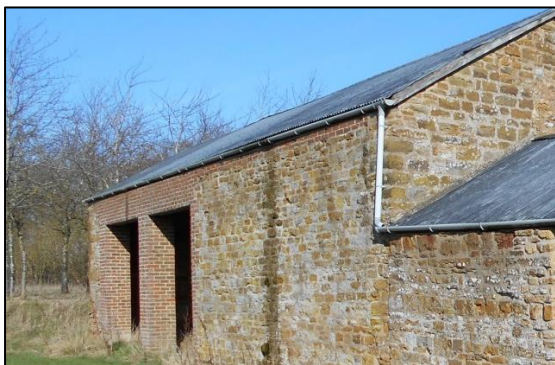
Almost the entire length of the west side has been re-built in recent decades, equally in ironstone and in red brick on the exterior, but with cement blockwork on the inside (Figs 8 & 9). It is not clear if the present layout copies an original configuration though this appears to be unlikely since it does not conform to a layout expected of a field barn. The present configuration of two wide and high openings separated by a central brick pier appears to be more likely a response to modern farm machinery which requires bigger entrances than historic farm equipment.

Fig 8: Barn A/B; modern west wall exterior

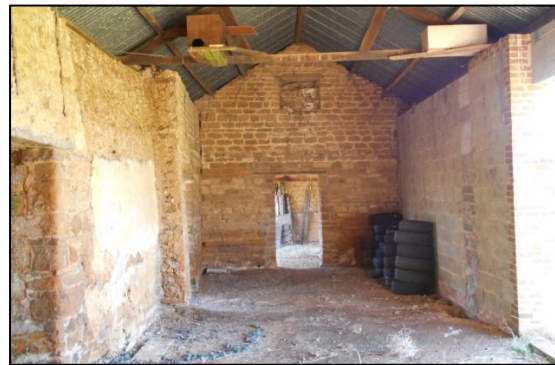
Fig 9: Barn A/B; modern west wall to right

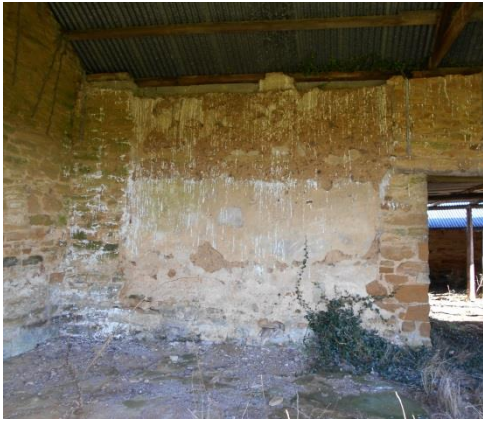
The east wall of Barn A retains two large panels of cob construction flanking a roughly central doorway (Figs 10 & 11). The cob is only visible internally, externally the east wall is partly nineteenth century red brick and partly ironstone with sections below the eaves over-rendered. Each jamb of the doorway is formed of ironstone and the lintel formed of three pieces of timber, almost certainly oak. There is no evidence for either doorframe or hinges. The north-east end of this wall where it joins the north gable wall is also ironstone.

Both of the cob sections of walling retain on the internal surface large areas of surface lime plaster added partly to provide a smooth surface but primarily to form a protective skin to the soft and friable cob.

Fig 10: Left (north) cob panel in east wall

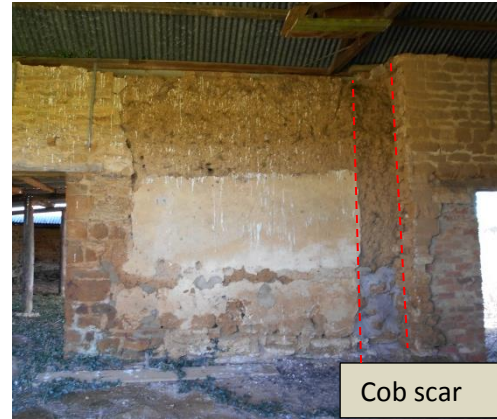
Fig 11: Right (south) cob panel in east wall

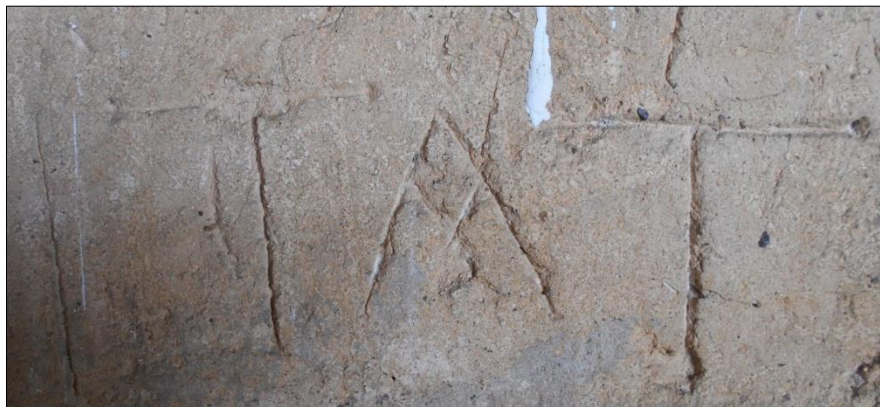
A variety of shallowly-inscribed graffiti is present on the plaster surfaces on both panels flanking the doorway; most comprises single letters or groups of letters. These may simply be a person's initials but some have a form which is distinctively 17th-century (Fig 12). Elsewhere a series of short, parallel lines are most likely tally marks used during the counting of produce.

Fig 12: A group of letters with a characteristic 17th-century style of letter 'A'

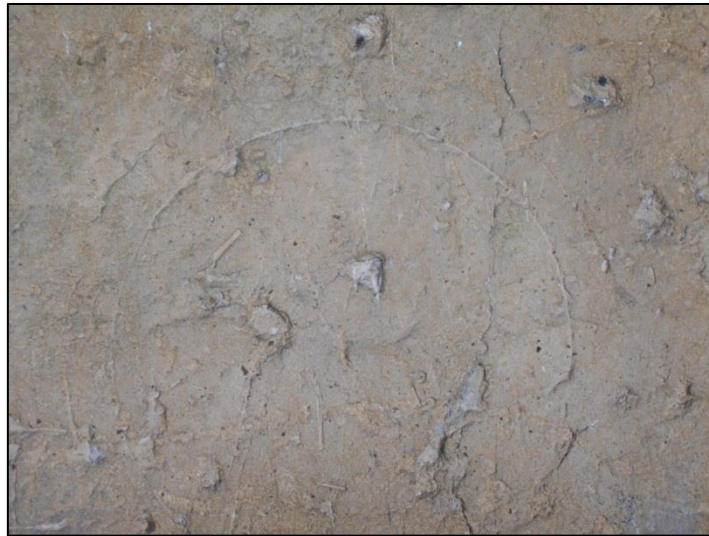
To the north of the central doorway a double concentric circle (222mm, 8 $\frac{3}{4}$ inches and 268mm, 10 $\frac{5}{8}$ inches in diameter) are *Apotropaic marks* (Hall 2005,150; Steane and Ayres 2013,394-7). These ritual marks, often situated close to doorways, windows and fireplaces were inscribed in order to protect a building from evil spirits, witches or animal familiars. They are also sometimes called 'witch-marks'. This fear of the occult was at its height during the seventeenth century (James I was a particular believer) although such marks are found in later buildings as well. A single circle is inscribed to the south of the doorway (200mm, 7 $\frac{7}{8}$ inches in diameter) which suggests that these circles were indeed added here for just such a purpose.

Fig 13: The more detailed of the two apotropaic 'witch-marks', the concentric circles

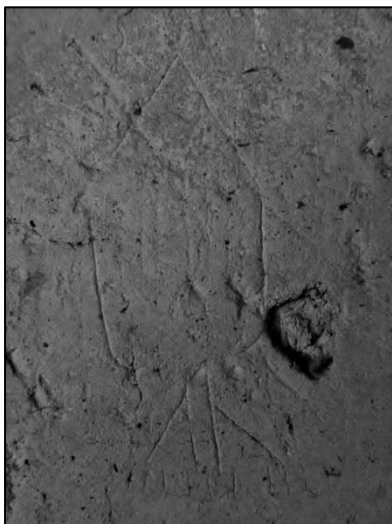
Towards the southern side and at the lower edge of the southern plaster panel is a crudely drawn image of a post-mill (Fig 14). Post-mills are the original forerunner of the tower-windmill which can still be seen across eastern England in particular, although most often now as sail-less towers. They were introduced into England in the 13th-14th centuries, and were often the product of entrepreneurial people who objected to the monopoly exerted by the existing hierarchy through monopolies of the feudally-controlled water-mills and their stranglehold on the rights to mill corn and with them the milling tolls. Thus many were unofficial and short-lived. The buried cross-trees of a medieval example were excavated at Warmington, Northants in 1995 (Chapman 1997).

Fig 14 Post-mill graffiti (190mm from base to apex)

The barns themselves retain very little historic character and cannot be said to have any architectural significance. However, the happenstance survival of the early graffiti is of note and may be considered worthy of preservation, and potentially of display, whether wholly or in part, in any re-building or conversion proposals. It is unlikely that, if the buildings continue as entirely redundant barns, the graffiti will survive much longer.

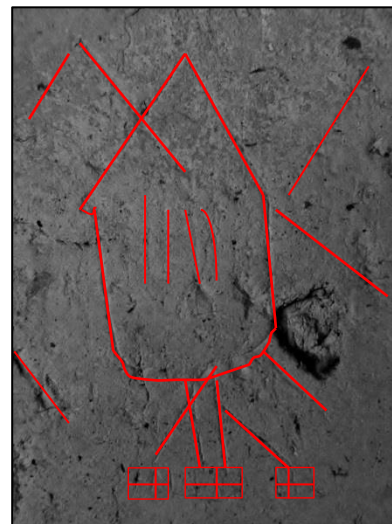
Fig 15: The mill, outlined

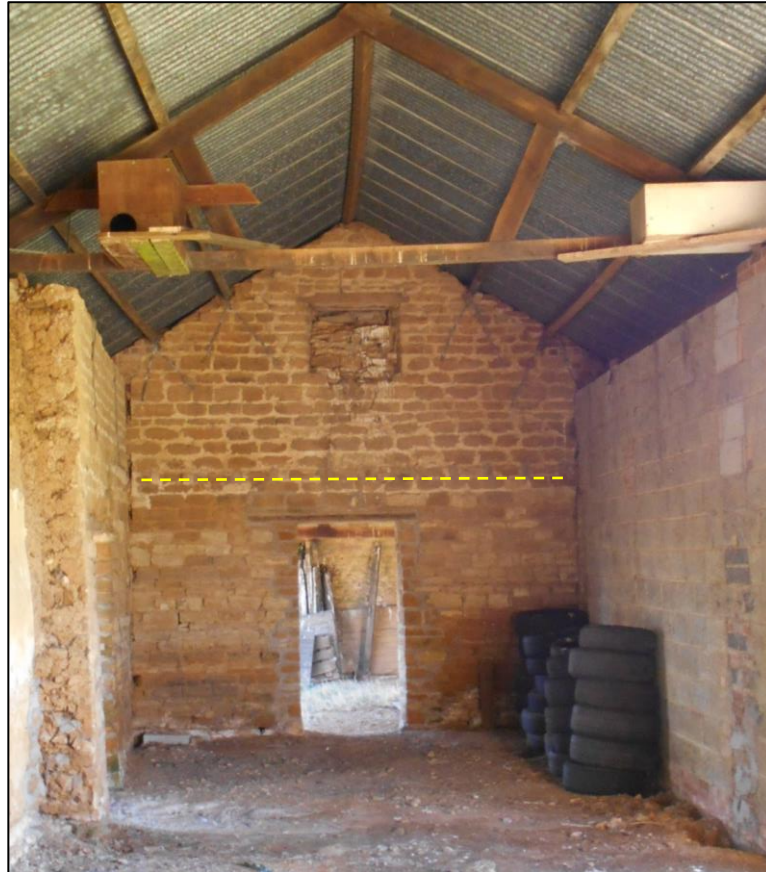
Abutting the south end of Barn A and internally incorporated into it, this section of the range is clearly a secondary addition to the northern barn (Fig 7). Its north wall would originally have been the now-lost south wall of Barn A. It, like Barn A, is of double-height.

Fig 20: Barn B interior, looking south, through the lost North wall. Note the former Hayloft floor level (dashed).

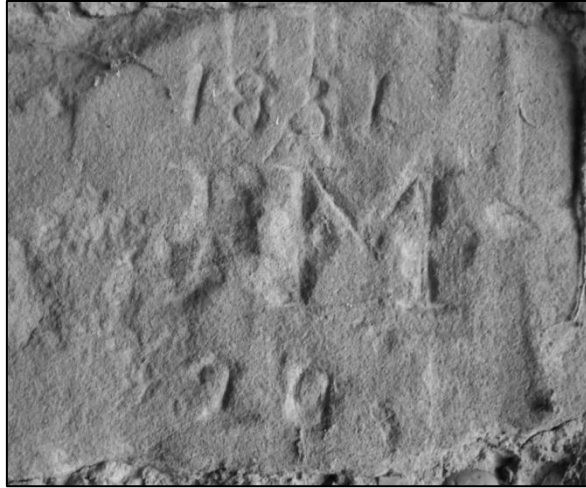
Fig 21: Dated Graffiti; R(?)M 1881

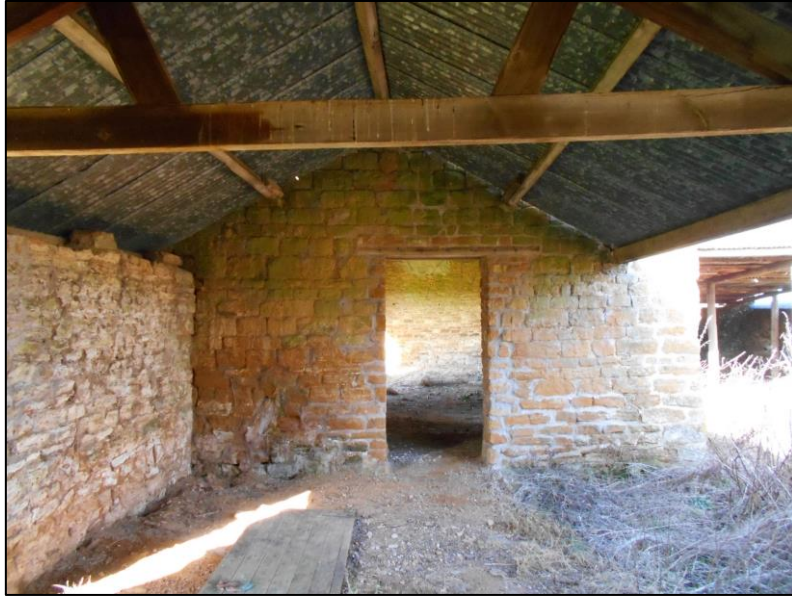
Joined to the south end of Barn B this simple, single storey open-sided shelter comprises only two walls located on the west and south sides (Fig 22). The north side is formed by the south wall of Barn B whilst the east side is, and always was, open with the eaves supported on a single timber post set on a concrete base. There is a clear butt joint where the west wall is joined to the south end of Barn B and it is constructed of roughly-coursed ironstone both internally and externally. There is a modern, inserted doorway in the west wall, the jambs re-built in the same way as that described in the south end of Barn B. There is a single, centrally placed truss situated directly above the post on the east side; like the trusses in Barns A and B it is not original. There is a single purlin on either side with a ridge plank; the covering is corrugated iron sheeting. There is no evidence of hayracks or mangers along the west wall suggesting that this was a simple shelter although it could also have served as a cart hovel, its open side facing east making it ideally oriented for this purpose.

Fig 22: Cart hovel, interior, looking north

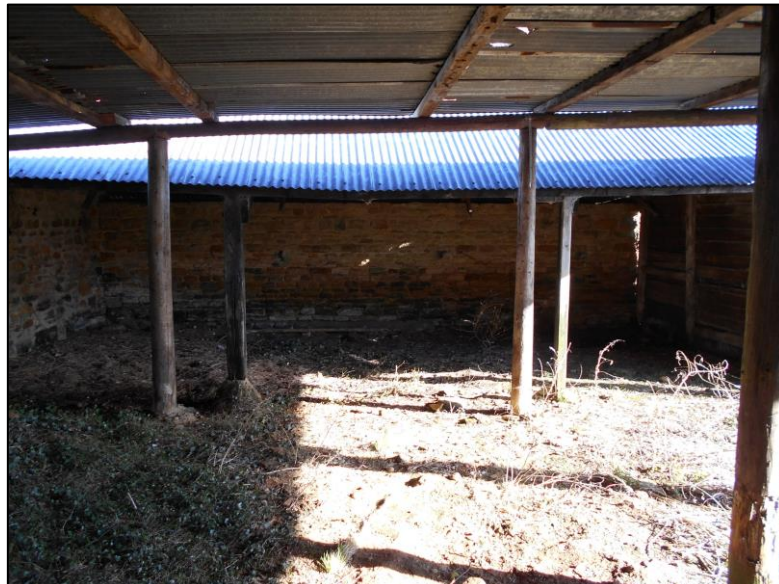
This is a simple construction created in the north and east angle of the stock-yard by simply slightly raising the east side slightly towards the north end of the east wall and adding a gable end above the east end of the north wall (Fig 23). The whole is constructed of roughly coursed ironstone with some red brick repairs, except for the south gable which is of flimsy timber studs covered with corrugated sheeting. The west side was open and supported on timber posts, their bases now set in concrete. Like elsewhere the roof covering is of corrugated metal sheeting.

Fig 23: Cattle shelter, looking east from Barn A
