Iain Soden Heritage Services Ltd

Excavations in connection with the rebuilding of a Listed Garden Wall at Coventry Charterhouse, 2015

27 November 2015

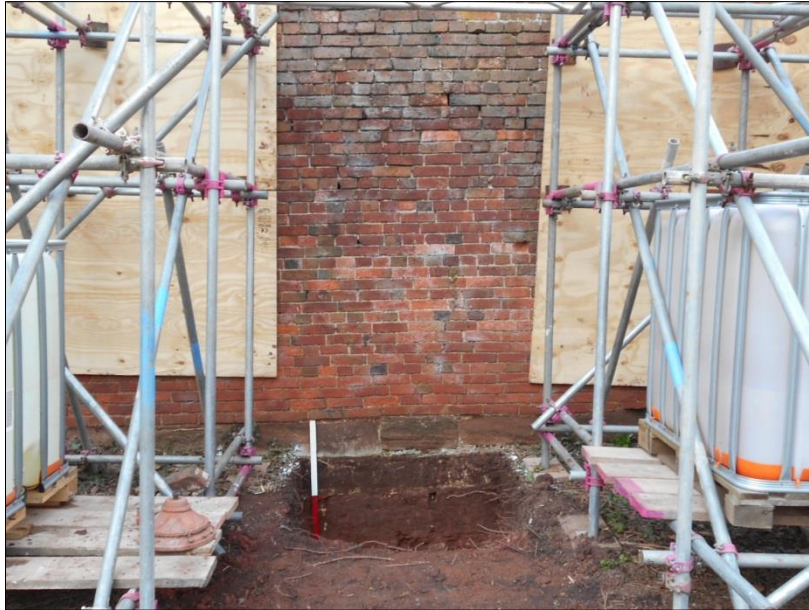
Fig 2: Buttress foundation hole between two temporary weighted wall-supports

At pre-selected points along the wall on its south side was dug a series of five rectangular foundation pits (Fig 1), positioned between scaffolded water-bowser weights (Fig 2), used to temporarily support the wall, which was leaning on a considerable angle. This was done under an archaeological watching brief. The four pits each totalled 1.2m wide and a little over 1.2m long. Each cut through thick topsoil and a little subsoil to the natural Keuper Marl geology at a depth of approximately 800mm deep. No archaeology was present in any of the pits, although the topsoil in the easternmost (gate-pier) pit contained large quantities of former brick-wall collapse, still mortared. The pits are now marked mostly by angled brick buttresses for which they were dug and a brick gate-pier at the east end (Fig 1 for locations). These will support the wall and an access gate for the foreseeable future.

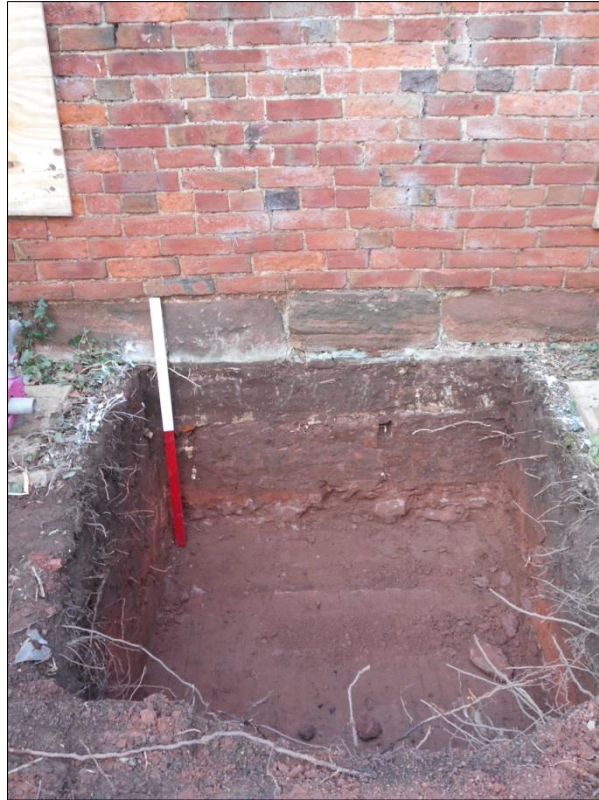
Fig 3: One of the foundation trenches for the angled buttresses; scale 1m

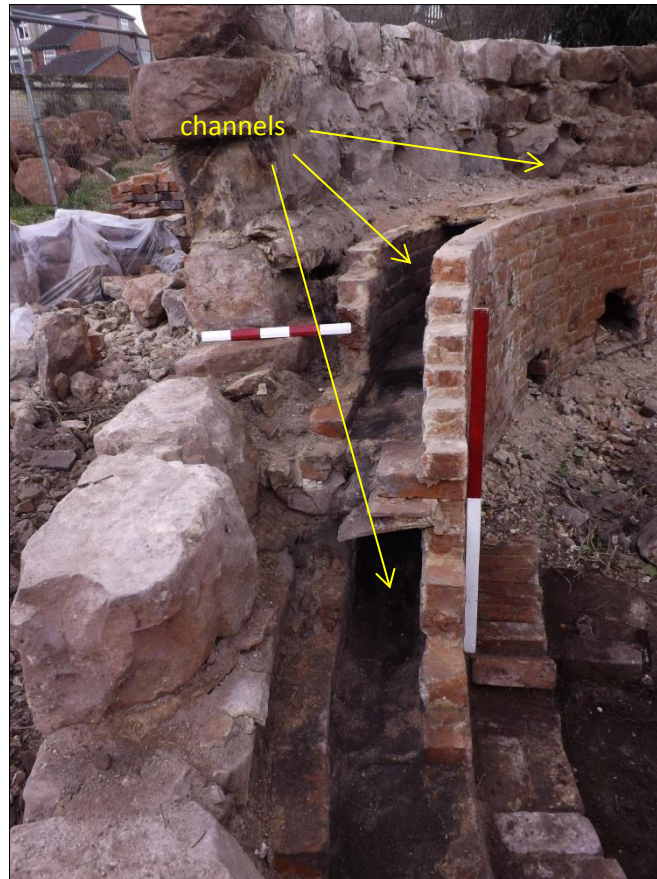
The state of the wall to the semi-circular orangery (Fig 1) was giving grave cause for concern. It comprised reused monastic stone on the exterior with a double skin of brick on the inside, the two skins separated by three tiers of surviving deep channels, each c200mm wide and used to circulate hot air from an unknown source, thereby warming the brick wall and beyond it the orangery interior (Fig 4).

The brick skins were built generally of stretcher-bond and each channel had a base/ceiling made from unused flat roof tiles. Each channel was heavily sooted, showing that however they were heated, the hot air passage system had worked long enough to clog them quite thoroughly.

Fig 4: The orangery wall at the point of maximum dismantling; scales 1m and 50cm

Each tier surviving of the spaces within the hot-wall was also heavily sooted. Although this proves conclusively that the hot-wall was indeed in use at some point, it also suggests that it may not have been very efficient, and the whole assembly appears to have lacked the mechanism by which it could be easily (or effectively) swept.

The hot-wall and the stone exterior were partly taken down and the remains cleaned up for photographic recording as part of the monitoring works on the wall-conservation (Fig 4). The figure below shows the system as it was exposed and cleaned. New work, re-using fallen and dismantled original masonry and new, conservation-grade brick, was thereafter built up off this base.

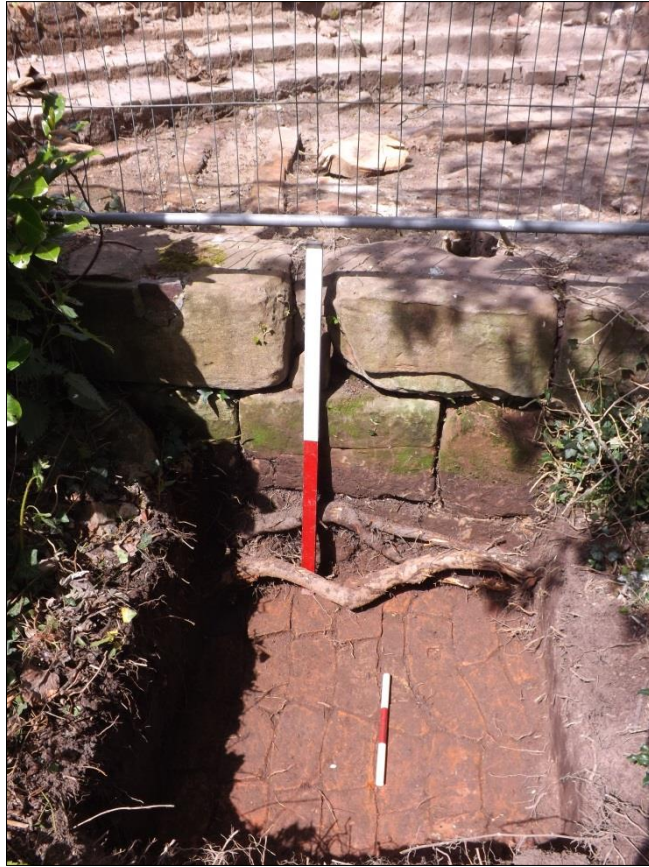
It was therefore agreed that without disturbing the deposits, some cleaning should be undertaken as part of the conservation monitoring works to better understand the layout of the orangery and obtain any dating which might be forthcoming in the process. A test pit had previously been dug in 2015 which showed that the area in front of the building had been provided with an ornamental interlocking brick hardstanding some 500mm down (Fig 5 [Test pit 10]).

Fig 6: Test pit with cleared orangery behind, looking north; scales 1m and 30cm

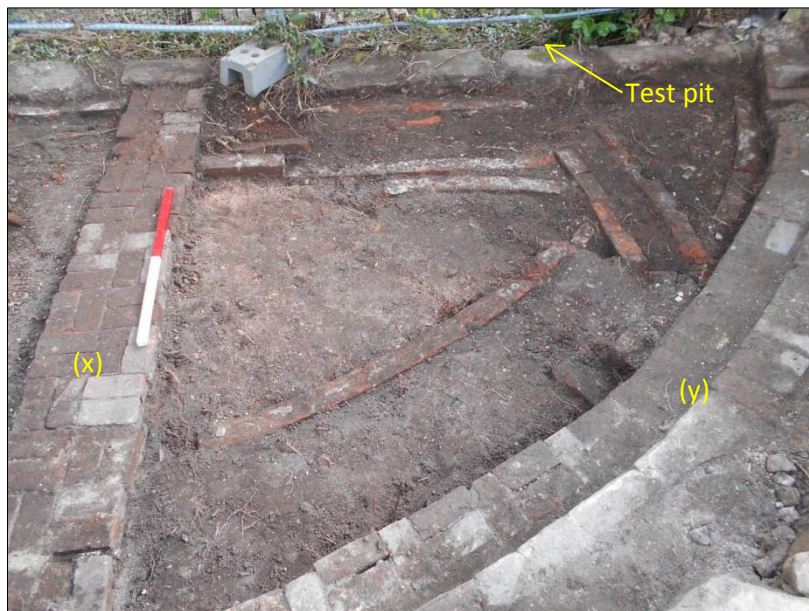
Fig 7: Western half of the orangery, looking south, cleaned to recognise sub-floor flues; scale 1m. At this point the orangery wall has been dismantled. Work showed that the left alignment of bricks (x) and the arc around the foot of the orangery (y) were both unrelated to the orangery when in use; they were merely neat stores/stacks of materials

The western half of the orangery was cleared and cleaned archaeologically to give some indication of what lay below the modern collapse, builders' trample and leaf-mould, which together covered the entire interior. This was cleaned down to undisturbed levels, which were seen to comprise root-rich topsoil around an array of curving lines of mortared brick, apparently of two different phases of sub-floor construction. Around the edge of the semi-circle and down the centre lay an un-mortared store of bricks, cleaned and put by at some previous episode, probably for re-use. These appeared not to be part of any floor-configuration; so neither did an arc of free-standing bricks around the inner edge of the semi-circle.

The layout of these lines of brick were largely unhelpful in addressing the way in which the heating of the orangery worked, not least because this side of the orangery had been completely dismantled due to its advanced state of decay.

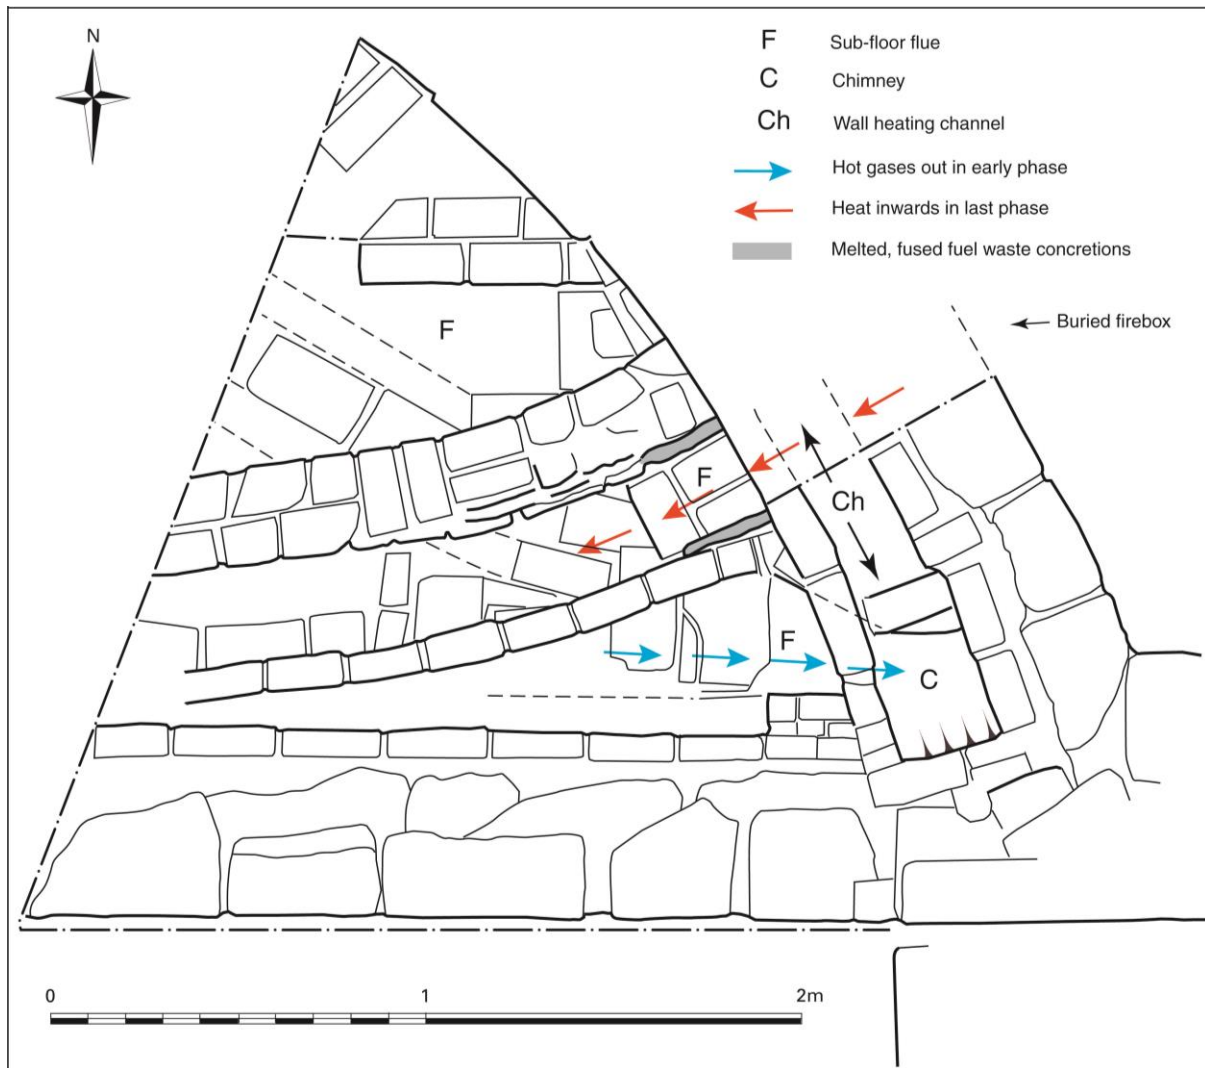
In the small area chosen, no orangery floor remained beneath a modern accumulation of scalpings, geotextile membrane over compacted leaf-mould and soils. It did however, contain an array of brick flues made of extraordinarily poorly-preserved and heat-damaged brick, re-used potentially many times, and vestiges survived of two, possibly three, heating flue arrangements.

In its earliest visible phase, former flues were only just visible in the base of the excavation. Their lines were indistinct and they had been reduced to merely mortar-lines, their bases characterised by lines of brick laid at angles, not respected by later, better-preserved flue edges. They were set partly upon re-used roof-tiles and Welsh Slate, perhaps to help level up the surface of the monastic Dissolution rubble thought to lie beneath the whole structure and give the flue walls a flat bed.

During either the earliest, or another, newer phase, the southernmost former flue had linked directly to a surviving chimney at the far eastern end of the orangery and which was housed entirely within the thickness of the brick and stone wall. However, this had been blanked off in subsequent re-arrangement.

Fig 8: The excavated portion of the east end of the orangery.

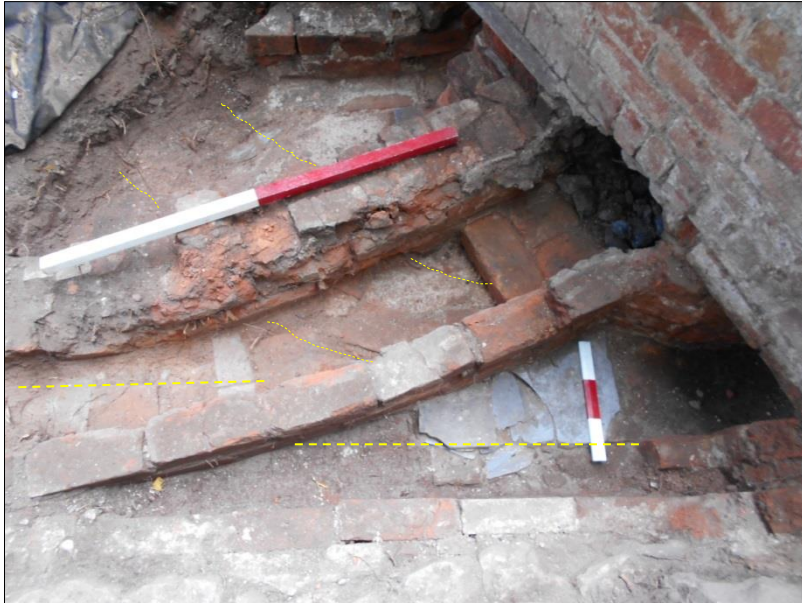
Fig 9: The excavated eastern portion of the orangery, north to top; scales 1m and 30cm. Vestiges of earlier flue edges are dashed-in. Note the heat-shattered bricks of one flue edge.

The bricks which formed the last-phase, surviving flue (most easily visible in the centre of Figs 9 and 10), were made up of at least 50% re-used brick-bats and fragments, almost all of which had been seriously heat-damaged in this, their last re-use.

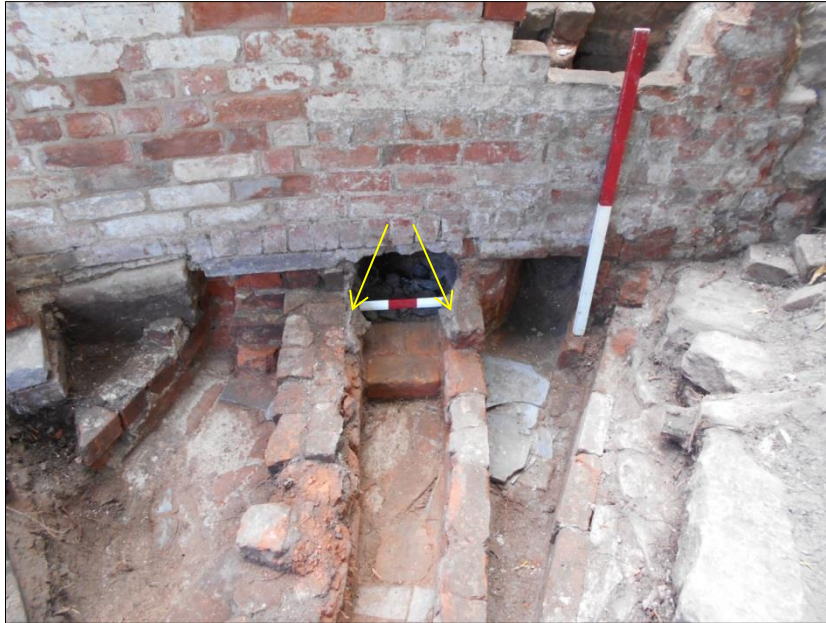
The temperatures reached in and close to the firebox were sufficient to damage the old re-used flue bricks for over a metre under the lost former floors (which ought to have been of stone flags, if only by reason of this heat). Inside and close to the inlet the brick was also covered in a concretion of fuel waste and gas-borne deposits, which had deposited, bubbled, spat and re-fused again and again. The entrance of the flue was stopped up with a mixture of this and ash, together with granular brick-dust, testament to the high temperatures once reached within. The unburnt fuel shows that both coal and coke were used at different times.

Fig 10: The excavated eastern portion of the orangery, north to left. Note the redundant chimney flue at top right; scales 1m and 30cm, the smaller scale is wedged between melted fuel-waste concretions on the heat-affected brick (arrowed)

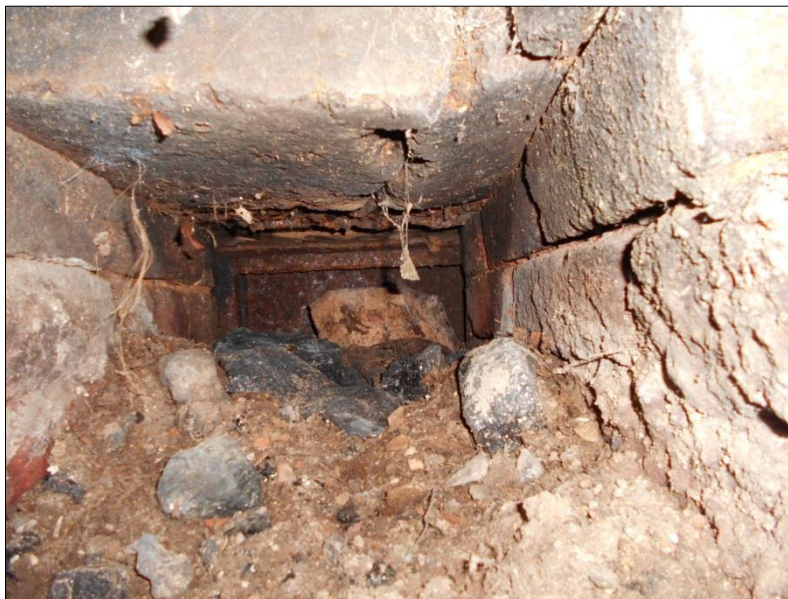
At the eastern end of the flue was the inlet from a stone and brick-lined firebox, at least one wall of which was curved, but whose interior was a straight channel. Unspent fuel from the last firing still litters the interior of this firebox (left intact), and a cast iron door can be seen closed tight shut in the outer surface of the orangery wall, buried below the exterior surface (Fig 11).

Fig 11: View through the flue within the wall, showing the buried cast-iron door on the exterior of the orangery. It is littered with unburnt coal and coke fragments.
