REPORT: MAPPING AND MONITORING CRACKS IN THE STANDING IGUANODON IN CRYSTAL PALACE  
PARK

India Carpenter

Post Graduate Diploma in Conservation  
Conservation Department 2017

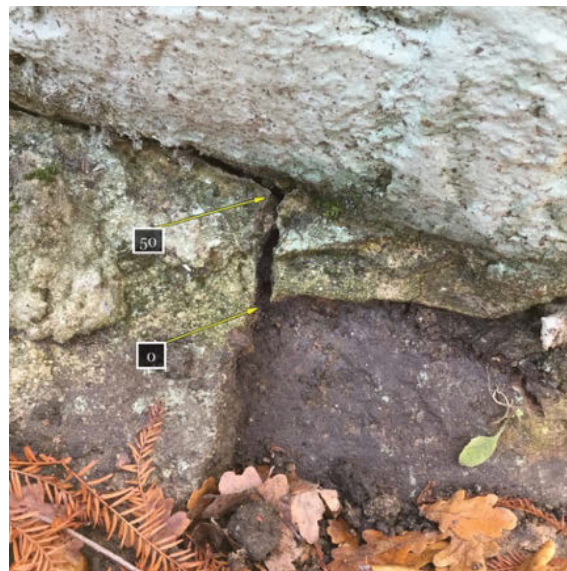
Plate 2. Photographed 14.12.16 – 0 identifies the origin and the first measurement point.

- The tail has 2 primary cracks, identified as 1a and 2a. Emanating from these are numerous secondary cracks, identified as 1b,1b1,1b2,1c, 2b,2c,2d.
- Between 14.12.2016 and 10.03.2017, both primary cracks increased *at points* in both width and depth – see graphs/tables 1.0 and 2.0.
- Crack 1a between points 470mm-1000mm and Crack 2a between points 3680-4850mm, indicate a crack created due to shear force, see plate 17. This crack has increased in width and depth between 14.12.2016 and 10.03.2017.
- Between 14.12.2016 and 10.03.2017, Crack 1a has developed a loss at 540mm, with a disassociated fragment measuring 60x25x18mm. See plates 2,3,4.

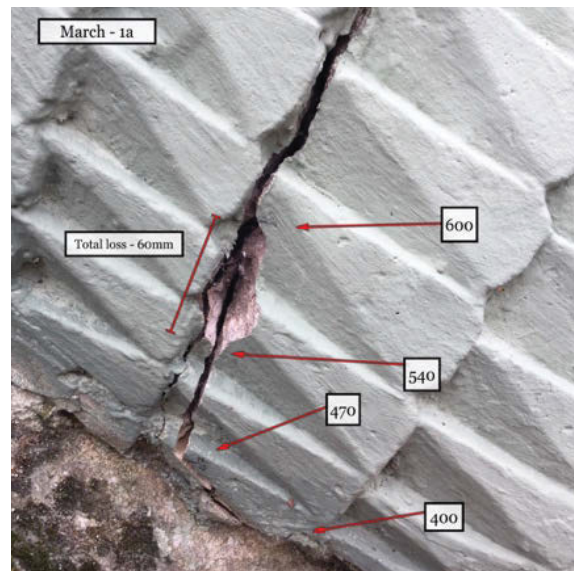
Plate 4. Photographed 10.03.17 – Indicating total loss to crack 1A.

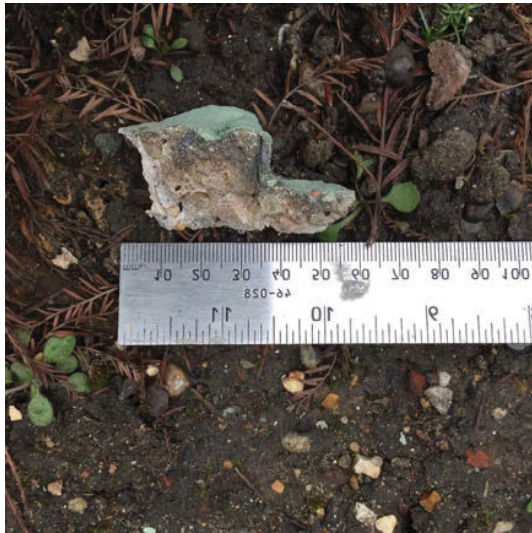
Plate 5. Photographed 10.03.17 - Disassociated fragment from point 540mm along crack 1A

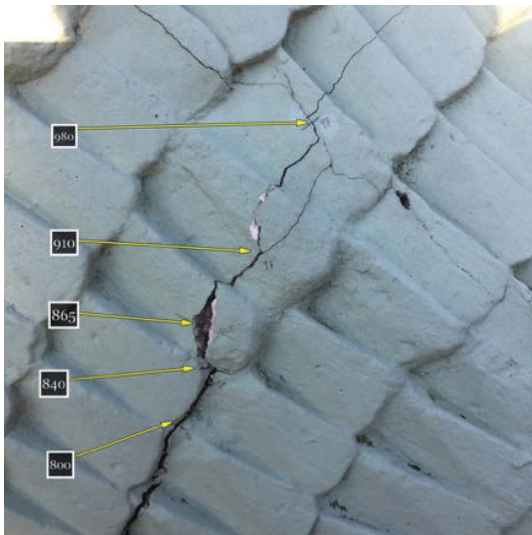
Plate 6. – Photographed 14.12.16 – Crack 1A.

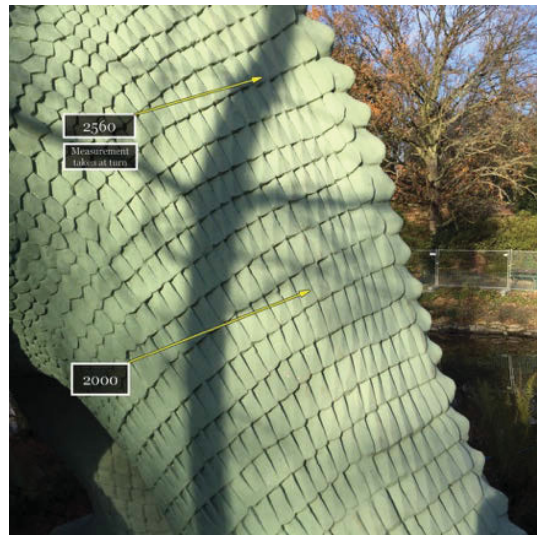
Plate 7. Photographed 14.12.16 – Crack 1A

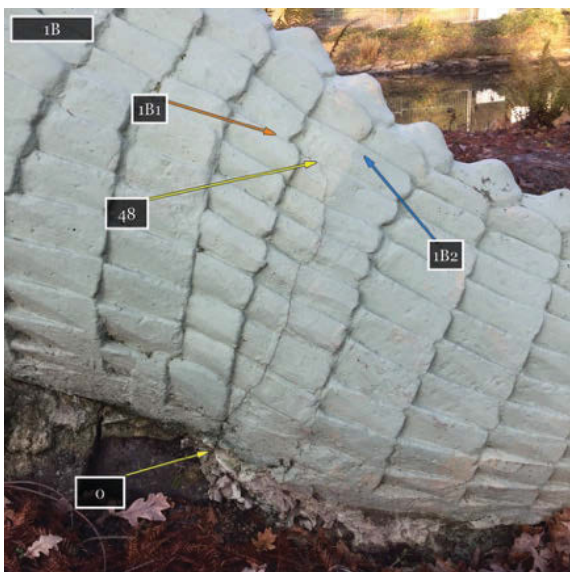
Plate 8. Photographed 14.12.16 – Crack 1B.

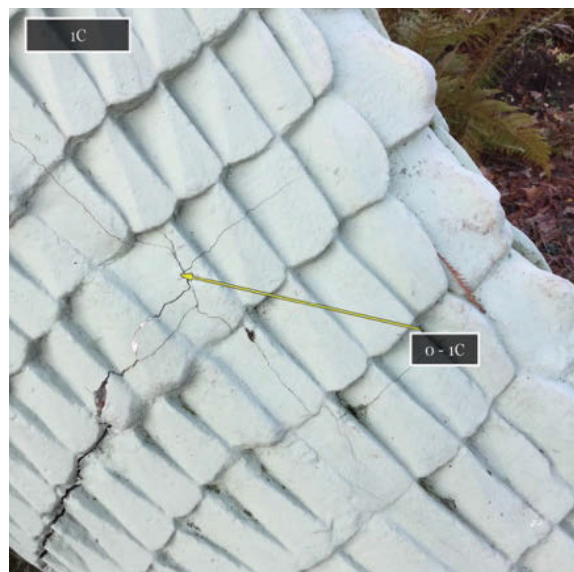
Plate 9. Photographed 14.12.16 – Crack 1C.

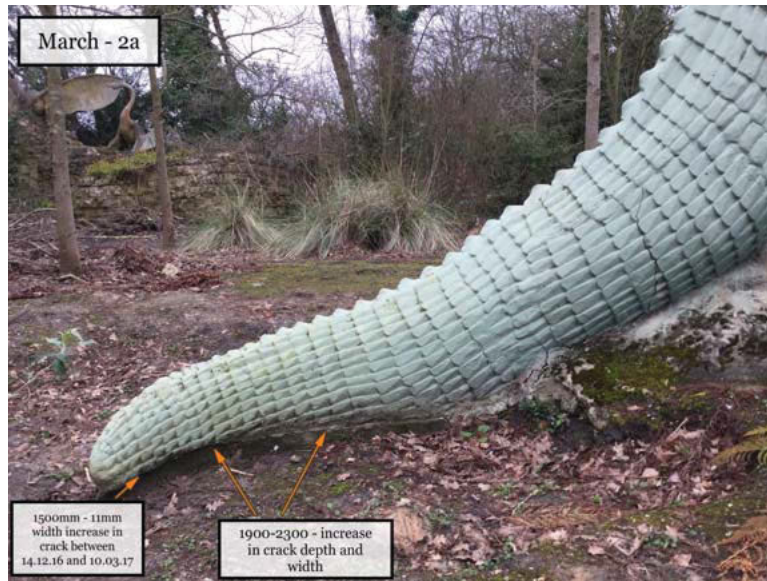
Plate 12. Photographed 10.03.17 - Locating the points of greatest crack depth and width increase.

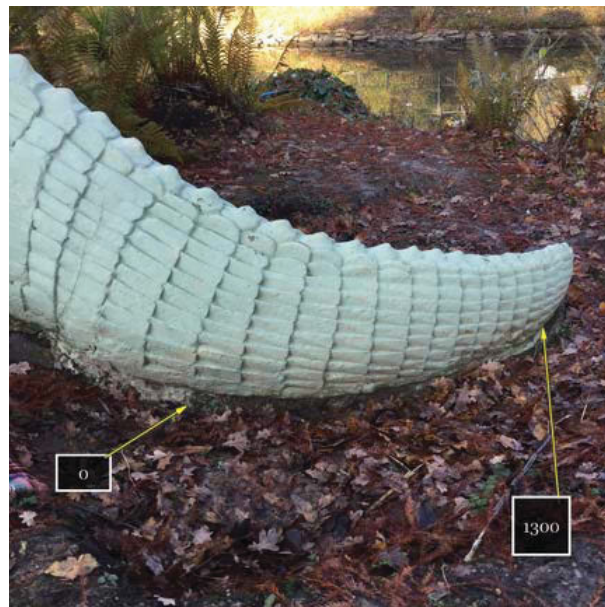
Plate 13. Photographed 14.12.16 – Crack 2A origin point and end of tail.

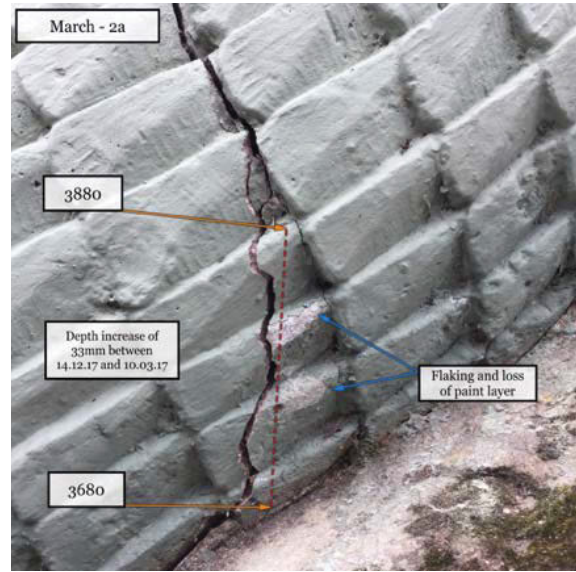
**Plate 15.** Photographed 10.03.17

Crack continues from base and over to the left side of the tail where it meets crack 1a. Crack 2a has formed in the original concrete, not in a historical repair.

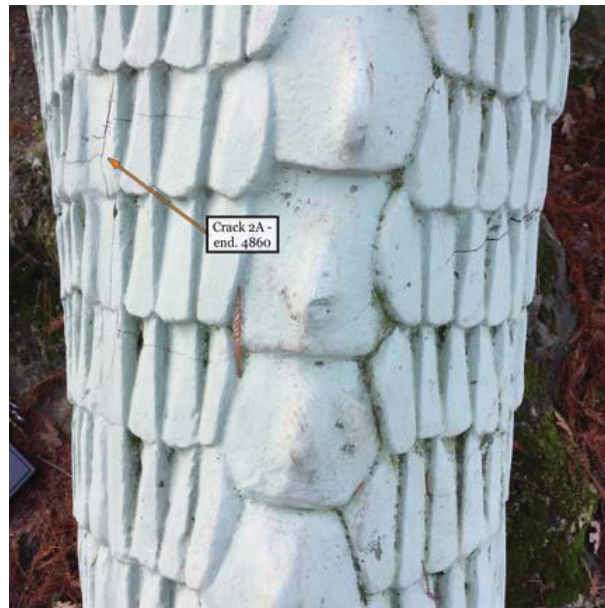
**Plate 16.** Photographed 14.12.16 – End measurement point of Crack

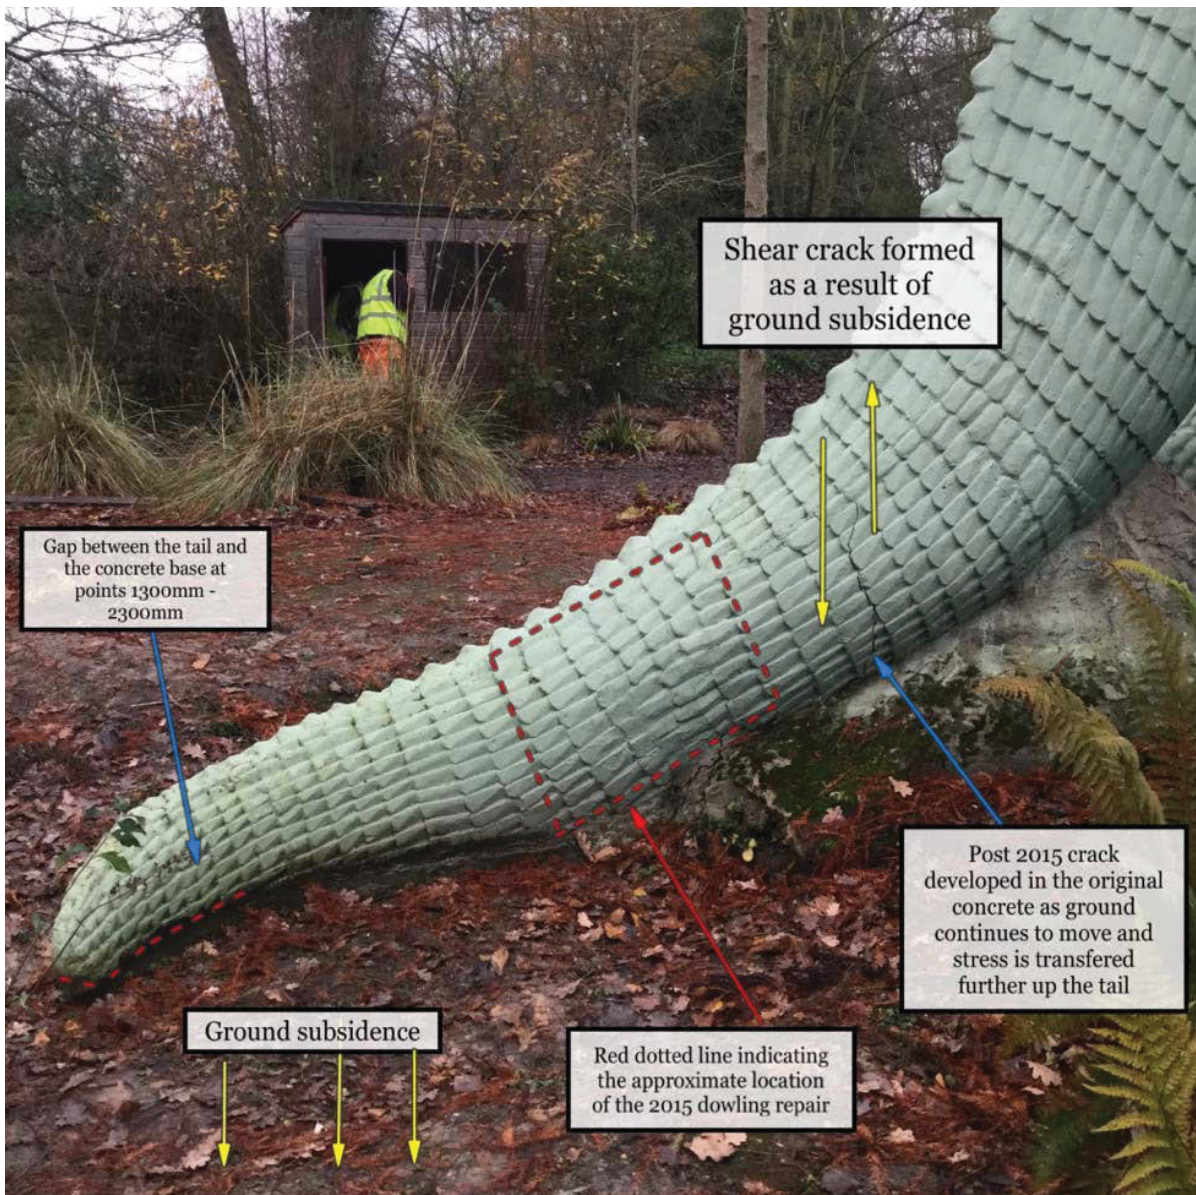
Plate 17.

- Crack 2a, between points 1300mm and 2300mm displays a complete detachment between the tail and the concrete raft on which it sits. See graph 2.0 and plate 17.
- There was no change in the dimensions of the secondary cracks; 1b,1b1,1b2,1c,2b,2c,2d.

Results from the monitoring of the tail cracks between 14.12.2016 and 10.03.2017 indicate a series of cracks formed due to shear stress as the ground beneath the lower section of the tail subsides. This is causing progressive cracking. The crack across the width of the tail has formed in the original concrete, not in the 2015 repair. The 2015 repair treatment included the insertion of a steel dowel (Cliveden 2015). It is likely that the rigidity of the steel dowels is preventing a crack forming at this point and the stress is transferring further up into the tail where the new crack has developed in the original concrete.

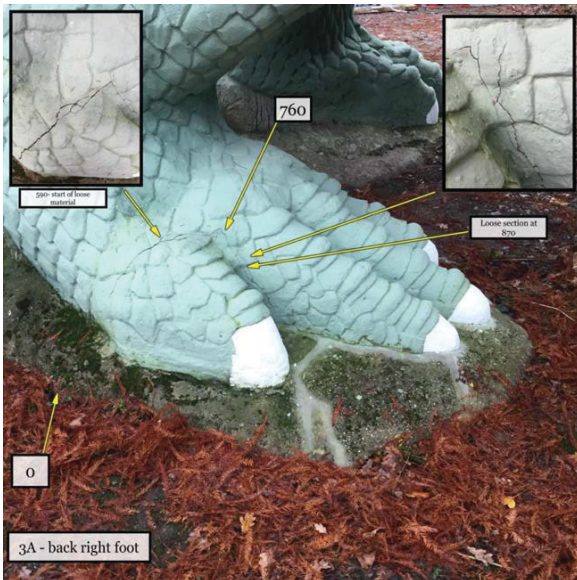
**Plate 20.** Crack 3A - Photographed 15.12.16.

- Crack 3a, between points 590-1100mm, displays an almost continuous length of spalling concrete, with numerous losses and disassociated fragments. Losses at points 950mm and 1050mm have occurred between 15.12.16 and 15.03.17. See plates 20-25.

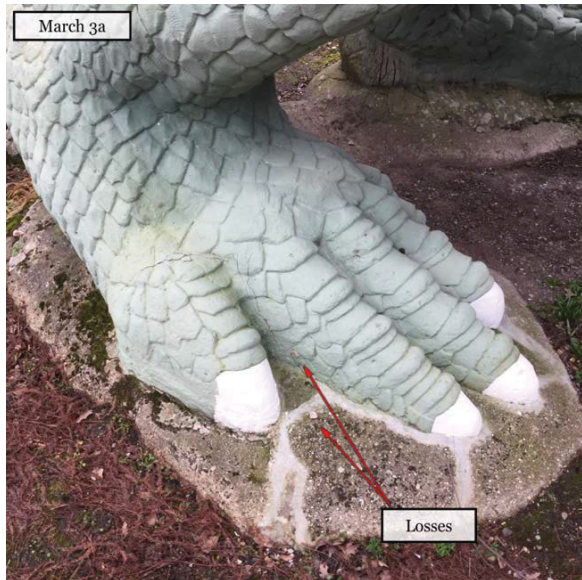
**Plate 21.** Photographed 15.03.17 – visible losses.

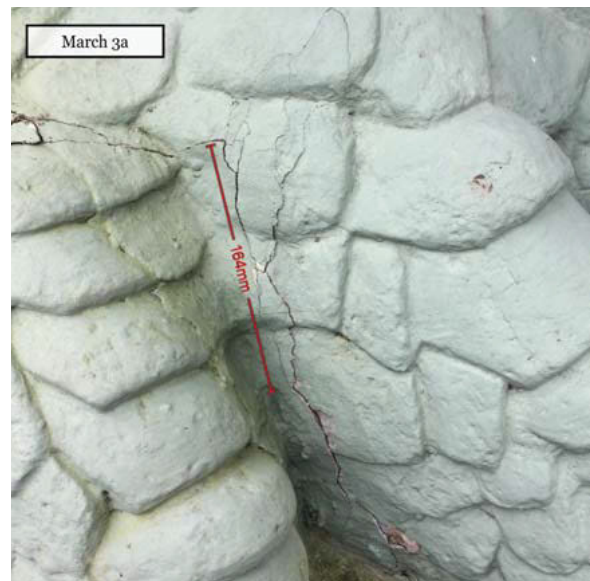
**Plate 23.**

**Plates 22-25-** photographed 15.03.17. Details of cracking and spalling in the concrete, including visible losses and detached fragments since 15.12.16.

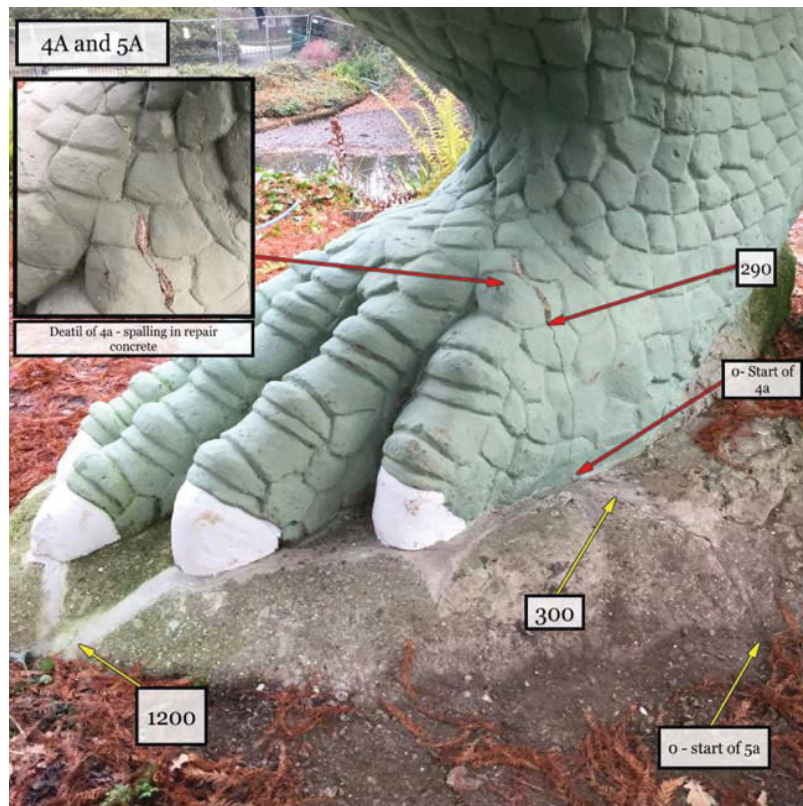
Plate 26. Crack 4A and 5A – Photographed 15.12.16.

- Crack 4a follows the site of a 2015 repair. Point 290-510mm along the crack displays delaminating repair concrete, with total disassociation of fragments occurring between 15.12.16 and 15.03.17. See plates 26,27,28.

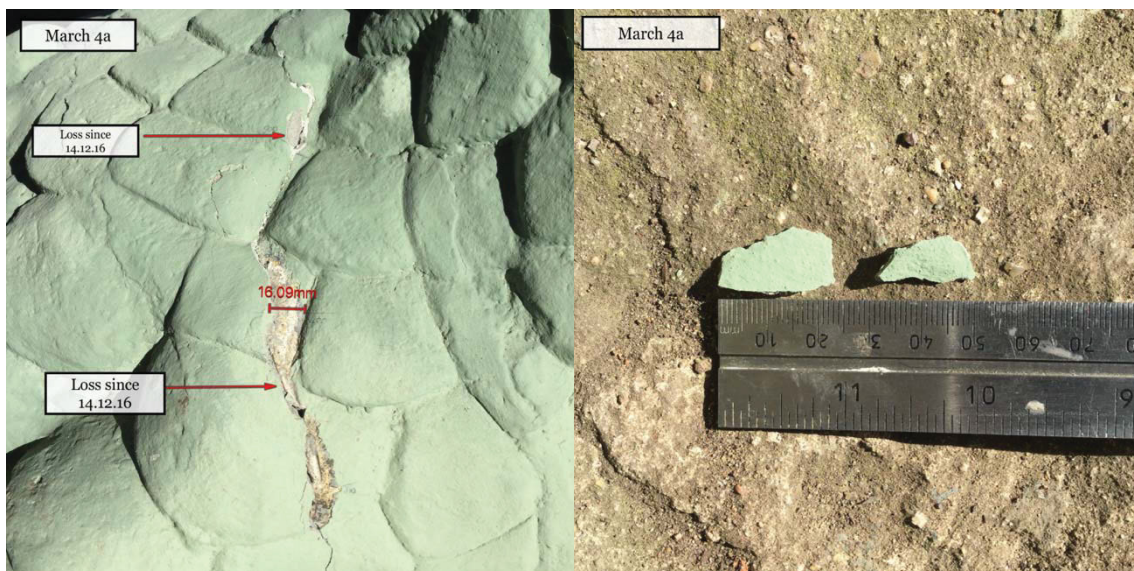
Plates 27 and 28. Crack 4A – Photographed 15.03.17 – disassociated losses incurred since 2016.

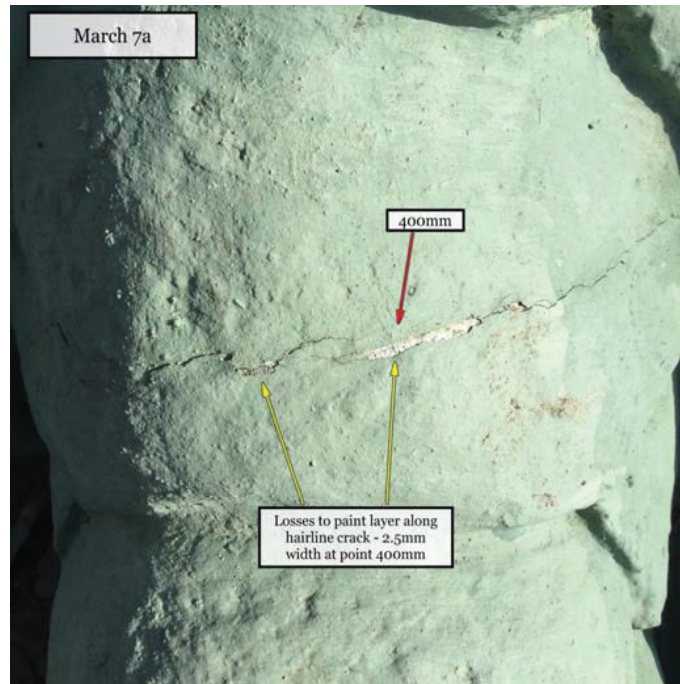
Plate 35 – Photographed 15.03.17 - Crack 7a – delamination and loss of paint along the crack.

Results from the monitoring of the front right and left feet between 15.12.16 and 15.03.17 indicate a series of hairline cracks. These cracks have formed since the 2015 restoration (Cliveden, 2015.) Crack 7a is the only crack to have increased in dimensions between 15.12.16 and 15.03.17. This increase is due to a loss in the paint layer, not due to increased cracking in the concrete. The delamination of the paint is possibly due to water ingress, facilitated by the hairline crack. All the cracks appear to be on the sites of previous restorations.

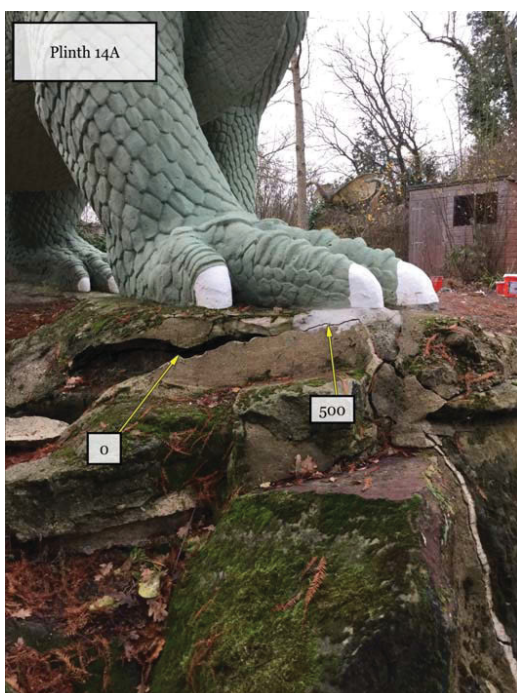
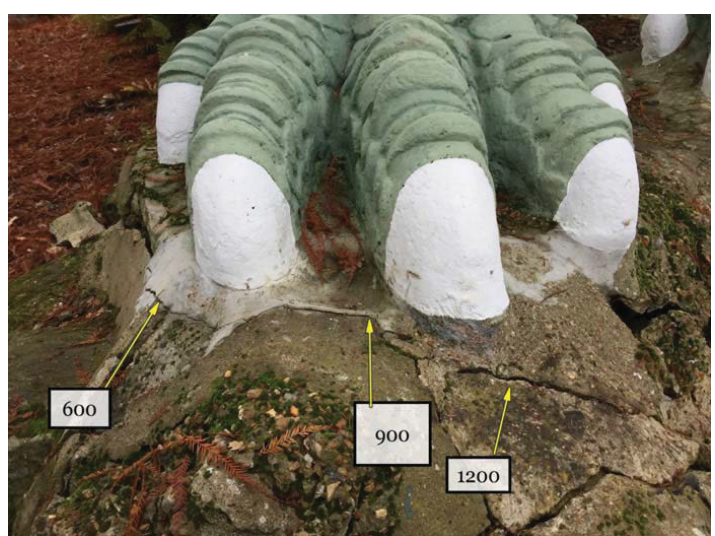
Plates 38 and 39 – Photographed 15.12.16 - Crack 14a

- The front plinth displays an extensive network of cracks. The two most prominent cracks were identified for monitoring, one horizontal 14a and one vertical 15a. See plates 36 and 37 for location.
- Crack 14a runs horizontally, through the site of previous concrete repairs, many of which are undocumented restorations.

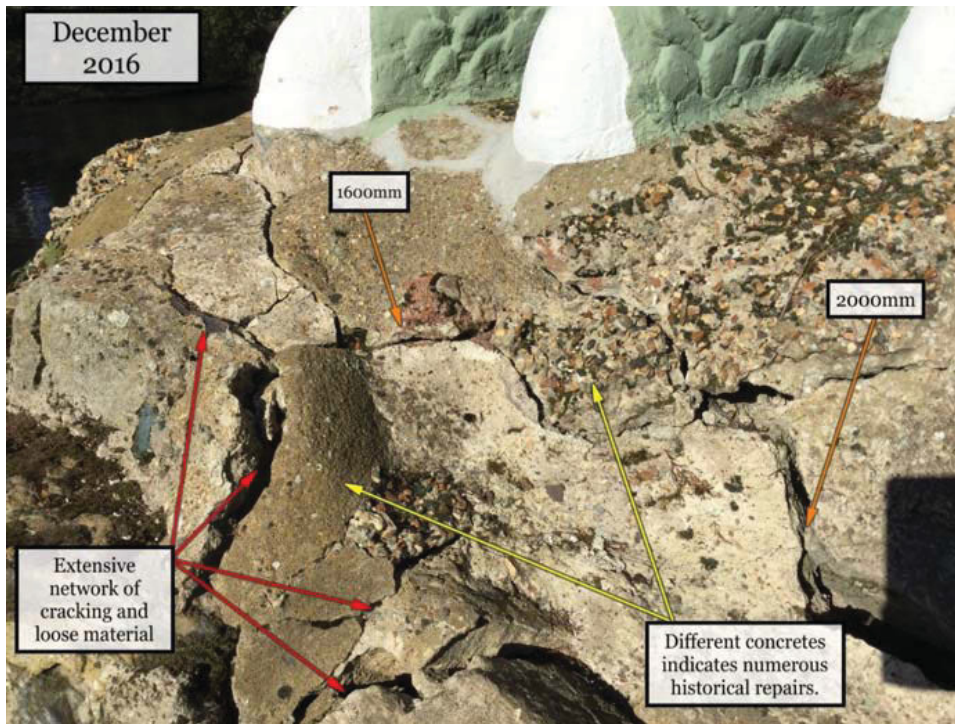
Plate 40. Photographed 15.12.16 – Complexity of crack network.

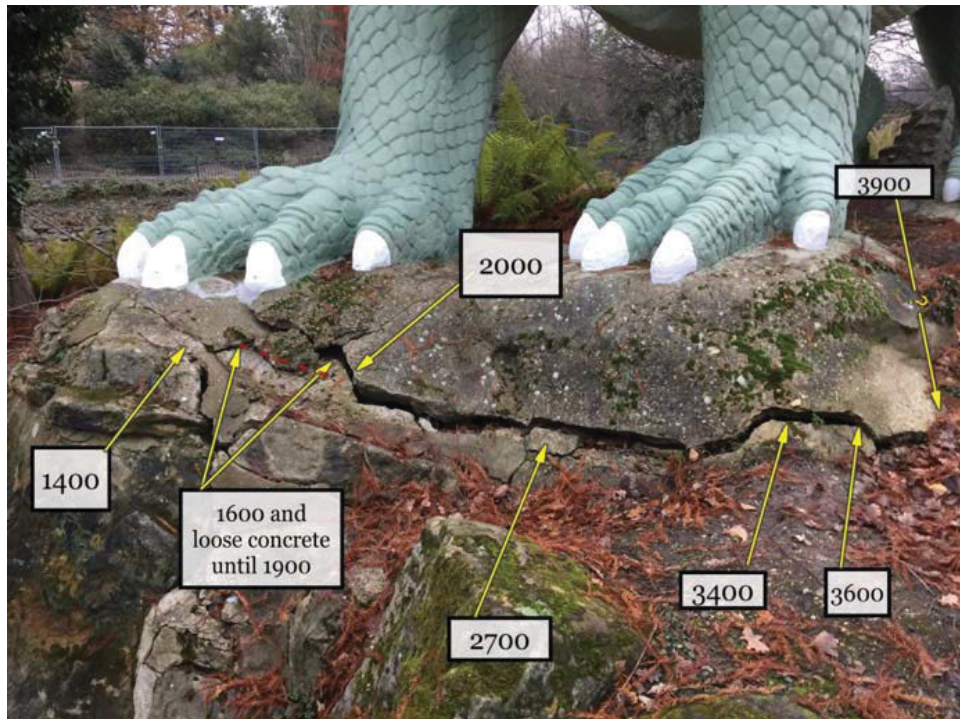
Plate 41. Photographed 15.12.16 – Crack 14A

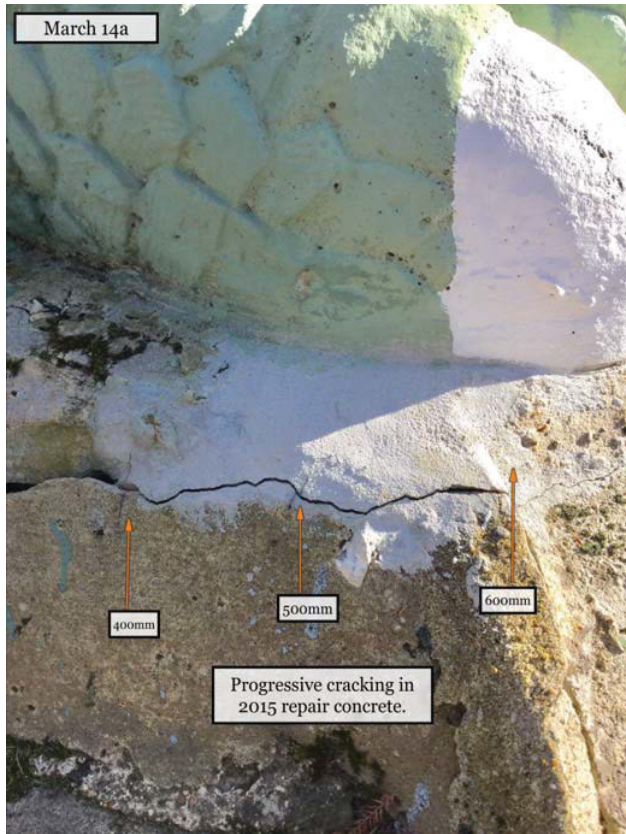
**Plate 42** – Photographed **15.03.17** – Crack 14A. Increase in width and depth between points 400-600mm between 15.12.16-15.03.17. Crack occurring in 2015 restoration concrete.

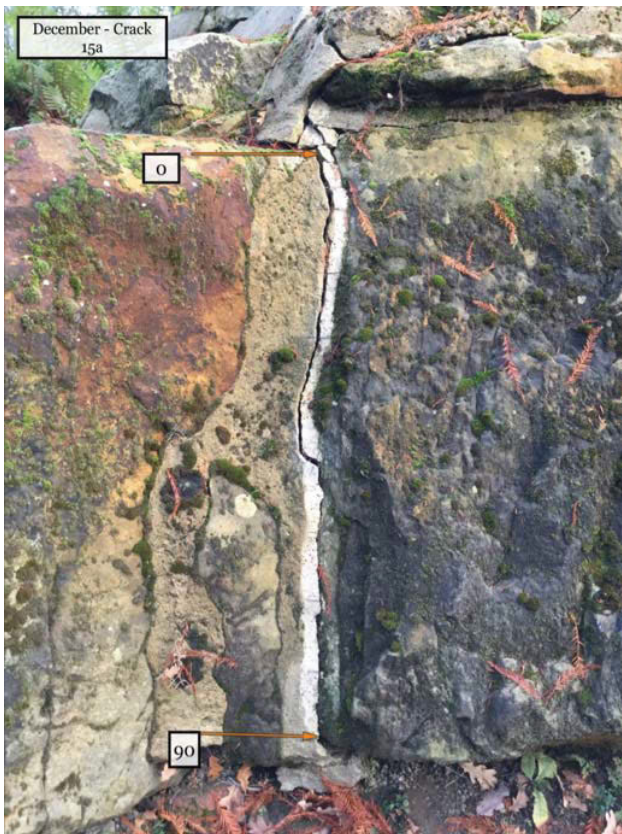
**Plate 43.** Photographed **15.12.16** – Crack 15A.

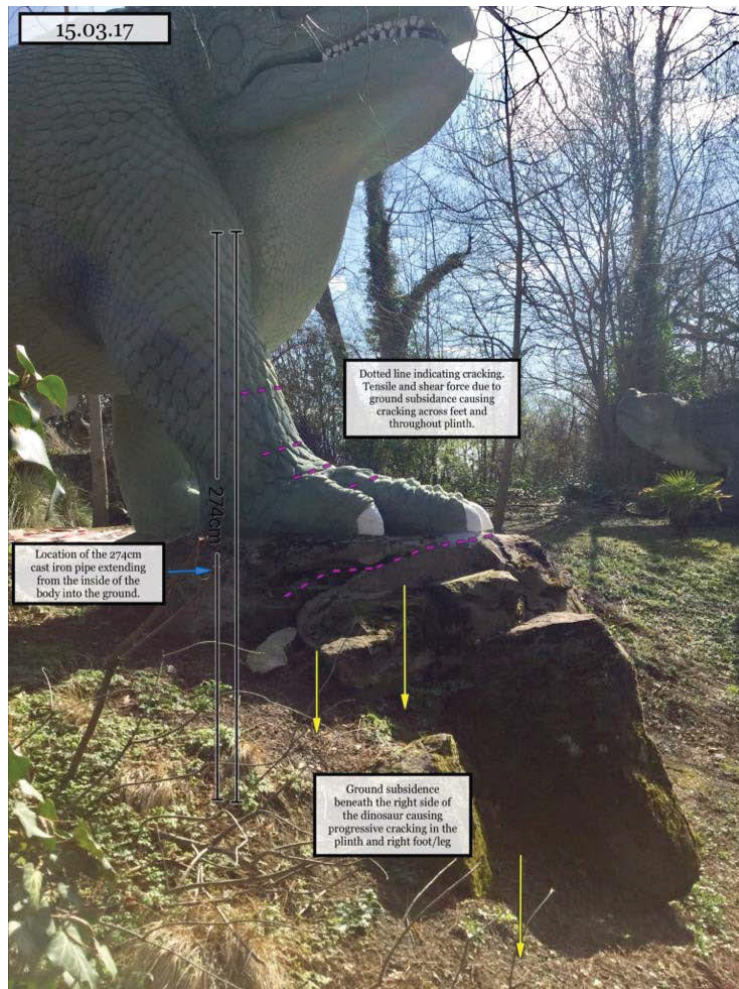
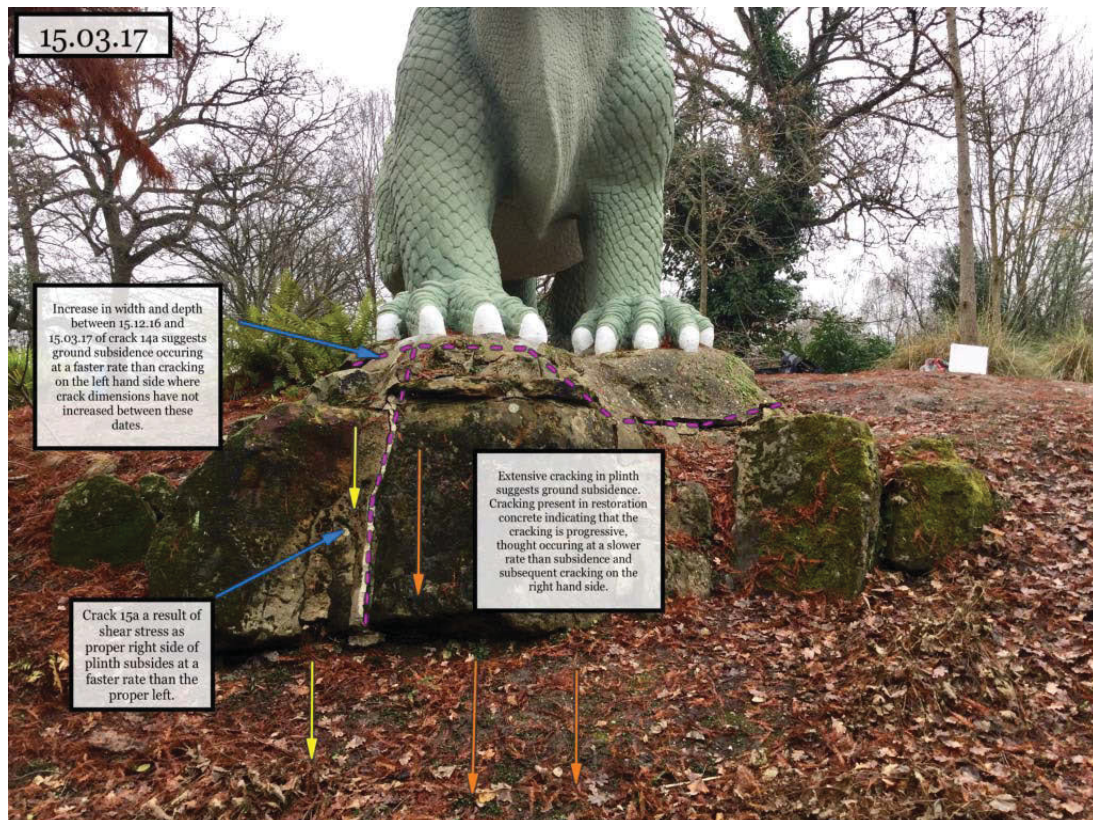
Plates 44 and 45 – Photographed 15.03.17

The plinth beneath the front right and left feet consists of large boulders of Weald sandstone and concrete. The extensive cracking in the historical concrete repairs indicate the cracking is progressive and due to ground subsidence. The increase in the width and depth of crack 14a on its proper right hand side and the apparent stability of dimensions of the crack on the left hand side suggest that the ground is subsiding at a faster rate beneath the right side of the dinosaur. See plates 44 and 45.

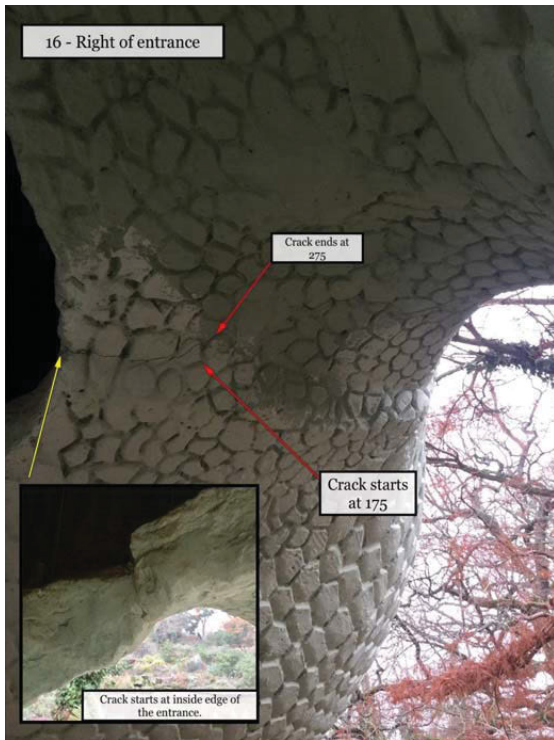
Plate 48 - Crack 16a – Photographed 15.12.16.

- The body has two primary cracks, identified as 16a and 17a. See plates 46 and 47.
- Both cracks start on the inside edge of the entrance to the dinosaur (on its underside), 16a on the right and 17a opposite on the left. The location of the cracks is fairly symmetrical. See plates 48 and 50.
- Both crack's widest and deepest points are on the underside of the dinosaur, emanating from the entrance. Both cracks then taper to a hairline from point 500/600mm onwards.
- Crack 16a increased in both width and depth between points 200mm-600mm between the dates 15.12.16 and 15.03.17. See graph 16.0.
- Crack 17a increased in both width and depth between points 100mm-500mm between the dates 15.12.16 and 15.03.17. See graph 17.0.
- Neither crack increased in length between 15.12.16 and 15.03.17.

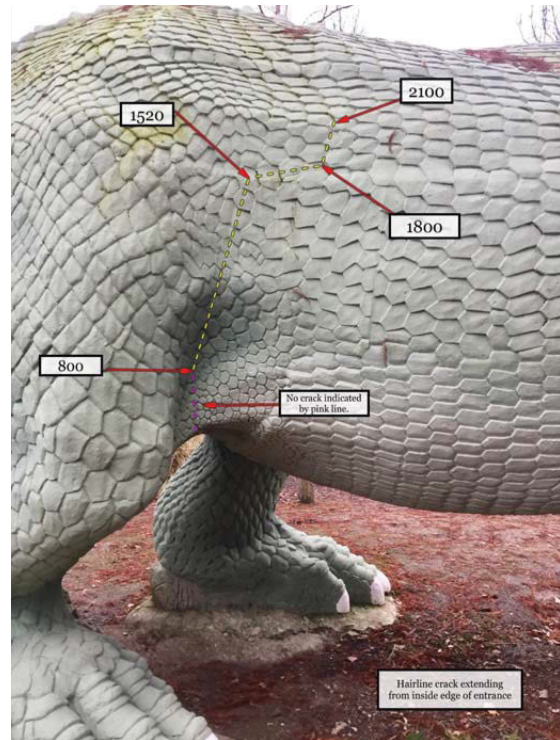
Plate 49 - - Crack 16a – Photographed 15.12.16.

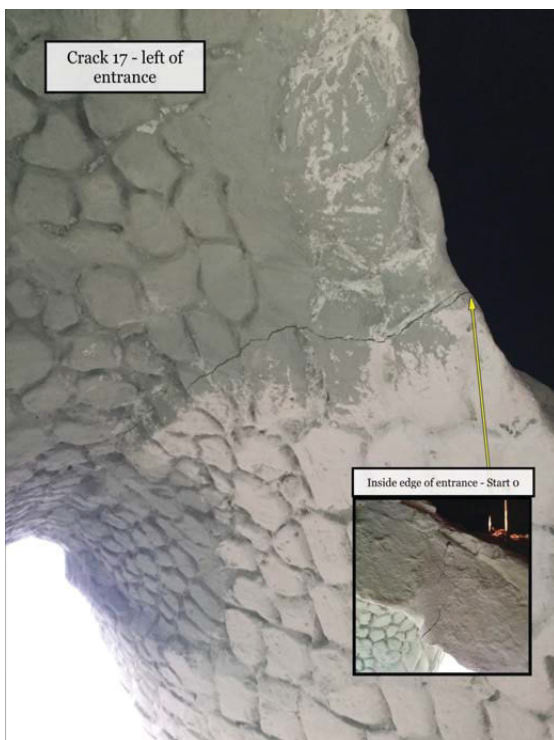
Plate 50- Crack 17a – Photographed 15.12.16.

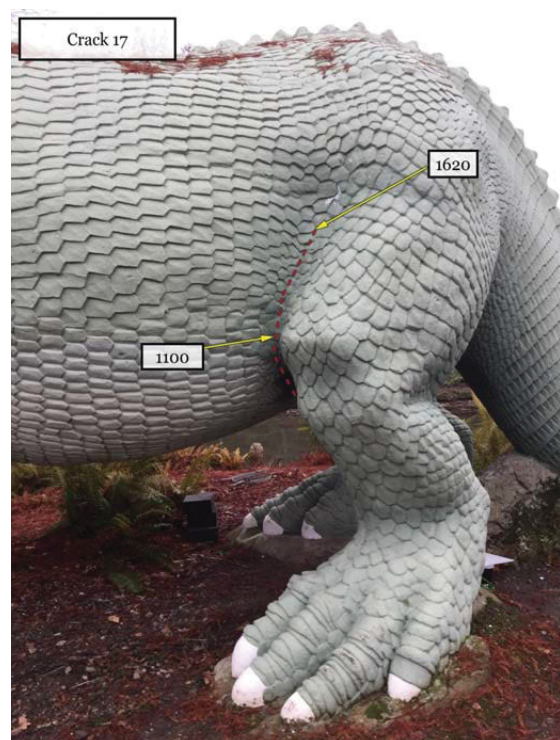
Plate 51- Crack 17a – Photographed 15.12.16.
