### A DEVELOPMENT OF A NEW METHODOLOGY FOR MAPPING AND MONITORING THE CONDITION OF 3DIMENSIONAL CULTURAL HERITAGE.

CASE STUDY: The Standing Iguanodon in Crystal Palace Park. Using Photogrammetry and 3D Digitalisation to Record Condition and to Map and Monitor Deterioration. Engaging Open Access as a Means of Digital Preservation and Project Outreach.

India Carpenter

Final Year Research Paper  
PG Diploma in Conservation  
Conservation Department 2017

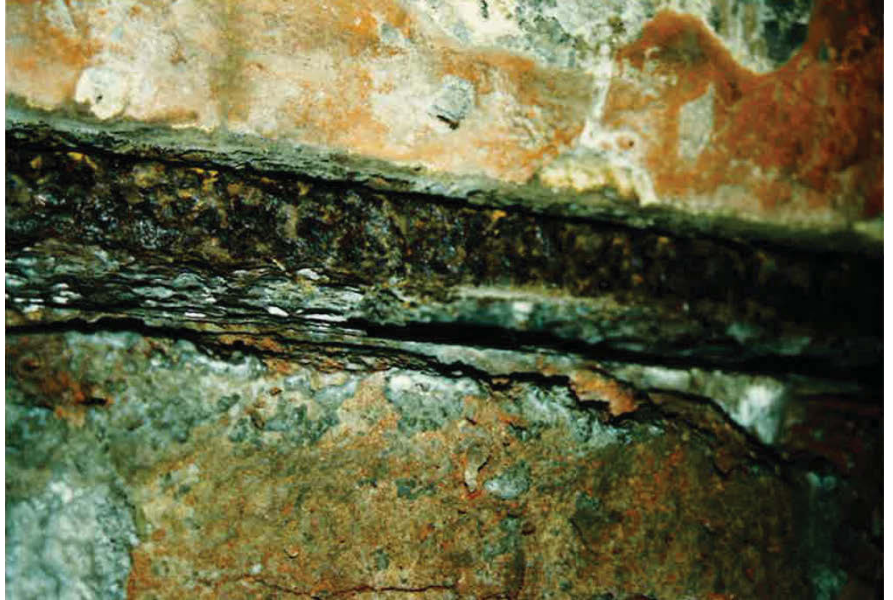
**Plate 9.** Corroded Iron hooping in the Iguanodon. Removed 2001<sup>10</sup>.

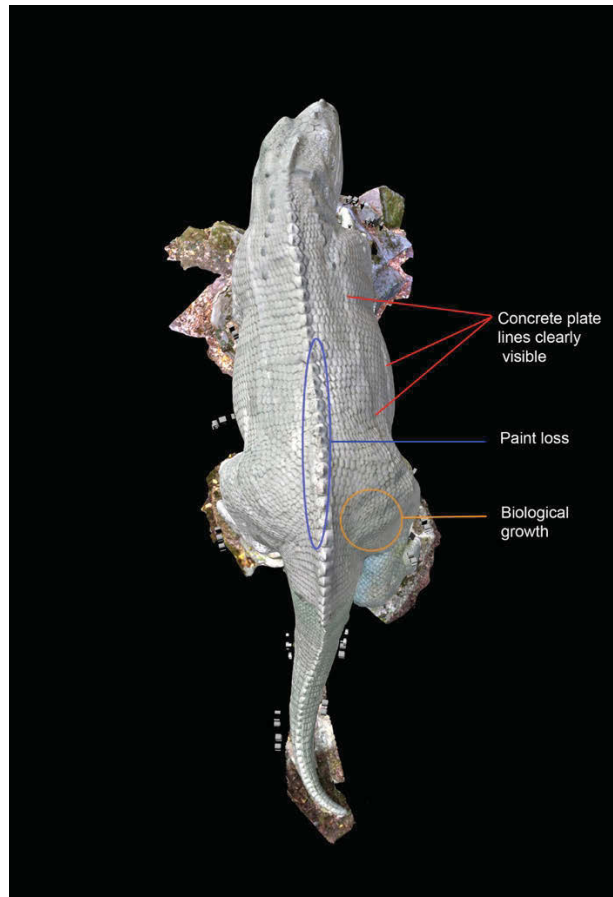
Plate 36 – Digital model viewed from the top – condition issues and structural details revealed<sup>35</sup>.

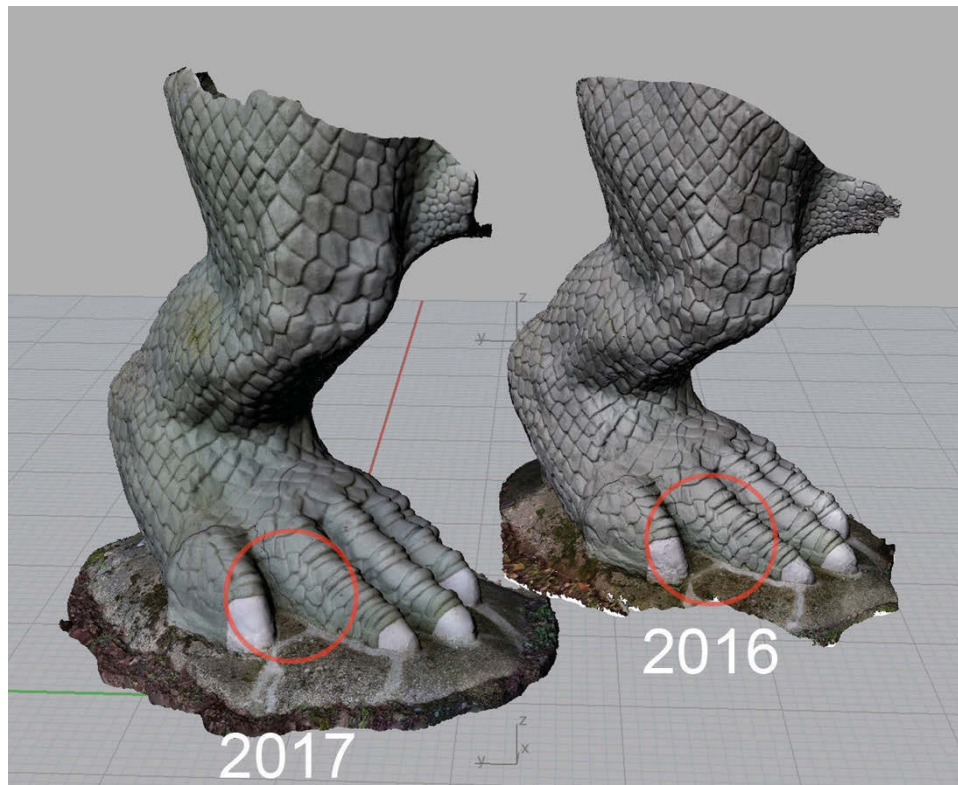
**Plates 37,38,39** –Images of the digital model comparing data from 2016 and 2017, red circles identifying concrete loss.<sup>37</sup>

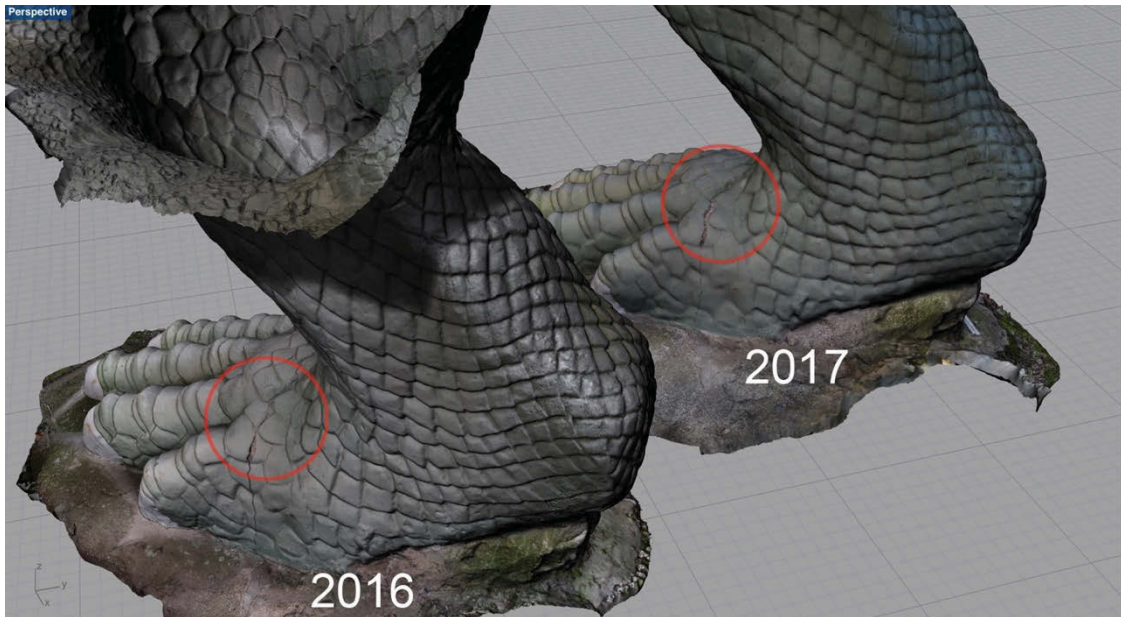
**Plate 40** – View of the inside leg 2016-2017 comparison. Red circles indicate areas of paint loss (crack 4A)<sup>38</sup>

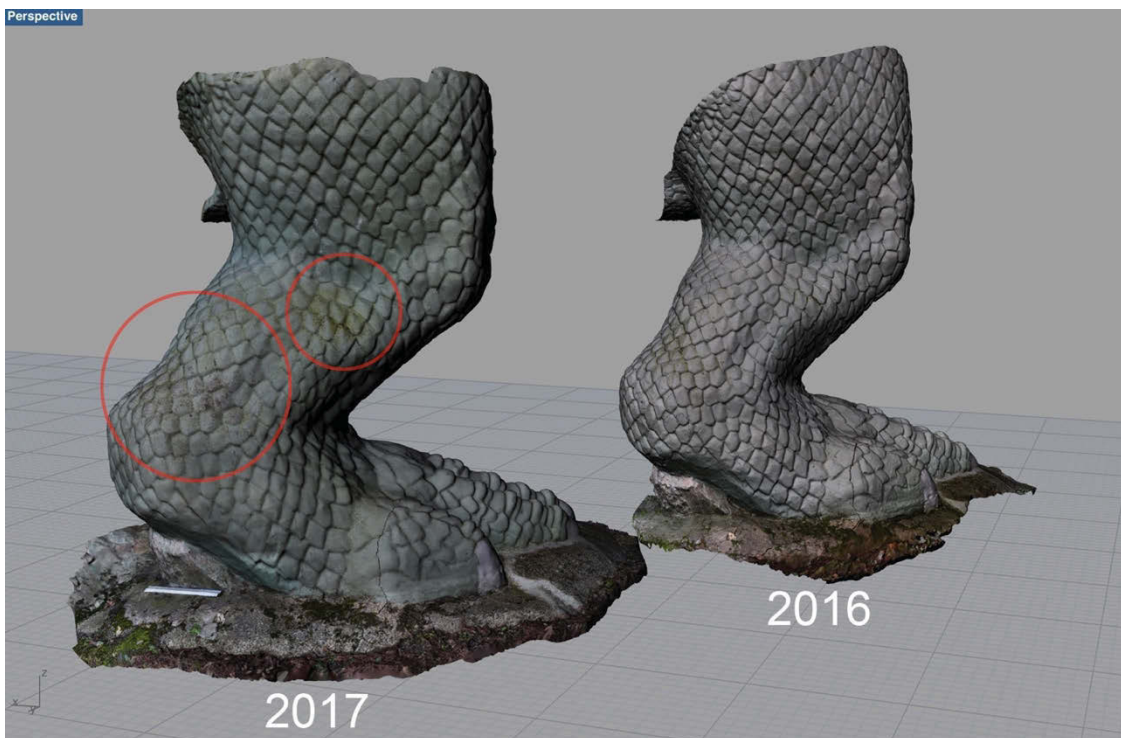
The models can also be used to compare other condition issues (see **plate 41**). The red circles highlight an increase in biological growth over the 3-month period and the muddy foot prints on the heel suggest that someone has tried to climb the side of the Iguanodon.

**Plate 41** – Red circles indicate biological growth and dirt<sup>39</sup>.

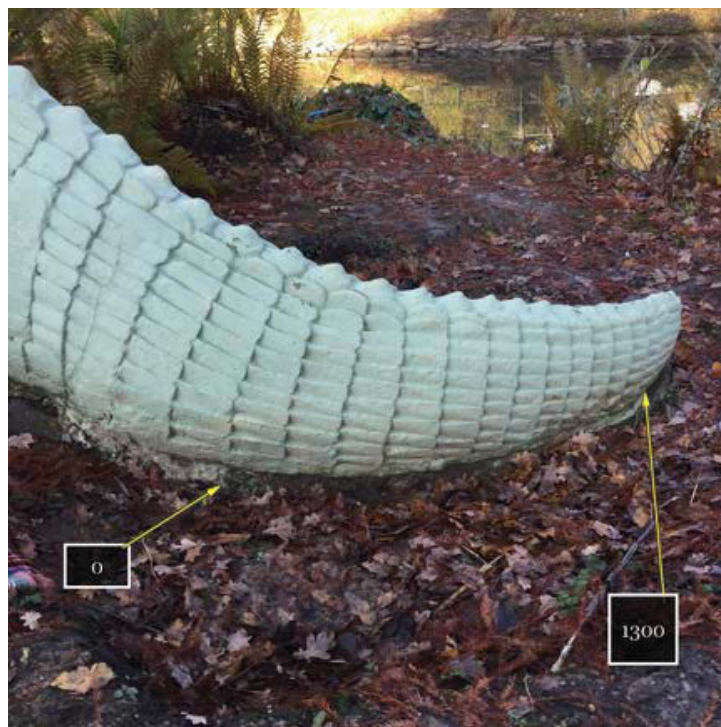
Plate 61-. Photographed 14.12.16 – Crack 2A origin point and end of tail<sup>56</sup>

Crack 2A continues from base and over to the left side of the tail where it meets crack 1a. Crack 2A has formed in the original concrete, not in a historical repair.

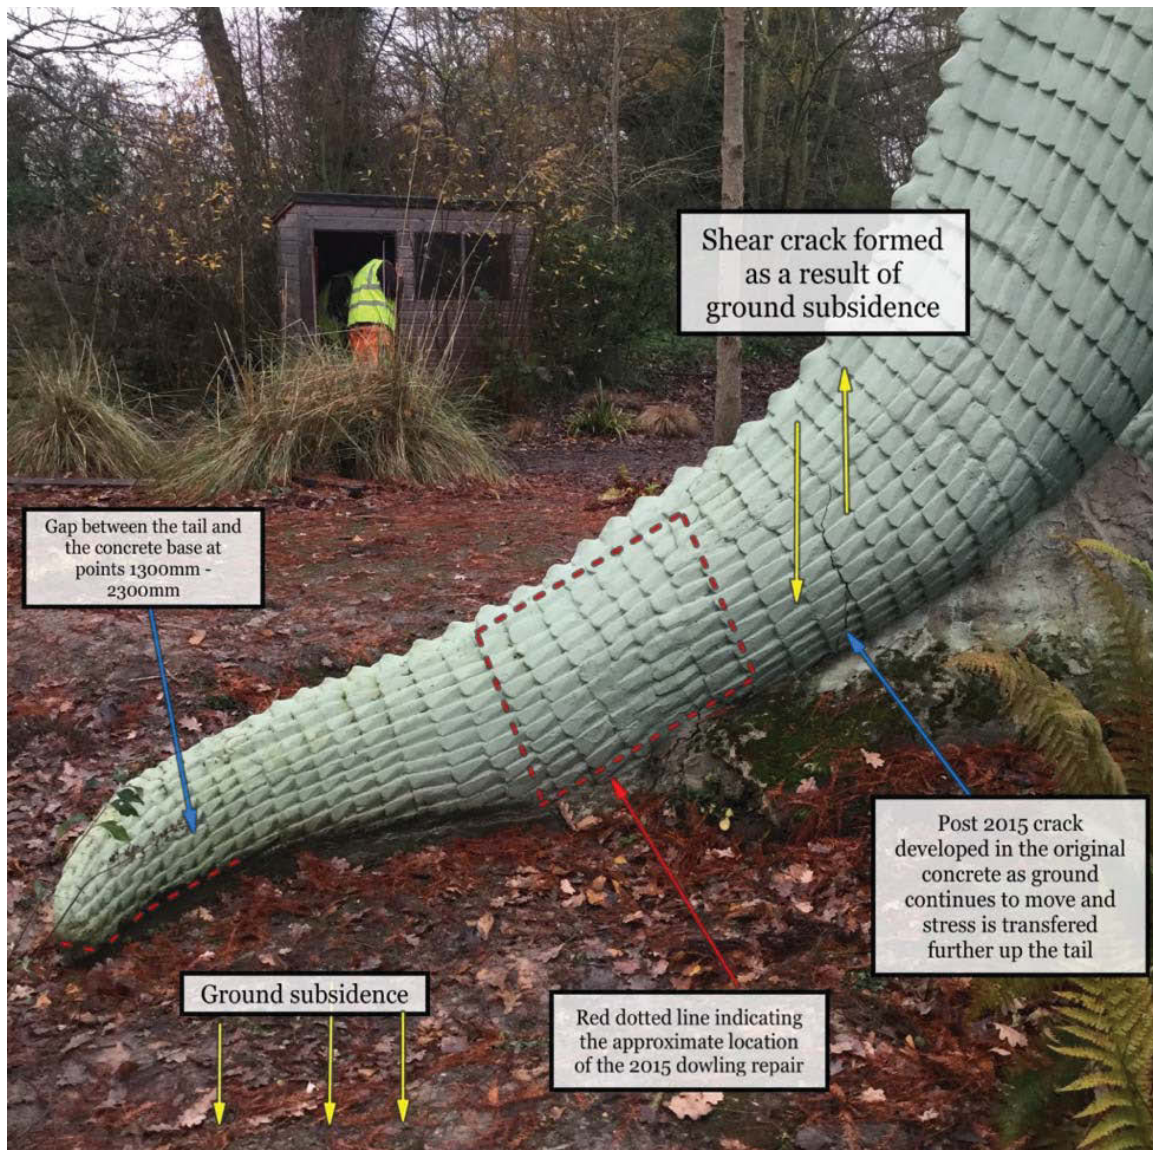
Results from the monitoring of the tail cracks between 14.12.2016 and 10.03.2017 indicate a series of cracks formed due to shear stress as the ground beneath the lower section of the tail subsides. This is causing progressive cracking. The crack across the width of the tail has formed in the original concrete, not in the 2015 repair. The 2015 repair treatment included the insertion of a steel dowel (Cliveden 2015). It is likely that the rigidity of the steel dowels is preventing a crack forming at this point and the stress is transferring further up into the tail where the new crack has developed in the original concrete.

Plate 65- Analysis of structural deterioration – Tail<sup>60</sup>

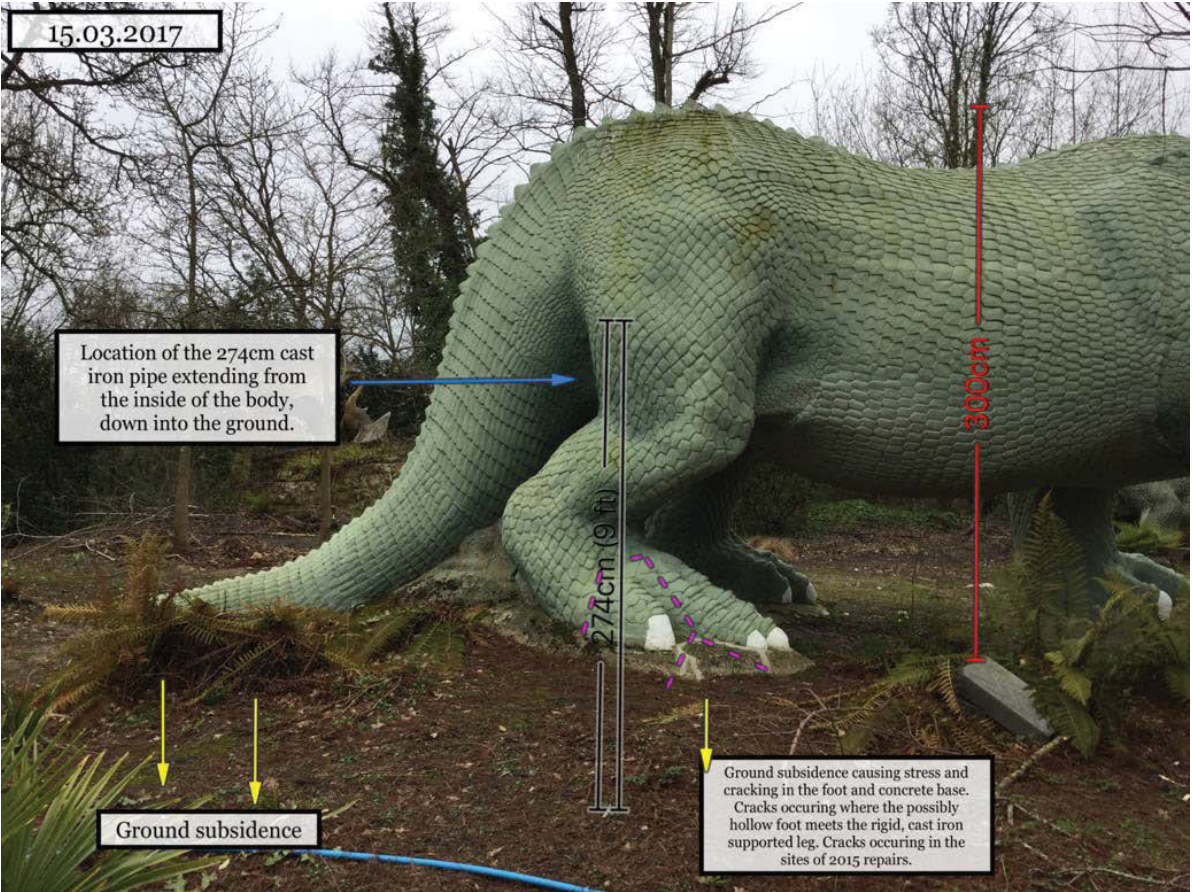
Results from the monitoring of the back left and right feet between 15.12.16 and 15.03.17 indicate a series of cracks, forming and increasing in width and depth at points, along the top of the back right foot and in the concrete base of the foot. These cracks are occurring at the sites of the previous 2015 repairs, indicating that these are progressive cracks caused by ground subsidence. The back right leg, formed around a 9ft (274cm) cast iron pipe which extends down into the ground, shows no evidence of cracking. Cracking appears at the point of stress where the apparently hollow foot meets the ridged leg. The back left leg displays only one short hairline crack, which has not increased dimensions between the two dates, suggesting that the ground is more stable on the left hand side of the dinosaur and subsiding on the right hand side. The numerous losses along crack 4a are the result of delaminating concrete applied during the 2015 restoration. The concrete has not adhered sufficiently to the concrete substrate and further delamination is developing.

Plate 68- Analysis of structural deterioration – back legs<sup>61</sup>

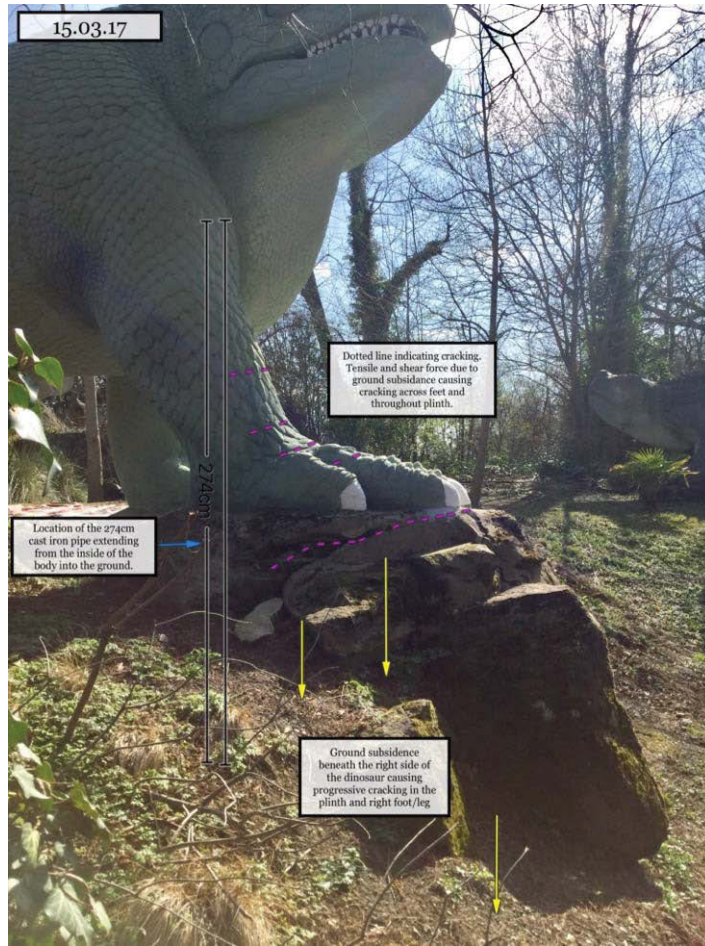
The plinth beneath the front right and left feet consists of large boulders of Weald sandstone and concrete. The extensive cracking in the historical concrete repairs indicate the cracking is progressive and due to ground subsidence. The increase in the width and depth of crack 14a on its proper right hand side and the apparent stability of dimensions of the crack on the left hand side suggest that the ground is subsiding at a faster rate beneath the right side of the dinosaur. See plates 73 and 74.

Plates 73 and 74 – Analysis of structural deterioration – Front Plinth<sup>62</sup>

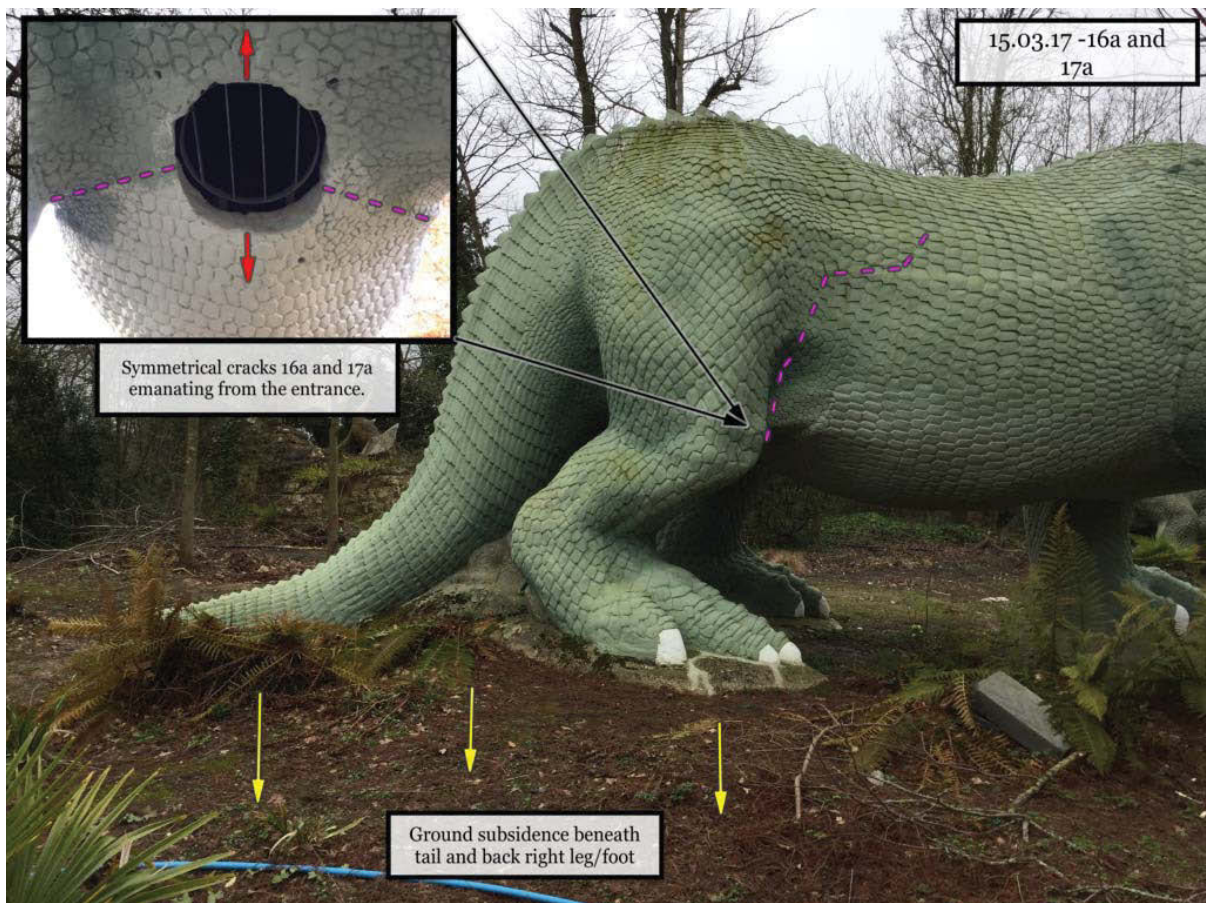
- The body has two primary cracks, identified as 16a and 17a. See plates 75 and 76.
- Both cracks start on the inside edge of the entrance to the dinosaur (on its underside), 16a on the right and 17a opposite on the left. The location of the cracks is fairly symmetrical. See plates 109 and 111.
- Both crack's widest and deepest points are on the underside of the dinosaur, emanating from the entrance. Both cracks then taper to a hairline from point 500/600mm onwards.
- Crack 16a increased in both width and depth between points 200mm-600mm between the dates 15.12.16 and 15.03.17. See graph 16.0.
- Crack 17a increased in both width and depth between points 100mm-500mm between the dates 15.12.16 and 15.03.17. See graph 17.0.
- Neither crack increased in length between 15.12.16 and 15.03.17.

Plate 77- Analysis of structural deterioration – Body<sup>63</sup>

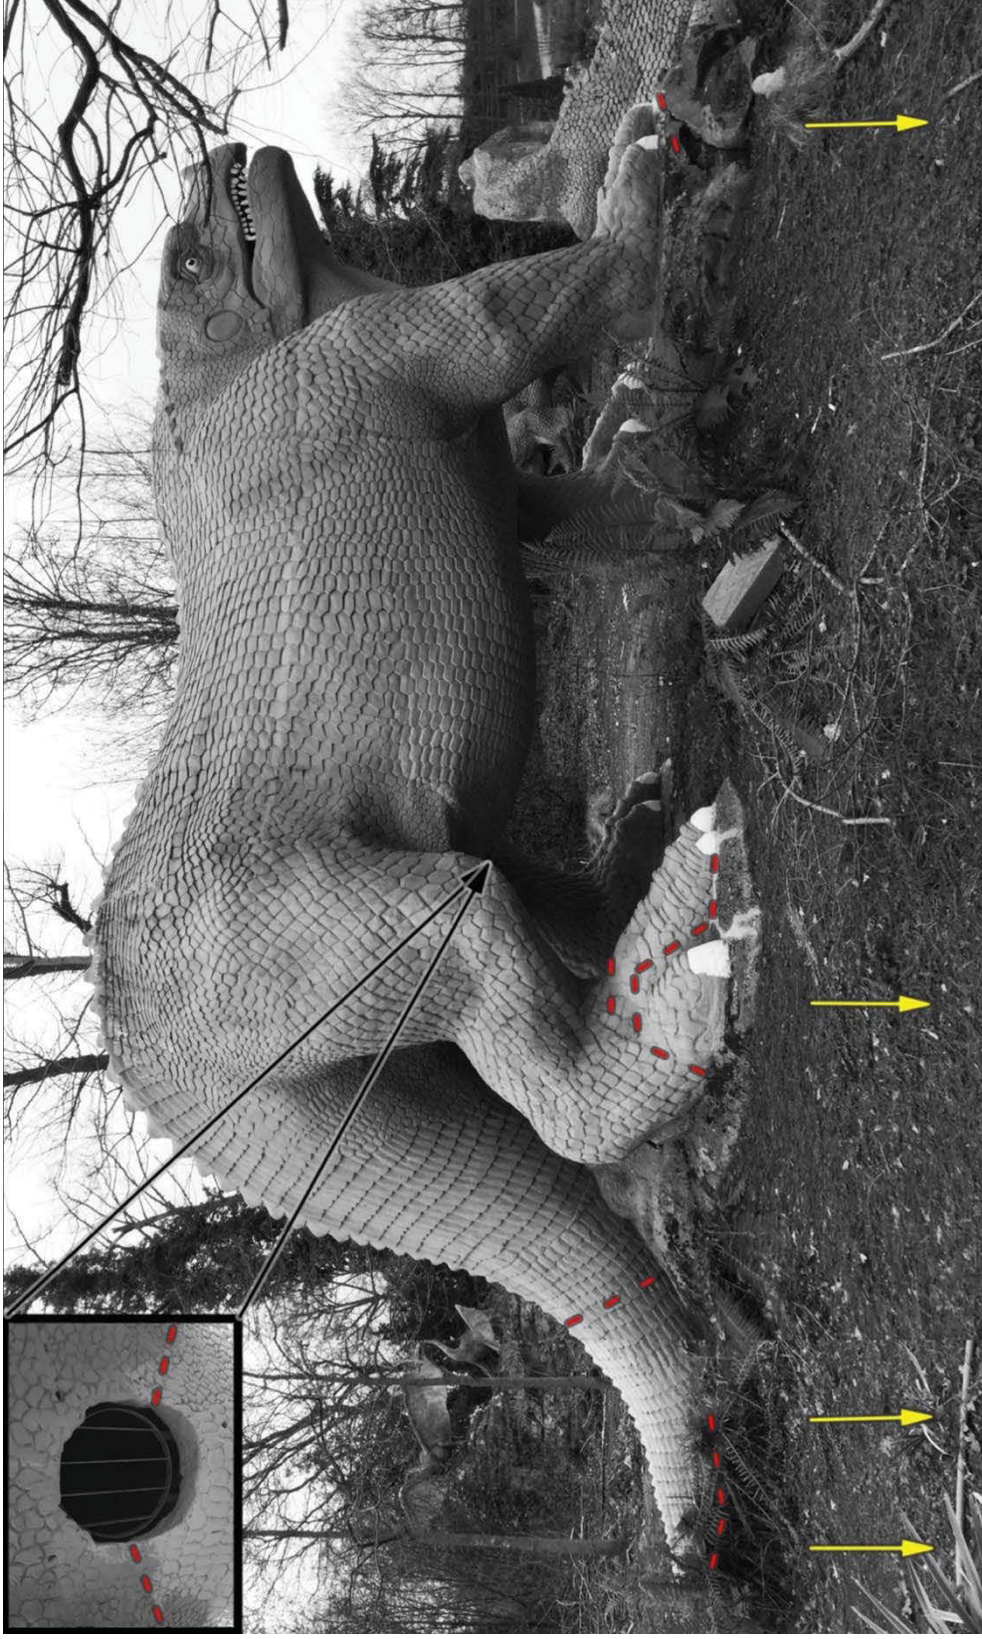
Plate 78- Conclusion of Structural Analysis<sup>64</sup>

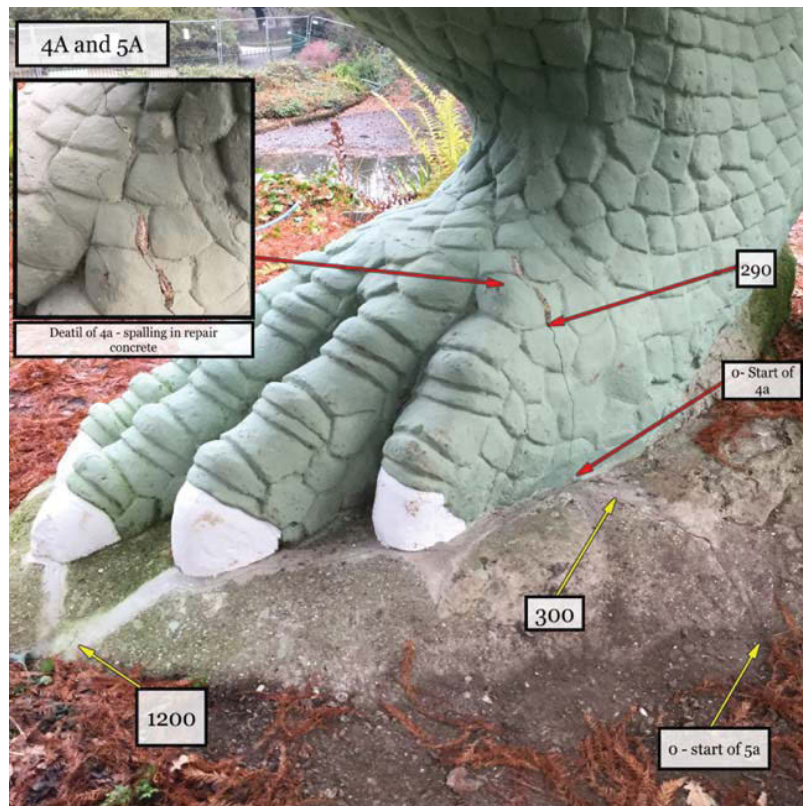
Crack 4a and 5a – see plate 19 for location. Detail images depicting progressive deterioration related to cracking. Numbers refer to measurement points along the length of the crack in millimetres.

Plate 89. Crack 4A and 5A – Photographed 15.12.16<sup>70</sup>

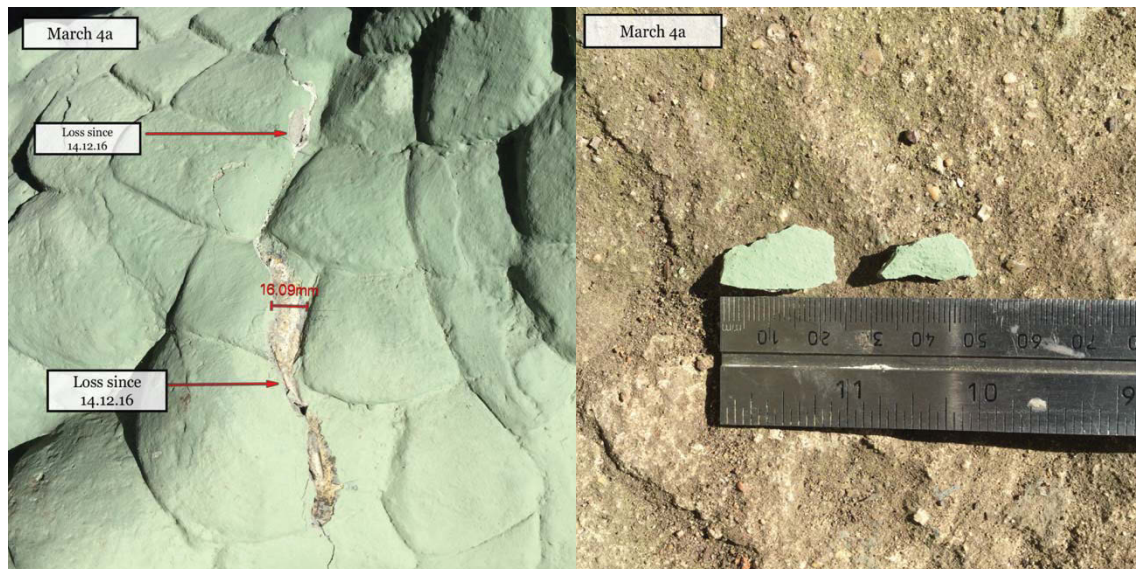
Plates 90 and 91. Crack 4A – Photographed 15.03.17 – disassociated losses incurred since 2016<sup>71</sup>

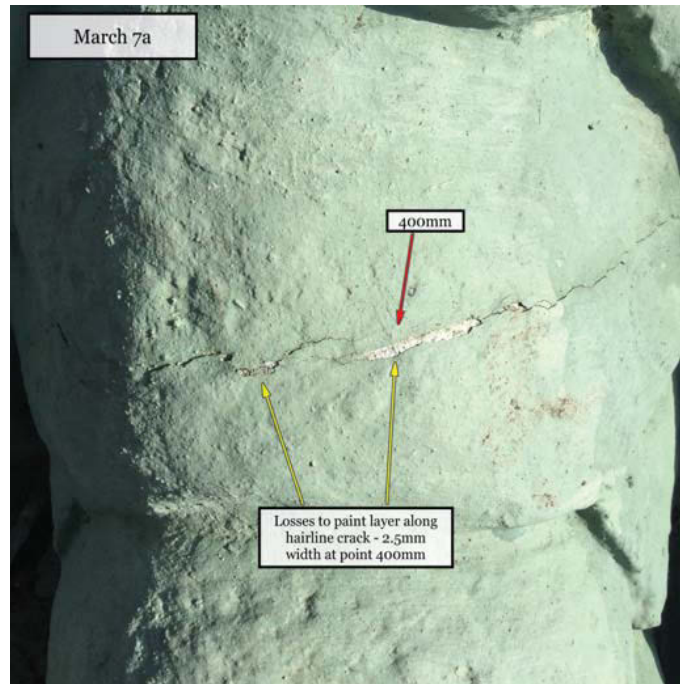
Plate 97 – Photographed 15.03.17 - Crack 7a – delamination and loss of paint along the crack<sup>75</sup>.

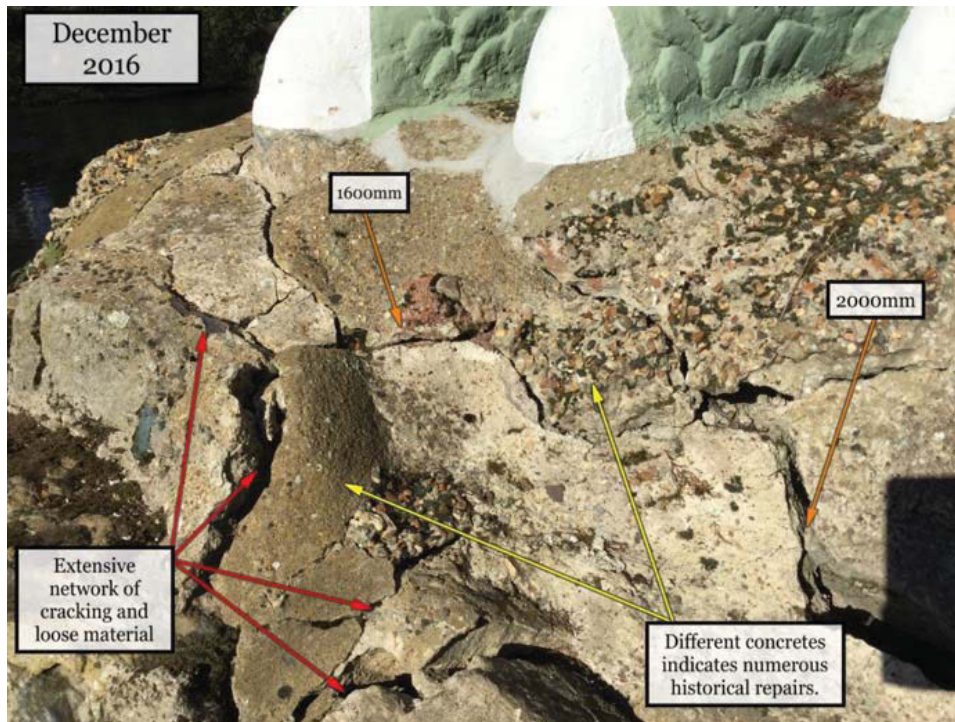
Plate 102- Photographed 15.12.16 – Complexity of crack network<sup>77</sup>

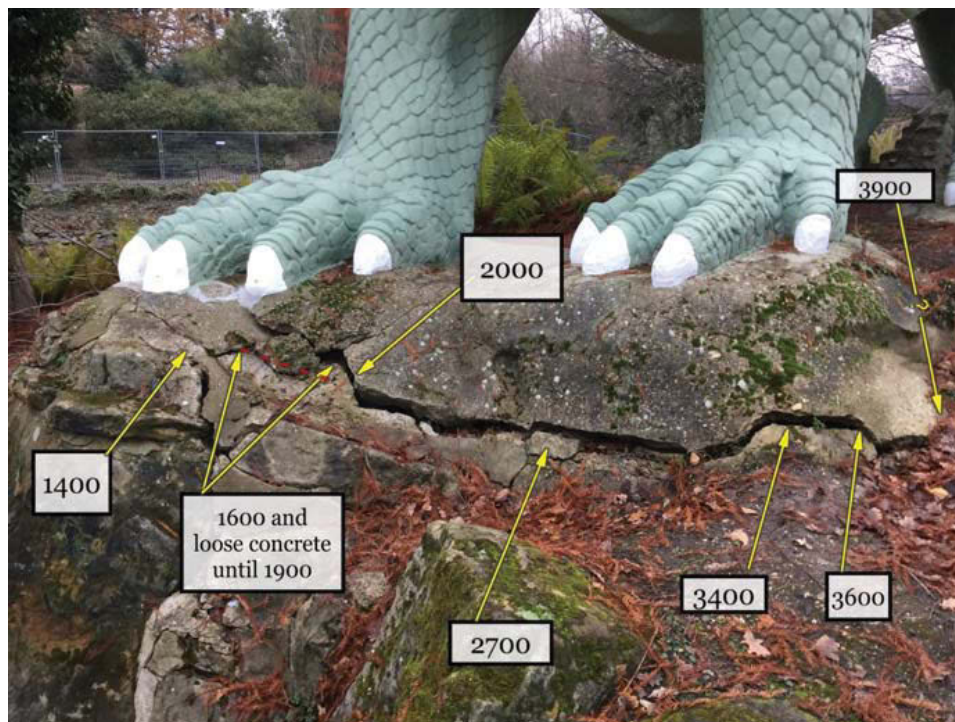
Plate 103- Photographed 15.12.16 – Crack 14A<sup>78</sup>

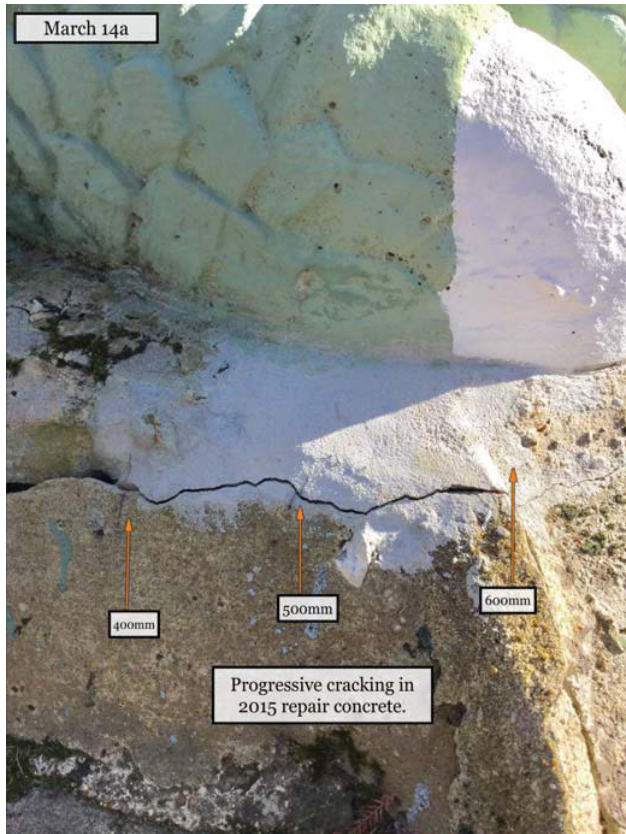
**Plate 104** – Photographed 15.03.17 – Crack 14A. Increase in width and depth between points 400-600mm between 15.12.16-15.03.17. Crack occurring in 2015 restoration concrete<sup>79</sup>

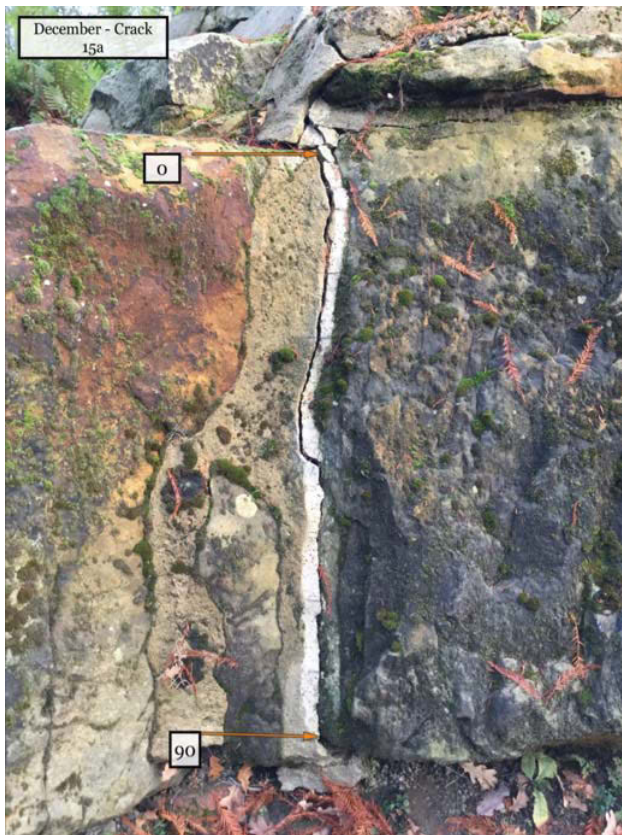
**Plate 105**- Photographed 15.12.16 – Crack 15A<sup>80</sup>

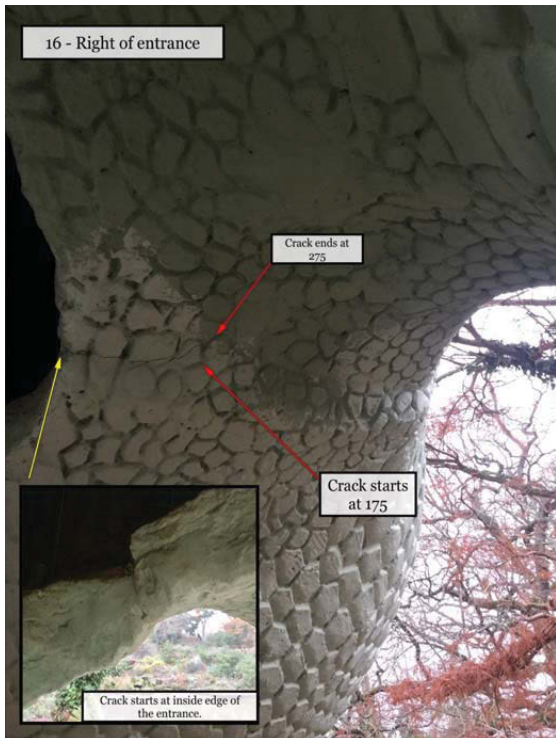
Plate 109- Crack 16a – Photographed 15.12.16<sup>81</sup>

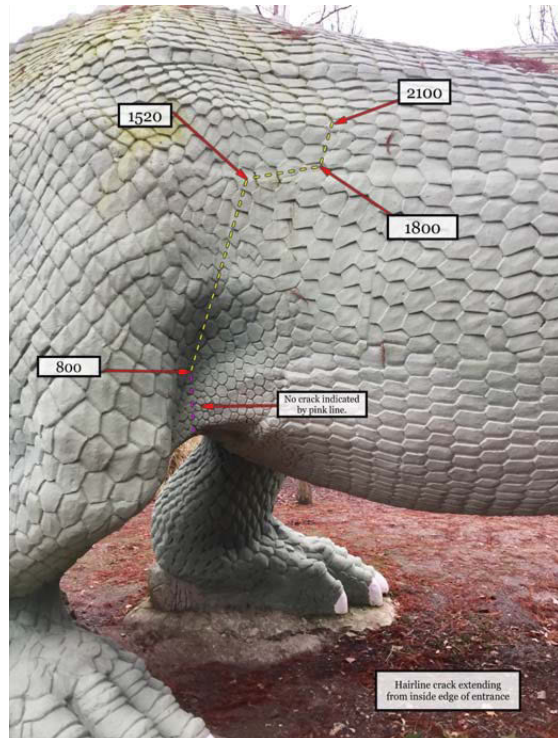
Plate 110- Crack 16a – Photographed 15.12.16<sup>82</sup>

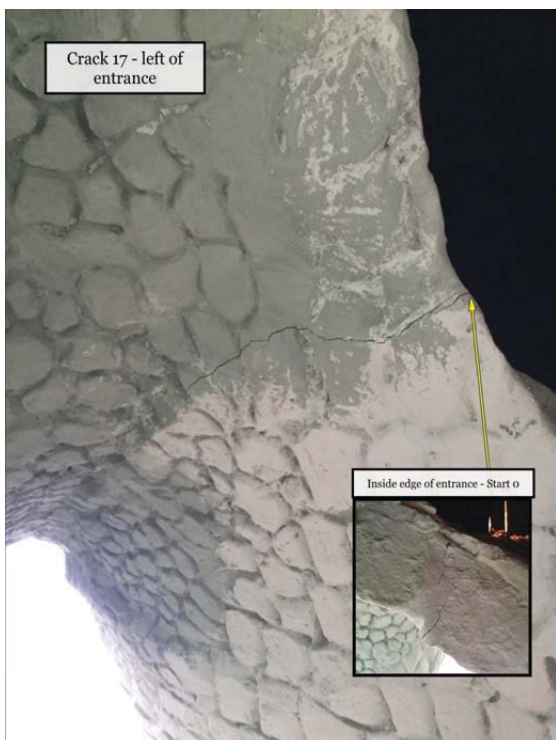
Plate 111- Crack 17a – Photographed 15.12.16<sup>83</sup>

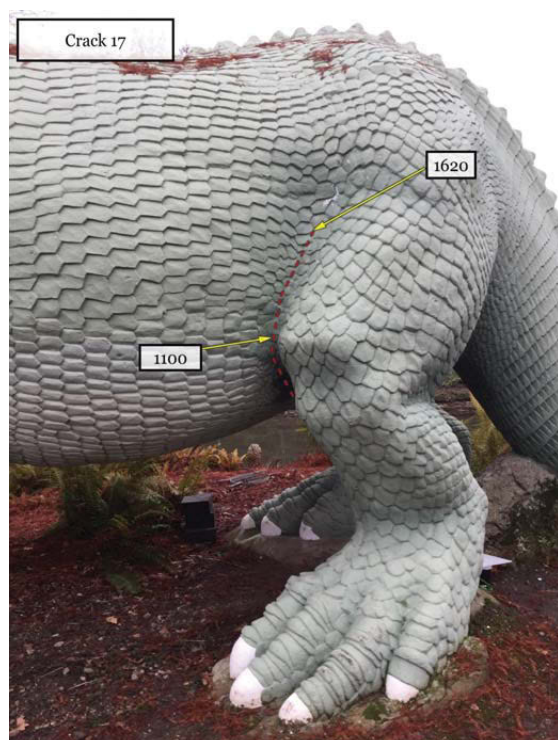
Plate 112- Crack 17a – Photographed 15.12.16<sup>84</sup>
