# BRIGHTLEY BARTON

## Archaeological and Historic Building Recording

**Location:** Brightley Barton  
**Parish:** Dolton  
**District:** Torridge  
**County:** Devon  
**NGR:** SS54961148

**Planning Application no:** 1/0343/2013/LBC  
**Proposal:** Alteration and extension to dwelling  
**Historical Environment Team Ref:** ARCH/DM/TO.201301  
**Museum Accession No:** NDDMS 2013.27

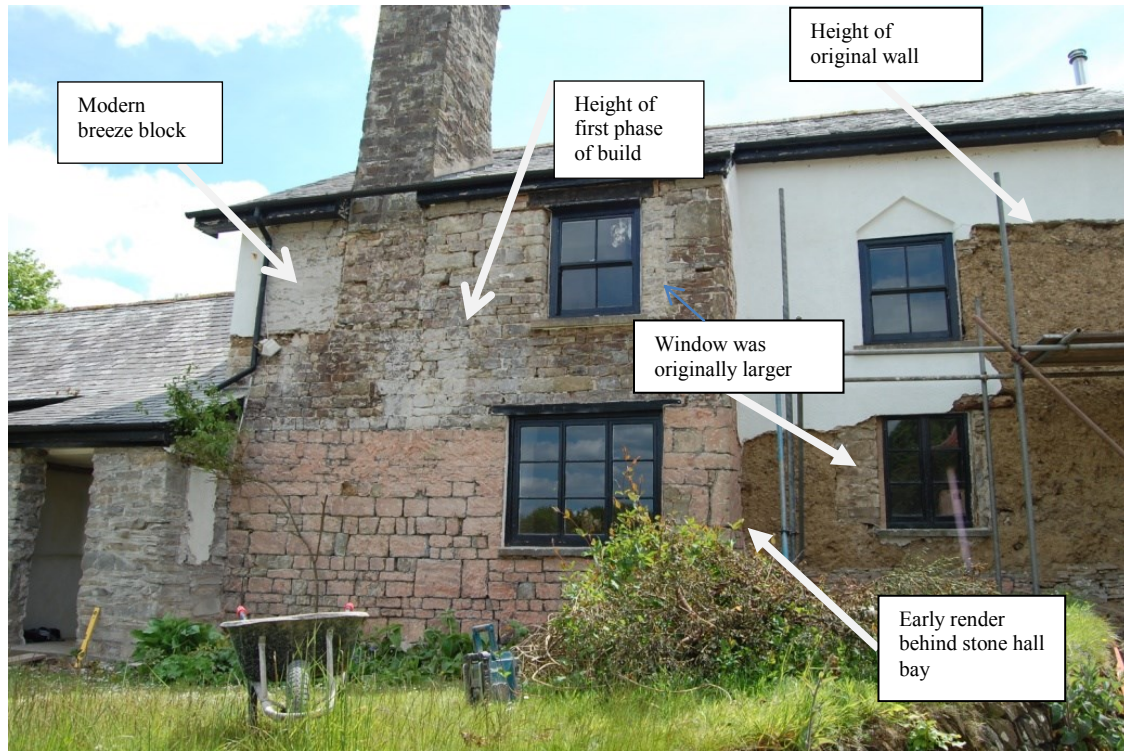
When the modern cementitious render was removed the most striking feature was the hall bay (Room 2) which is constructed from dressed stone. This feature was almost certainly designed to be seen as exposed stonework rather than rendered. Dressed stonework would have been a costly undertaking and it was therefore clearly a symbol of status.

Close examination of this hall bay reveals that it was most probably built in at least three phases. It is possible to see the early render behind the dressed stone bay. This categorically indicates that the central bay is a later addition to the building.

The hall bay was originally built at ground level only and incorporated the lateral stack of the chimney. The hall bay was then extended to first floor on the right of the stack but the roof would have still swept around the left hand side of the gable end above Room 1. The swept thatch can clearly be seen in an old photograph of Brightley. It is interesting to see that the current porch is a later addition to the glass porch in the early photograph.

*Figure 2: Removal of Render in Progress Revealing Dressed Stone of Hall Bay*

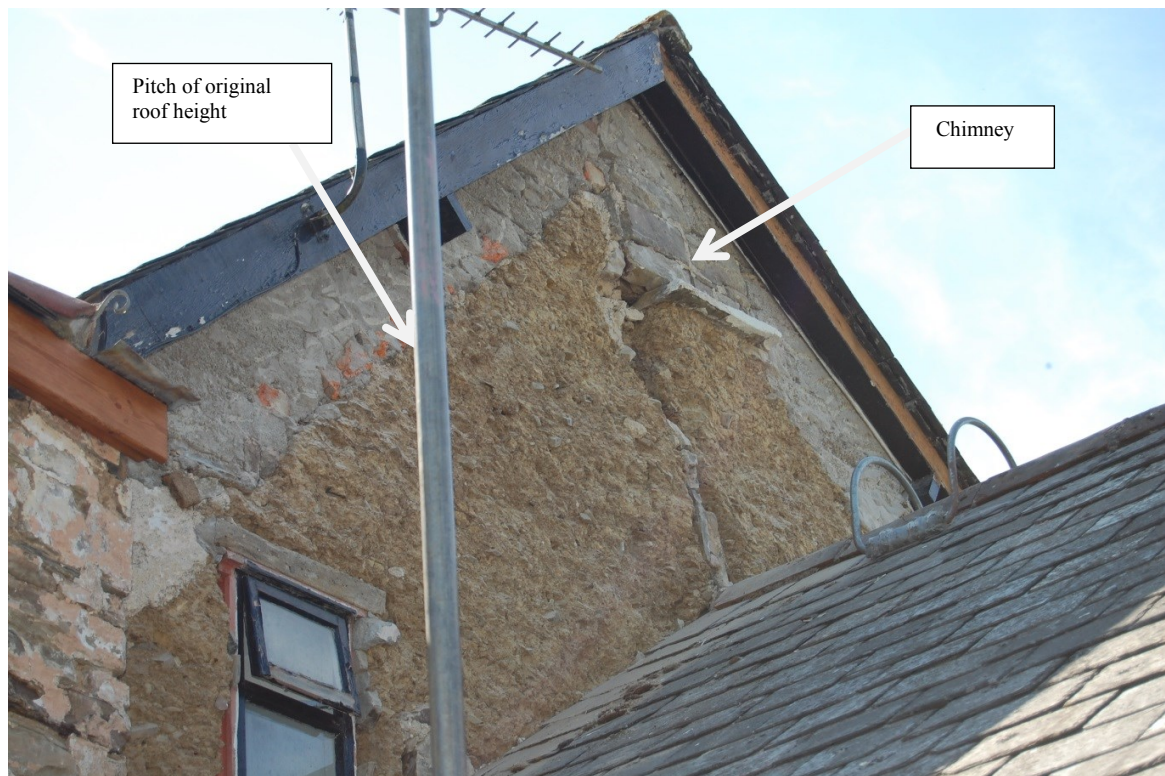
The render on the gable end facing west (of Room 2) was removed and this revealed stone above a feature that was previously described as a drip moulding. This stone probably forms the base of what was an earlier chimney stack serving a fireplace backing onto the cross passage which was replaced by the lateral stack built in conjunction with the hall bay.

*Figure 3: Gable End of Room 2 Facing East*

The cob wall now exposed on the west and east gable end has been heightened to accommodate a first floor when the stone hall bay was added.

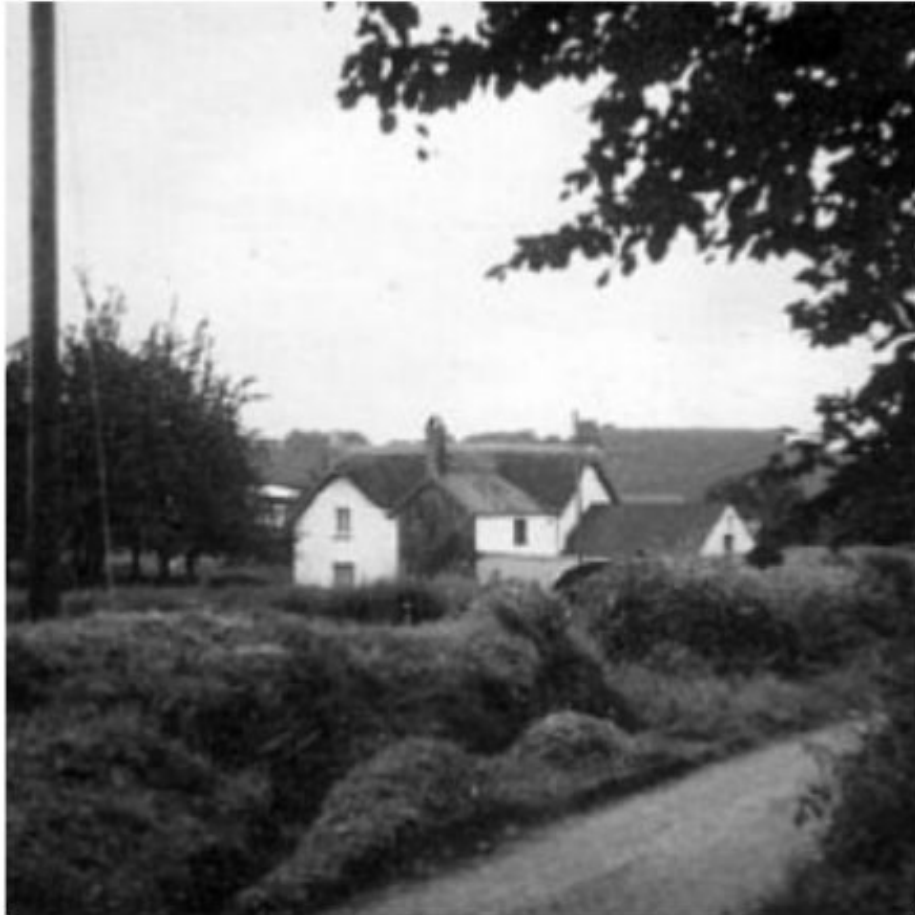
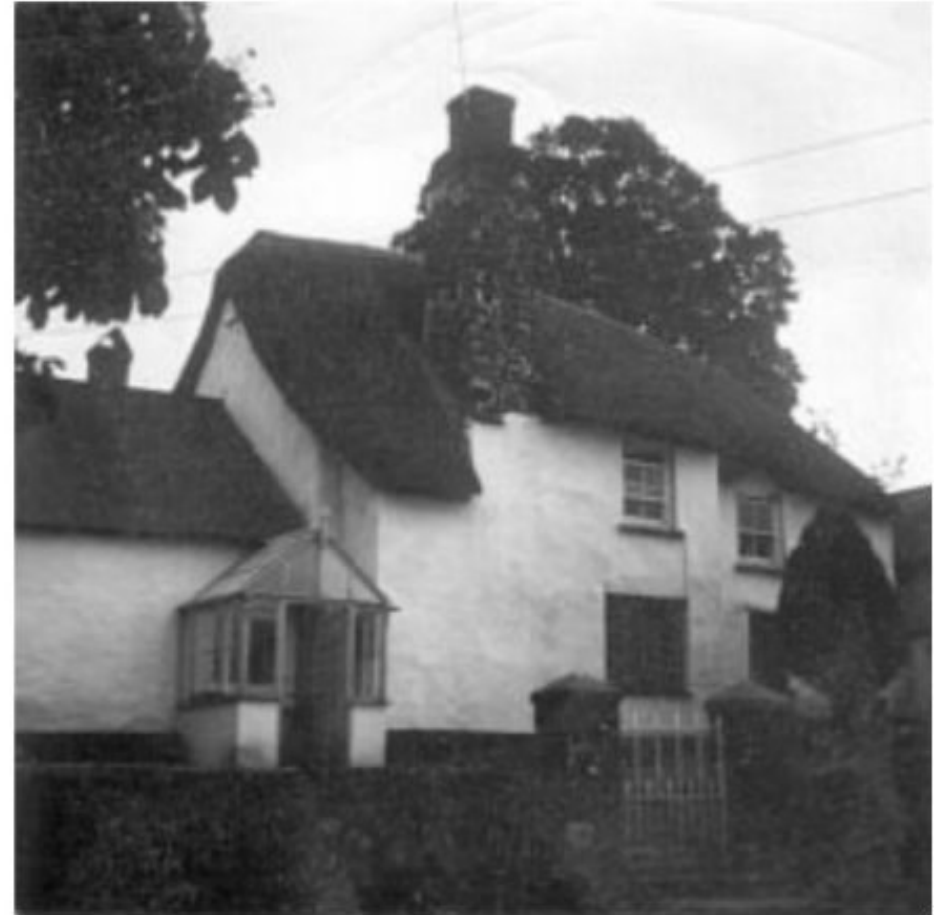
*Figure 4: Unreferenced photographs showing front and rear elevation.<sup>1</sup>*

<sup>1</sup> Note the swept thatch and part glazed porch and the un-rendered kitchen wing

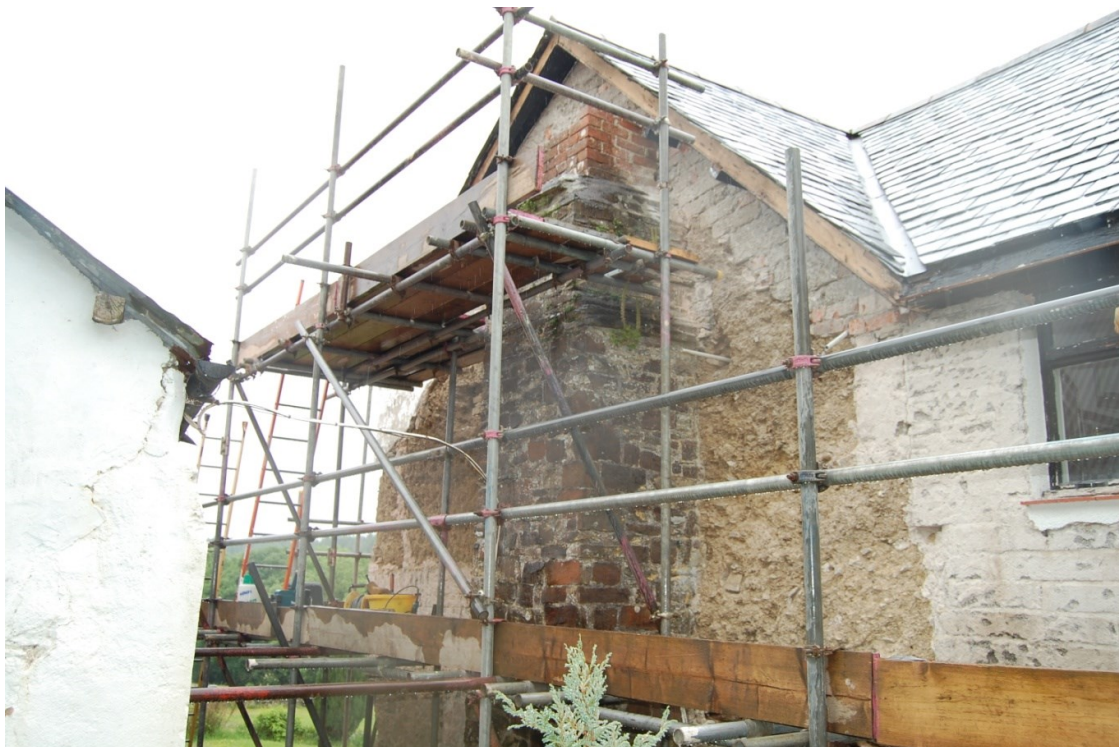
The left side of the hall bay was built up in breeze block and the roof was heightened, evident at the gable ends and at first floor height above Room 3. This appears to have been done solely to alter the pitch of the roof as the building wasn't significantly heightened internally. The entire building would then have been rendered in cementitious render.

*Figure 5: West Gable End Showing How the Breeze Blocks Have Been Added Above Cob*

The external chimney on the west end existed prior to the upper storey being heightened, but a brick extension was added to give the stack more height. The ground floor window of Room 3 would originally have been much wider, possibly three mullioned and this has been reduced in size.

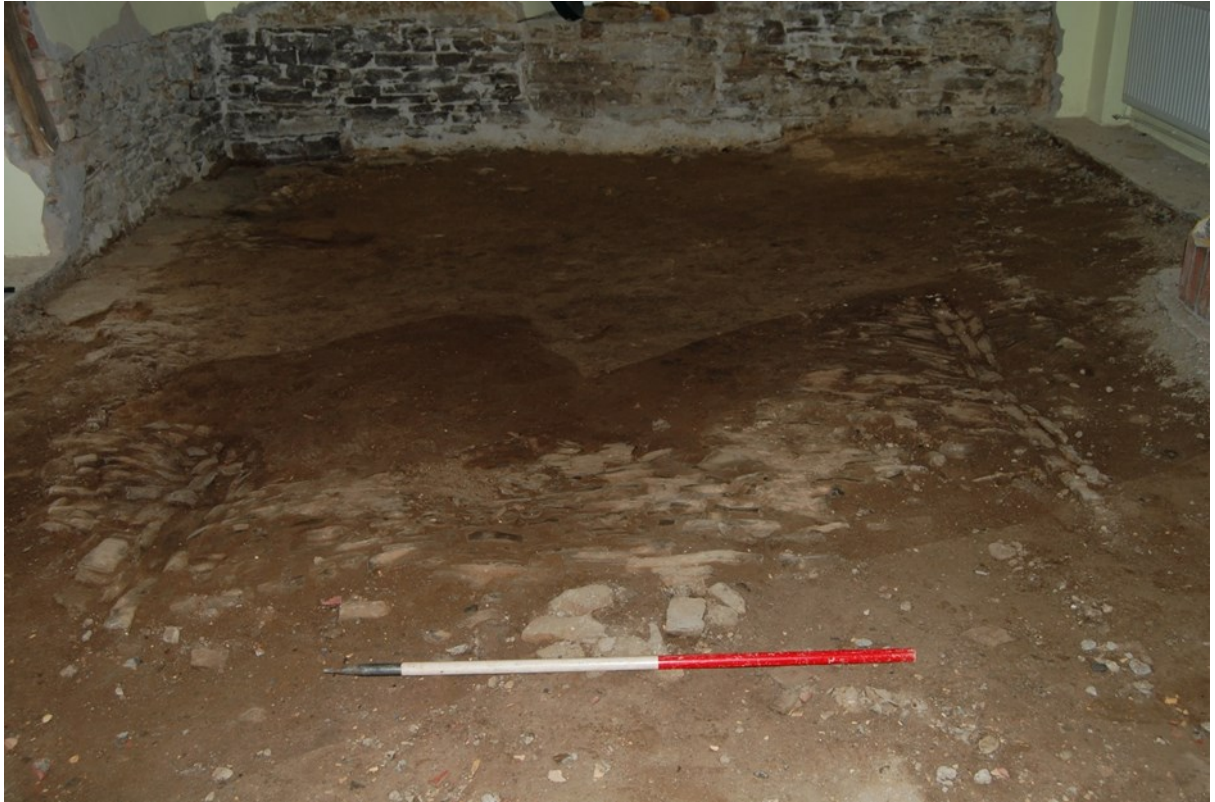
The concrete and tiled floor was removed to reveal a rather fine cobbled floor with two drains either side running east – west. The run off for this drain is in the east gable end.

Clearly this room had an agricultural function as was proposed in the Statement of Historical Significance. One would expect to find a floor of this type in a Devon longhouse, but this floor is slightly narrower in width than traditionally found. For a building of this width a central drain would normally have been more likely.

*Figure 7: Cobbled Floor, Room 1.*

It is recommended that the cobbled floor in Room 1 should be retained in situ and covered using a geotextile material such as "Terram". This would protect the cobbles as they do not need to be lifted in this room to achieve the levels necessary elsewhere in the house.

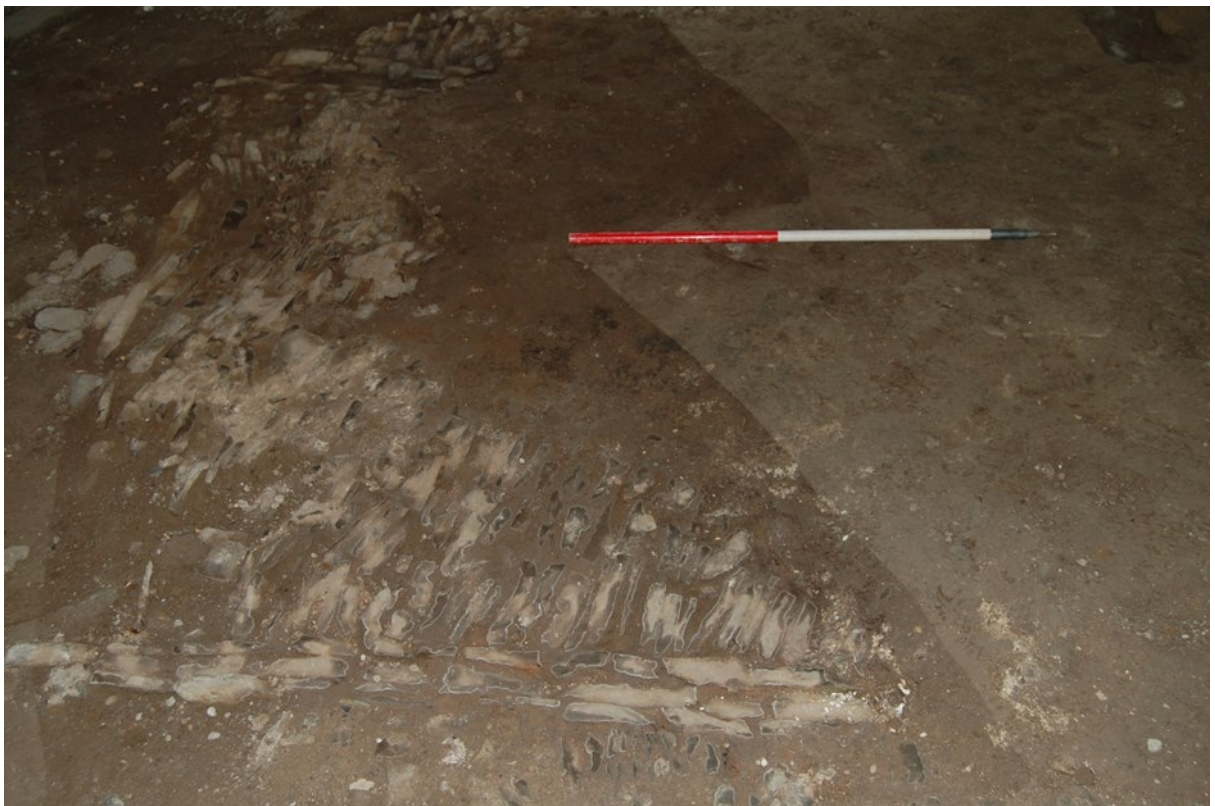
*Figure 8: Close Up Of Cobbled Floor In Room 1.*

It was felt necessary to excavate the floor and record any significant features as there was evidence of charcoal within the rubble and earth above the cobbled stone floor.

The floor was divided into four and the opposing sides (north east corner and south west corner) were excavated and recorded. At first it was thought that this charcoal may be evidence of a central hearth but further investigation and cleaning revealed a distinct layer of burning above the cobbles. This layer is probably indicative of a thatch fire as the roof has been replaced and a large amount of charcoal was found across the whole floor, even into the corners of the room. This would explain why only one cruck exists as the other could have been damaged in a fire. No finds of any historical significance were found during the excavation.

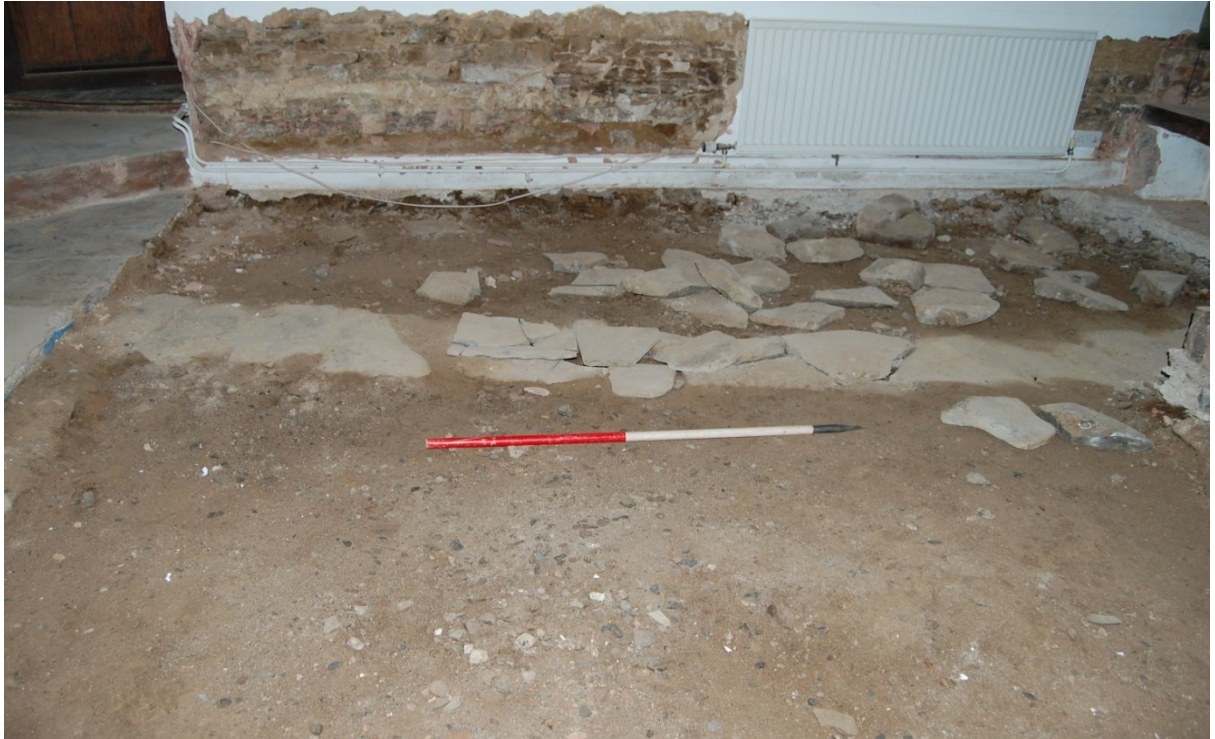
Internally within the floor is a stone linear feature that runs north to south. It consists of large stones which overlay a stone lined gully. Whilst it is obvious that this is a drain it is difficult to date and could at its latest be contemporary with the earliest phase of the house.

*Figure 9: Stone Linear Feature within Room 2*

No finds of any significance were found during the initial excavation of this feature internally. A new floor has been laid in Room 2 but the stone lined drain has been protected by shuttering either side. The eventual floor finish will then be laid on top of the concrete floor either side but be suspended over the stone lined drain. No further features or finds were discovered during this work.

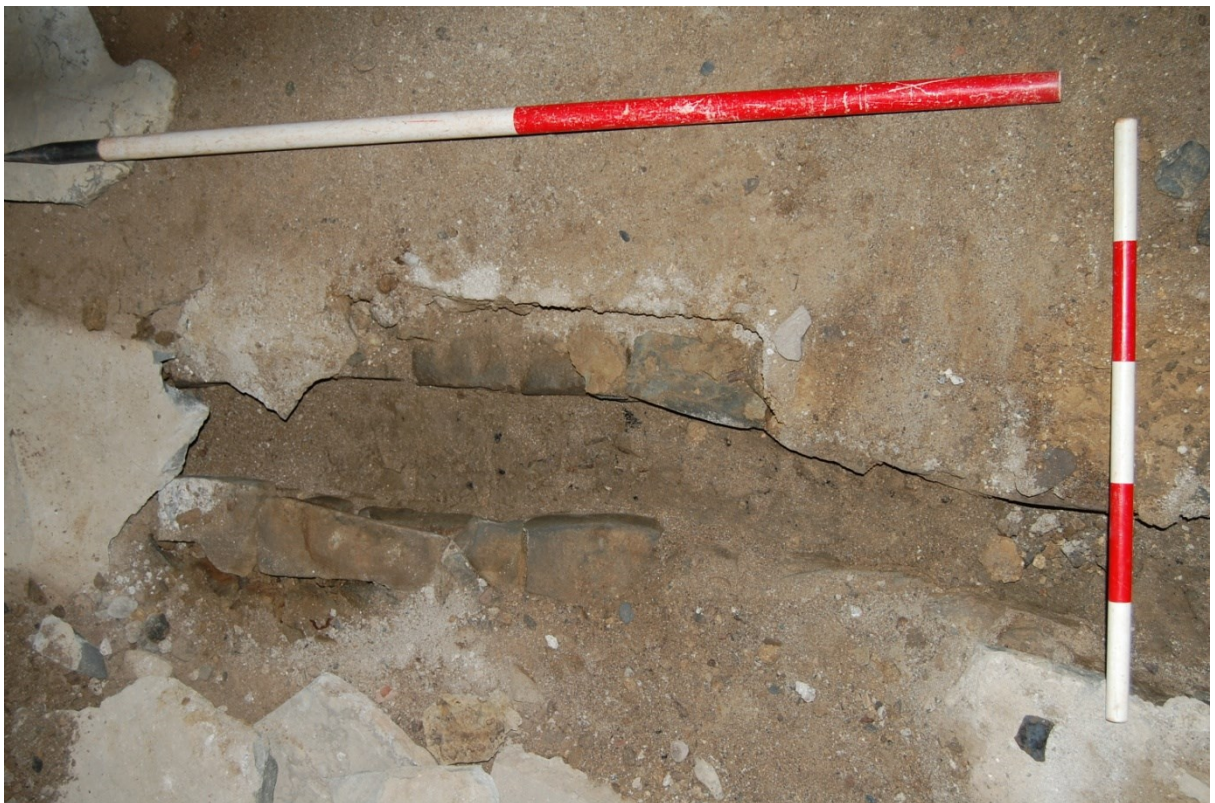
*Figure 10: Detail of Stone Linear Feature within Room 2*

This feature was photographed and drawn in case a continuation of the feature is uncovered during ground works outside of the building. The feature was drawn at a scale of 1:20 and consisted of fourteen large stones laid on top of a stone lined gulley. The feature measured 14cm wide and 4cm deep.

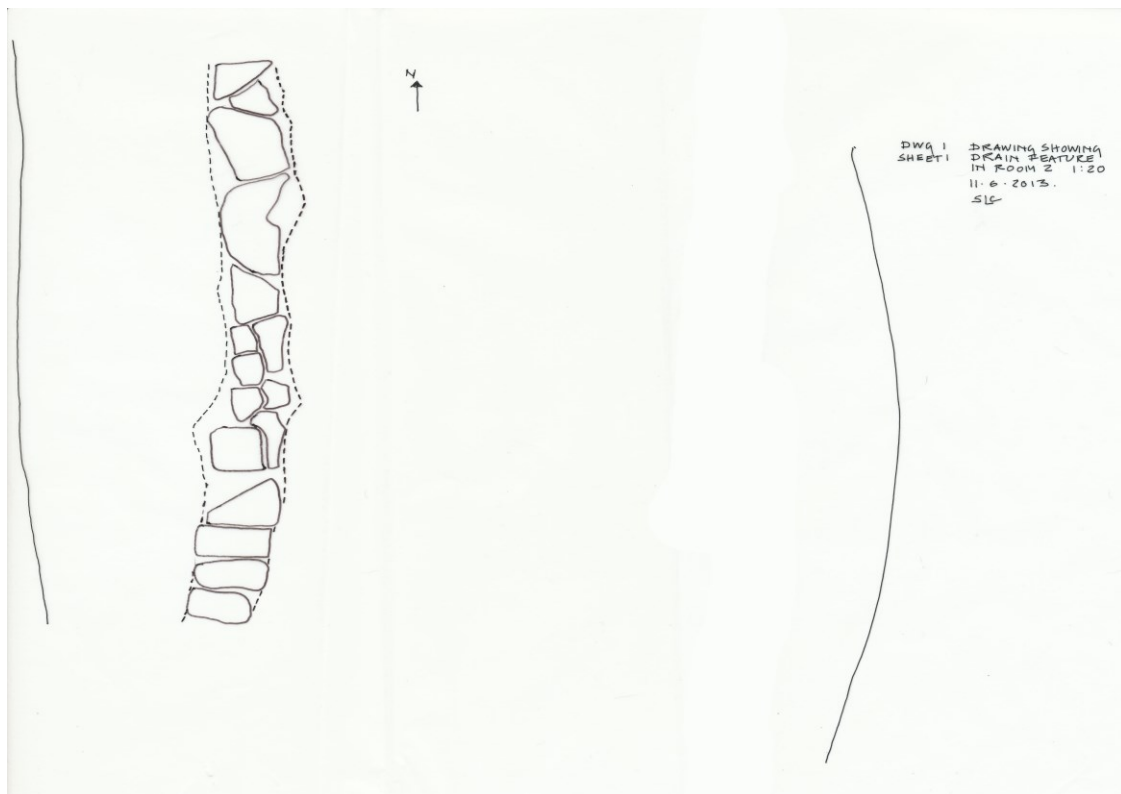
Figure 11: Drawing of Stone Linear Feature within Room 2. Scale 1:20

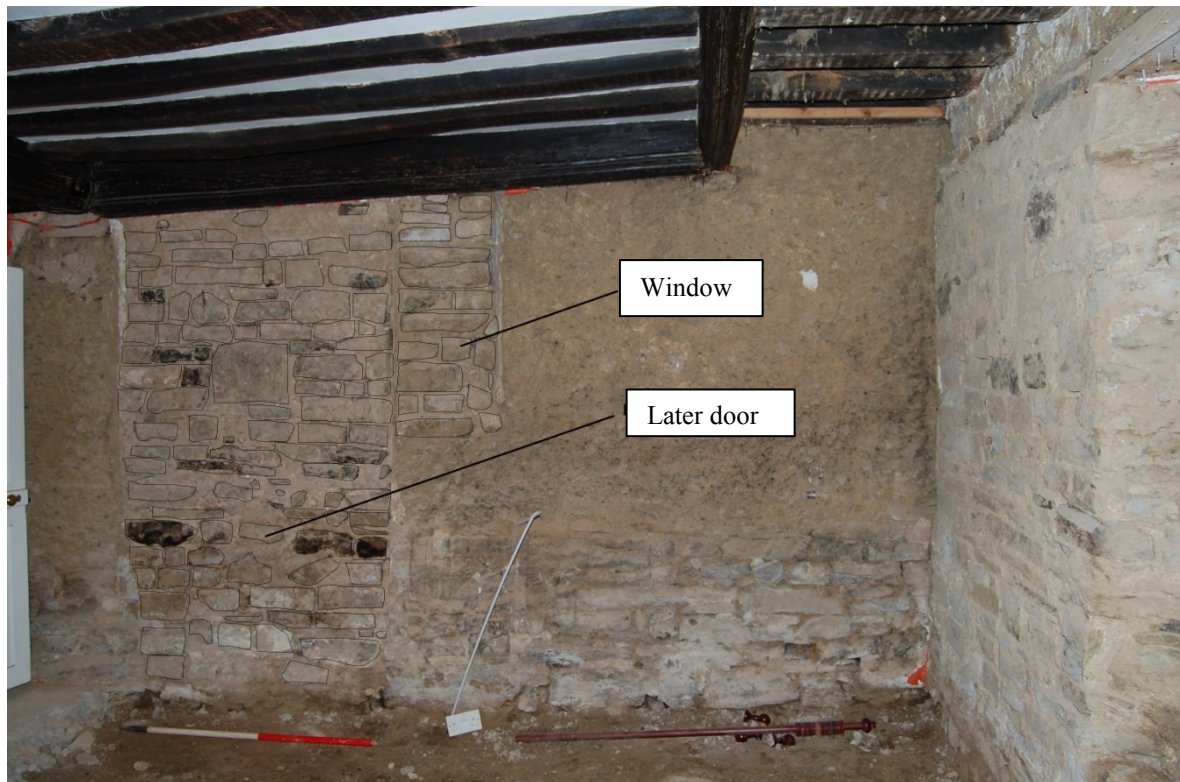
On the interior west wall is a blocked doorway. This appears originally to have been a window which was then enlarged to be a doorway when the building was further extended, leading in to Room 5.

*Figure 12: Blocked Window and Later Blocked Doorway Room 4*

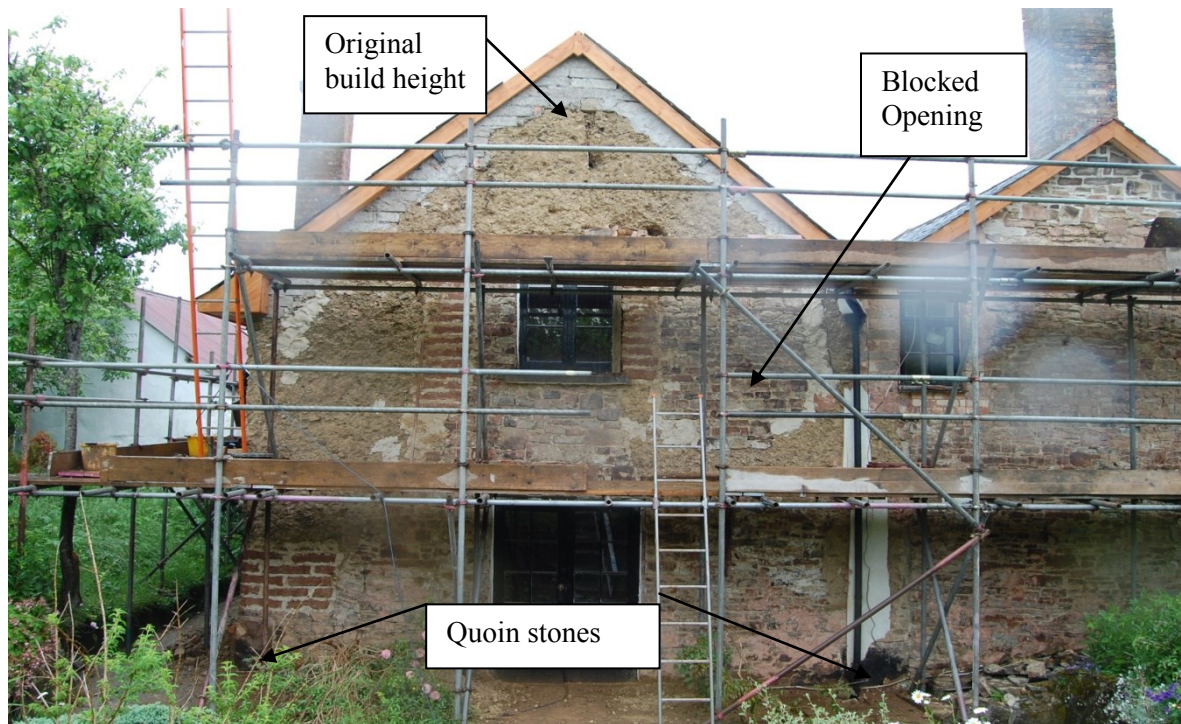
The rear gable end has French doors and above at first floor is a window. There are blocked openings at ground floor and first floor to the right of the current openings. The first floor opening is an unusual shape which is either a large window or short doorway that has been blocked in.

Externally this extension has two large quoins at ground floor level which set out this phase of the build.

*Figure 13: Rear of Property Showing Earlier Extension to Left and Later Extension on Right*

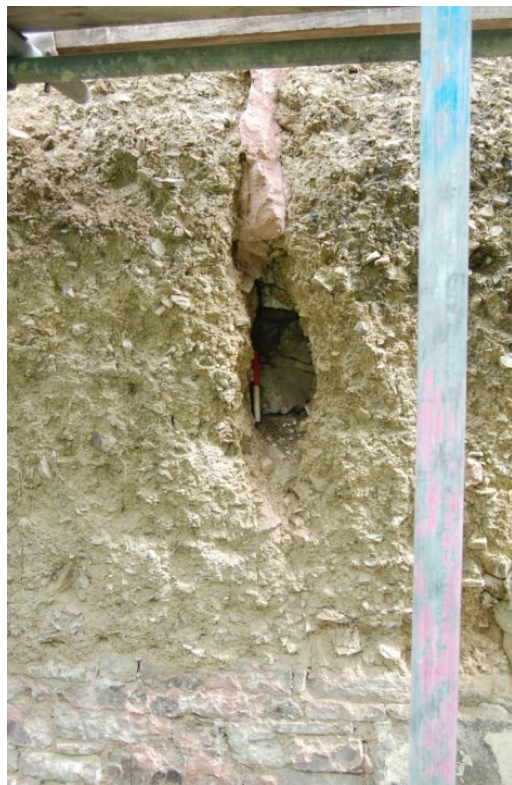
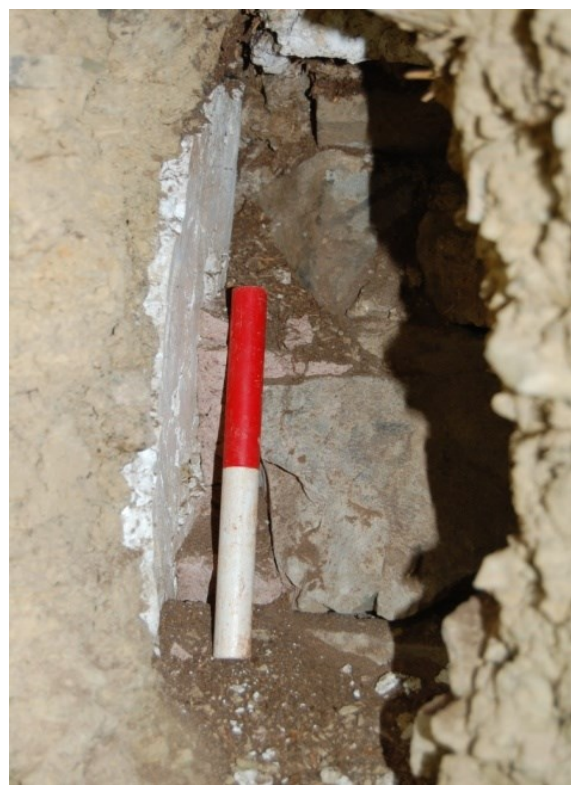
During building works a small plastered opening was uncovered on the west wall of Room 4.

*Figure 14 and 15: Plaster Lined Feature and Detail in External West Wall of Room 4*

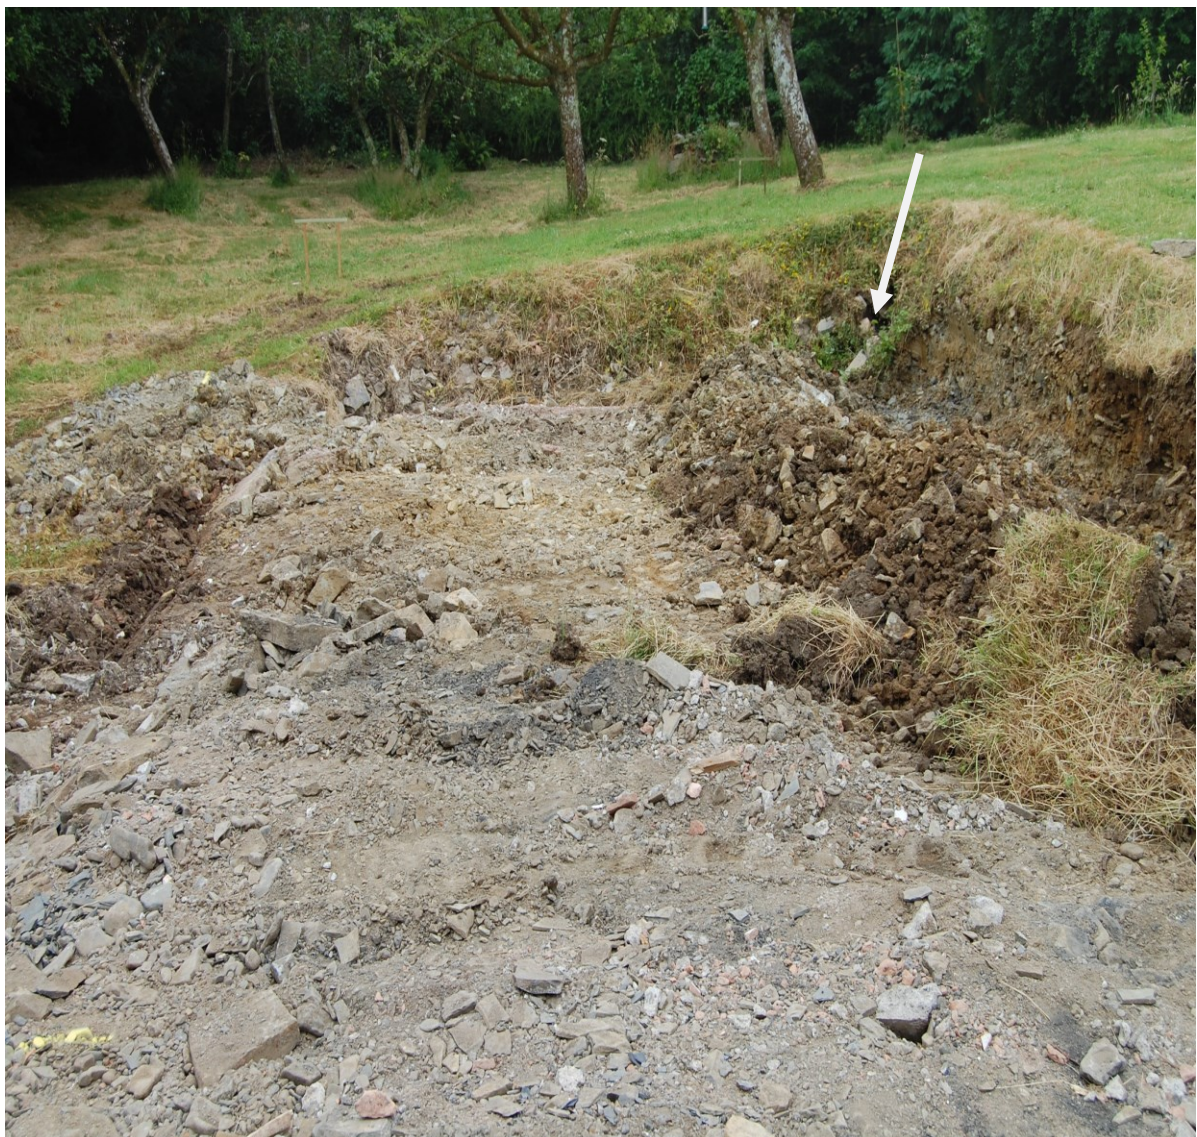
A stone lined drain was discovered in the top right hand corner. This was photographed but was not disturbed. It was approximately one meter below ground but exits at ground level in the top right area of the photograph (see arrow). There is a natural spring in this area as water was noted as lying on the surface of the ground despite one month's dry weather.

The soil found below the top soil was clayey with large stone inclusions. In the north facing section was a layer of three stones 30cm below the ground, see Figure 15. This was later discovered to be the bottom of a further stone lined drain found running east to west and is marked in red in Figure 16. This area had previously been disturbed as a modern drain runs parallel to the stone lined drain.

*Figure 16: Area Once the Prefabricated Garage had been Removed, Prior to Excavation.*

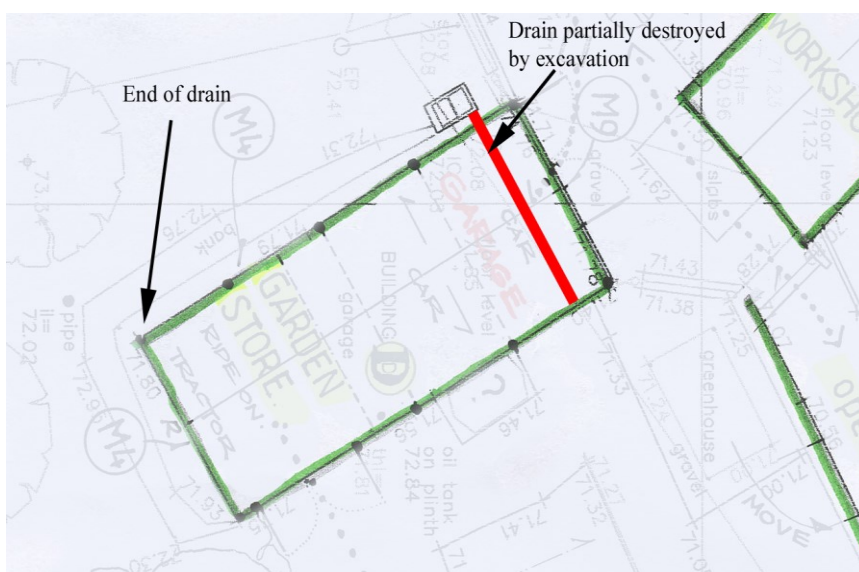
Figure 18: Exit Point of Stone Line Drain and Drain that was Partially Destroyed by Ground Works.

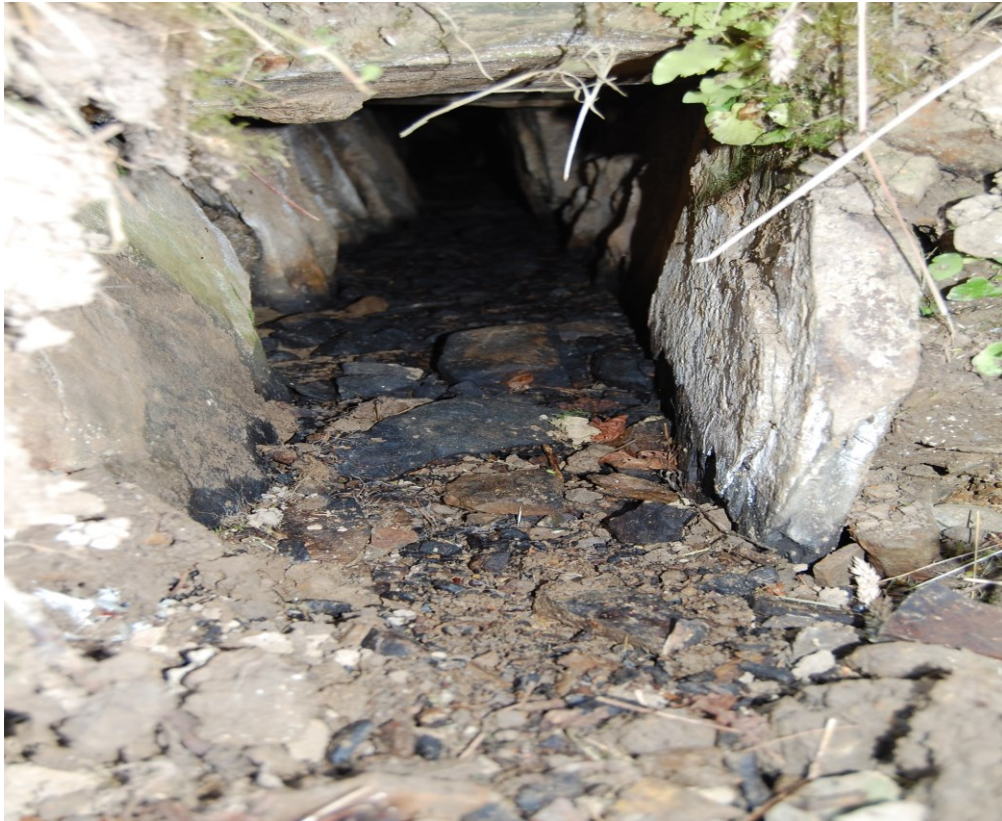
*Figure 19: Close up of Stone Lined Drain in South West Corner of Garage Area.*

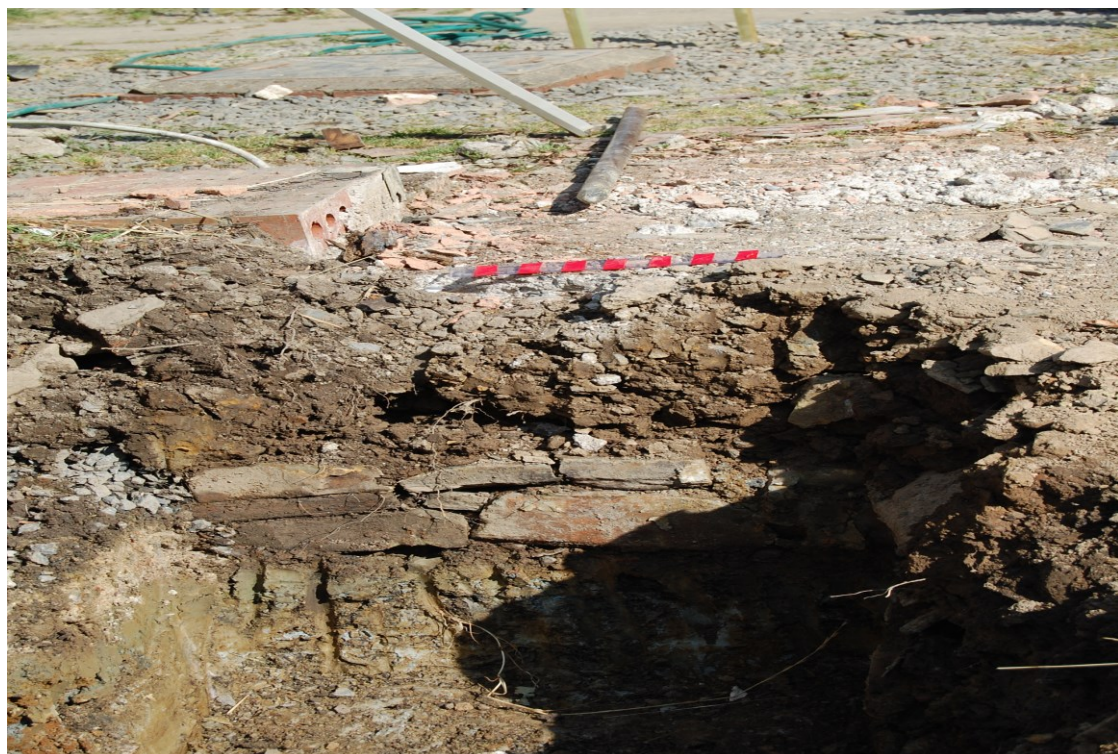
*Figure 20: North Facing Section Showing Layer of Three Stones found 30cm Below Top Soil.*

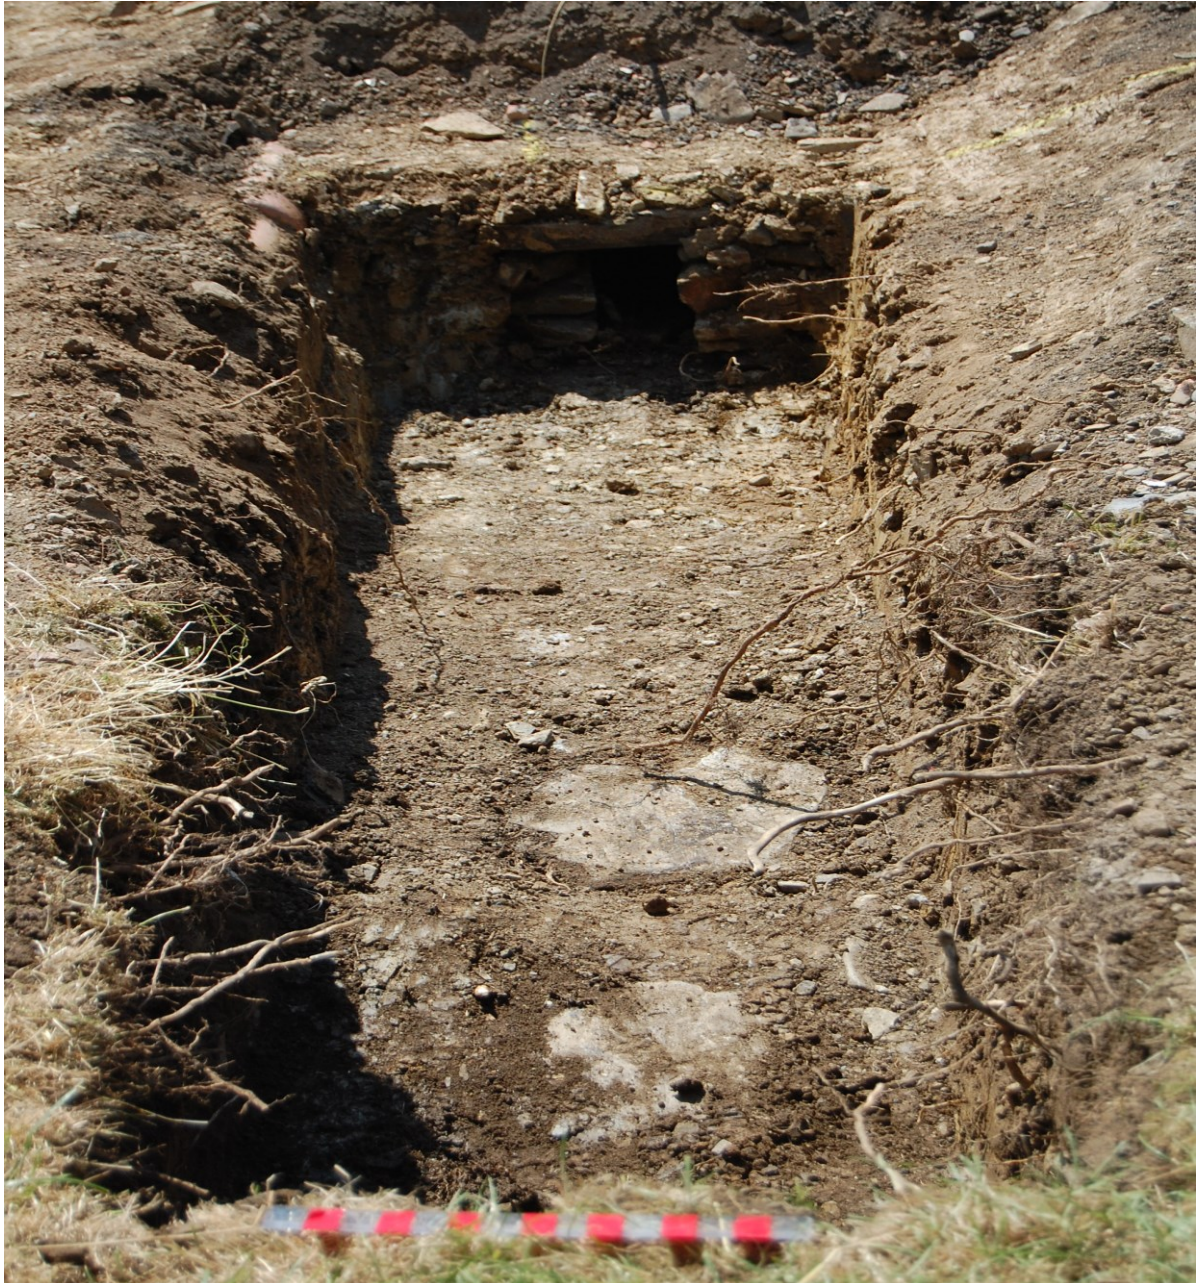
*Figure 21: Stone Lined Drain That Runs East to West and Was Partially Destroyed by the Ground Works.*

The second drain discovered ran horizontally to the rear of the property and was partially destroyed by the ground works. The feature was stone lined. No finds of any significance were discovered. Both drains were similar in appearance to the drain in Room 2. It was noted that there are a number of natural springs in the area and that the stone lined drains had modern drains running close by indicating a continuing need to deal with ground water. A modern clay drain can be seen near the surface running parallel to the drain that was partially destroyed. This modern drain had already disturbed the area.
