An Agricultural Barn at Grange Farm, Gedding, Suffolk

Suffolk HER: ESF25652 / GDD 016

August 2017

Richard Hoggett Heritage

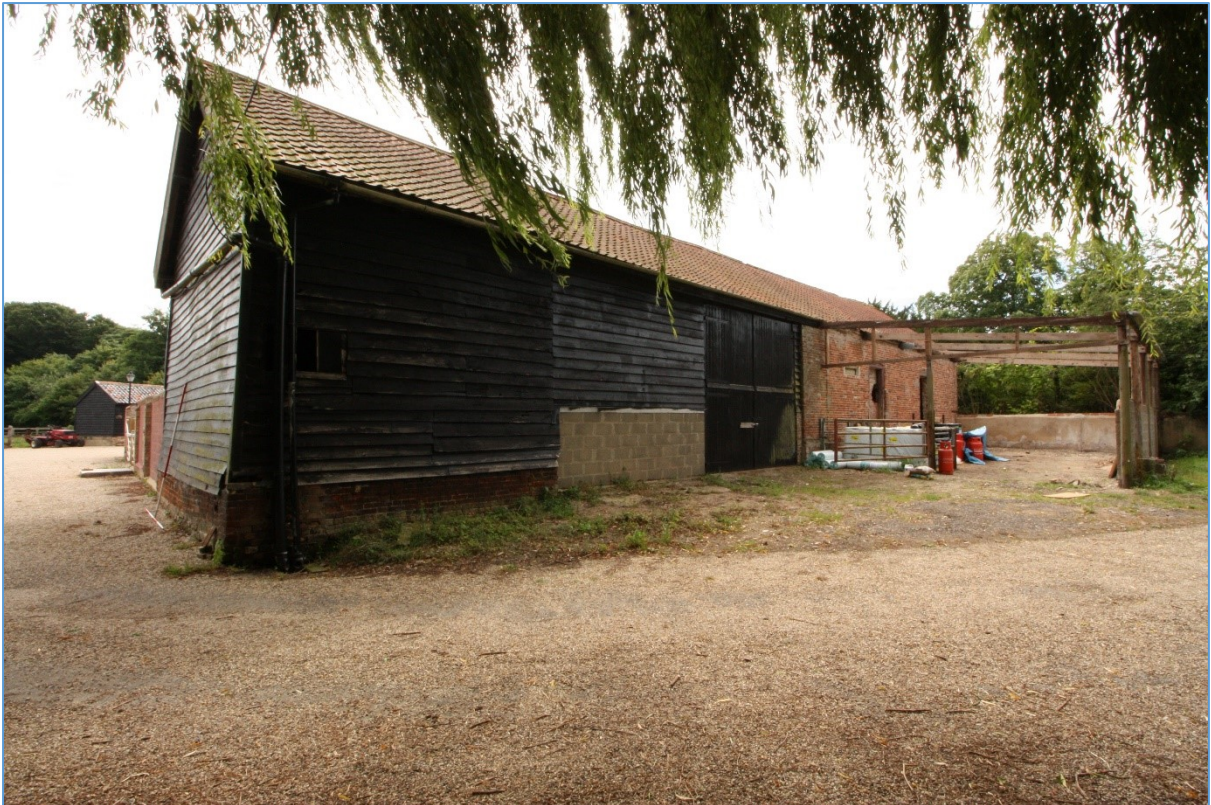
Plate 3. General view of the barn from the north-west, showing the weatherboarded northern end (Barn 1) and the brick-built southern end of the structure (Barn 2).

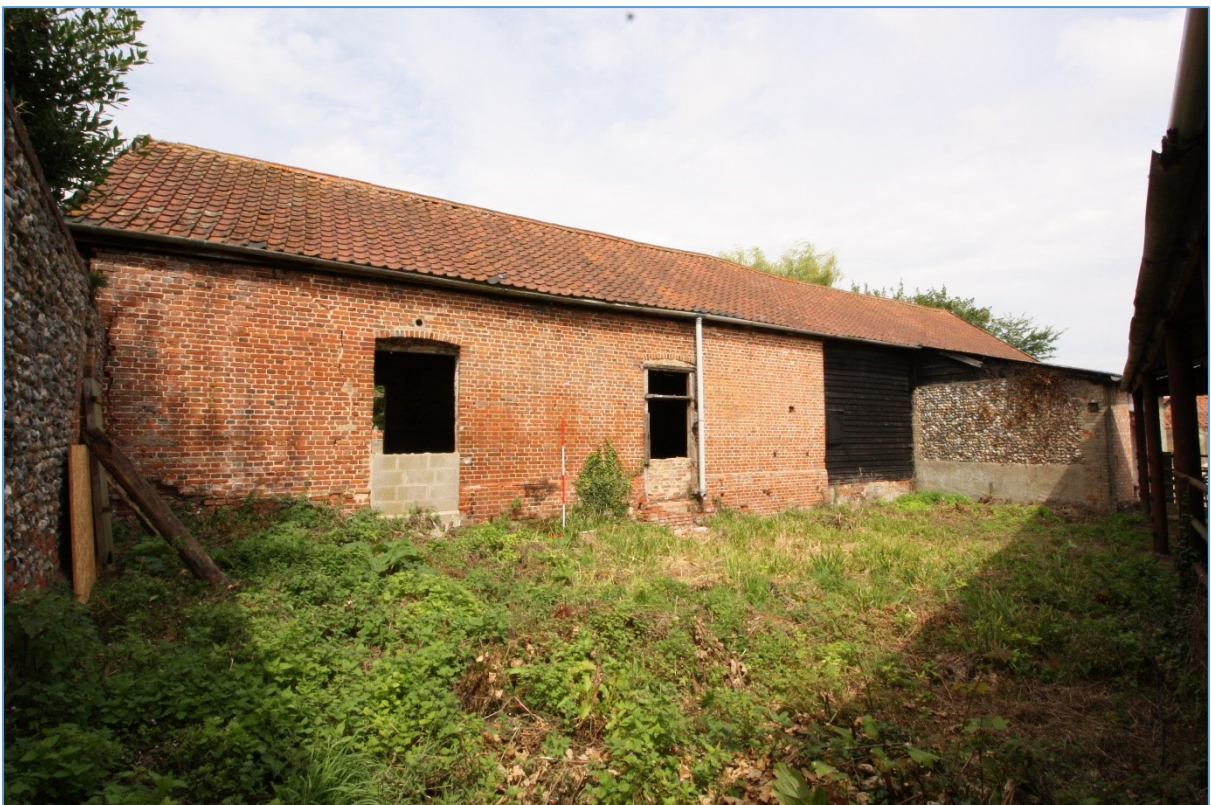
Plate 4. General view of the barn from the south-east, showing the brick-built southern end of the building (Barn 2) with the weatherboarding and brick-and-flint outshot extension of Barn 1 beyond.

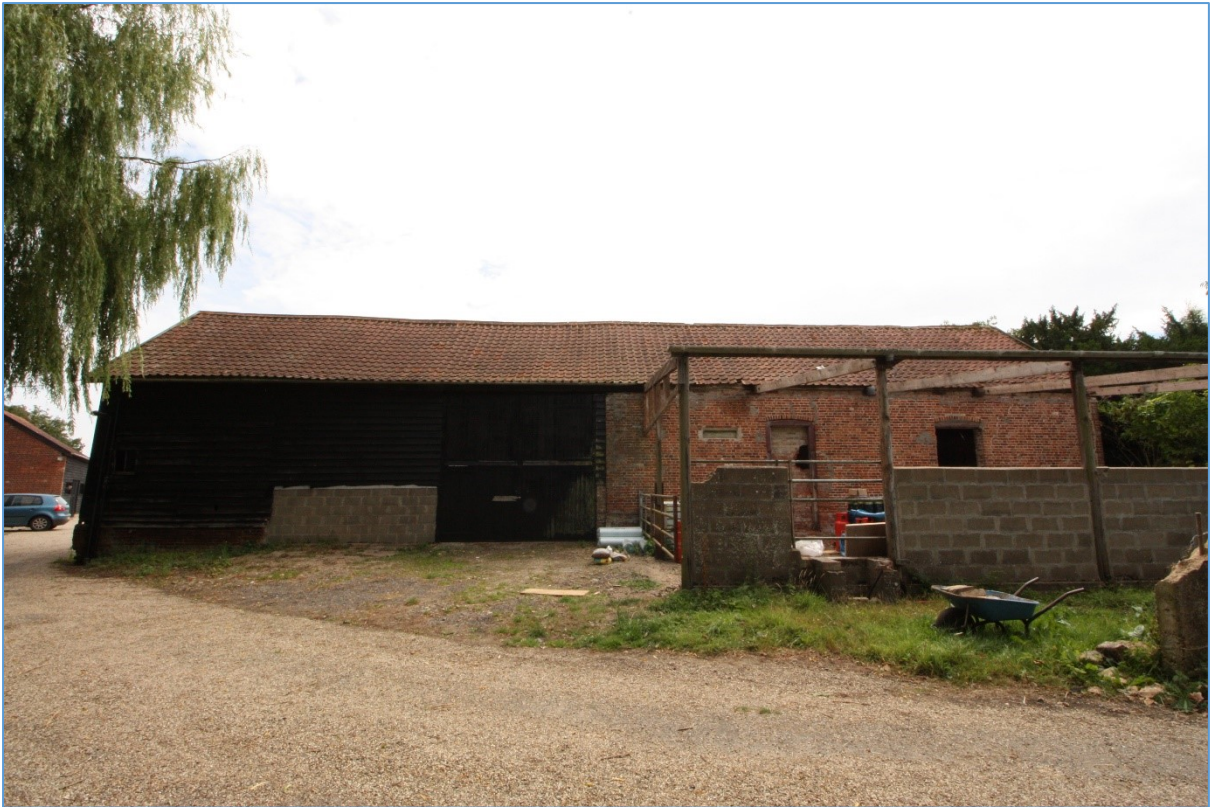
The western elevation of the barn clearly illustrates the structural history of the building: its northern half comprises black softwood weatherboarding mounted on a timber-frame and supported on a red-brick plinth (Barn 1), while its southern half is entirely of red-brick construction (Barn 2) (Plate 5).

Plate 5. General view of the western elevation of the barn, showing the clear division between the construction of Barn 1 and Barn 2 and the single pantiled roof of the building.

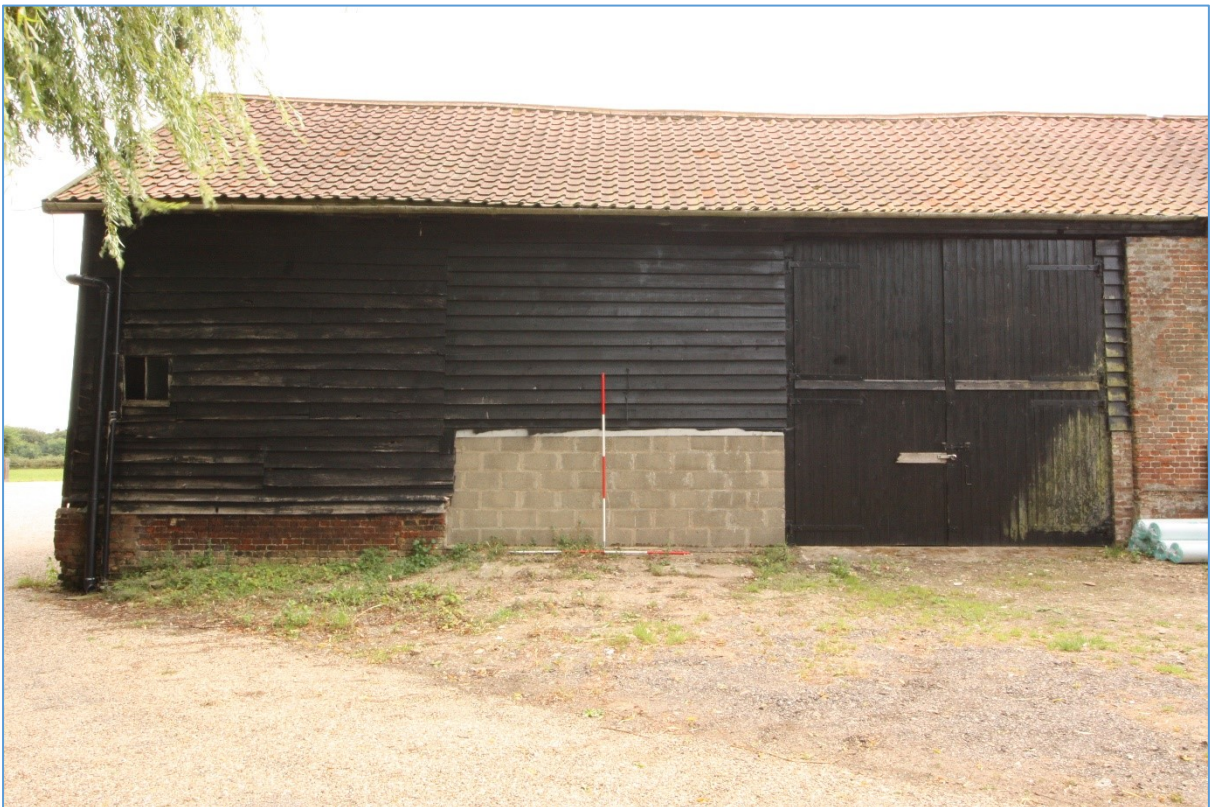
Western Elevation: Focussing on the western elevation of Barn 1 (Plate 6), the elevation is divided into three bays, with the northernmost bay consisting of a short plinth of $9 \times 4\frac{1}{2} \times 2\frac{1}{2}$ inch red-bricks laid in a rough Flemish bond on which stands a panel of black weatherboarding to an eaves height of 4.5m. There is a small three-light window at the northern end of the elevation, close to the north-western corner of the building.

From the outside, the central bay of Barn 1's western elevation is clearly differentiated by a full-height butt joint between the weatherboarding of the central and northern thirds, and by a marked difference in the construction and height of its plinth. In stark contrast to the red brick, the central plinth is built from concrete breeze blocks to a height of 1.2m, with the rest of the elevation comprising more recent weatherboarding to the full eaves height.

To the south, the final bay of the elevation comprises a full-height pair of modern outwardly-hinged double doors of vertical planking, which are framed to the south by a short length of 1.2m high red-brick plinth topped by a narrow strip of weatherboarding which looks to be akin to that of the northern third.

Plate 6. Barn 1's western elevation, showing the blocked-up location of the former western doorway and its modern replacement.

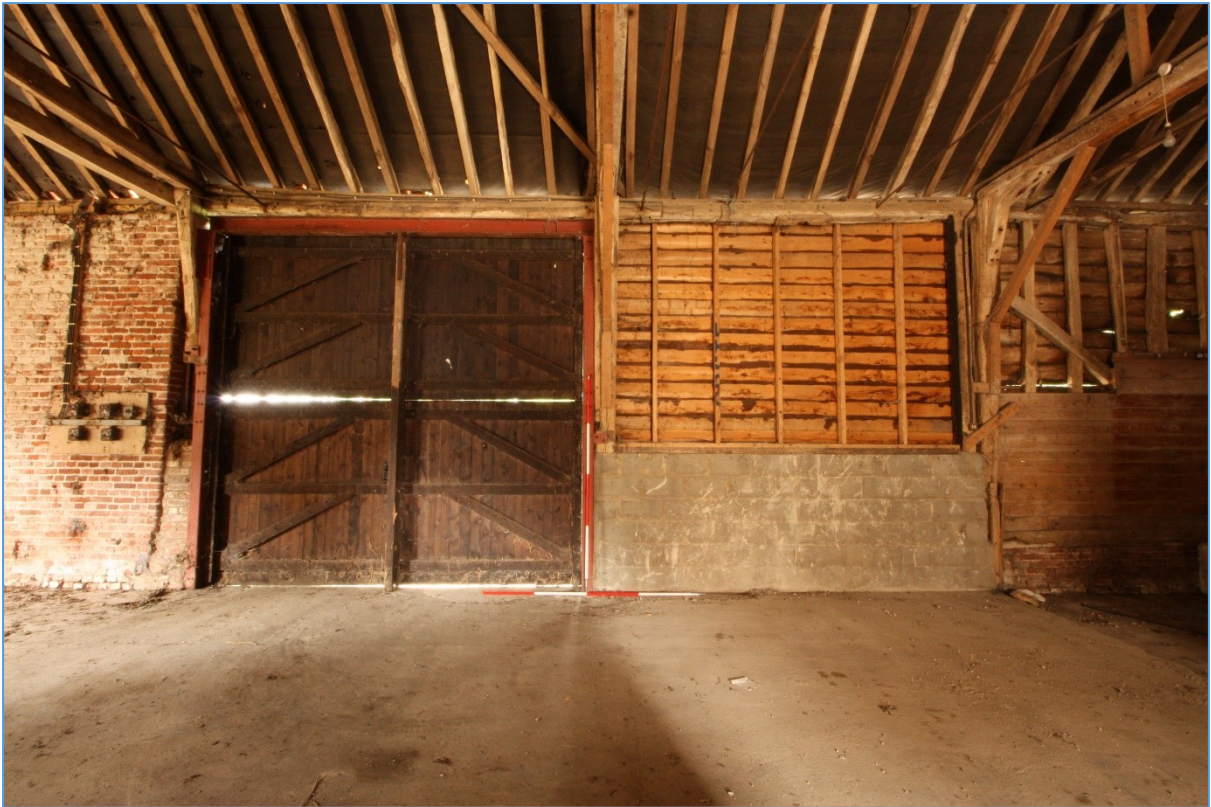
When the western elevation of Barn 1 is viewed from the inside it is immediately apparent that the breeze blocks are filling the former location of a large western doorway, which would have spanned an entire bay of the timber-framed barn and would have measured 3.6m wide and 4m high (Plate 7). The vertical timber studs mounted above the breeze blocks are clearly relatively modern insertions, as is the weatherboarding itself. Likewise, the large double doors to the south are also clearly a relatively modern insertion into the southernmost bay of the original timber-framed structure and their creation has removed all trace of any original timber studwork which may have survived in this area. The substantial frame of the door is made from rolled steel joists affixed to barn's surviving box frames.

Plate 7. Interior view of the Barn 1's western elevation, showing the blocked-up location of the former western doorway and its modern replacement.

Conjunction with Barn 1: Barn 2 was clearly built against the then extant southern elevation of Barn 1, which has subsequently been dismantled in order to create a single space. Examination of the brickwork at the conjunctions of the northern ends of Barn 2's elevations shows no trace of there ever having been a northern brick gable to Barn 2, with both walls butting flush against the southern extremities of Barn 1's timber framing. This is most clear on the eastern elevation, where this join survives intact and can clearly be seen in the interior (Plate 14). The join is less clear, but still discernible, on the western side of the building, where the later insertion of a new pair of large double doors has somewhat obscured and disrupted the structural relationship between the two elements (Plate 7).

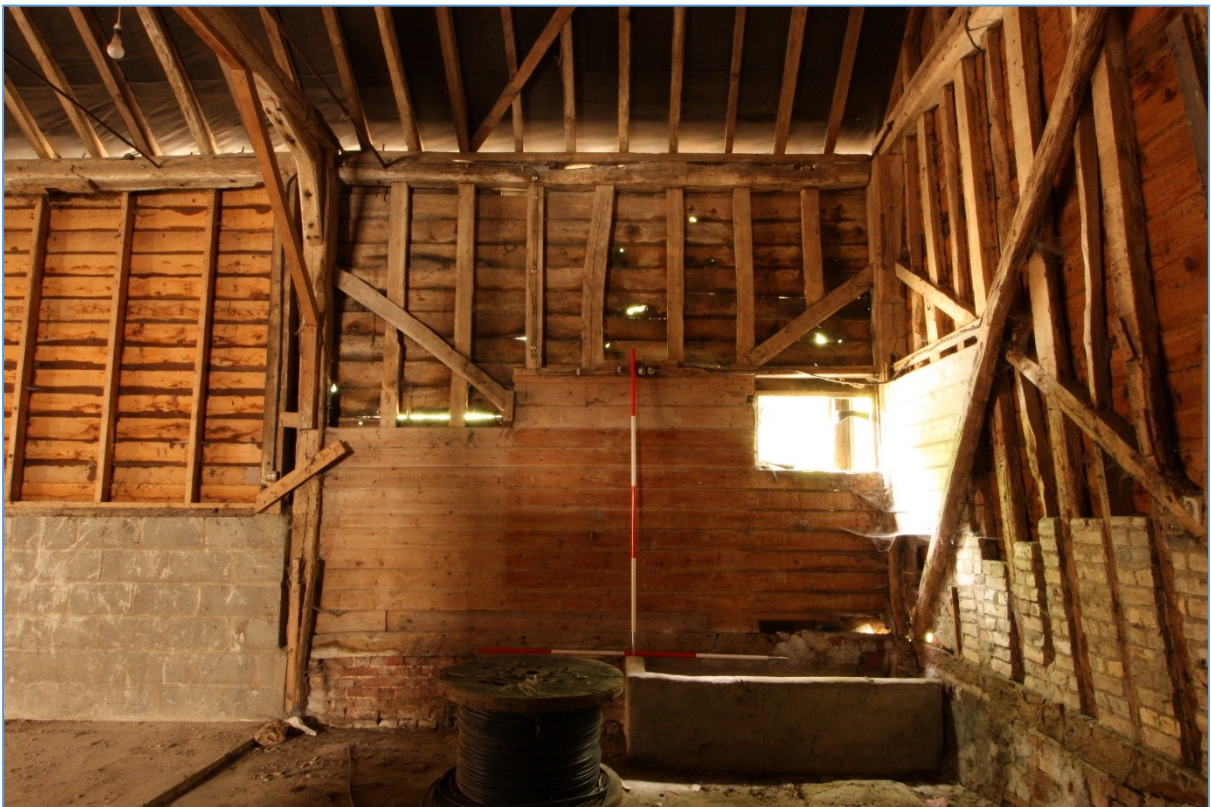
Plate 8. Interior view of the northern bay of Barn 1's western elevation, showing the remaining panel of studwork.

As a consequence of the blocking and creation of the doors, the only surviving panel of timber studwork in this elevation is to be found in the northern bay of the barn, where the upper half of the studwork remains exposed above a screen of horizontal planking. The panel comprises seven vertical studs, of which only the central stud appears to be original, with two diagonal timber braces which converge behind the planking. The northernmost stud has been cut to accommodate the frame of the small three-light window, which is situated above a large trough built against the inside of the plinth and it is presumed that the two features were inserted at the same time.

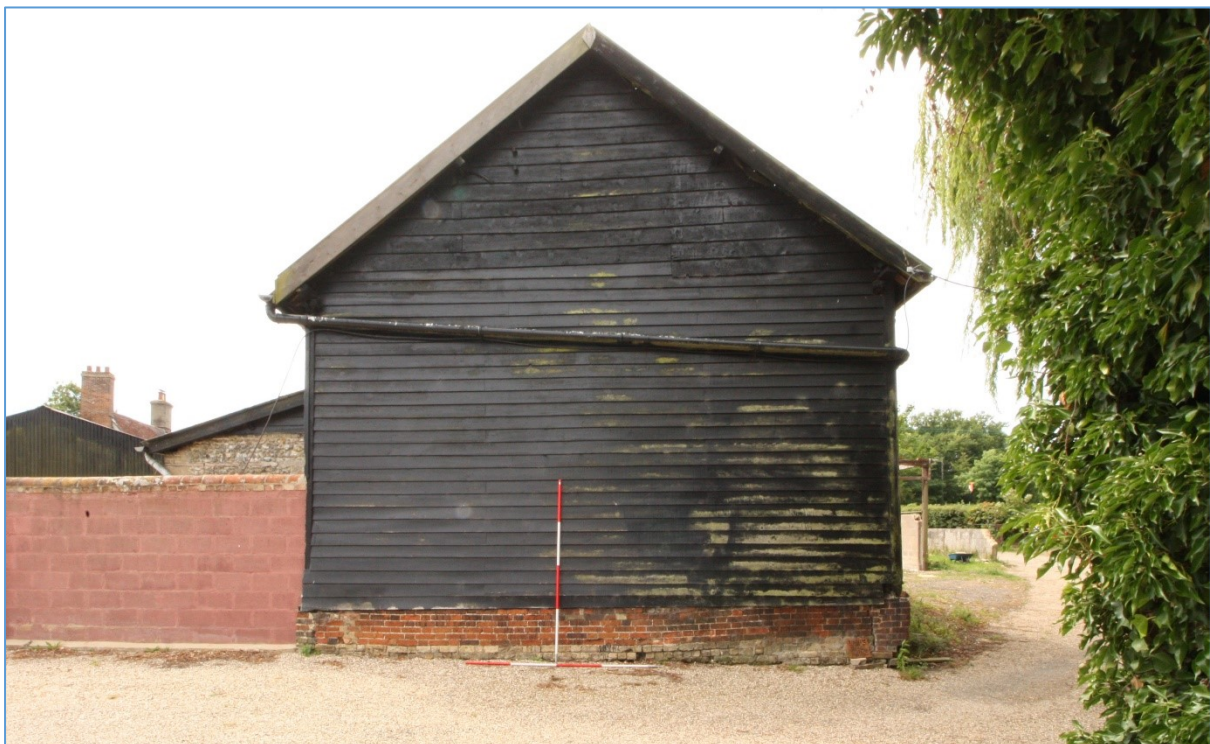
Plate 9. The northern elevation of Barn 1, showing the exposed footings of the brick plinth.

Northern Elevation: The northern elevation of Barn 1 now forms the northern gable of the combined barn (Plate 9) and it comprises a 0.5m high brick plinth laid in rough Flemish bond below black-painted softwood weatherboarding to roof height. Due to a slight lowering of the surrounding ground level, three courses of gault-brick footings of the plinth are exposed, with red-brick being used for the rest of the plinth. The western and eastern plinths do not appear to be particularly well keyed into the northern plinth, and butt joints are in evidence at both ends of the elevation, suggesting that this stretch of plinth may be a later infill or replacement of an earlier incarnation.

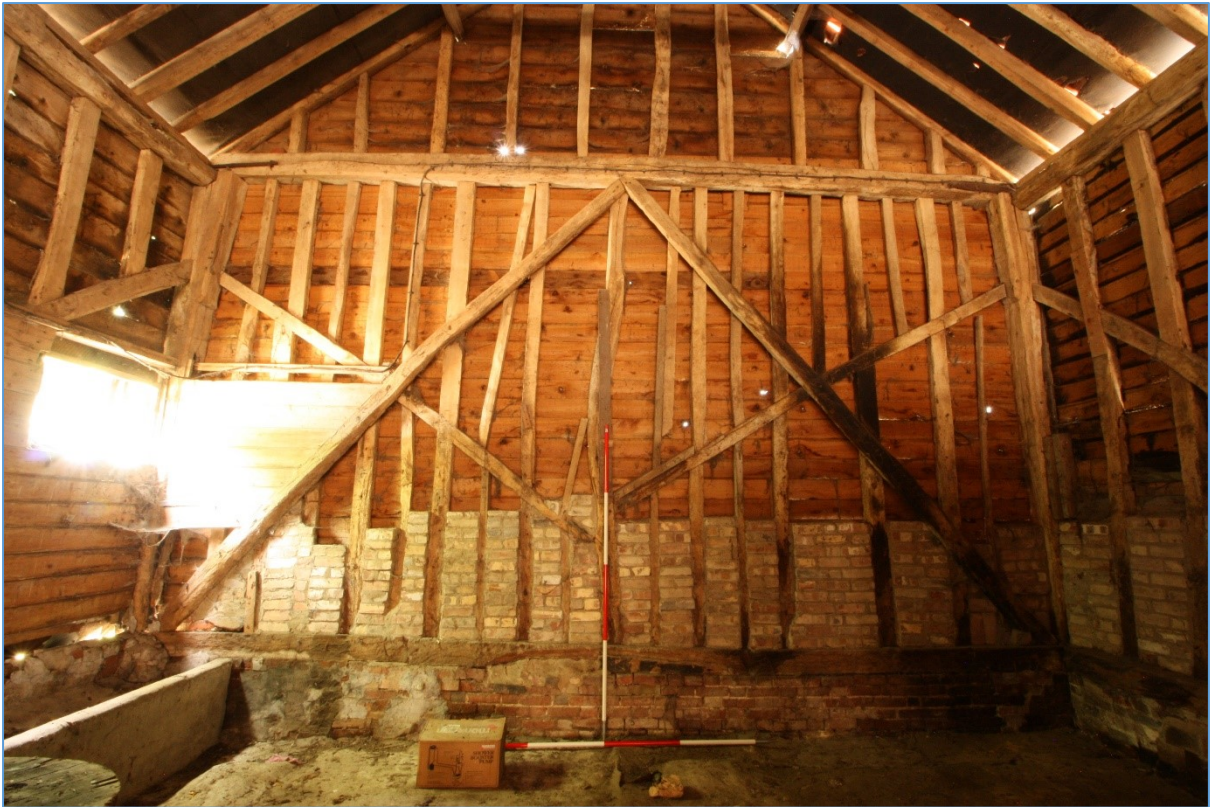
Plate 10. Interior view of Barn 1's northern elevation, showing the remaining panel of timber studwork.

The interior of the northern elevation (Plate 10) reveals that, although the weatherboarding is comparatively recent, much of the surviving timber studwork below the wall plate is likely to be original, or at least an early replacement. A substantial timber cill beam is laid across the top of the brick plinth, into which 17 studs are mounted. These are braced by a pair of diagonal timbers which span the outside bottom corners to the centre of the wall plate, and an additional two downward diagonal timbers which mirror those on the western and eastern elevations. To the west, some of the plank screening continues above the trough, but the rest of the studwork is exposed, with its lower 0.75m being protected by roughly infilled panels of 9 x 2 $\frac{3}{4}$ x 4 inch brickwork.

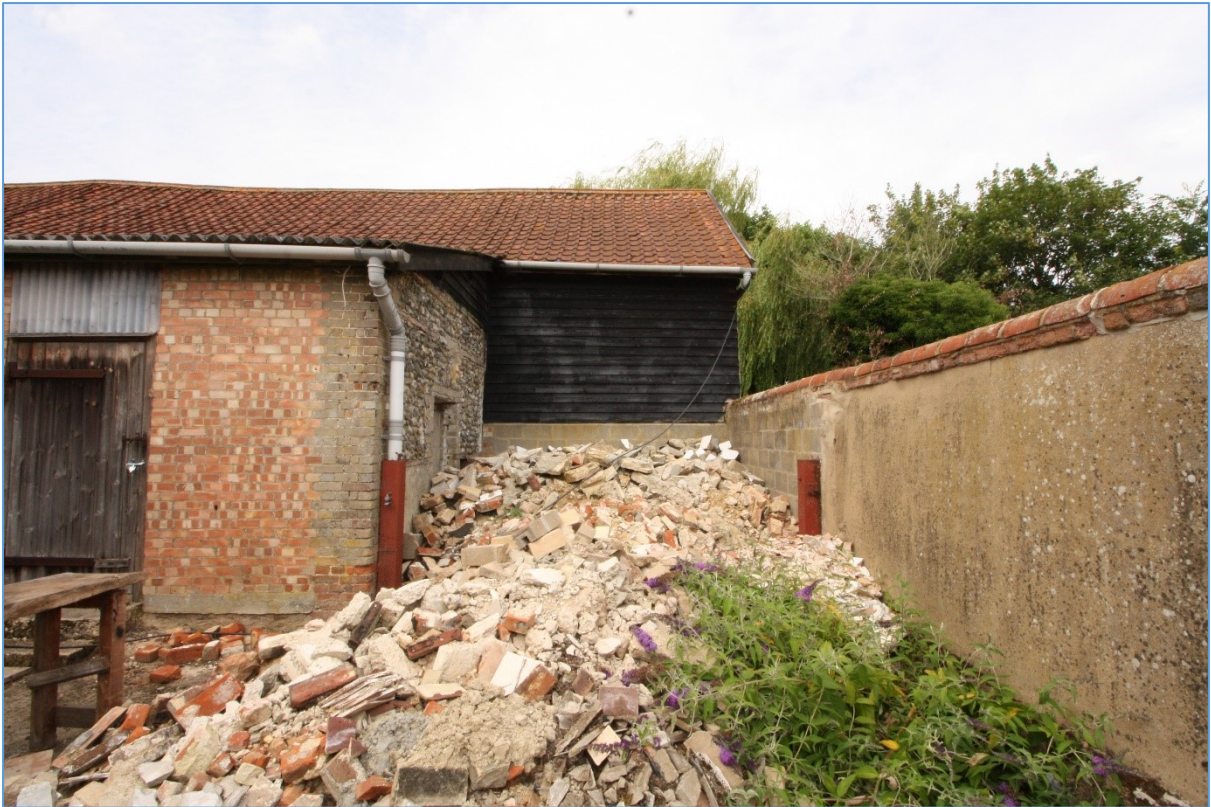
Eastern Elevation: The eastern elevation of Barn 1 has again been heavily altered over time, but despite this several elements of the original timber framing still survive. Like the western elevation, the eastern elevation is divided into three bays, with the northern and southern bays comprising timber studwork mirroring that on the opposing wall, and the central bay featuring a later brick-and-flint outshot extension under an asbestos sheeting roof (Plate 11).

The lower half of the exterior of the northern bay is currently obscured by a large pile of demolition rubble, which has been heaped into the angle between the outshot extension, the barn and the adjacent farmyard wall (Plate 11). Despite this, it is possible to see that the lower portion of the elevation, to a height of approximately 1.5m, is constructed from breeze blocks, with relatively new weatherboarding above up to eaves level (Plate 11). It was not possible to ascertain whether or not the brick plinth is exposed on this face or hidden behind the blockwork.

Plate 11. Barn 1's eastern elevation, showing the heaped-up demolition rubble in front of the northern bay.

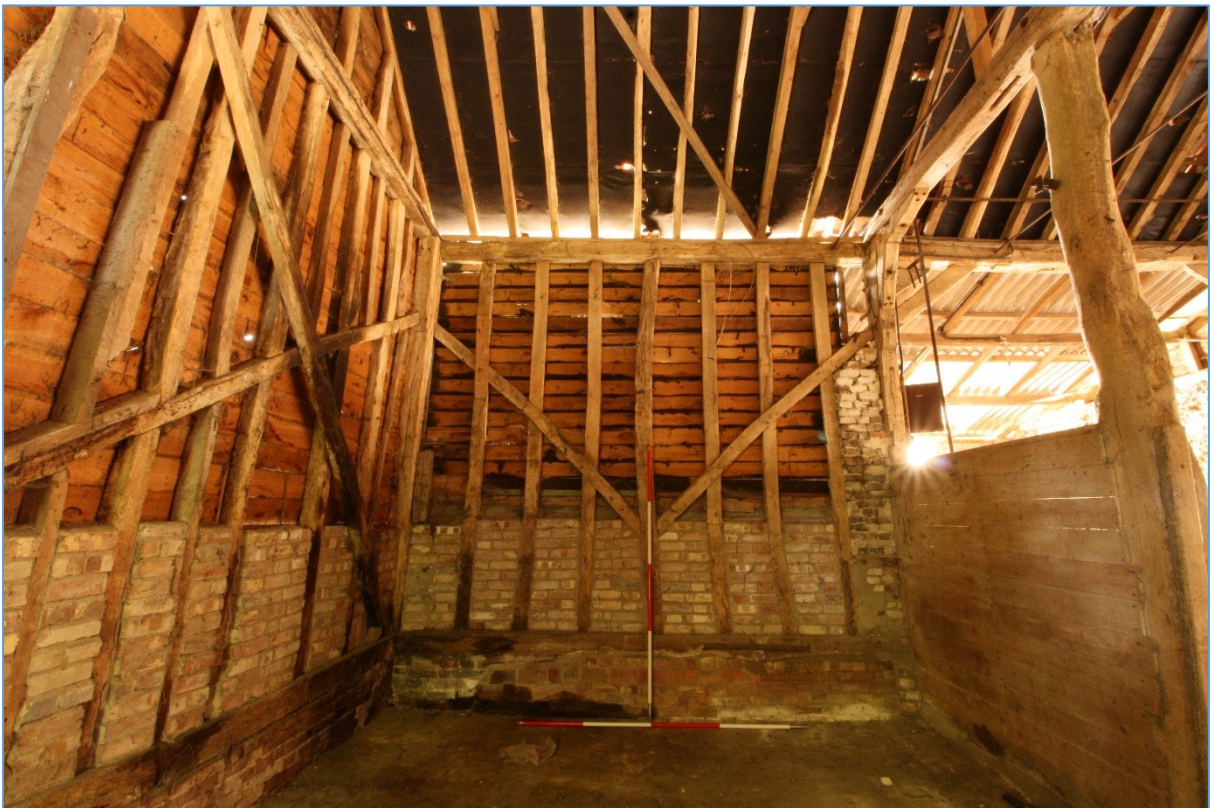
The interior face of the northern bay closely resembles that of its opposing wall and the northern gable, and again comprises a short height of red-brick plinth supporting a substantial cill beam, into which seven vertical studs are set (Plate 12). Only the central stud appears to be original, the others being much straighter and more neatly cut, and two diagonal timber braces span the gap from the edges of the frame to the central stud. The northernmost stud has been repaired and a new length of timber has been spliced into it, bringing this stud in front of the diagonal brace. As with the northern elevation, the gaps between the studs have been infilled with rough 9 x 2 ¾ x 4 inch red brickwork to a height of approximately 0.75m. Between the southernmost stud and the frame this brickwork has been continued up to a height of approximately 2m to completely fill the space beneath the diagonal brace. This brickwork forms the western edge of the northern wall of the outshot extension, which fills the adjacent bay.

Plate 12. Interior view of the northern bay of Barn 1's eastern elevation, showing the remaining panel of studwork.

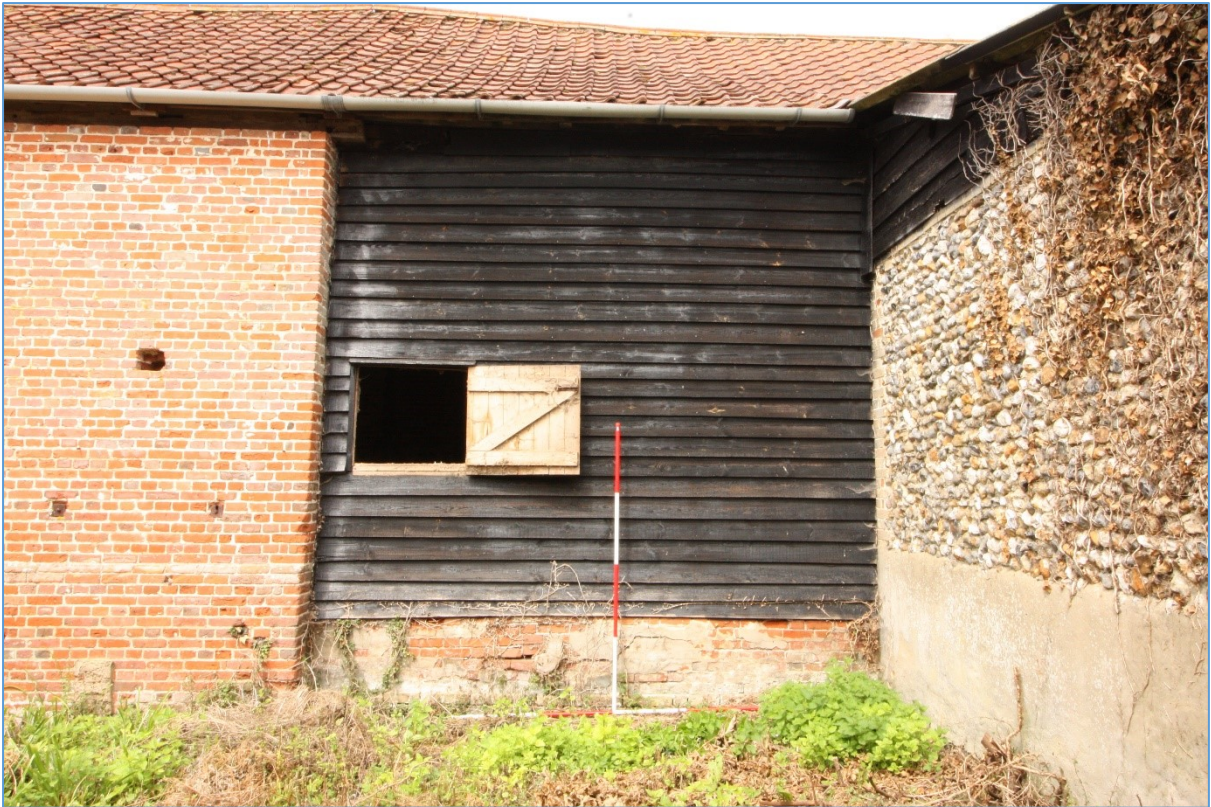
The arrangement of the southern bay of Barn 1's eastern elevation is much the same, and from the outside the brick plinth is again visible, emerging from behind a rough coat of protective render (Plate 13). Above the plinth, the wall is weatherboarded to eaves height, with a small, square, outward-opening hatch set 1.5m above the ground at its southernmost end.

Plate 13. The southern bay of Barn 1's eastern elevation, showing the outward-opening hatch.

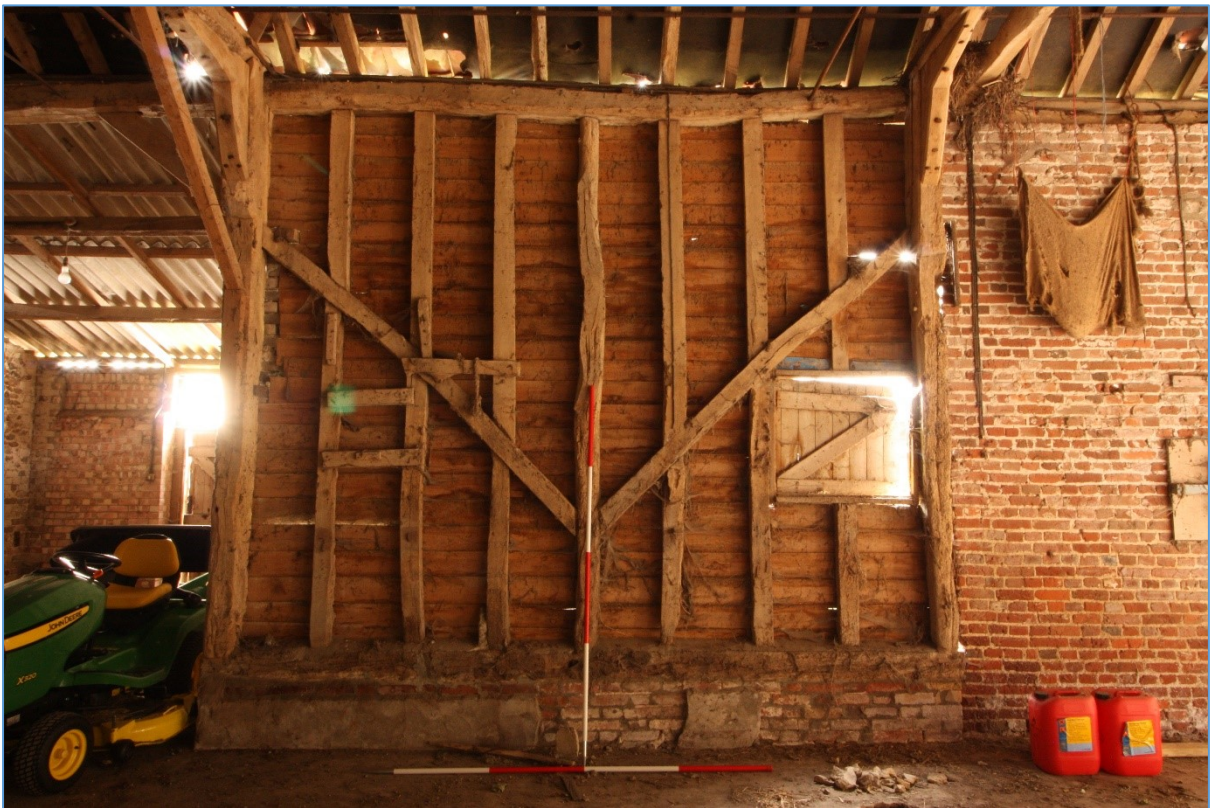
Plate 14. Interior view of the southern bay of Barn 1's eastern elevation, showing the remaining panel of studwork.

The interior face of the southernmost bay closely resembles that of the northernmost bay and presumably reflects the panel of timber framing lost to the creation of the new double doors on the western elevation (Plate 14). Here, the red brick plinth is partially protected by a coat of render, which is falling away, and the relationship between the cill beam, the principal posts and the studs can be clearly viewed as there is no wooden screening or brick infilling to obscure the details. Again there are seven studs, with a pair of diagonal braces converging on the central stud, and the southernmost stud has been cut through to accommodate the small, square hatch which opens outwards into the yard.

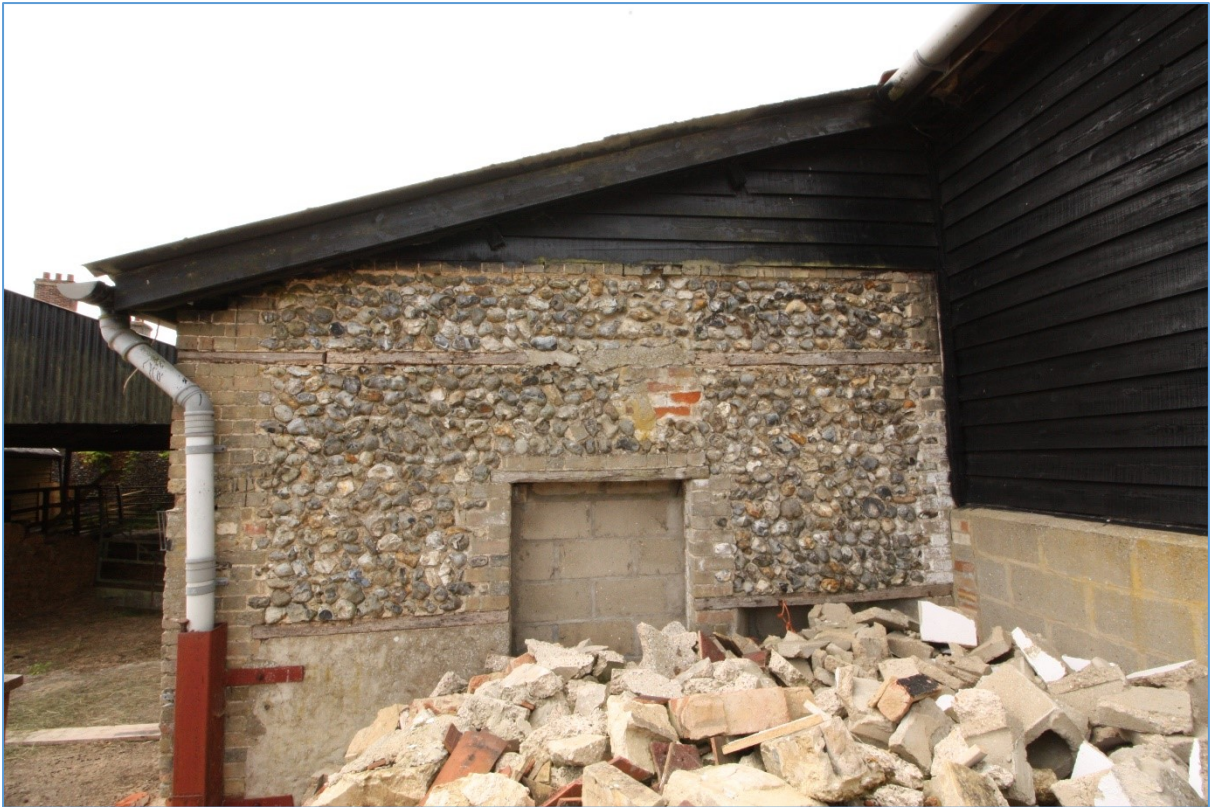
Although partially obscured by demolition rubble, the northern wall of the extension is of brick-and-flint, with brick quoins and a weatherboarded gable. A brick-edged doorway is set into the centre of the wall, although this has subsequently been closed up with breeze blocks (Plate 15). The interior face of this wall is of brick to the height of the blocked door, with flint pebbles laid in rough courses above (Plate 16). To the west of the door there are traces of an additional blocked low-level opening, and the former electrical fusebox is also mounted on this wall. This construction is mirrored in the southern wall of the extension, which has the same configuration of brick and flint, but no doorway (Plates 19 and 20). The eastern wall of the extension is clearly a much more recent replacement in modern brick and has been keyed into the quoins of the side walls (Plates 17 and 18). There is a wooden door topped with a transparent corrugated plastic sheet above and the internal timberwork suggests that this is contemporary with the re-roofing of the extension. A channel of bricks laid on edge is set into the floor of the extension, and this is presumed to be contemporary with the side walls.

Plate 15. The northern elevation of the outshot extension, showing the blocked doorway.

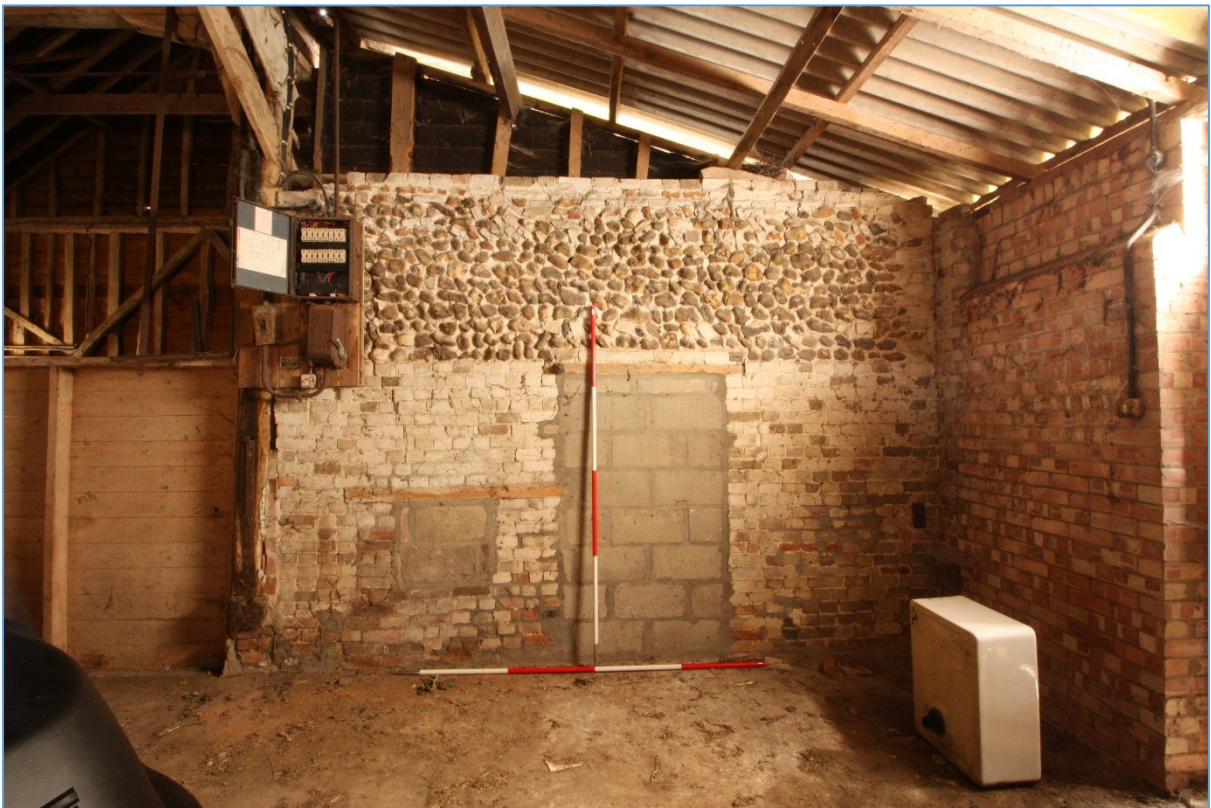
Plate 16. Interior view of the northern elevation of the outshot extension, showing the blocked doorway.

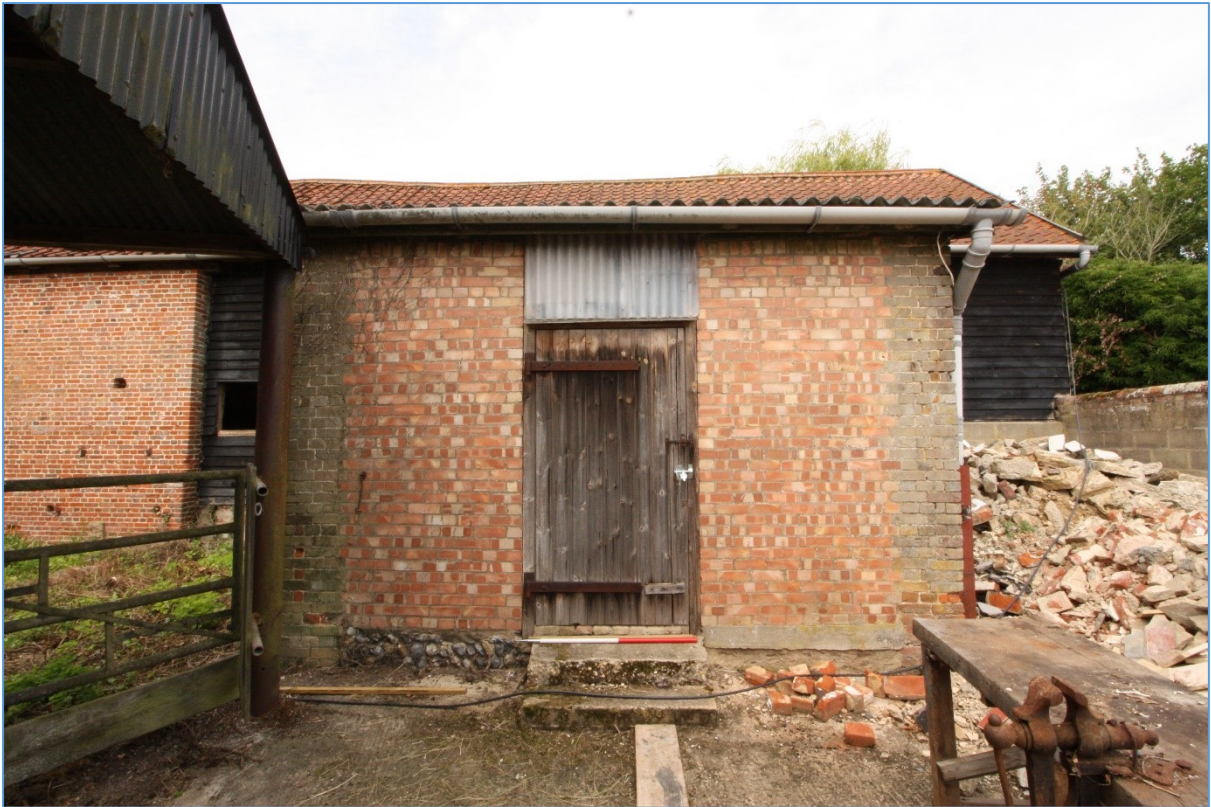
The central bay of the eastern elevation is now occupied by a brick-and-flint outshot extension with weatherboarded gables under an asbestos-sheet roof (Plates 15, 17 and 19). This is clearly a much later addition to the structure and the map evidence suggests that it had been erected by 1838, although it has been much altered since. The central bay would have originally housed an opposing door similar to the blocked example on the western elevation, so that carts could drive into one door and out of the other, and it is possible that there was once an earlier timber-framed porch, although there is no surviving evidence for one.

Plate 17. The eastern elevation of the outshot extension.

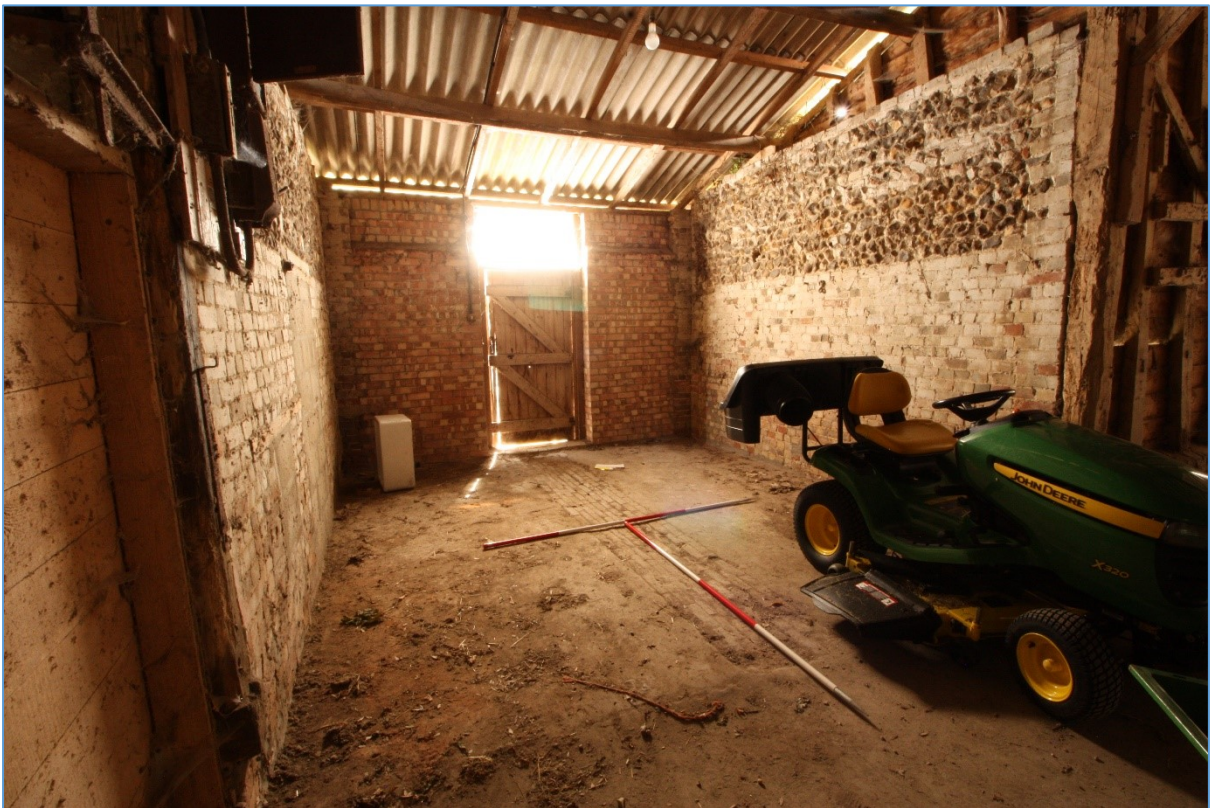
Plate 18. Interior view of the outshot extension, showing the brickwork set into the floor.

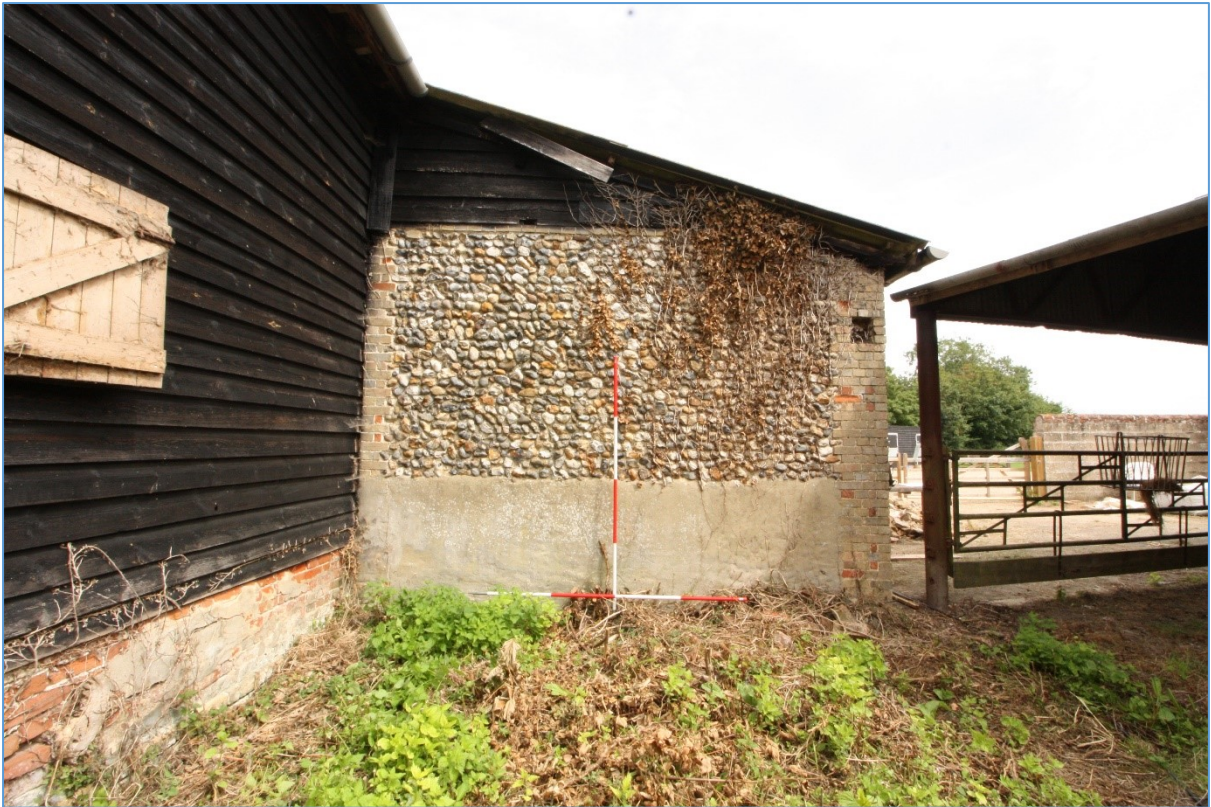
Plate 19. The southern elevation of the outshot extension.

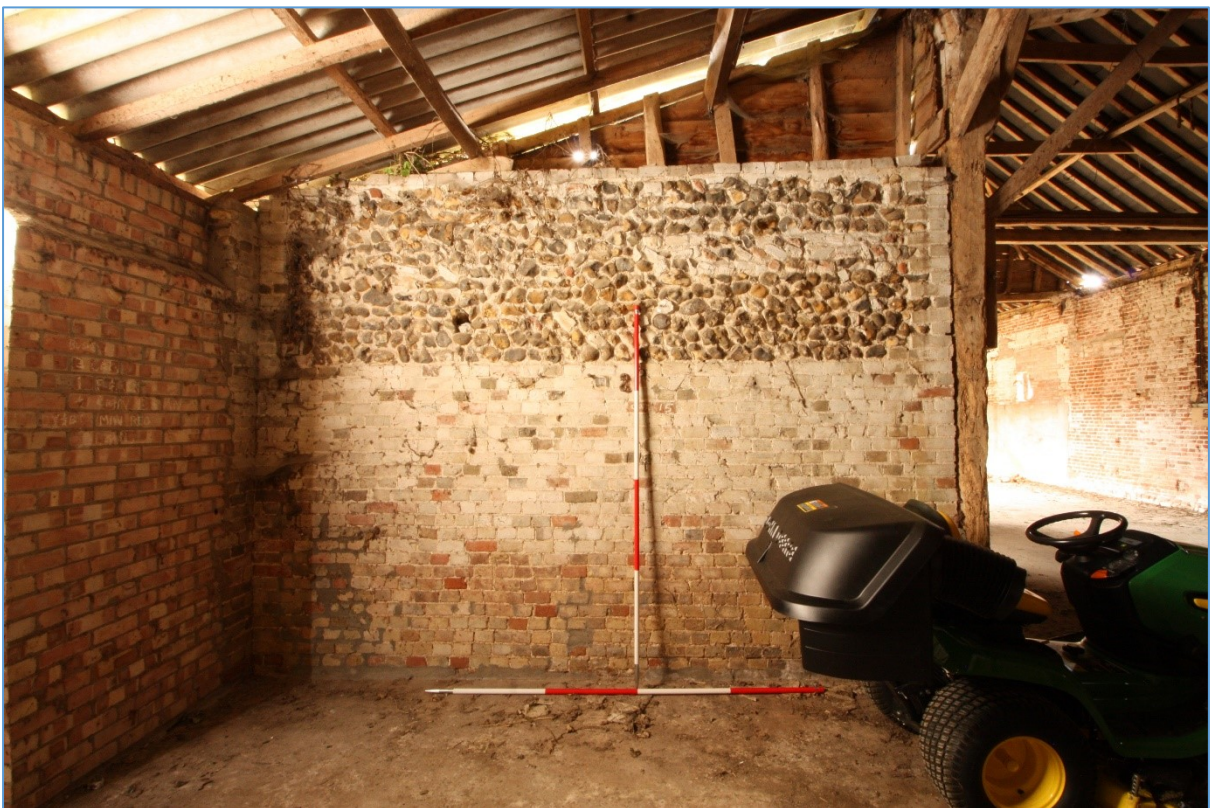
Plate 20. Interior view of the southern elevation of the outshot extension.

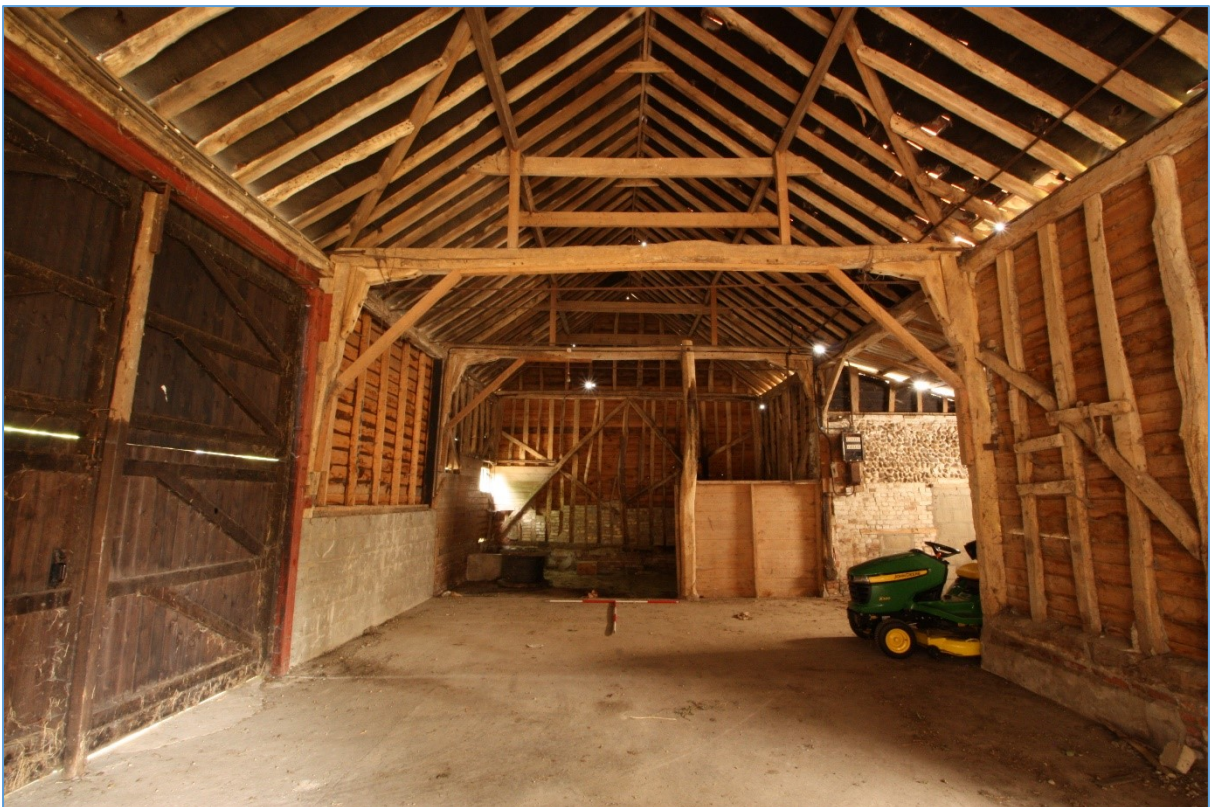
Plate 21. Interior view of Barn 1, looking north from beneath the southernmost frame of the barn.

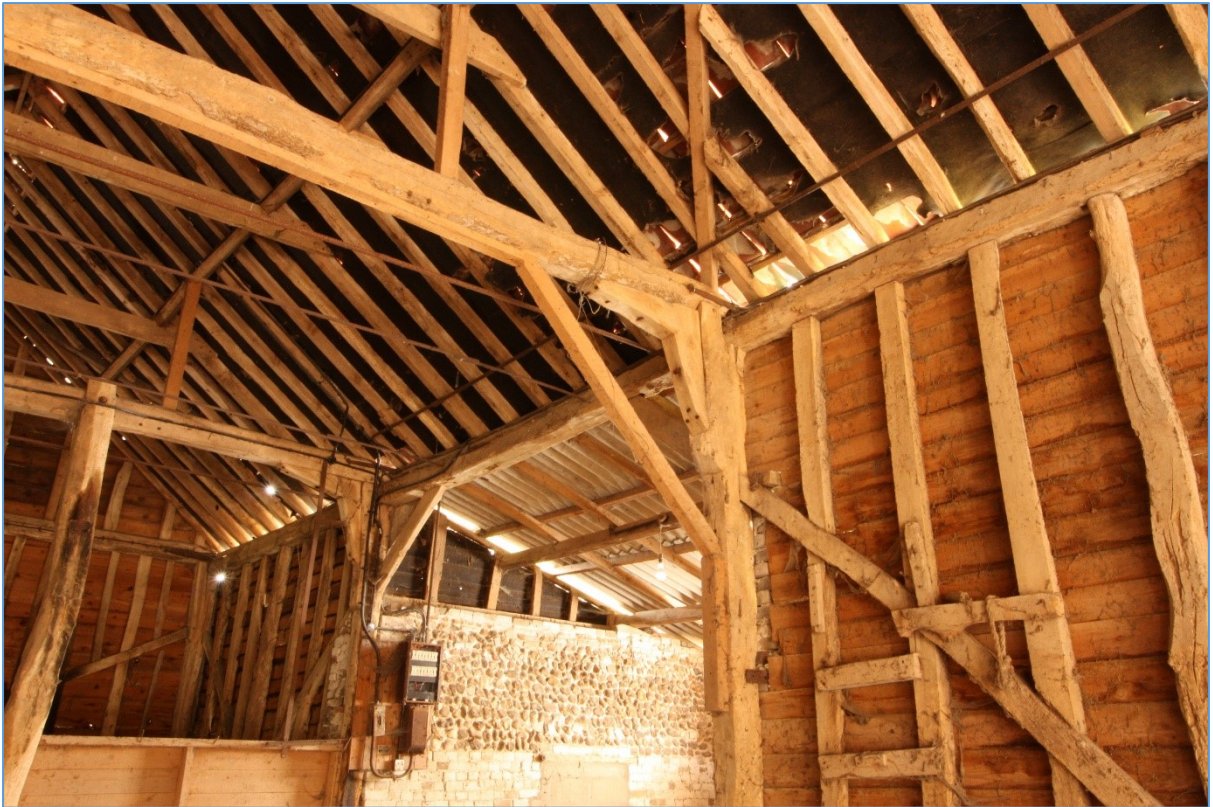
Plate 22. Close-up view of the carved haunch joint at the eastern intersection of the central and southern bays..
