An Agricultural Barn at Grange Farm, Gedding, Suffolk

Suffolk HER: ESF25652 / GDD 016

August 2017

Richard Hoggett Heritage

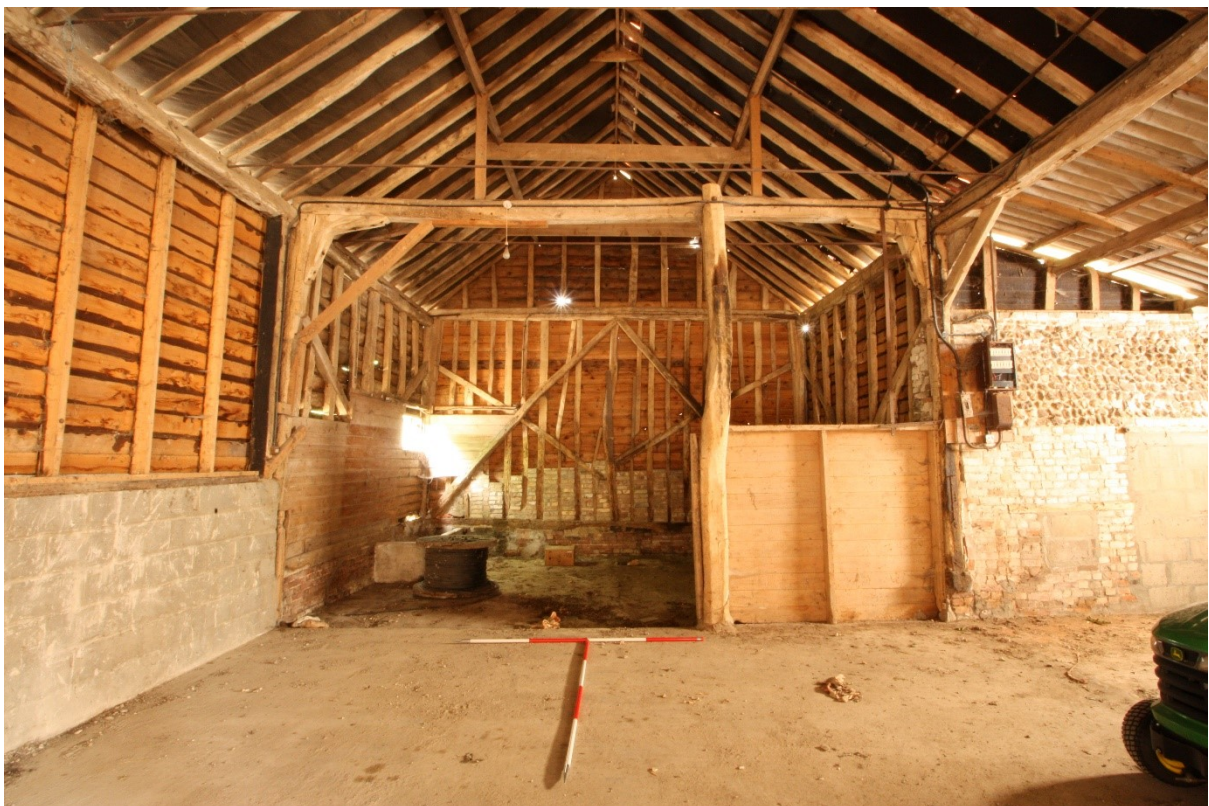
Plate 23. Interior view of Barn 1, looking north from beneath the second southernmost frame of the barn.

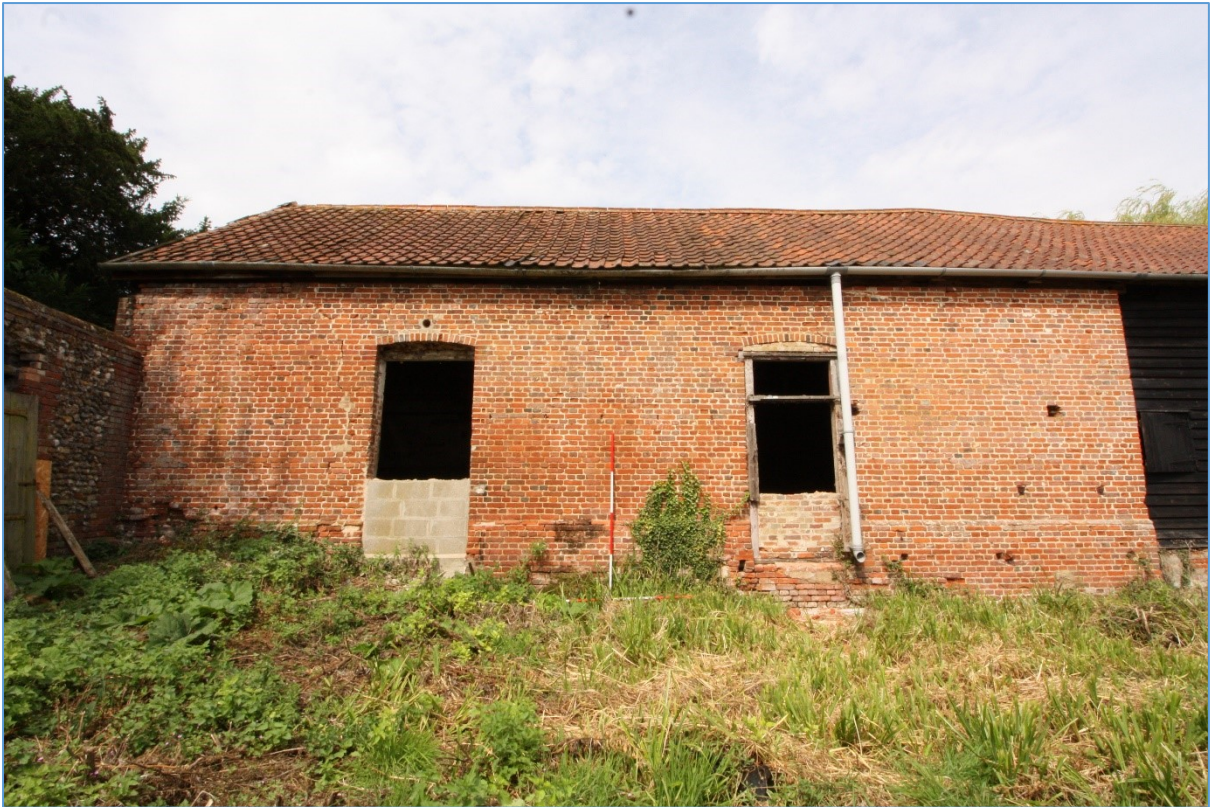
Eastern Elevation: The eastern elevation of Barn 2 butts against the weatherboarding of the southern bay of Barn 1 and is constructed of 9 x 4 x 2 ½ inch red bricks laid in an English bond with a plinth course approximately 1m above the ground (Plate 24). There are two doorways with brick arches in this elevation, presumably former stable doors, and both doorways have subsequently been closed up, with brick in the case of the northernmost doorway and breeze blocks in the case of the southernmost doorway, suggestive of the blocking up having occurred at different times. This blocking has been partially cleared as part of the preliminary works for the conversion of the building (Plate 25). The thresholds of both doors are level with the internal floor of the barn, but now open some distance above the ground level of the yard outside, suggesting that the surface at the southern end of the of the yard has been lowered since the barn was built.

Plate 24. Barn 2's eastern elevation, showing the two partially blocked doorways and the junction with Barn 1..

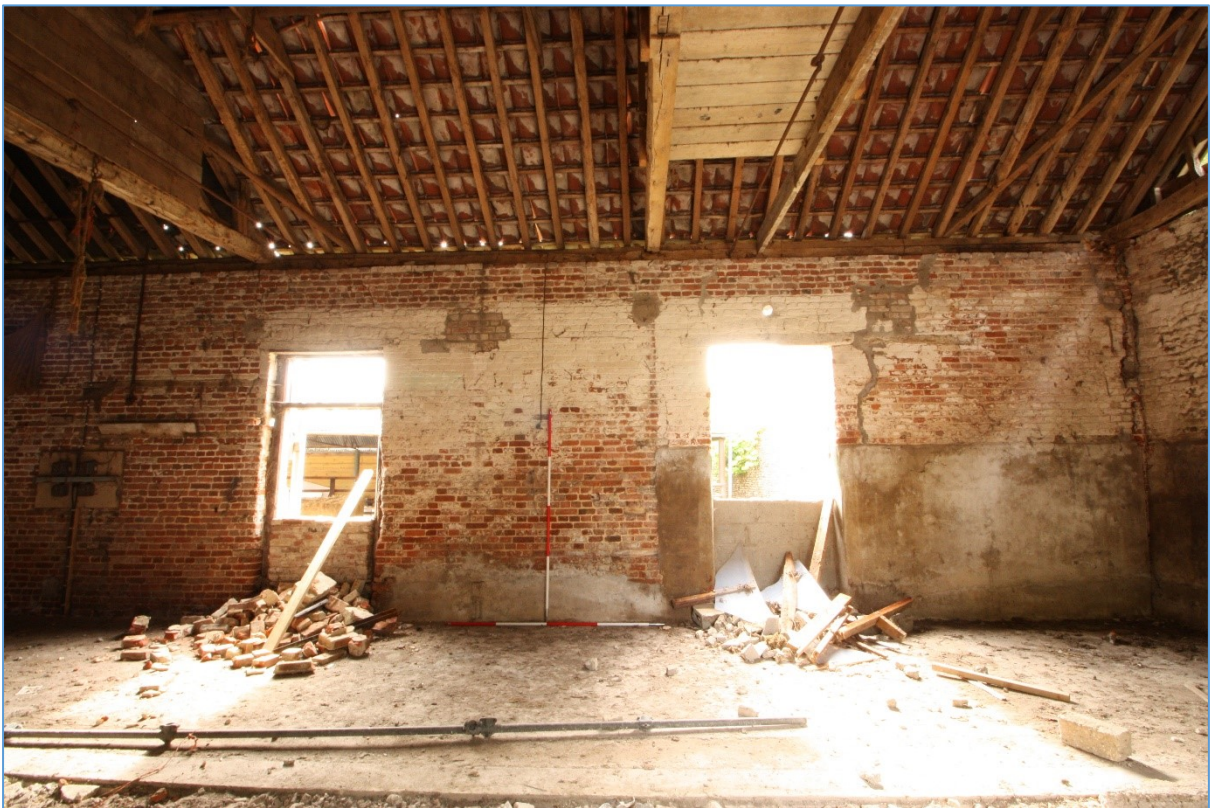
Plate 25. Interior view of Barn 2's eastern elevation, showing the two partially blocked doorways.

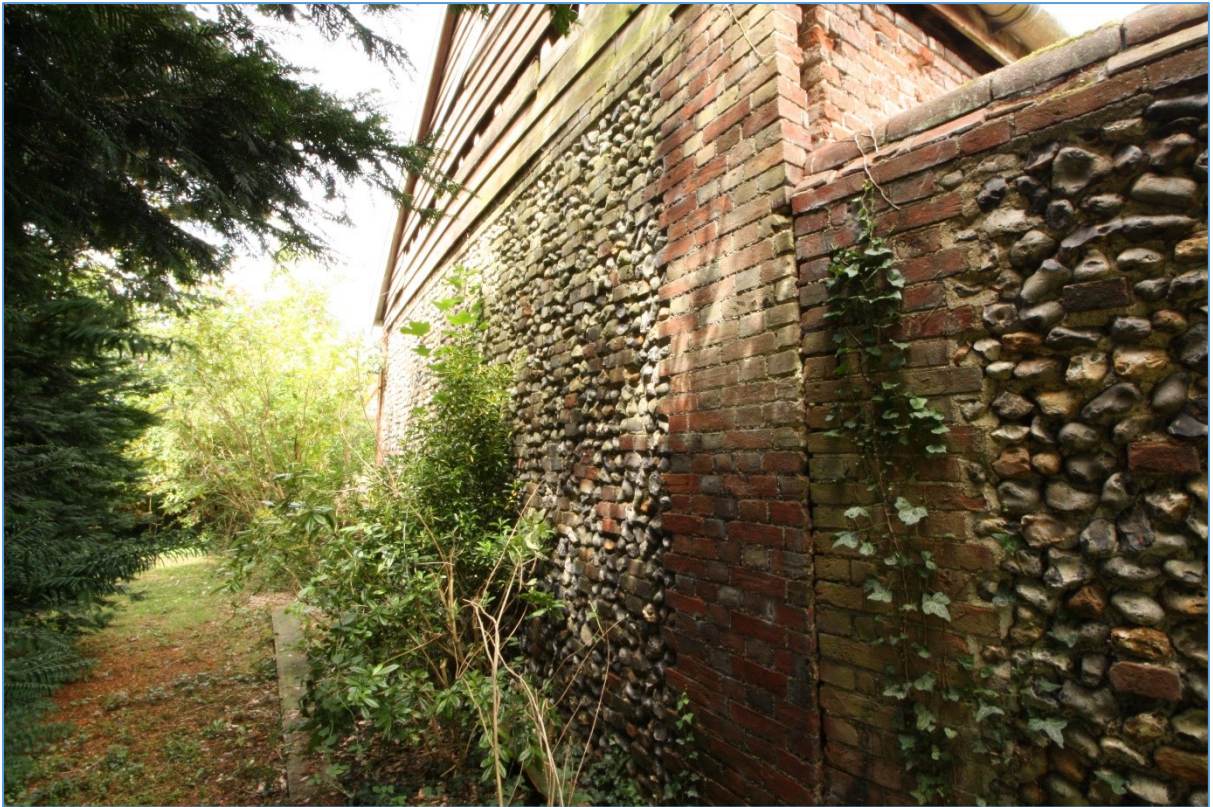
Plate 26. Barn 2's southern elevation, showing the close planting which prevents a straight-on photograph.

Southern Elevation: The southern elevation of Barn 2, which also forms the southern elevation of the modern combined barn, is of flint-and-brick construction with brick quoins and a weatherboarded gable. This elevation has also been incorporated into the boundary wall of the garden of Grange Farmhouse to the south-east and is closely planted with trees, making it very difficult to view the wall in its entirety except from an extreme angle (Plate 26). The interior face of the southern elevation comprises flints laid in rough courses, interspersed with brick levelling courses, to the height of the timber wall plate (Plate 27). The bottom 1.5m of the wall is protected by a coat of grey render, as are the southern ends of the eastern and western elevations (Plates 25 and 29), indicating that this end of the barn was actively used for keeping animals until comparatively recent times.

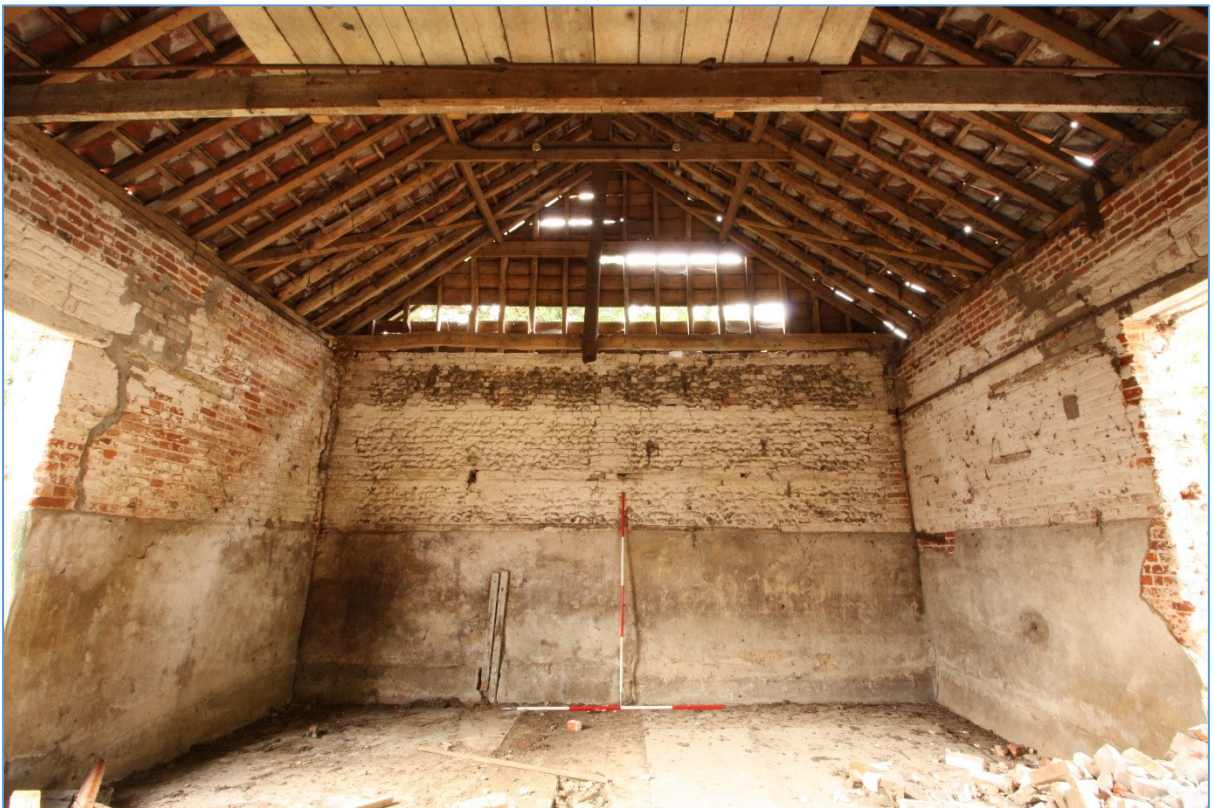
Plate 27. Interior view of Barn 2's southern elevation, showing the extent of the protective render.

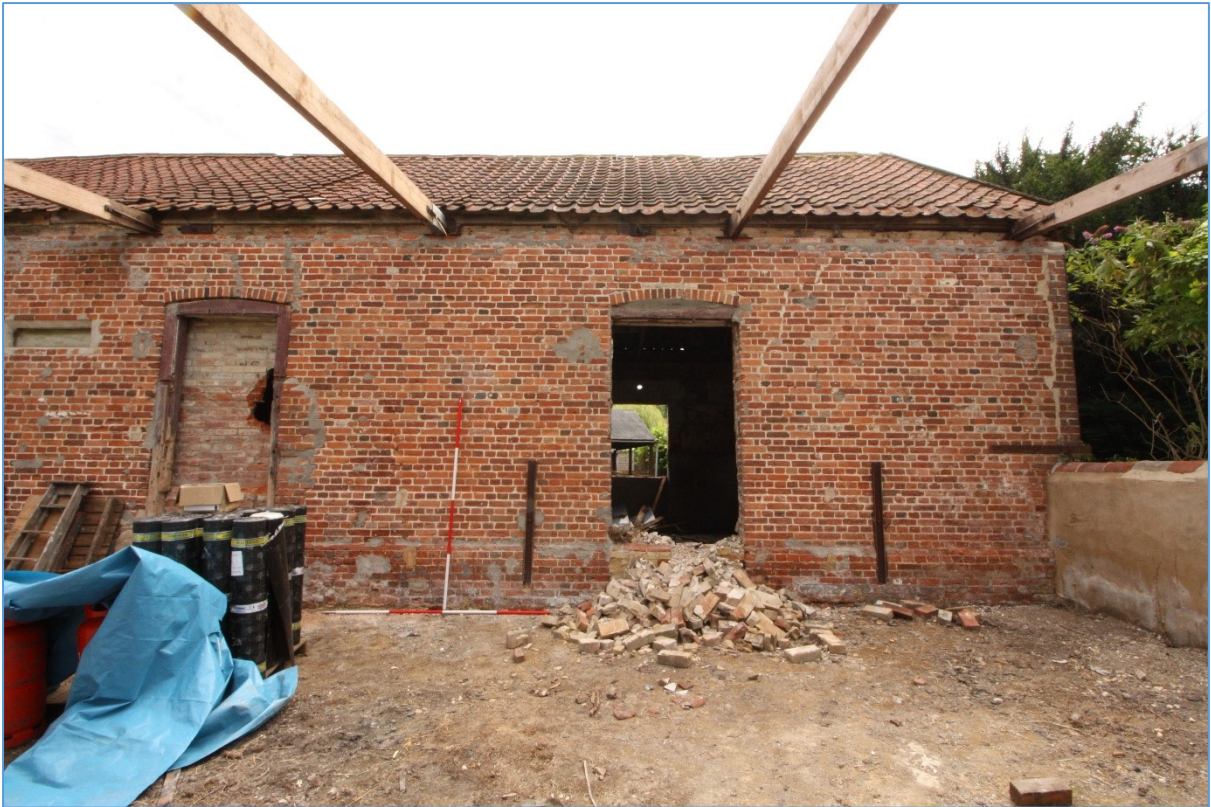
Plate 28. Barn 2's western elevation, showing the reopened southern doorway.

Western Elevation: The western elevation of Barn 2 mirrors the eastern elevation, and is constructed of red brick laid in an English bond with a plinth course (Plates 28 and 30). There is another pair of brick-arched stable doors, both aligned with their eastern counterparts, and their thresholds enter the small yard to the west of the barn at an appropriate walking height. The southernmost door was blocked with a mix of bricks and breeze blocks, but has been recently opened up again as part of the preparations for building works, while the northernmost door was bricked up completely and has only been partially reopened (Plate 29). To the north of the doors is a long low opening, presumably a former window, which has also been bricked up (Plate 31). The protective render discussed above continues along the internal face of this elevation beyond the northern doorway, and there is a wall scar between the two doors indicative of the space having been sub-divided to create stalls (Plate 29). This scar corresponds with similar scars of the concrete floor of the barn, which suggest that this enclosure extended into the centre of the space and then ran southwards to the southern elevation.

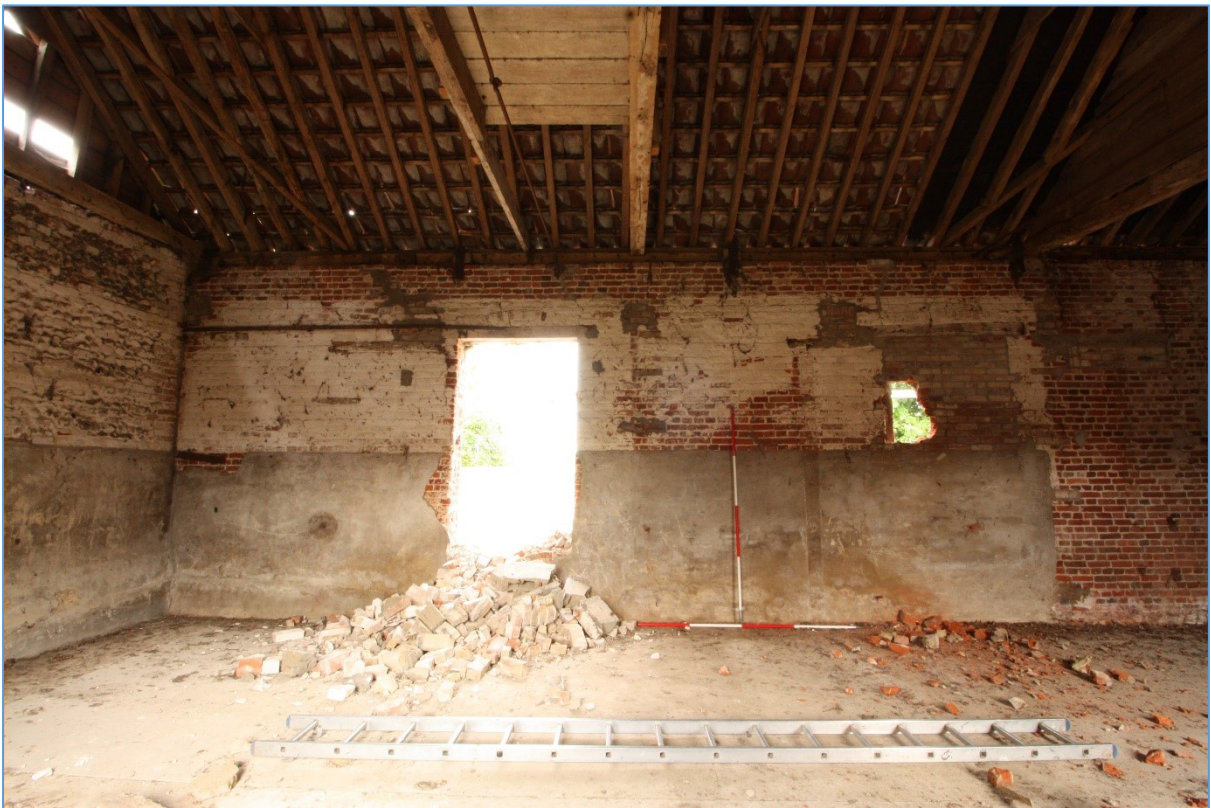
Plate 29. Interior view of Barn 2's western elevation, showing the reopened southern doorway and partially unblocked northern doorway.

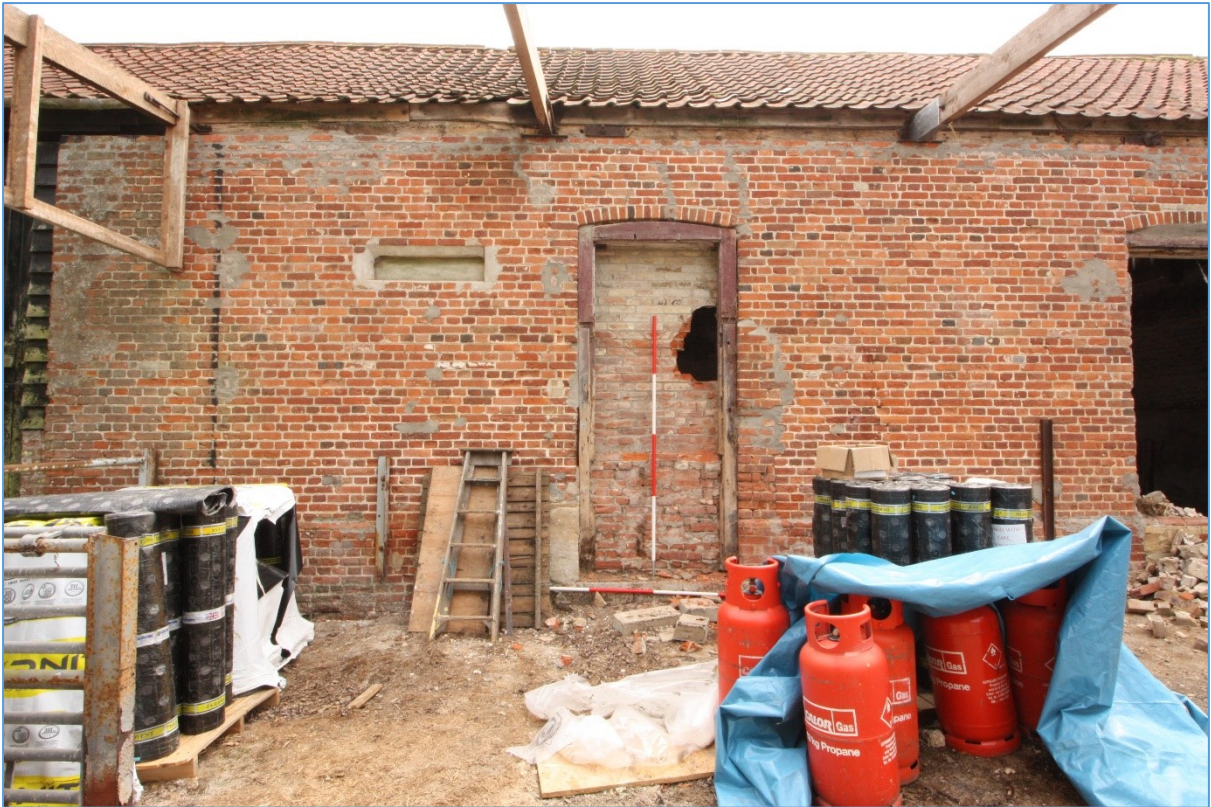
Plate 30. Barn 2's western elevation, central section, showing the partially unblocked northern doorway and associated blocked window.

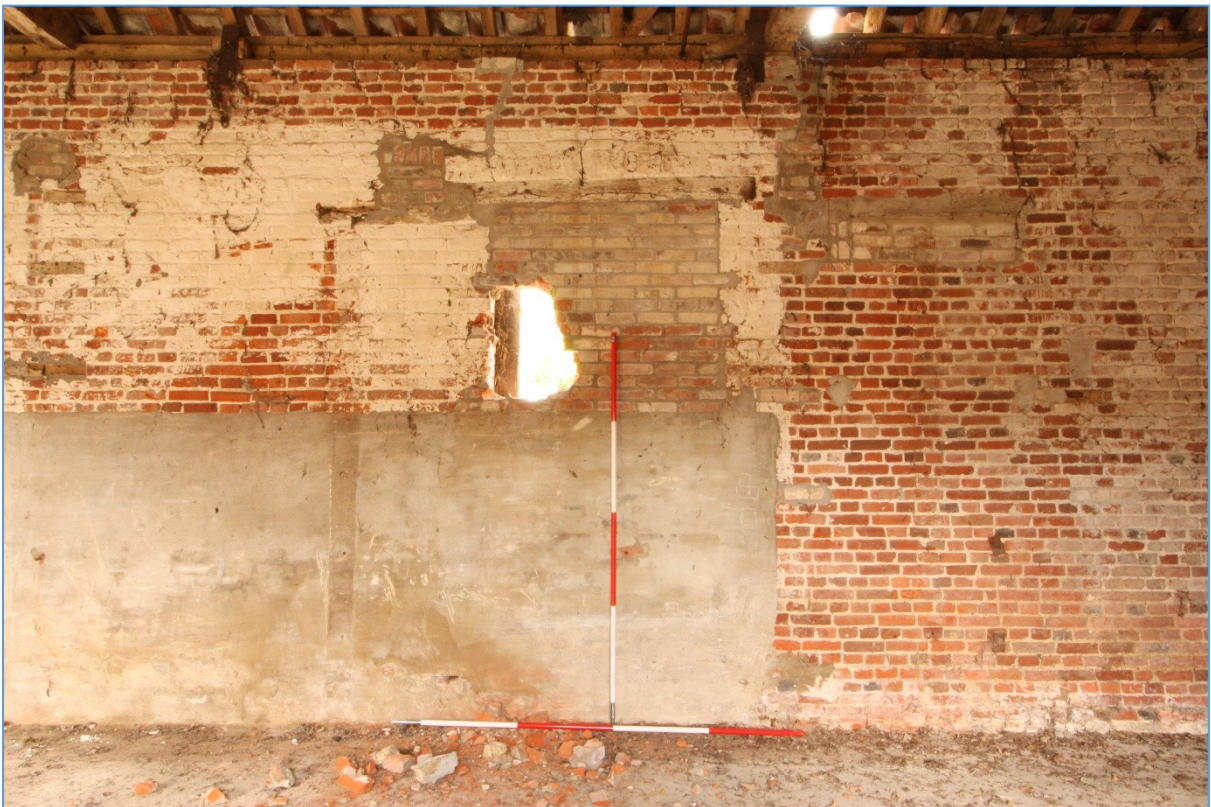
Plate 31. Interior view of Barn 2's western elevation, central section, showing the partially unblocked northern doorway and associated blocked window.

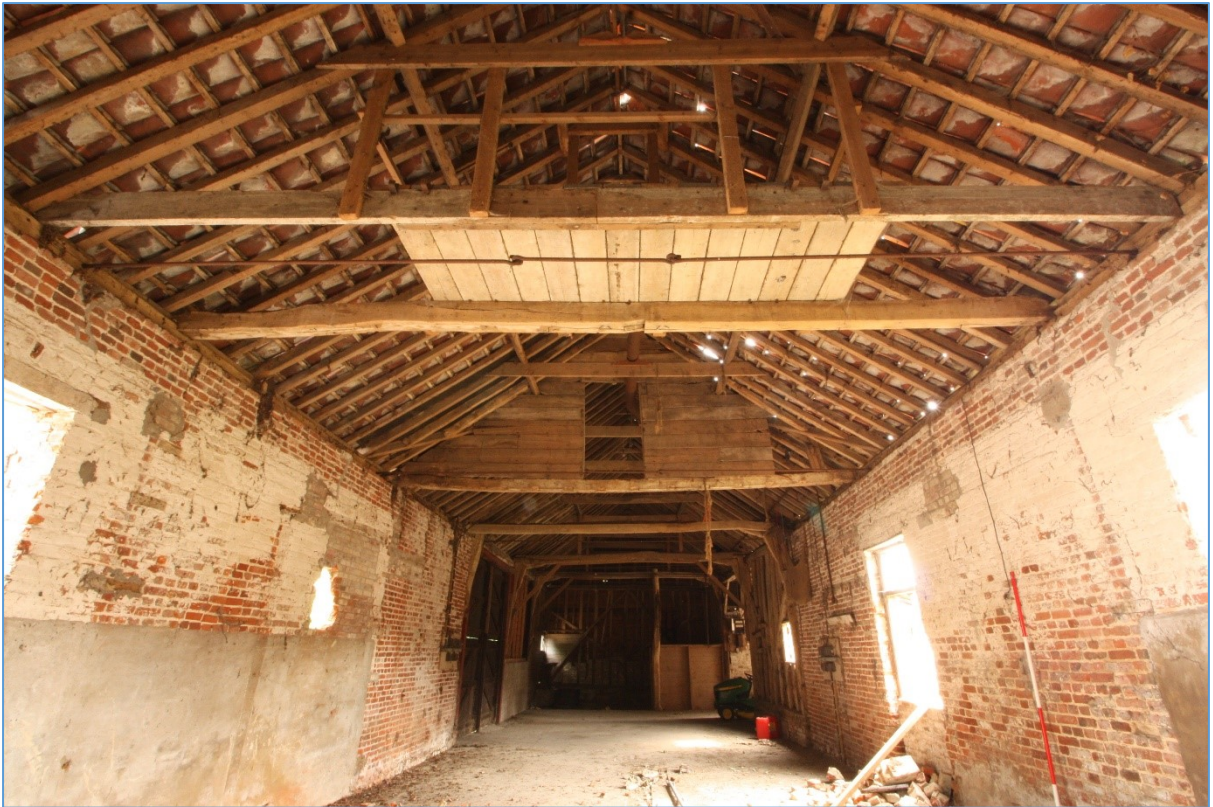
Roof: The roof of Barn 2 is supported on timber wall plates which lie along the longitudinal walls and a series of four evenly-spaced timber tie beams which span the width of the building (Plate 32). As discussed above, the rafters and roof covering now form a single run along the full length of the building, although this is unlikely to have always been the case, and it seems likely that Barns 1 and 2 had different roofs in the past.

Plate 32. Interior view of Barn 2, looking north, showing the tie beams and raised platforms in the roof space.

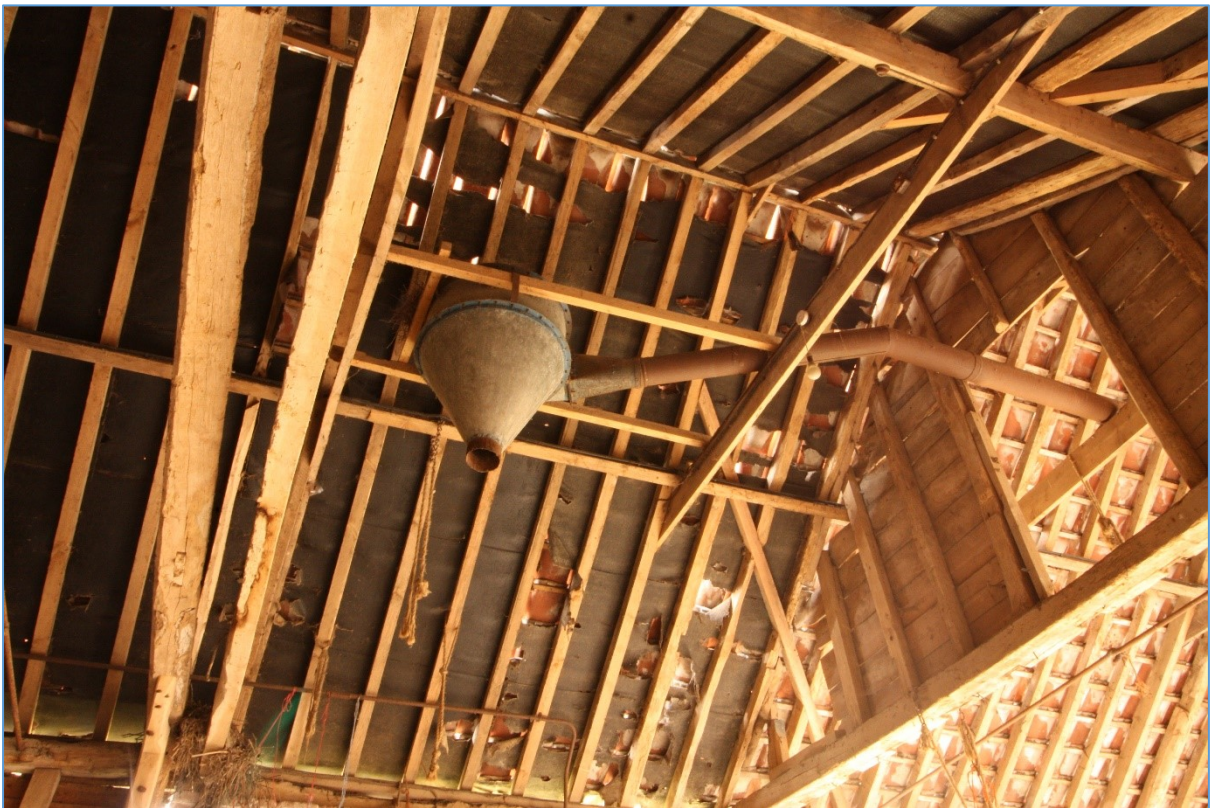
Plate 33. Detail of the silo-related pipework and funnelling still present in the roof space of Barn 2.

There is clear evidence for Barn 2's roof-space having had a functional use in the past in the form of suspended platforms which have been created via the insertion of additional ties beams and lateral planking, along with the creation of handrails and, in one instance, a planking wall complete with doorway (Plate 32). An indication of the function of these features is given by the presence of branching stretches of circular metal pipework running through the roof-space, at least one of which feeds into a metal funnel which presumably relates to the former position of a feed silo on the concrete floor below (Plate 33).
