34, 36 Churchgate, Hallaton, Leicestershire

Site Code: HAL-B

The Medieval Peasant House in Midland England

HAL-B: 34, 36 CHURCHGATE, HALLATON, LEICESTERSHIRE

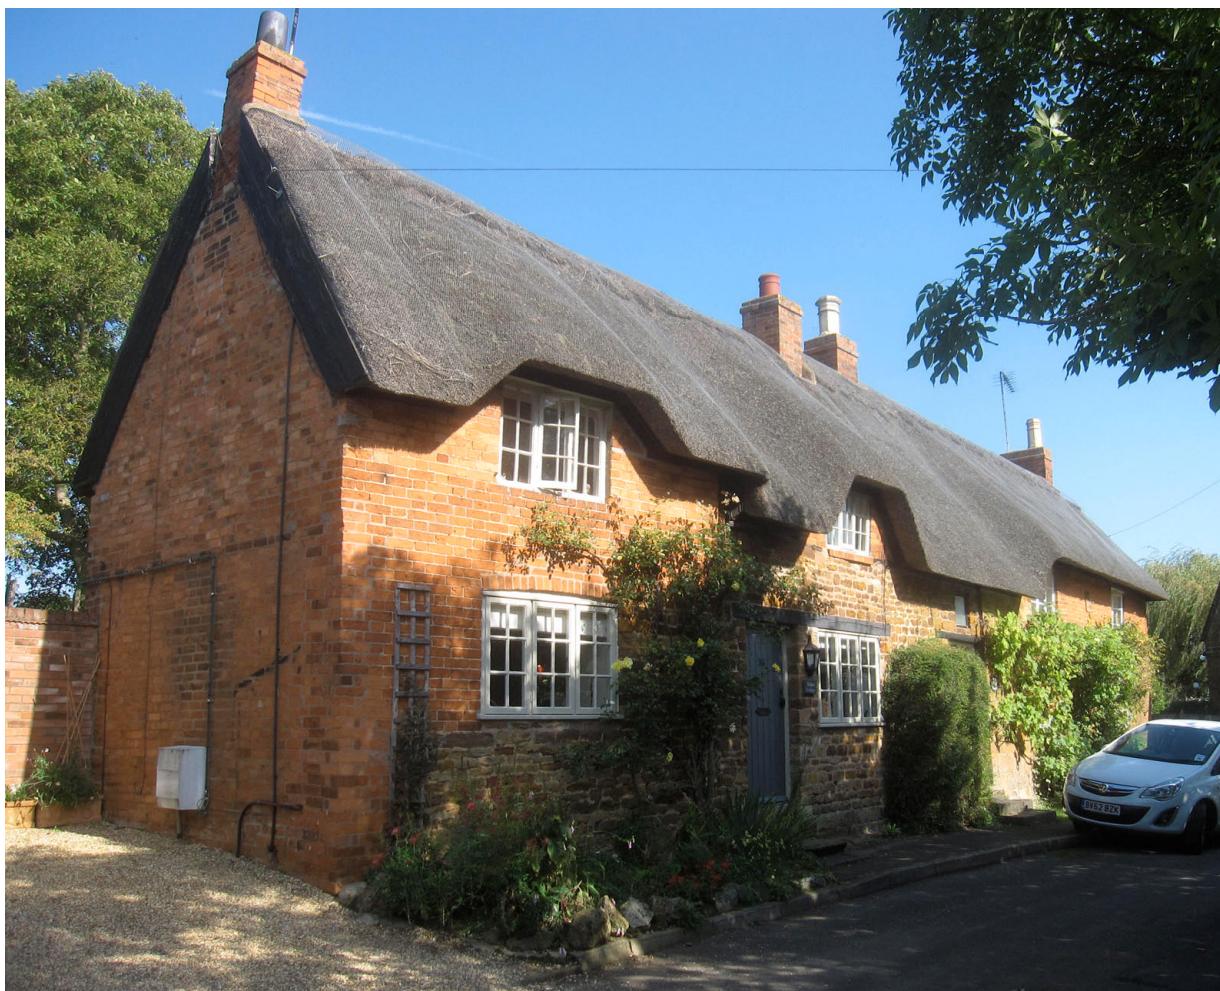
Fig. 1. View of no. 34, Hallaton, from the south (Photo: Nick Hill)

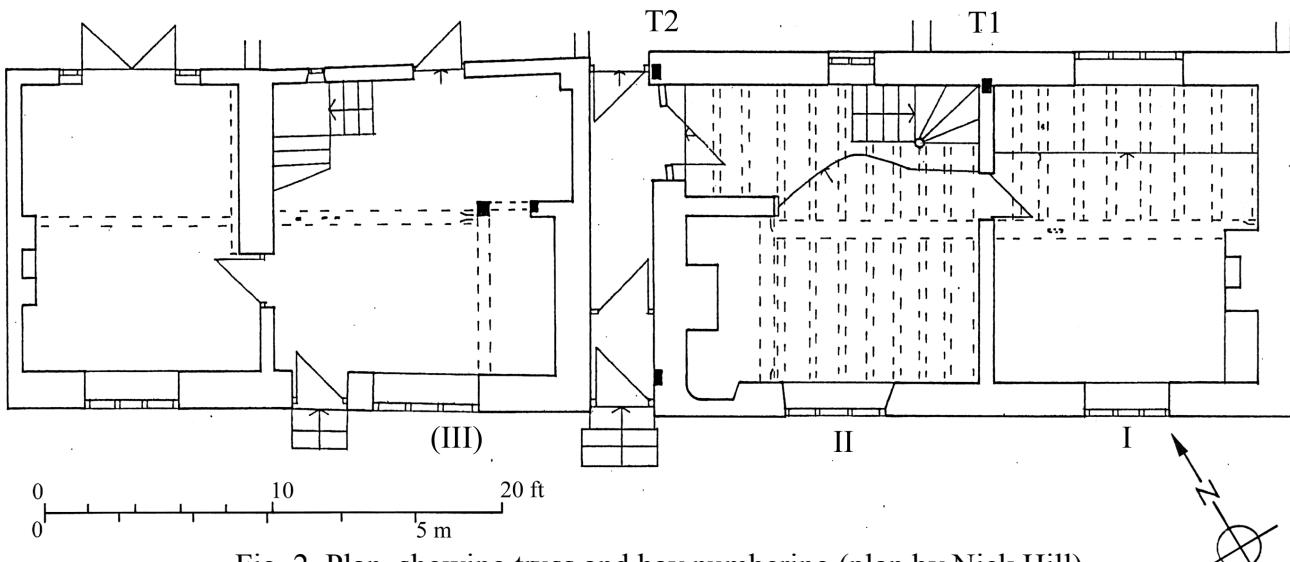
Fig. 2. Plan, showing truss and bay numbering (plan by Nick Hill).

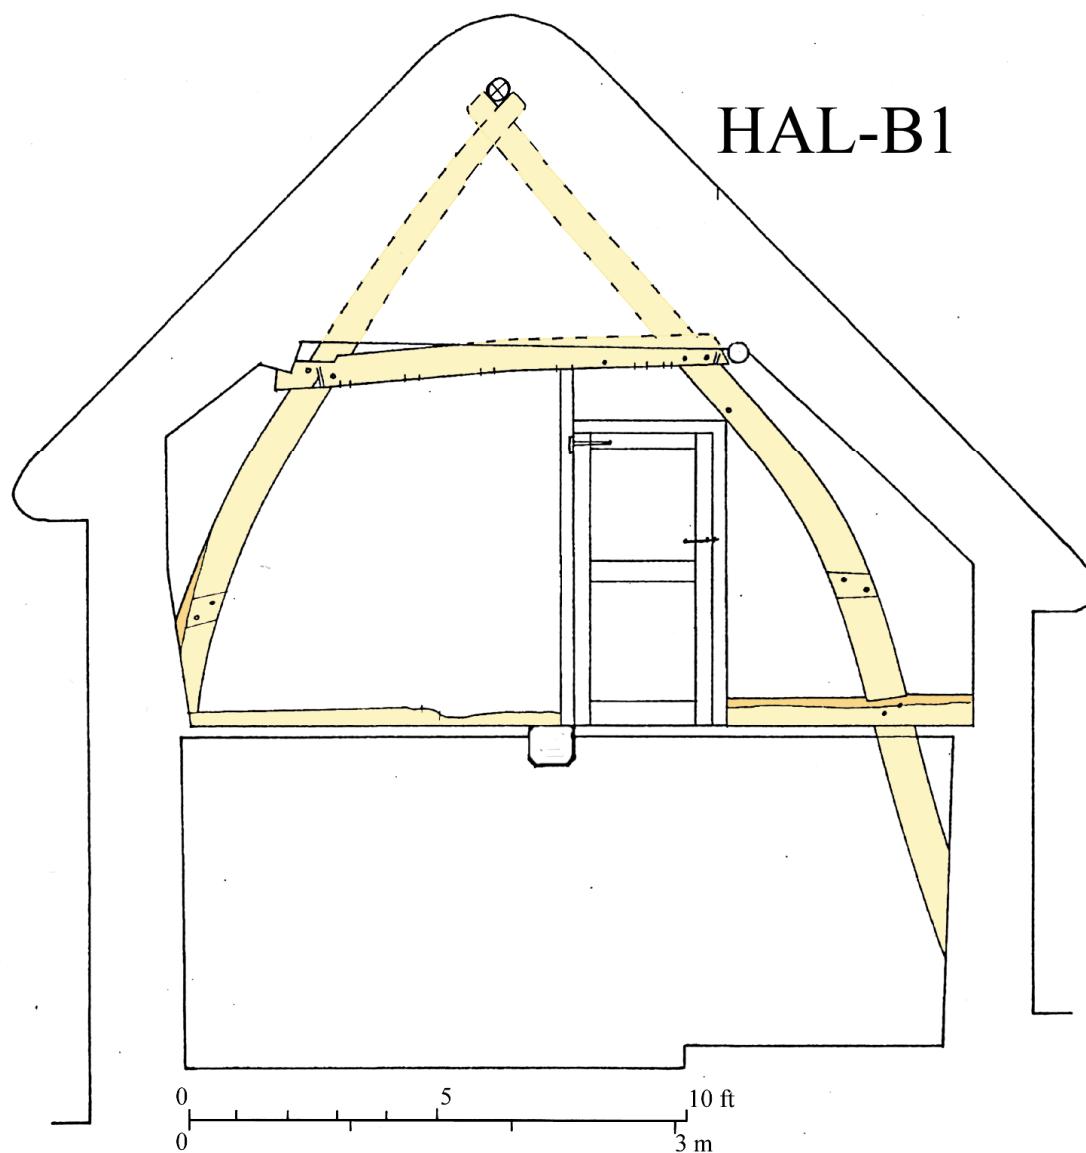
Fig. 3. Section of truss T1 from the east.

PHASE 1: Truss T1 (Fig. 3) has its cruck blades crossed at the apex to carry the diagonally-set ridge. A collar is half-dovetailed to the east side of the crucks with double skew pegs. Halvings are visible lower down for cruck spurs, now removed. The tiebeam is still in situ, extending beyond the blades to connect with the cruck studs. It appears that these studs would have been jointed into the underside of the spurs as well as being connected by the tiebeam. The front purlin (boxed in) sits on the end of the collar and measures 7½ by 6in. Most of the windbraces (7 by 2in) have been removed.

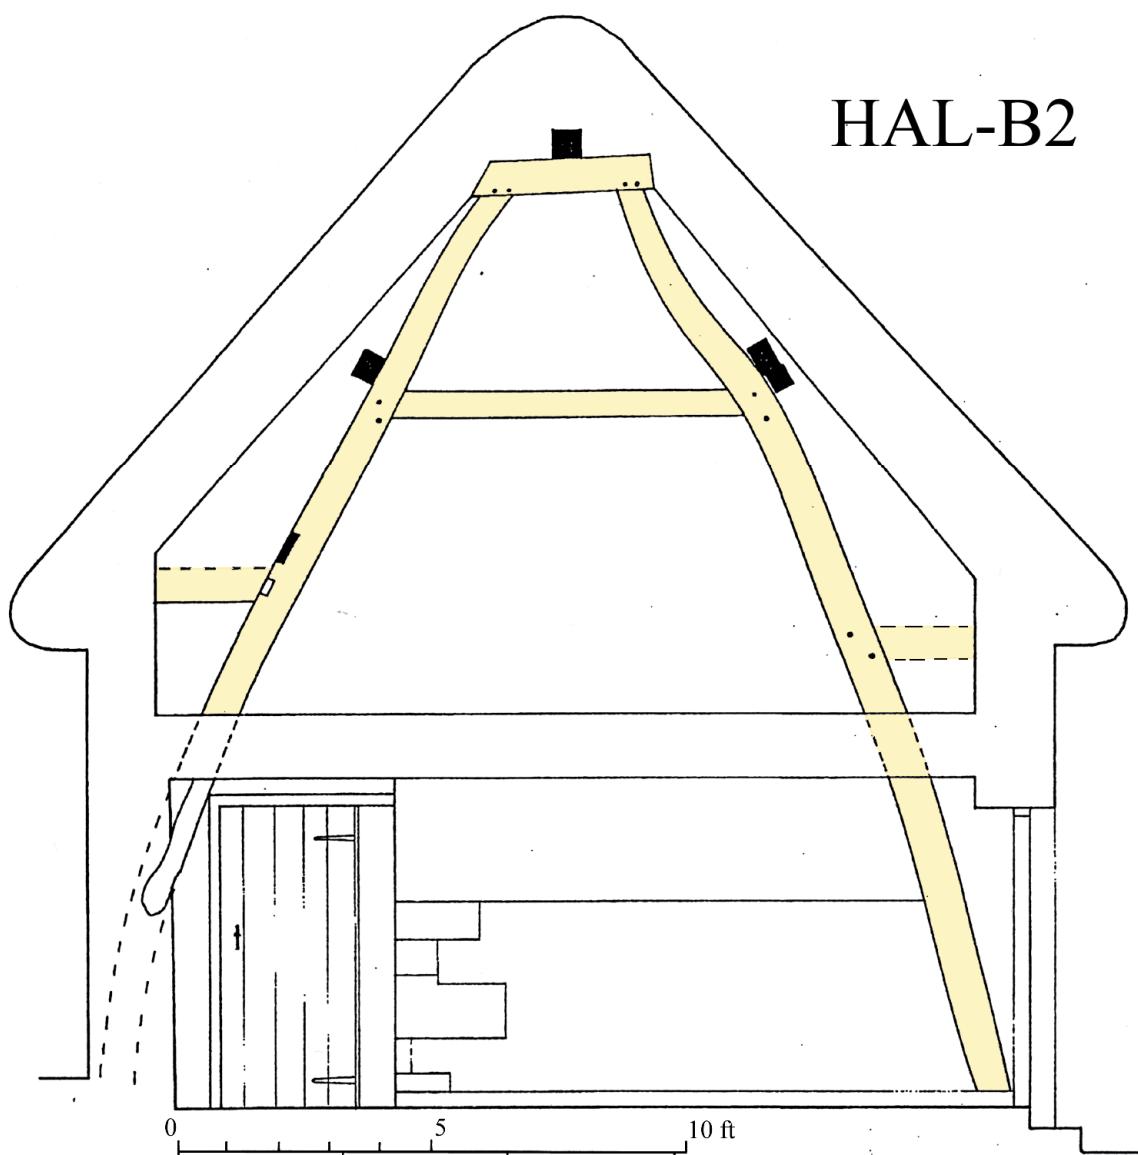
Fig. 3. Section of truss T2 from the west (drawing by Nick Hill).

Truss T2 (Fig. 4) differs from T1 in having a saddle apex, which still carries a square-set ridge over bay I. Some later wattle and daub infill survives at the top of the truss. It has assembly marks on the east face of the collar, comprising two strokes, the front one having a tag. The present ridge in bays 2 and 3 is a later replacement in roundwood. Most of the rafters in bays II and III have also been replaced. The end

of the rear purlin (visible in bay III) is clearly weathered, indicating that this was the end of the house; it has a peg hole for fixing it to the missing cruck truss.
