Report for
**Godfrey's Farm, 2 St Mary's Road, East Hendred,
Oxfordshire**

The Medieval Peasant House in Midland England

EAH-C: GODFREY'S FARM, 2 ST MARY'S ROAD, EAST HENDRED,
OXFORDSHIRE

Grid reference: SU 4604 8852 Survey Date: 2 August 1988 By: D Miles

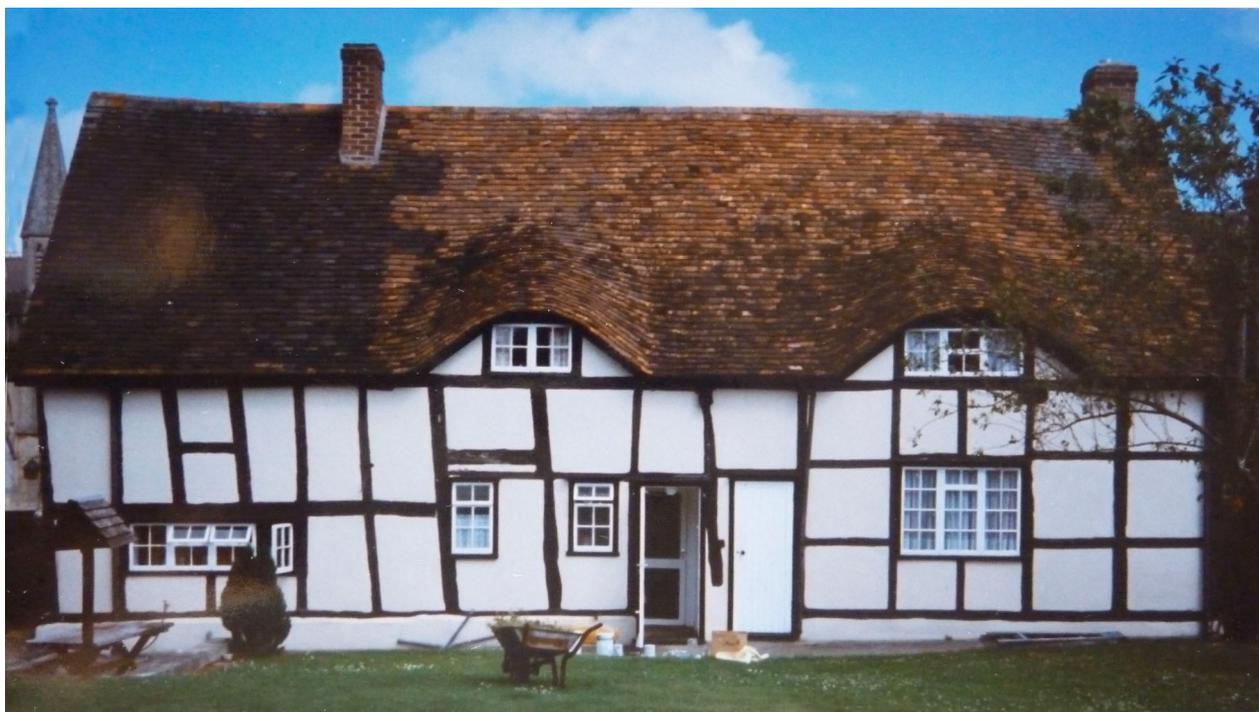
Fig. 1. View of the house from the west.

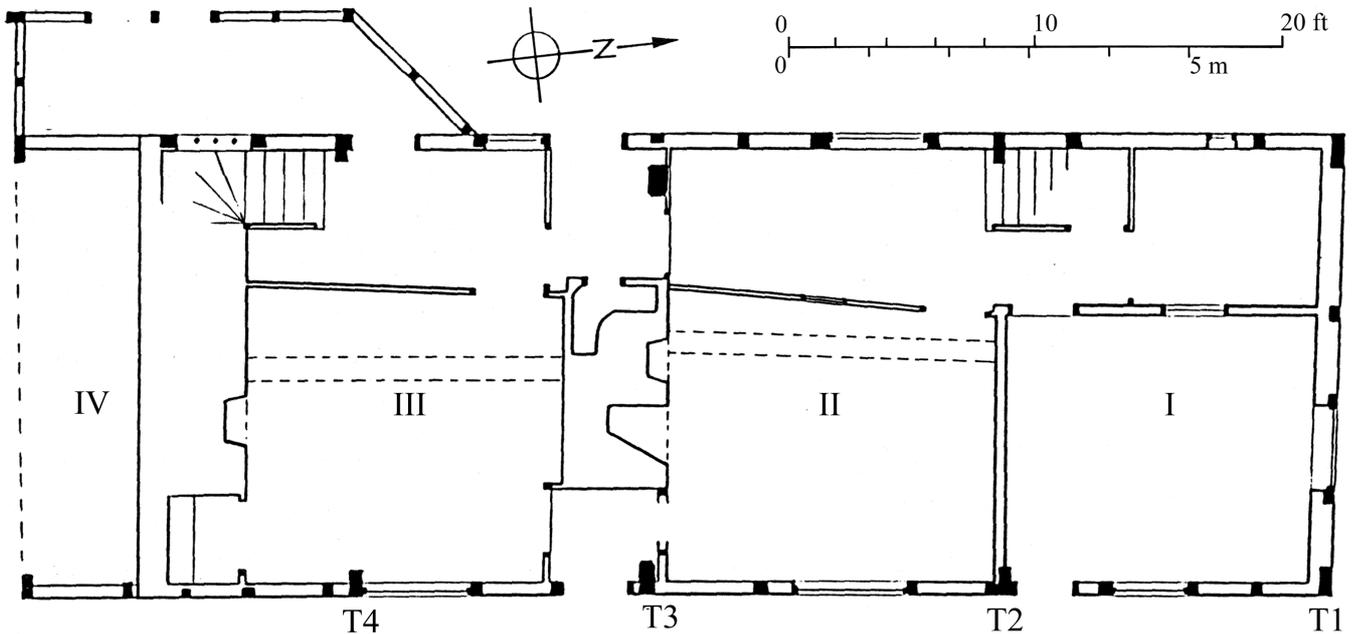
Fig. 2. Plan, showing truss and bay numbering (after Currie (1976)).

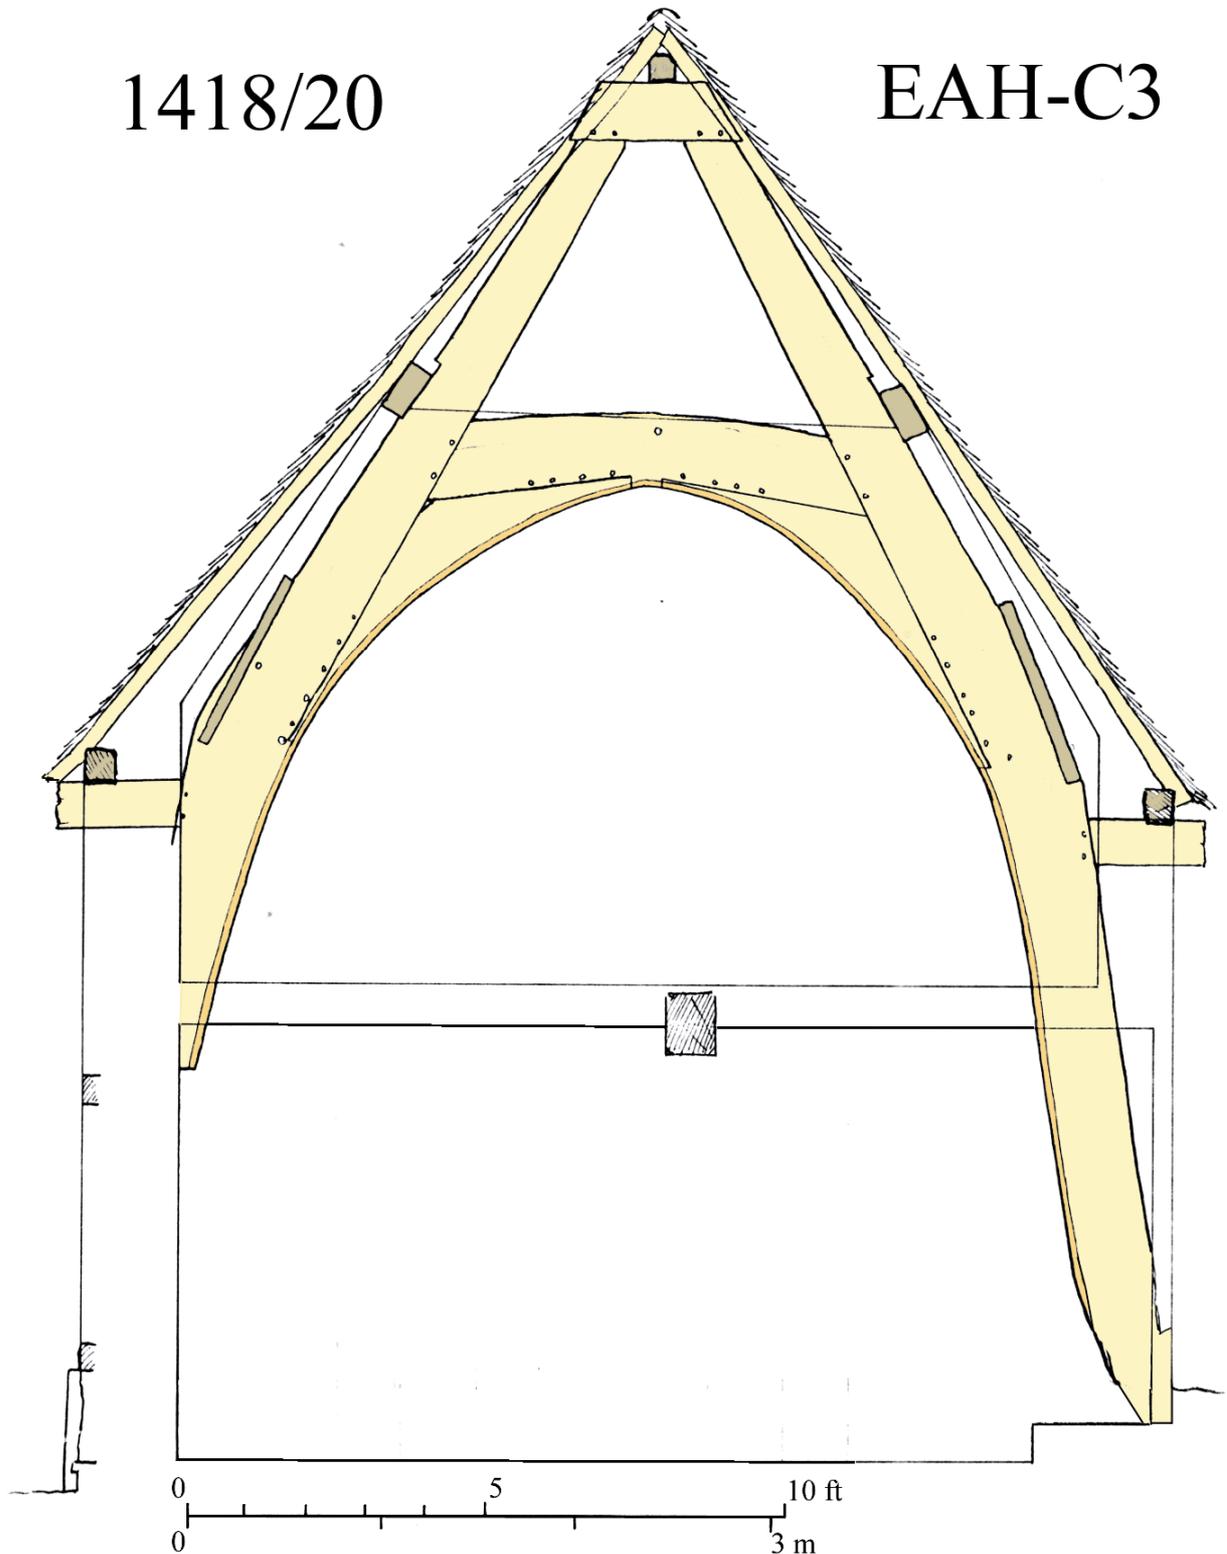
Fig. 3. Section of truss T3.

PHASE 1: The most interesting feature of this period is the two bay open hall. Truss T3, dividing bays II and III, is a massive arched-braced cruck open truss with a continuous 2in chamfer on the underside of the crucks and braces creating a slightly four-centred arch. The blades are of elm and measure 21 by 7in

thick at eaves height. They have been cut from a single tree, halved down the centre to give a perfectly matching pair. Two scribe marks were noted on the north side of the collar and arch-brace, just to the east of centre. It has a saddle at the apex (type 'C'). Large elbowed windbraces are present in the hall, 18in across by 3in thick, rising steeply from mortices set near the back faces of the blades. The top centre of the collar contains a large peg hole, presumably to suspend some object. The top of the collar has a groove for staves, but neither the inner face of the crucks or the underside of the saddle have any stave sockets. However, it is possible that the central truss was closed above the collar with the staves being nailed to the timbers. The wall-plates are carried on cruck spurs tenoned into the back of the blades and supported at the outer end by cruck studs or wall posts. The method of jointing at the bottom of the cruck is not visible but the stud is likely to be set in a notched housing on the back of the cruck blade.

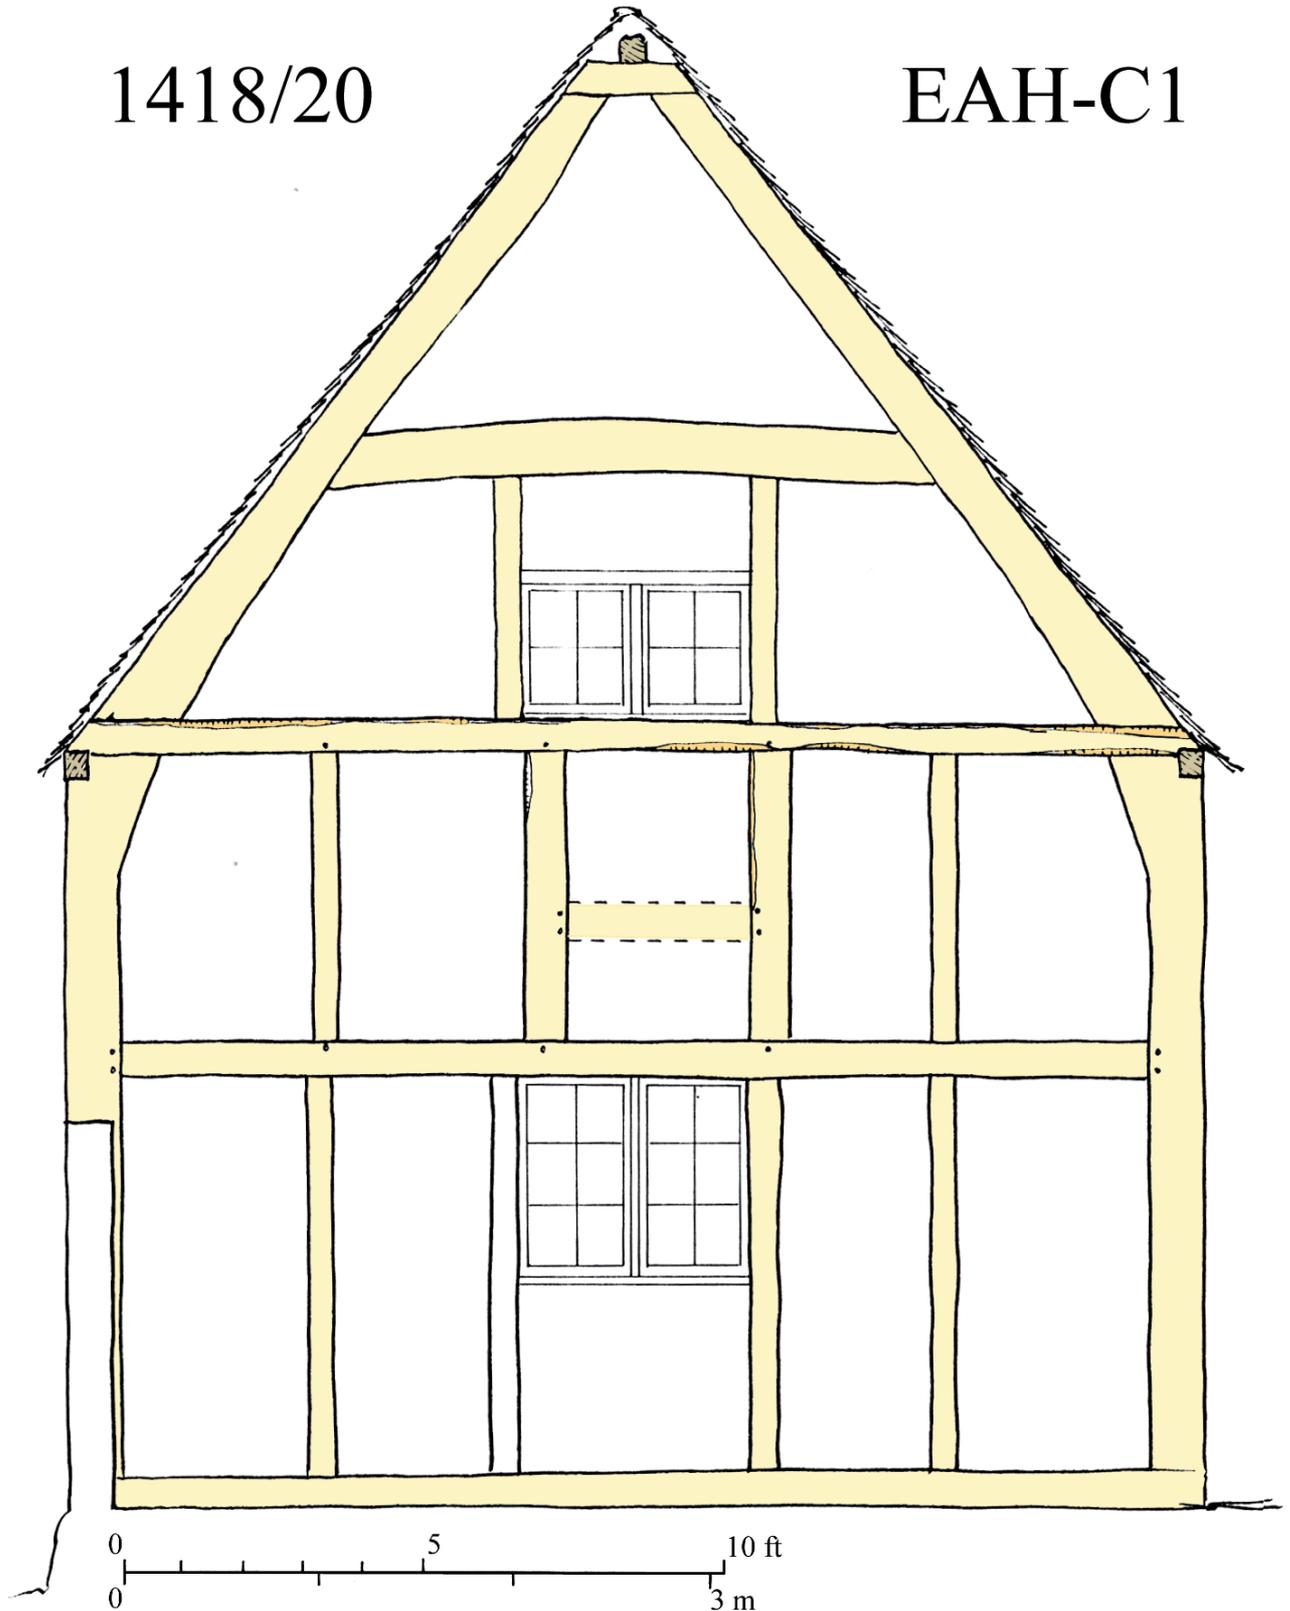
Fig. 4. Elevation of truss T1.

The other three surviving trusses (T1, T2 and T4) are of post-and-tiebeam construction. The principal rafters have thickened feet sitting on square-section tiebeams and are joined at the top with saddles (as in T3). The tiebeam in truss T4 has been removed, but the collar has the stave holes for a partition. The roof has been entirely renewed with the exception of the principal timbers. The purlins are of elm, 11 x 5½in in section, and are trenched on the back of the crucks and principals. Several complex scarf joints were noted, the purlin joint at T4 being a splayed scarf, counter tongued-and-grooved with four edge pegs (see Fig. 5.7g). The ridge runs from truss T1 to just beyond truss T2 where it is joined with a similar scarf. This second length of ridge finished just beyond the open truss (T3) where the cut end is clean. The ridge over bay IV has been reset under the saddle, being clasped in a yoke which is itself somewhat smoke blackened, as is the cut end which projects about 12in beyond truss T4. Smoke blackening is present throughout bays II through IV. The soot is particularly thick on the central truss, as much as ¼in near the top. The removed chimney stack immediately to the south of this truss was most likely on the site of the original open hearth.

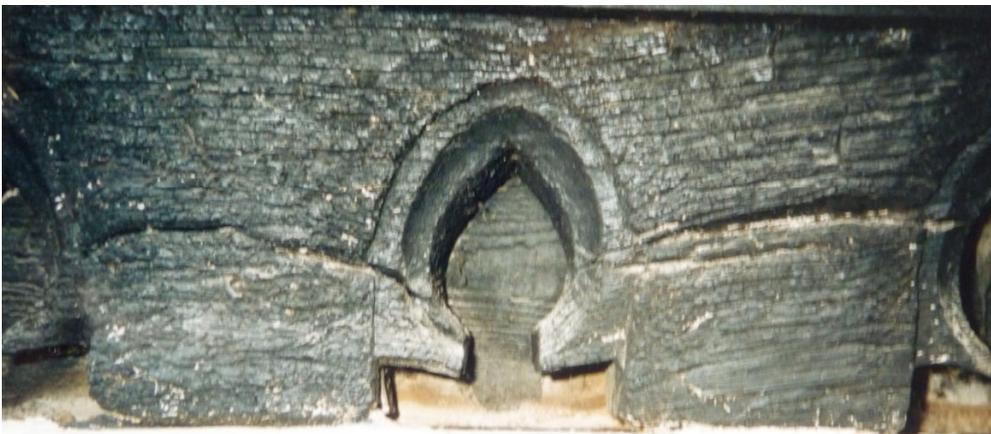
Fig. 5. Detail of the head of the hall window.

Bay II has two full-height wall posts on the front elevation with the elaborately carved cusped head for a five-light window between them. The west wall has three full-height posts/studs although the one furthest to the south has been renewed; two of these serve as the jambs of a smaller window. The framing to bays III and IV appears to have been reconstructed, although the mid-rails seem to be in situ.
