THE REPAIR OF OLD MALDEN CHURCH

THOMAS F. FORD, A.R.I.B.A.

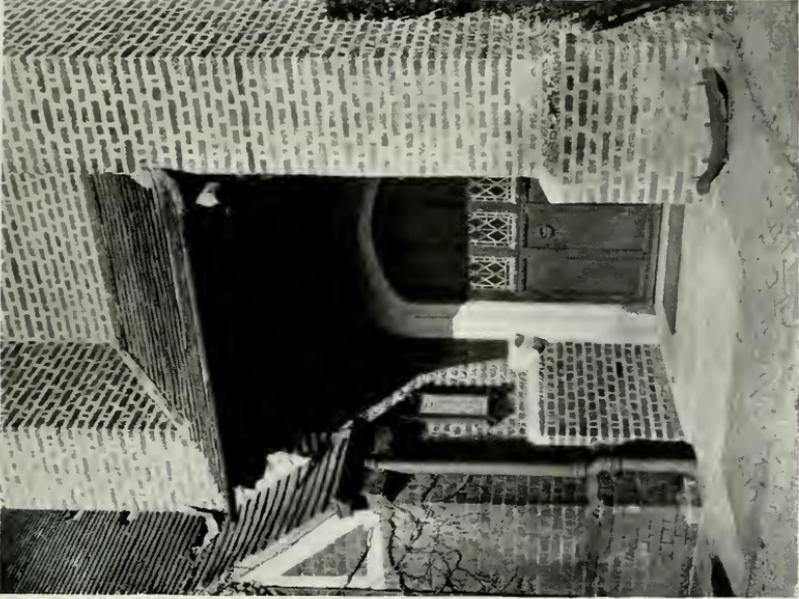
ENTRANCE TO TOWER, SHOWING SEVENTEENTH-CENTURY DOOR.

The entrance to the Church is now through a door in the west wall of the tower, though the date of its construction is not clear. The six-panelled oak door itself however is of seventeenth-century date with its three upper panels now filled with glass which was inserted about 1840 to judge from its peculiar type. The door case is of Bath stone with a small two-light window of the same stone above it, the whole protected by a modern tiled pent roof. The latter being decayed was stripped and retiled, the painted glass in the doors releaded and the smooth face of the modern Bath stone dressings tooled over to improve the appearance.

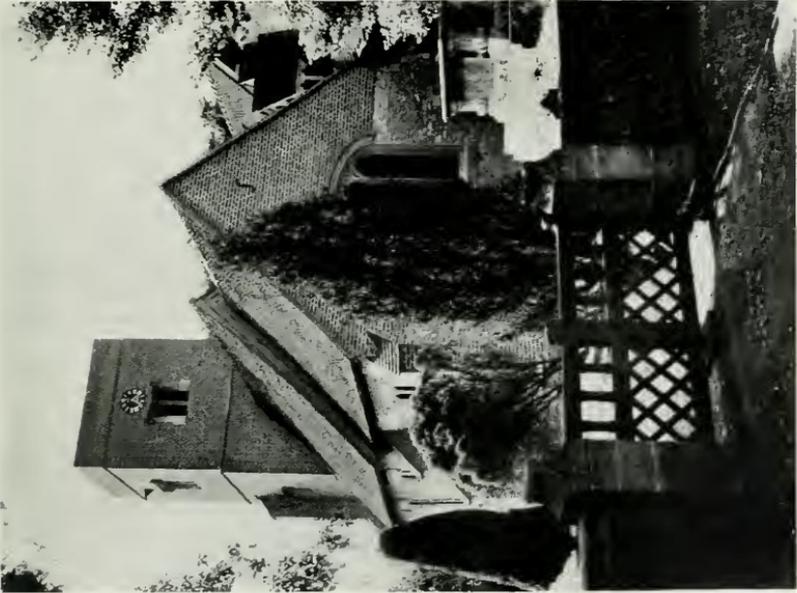
VIEW OF CHURCH FROM THE EAST.

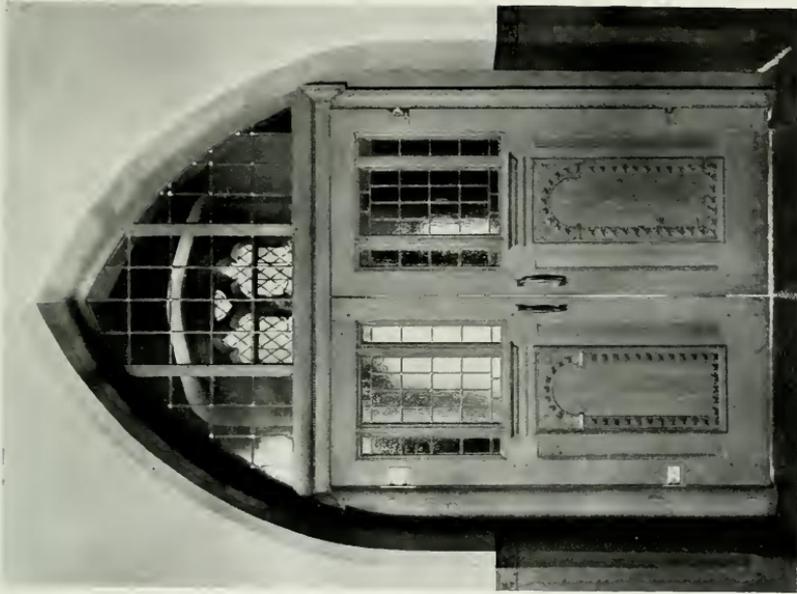
NEW DOORS FROM TOWER TO NAVE, SHOWING SEVENTEENTH-CENTURY PANELS IN LOWER PORTIONS.

This description is incomplete without a reference to four interesting oak panels of seventeenth-century date which once formed part of the pulpit, and which have now been incorporated into new swing-doors placed between the Tower and the Nave. The pulpit was destroyed some years ago when it was replaced by the present one of highly carved alabaster.

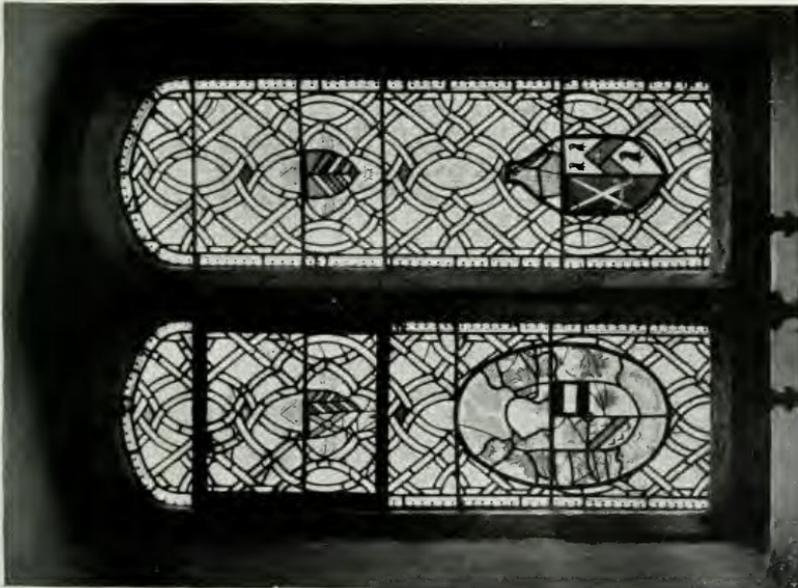
WINDOW IN CHANCEL OF OLD CHURCH WITH SEVENTEENTH-CENTURY GLASS.
