Great Eastern Hotel,
Glasgow

Archaeological Evaluation and
Historic Building Record

Data Structure Report

September 2007

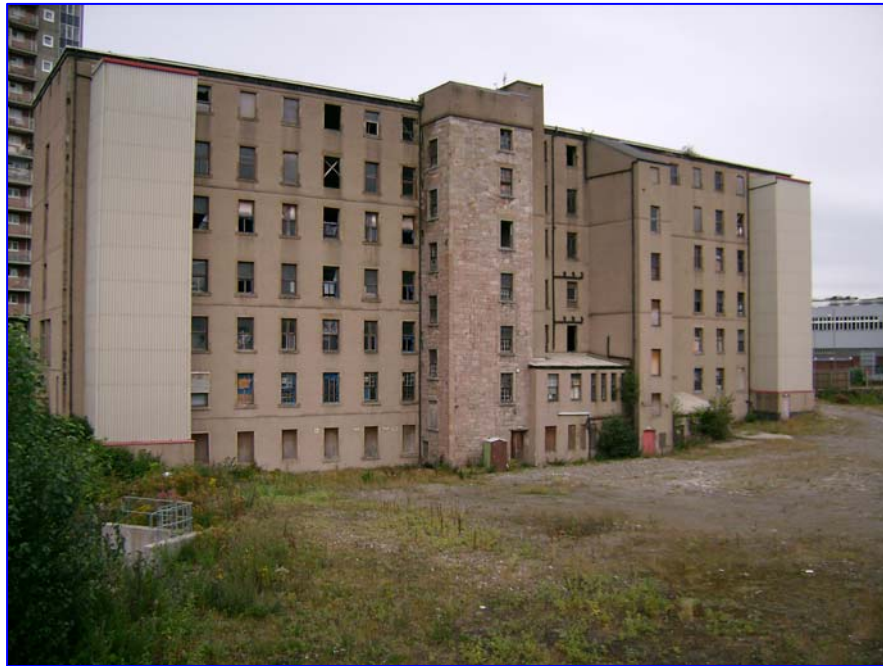
The pebble-dash harl that covers most of the rear elevation (**Plate 5**) masking a stone rubble build (as identified on the internal elevations). The stonework is only revealed on the main staircase (C) which extended to all floors. The snecked roughly dressed stonework on the staircase includes rounded quoins to the outer corners. In addition to this, the staircase has large windows to each of the six floors on both the south and west elevations, all with stone surrounds and projecting sills (**Plate 6**). A series of smaller windows are located to each floor on the west face of the staircase as it met the main south-facing elevation. The basement level includes two doors, although the one on the west face has

General view of the rear south-facing elevation of the hotel

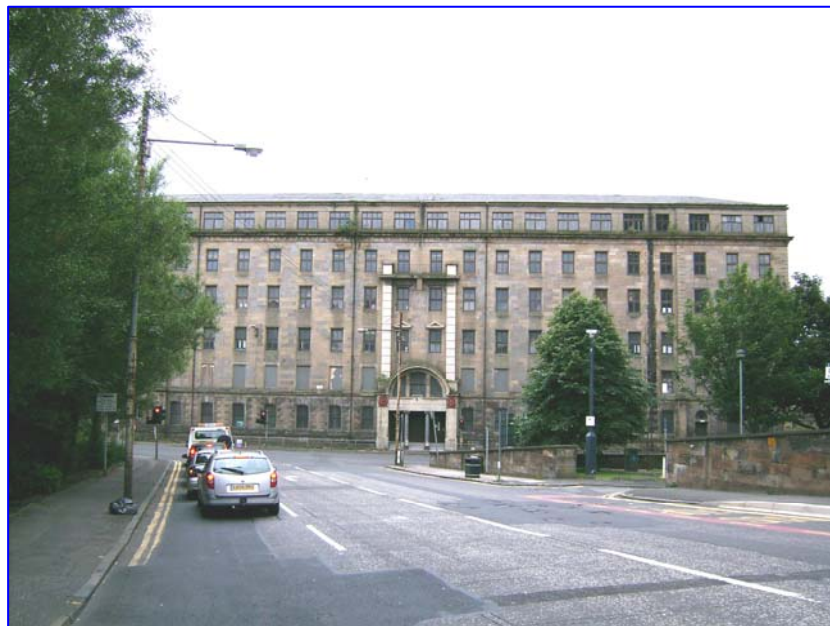
General view of the main front north-facing elevation

The front (north-facing) elevation of the building is a visibly striking balanced façade (**Plates 4 & 9**) comprising five main sections within the 22 bay elevation including two slightly projecting wings (K and O) flanking the main façade (L and N) with a central elaborately-decorated central entrance (M) (**Plate 10**). The six main floors of the building are visible from the north, the basement level being below street level. The ashlar stonework is complimented by raised stone quoins to the corners of the projecting wings and a ground floor of rusticated stonework with pecked decoration. A raised string course divides the ground floor from the upper levels. A second corbelled string course with dentil decoration separates the fourth and fifth floors before the raised decorated cornice.

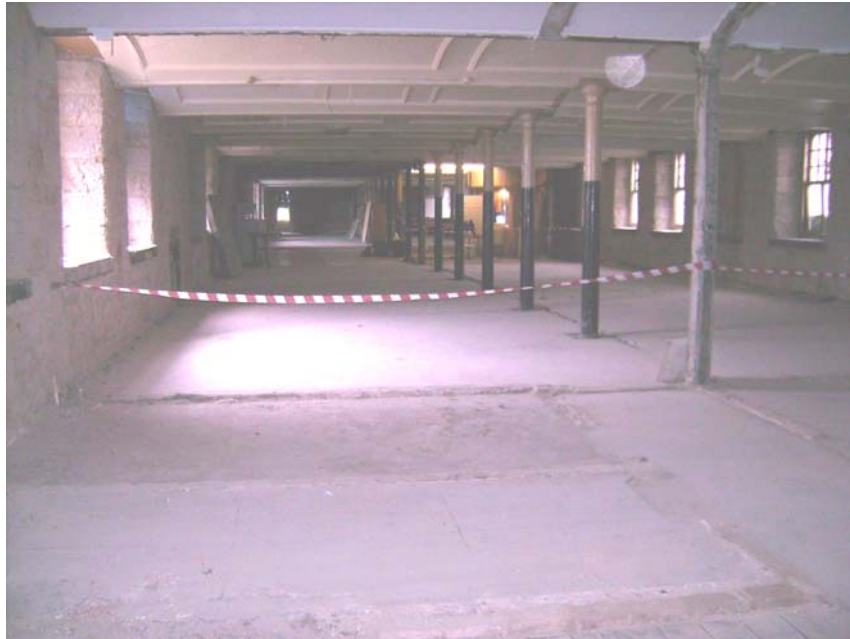
General view of ground floor

Now one large open space, this was defined by a central row of cast-iron columns supporting a brick-vaulted roof, as with the basement level.

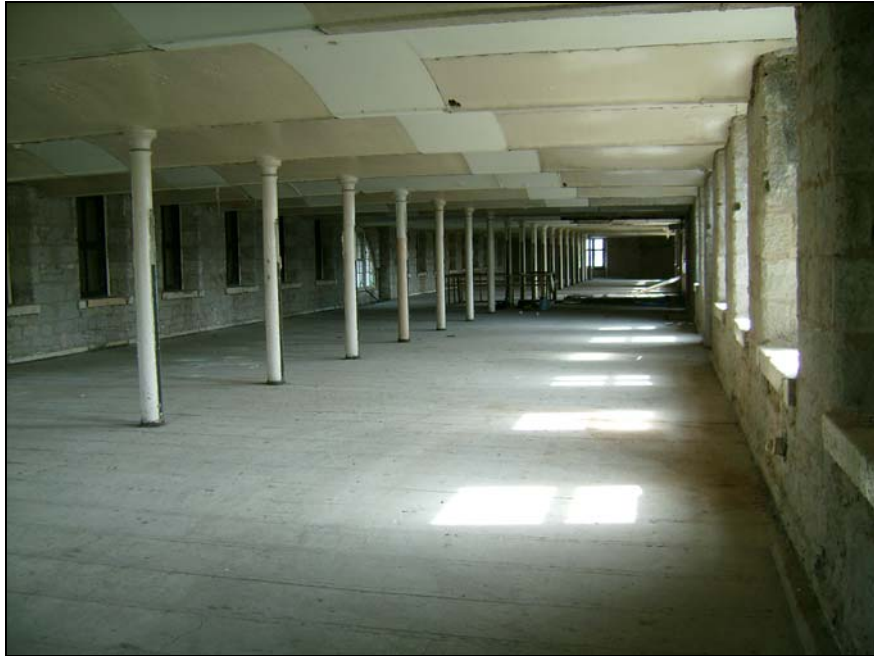
General view of first floor

The first floor, as with the ground and basement levels, is now one open warehouse, more or less in its original form as a cotton mill. It had a central row of plain cast-iron columns supporting a brick-vaulted fireproof ceiling (**Plate 25**).

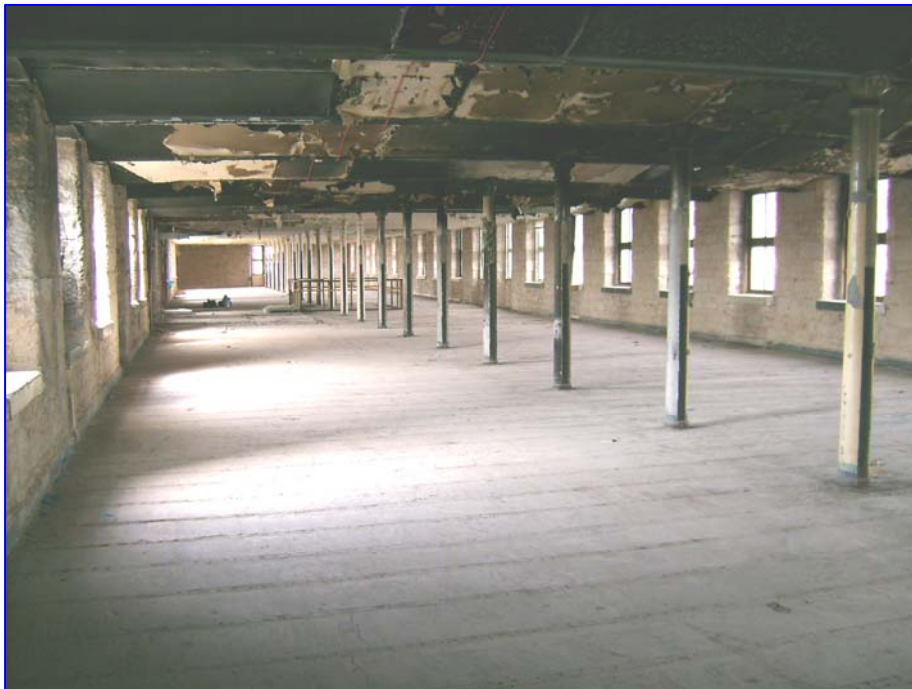
General view of the second floor

The second floor is of a similar design to the first with concrete floor inserted with timber strips (**Plate 29**) with stone rubble walls and fireproof corrugated-iron vaulted ceiling supported on cast-iron columns (**Plate 30**). The west wall includes a central window (F2/1) below which is a recess in the southern half of the stone wall and a section of brickwork on the upper section of the south side of the surround. To the north of the window is a section of brick chimney flue (F2/2).

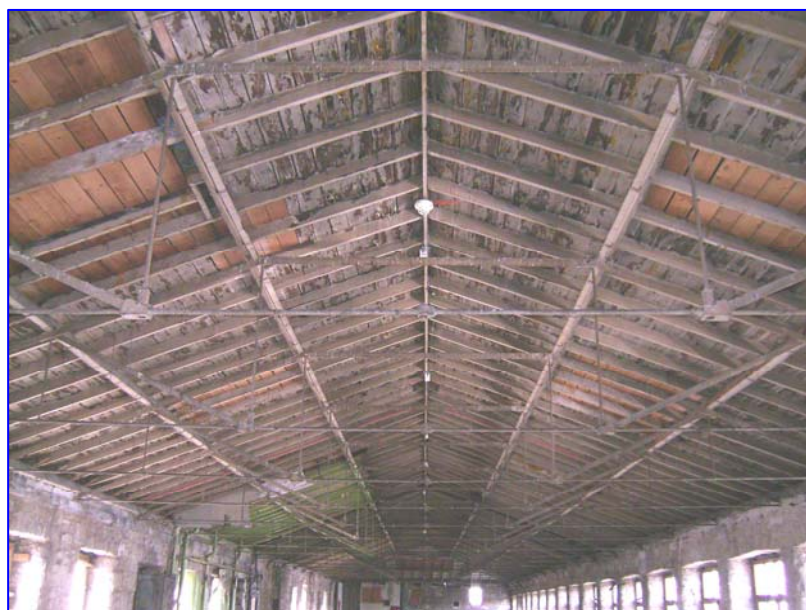
The fifth floor is open to the hipped timber-framed roof which is strengthened with a series of interlocking cast-iron rods (**Plate 39**). There are numerous small square machine footprints across the entire concrete floor area (**Plate 40**). The sneaked stone west wall has a number of features including the three small windows (F5/6, F5/26 & F5/27) high on the wall and two bearing boxes (F5/7 & F5/9) which have been subsequently covered with brass grilles (**Figure 26**). This wall also contains a central fireplace F5/8 with a brick flue above along with a small section of brickwork to the north (F5/10) (**Plate 41**).

Detail of the roof as seen from the fifth floor

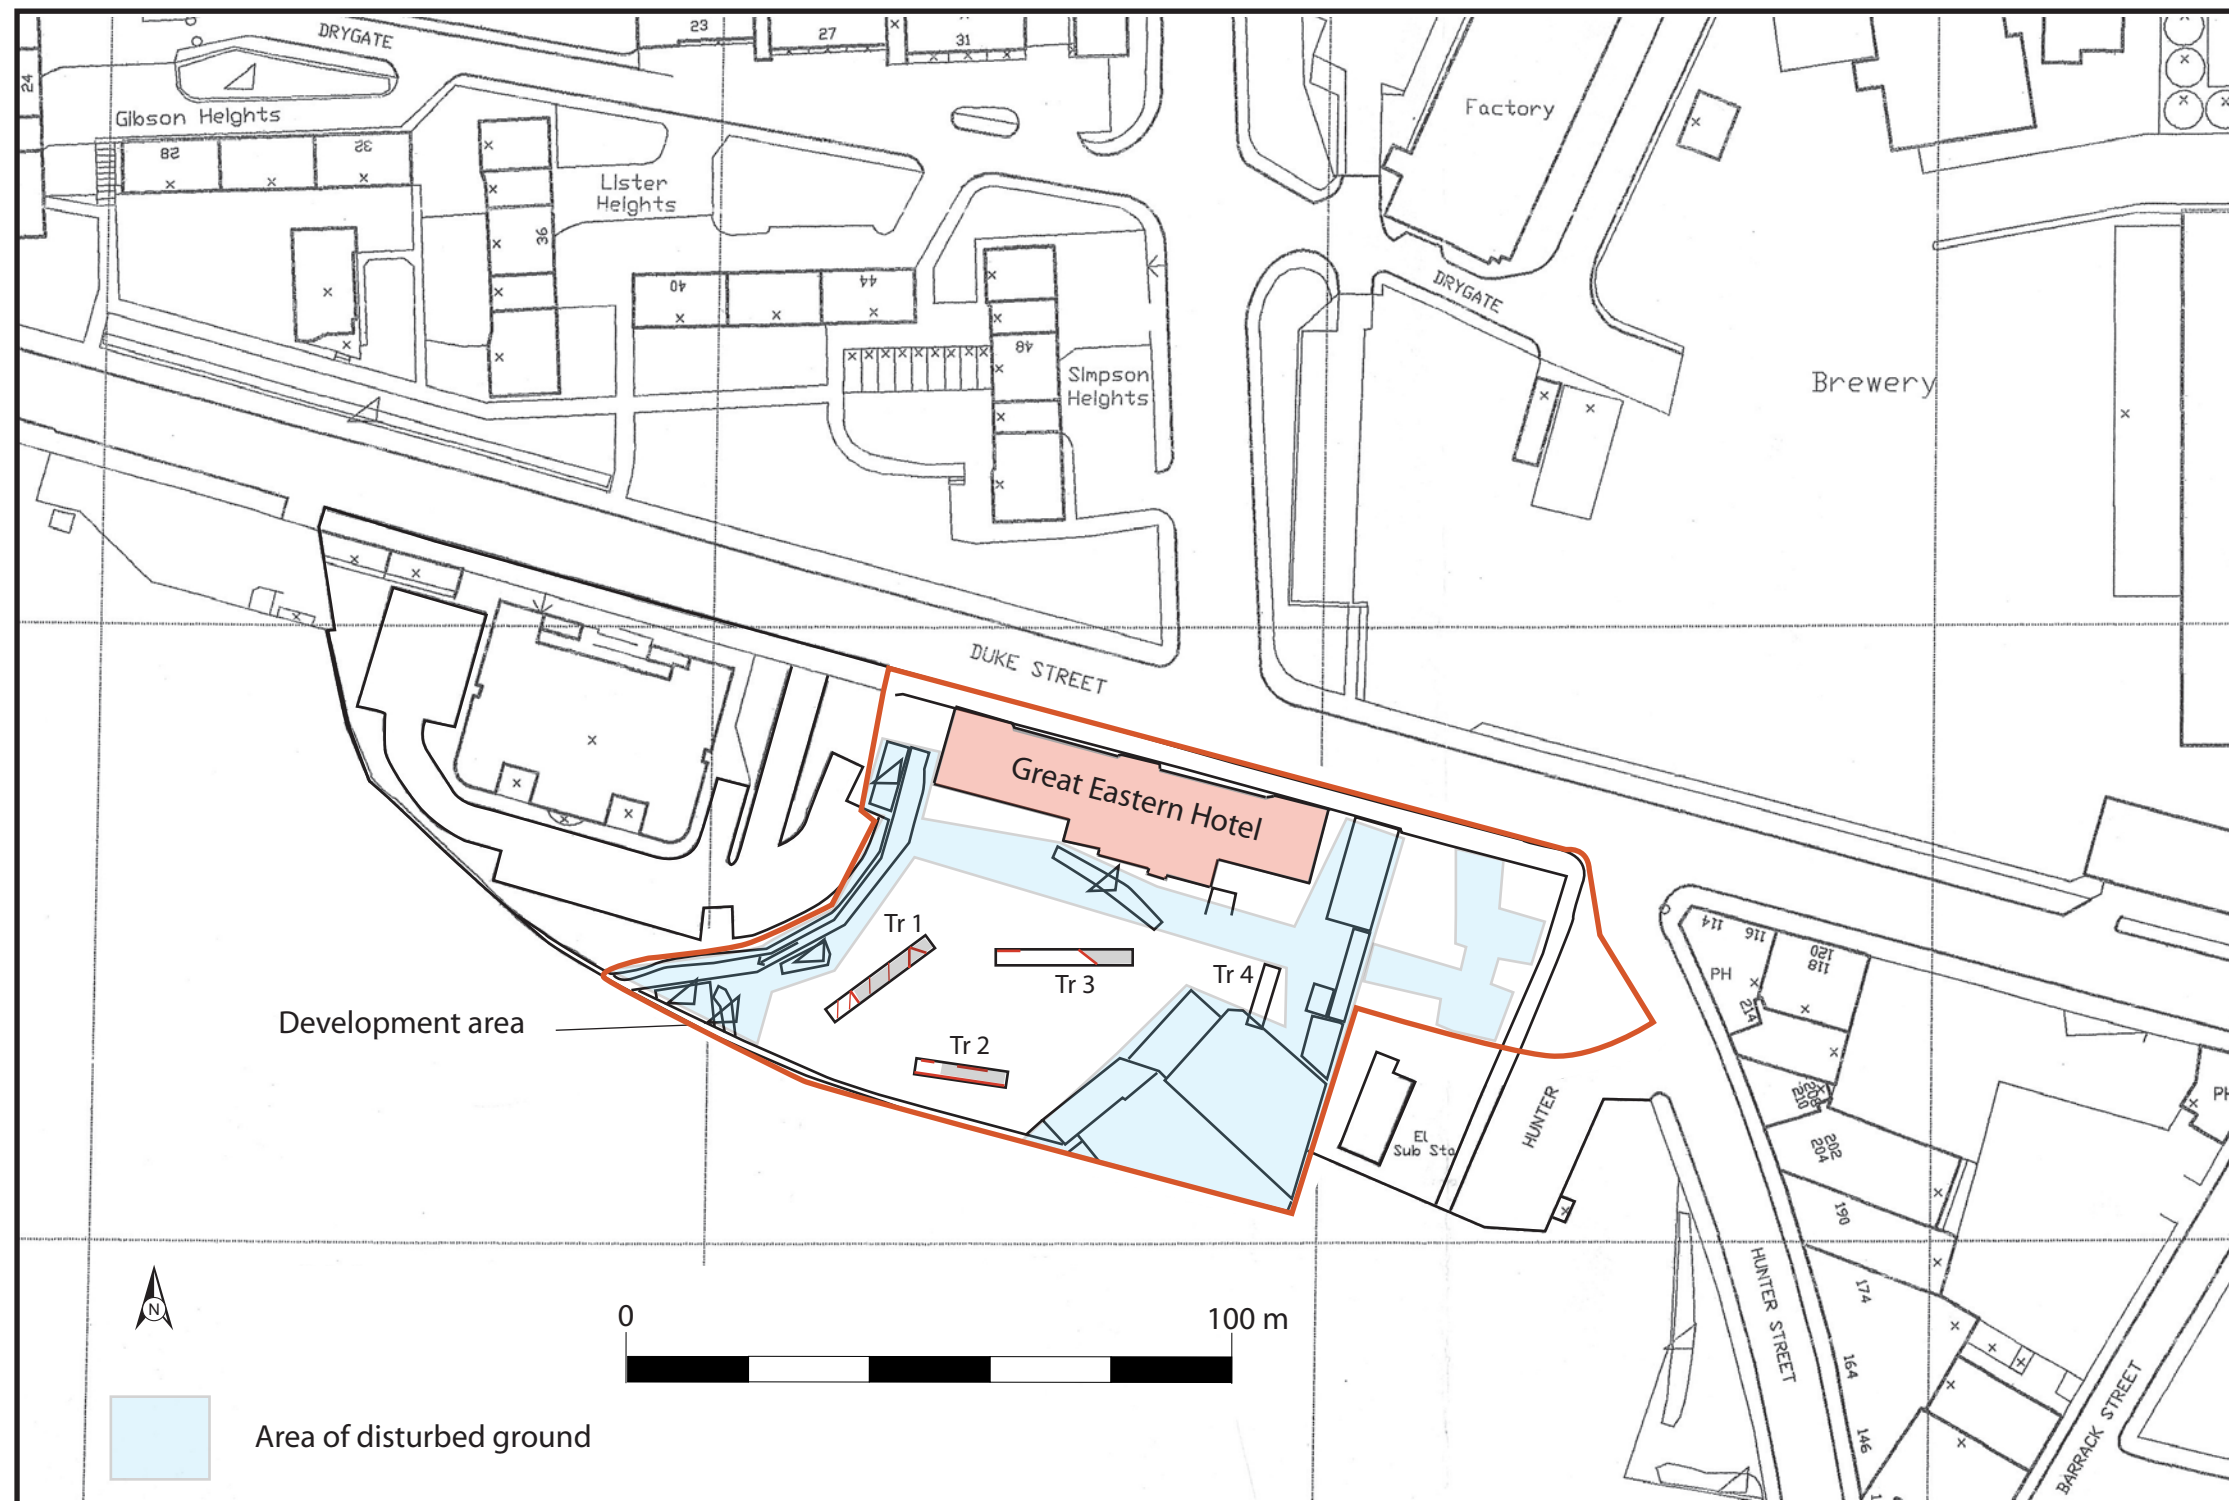
5.3.1 Trench 2 measured 10 m in length and aligned east/west. It was excavated to a maximum depth of 2.3 m. A brick wall ran the entire length of the south side of the trench and an intermittent wall was recorded along the northern section. The west end of the trench was excavated to a depth of 2.3 m comprising of made-ground which included a large dump of broken clay pipes. 2 m from the west end of the trench, a concrete floor was also recorded at 2 m depth which continued to the east end of the trench. The natural ground surface was not encountered in this trench.

Figure 2: Location of evaluation trenches showing the brick walls and concrete floors recorded

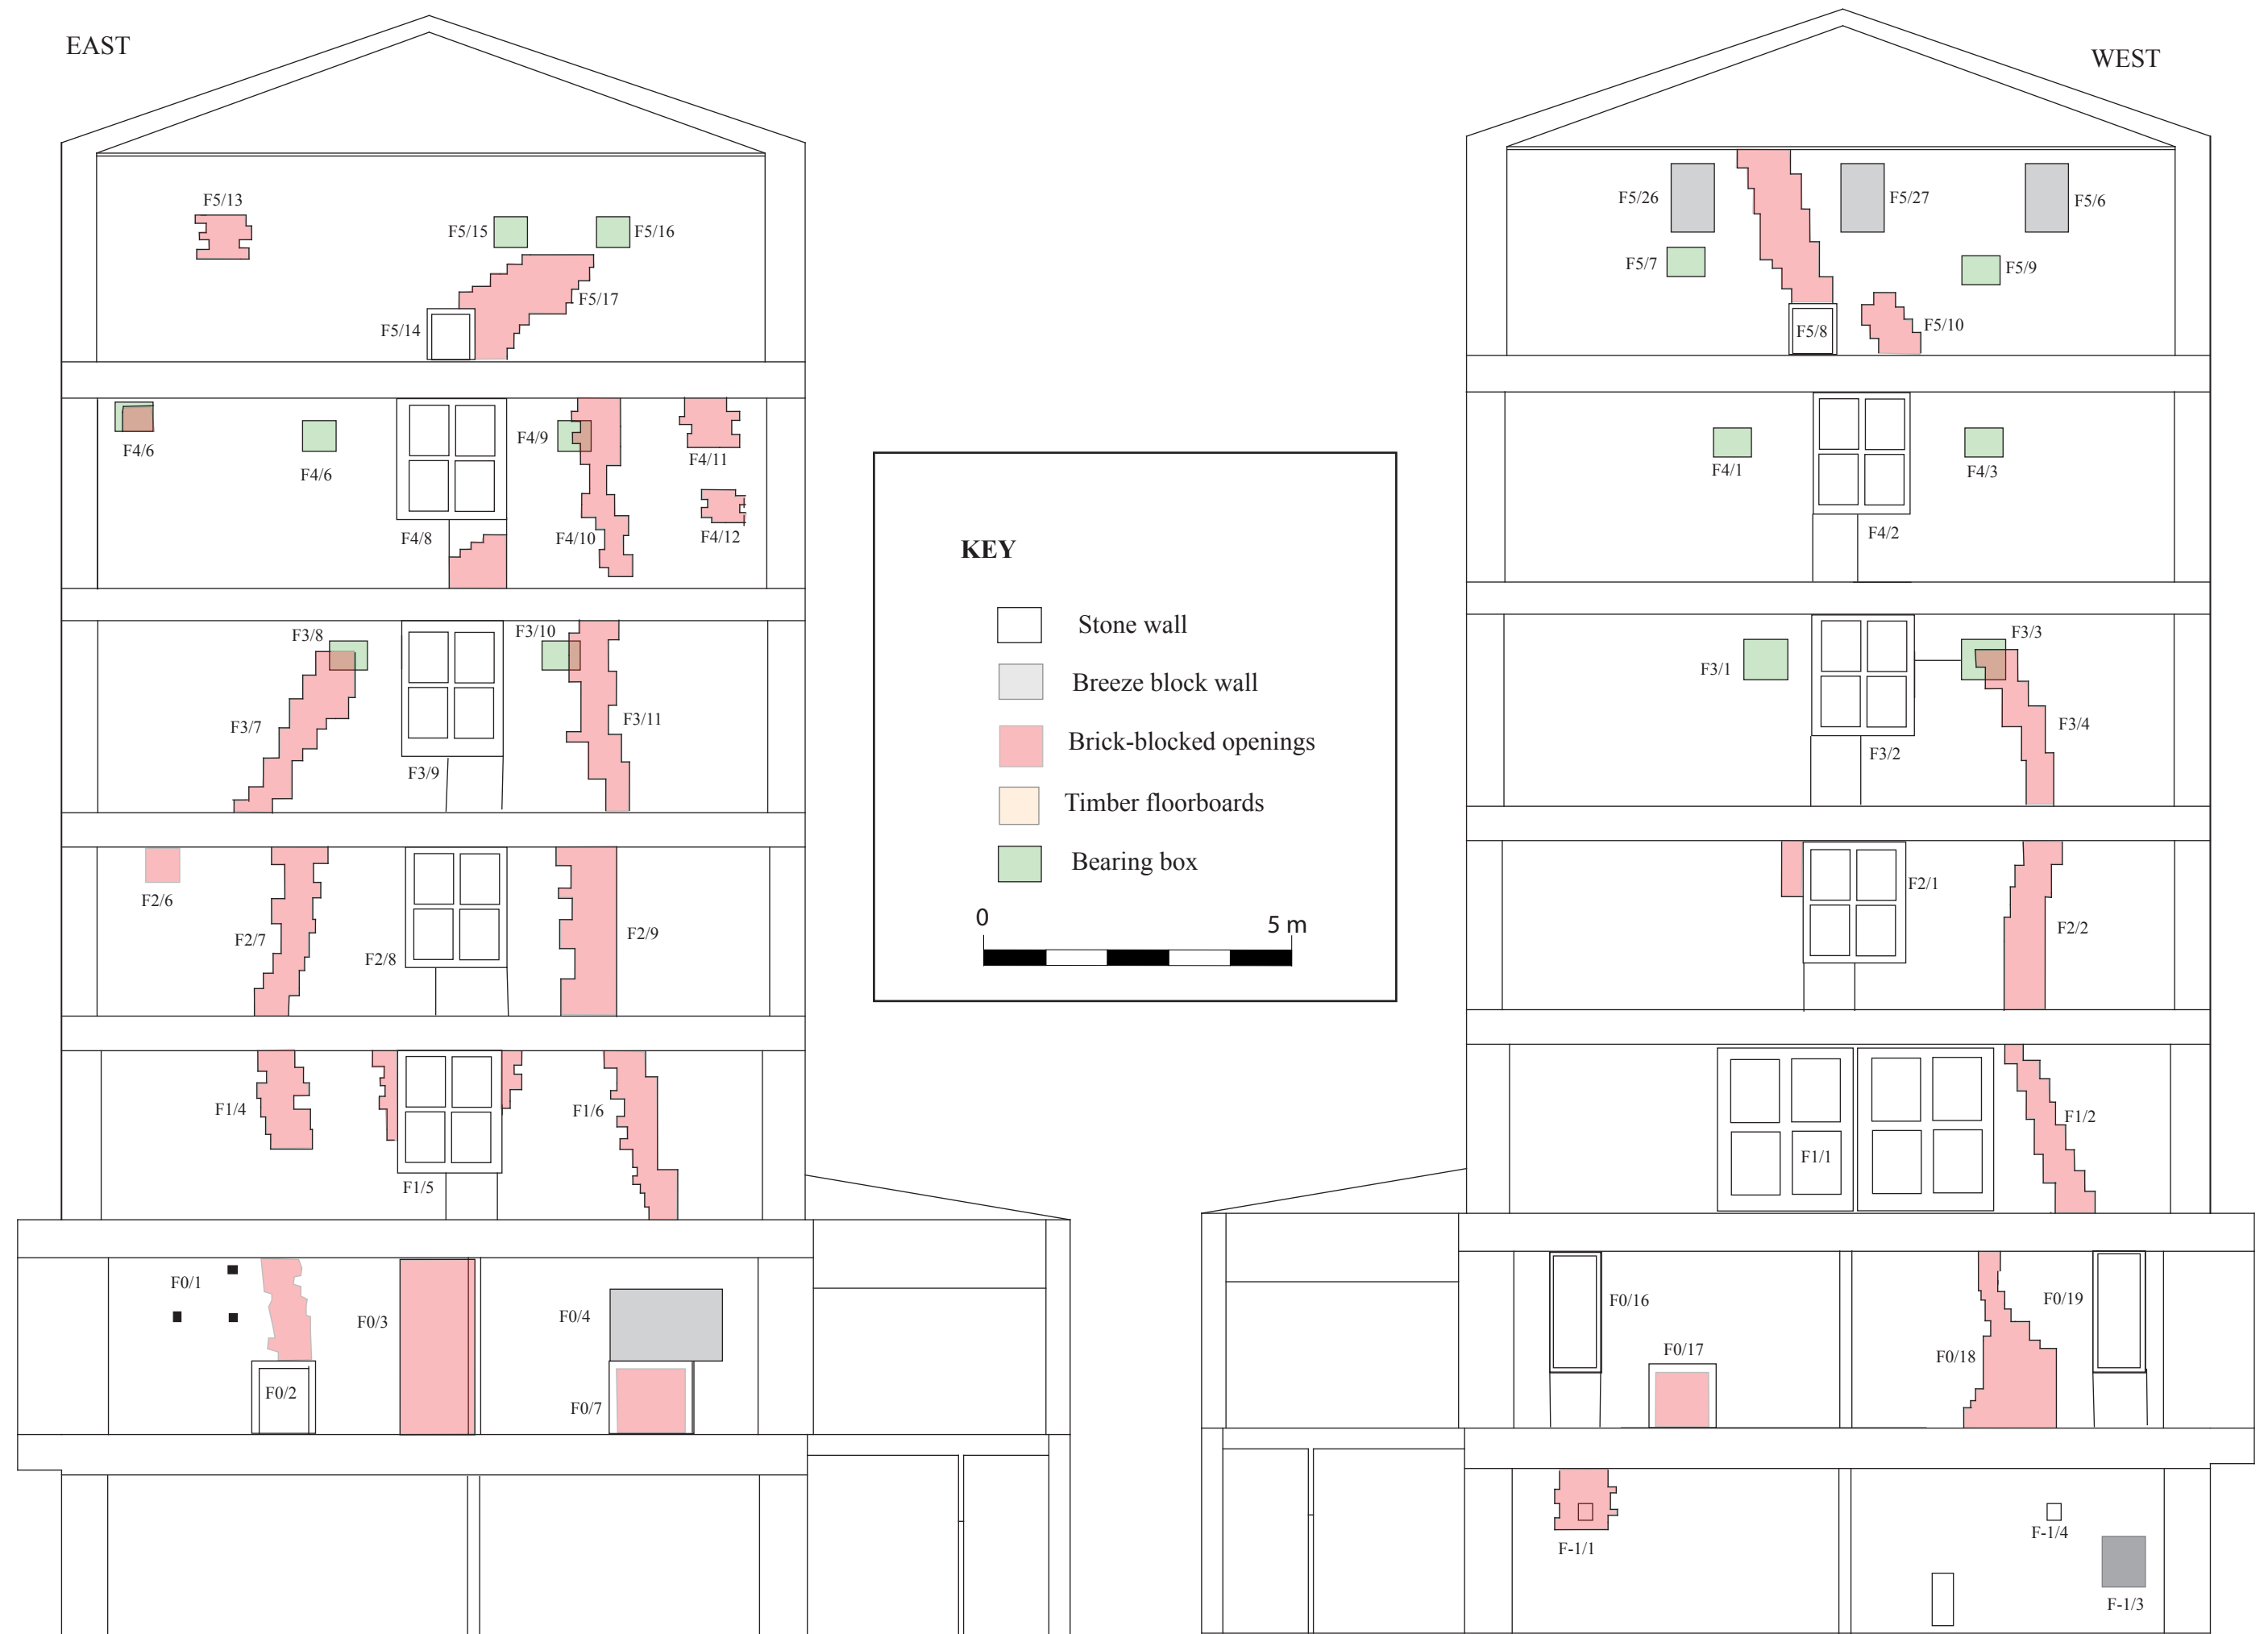
Figure 26: Cross section showing the features on the internal face of the end walls

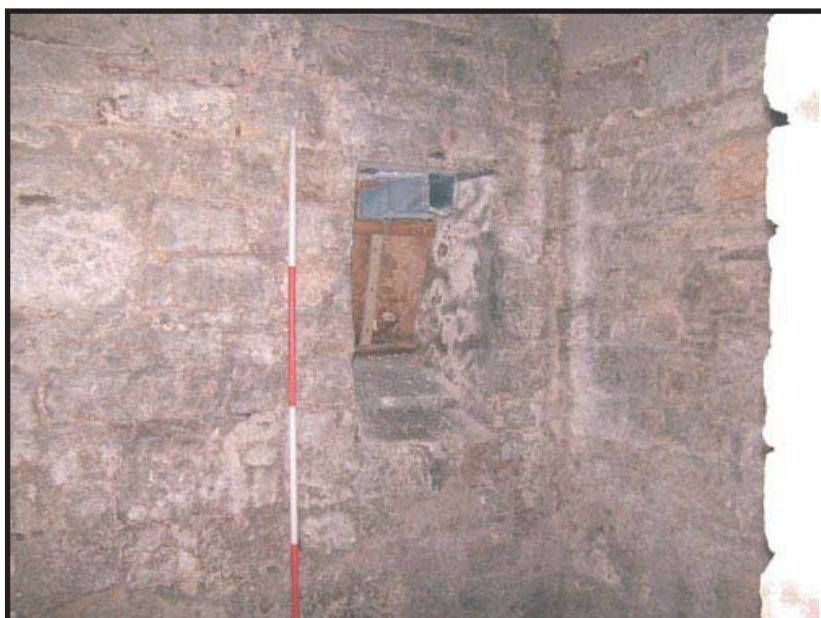
Plate 15: Opening on the west wall of the basement (F-1/3)

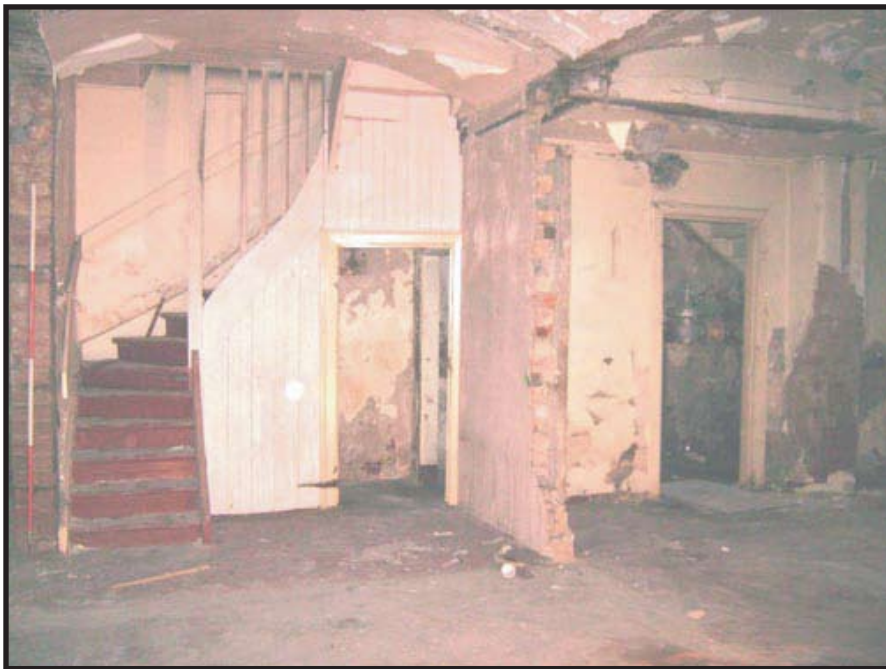
Plate 16: View of the partition walls in the basement level on the western end of the north wall

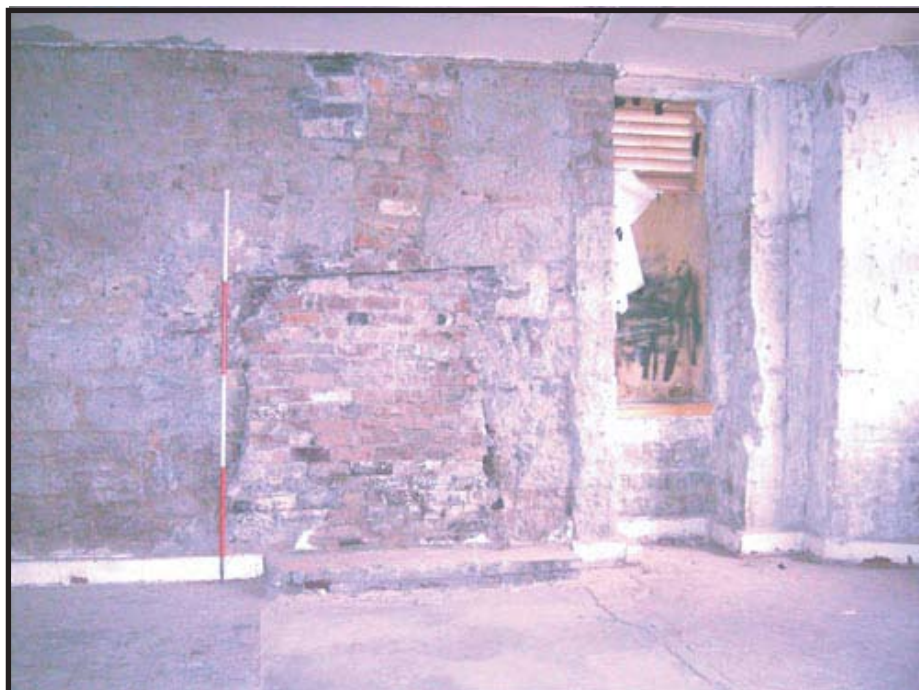
Plate 22: Detail of the north side of the west wall showing features F0/17 (window recess) and F0/18 (fireplace) on the ground floor

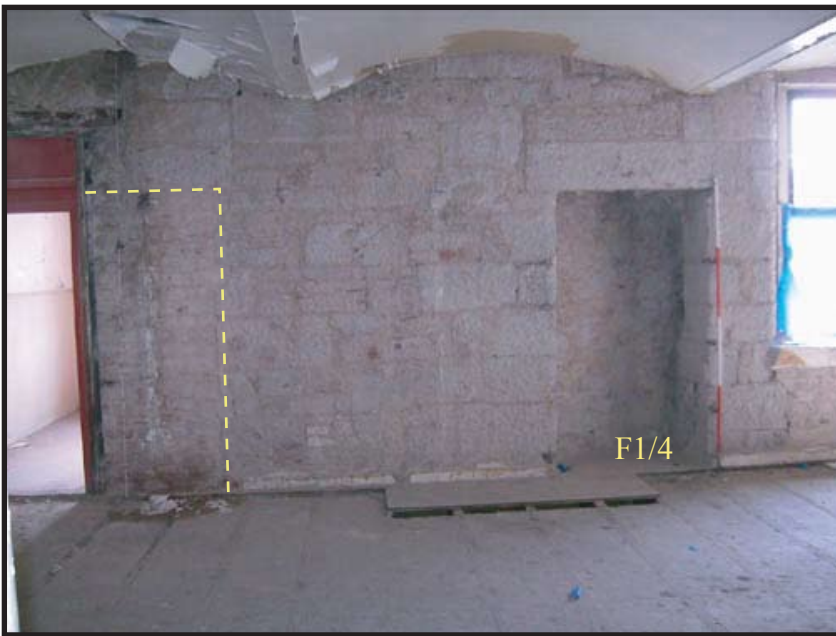
Plate 28: Detail of the bricked-up doorway F1/3 and opening F1/14 on the south wall of the first floor

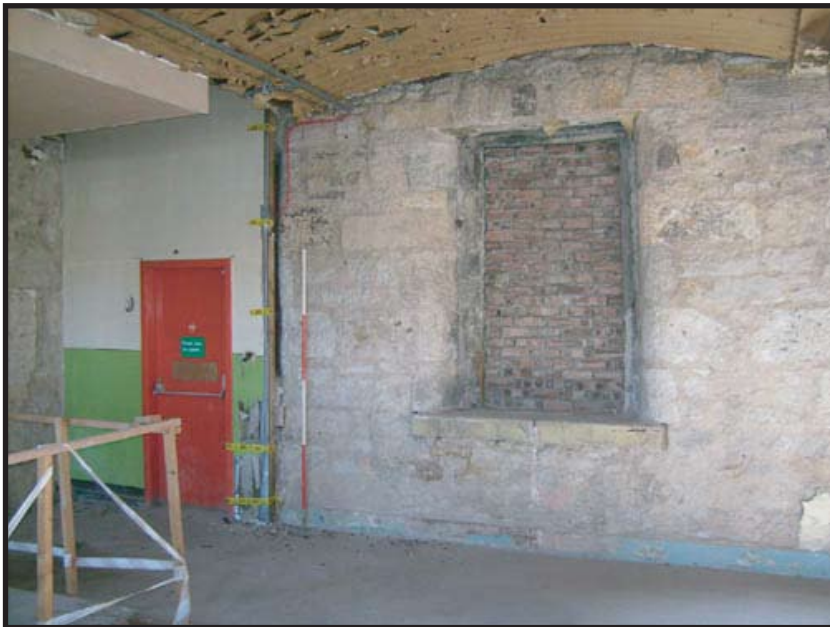
Plate 34: Detail of the frie escape door F3/12 and blocked window F3/13 on the west side of the south wall

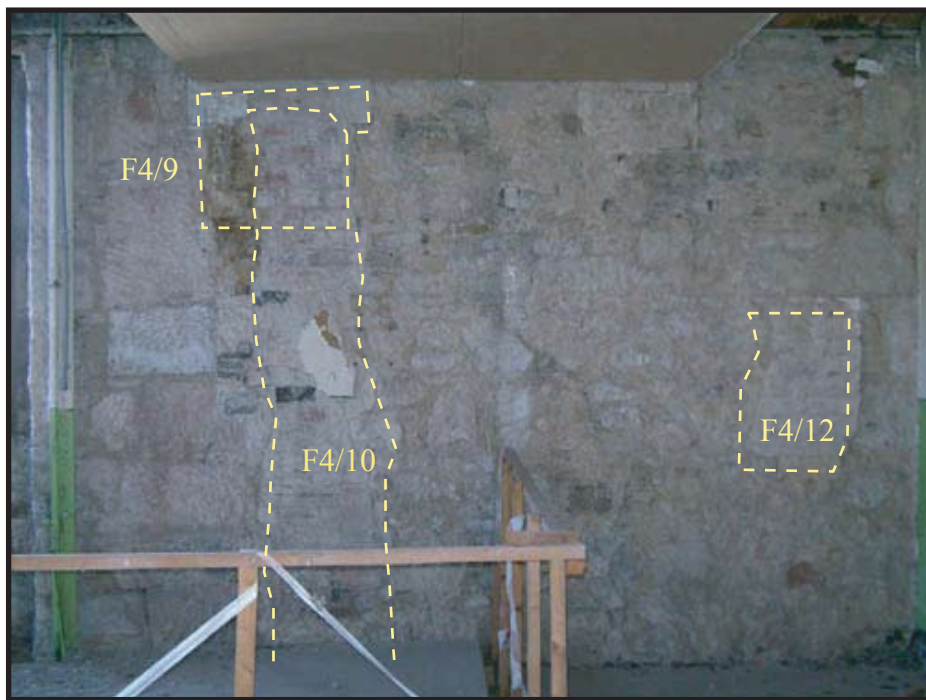
Plate 37: North side of the east wall showing the bearing box F4/9 plus area of brick wall F4/10 & F4/12
