**Granary & Cart Lodge at
Mulberry Farm,
Risby, Suffolk
RBY 045**

Heritage Asset Assessment

**Leigh Alston MA (Oxon), Architectural Historian
on behalf of
Suffolk County Council Archaeological Service**

January 2013

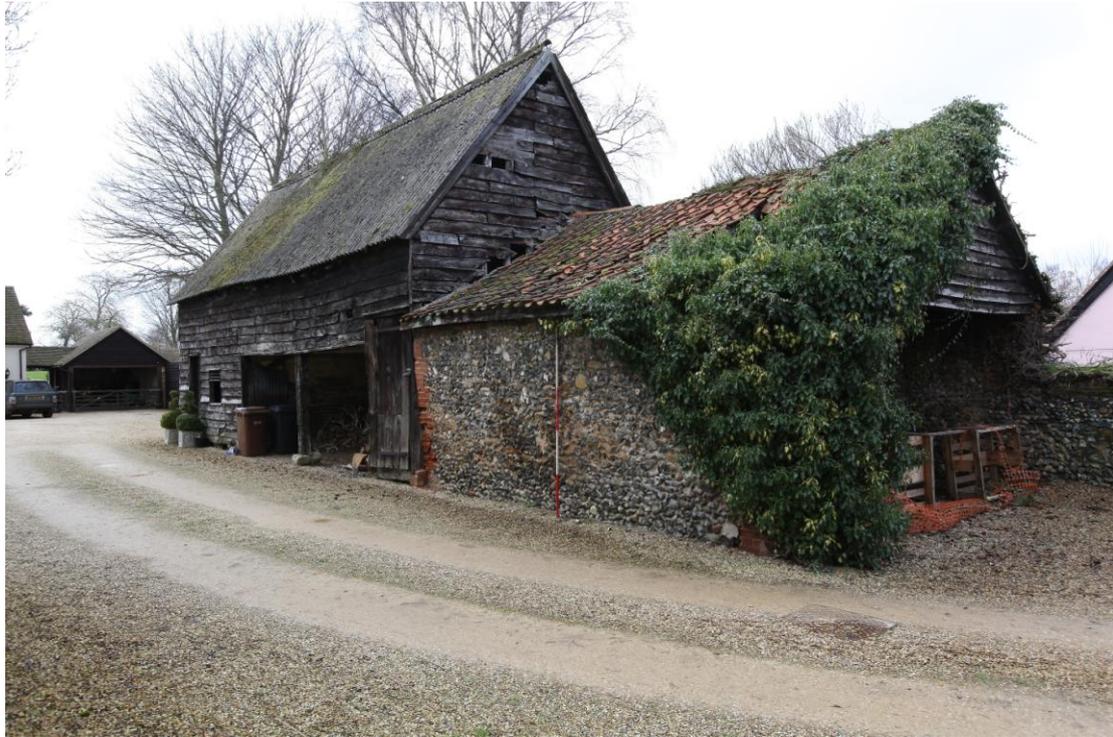
Illus. 3. The exterior of the weatherboarded granary and cart lodge from the south-east showing the open gable of the later flint-rubble pantiled cart shed (2) on the right.

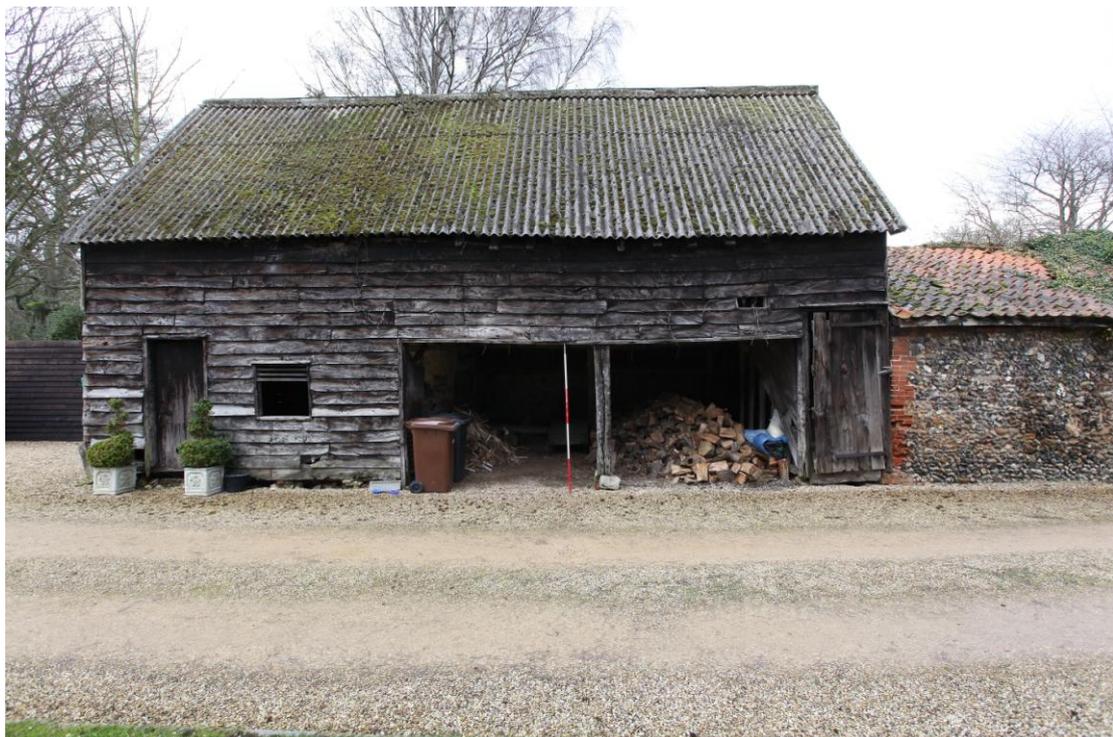
Illus. 4. The southern exterior of the granary (1) showing the open cart-lodge (2) to the right and the enclosed stable (1a) to the left. The tall door to the extreme right opens onto a boarded stair leading to the grain floor.

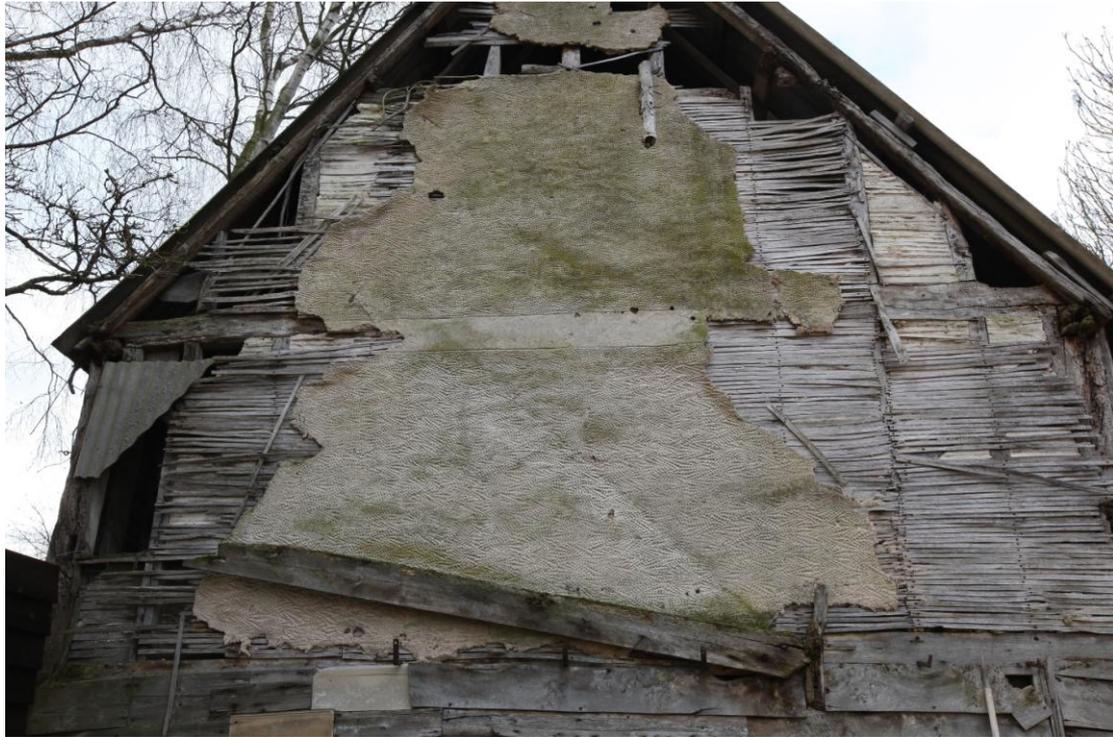
Illus. 5. The remains of herringbone pargeting to the western external gable of the granary (1). The attached angled plank corresponds to the scar of a mono-pitch roof immediately above, and relates to a recently demolished narrow, single-storied structure; but pegged mortises in the corner posts to right and left indicate that the granary originally extended further to the west.

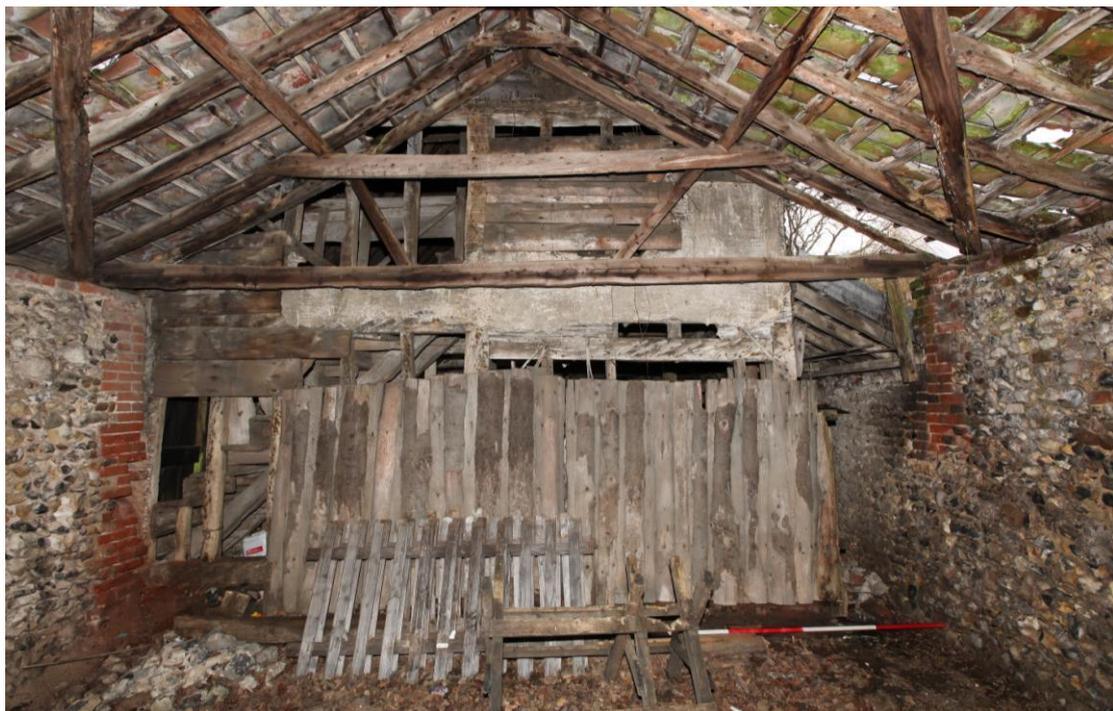
Illus. 6. The eastern external gable of the granary (1) seen from the later cart shed (2). The vertical boarding is relatively modern but the remains of herringbone pargeting survive above. The right-hand (northern) flint-rubble wall of the cart shed continues alongside the formerly open elevation of the cart lodge (1b) to form a narrow lean-to extension.

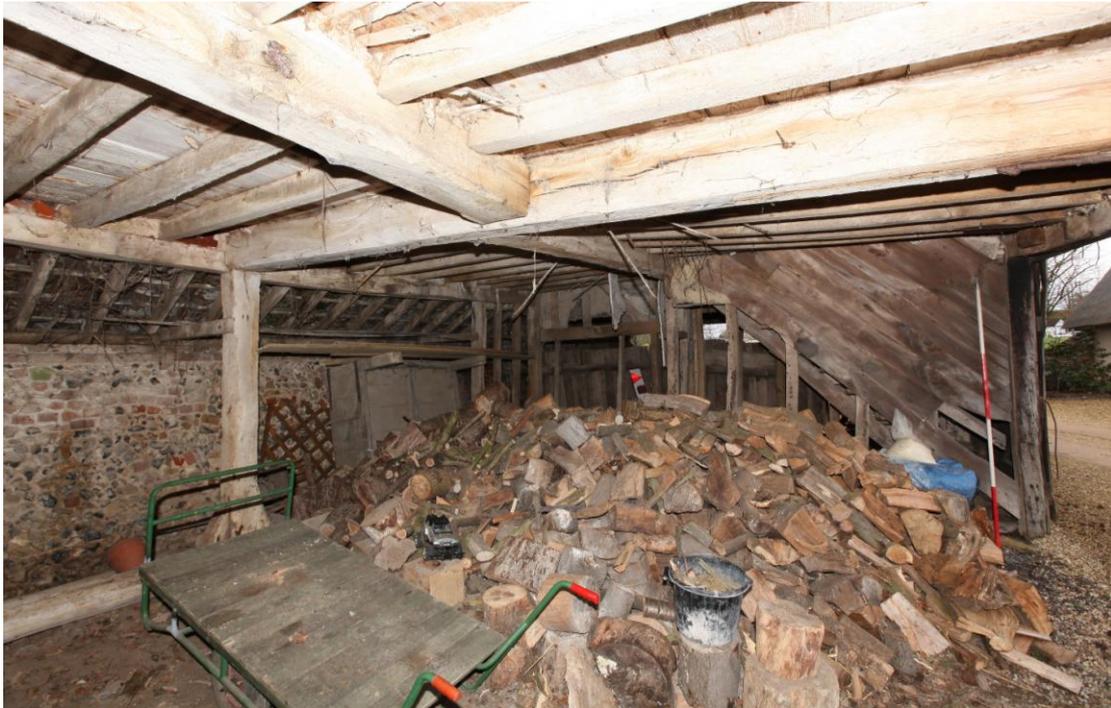
Illus. 7. The interior of the cart-lodge (1b) from the west, showing the enclosed original stair (with later boarding) to the right. This space was initially open to both from and rear but the rear (northern) elevation was later enclosed by a low flint-rubble wall linked to the original structure by a pentice roof to create a narrow extension.

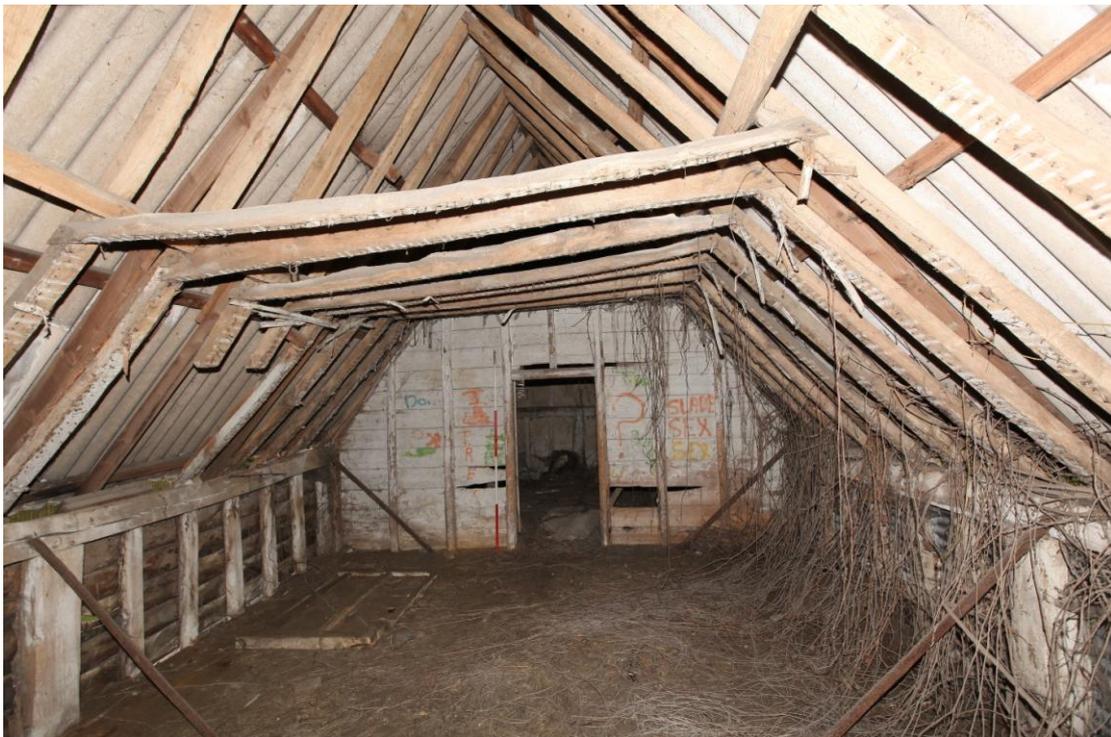
Illus. 8. The interior from the east of the grain floor above the cart-lodge (1b) showing the partition of boarded studwork to the smaller compartment above the stable (1a). The principal collars of the clasped-purlin roof are halved and pegged to their respective rafters but the majority are nailed and were designed to secure a missing lath-and-plaster ceiling that may have been a later insertion. Note the probably original raking iron straps linking the roof-plates to the mid-rails (in lieu of tie-beams).

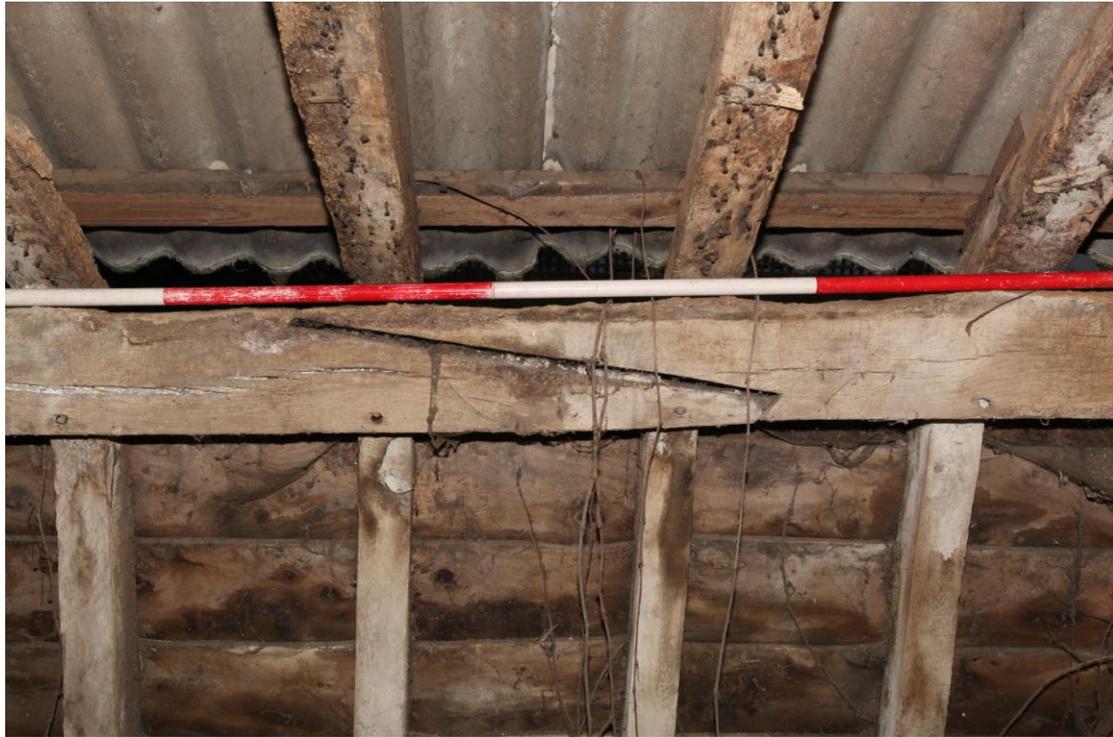
Illus. 9. The splayed and under-squinted scarf joint with a single vertical face-peg in the southern roof-plate above the cart-lodge (1b). An identical joint occurs in the northern plate immediately opposite. This joint is normally found only in 13th and 14th century structures and is notoriously weak; it may have been copied by an adventurous carpenter from a medieval building. The narrow studs, all tenoned and pegged to the roof-plate, are typical of the late-18th and early-19th centuries.

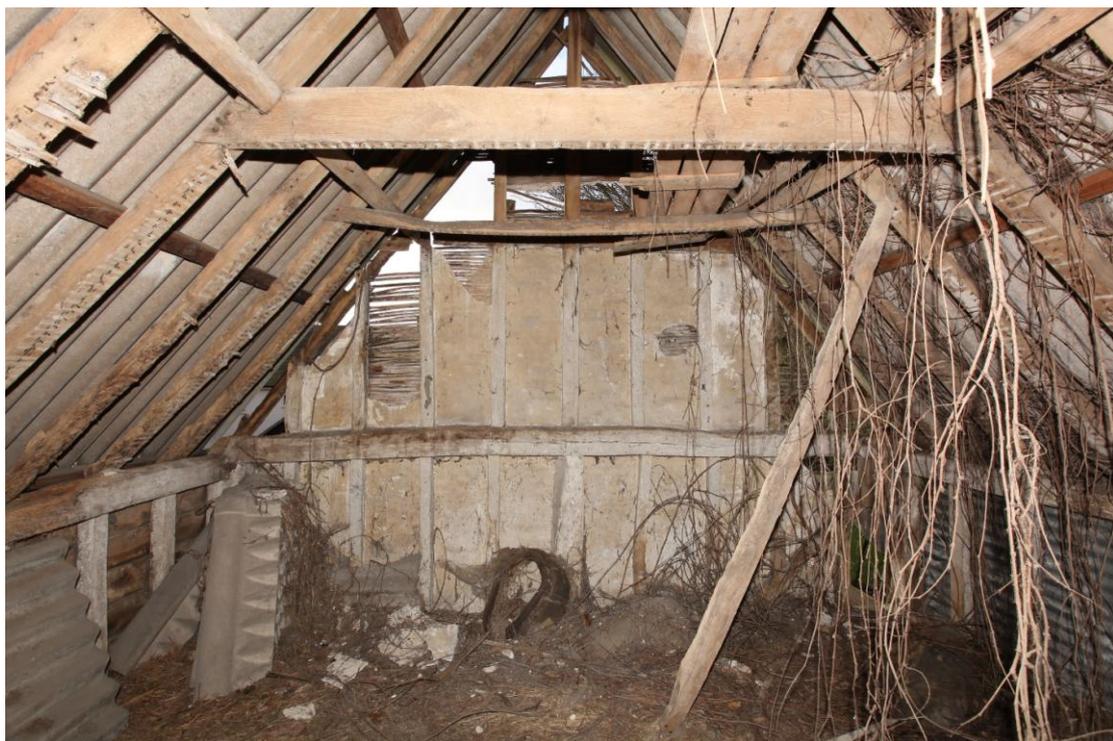
Illus. 10. The internal western gable of the grain floor above the stable (1a) showing the remains of clay-daub infill with primary wall braces and jowled posts to left & right.

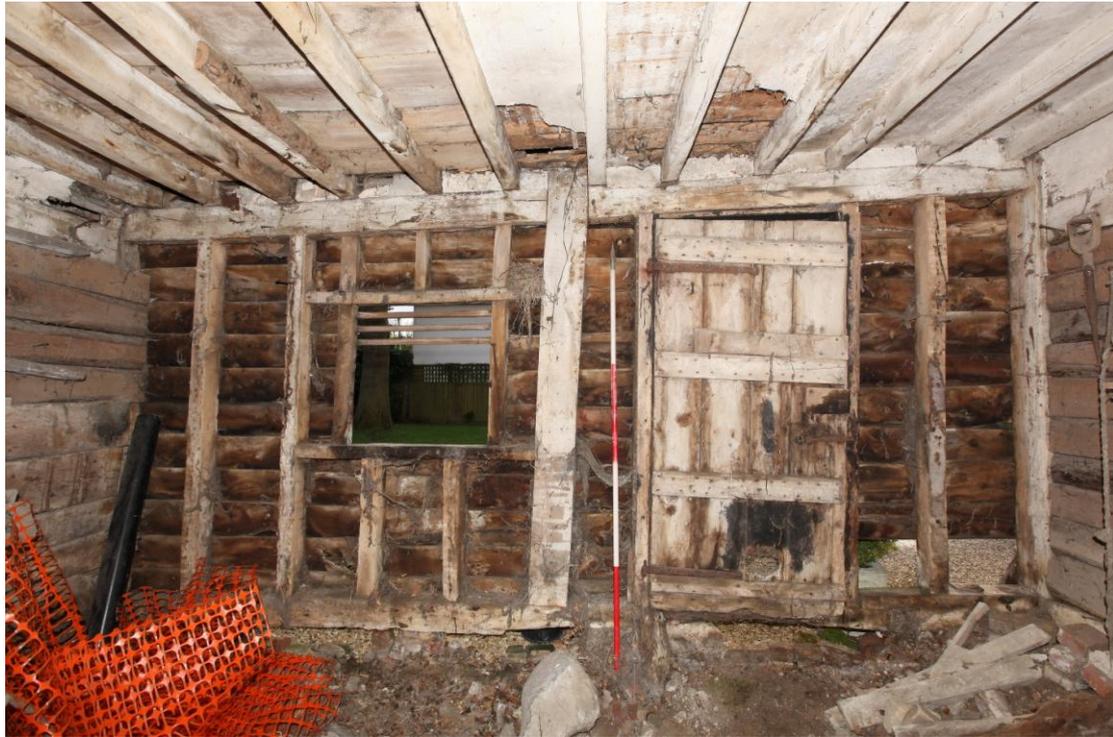
Illus. 11. The southern interior of the stable (1a) showing the original entrance door and louvered window, both respected by the studwork. Several panels of original lath-and-plaster survive between the ceiling joists.

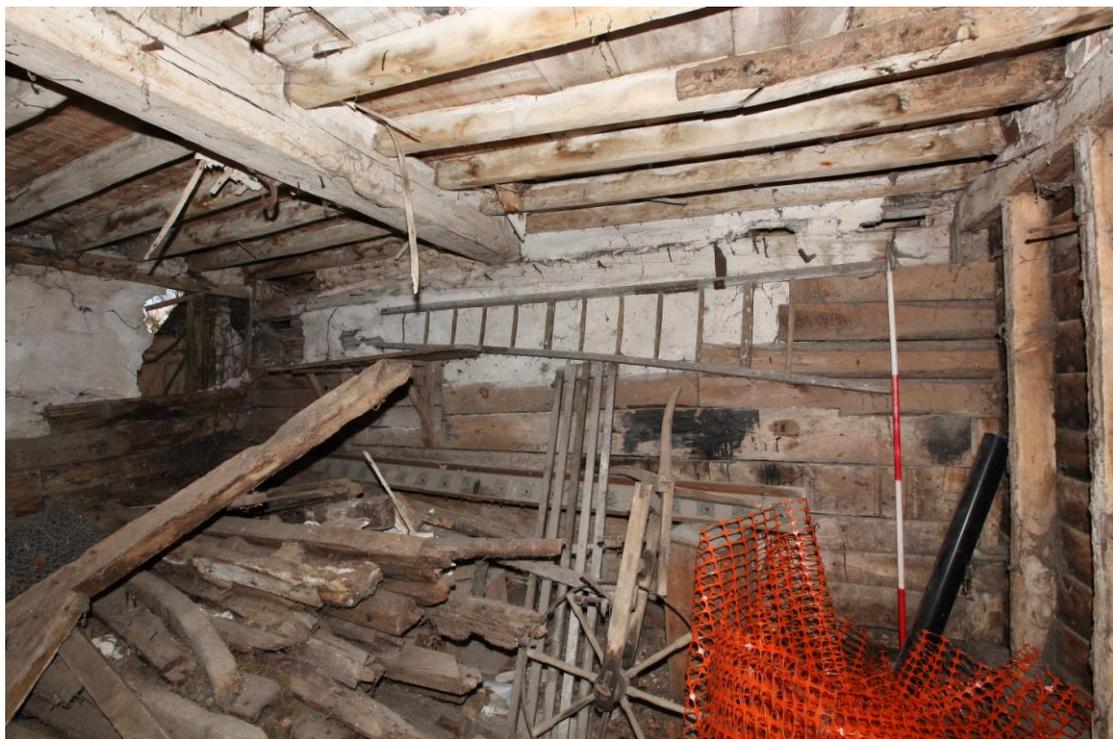
Illus. 12. The interior of the stable (1a) from the west (1a) showing later boarding to the original studwork partition adjoining the cart lodge (1b). An old seed drill is visible beneath the ladder, but there is no obvious evidence of a hay rack and manger.
