Date of report: 1st April 2008

Client: Landmarc Support Services Ltd (for Defence Estates)

## Barry Buddon training camp; a baseline condition survey of archaeological sites

# Barry Buddon training camp: a baseline condition survey of archaeological sites

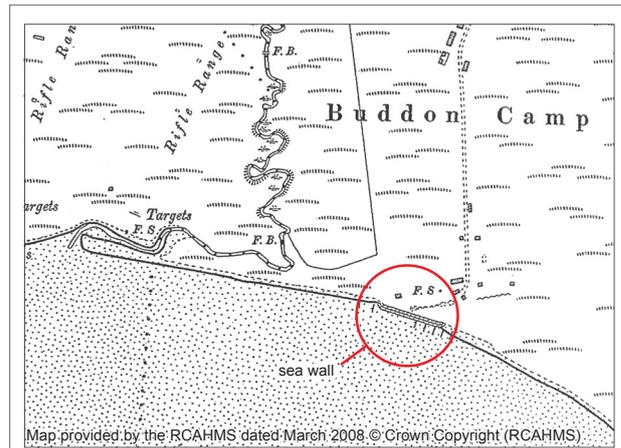
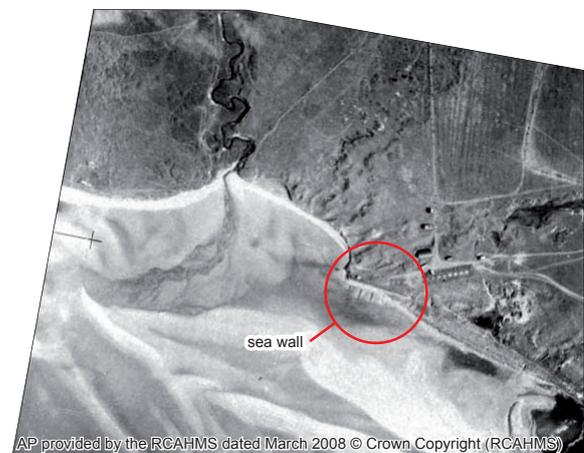
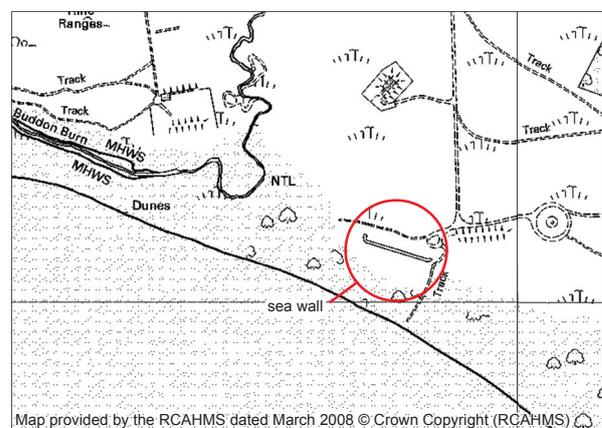
**Illus 4: Changes in the coastline near Buddon Burn over the last 100 years**

6.6 On the west side of Buddon Burn there has been a net loss of some 12 ha since the 1<sup>st</sup> edition survey in 1858. Most of this loss occurred over the last 100 years destroying the target areas of several early firing ranges in this area. Erosion also occurred on the east side of the burn, with the shoreline receding some 50 m during the second half of the 19<sup>th</sup> century. Presumably to protect the gun battery near the shore at this point, a sea wall was constructed around the turn of the century (Illus 4). On aerial photographs from 1941 the effect of the wall can be clearly seen, as a bay has formed in the unprotected area to the west between the wall and the burn outlet. During the last 60 years the coastal processes have changed from erosion to deposition and today the sea wall lies over 100 m inshore.

6.7 On the east-facing side of the area there has been net loss of some 50 ha of land to sea erosion with the shoreline receding up to 300 m near Buddon Ness. The map evidence indicates that most of this loss has occurred over the last 100 years. To protect the Carnoustie golf course and the target areas of the shooting ranges at the northeast part of the camp, a 2.5 km long sea wall has been built southwards along the shore from the outflow of Barry Burn.

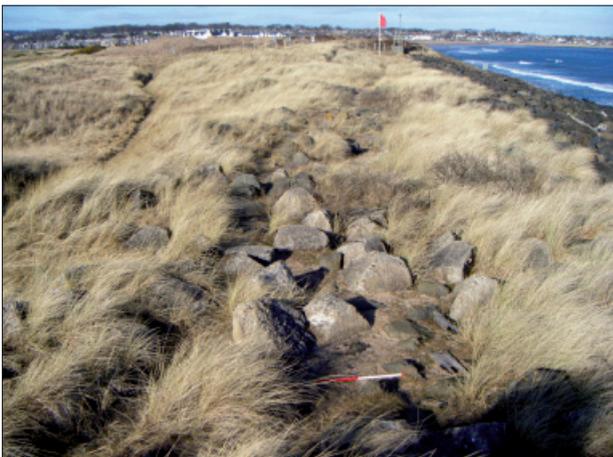
6.8 While the construction of the sea wall means protection of vulnerable sites on the east side of the camp it has also had some detrimental impact on the sites along the shore. Two coastal WW2 pillboxes (Sites 31 and 32) that are depicted on 1946 APs were no longer visible on the ground. Although they could be totally buried in windblown sand, it is more likely that they were on the line of the sea defences and were destroyed during its construction. A pile of concrete rubble seen at the back of the sea defences may be the remains of one of the pillboxes (Illus 5).

**Illus 5: Concrete rubble. Possible remains of pillbox**

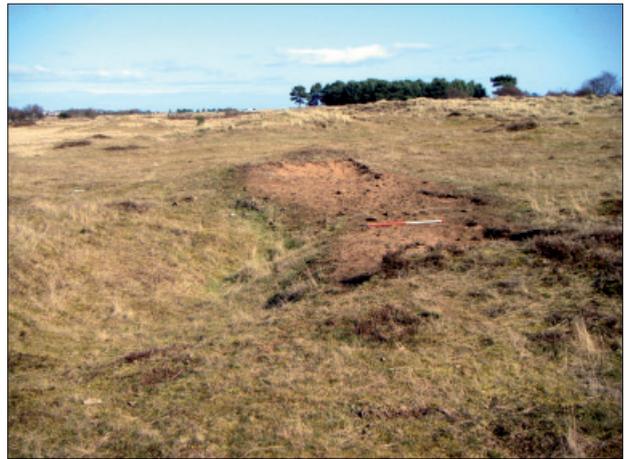
6.10 To maintain a balanced habitat and halt the spread of gorse in the area highland cattle had been introduced to some areas of the camp. Although beneficial for the habitat, there was some evidence of damage caused by cattle trampling mainly in areas where the animals had gathered (Illus 6).

**Illus 6: Erosion on WWI training trenches (HA site 28) caused by cattle**

7.4 The main problem in the area seems to be the general expansion of trees and gorse. This problem is already being addressed generally in the area. However the efforts should perhaps be more targeted towards the trench systems to clear these first to stop further damage. But, at the same time one has to find a way to encourage the highland cattle to locate their resting places in less sensitive areas away from the trenches.

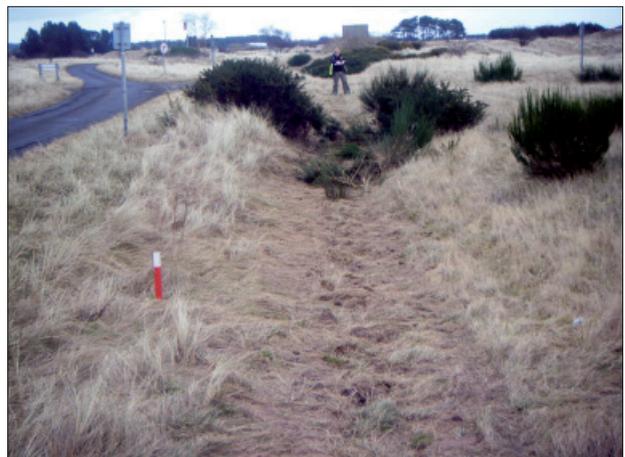
6.13 Only a few sites had been damaged by recent military activity. There was some damage resulting from a vehicle that had driven along a trench at Site 03 (Illus 7). At Cowbyres (Site 25) a rectangular area

**Illus 7: Vehicle tracks running along WWI training trench (HA site 03)**

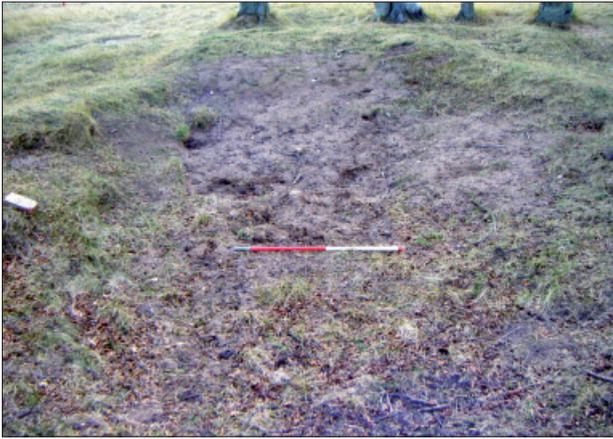
had been excavated into the end room and part of the wall at the west end of the remains of the old farm building (Illus 8). It had later been backfilled, but sand from the excavation was still visible next

**Illus 8: Infilled trench cut into the remains of the 18th century farmhouse at Cowbyres (HA site 25)**

to the trench. An animal burrow had been dug into the edge of the cutting. A couple of similar backfilled rectangular trenches were seen in the vicinity of the building. The circular hard standing of the old parachute balloon inflation position (Site 11) is currently used as a site for burning rubbish. The heat from the fire will accelerate the decay of the hard standing surface.

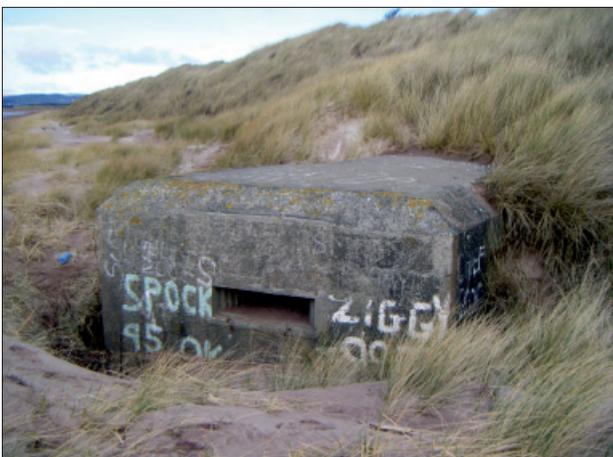
**6.15** Most of the bunkers were affected by painted graffiti, especially on the interior but in two cases also on the outside (Sites 28 and 51) (Illus 9). Other cases of 'vandalism' included a burnt wooden door frame in the east target bunker on Site 42, and possible the removal of the door from an Allan Williams Turret (Site 29). The door was found lying on the ground some 300 m to the SSW of the turret (Illus 10).

**Illus 9: External graffiti from the 1990s on pillbox (HA site 51)**

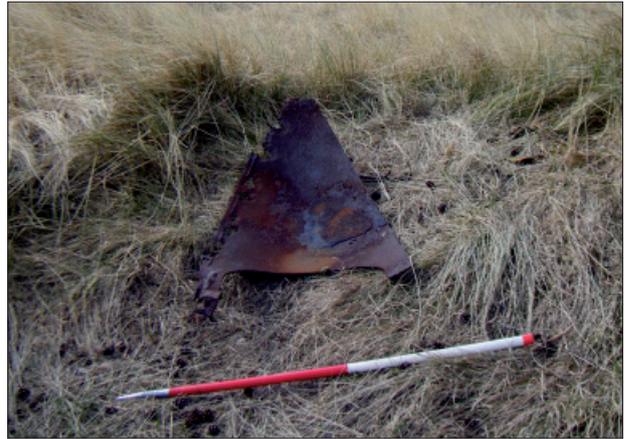
**Illus 10: Detached door from Allan Williams Turret (HA site 29)**

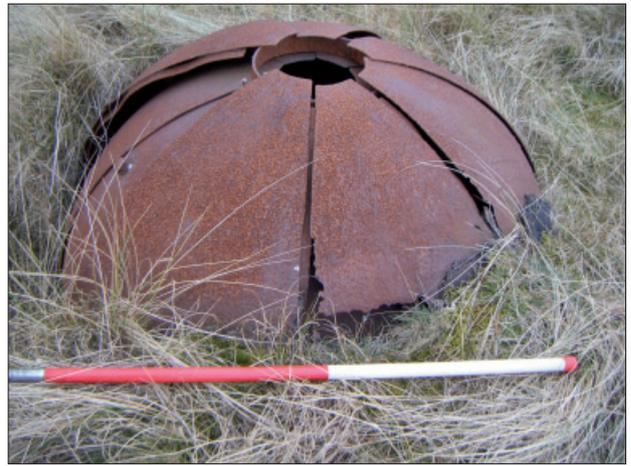
6.19 The sites at high risk were the Allan Williams Turrets (Sites 29, 37 and 48) and the former keeper’s cottage (Site 57) at the Low Lighthouse. The turrets appeared to originally have had some form of protective coating which is now largely weathered away leaving the iron exposed to the salt spray from the sea. As a result the metal is corroded through in places (Illus 14) and part of the structures has become detached. The door from the turret at Site 29 was found on the ground 300 m to the SSW, and the top plate of the turret at Site 37 was lying loose on the ground (Illus 15). Whether this is caused by vandalism or just high winds, the detachment is made easier by the general decay of the metal.

Illus 14: Corrosion on Allan Williams Turret (HA site 29)

29					BARRY LINKS, BARRY BUDDON MILITARY TRAINING AREA	ALLAN WILLIAMS TURRET	Angus	354793 732857	None		√					√				17/03/2008	The iron is fairly badly corroded. The front panel is missing and the sides are also corroded. The inside of the structure is filled with water. The 'turret' on top of the structure is missing, as is the door. The front panel of the cupola was found in one of the trenches to the west.
30	NMRS NO53SE 37				BARRY LINKS, BARRY BUDDON MILITARY TRAINING AREA	FIRING RANGE	Angus	355468 733036	None		√				√					04/03/2008	The rifle range originally extended to 1700yds. The wooden post distance markers are still present as is an earthen bank c. 1500yds from the w end. Work was being undertaken on the eastern bank of the rifle range, probably to heighten it. The range seemed to be in a good state of repair and was still in use.
31	NMRS NO53SE 12				CARNOUSTIE, BARRY SANDS	PILLBOX	Angus	355950 733250	None			√						√		04/03/2008	None of the site is visible. Made ground, acting as a sea defence runs NE – SW along the sea. It is possible that the pill box was either destroyed or covered during this time. Although no traces were visible, several lumps of concrete (possibly from the feature) were observed in the area.

7.5 The three Allan Williams Turrets are slowly corroding away in the salt-laden coastal climate. Some basic conservation work including a protective coating would, combined with a close monitoring of their condition, ensure that the turrets would survive for much longer.

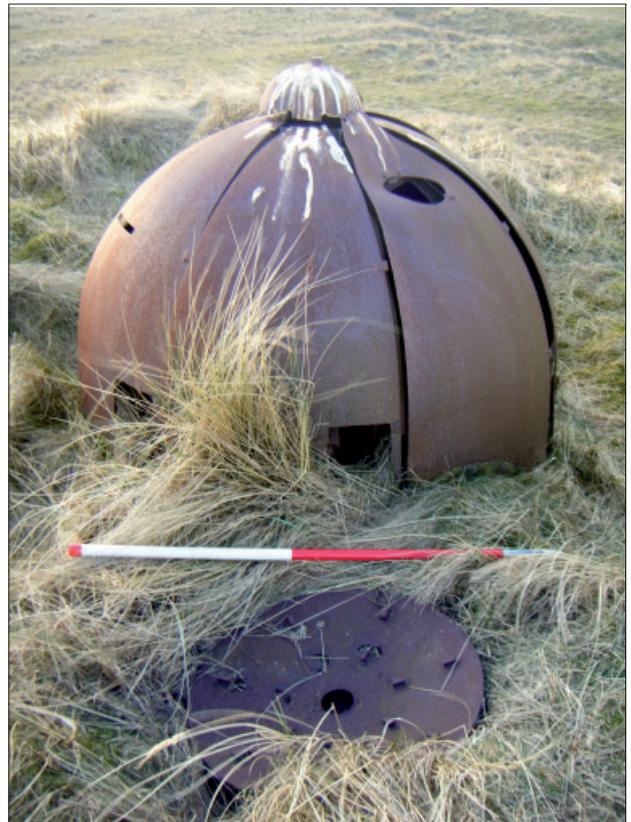
Illus 15: Detached top segment of turret (HA site 37)

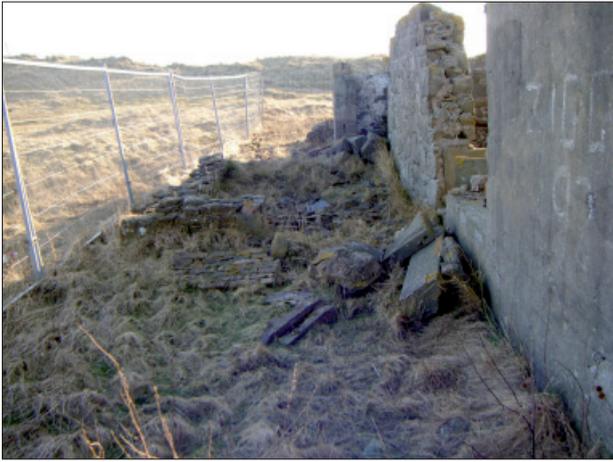
6.20 The keeper’s cottage has decayed badly and is now in a dangerous condition (Illus 16). To avoid accidents the ruins have been fenced off. The ruins are designated as a listed building which requires that consent must be obtained prior to making any repairs, and the nature of those repairs may be restricted in terms of materials used and final finish.

**Illus 16: Collapsed masonry at lighthouse keeper's cottage (HA site 57)**

7.6 The keeper's cottage is in urgent need of repair. At the moment it represents a danger to the public and has therefore been fenced off. As it is listed the remains of the building should be fully surveyed. This survey would serve as a record of the building before further decay or could form the basis for drawing up a conservation plan to make the building safe.
