Greenhow Hill Lead Mines Survey

September 2003

Surveyed by Martin Roe on behalf of the Northern Mine Research Society

Commissioned by the Nidderdale AONB

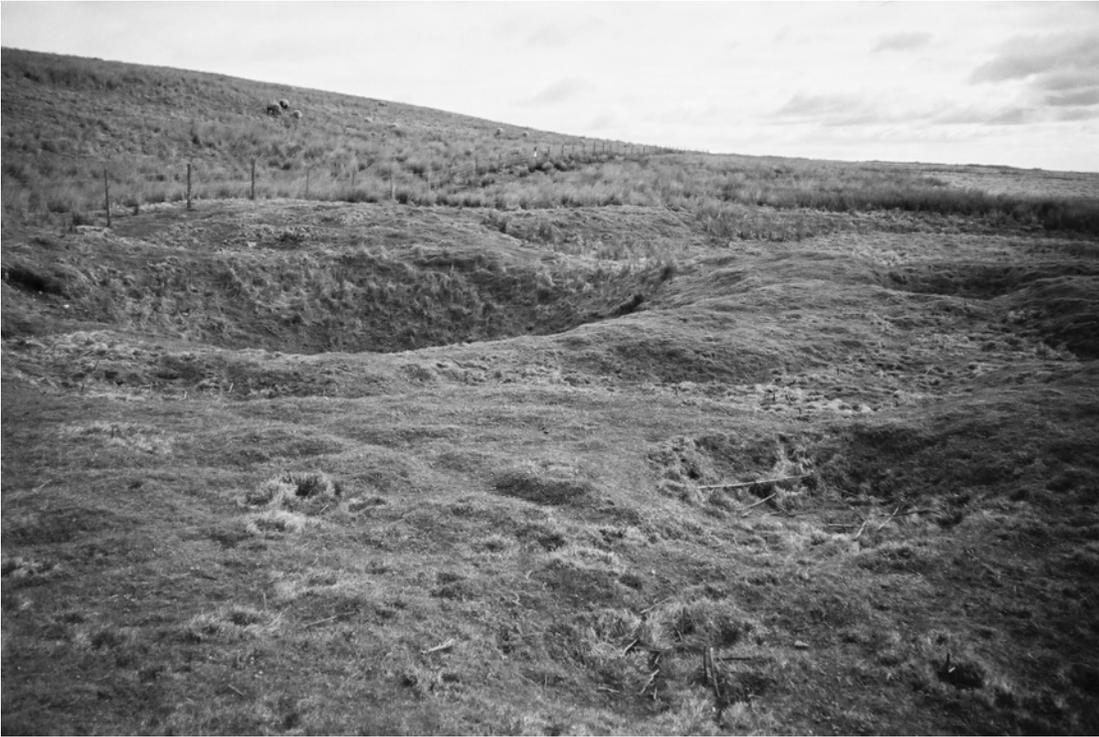
Fig.7 Hope Shaft (feature 9)

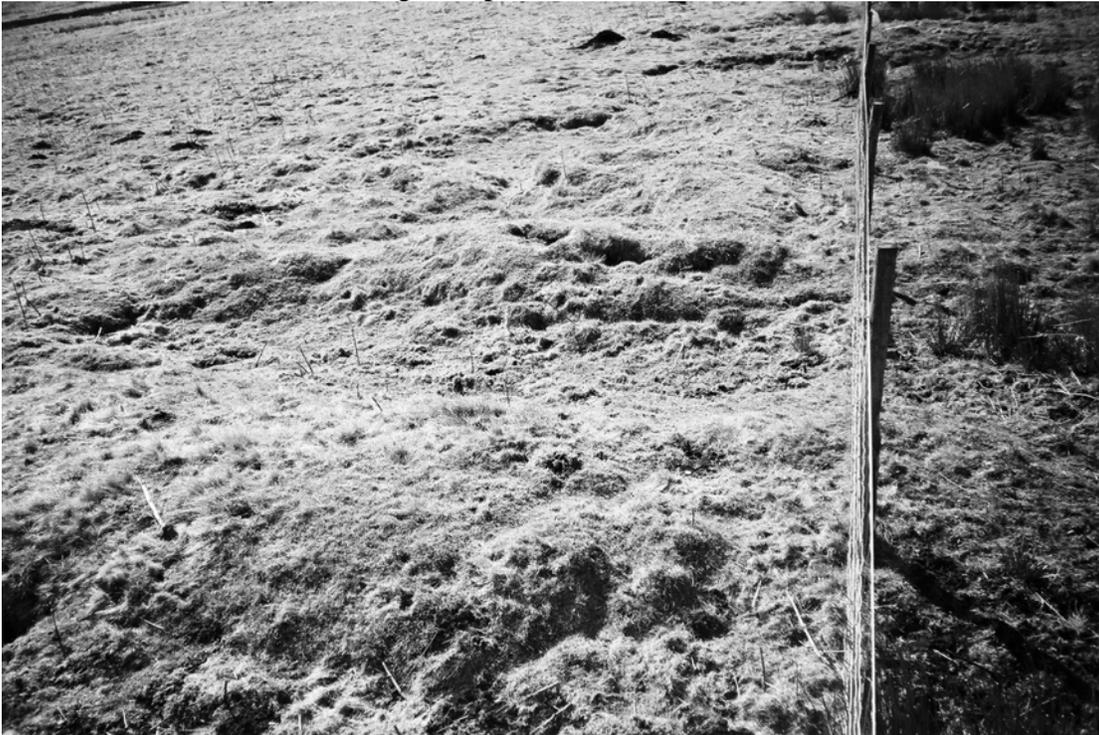
Fig.8 Buddles (feature 17)

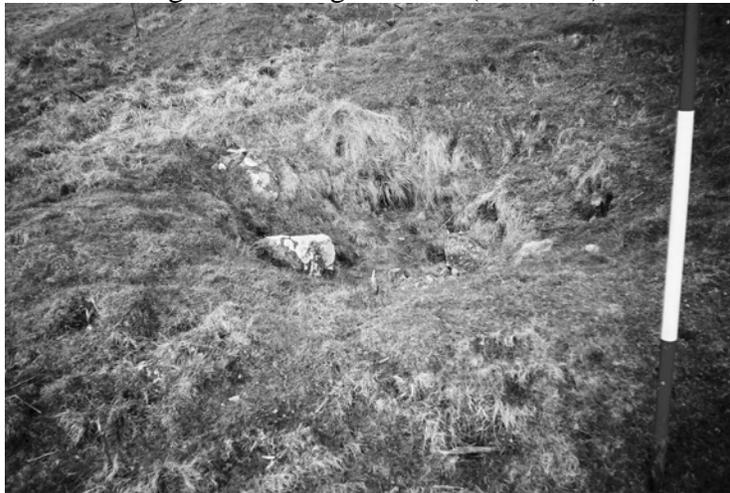
Fig. 11 Possible climbing shaft: East Engine Shaft (feature 20)

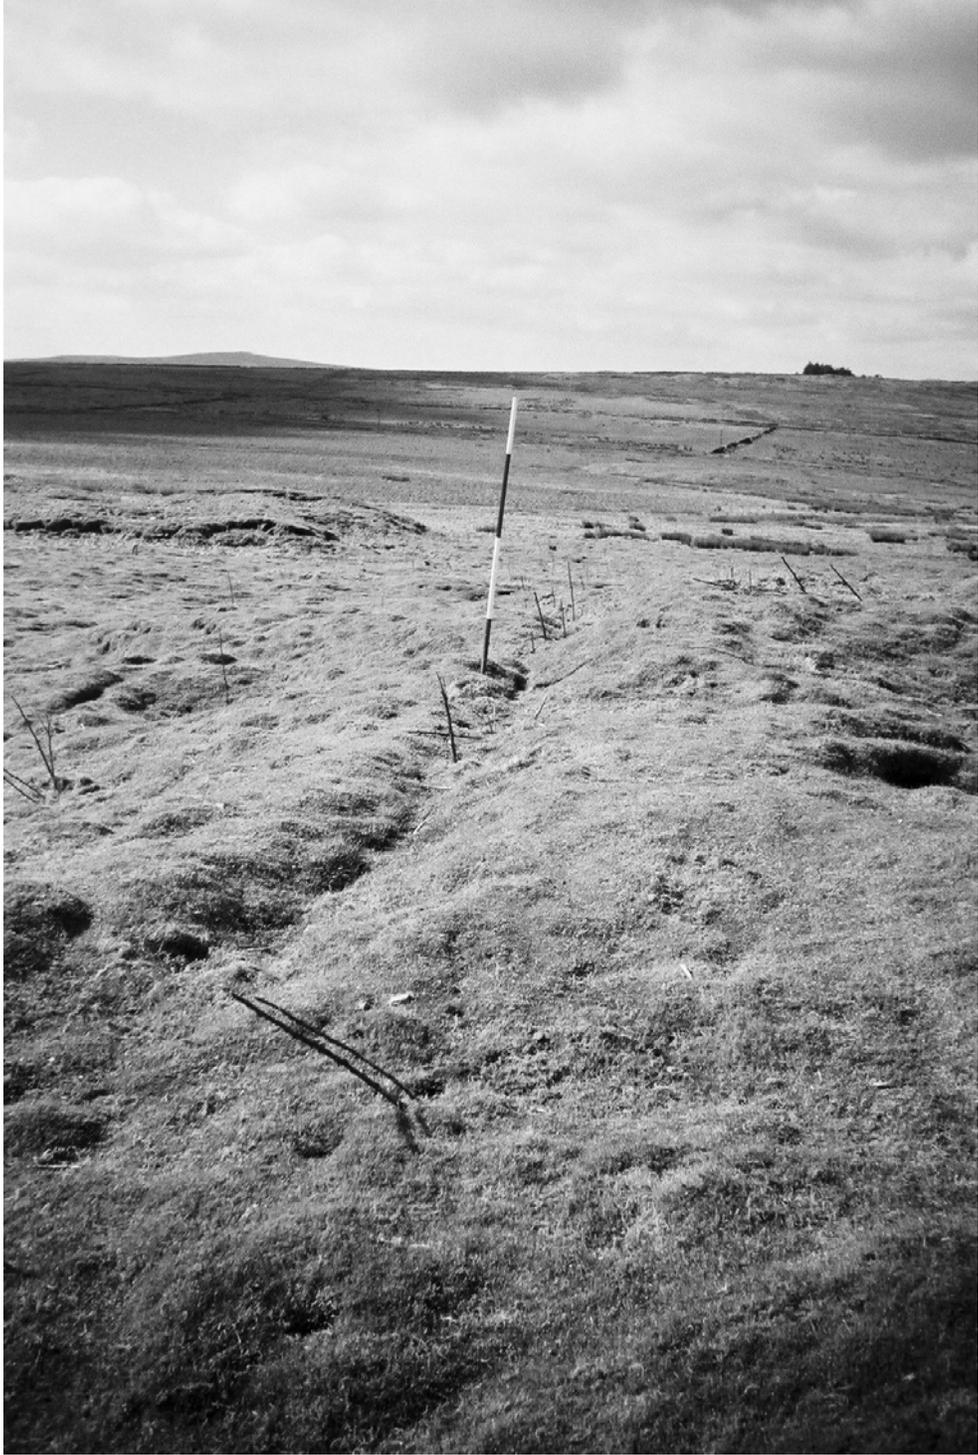
Fig.13 Water Leat (feature 12)

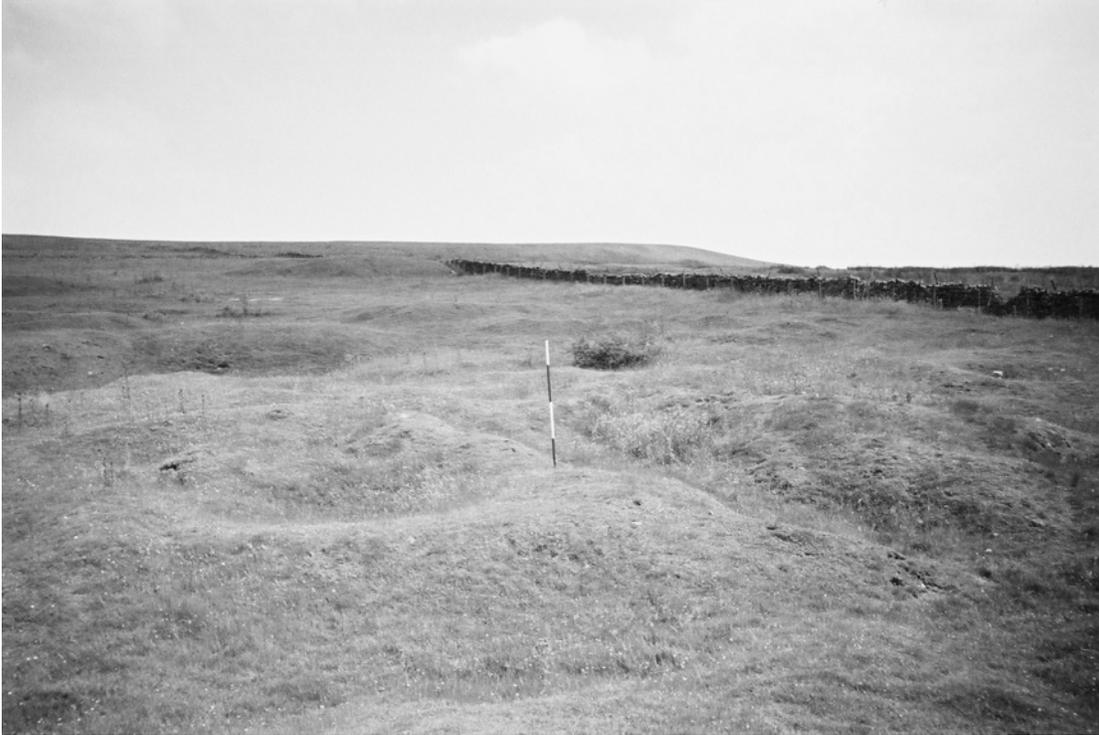
Fig. 15 Closely spaced shaft mounds

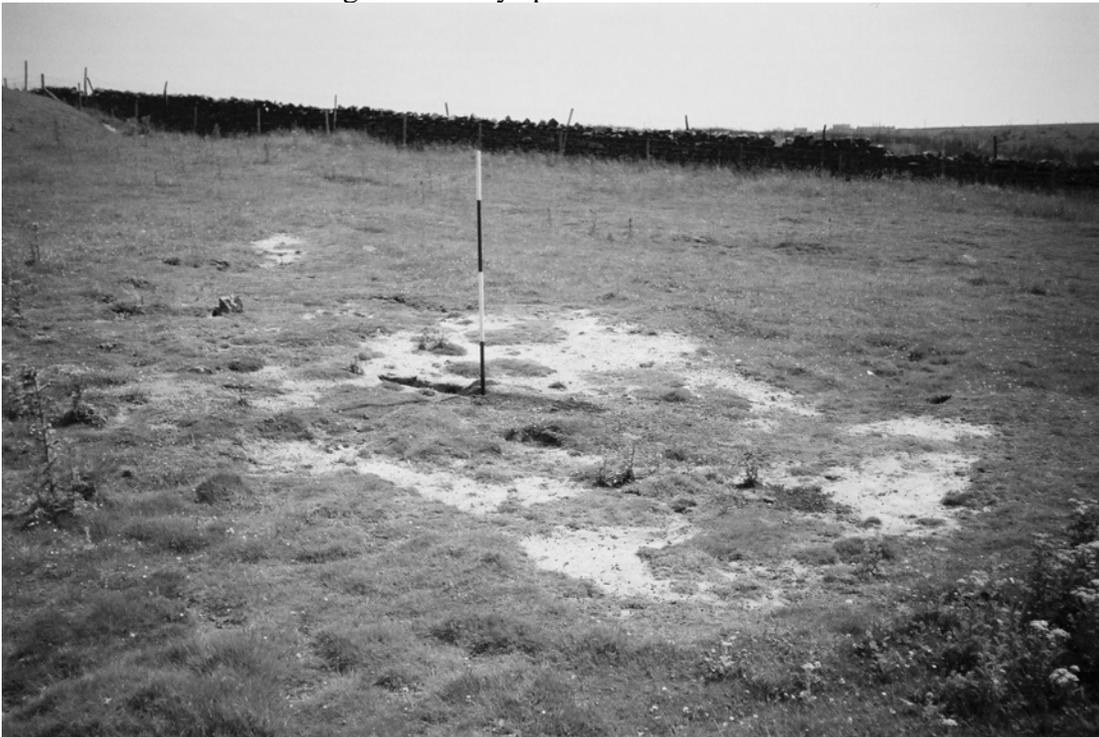
Fig.16 Dressing waste (feature 57)

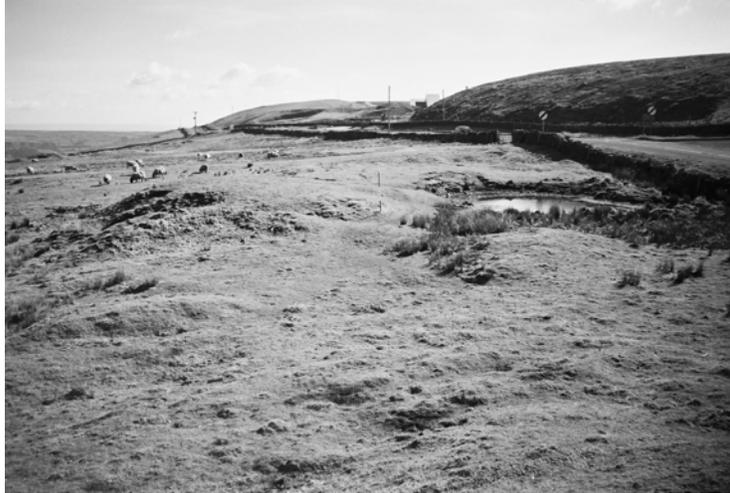
Fig.19 Cow Grooves Shaft (feature 23)

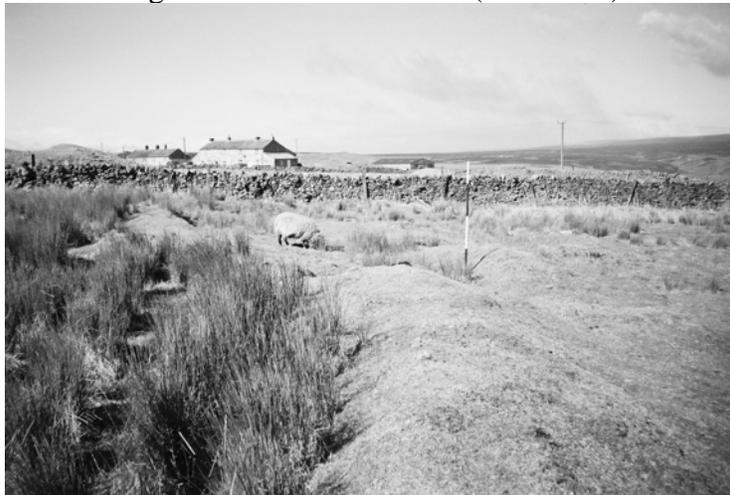
Fig.20 Earth and Stone Dam (feature 2)

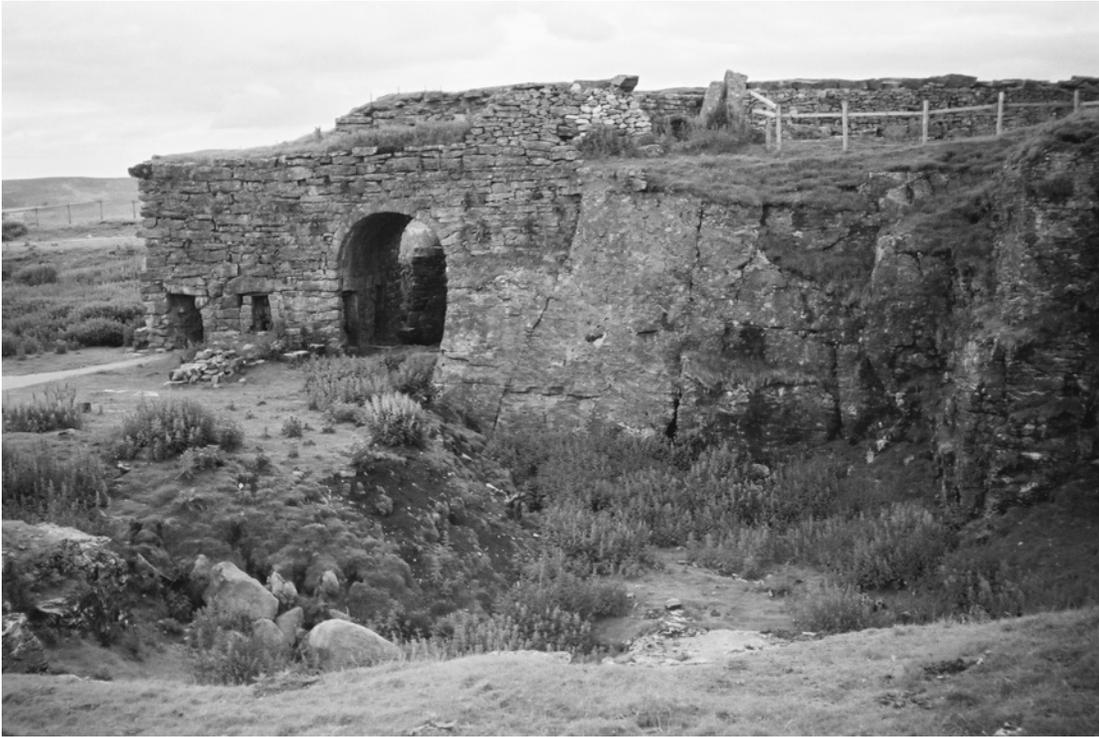
Fig.24 Toft Gate Lime Kiln (feature 9)

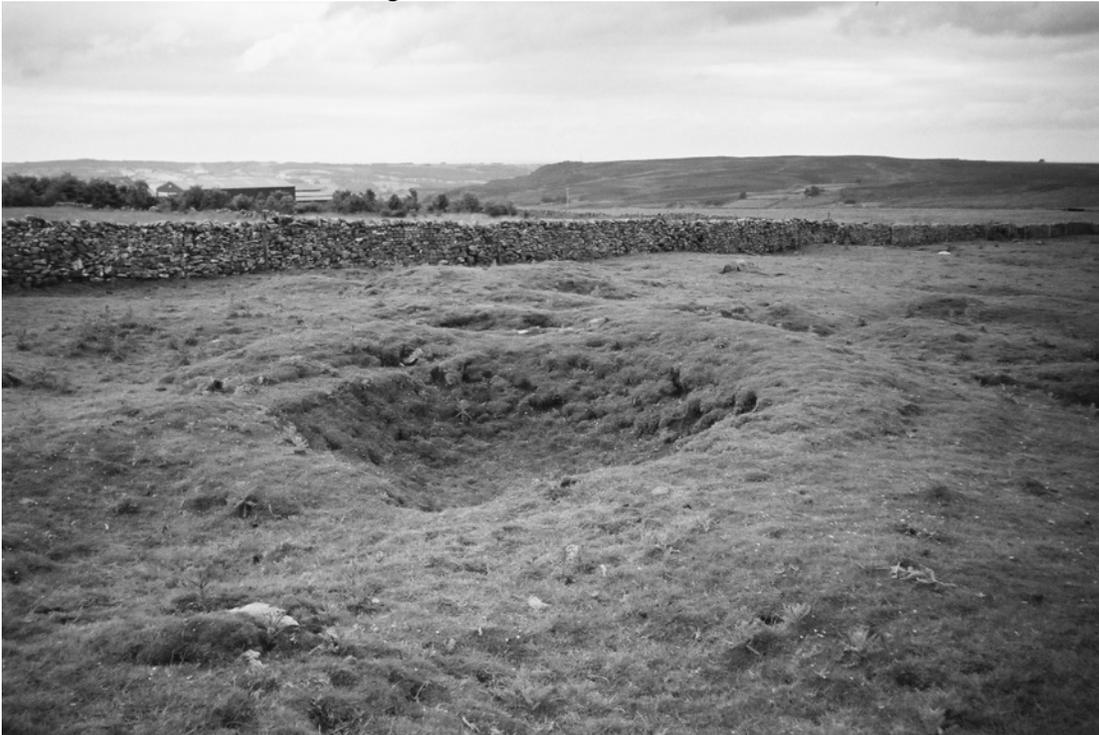
Fig.25 Line of shaft mounds (feature17-21)

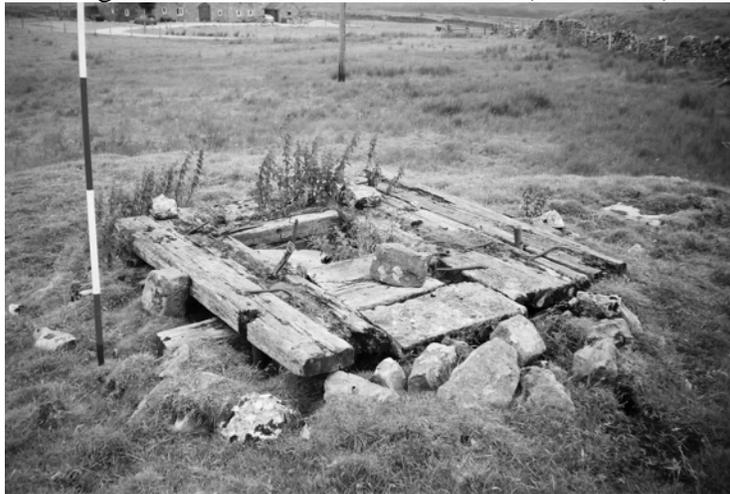
Fig.28 Chimney Shaft (feature 25)

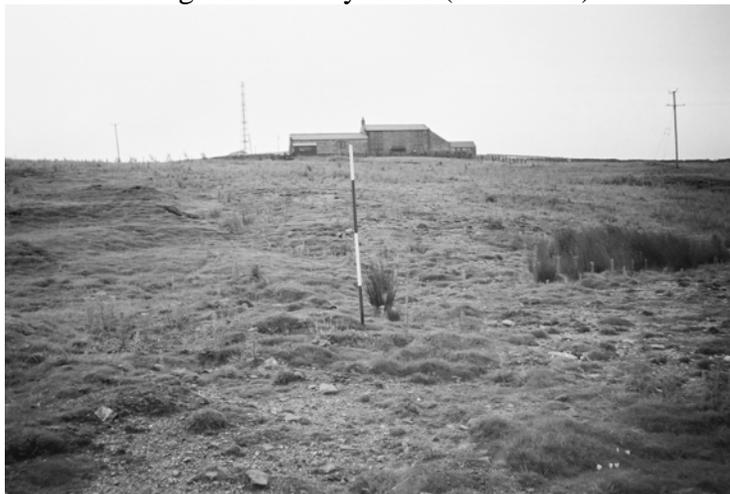
Fig.29 Filled ground over Greenhow Rake Vein (feature28)

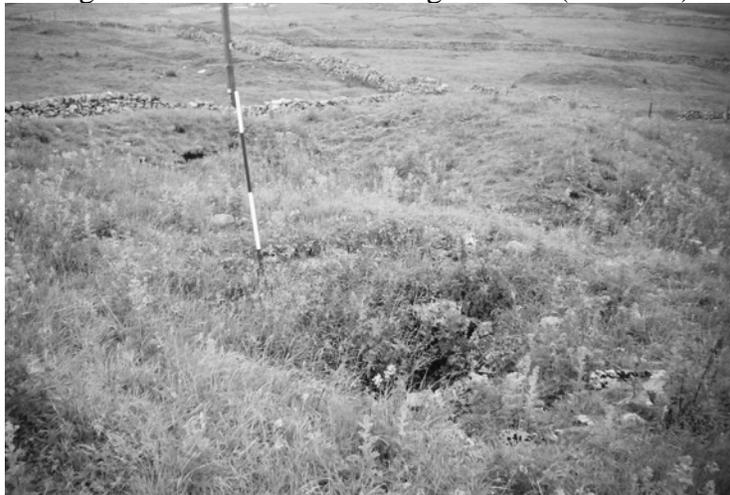
Fig.31 Climbing shaft Jervis Waygate Shaft (feature 5)

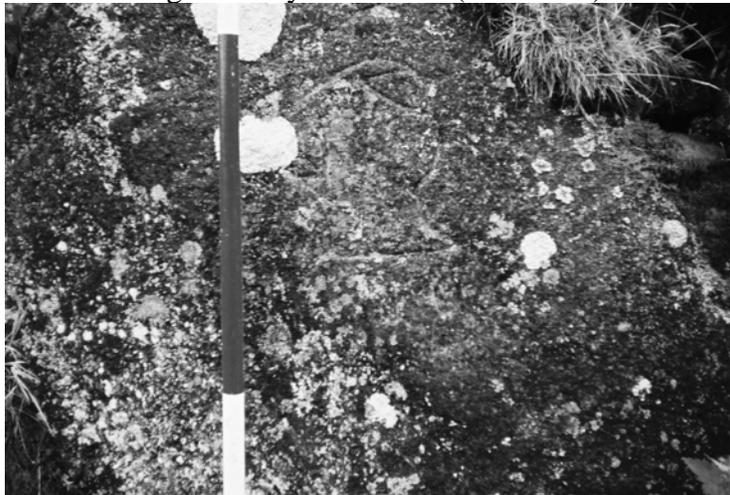
Fig.34 Head carved onto boulder near Sam Oon Level (feature 41)

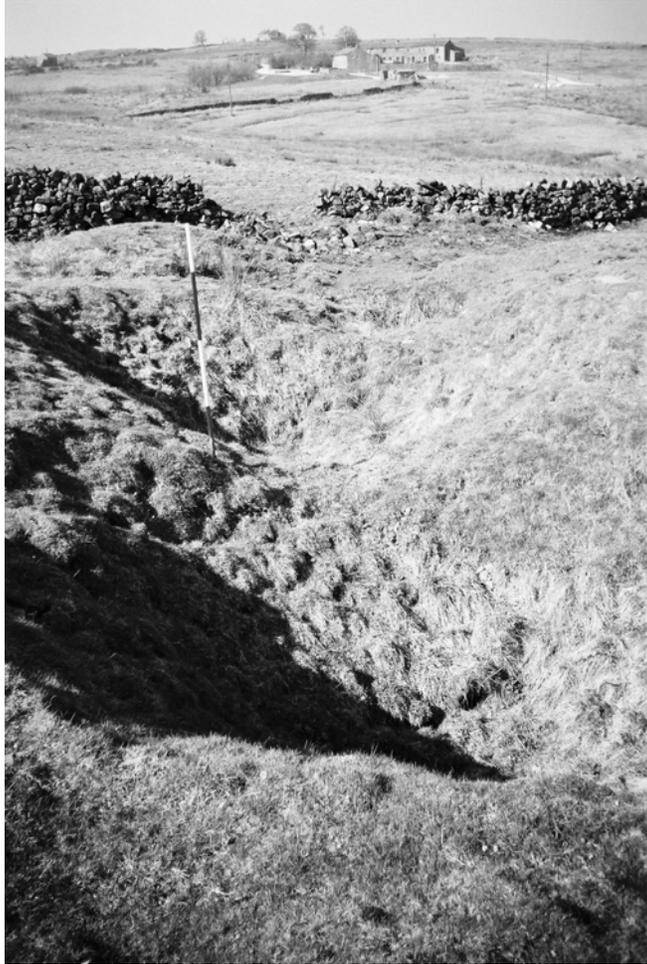
Fig.37 Shaft on The Virgins Vein (features 14-15)

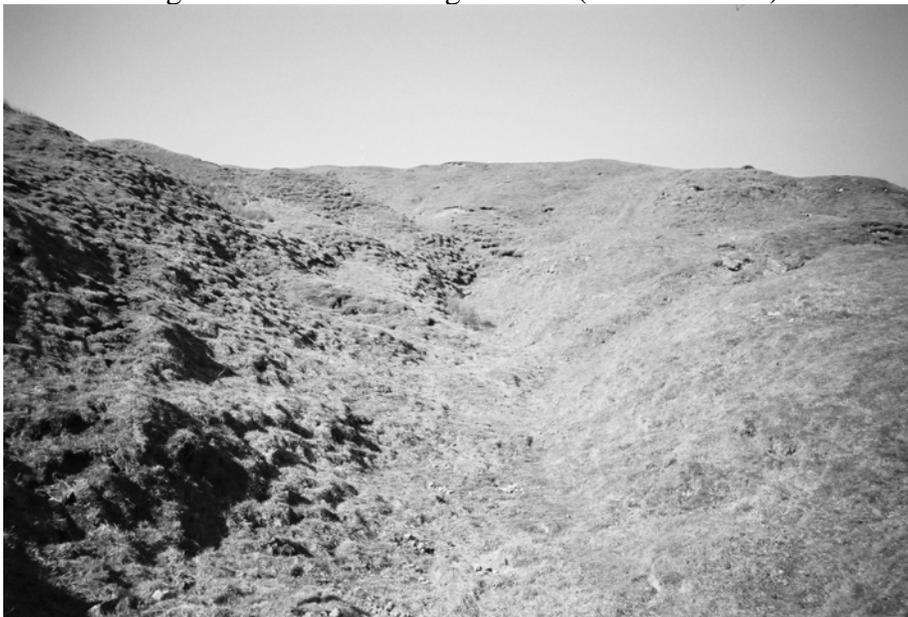
Fig.38 Large open-cut (feature 39)

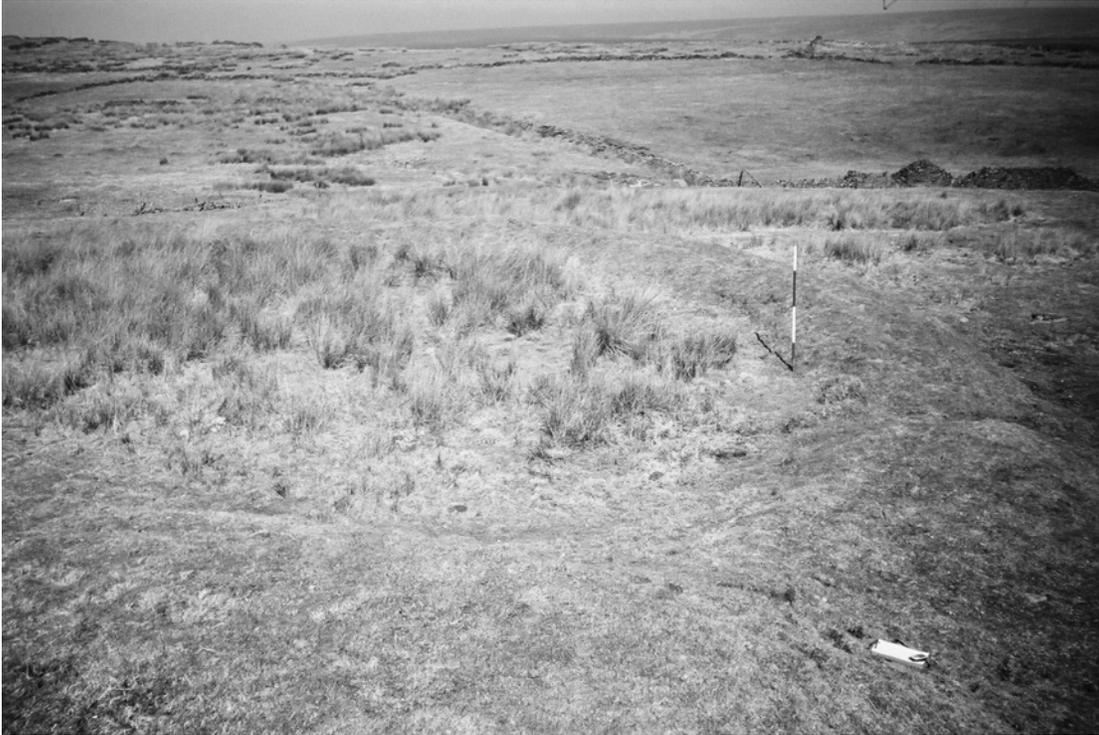
Fig.39 Earth and stone dam (feature 44)

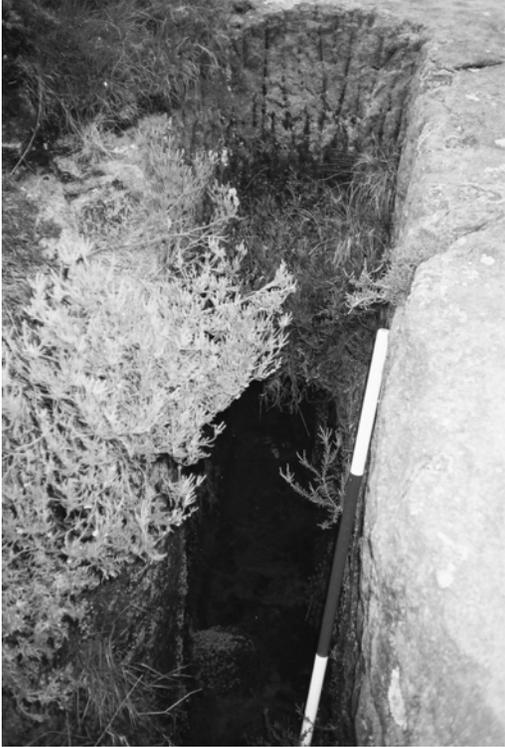
Fig.41 Entrance to Jackass Level
(feature 5)

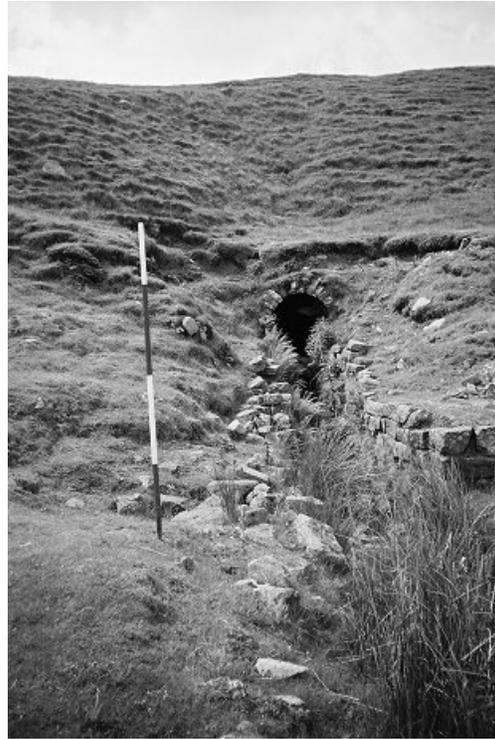
Fig.42 Entrance to Cockhill Level
(feature 23)

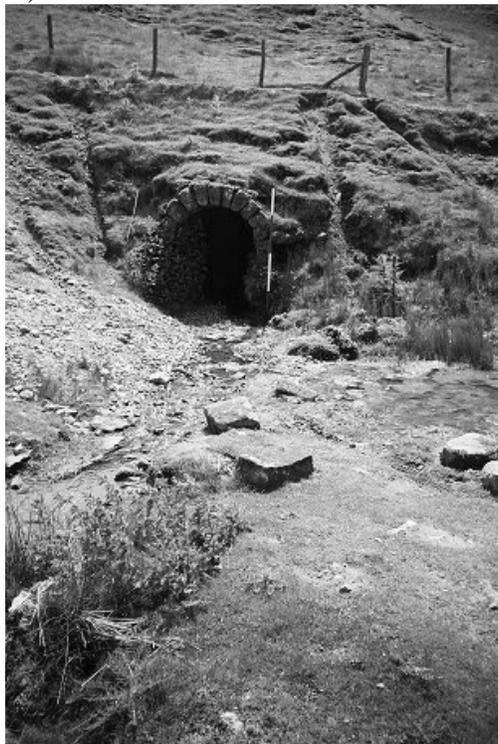
Fig.43 Entrance to Gillfield Level (feature 17)

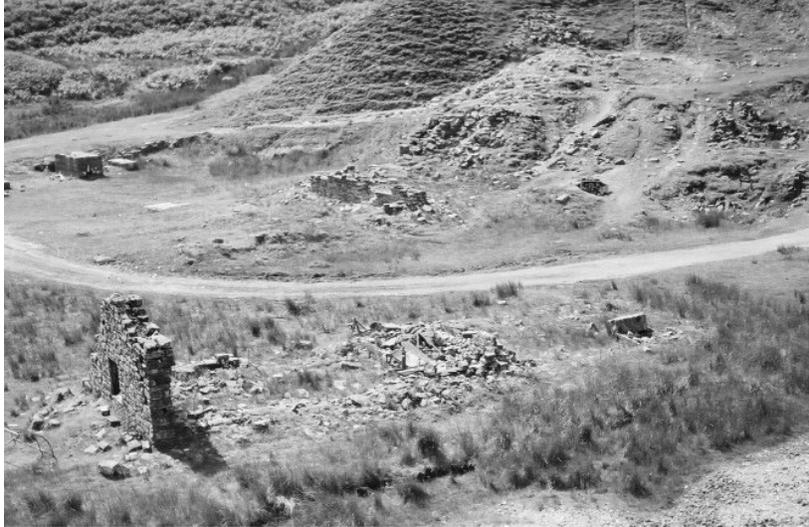
Fig.44 Cockhill smelt mill (feature 14)

4. Most of the remaining structures in the Cockhill area would benefit from some consolidation work to slow down their rate of decay and at the same time stabilise structures, which may be perceived as a danger to the public.

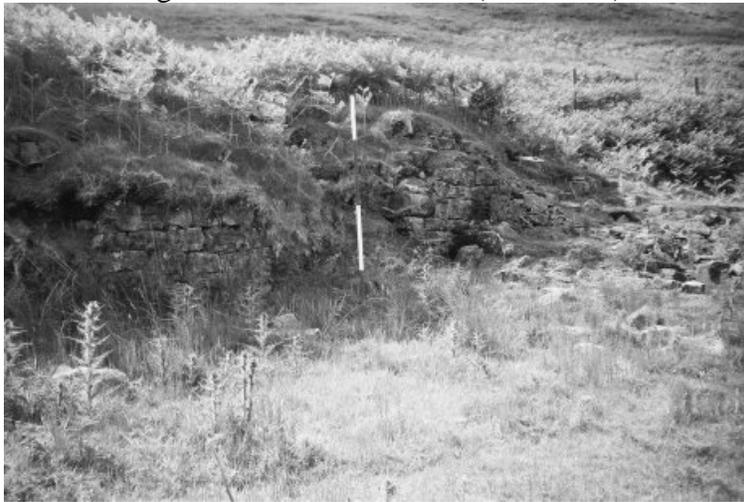
Fig.45 Gillfield smelt mill (feature 10)

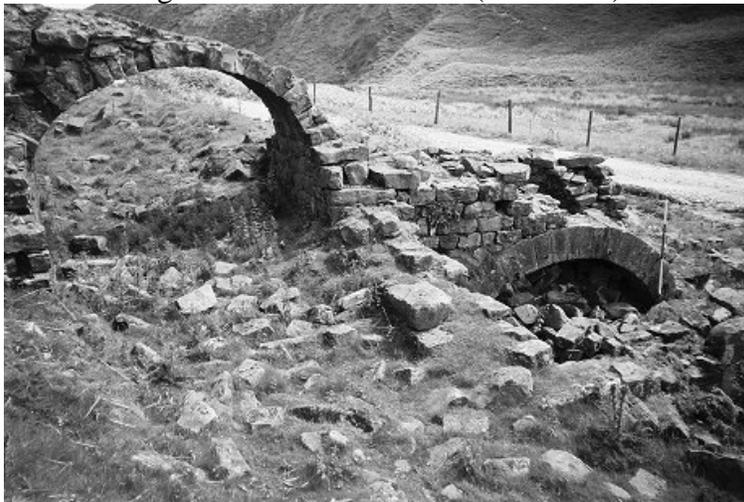
Fig.46 Providence smelt mill (feature 33)

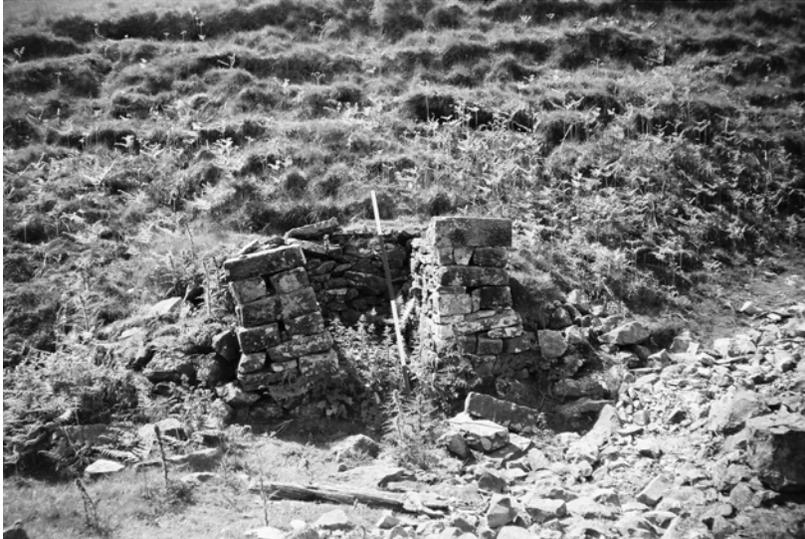
Fig.47 Possible explosive store (feature 29)

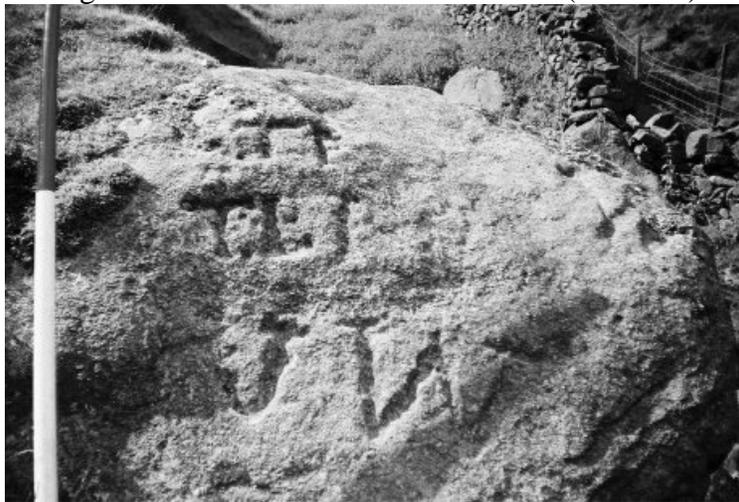
Fig.49 Carved stone near Jackass Level (feature 4)

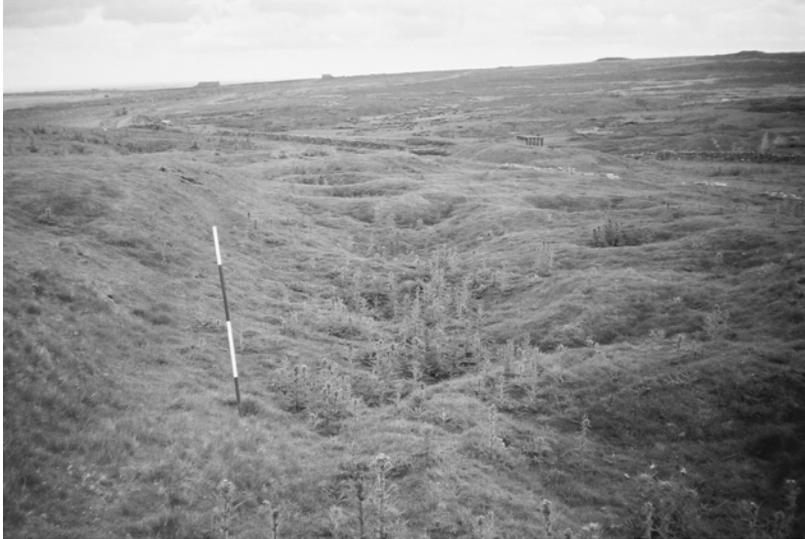
Fig.52 Line of shafts and pits marking the course of Prim Gap Vein (features 77-80)

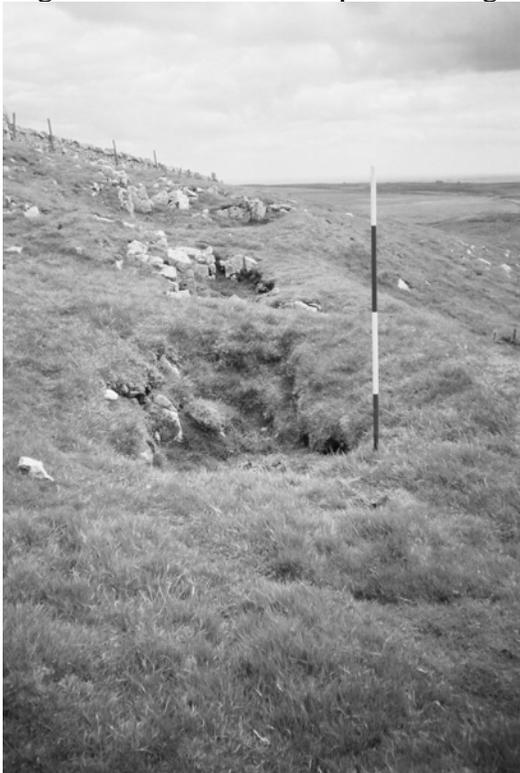
Fig.53 Shallow pits (features 118-9)

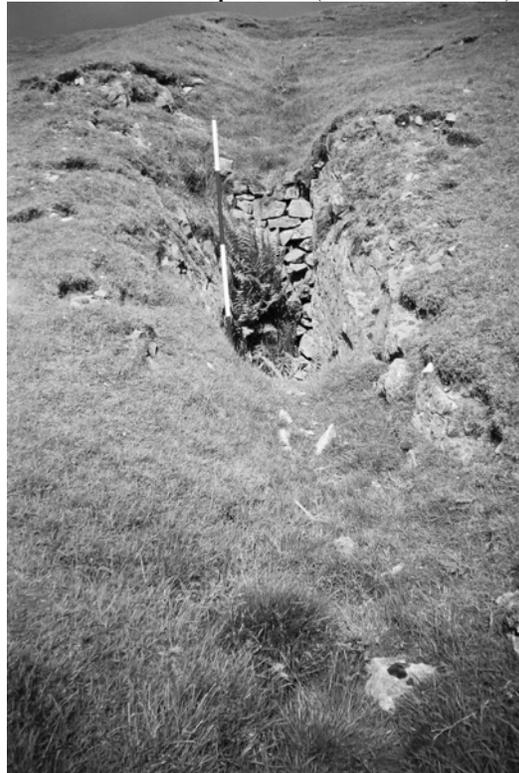
Fig.54 Backfilled open-cut (feature 38)

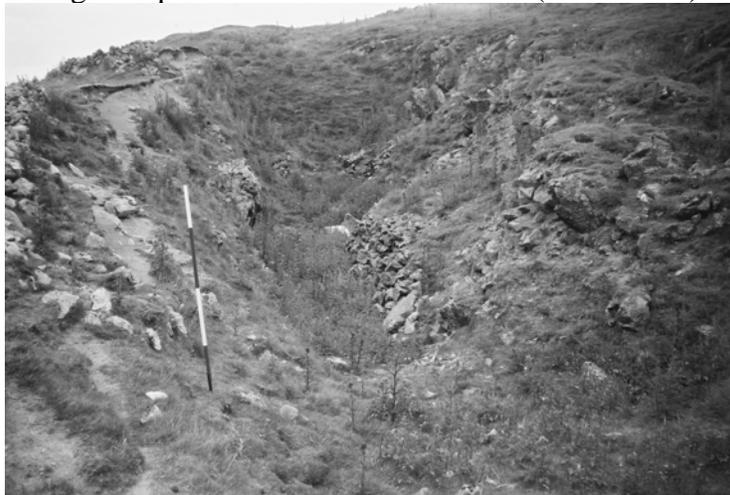
Fig.56 Opencut Greenhow Rake Vein (feature 200)

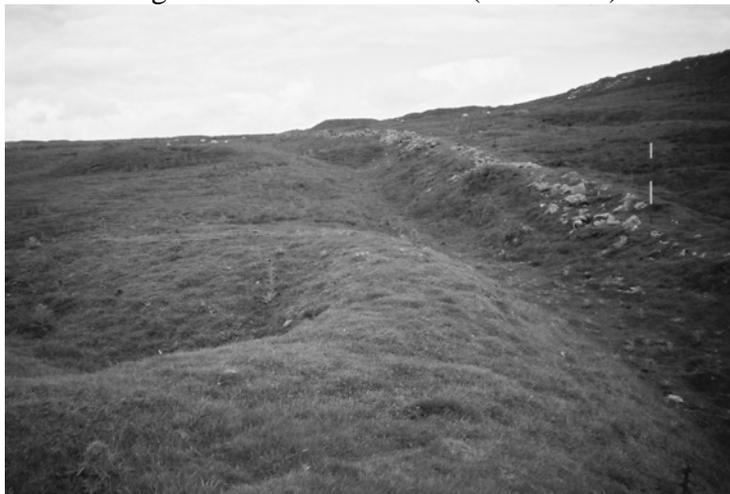
Fig.60 Holloway with wall on one side (feature 96)

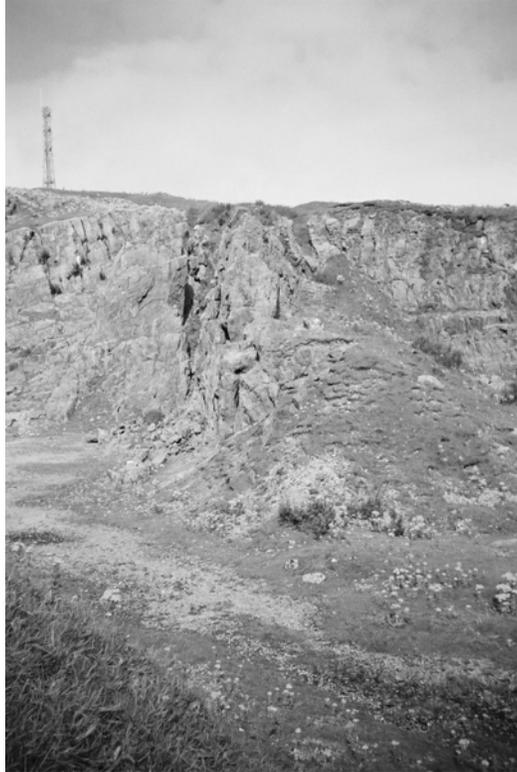
Fig.61 Greenhow Rake Vein Out cropping in the side of Duck Street Quarry (feature 217)

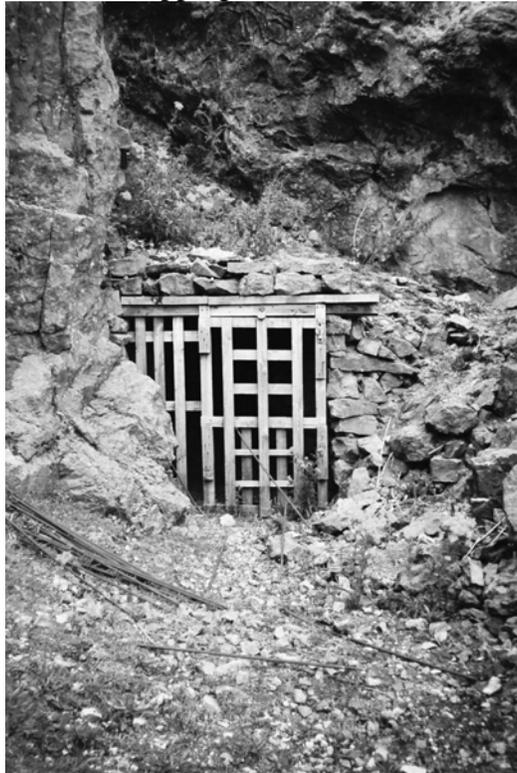
Fig.62 Level driven into Greenhow Rake Vein (feature 218)

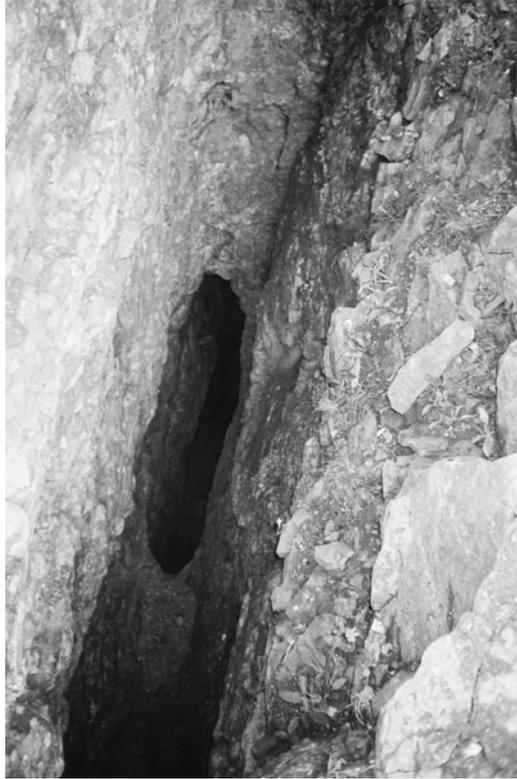
Fig.63 Open stope Greenhow Rake Vein (feature 218)

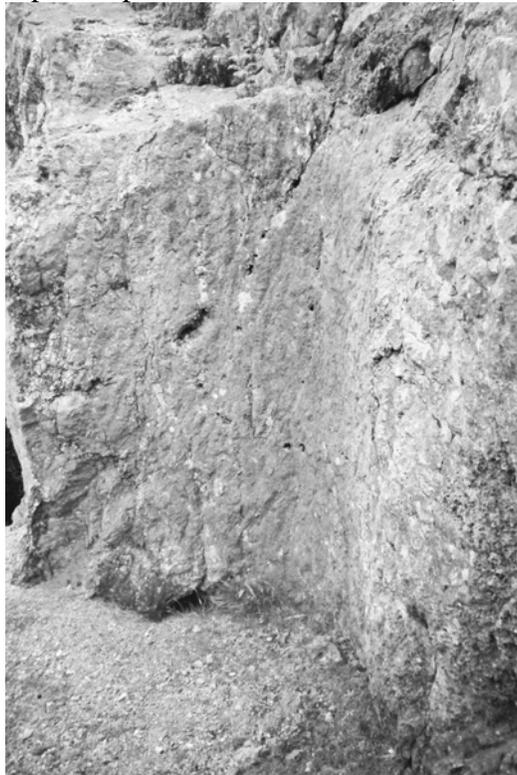
Fig.64 Section of a pre gunpowder shaft in the side of Greenhow Rake Vein (feature 218)

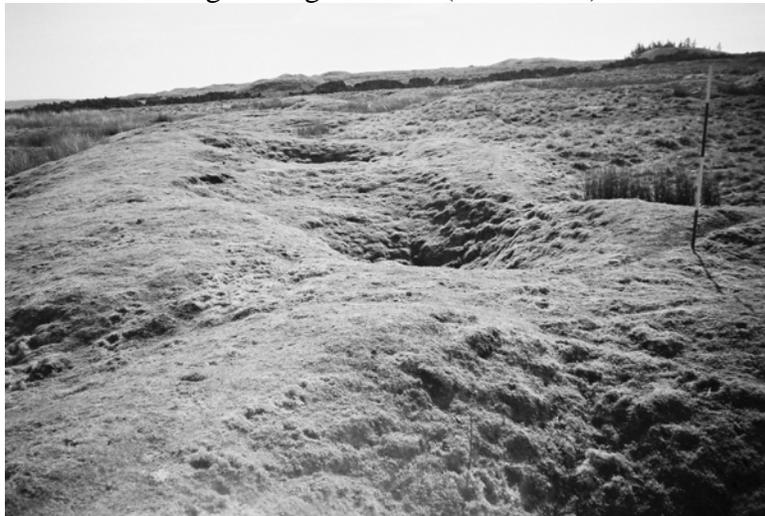
Fig.69 Closely spaced shaft mounds (feature 221)

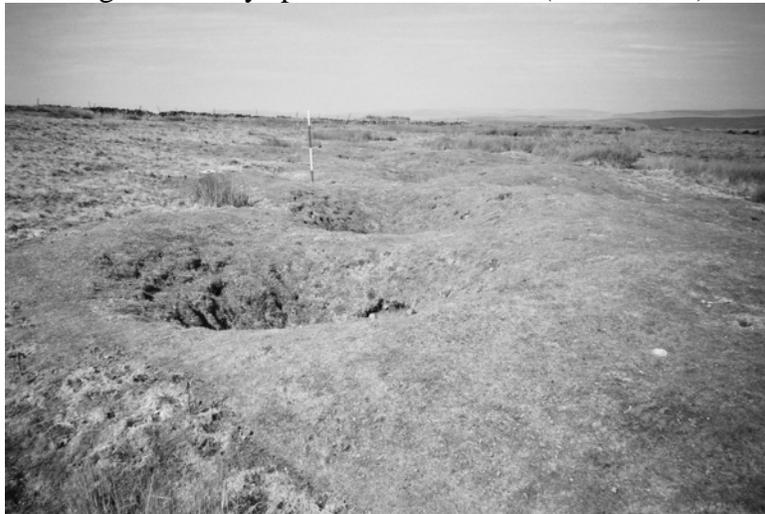
Fig.70 Closely spaced shaft mounds (feature 221)

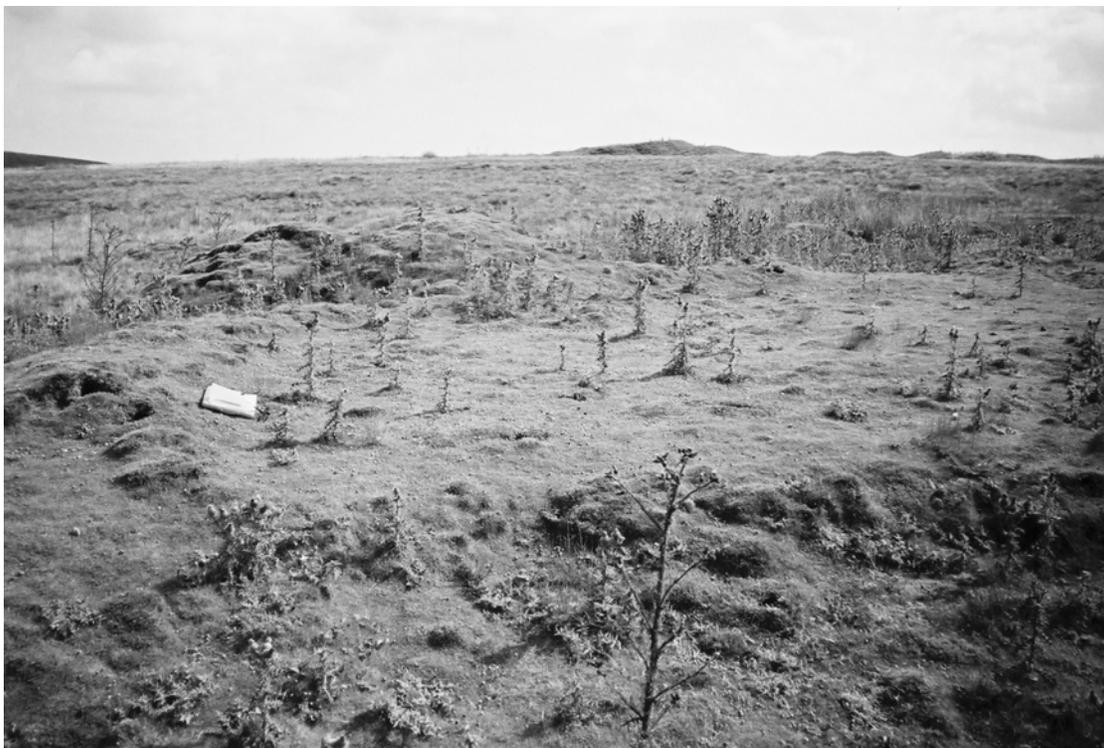
The largest shafts (32, 20, 44) are all connected by causeways running from the enclosures near Craven Keld. This would suggest that they may all date from the same period. Feature 20 is a very large but disturbed site representing a shaft mound and ore dressing area. The shaft mound is flat topped and displays evidence of a low circular turf wall adjacent to the slumped shaft. This is the only definite evidence of a horse gin found during the course of this survey.

Fig.79 Remains of horse gin circle (feature 20)

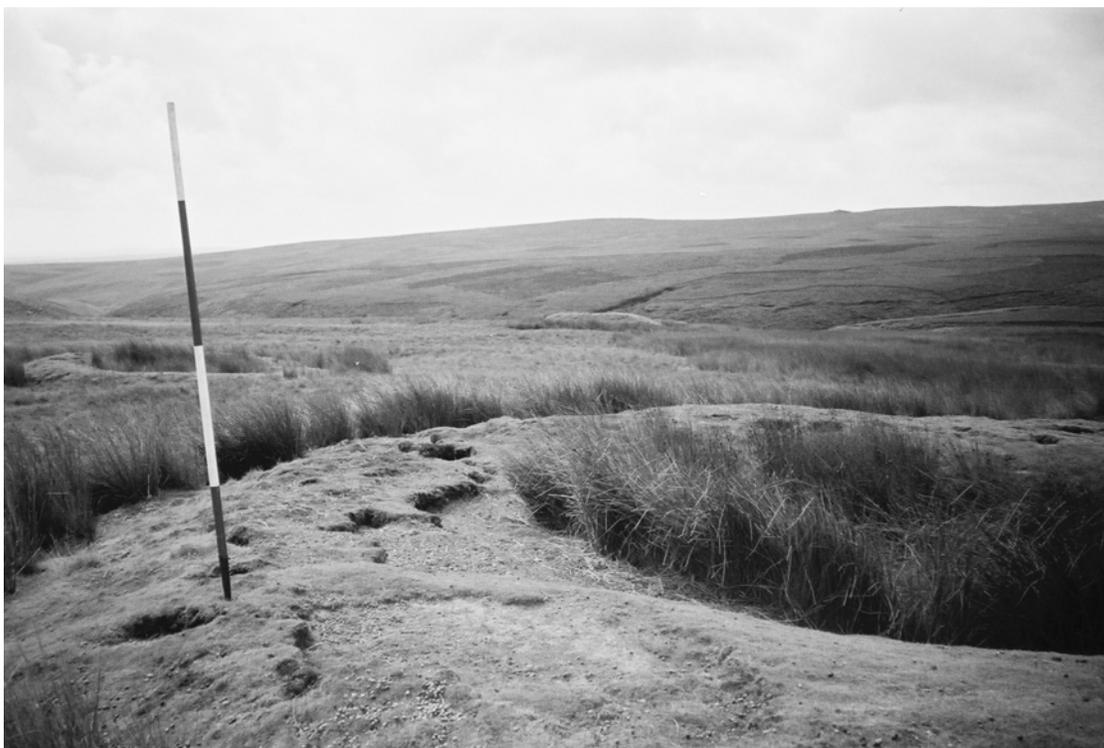
Fig.80 Shaft mound (feature 45)

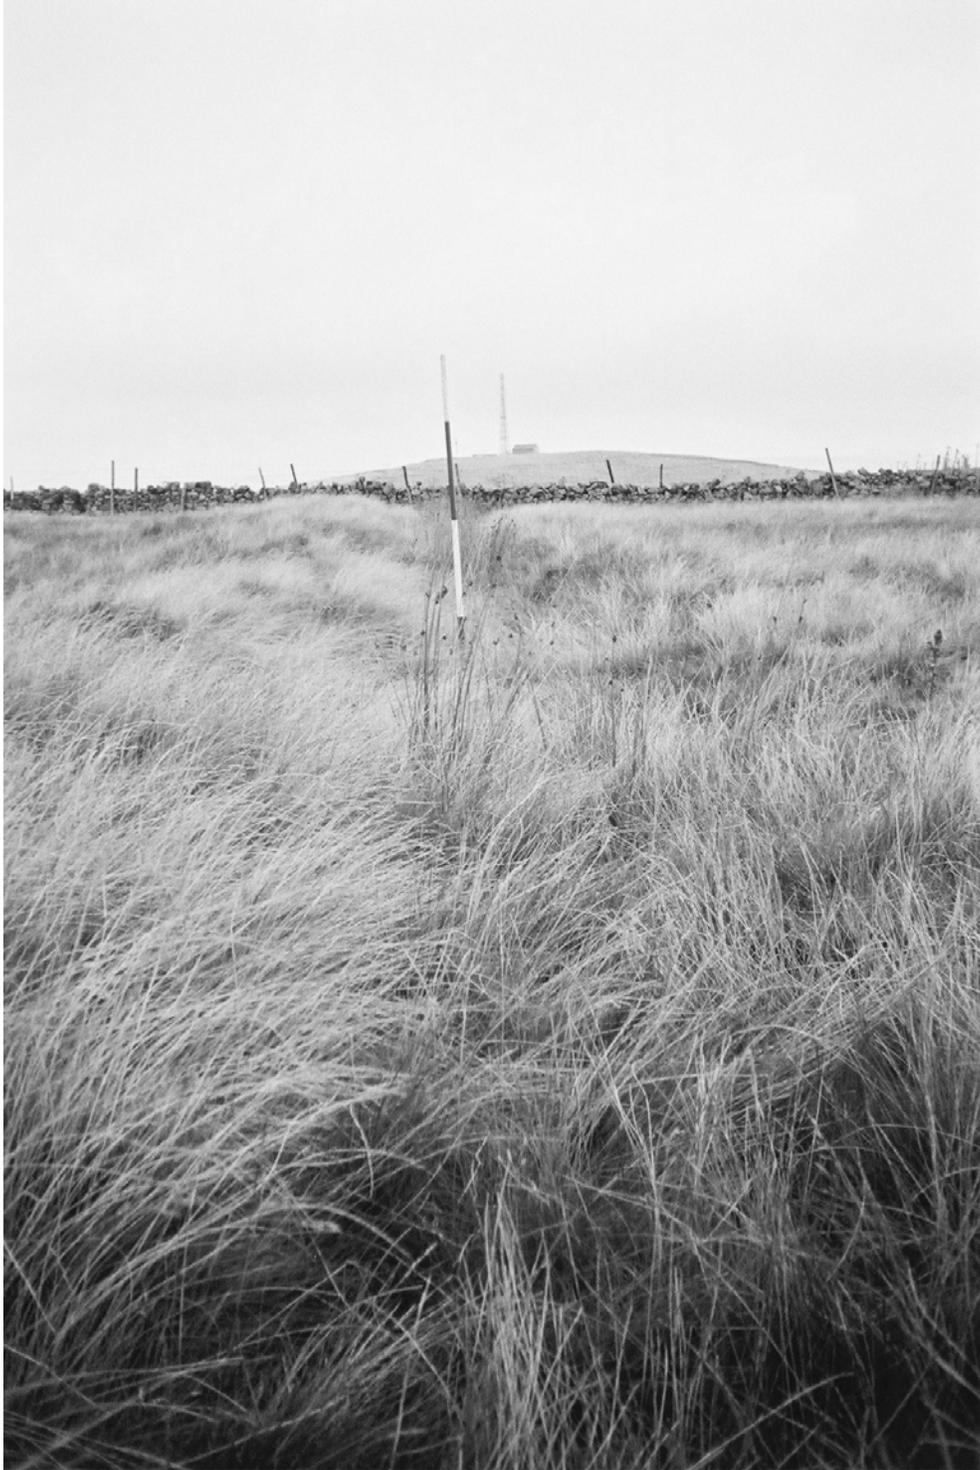
Fig.81 Ditch and bank (feature 4)
