**ST MARY'S CHURCH
RUSHDEN
HERTFORDSHIRE**

ARCHAEOLOGICAL FIELD EVALUATION

Document: 2003/60
Project: SMR 950

28th October 2003

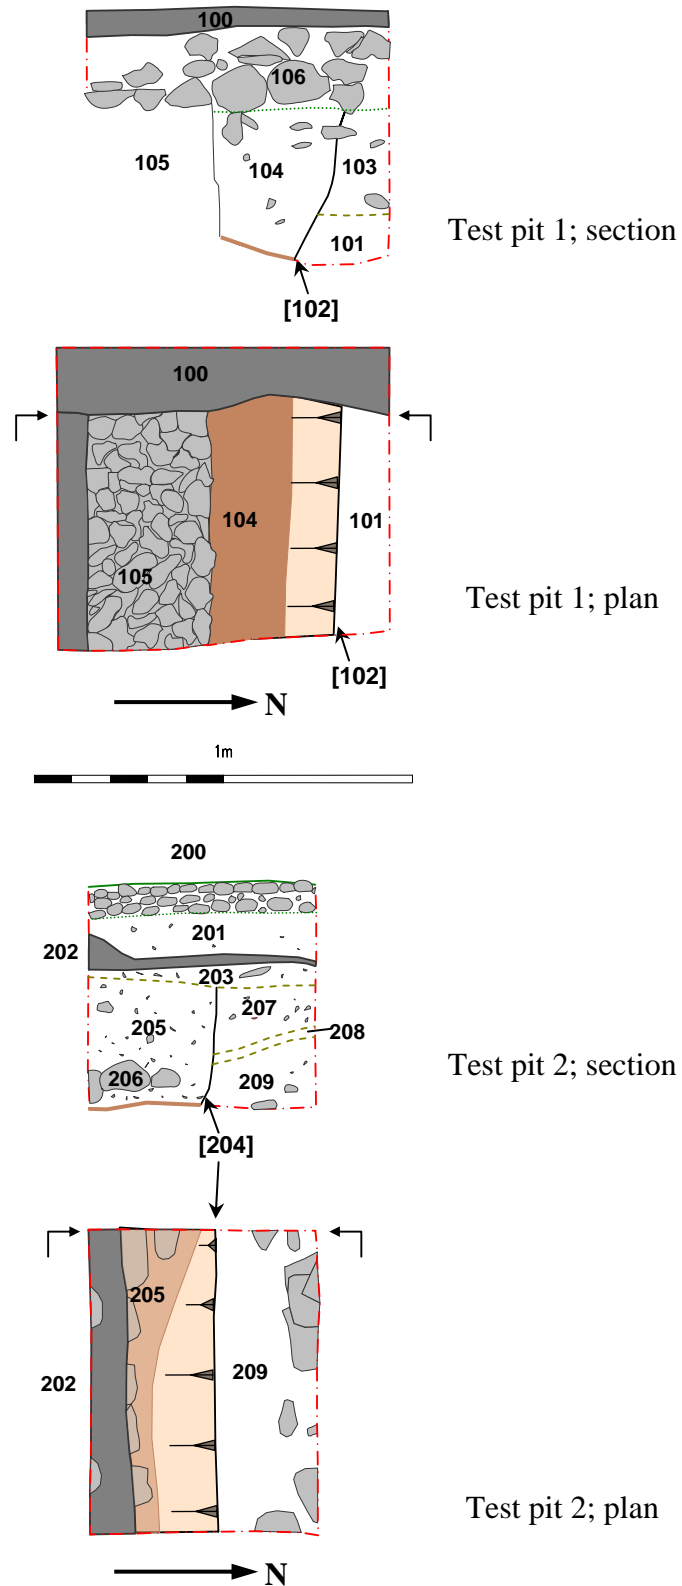
Figure2: Test pits 1 and 2; plans and sections
see figure 4 for key

A surface layer of loose, clean gravel was recorded in Test Pits 2 (**200**) and 3 (**300**), between 80mm and 130mm deep (Figures 2-3). Although not shown on the section drawings of the remaining test pits, this layer extends along the length of the northern side of the nave and chancel. It is the result of an earlier attempt to improve the drainage when the ground level in this area was lowered slightly and the surface covered with gravel.

The construction of the chancel was examined in Test Pit 1, which was situated in the angle between the north wall of the chancel and the east end of the nave (Figure 2). The foundations of the medieval chancel (105) were made of flint nodules set in a light yellow brown mortar and continue more than 0.6m below the modern ground level. The foundations were set within a wider construction cut [102], suggesting that they had been built up within a trench rather than being deposited into one. The construction cut extended between 0.3m and 0.4m from the north face of the foundation. Following the construction of the wall, the trench had been backfilled with material (104) largely derived from construction debris.

It was hoped to examine the relationship between the foundations of the chancel and the nave in Test Pit 1. Large flint nodules (106) at the base of the nave wall appeared to be part of its foundation. However, lower down in the test pit nothing was found of the foundation for the nave. It was impossible to examine the relationship further without undermining the wall of the nave.

The present chancel was built in 1849 and its footings (107) were laid directly on top of the foundations of the demolished medieval chancel. The outside of the 19th century construction was stepped in from the edge of the medieval foundations, leaving approximately 0.3m of the original foundations visible in the test pit.

The foundations of the nave were built within a construction trench measuring between 0.3m and 0.6m wide [204] [401] (Figures 2, 3). The backfill within the construction cut (205) (402) (403) consisted of either brown clay with few stones or orange/yellow clay material containing construction debris. One of these deposits (402) contained a pottery sherd (24g) dating from the 12th or 13th centuries. The sherd is in a sand tempered fabric, recognisable as Hertfordshire-type greyware. The foundations (206) (307) (406) were constructed of large roughly coursed flint nodules that continued to a depth of more than 0.6m below

the modern ground surface. The line of the wall above (407) (306) was offset a short distance (50mm) from the face of the foundation. A mortar fillet (202) (308) (412) had been formed over the offset to create the effect of a chamfered plinth.

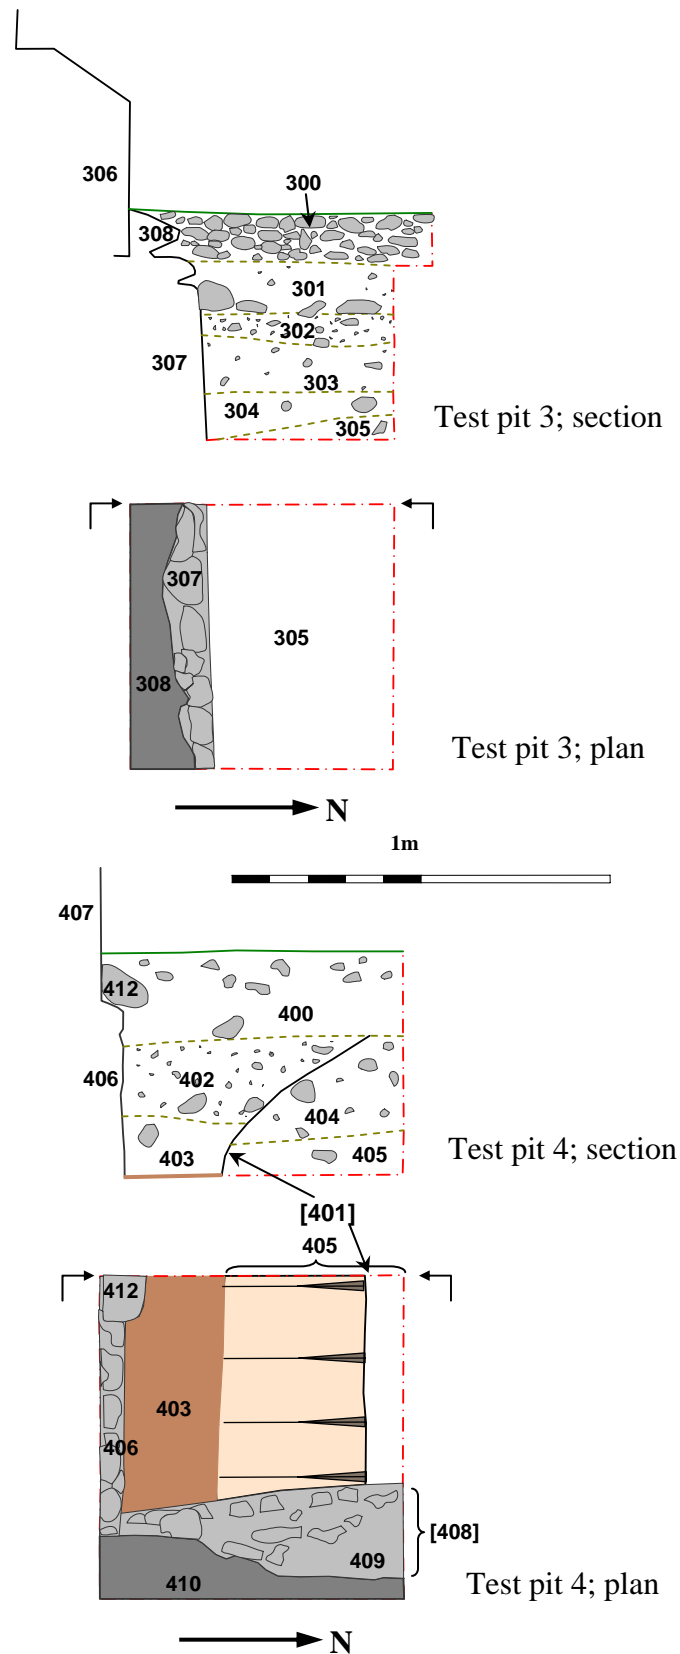
Figure 3: Test pits 3 and 4; plans and sections
see figure 4 for key

In Test Pit 3, the construction trench was not recognized. It may be that the foundation trench was wider at this point, with the northern edge lying beyond the limit of the test pit. A series of layers lay against the foundations of the wall at this point. Two comprised material probably derived from construction activity, redeposited Boulder Clay (304) and light yellow brown clay mixed with stone, flint and chalk debris (302). These were interleaved between mid grey brown silty clay (303) and (305), possibly derived from topsoil. These layers may have been related to something other than the nave wall, particularly as the test pit lay directly outside a former access to the church in the form of a blocked door.

In Test Pit 4 it was possible to examine the base of one of the buttresses that support the wall of the nave. The foundation of the buttress (409) consisted of randomly arranged flint nodules with occasional fragments of clunch set in a fine grained light yellow or cream coloured mortar. The foundation filled the full width of its construction cut [408], cutting across the construction cut for the foundations of the nave. The construction and composition of the buttress foundation contrasted with that of the nave and it was clearly a later addition to the nave.

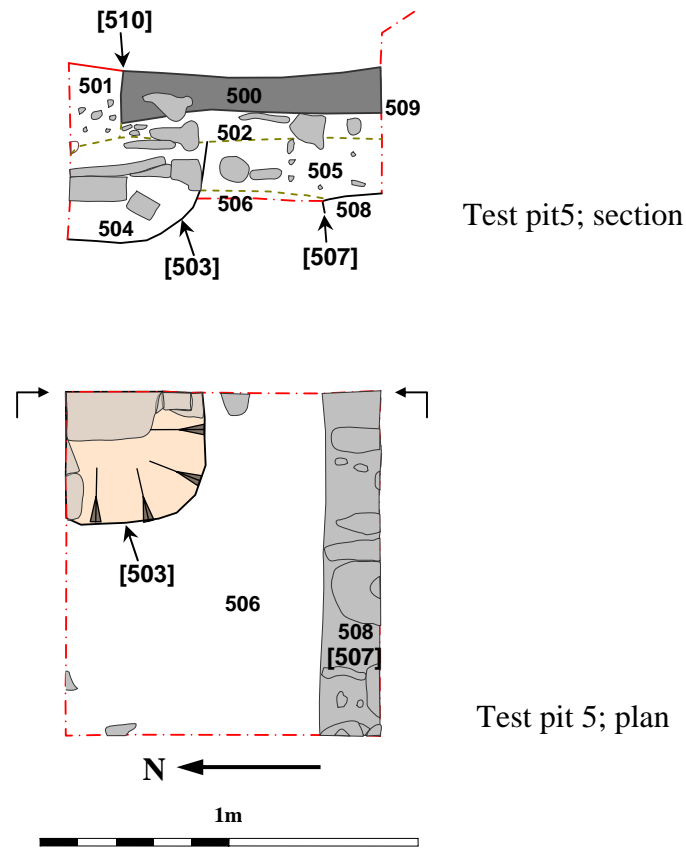
Figure 4: Test pit 5; plan and section.

A concrete apron was recorded in Test Pit 5 (**500**), extending 700mm out from the wall at the base of the tower (Figure 4). Its surface sloped gently downwards from the wall. The concrete was set into a construction cut [**510**], 180mm deep, the base of which was covered by a layer of hardcore or levelling material (**502**) composed of a mixture of large flint nodules and mortar. This apron was probably added to improve drainage of water away from the base of the tower.

A cut [**503**] was observed in the north-eastern corner of Test Pit 5, close to the tower. Its full extent was obscured by the limits of the test pit but its sides were nearly vertical, rounding out to a flat base. The loose soil fill of this feature (**504**) included a large proportion of modern occupation and building debris comprising, brick, tile, ceramic drain pipe, earthen ware and glass vessels. These artefacts, dateable to the late 19th or early 20th centuries were not collected.

Chalk bedrock was observed towards the western end of the church in the base of Test Pit 5 (506) where it occurred only 300mm below the ground surface.

At the base of the tower, roughly coursed flint nodules (509) in mid orange brown sandy clay (508) filled a construction cut [507] to form a foundation that projects 0.15m beyond the plinth at the base of the tower. Directly above the foundation a few courses of flint nodules in mortar lie beneath a carefully constructed chamfered plinth of large limestone blocks.
