PARKHOUSE FARM, PARKHOUSE ROAD, BARROW-IN-FURNESS, CUMBRIA

Archaeological Building Recording

Client: Mr and Mrs Beck
Planning Ap. Ref.:
42/2004/0626
NGR: SD 22393 71111

© Greenlane Archaeology Ltd
February 2006

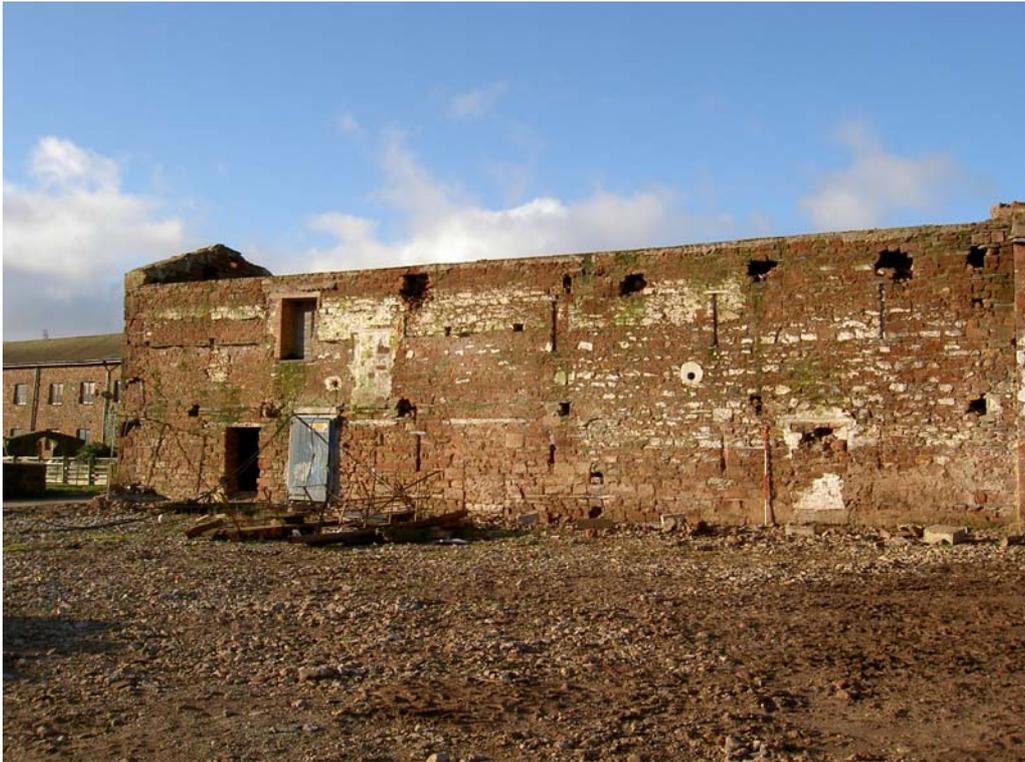
4.3.2 **North-east elevation:** the whole elevation has a thin skim of limewash. There are two rows of narrow ventilation slots, one on both the ground and first floor, each approximately 0.8m tall (Plate 4). The majority of those on the ground floor have been blocked, often with brick, and many of those on the first floor have also been blocked. There are a number of additional holes knocked into the wall on the first floor (probably associated with the recent removal of the roof) as well as two plastic pipe vents, and water pipes and electrical cables are attached in various places. The north-west end comprises the former gable end of Building B; it is evident that the rebuilding associated with the removal of the gable has continued across the entire elevation. On the ground floor of Building B there is a doorway on the south-west side.

Plate 4: North-east external elevation of Building A

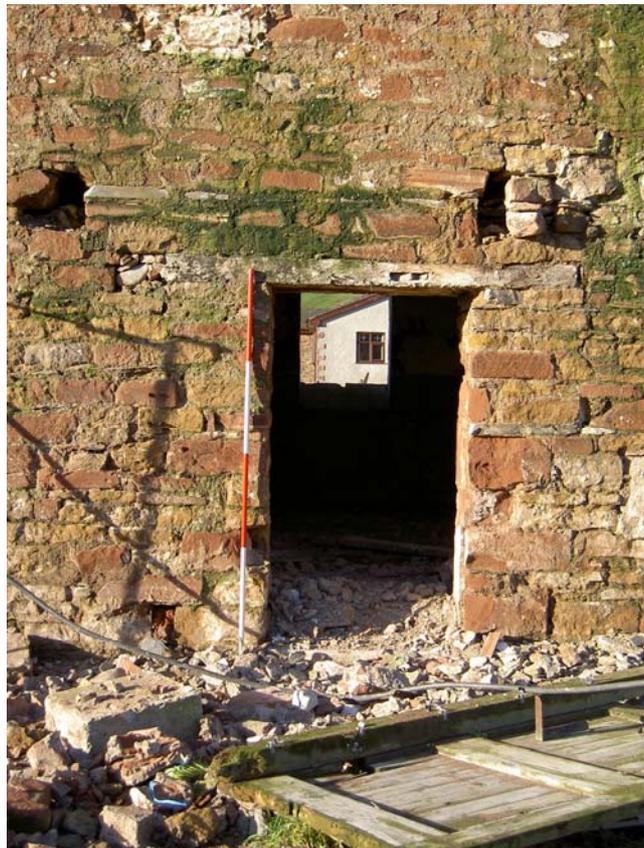
Plate 5: Re-used timber 1 used as a lintel above the south-western doorway in the north-east elevation of Building A

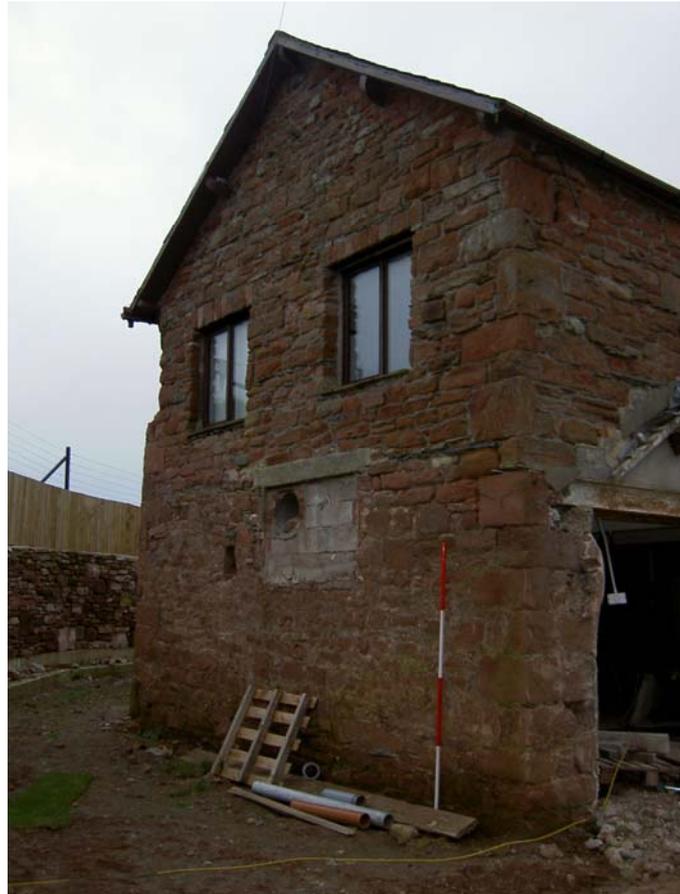
4.3.5 **South-west elevation, Building B** (Fig 4): this forms the gable end of the lower extension added to the threshing barn making up the initial part of Building B (Plate 8). There are two inserted windows on the first floor and an inserted aperture below, which has been blocked with concrete blocks and bricks, leaving a circular opening approximately 0.4m in diameter. To the north-west of this there is a smaller, square hole of unknown function approximately 0.2m wide and 0.3m tall. Below the

Plate 8: South-west external elevation of Building B

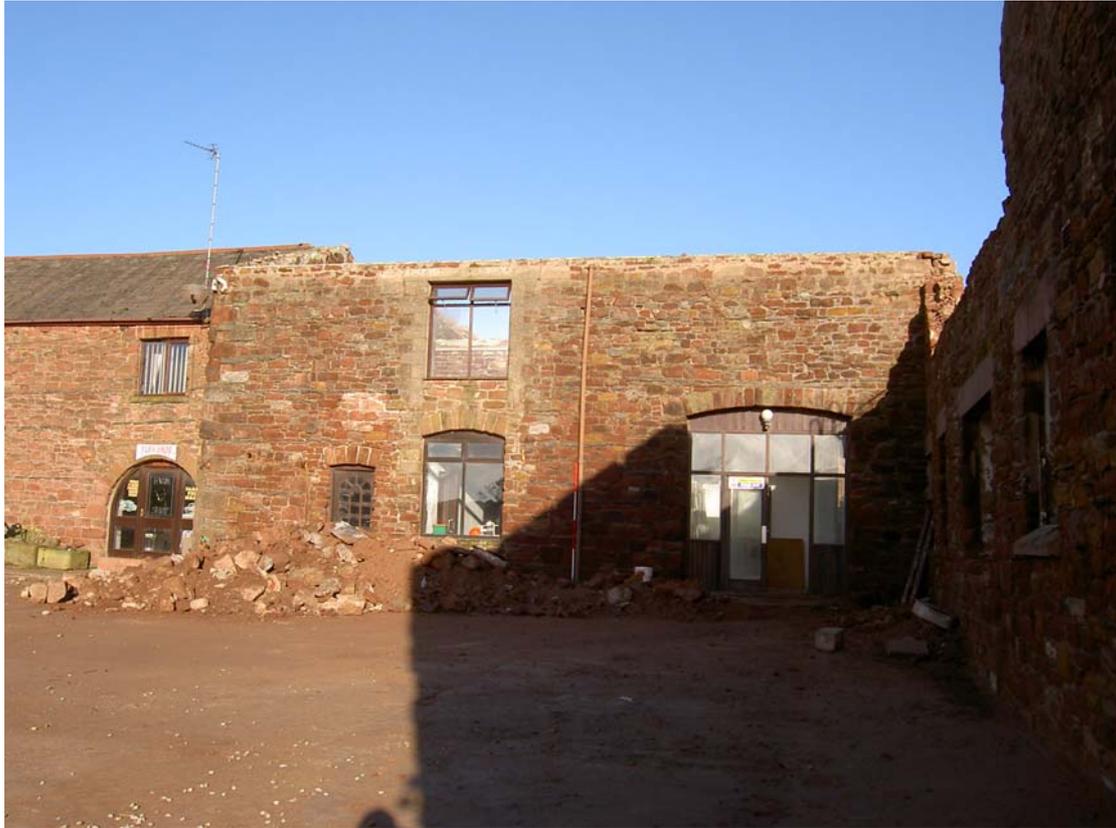
4.3.7 The north-east end has two ventilation slots on the ground floor and another on the south-west side of the first floor (Plate 10). There is a large wagon doorway on the north-east side, which has a modern glass and timber window and pedestrian doorway inserted into it. On the south-west side of the ground floor there is a small window with a flat voussoir arch. Between these there is a large window on the ground floor with a round-headed arch beneath another large window. The first floor window is definitely inserted, and the jambs are rebuilt in concrete blocks, and the ground floor window has evidently been altered too. It is also apparent that the whole of the wall top has been rebuilt at some stage, probably before the insertion of the first floor window.

Plate 10: North-east end of the south-west external elevation of Building B

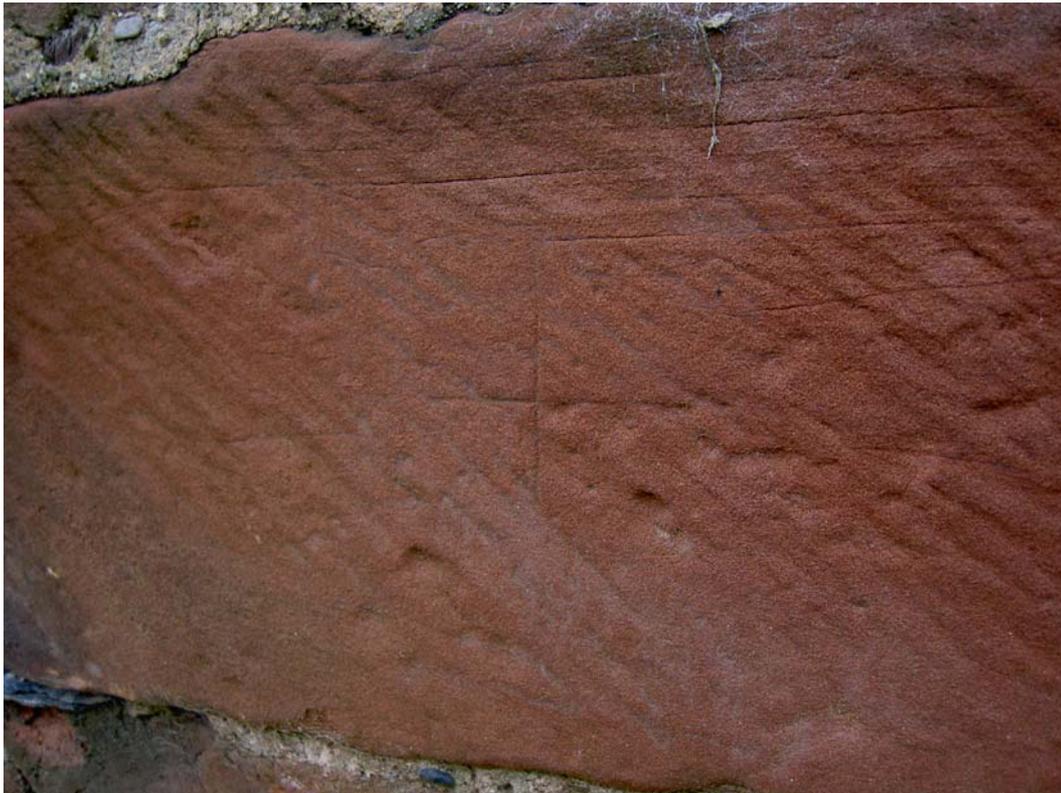
face finished limestone, and drill holes left from quarrying are evident in various places. There are iron downpipes at either end and on the south side a mason's mark (mason's mark 3) in the form of a simple carved cross 0.07m by 0.07m is present (Plate 14).

Plate 14: Mason's mark 3 to the south of the large opening in the east external elevation of Building D

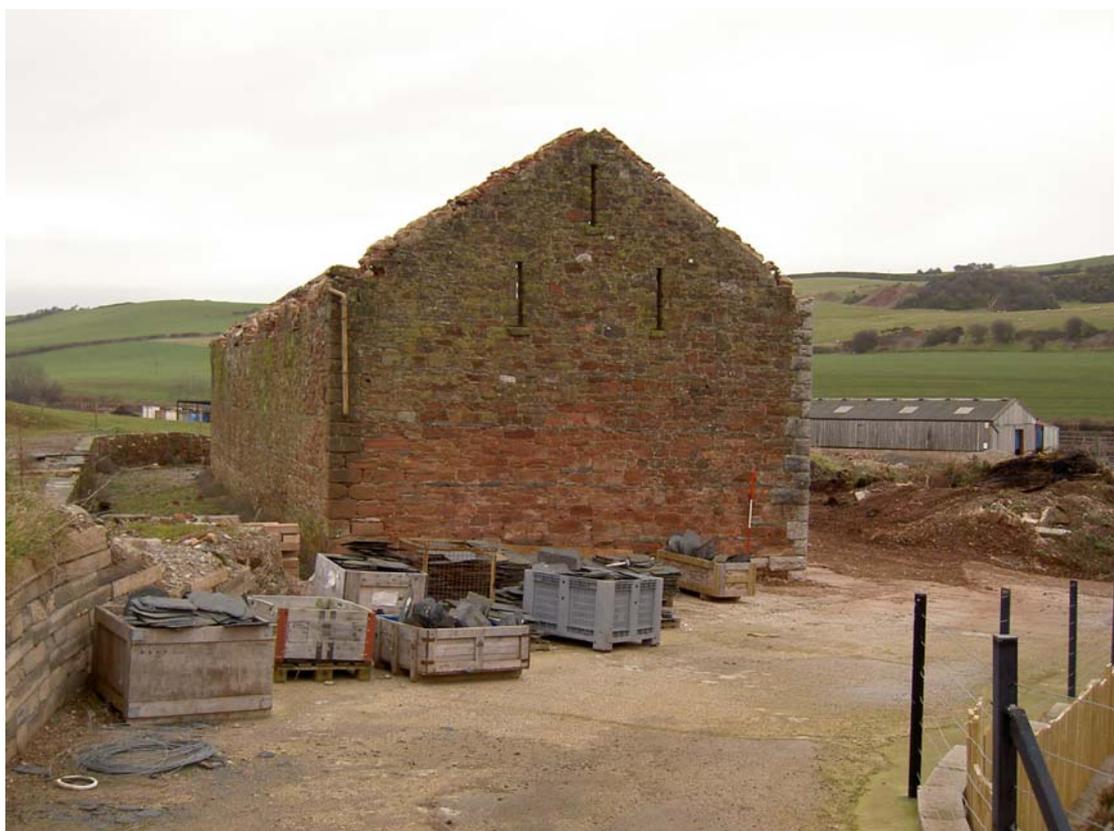
4.3.10 The south gable (Fig 14) has three ventilation slots with projecting sills high in the wall (Plate 15). Towards the west side there is a re-used piece of sculpted masonry (re-used stone 1), presumably part of a decorative arch with a rolled and chamfered moulding (Plate 16). The west elevation is relatively plain, although the courses of black slate are very evident throughout (Fig 15). There is a small rectangular hole, resembling a put-log hole, on the south side and the words 'T Harding' have been pecked into one of the blocks towards the centre of the elevation. This may also be a re-used stone, however, as the inscription is upside down. The north gable is essentially the same as the south, with three narrow ventilation slots. There is an iron downpipe on the west side and another piece of re-used sculpted masonry (re-used stone 2) with a rolled moulding high on the east side. Below the downpipe the corner of the wall has been repointed and some distance to the east of this the words 'Andy Coward 1955' have been scored into a patch of concrete.

Plate 15: South external elevation of Building D

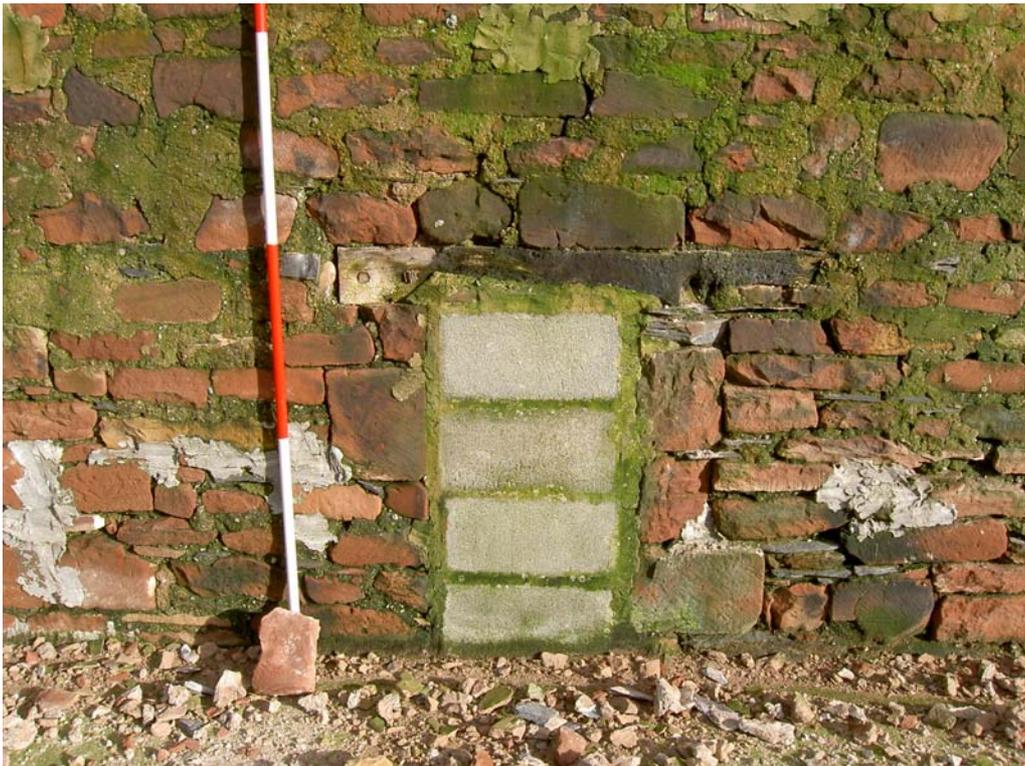
Plate 18: Re-used timber used as lintel to a ventilation slot in the north-east internal elevation of the first floor of Building A. Two masons' marks are present to the left (see plates 19 and 20)

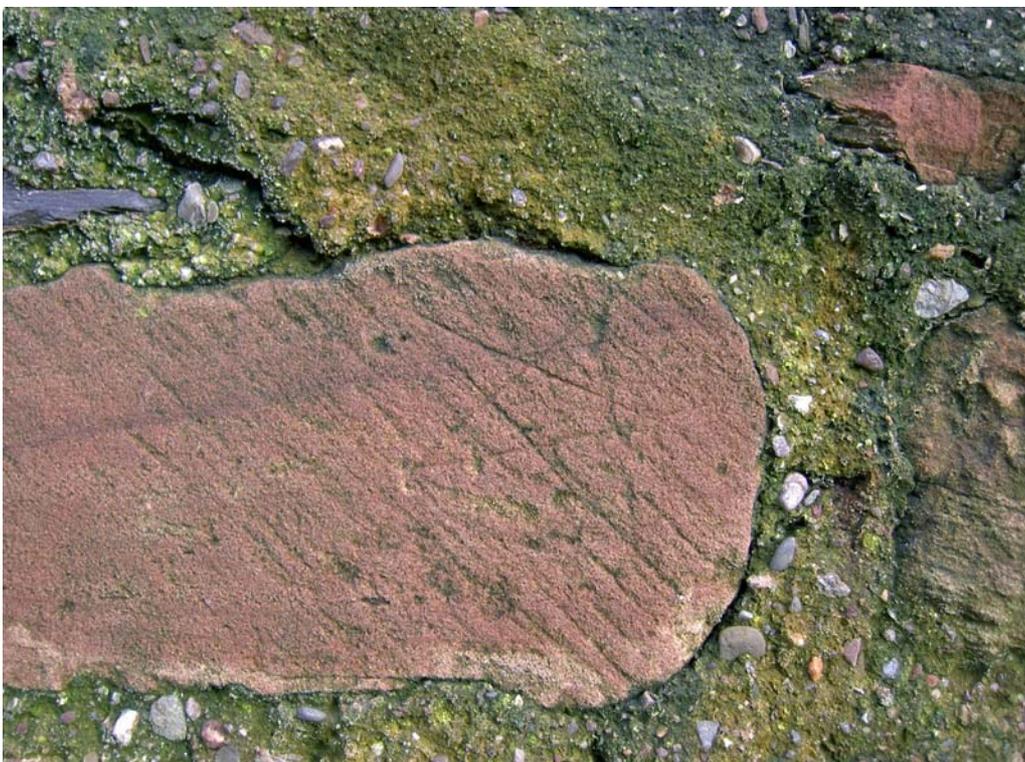
Plate 19: Mason's mark 2 in the north-east internal elevation of the first floor of Building A

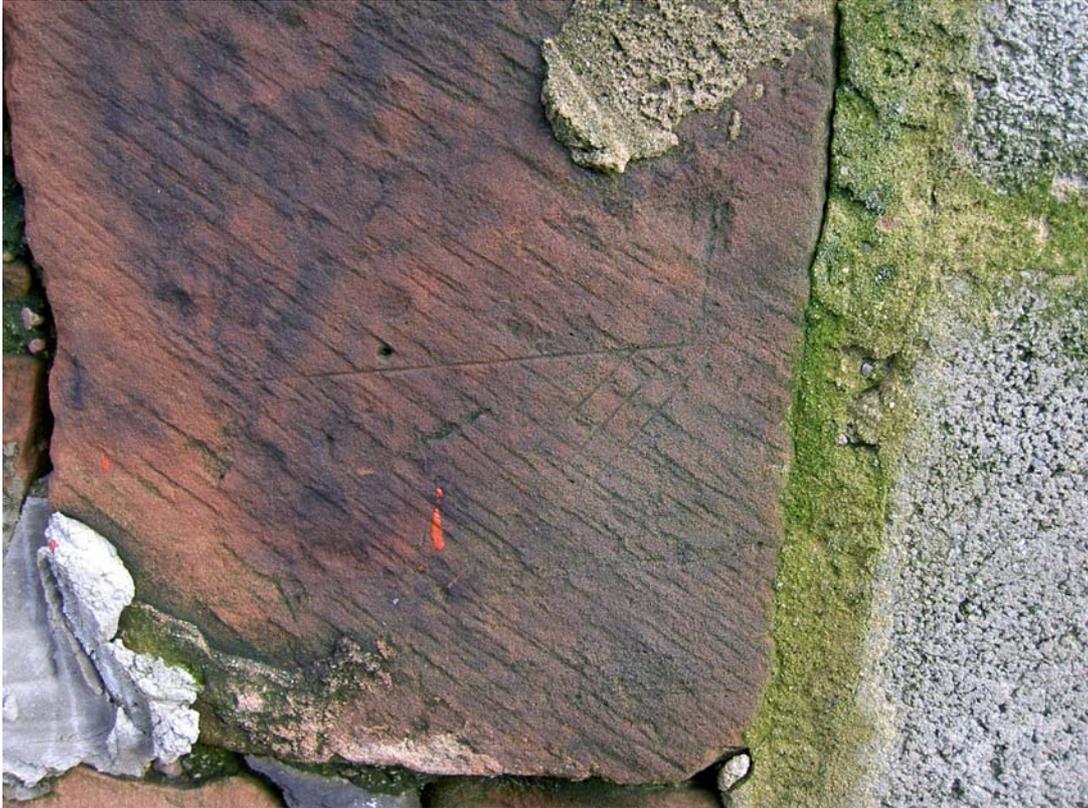
Plate 20: Mason's mark 1 in the north-east internal elevation of the first floor of Building A

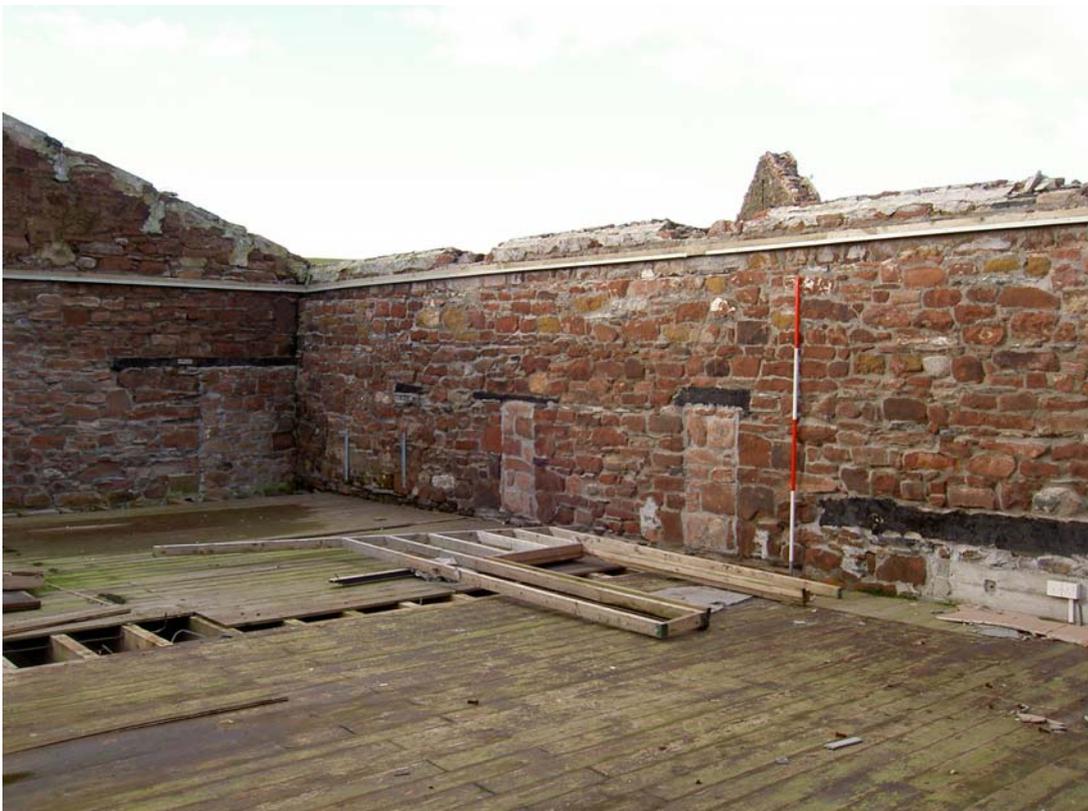
4.4.4 The first floor of the north-east end comprises a single room (F1) that contains many of the features visible on the first floor of Building A, with blocked ventilation slots with re-used and scorched timber lintels and a large inserted window in the north-west facing gable (Plate 21).

Plate 21: First floor of the north-east end of Building B

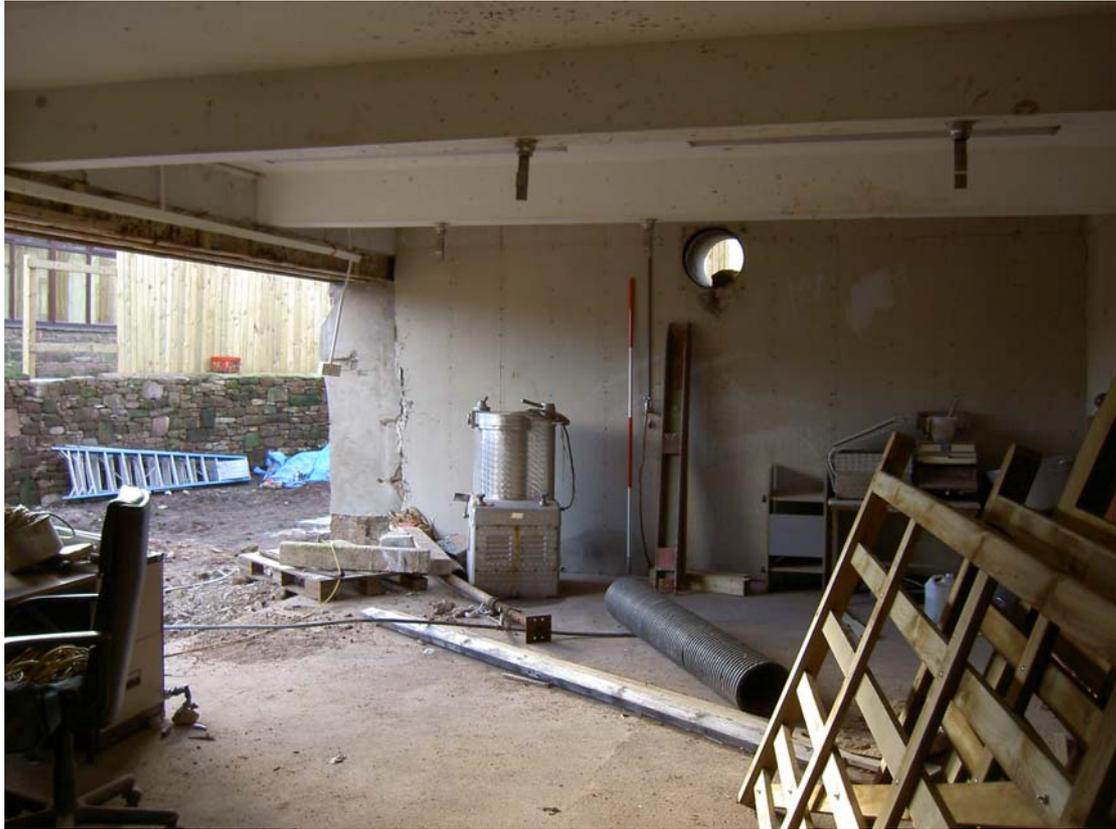
4.4.5 The ground floor of the south-west end is divided into two rooms (G4 and G5) by modern partition walls (Fig 8). Room G4 is plain and entirely finished with plaster and has a tiled floor and two large boxed beams orientated north-west/south-east. There is an arched doorway in the south-east elevation and attached electrical fittings throughout. Room G5 is large, with a tiled floor and modern plastered ceiling supported by three large boxed beams. The walls are finished by plaster board in places and there are electrical fittings throughout. A large aperture with an iron I-beam lintel has been knocked through the south-west end of the south-east elevation, originally providing access to Building C (now demolished) (Plate 22).

Plate 22: Room G5, south-west end of Building B

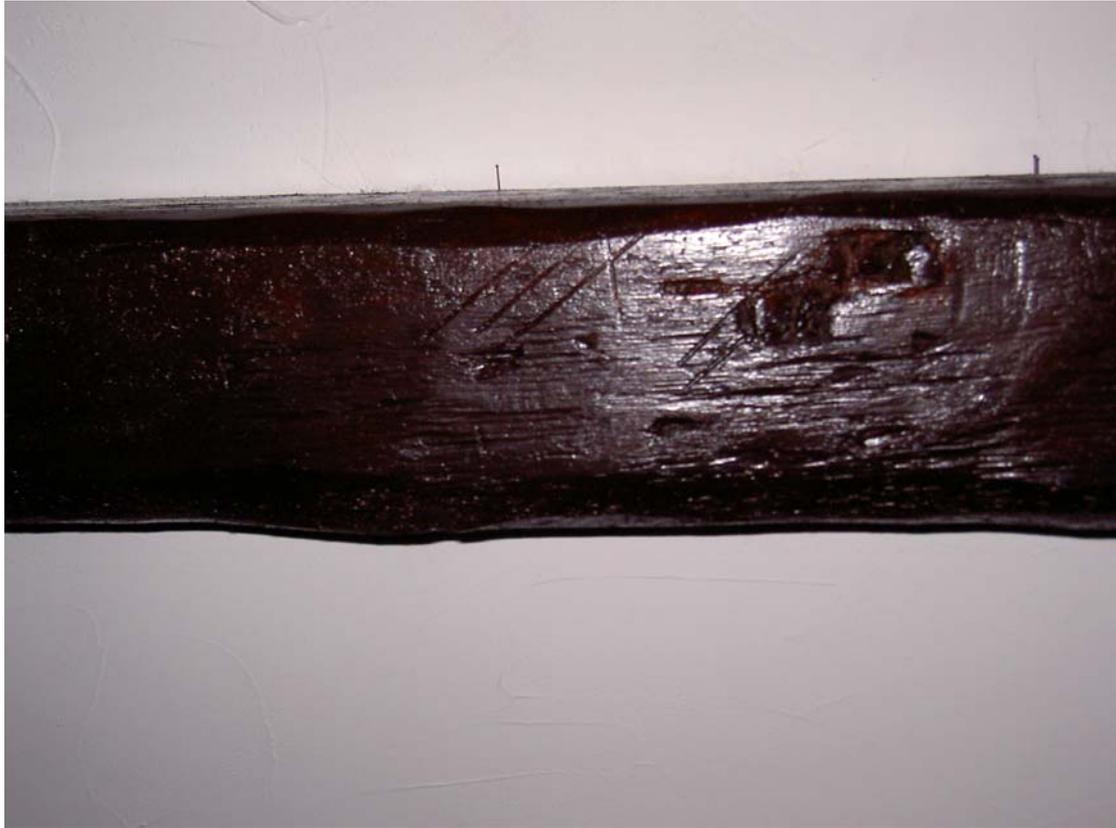
Plate 24: Baltic timber mark in Room F2, south-west end of Building B

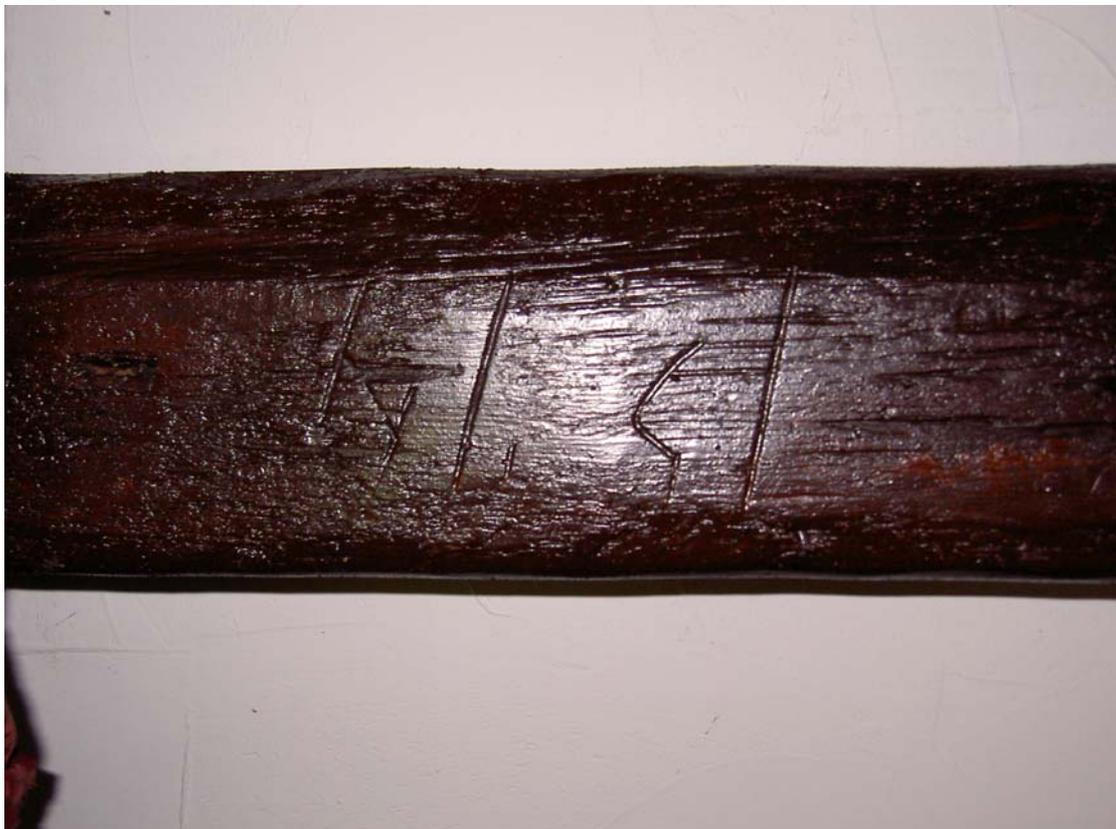
Plate 25: Baltic timber mark in Room F2, south-west end of Building B

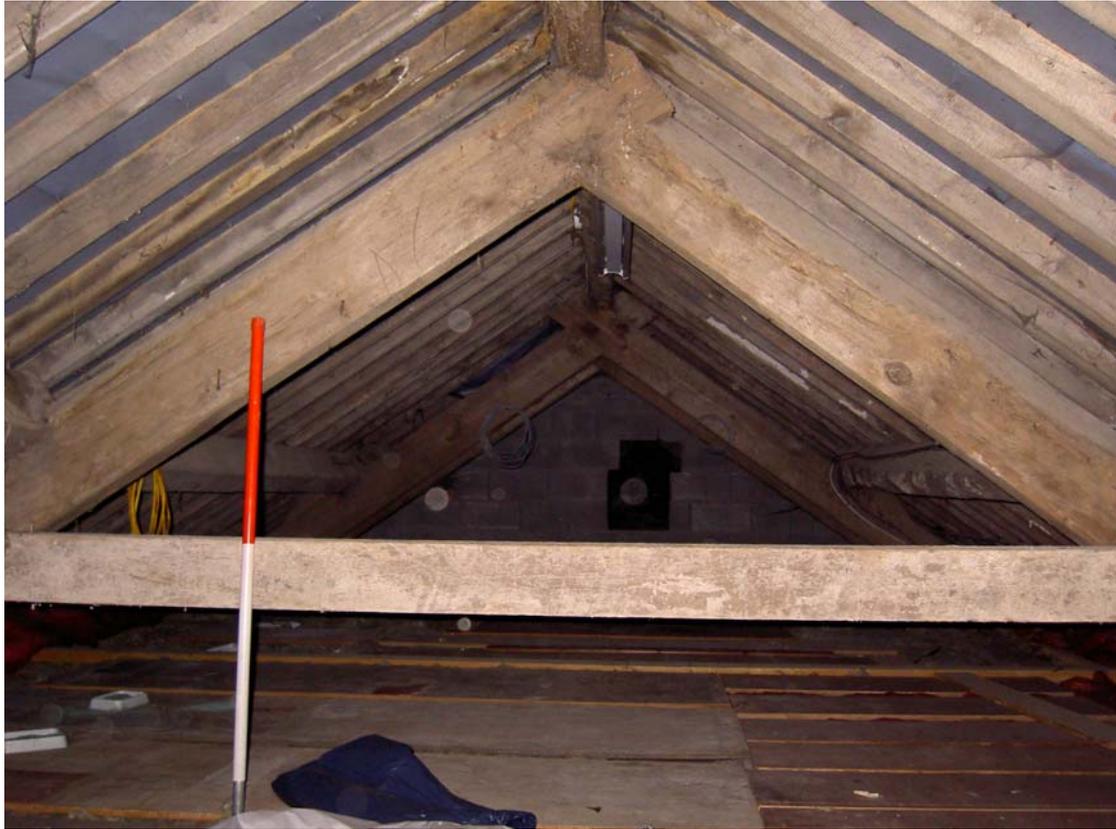
Plate 28: Truss 'III' showing the Baltic timber mark in the roofspace above the south-west end of Building B

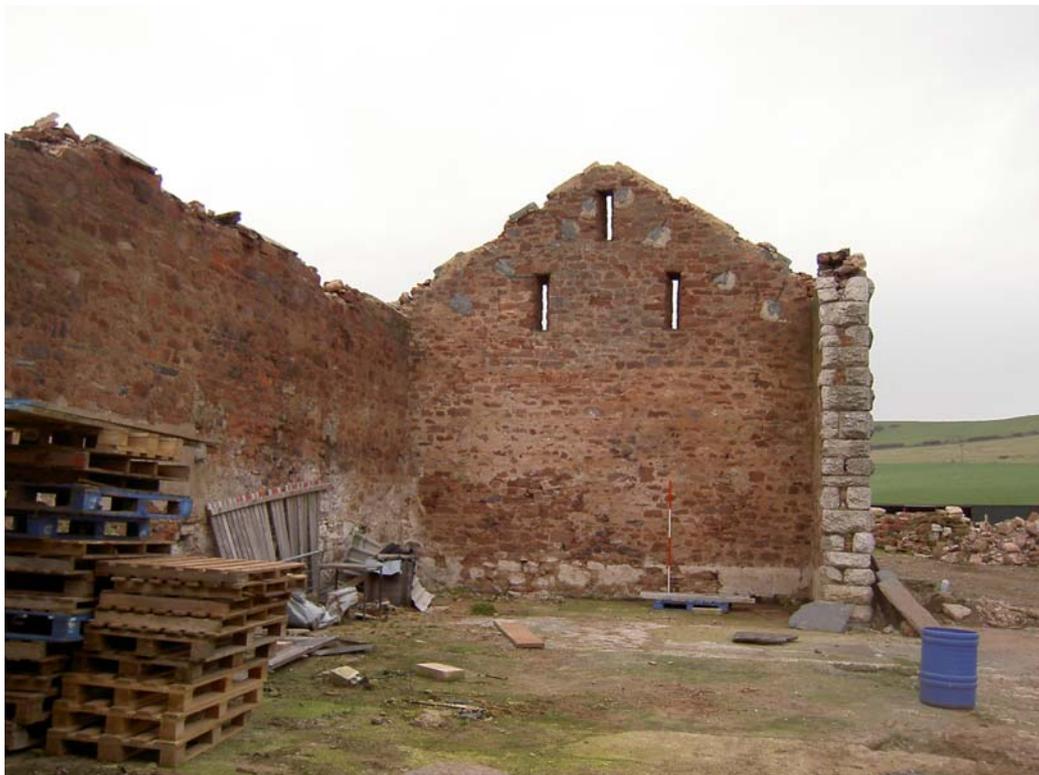
4.4.3 **Building D:** this comprises a single room with a concrete floor (Plate 29; Fig 17). The north elevation has three ventilation slots beneath the gable and traces of whitewash. There are iron ties along the roof line, which evidently held the roof in place, with patches of concrete around where these have been inserted. The west elevation is relatively plain, although it is finished with patchy render and some concrete. Various pipes have been inserted through the walls and there is a piece of re-used sculpted stone north of the centre, with a beaded moulding (re-used stone 3). The south elevation is essentially the same as the north. The concrete patching around the roof ties is scored with the words 'D. Wright 1957', '1957 Dec 13' and 'E. Tyson E. Fisher' in three separate areas. The east elevation is unremarkable apart from the large opening, although there is another piece of re-used sculpted stone with a beaded moulding on the north side (re-used stone 4).

Plate 29: Interior of Building D, looking north
