BLACK BECK HALL, AYSIDE, CUMBRIA

Archaeological Building Recording

Client: Laing O'Rourke Infrastructure
NGR: SD 3956 8362

© Greenlane Archaeology Ltd
October 2006

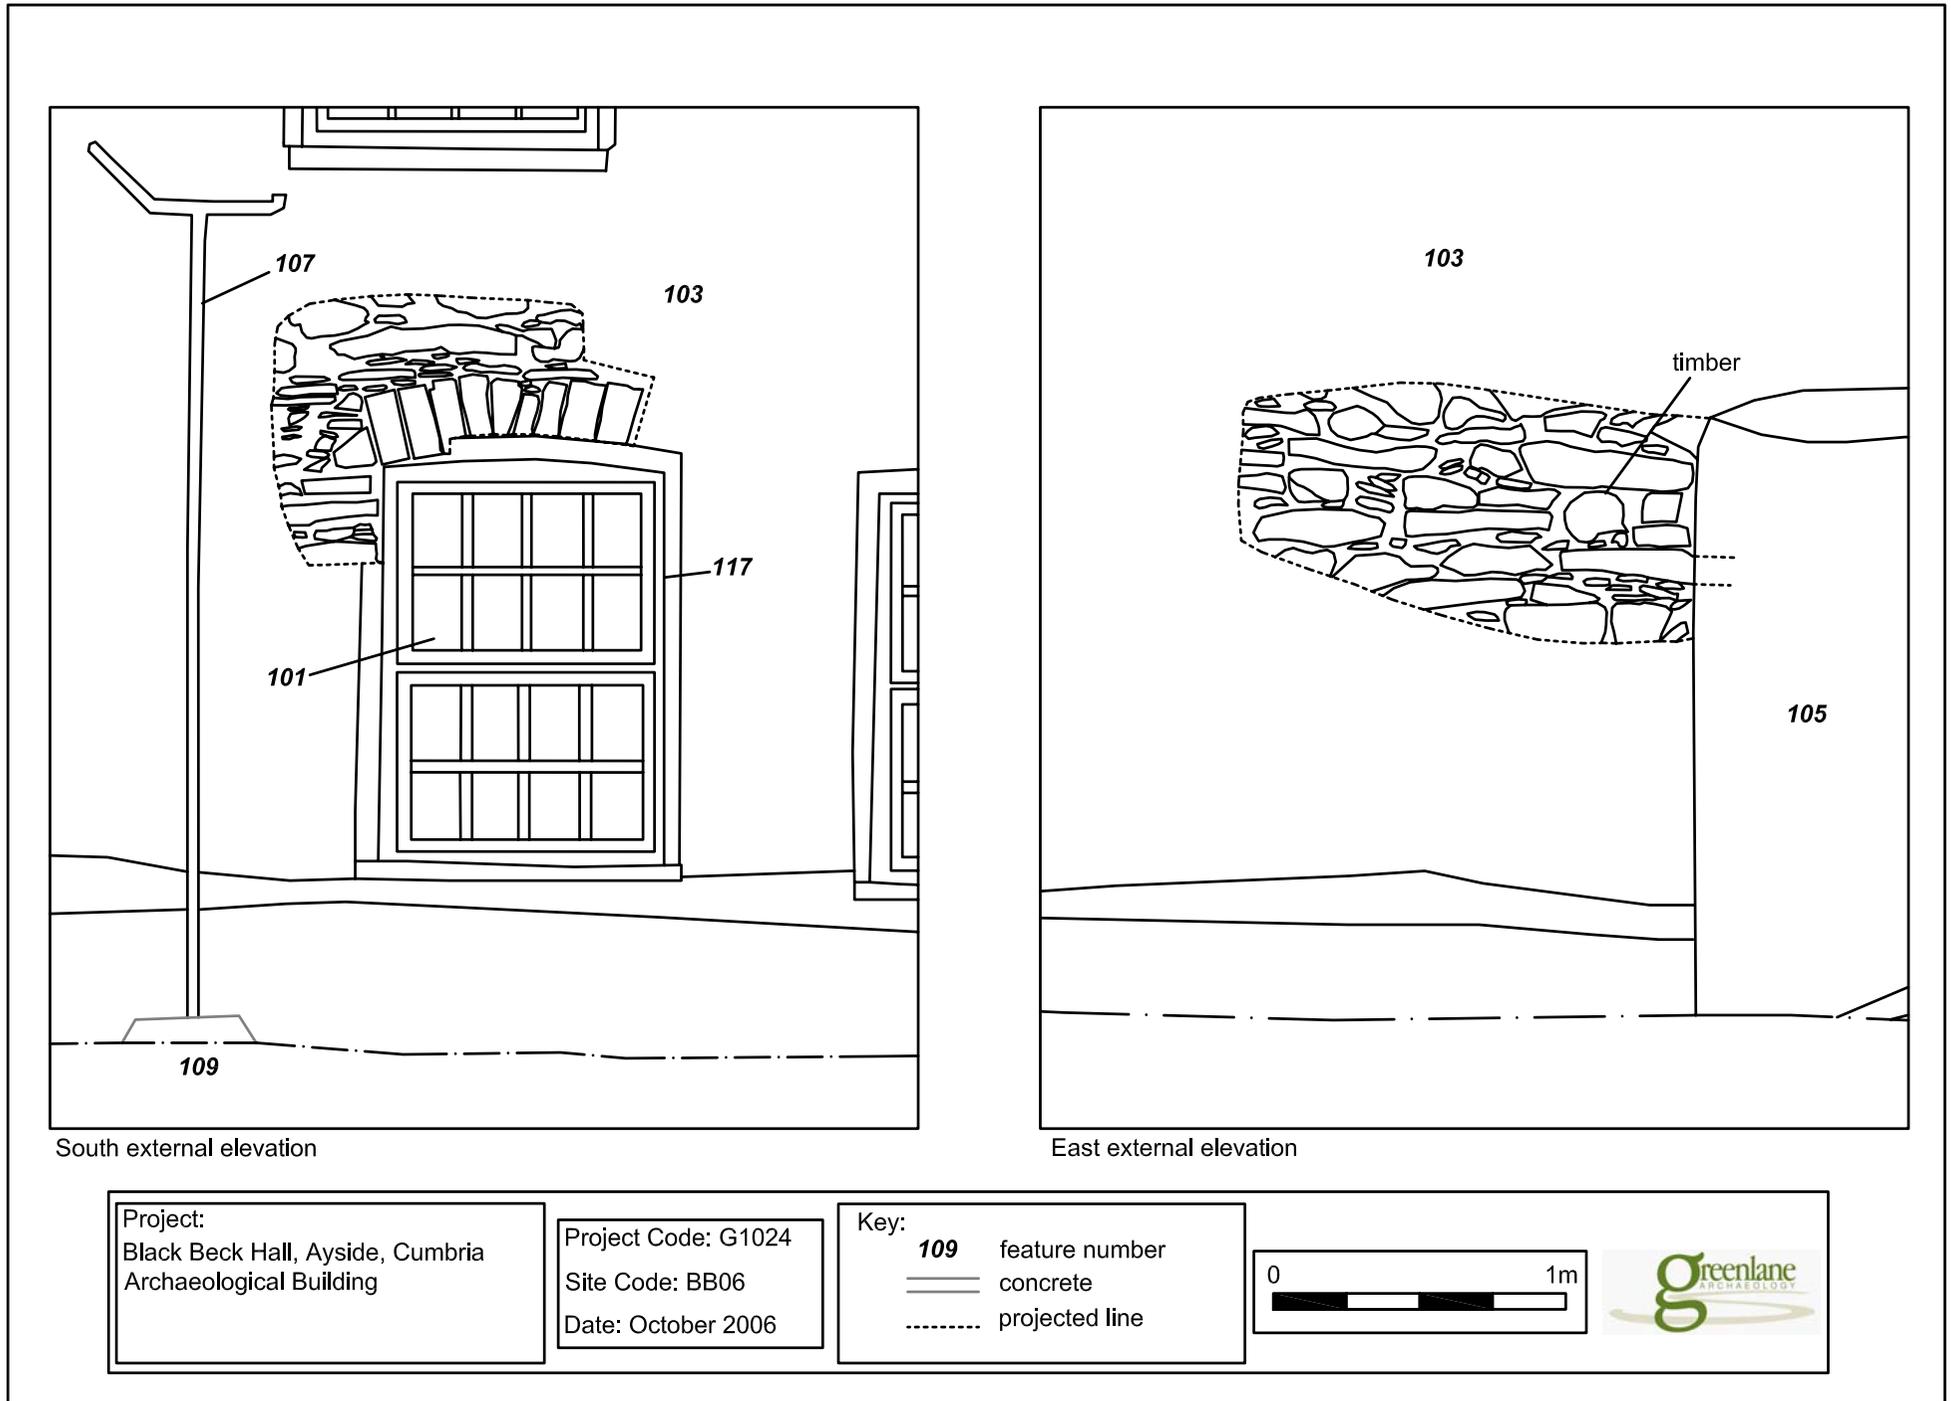
Figure 19: Features exposed during the watching brief after the removal of render

6.2.6 *Watching brief:* the removal of the slate slab on top of the possible mounting block (**110**) revealed that it comprises a hollow structure held by concrete mortar filled with loose rubble. The removal of a patch of render from around the ground floor windows revealed that the apertures were their original size, and that the wall is constructed from roughly coursed slate. The westernmost window was revealed to have a large single block, possibly of limestone, forming the lintel.

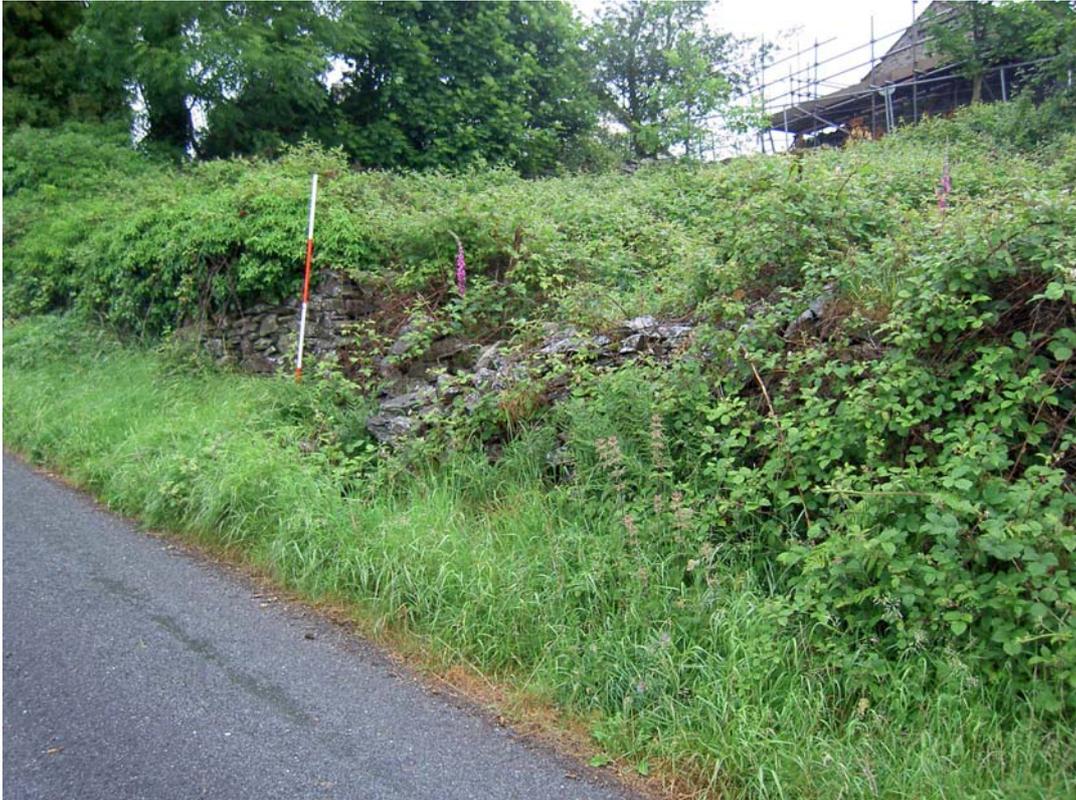
Plate 25: The continuation of the boundary wall to the north-east, looking south-west (film refs. 1_69/23+24_3-4)

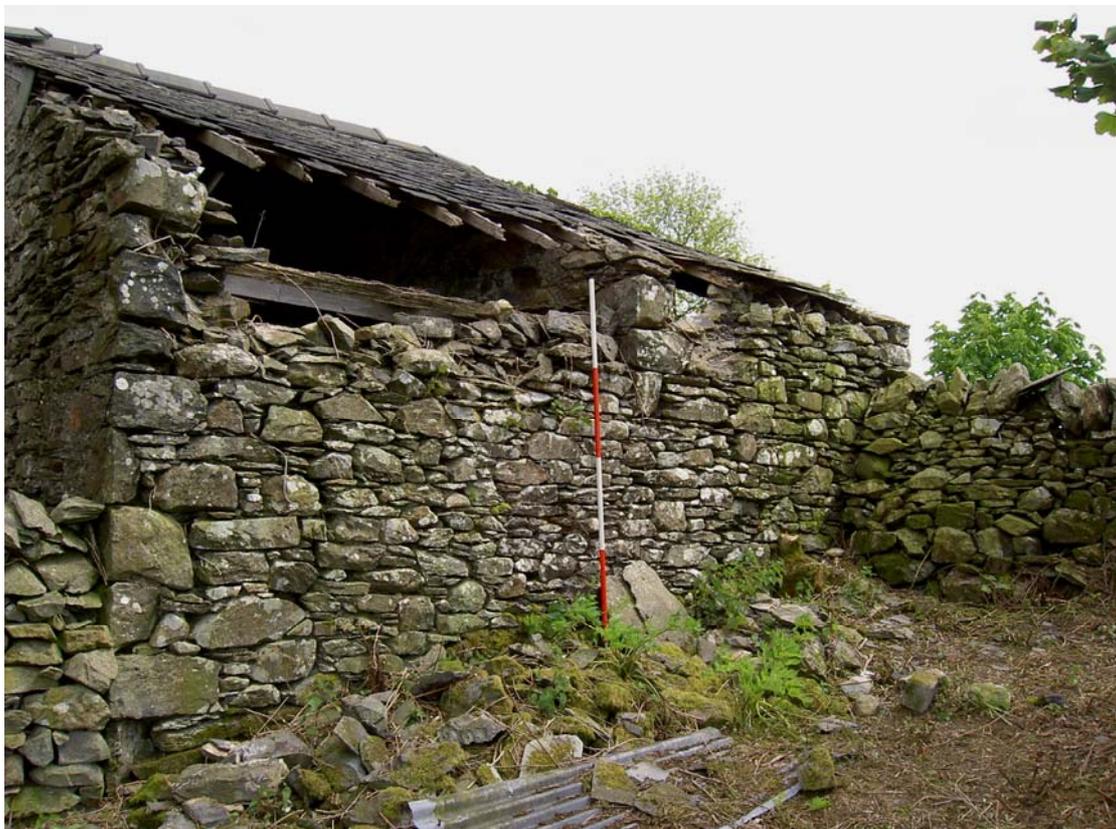
5.2.2 The west elevation is in a relatively poor condition, with large areas of collapse (Plate 34). There are quoins at the corners, which are also butted by adjoining boundary and field walls, and further quoins in the centre, denoting the position of the internal dividing wall.

Plate 34: West external elevation of the pigsty, facing south-east (film refs. 1_19/2+3_25-26)

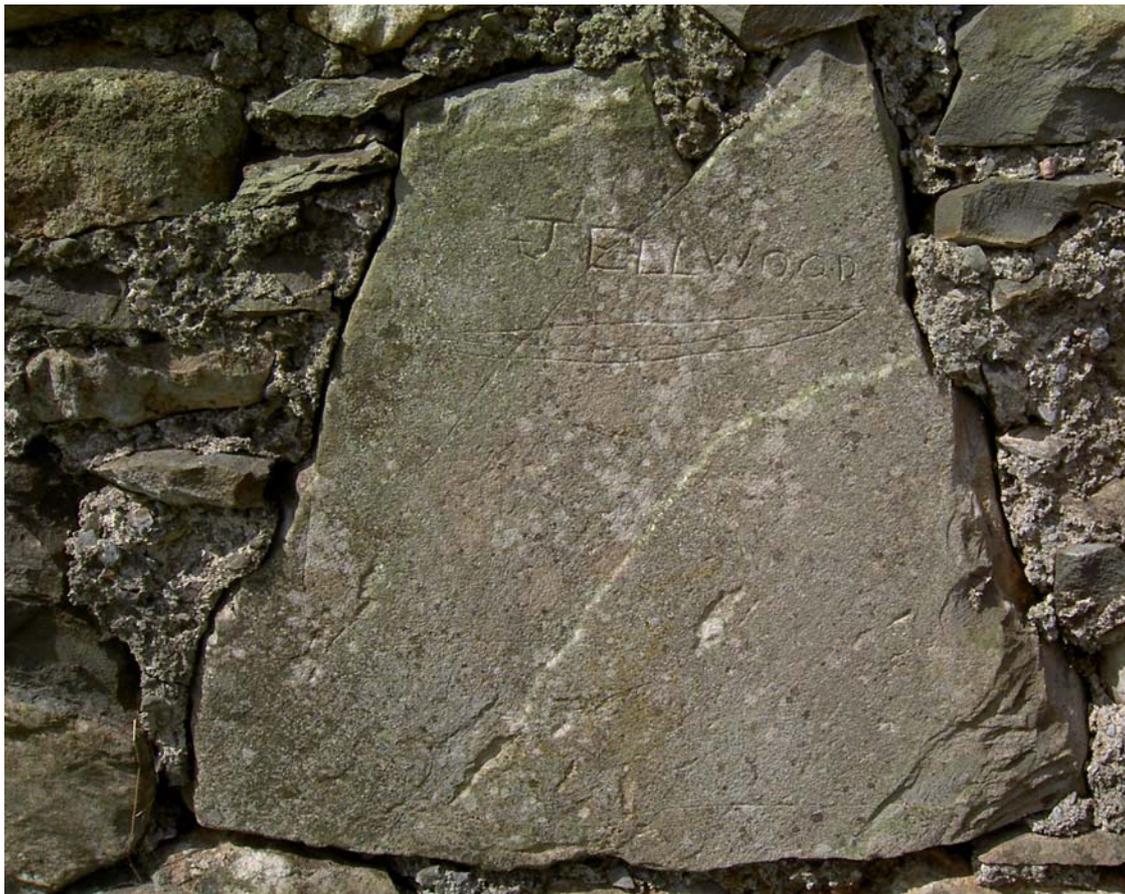
5.2.3 The south elevation is also in a poor condition, with large amounts of collapse, particularly around the west side of a large central aperture (Plate 35). The remains of a render finish are present on the east side, showing the position of the frame, and the purlins, comprising round wood logs, project through the wall. The name 'J ELLWOOD' has been scratched into a large block of stone on the west side (Plate 36).

Plate 36: Detailed view of large stone in previous plate, showing 'J Ellwood' graffiti, facing north (film refs. 1_22/2+3_30-31)

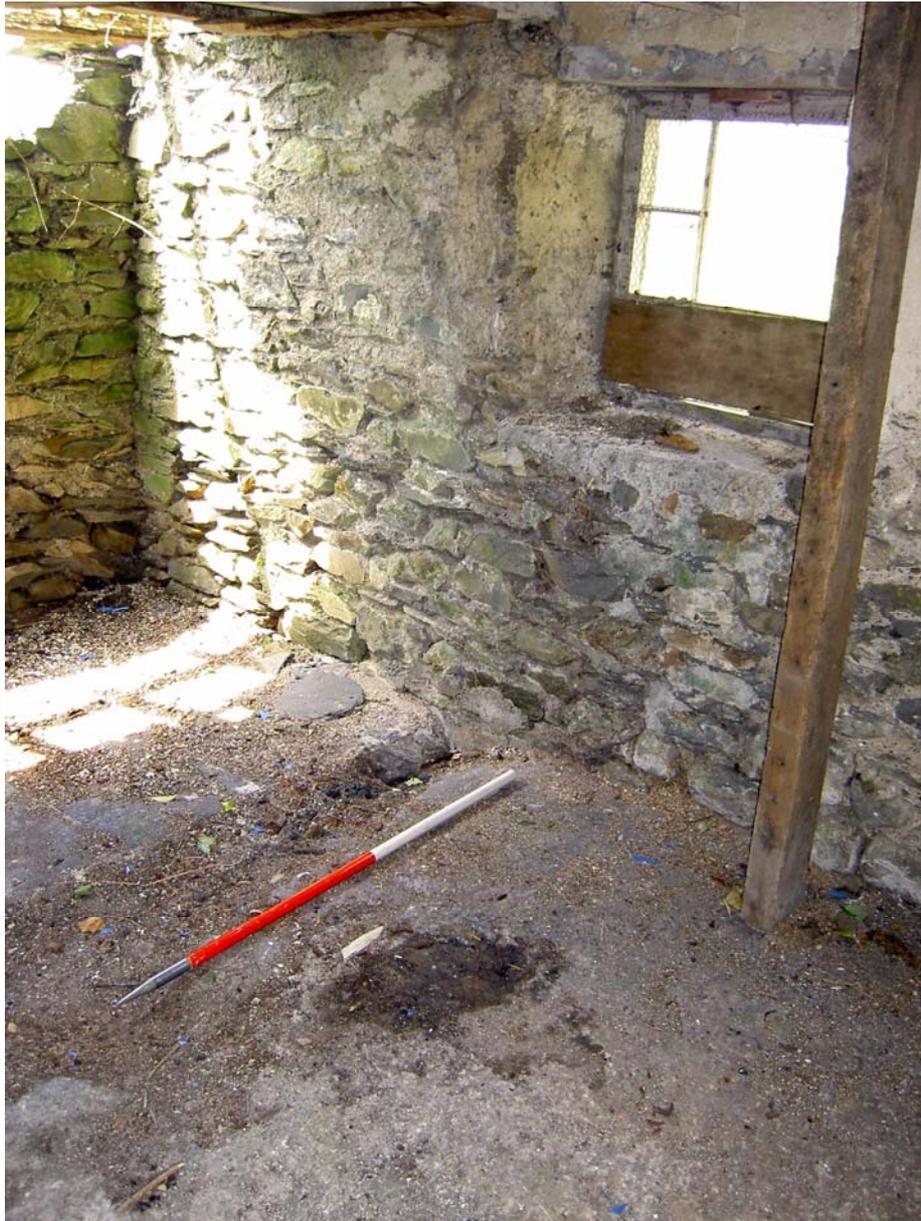
Plate 41: Interior of the northern ground floor room of the pigsty showing the concrete drainage channel in the floor, facing north-west (film refs. 1_14/2+3_15-16)

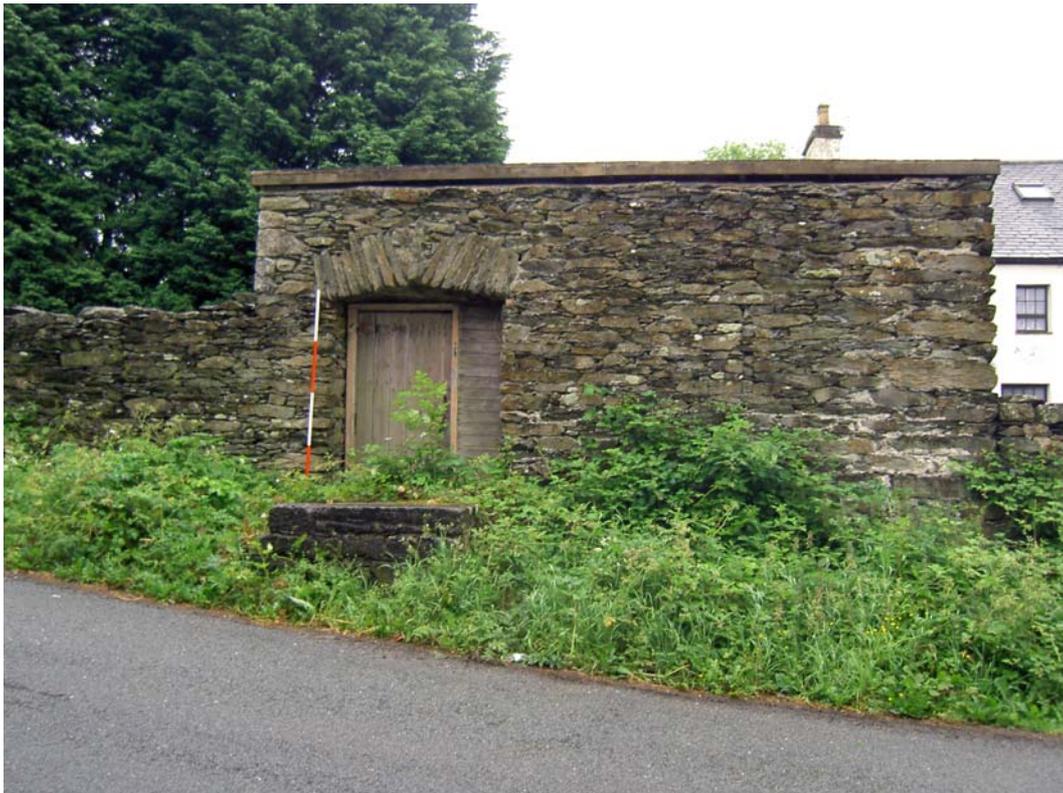
Plate 42: North external elevation of the barn, showing the wagon doorway, facing south (film refs. 1_55/6_8-9/7_9-10)

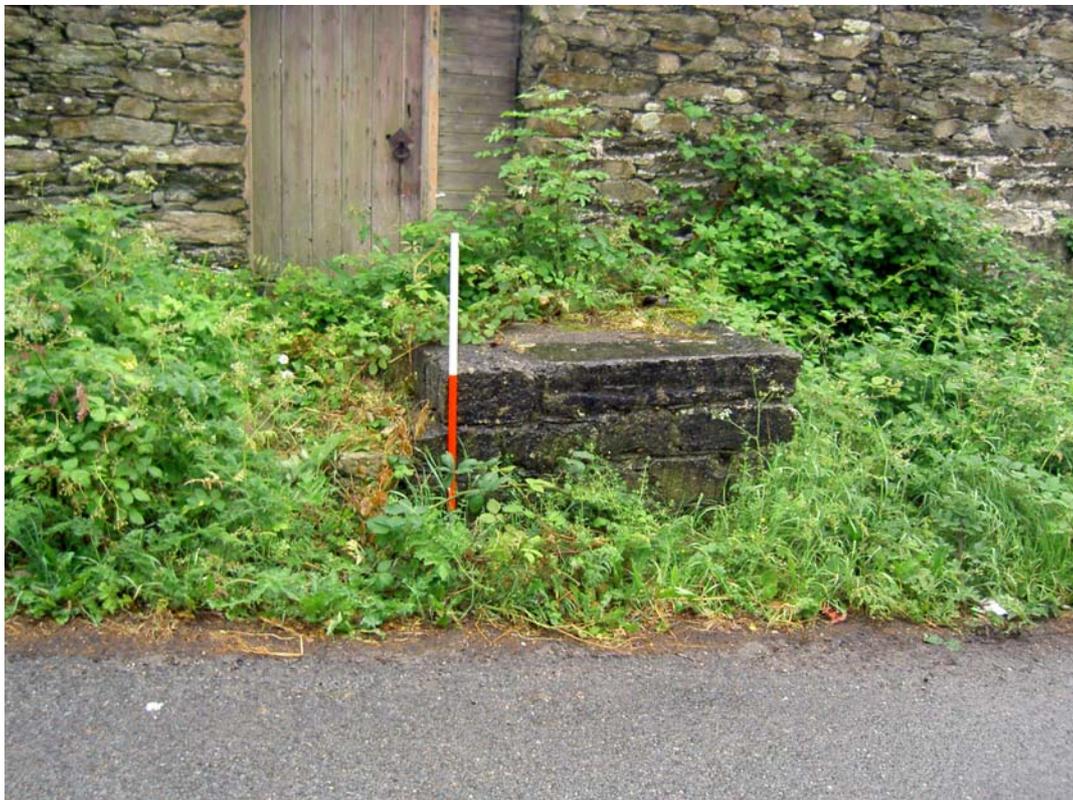
Plate 43: Detail of the mounting block adjacent to the north external elevation of the barn, looking south (film refs. 1_56/6+7_13-14)

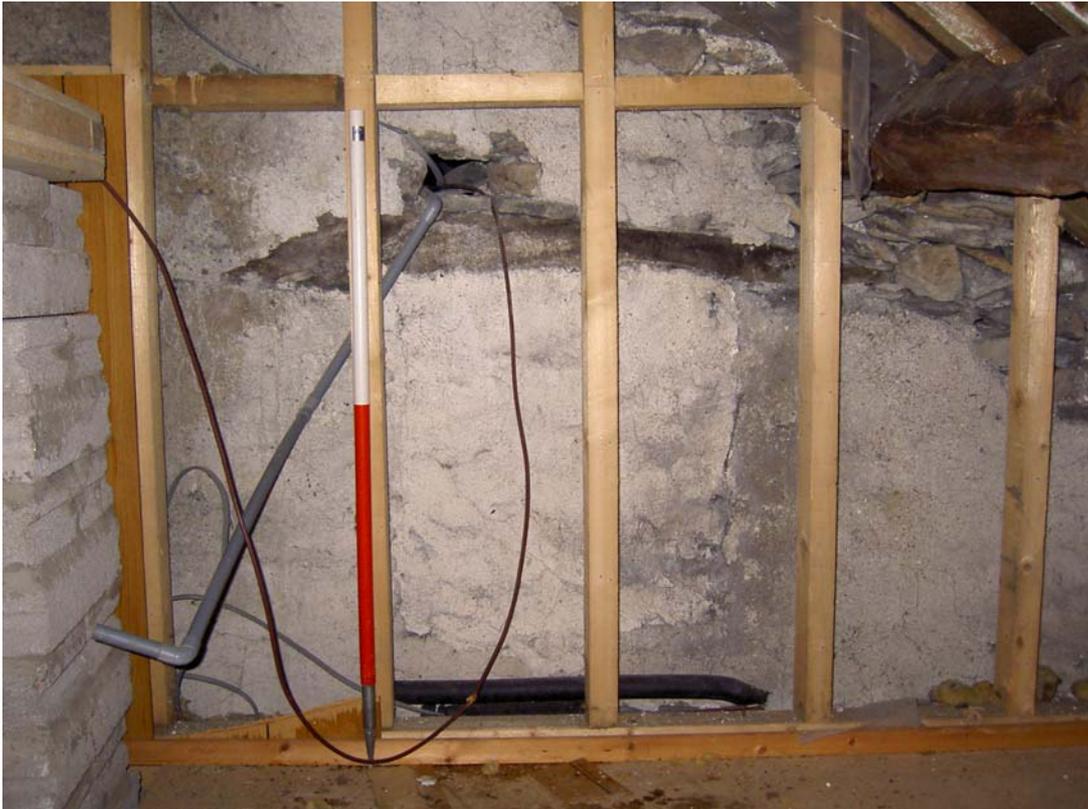
Plate 105: Detail of northern blocked window in west elevation of S3, facing west (film refs. **20_30/21_21/22_21-22**)

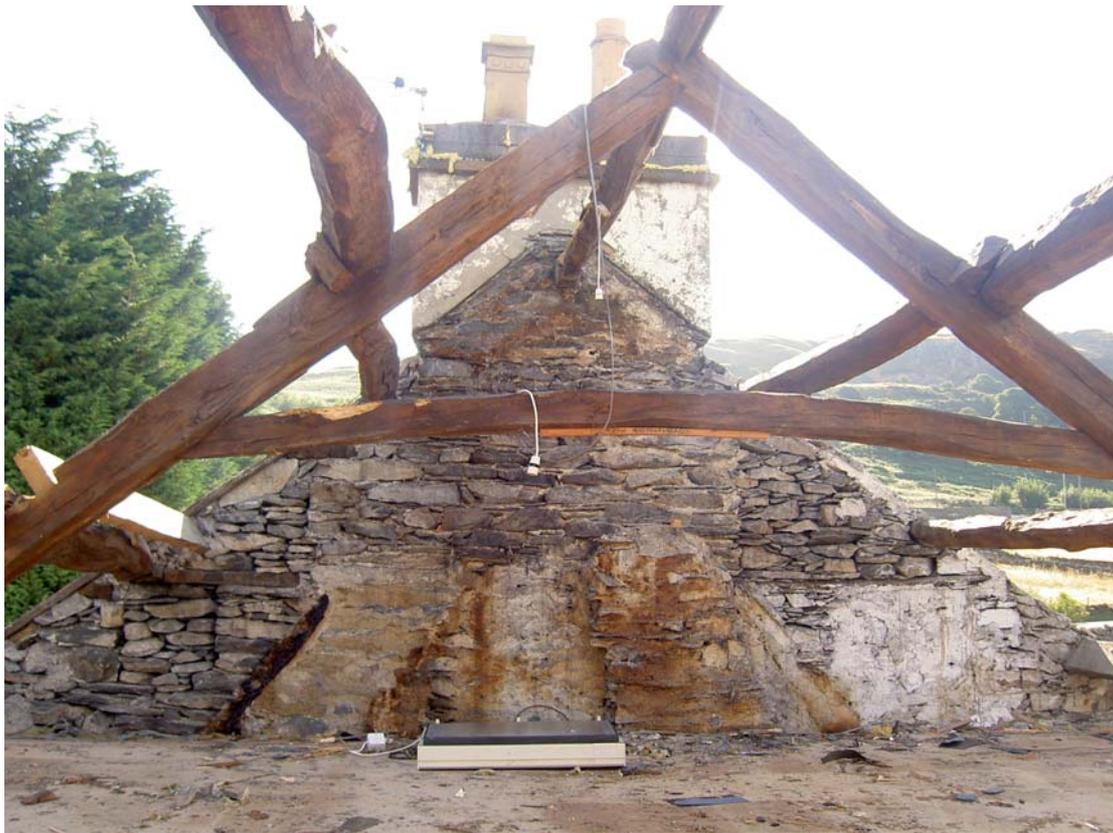
Plate 107: Roof structure and smoke hood exposed during demolition, facing east
(film refs. **20_32-32a/21+22_23-24**)

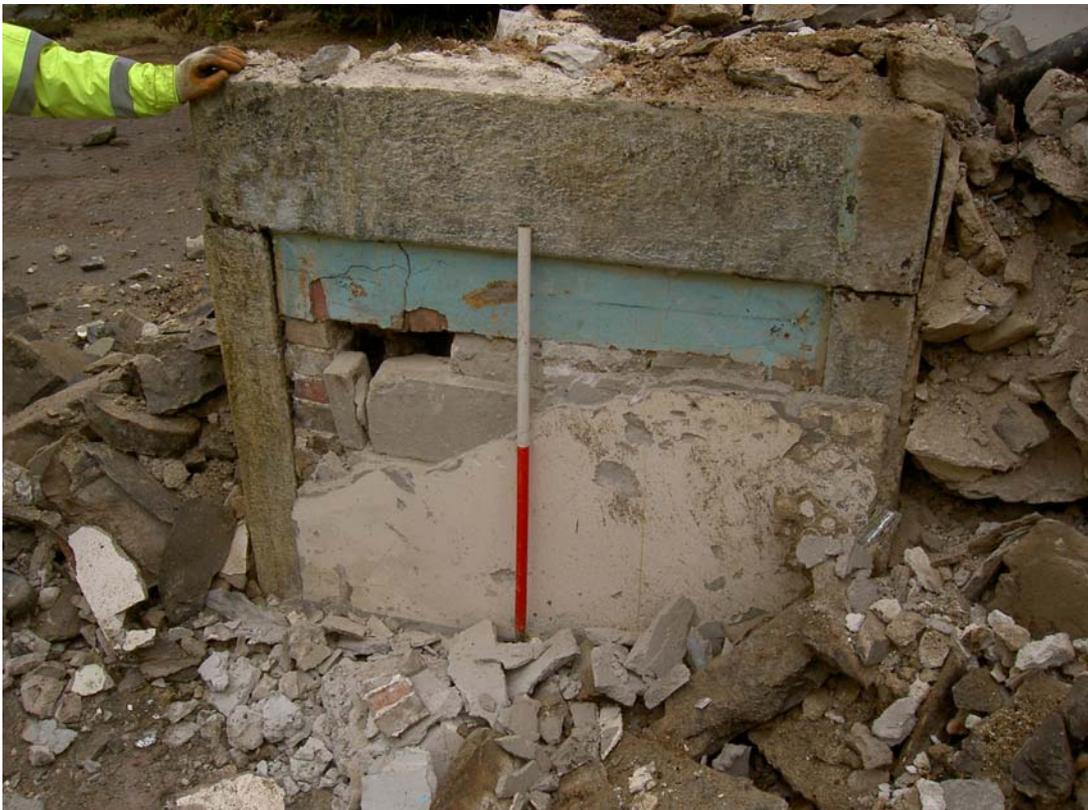
Plate 110: Fireplace **149** during demolition and following removal of plaster, facing north-east (film refs. **20_63/29+30_15-16**)

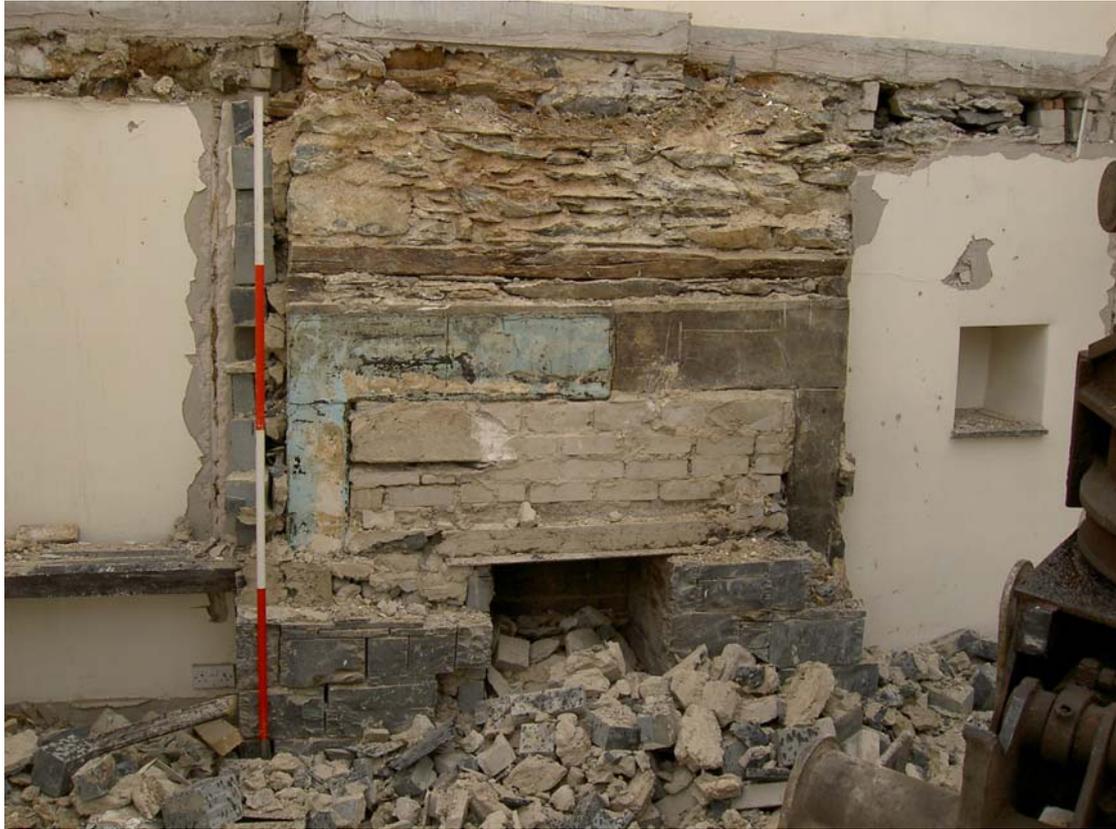
Plate 111: Fireplace **137** during demolition and following the removal of modern cladding, facing south-east (film refs. **20_56-57/29+30_1-4**)
