1 INTRODUCTION

- 1.1 The North Pennines Heritage Trust was invited to submit a tender for a building survey to be undertaken at Bantling limekilns in Derwentside County Durham. The Trust was awarded the survey project in November 2001.
- 1.2 The archaeological brief was prepared by Nail Hammond of Durham County Council. The brief required a level 2 building survey and a basic survey of the surrounding earthworks.

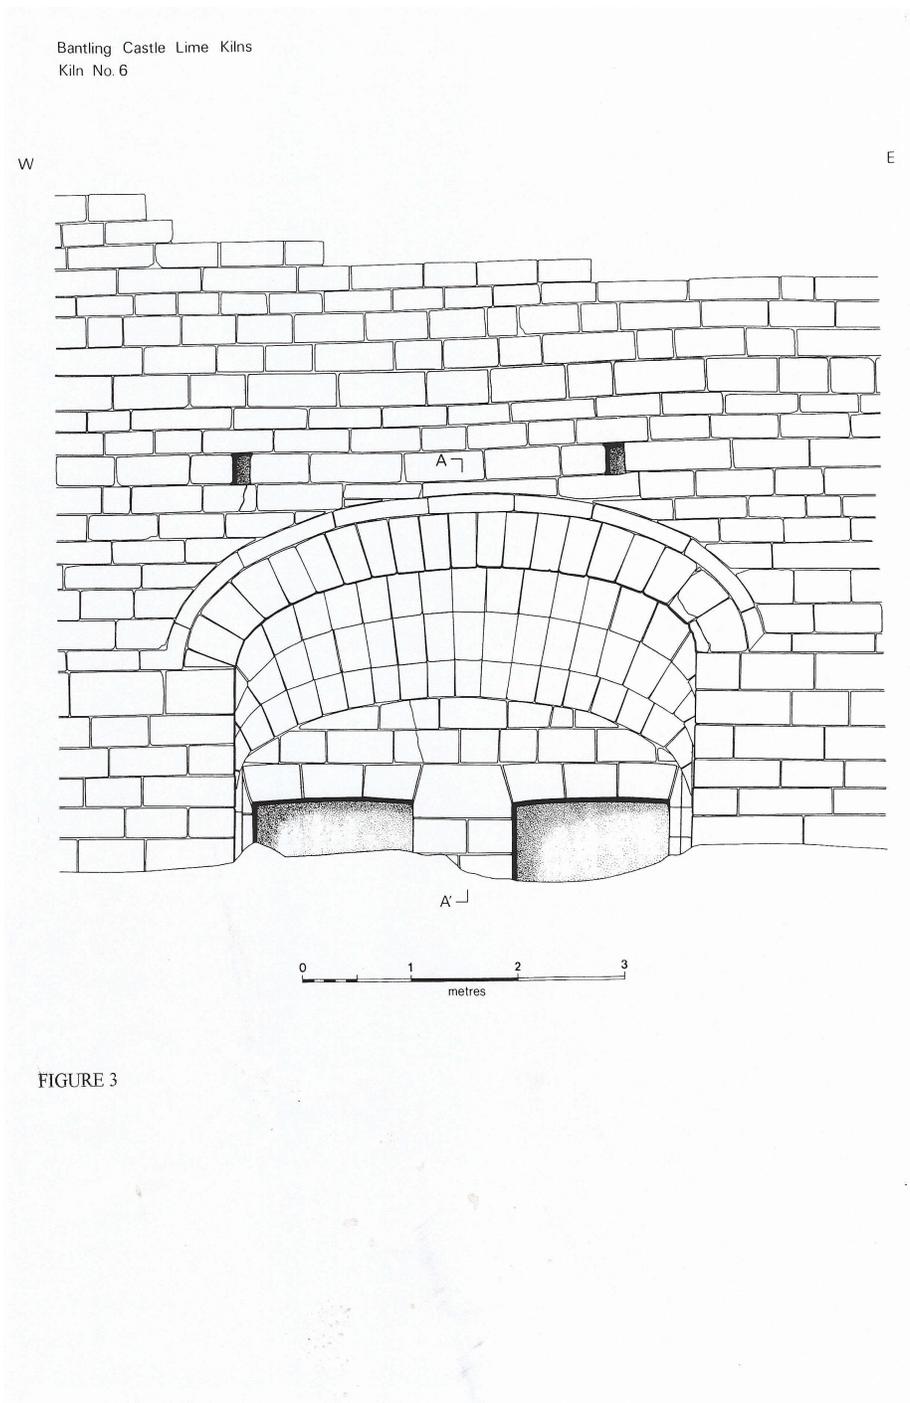
FIGURE 3
DETAIL OF ARCH 6

The arch is in good condition with only a very slight sag. No action is necessary. For detailed elevation and section drawing see figures 2 and 3.

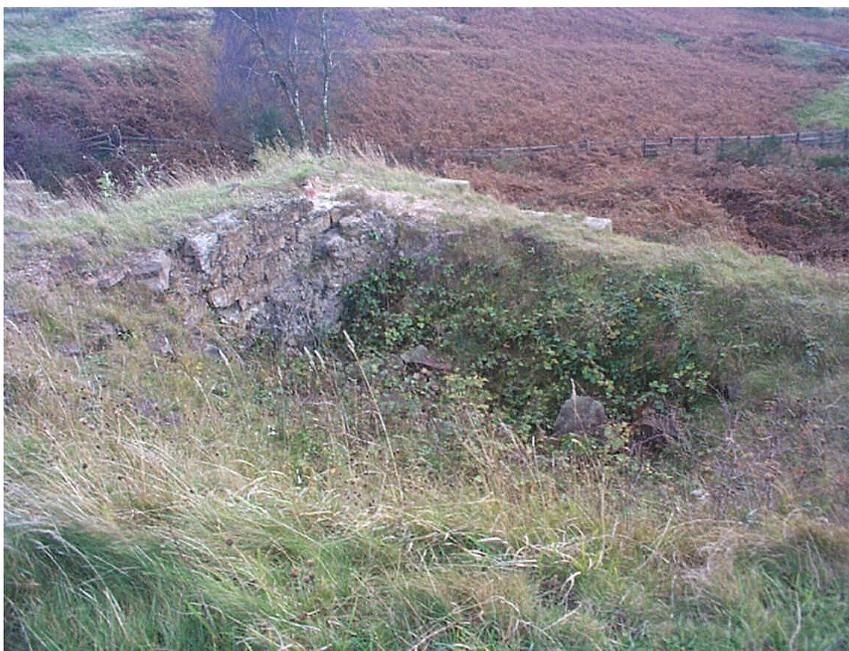
FIGURE 7 REMAINS OF KILNPOT ABOVE ARCH 6

- 8.1 All six pots are in a very poor state of repair with little or no stonework visible and very overgrown with vegetation. The rubble inside the pots offers its own protection against further collapse. The NPHT recommend a minimal amount of work in this area limited to the removal of vegetation and tree roots.
- 8.2 If the structure is to be accessible to the general public, a fence should be erected at the top of the structure consisting of treated wooden posts and rails.
