# Glastonbury Abbey South Nave Aisle

## Archaeological Survey of the standing fabric - 2004

Jerry Sampson

13 December 2004

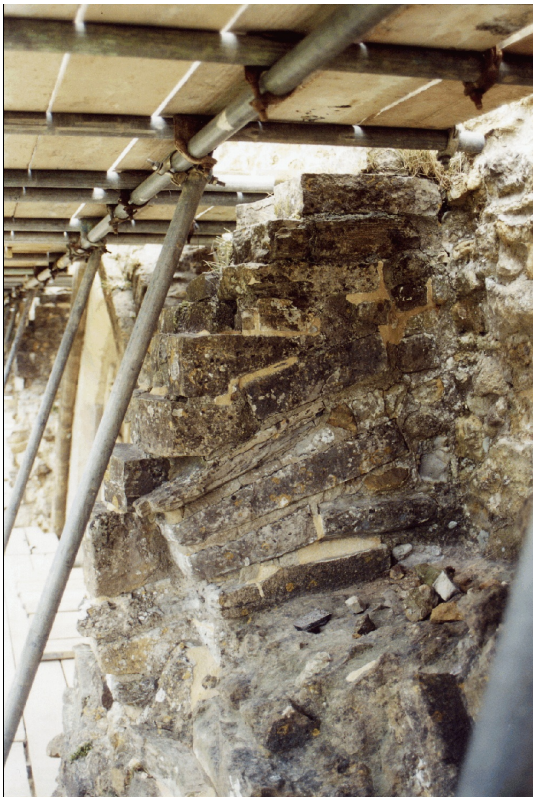
Left: the base of the internal flying buttress originally situated beneath the nave aisle roof, looking east. The lias voussoirs forming the base of the arch at the bottom, with the nineteenth century repairs set above not following the curve of the arch.

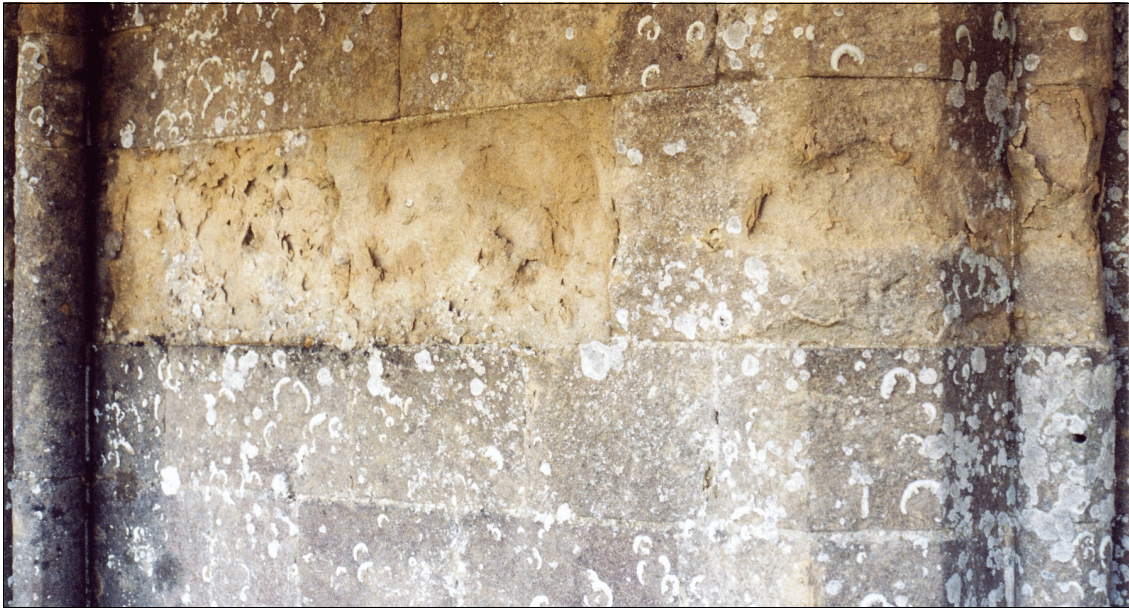
Above: decay along the interface between the Phase 1 and Phase 2 fabric - possibly the result of the extreme carbonation of the lime mortar core of the head of the Phase 1 wall

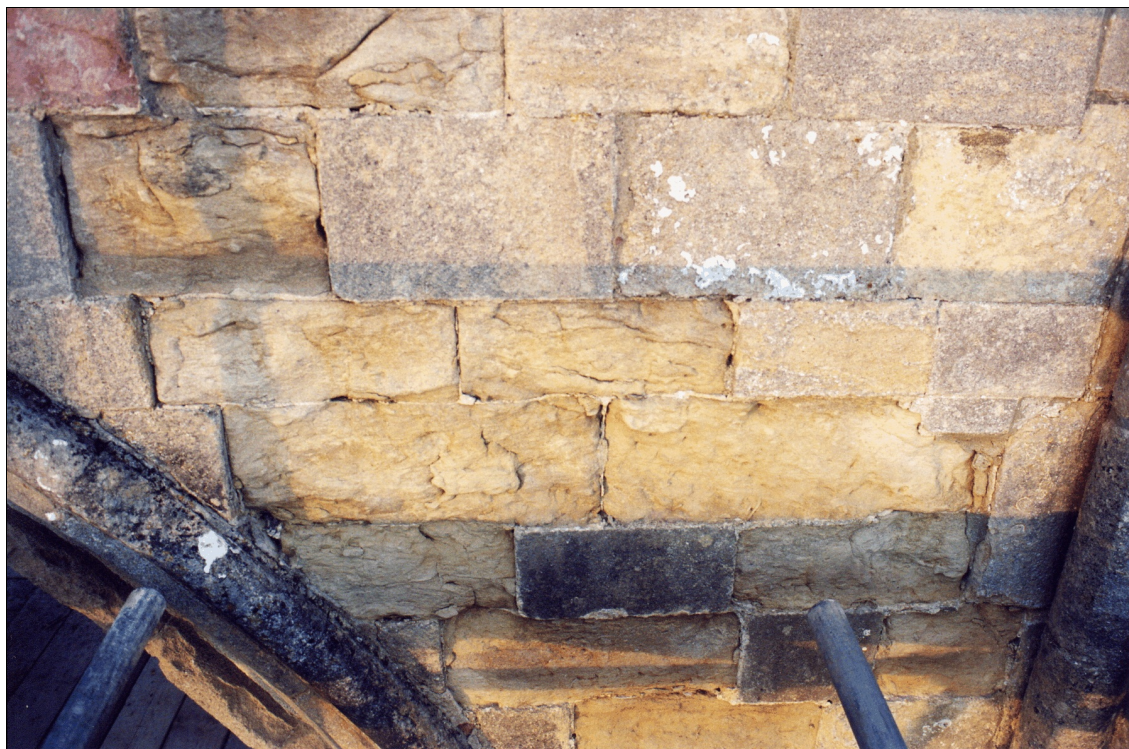
Above: Upper lias ashlars in the eastern spandrel of Bay 6. Much of the Douling stone at the top of the wall is repair dating from 1912. Note the burnt block at upper left.

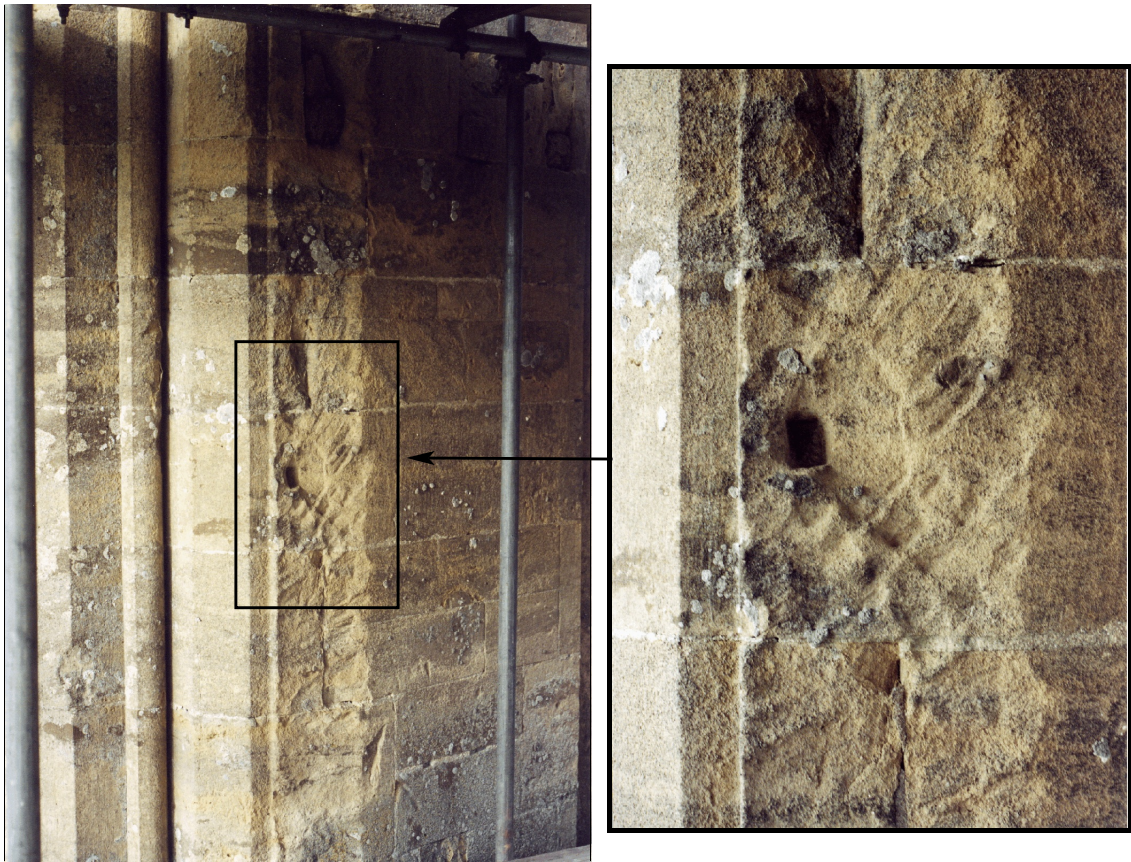
- 2.7.6 The extensive damage to the outer frame of the remaining window jambs - clearly caused by the deliberate cutting away of the southern 20 cm or so of the jambs to a maximum depth of about 5 cm - suggests the possibility that the glass may have lain on the inside of the ferramenta at the time of the Dissolution. Such brutal treatment of the stonework could represent an aspect of the despoiling of the abbey following its surrender to the King's commissioners, in the rapid and careless cutting out of the glazing, probably to retrieve its lead rather than for the reuse of the glass. If, however, the glass were in external frames it would have been much more accessible from the exterior and could probably have been removed from the cloister roof without needing to attack the stone. Therefore, in this scenario, it seems likely that the glazing had been renewed in the later middle ages and had been set into the jambs in a fairly deep groove, which seems to have been entirely cut away in the process of extracting it.

The chamfered face of the C12/13 window jamb cut away to accommodate the inserted tracery of the C14/15 windows, the inset showing both the roughly tooled surface and one of the sockets for the saddle-bars. Below: vertical tooling on the upper part of the wall.

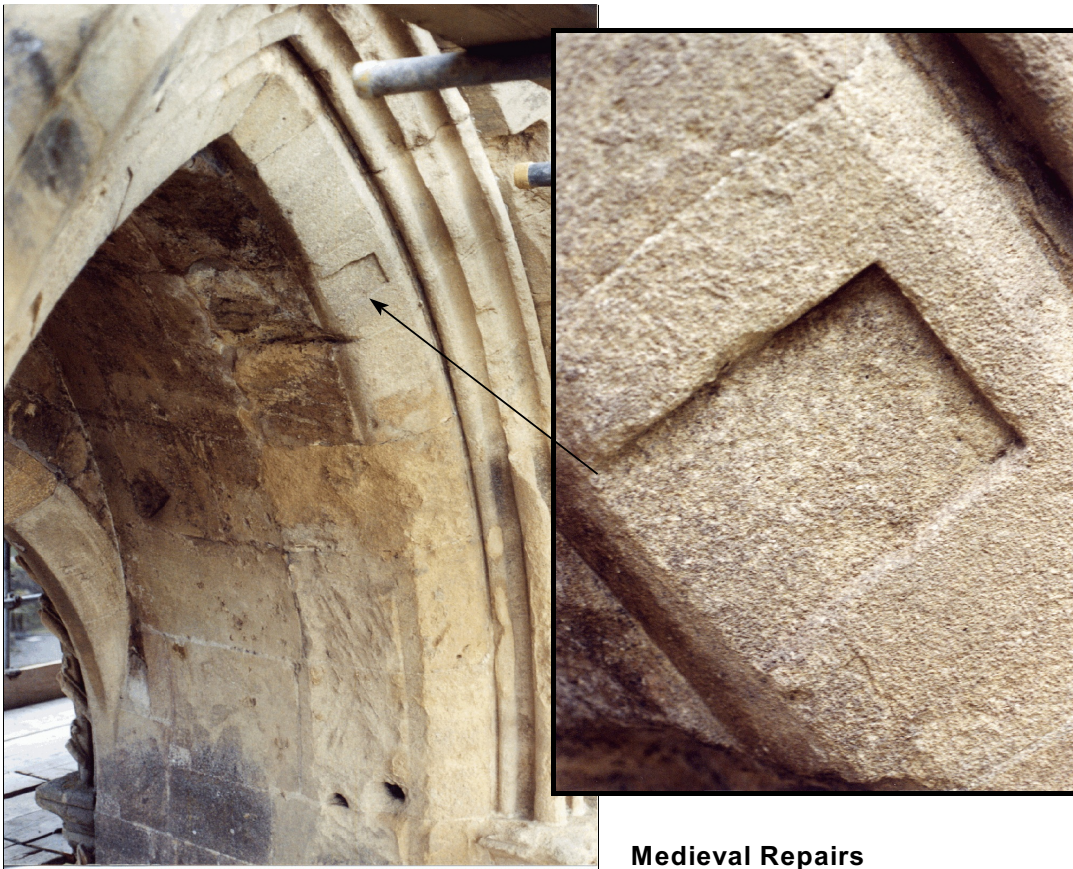
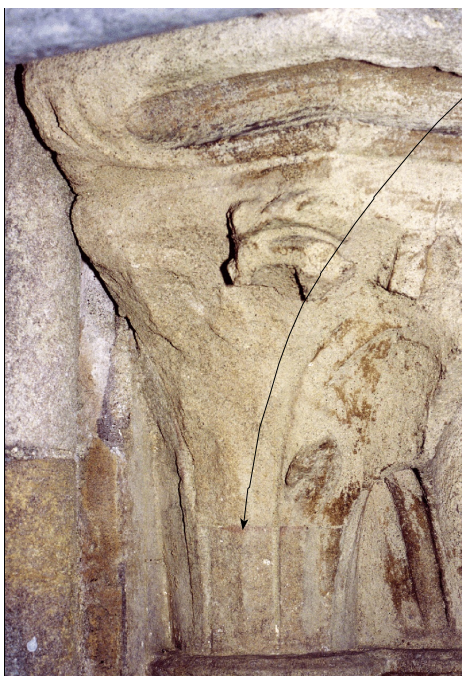
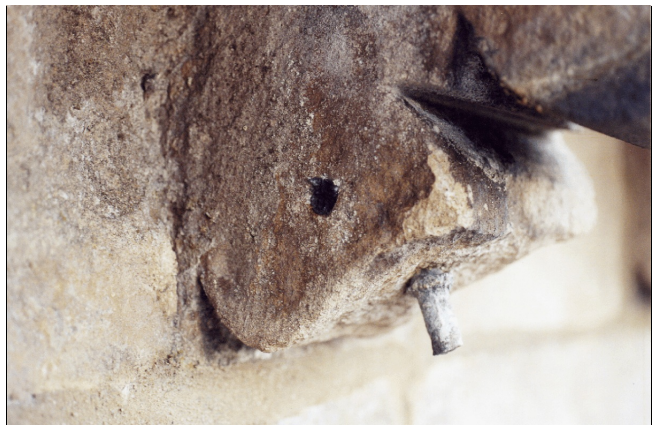
Above: lost mastic repair.  
Left: mastic repair at base of neck of capital  
Below: poured lead dowel in corbel, the lower stone of the repair lost exposing the end of the dowel. Pouring hole in side of block.

2.9.1.3 In Bay 5 there is an instance of a second form of medieval repair involving the use of a poured lead dowel. Here, the westernmost of the corbels has lost the lower half of the lower roll-moulding exposing a lead dowel which has an expansion at the point where the joint previously existed, and there is a lead pouring hole on the western end of the block, showing that the repair was executed before the block was fixed.

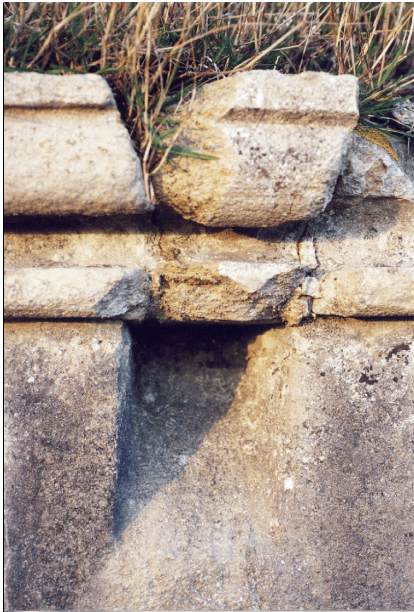
Left: The rain-water chute at the wall-head, closed off with Caroe period repairs

Bottom left: the lead straps securing the down pipes were held by two iron nails in wood plugs, only one of which still survives (bottom right), retaining a fragment of the lead strap beneath the round head.

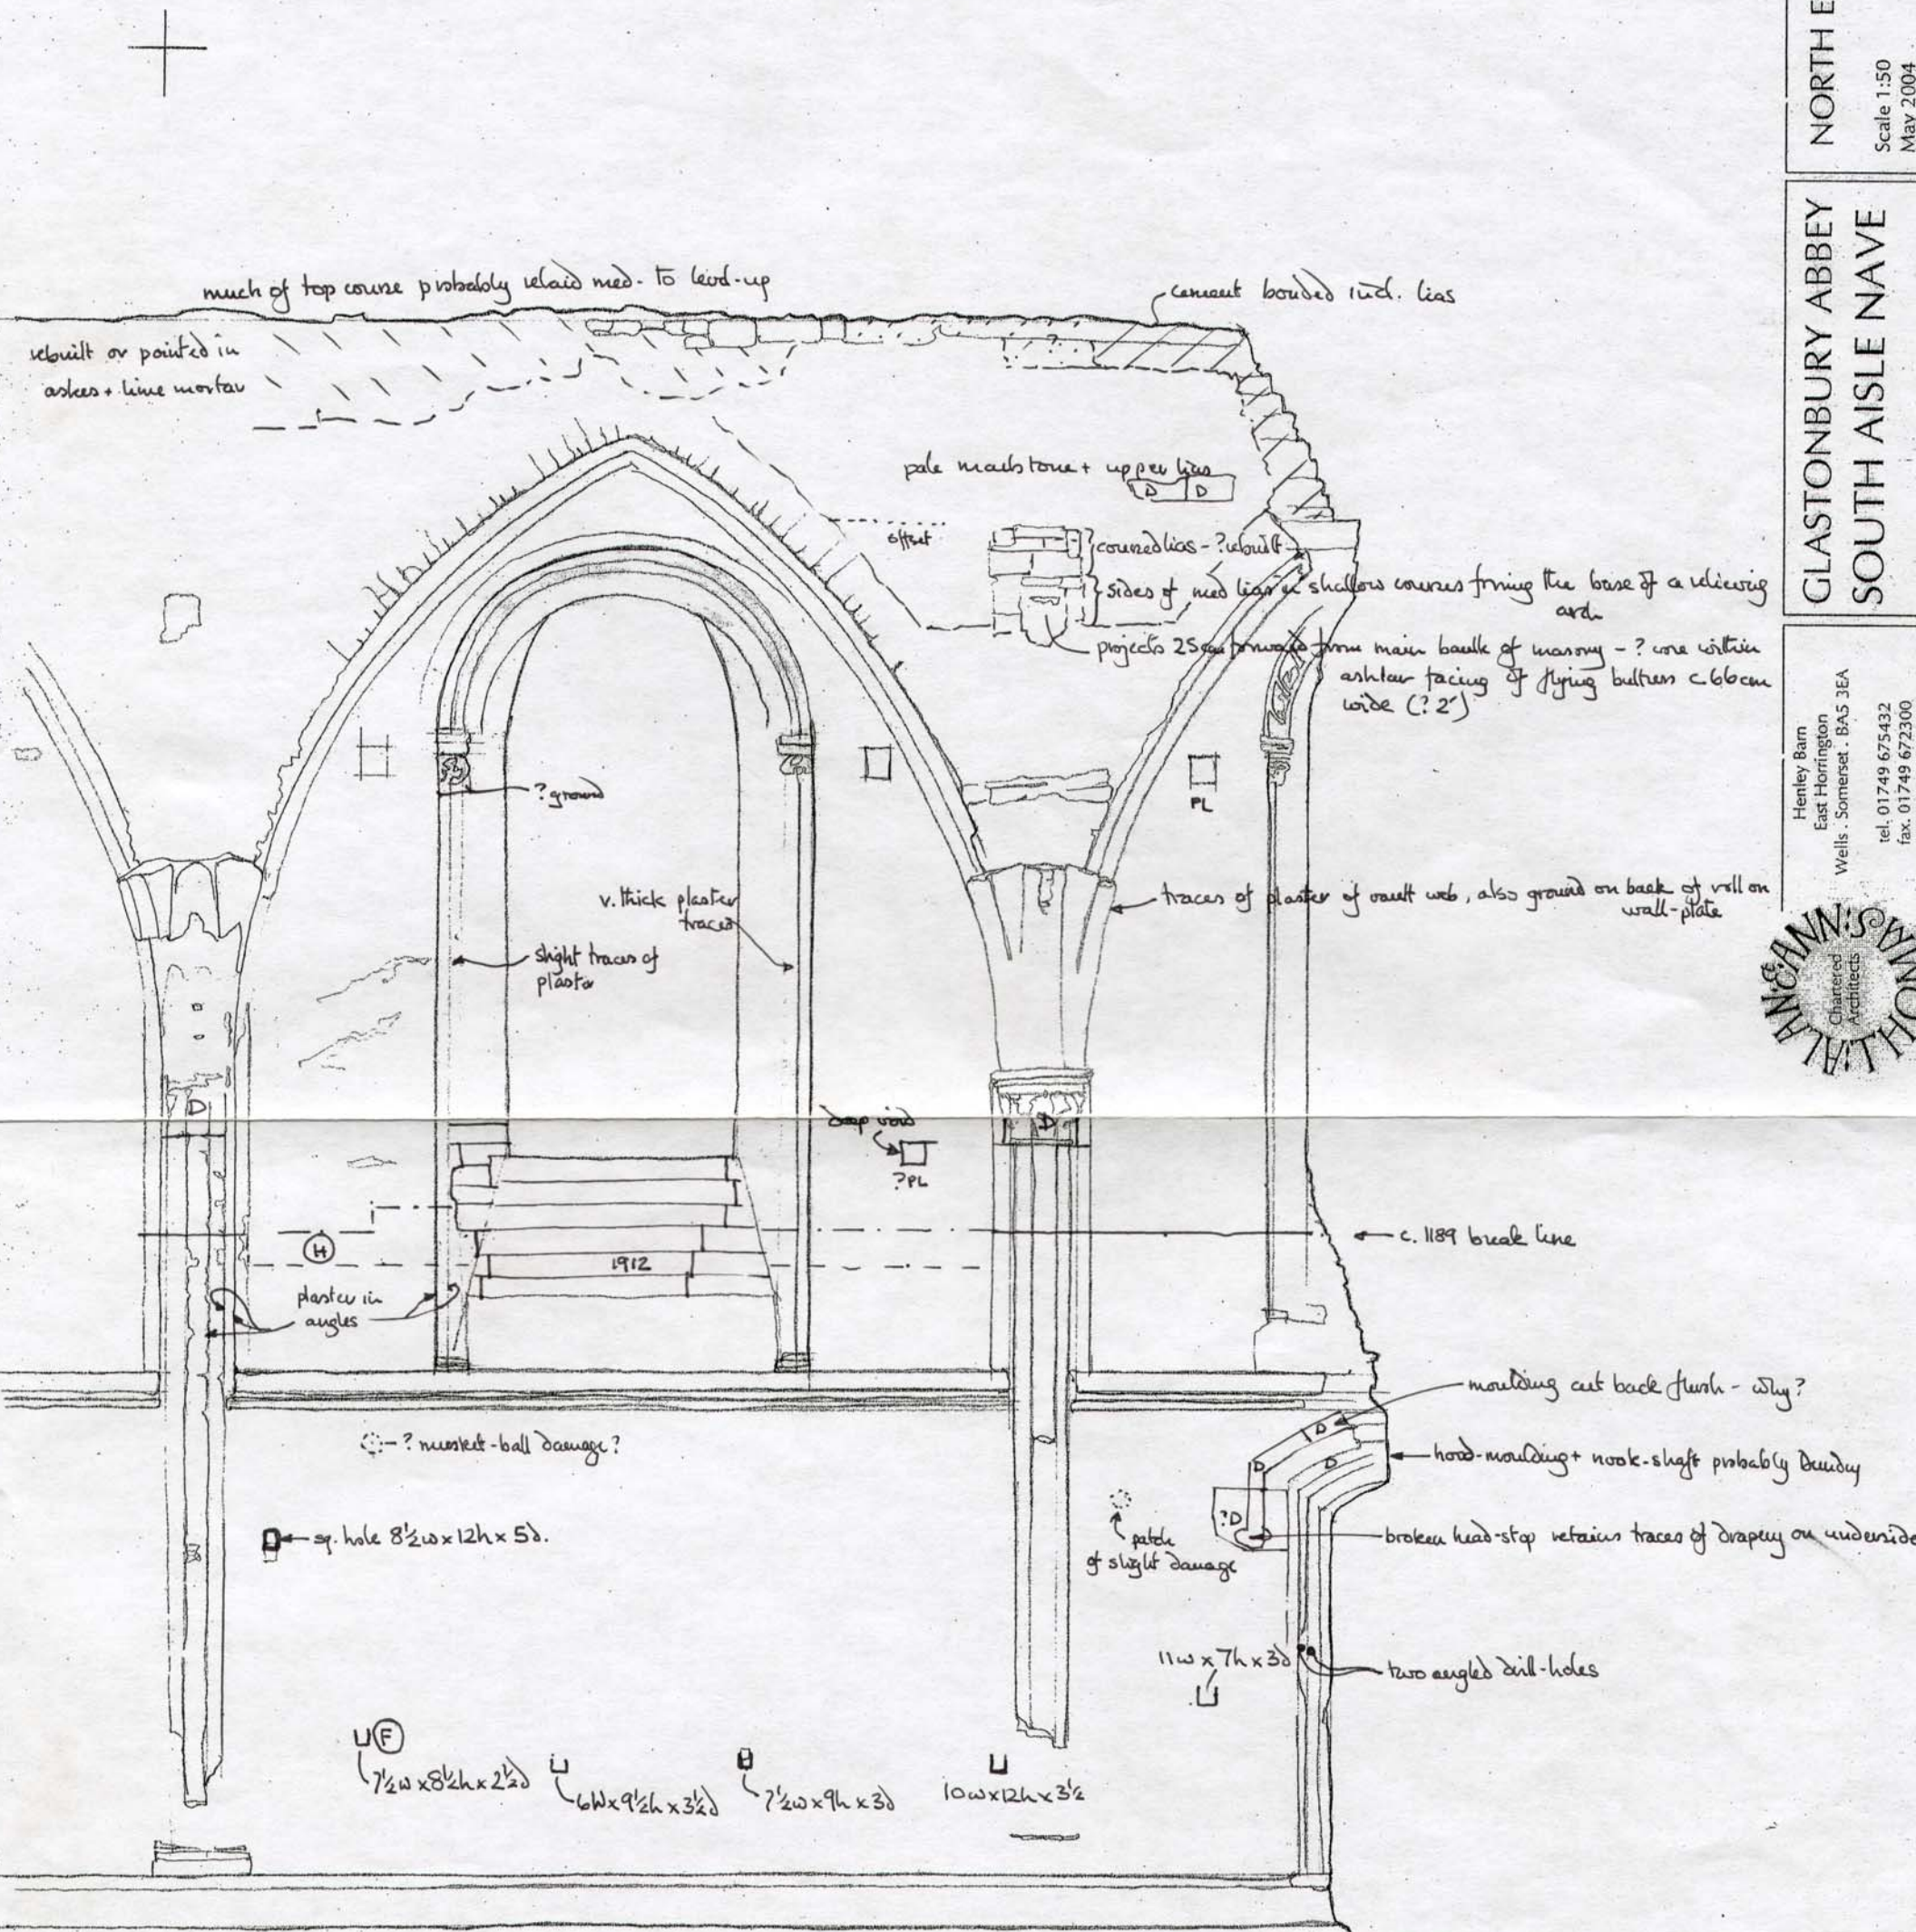
(F) See sheet for area E of here. The two deflections in the level of the sockets is difficult to account for - they all lie with their base on a bed joint, but drop from 98 1/2 above bench to 76 cm above, and then rise in the W bay to 124 above. Their relative sizes suggest a greater raking angle for the lower slots suggesting that they are supports for timbers with their soffits at the same ~~relative~~ height.

(H) While the break-line in bays 4 + 5 and the remnant of Bay 7 is fairly clear (dropping from 120 cm to 1m above the top of the sill string-course) there is a possible (more subtle) indicator of a change in that there tends to be a band of decay which may occur above a hiatus point. This coincides with the stylistic change in Bay 4, but is more variable elsewhere, and here and in the W side of Bay 5 suggests a break at 80-75 cm - perhaps the over-winter break-line prior to the main break - the mortar having gone off hard enough to provide a relatively impervious horizon, concentrating decay agents in the course above.

(E) The E diagonal and N transverse ribs are on the same springer, but the W diagonal rib is entirely separate throughout its remaining height. There is no discernible curvature of the N transverse rib. Unlike the topmost stone of the external rib may not be in situ the three lower stones ~~are~~ all comprise both diagonal and transverse ribs and must be as built - surely the arch could not have been stilted to this degree? Could it have been configured thus to accommodate the temporary wall closing off the E nave - but if so why cause the mouldings rather than just leave a vertical face?

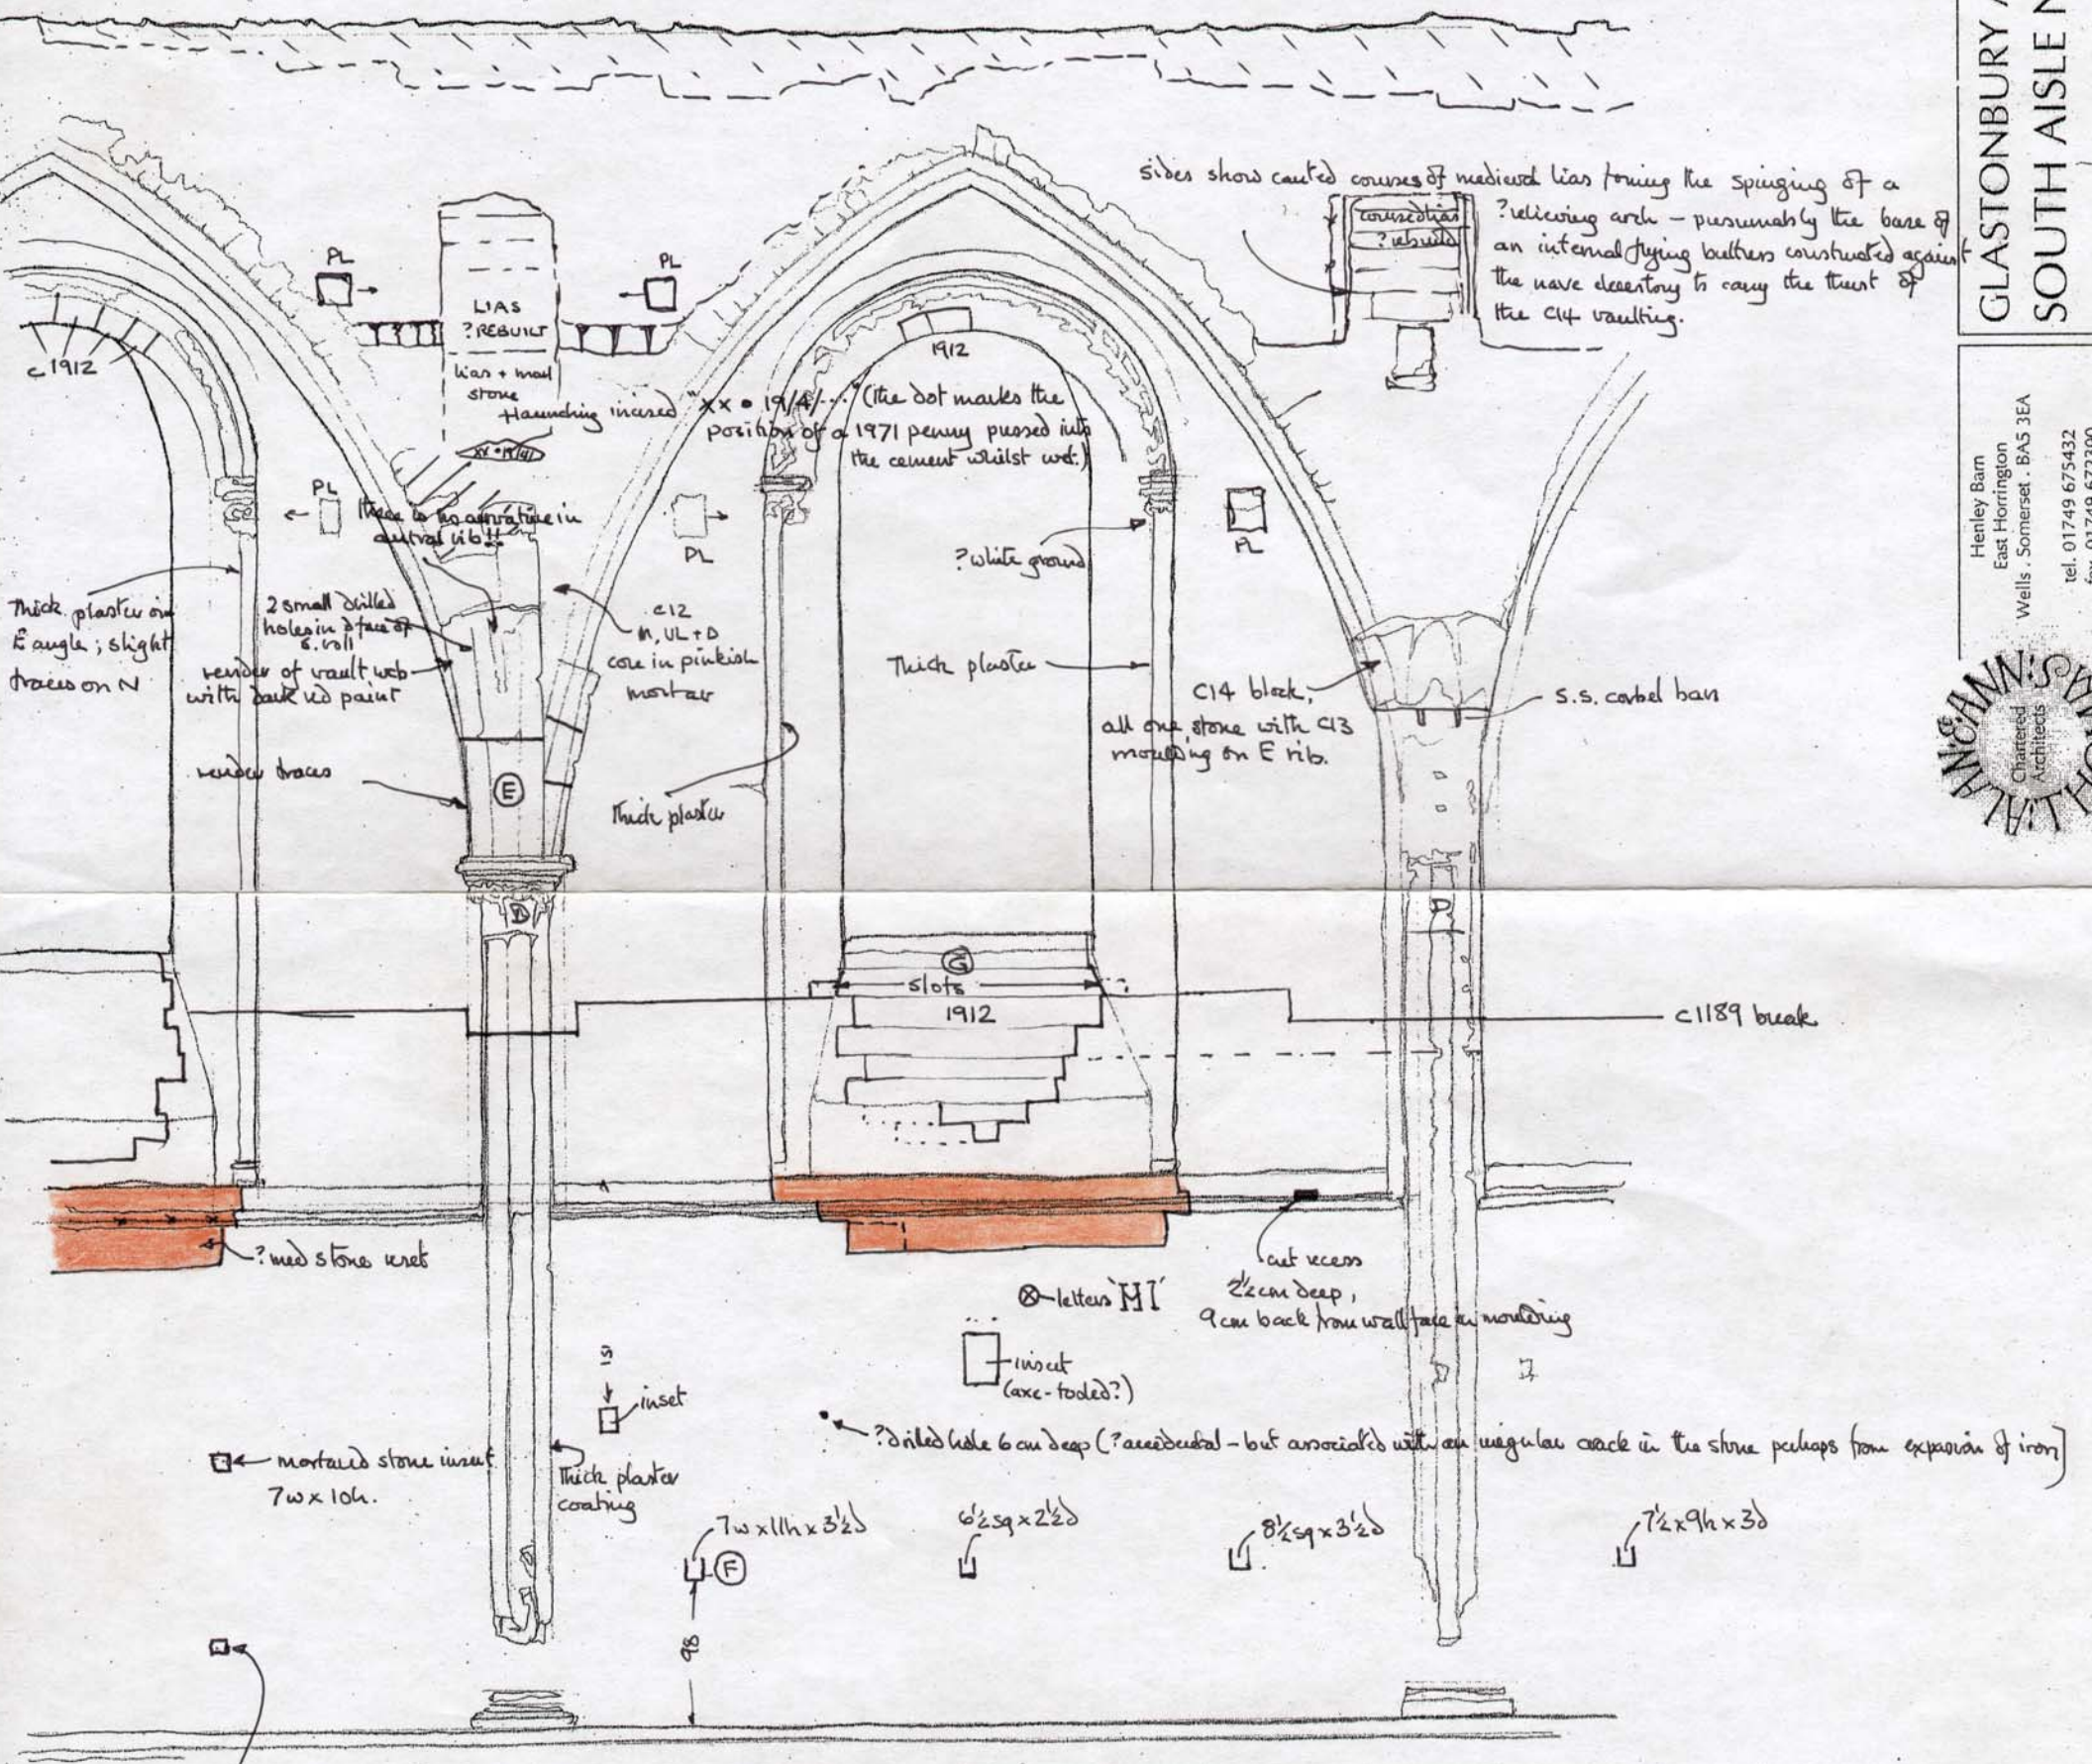
NORTH ELEVATION (2 of 3)  
Scale 1:50  
May 2004

(E) roughly worked square recess 7cm sq + 7cm deep, at its lower centre is the end of a circular (?drilled) hole lying on the topmost point of the perpendicular bed joint [caused 175cm E of E edge of wall-shaft].

(G) Two square holes in the weeds: E = 9 1/2w x 10h x 16d; W = 9w x 8 1/2h x at least 9cm deep; the eastern is open, the western is filled with mortar and a piece of turf (?∴ at same date as holes higher in these jambs?). Purpose?

(F) Series of shallow squared recesses, all cut with their base on the same bed joint and one edge on a perpendicular - implying that they must have been made at a time when the masonry was exposed (and not plastered over). This would appear to indicate a date during the period of construction. Each recess is wedge-shaped, dying out at the top, all but one 3-3 1/2cm deep [(ii) is only 2 1/2cm]. The shape suggests the seating for the end of a raking beam, and their similarity to the holes associated with the first cloister on the S elevation suggests both similar date and similar purpose. As a working hypothesis there may be suggested as the seatings for a temporary (provisional) passageway to/from the cloister used while the nave was incomplete.

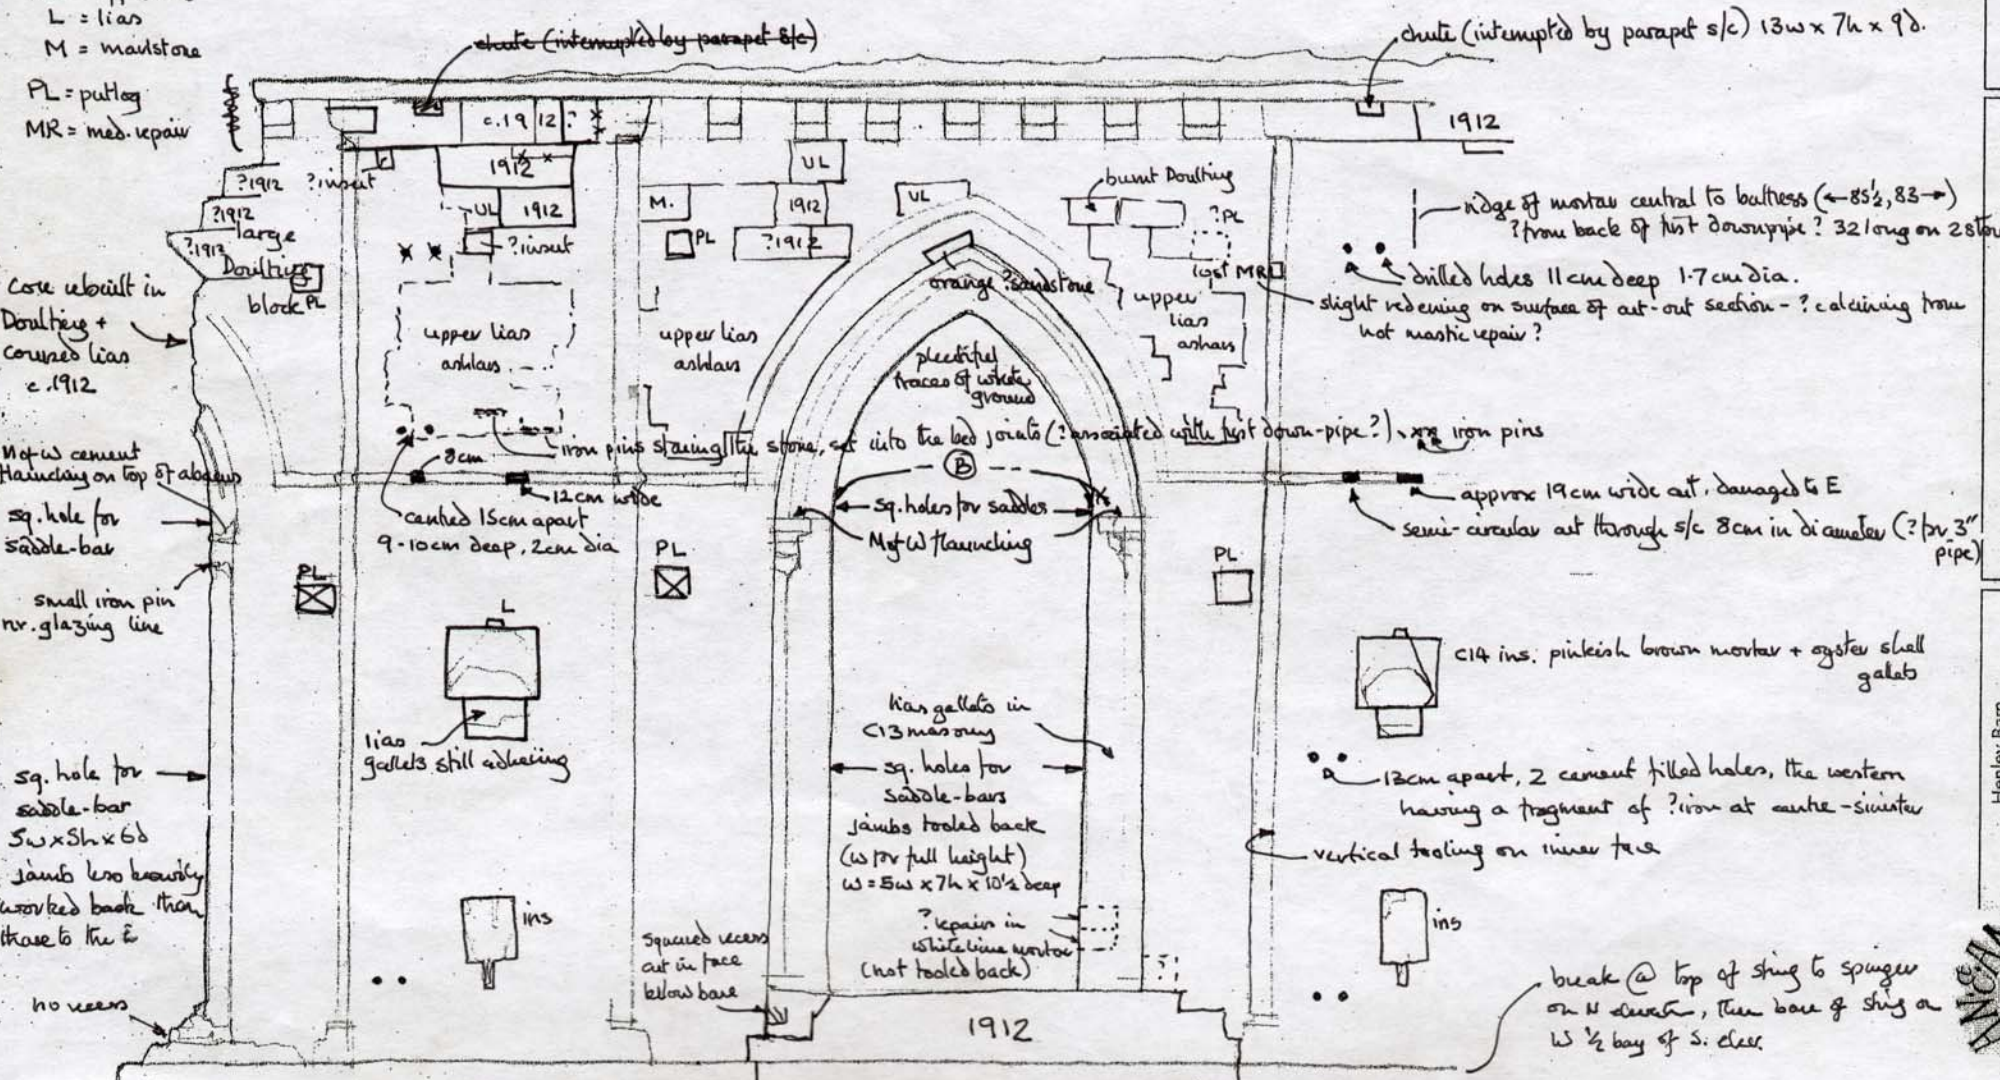
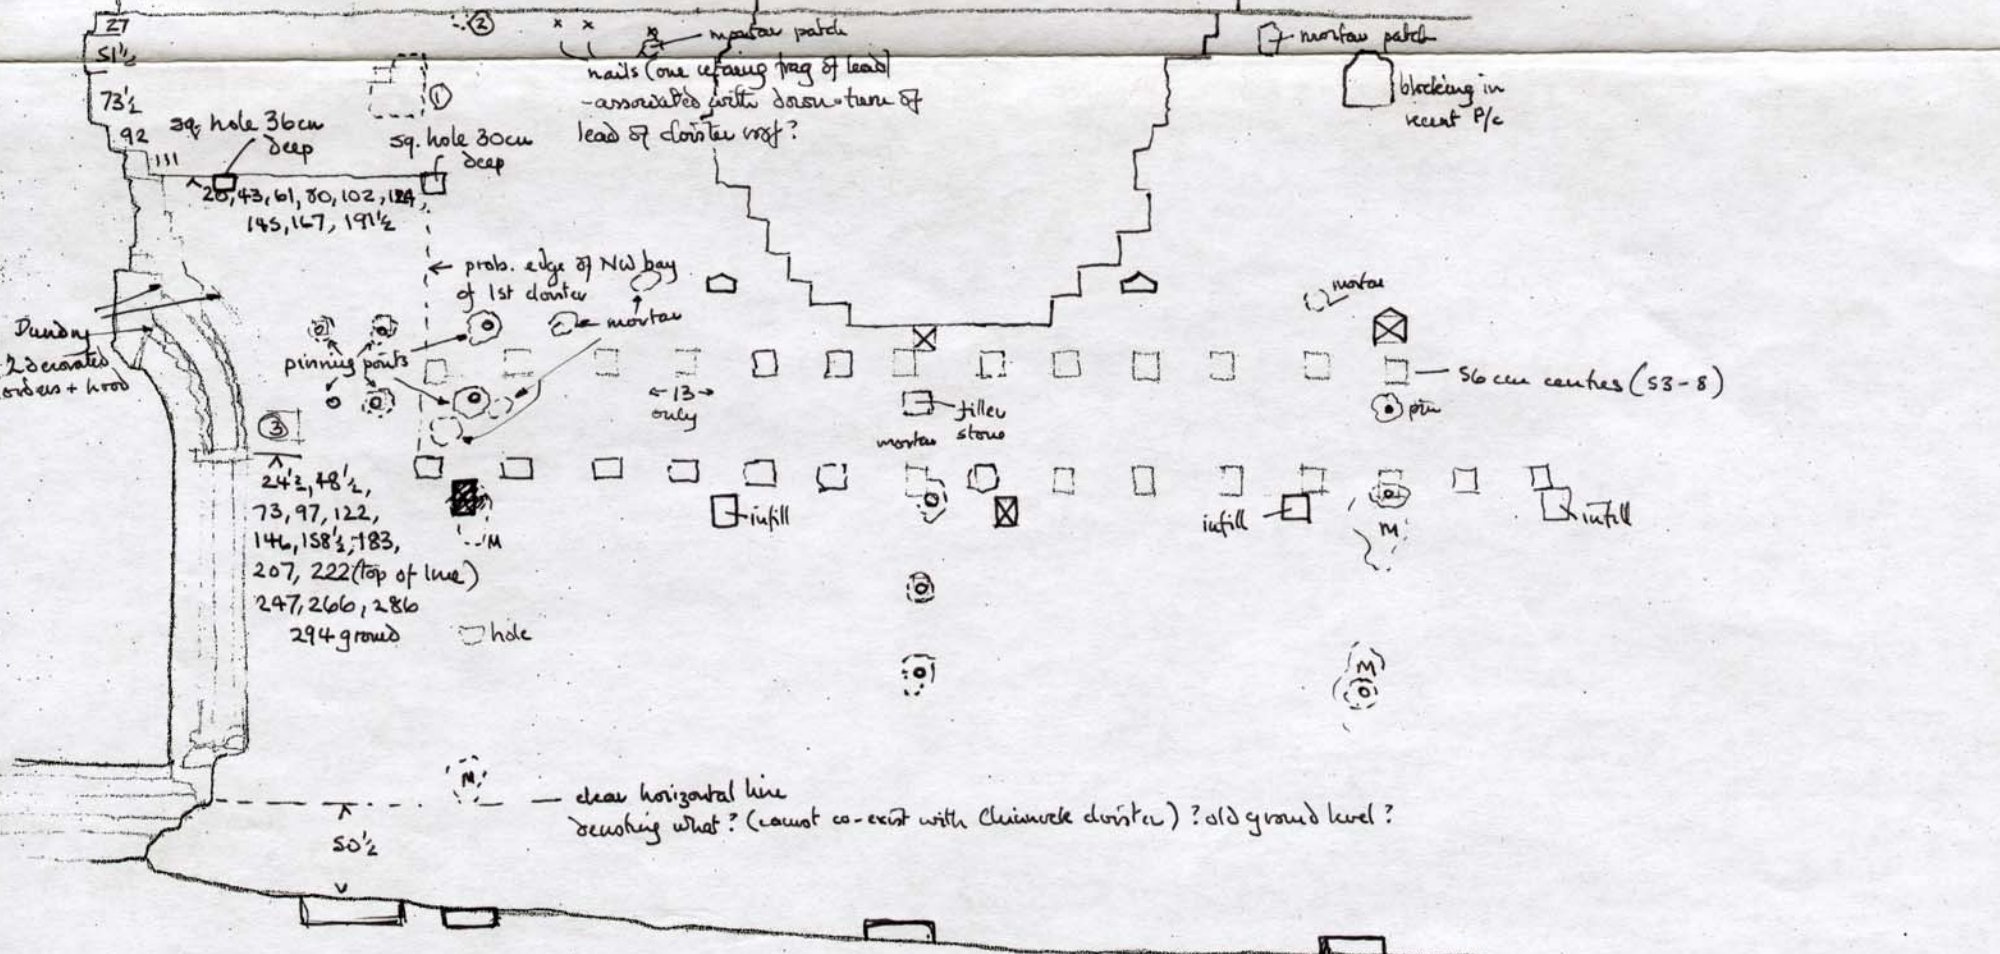
WEST ELEVATION  
Scale 1:50  
May 2004  
262/57

- ① blocking of hole left by withdrawal of corbel for wall plate
- ② mortar patches adhering to block below s/c (? associated area of carbon accumulation) - to do with roof?
- ③ blocking of destroyed label stop includes a piece of moulded ?Dundry with lime wash on the surface. Blocking initially fixed in a rich brown ?roman cement, with later P/c pointing

Lies forming the N edge of the rebuilt face, with (large) pieces of marble and some upper lies (generally in the top course) All with cement haunching.
