## ***Hanover protected wreck***

*Marine assessment for possible de-designation*

Historic England

May 2017

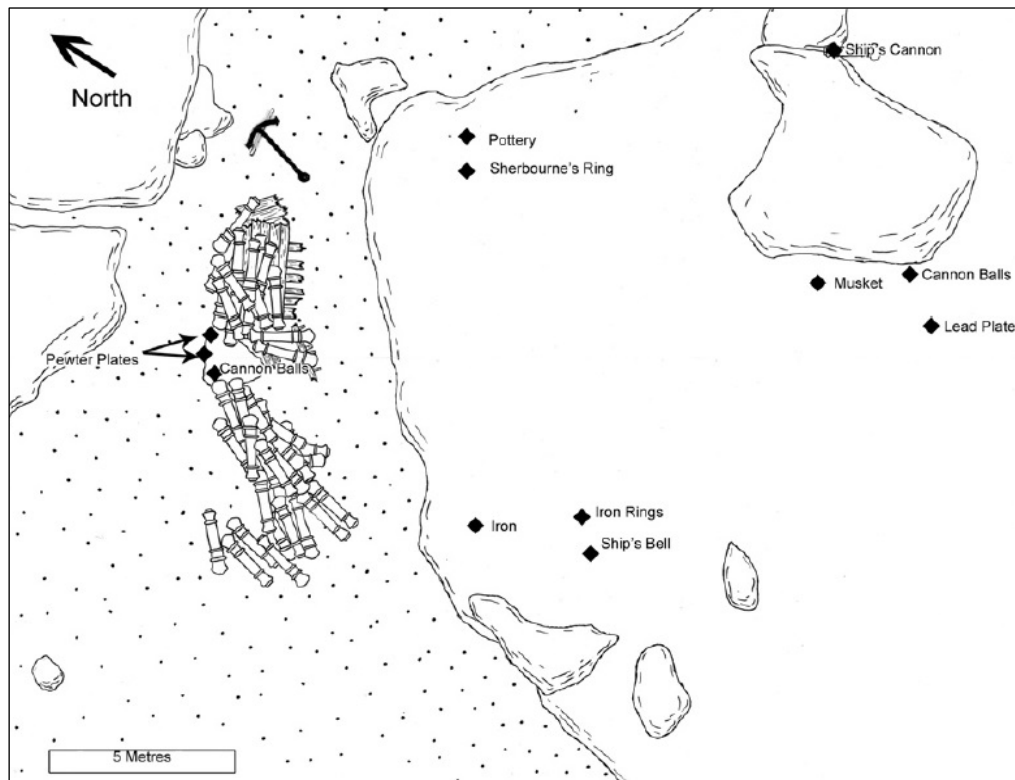
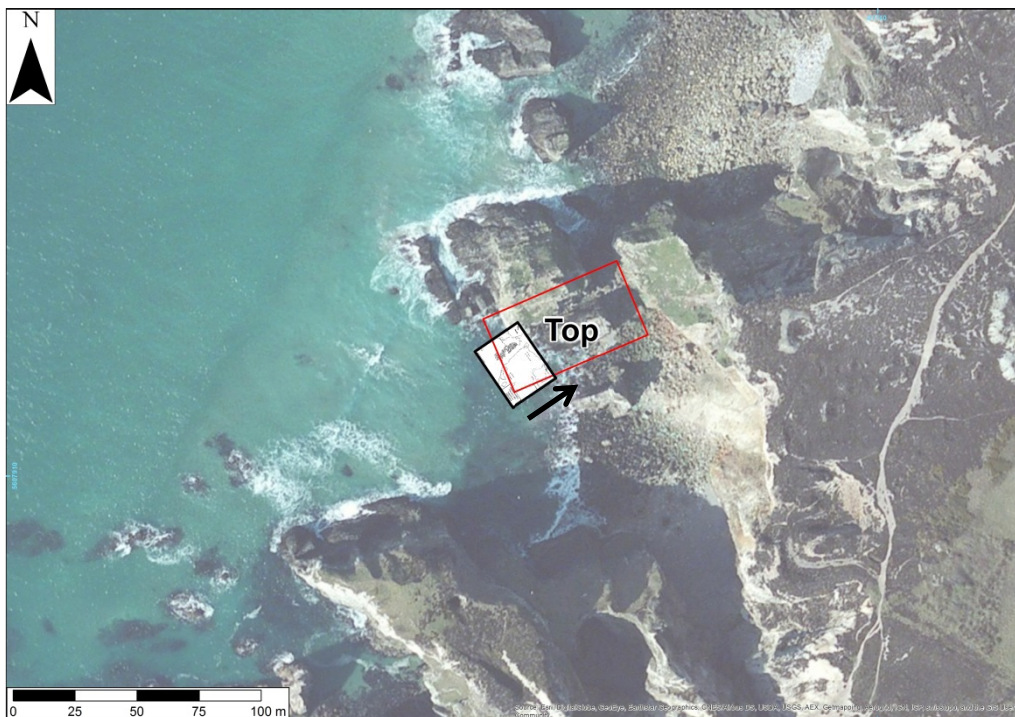
- 3.9. A large rock located across the centre of the wreck coincides with the finds locations of the pewter plates and cannon balls among the cannon (Figure 3). It stands higher than the surrounding seabed, and may have been the rock that the ship struck. After striking the rock it is likely that the ship broke to pieces and subsequently fragmented very quickly in the rough seas, which is corroborated by the fragmentary nature of the surviving hull structure. The remains found by the salvors in the week following the accident are likely to have been pinned in place by the weight of the cannon. The relationship between the cannon pile and the fragmentary remains of the wreck structure (the first futtock and associated timbers) suggests that the cannon may have shifted in the hold, reducing the stability of the ship during wrecking (Parham, *et al.*, n.d.).

Figure 3 Hanover site plan as reported by Hydrasolve (Parham, *et al.*, 2013) (top) and plan location overlaid (with orientation shown) on aerial photography (bottom). The area identified as the extent of wreck (Parham *et al.* 2013) is shown in red

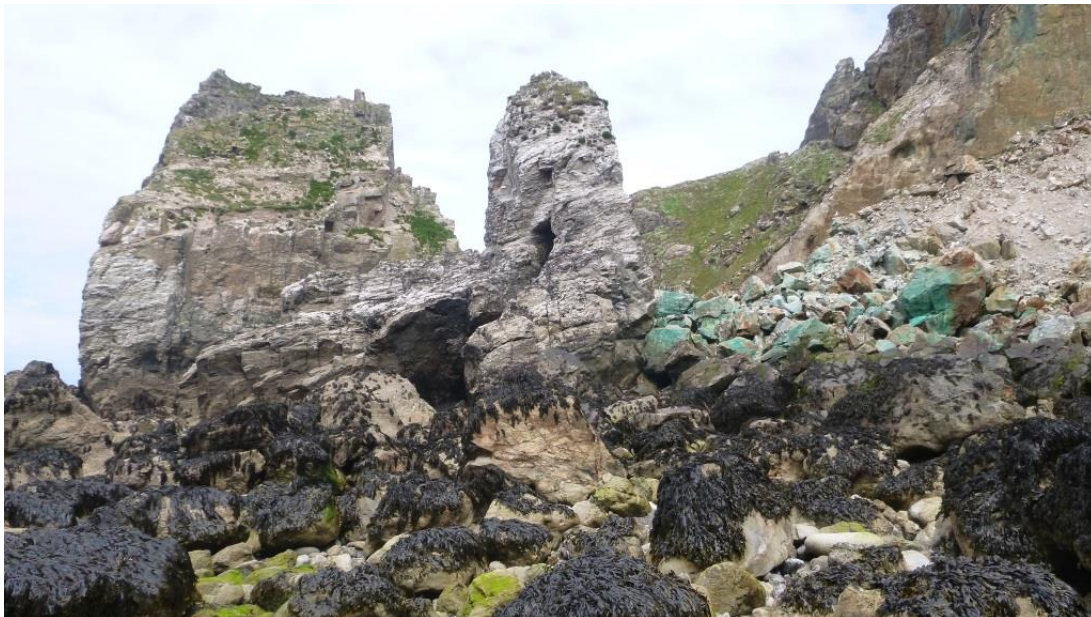
- 5.3. The foreshore and intertidal walkover survey covered an area of c. 4.3ha (Figure 2). The foreshore covered by the walkover survey was comprised primarily of large to medium sized boulders, with a limited sandy area at the south-east limit of the site. Owing to the large number of crevasses and rock pools (Figure 4) it is possible that small archaeological items may have been overlooked although the limited sand coverage is unlikely to conceal substantial remains of a buried wreck in this area.

Figure 4 Hanover Cove looking north (see Figure 2 for location) towards the centre of the designated area

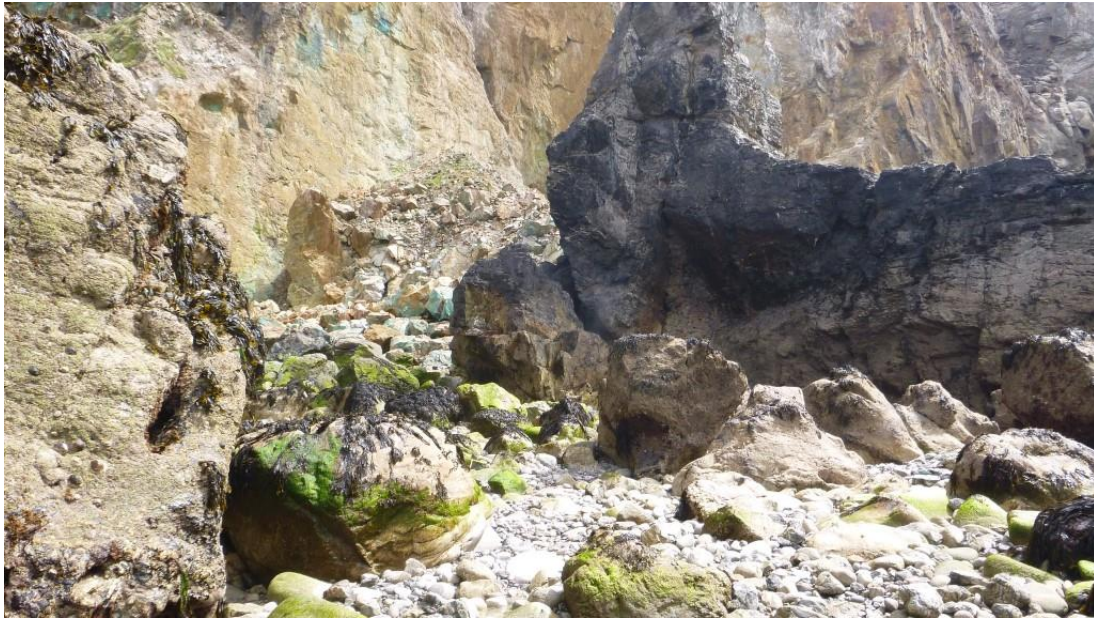
- 5.4. The area recorded as containing the most wreck material (Figure 3) and previously described as being buried under 2 – 5m of sand is now a boulder field similar to the rest of the beach. No wreck material was observed in this location (Figure 5).

Figure 5 Detailed view looking east (see Figure 2 for location) of area previously recorded as centre of wreck debris showing large number of boulders

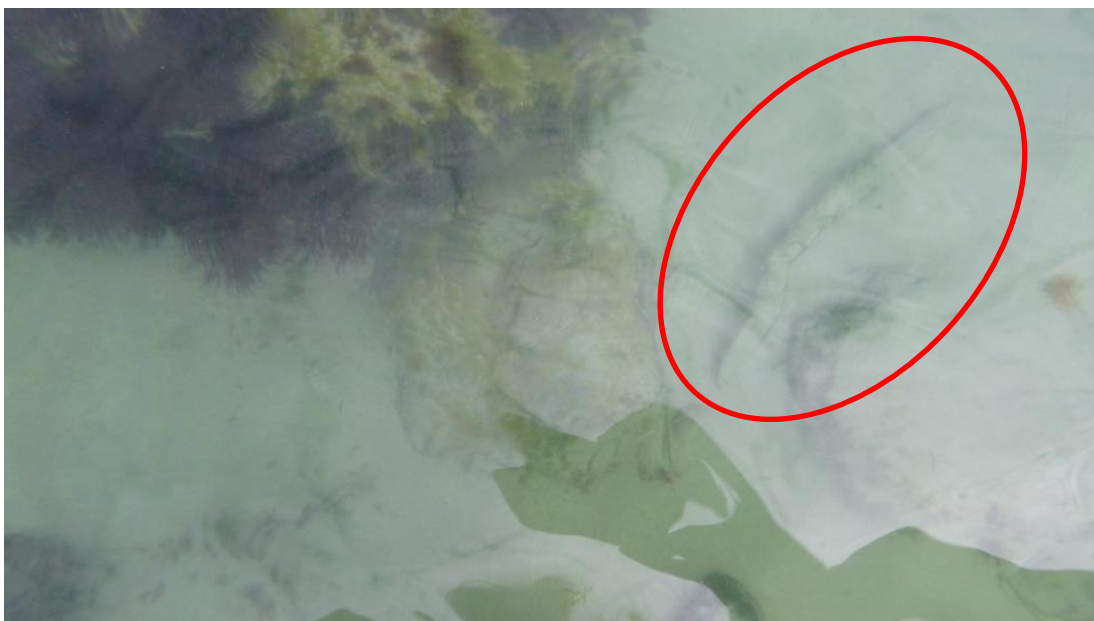
- 5.5. Debris, both historic and modern, was mostly absent from the designated area with the occasional piece of fibreglass or other modern debris observed. A single object was observed c. 70m north of the centre of the designated area (Figure 2: **CA1**). This object was located in an area that was still submerged at low tide and could not be examined closely, however owing to the good through-water visibility it could be seen to be a partially buried elongated object with estimated dimensions of c. 50cm long with a 5cm diameter, and may have been a cable (Figure 6).

Figure 6 CA1: elongated object circled in red to right of rocky outcropping, view looking east

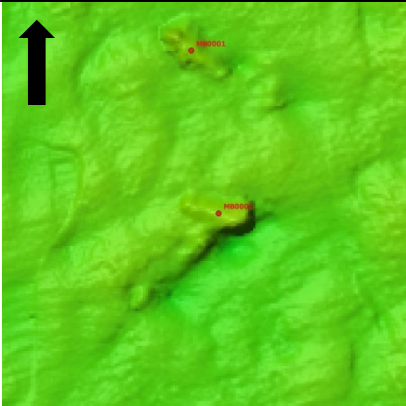
4.1.2 Two anomalies of potential archaeological interest were identified in the multibeam data, however it is highly likely that these features represent rocky outcroppings that have been partially uncovered due to sand movement.

344685.863	5578192.009	Anomaly MB0002 is a feature made up of a linear anomaly 4.7m in length with another linear feature 2.5m in length at the northern end. The smaller linear feature has a curved element to the eastern end.
--------	---	------------	-------------	--

6.0.1 As evidenced by the aerial photography it is possible to walk around the two anomalies, MB001 and MB002, identified in the multibeam data at a low spring tide although access would have to be by boat. It is likely that the anomalies are not anthropogenic in origin and represent the

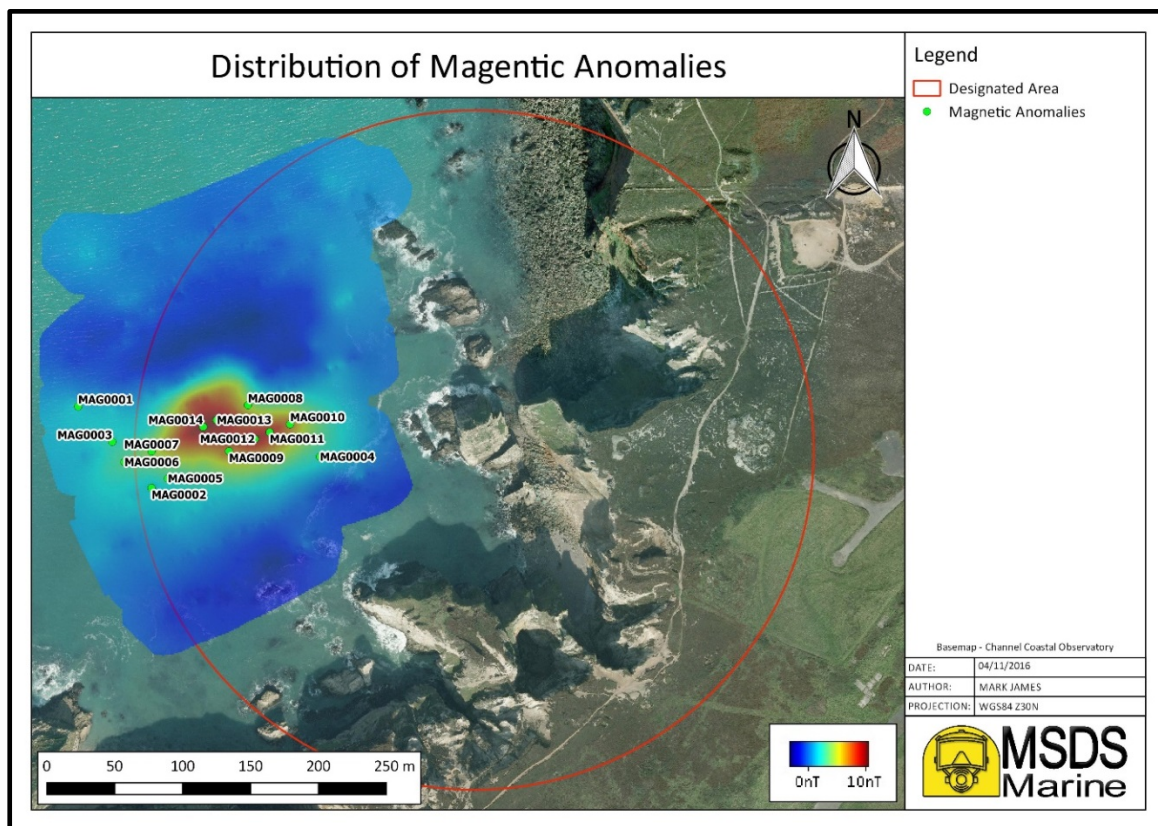
Figure 7: Distribution of magnetic anomalies

4.3.6 None of the identified magnetic anomalies correspond with anomalies identified in the multibeam data. This suggests that the magnetic anomalies are either very small or buried. If these anomalies are associated with wreck material and debris they are likely to be buried under sand. Although rocky outcroppings have been identified near the bathymetric anomalies, the anomalies' location c. 40m east of the MAG0004 leaves open the possibility that they may be debris trapped amongst the rocks.

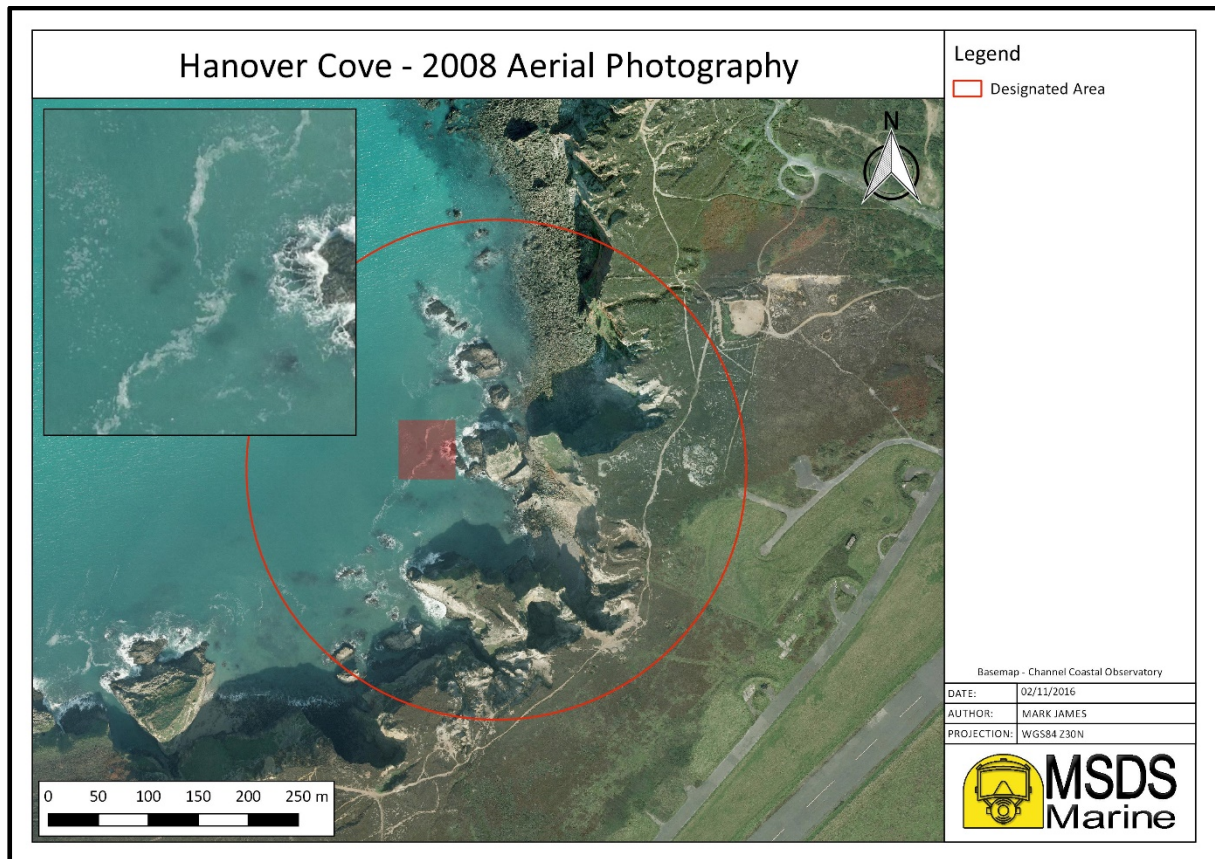
Figure 9: Hanover Cove - aerial photograph from 2008

4.4.2 One area where the rocks are more visible in 2008 than in 2010 has been highlighted in the images above (Figure 9 and Figure 10). This is suggestive of changes in sand levels.

4.4.3 It must be noted, however, that the tide is higher in the 2008 image than in the 2010 image so direct comparisons are more difficult. However, even with deeper water a number of rocks are visible in the selected area of the 2008 image including one just breaking the surface. This rock is more exposed due to the lower water level in the 2010 image, but none of the other rocks are visible suggesting an increase in sand levels.

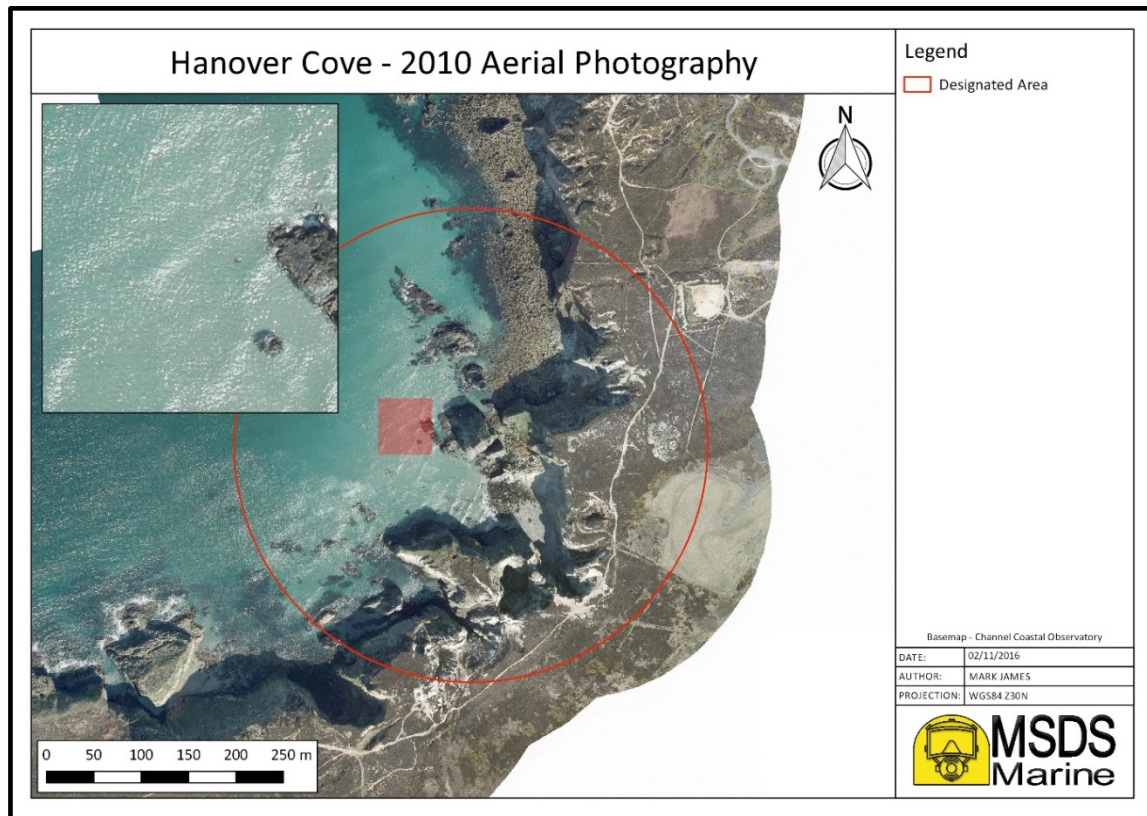
Figure 10: Hanover Cove – aerial photograph from 2010

4.4.4 Although the tide is noticeably lower in the 2013 image there appears to have been little change in the sand levels since 2010, based on the visibility of features such as rocks. The 2013 image illustrates not only that at least two-thirds of the designated area can be accessed on foot, but also how shallow the water depth can be over the remainder of the site.

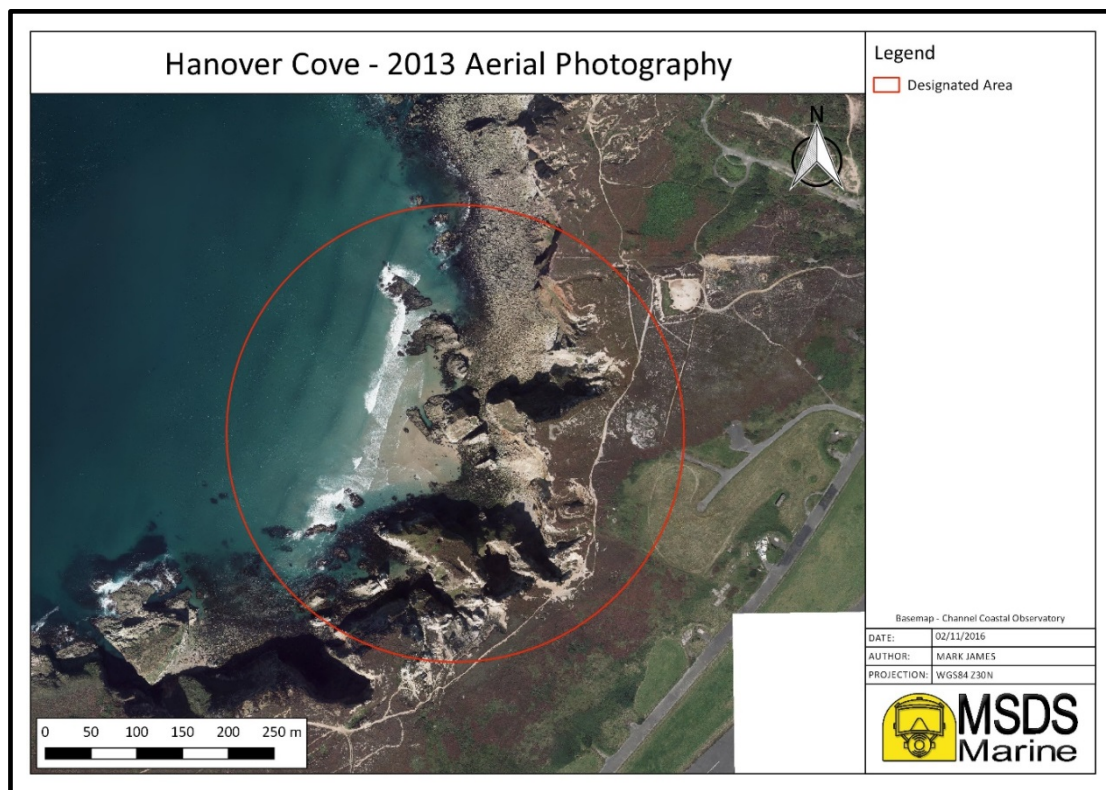
Figure 11: Hanover Cove - aerial photograph from 2013

4.4.5 The only notable difference between the 2010 and 2013 images is that the rocky area of the beach appears to extend further out to sea in 2013. This is likely to represent fallen debris as a result of cliff erosion.

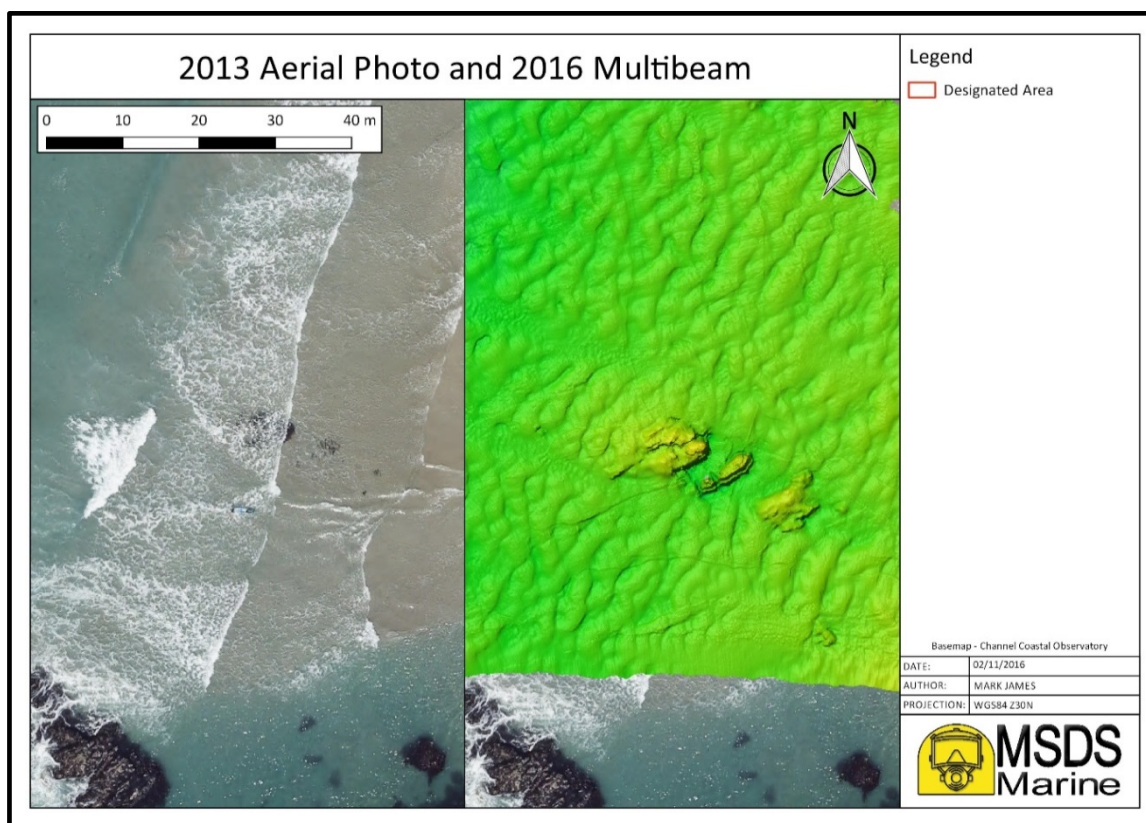
Figure 12: Comparison between the 2013 aerial photograph and the 2016 multibeam data

4.4.7 The sand levels appear to have reduced slightly between 2013 and 2016. A cluster of three rocks, one of which was visible and two that were faintly visible in 2013, are now more exposed. A further smaller rock to the south of the eastern rock that was covered in 2013 is now also visible.

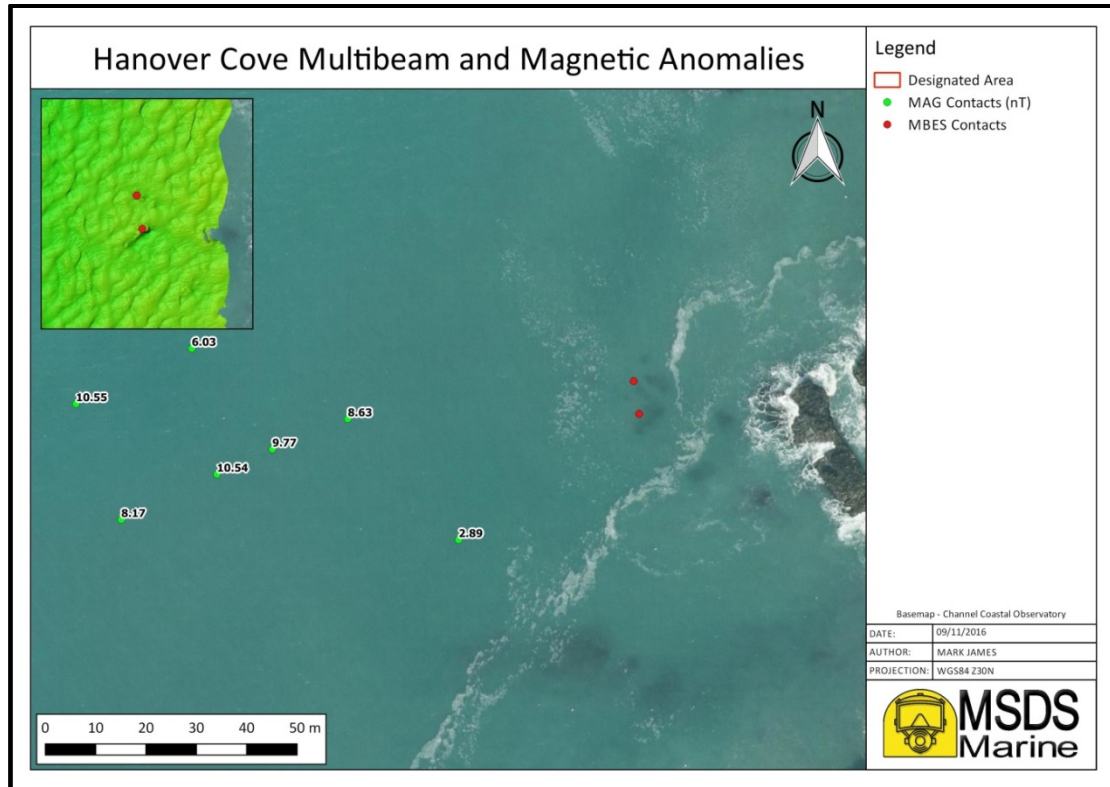
Figure 13: Position of bathymetric anomalies in relation to magnetic anomalies

uppermost surfaces of partially buried rocks. Considering the bathymetric anomalies' relative proximity to the cluster of magnetic anomalies (c. 50m east of MAG0004) and their accessibility, it is considered prudent to ground truth them.

6.0.2 The magnetic anomalies, particularly the eight anomalies over 5nT (MAG0007 - MAG0014), may demonstrate the presence of wreck material. However, the multibeam data suggests that these anomalies are buried and any further investigation would therefore require excavation to determine their nature, which is beyond the scope of this investigation.
