Hollies Barn, Cargo, Near Carlisle Standing Building Survey

Report No. 1543

This report presents the results of a Level 2 standing building survey carried out by CFA Archaeology Ltd (CFA) in August 2008 on behalf of Giles Finnegan at a barn to the rear of the Hollies, Cargo near Carlisle Cumbria (NGR NY 365459 centred on; Fig. 1). A planning condition has been put in place to record the historic barn (County Historic Environment Record No. 41928) in advance of its conversion into a dwelling.

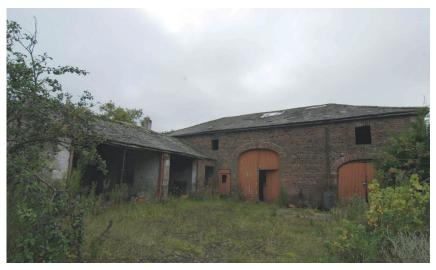
The east-facing elevation is 15.3m long and 6.5m high and constructed of red-brick (033) in English garden bond with four stretchers and a single row of headers. Red and cream sandstone quoins (005) are present at the western end. The roof is slate (002) with semi-circular ridge tiles (001). Two glass and Perspex skylights are present (022 and 023). The rain goods are cast-iron (054). At ground floor level there are two arched openings. The larger of the two occupies the centre of the elevation and has a three-pointed segmented arch with brick vousoirs (030) and ashlar sandstone surrounds (031). A double-leafed, plank-built door (029) is present. The smaller arched opening is also three-pointed with brick (028) and ashlar surrounds (027). A double-leafed plank-built door is present. Between the arched openings at ground floor level there is a stone foundation course (037). On the left-hand side of the largest arched opening there is a plank-built door (032). At the first floor level there are two square-headed window openings (024 and 025). Both have brick surrounds and sandstone sills.

Plate 1 - General view of the east-facing elevation of the barn

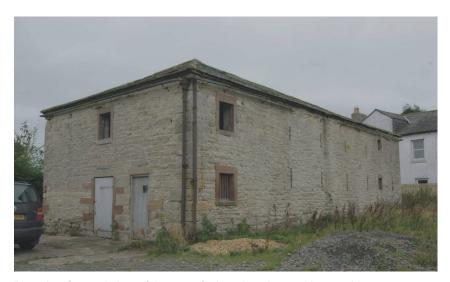
The west-facing elevation represents the rear of the barn and is constructed of coursed sandstone (043) with ashlar quoins (005). The principal features include ten slit vents (039) and four square-headed windows (038 and 040). A metal fitting (052) is present below the topmost window (040), its function is not clear. At the base of the elevation there is a patch of brick blocking work (042) and a circular aperture (051) that extends through the wall.

Plate 2 - General view of the west-facing elevation and barn gable

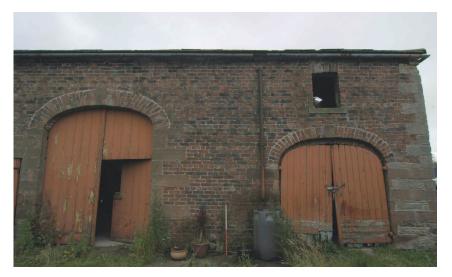
Plate 3 - Close-up of the two arched barn doorways

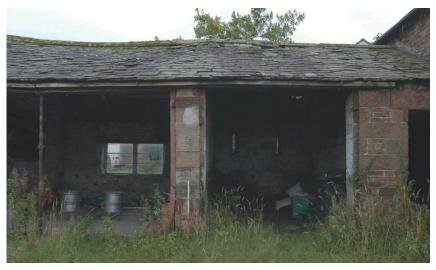
Plate 4 - General view of the garage doorways on the east range

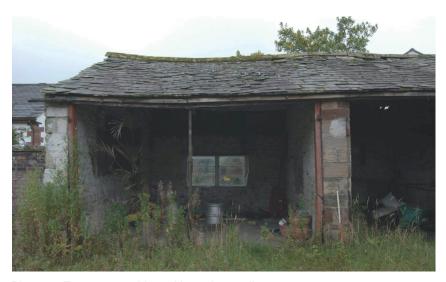
Plate 5 - East range gable and boundary wall

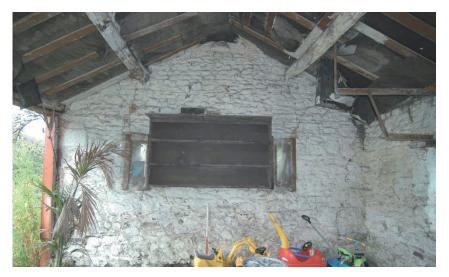
Unit H has a large bay opening and is opposite a large window on the rear wall (047). The presence of slit vents on the east gable wall suggest that it was originally used as an animal house and later used as an implement shed and garage. The roof timbers have been renewed but the main purlins running laterally across the unit appear to be original. These are incorporated into the fabric of the gable. Mortise joints point to the position of

Plate 6 - Interior shot of Unit H

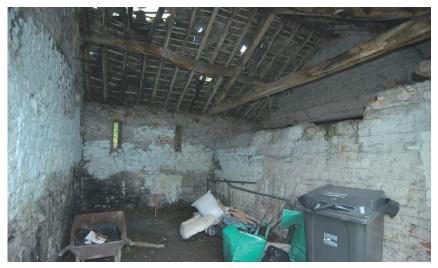
This unit was last used as a garage but the presence of slit vents in the south-facing elevation (Feature 050) suggest that during the 19th and early 20th centuries the unit was used as an animal house. The partition wall between units G and F is very low suggesting that it may either be secondary or reduced in height. The entrance to the garage is on the north facing elevation. The floor is cobbled and hard compacted earth.

Plate 7 - Interior shot of Unit G

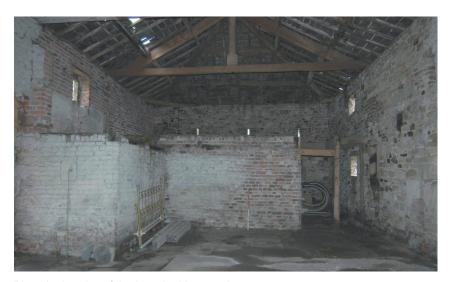
The barn floor is open plan. Unit D is open to the roof. At the north end of the barn a set of brick and stone steps lead up to the loft space. The east facing elevation is mainly whitewashed stone with occasional brickwork visible at the south end. The floor includes flagstones, concrete and mortar and clay. It is likely that flagstones covered the whole of the barn interior.

Plate 8 - Interior of the barn looking south

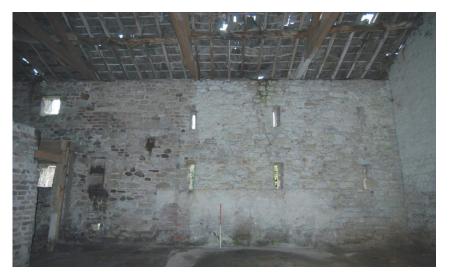
Inserted into the rubble-built west-facing elevation is a wooden frame supporting two bearings for supporting drive-shafts associated with either a threshing device or cattle cake crusher. Below this feature there is an aperture through the wall which may mark the position of an early horse-engine drive shaft. The 1865 First Edition map shows the position of a circular horse-engine house built against the west-facing elevation. No scars from this feature such as roof raggles or sockets are visible on the external elevation.

Plate 9 - Interior of the barn looking west

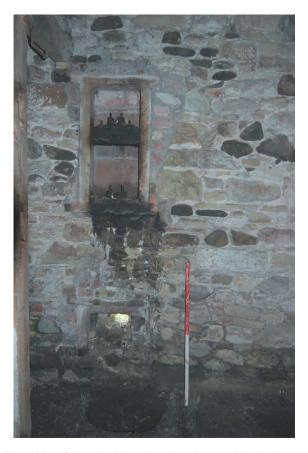
There is evidence of two phases of power-generation for crushing animal feedstuffs (cattle cake which was supplied to farms as hard blocks had to be crushed before it could be used). The first is represented by a hole in the base of the west-facing elevation (Feature 051) and is related to a circular horse engine that is shown only on the 1865 Ordnance Survey map. The horse engine was removed before the survey of the 1901 Ordnance survey map. The second form of power-generation was belt driven shafts that ran through the wall supported on two bearing plates (see Plate 10) housed in a wooden frame and inserted in the barn wall. These are probably early 20th century in date; the primary power source probably being a small diesel engine housed outside the barn.

Plate 10 - Oil stained bearing plate inserted in the barn wall

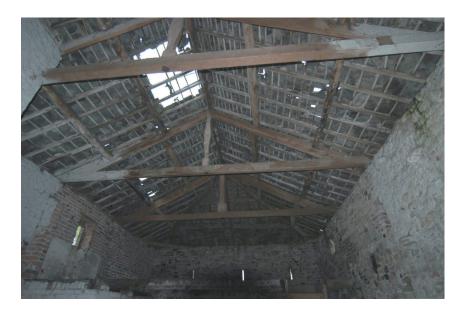
The barn roof is supported on A-frame trusses (Fig 3c, Plate 11) that rest directly on the wall head. These are machine-sawn timbers with carved king posts which are tied by iron bolts. The scarfe-jointed trusses support the large through purlins that are formed from large rounded branch wood. The piended roof configuration on each gable wall requires the timbers to be braced at the corners. Here cross-braces straddle the corners and carry the main trusses.

The bolted king-post A-frame trusses are probably late 19th century in date and have replaced an earlier A-frame truss arrangement, elements of which, namely the purlins, were in a suitable condition to be re-used. When the new roof was introduced the brick partition walls were built on existing rubble walls that may not have been carried through to the roof space.

Plate 11 - General view of the A-frame roof structure
