Western Breakwater, Granton Harbour, Edinburgh

Archaeological Watching Brief & Standing Building Survey

Report No. 1581

December 2008

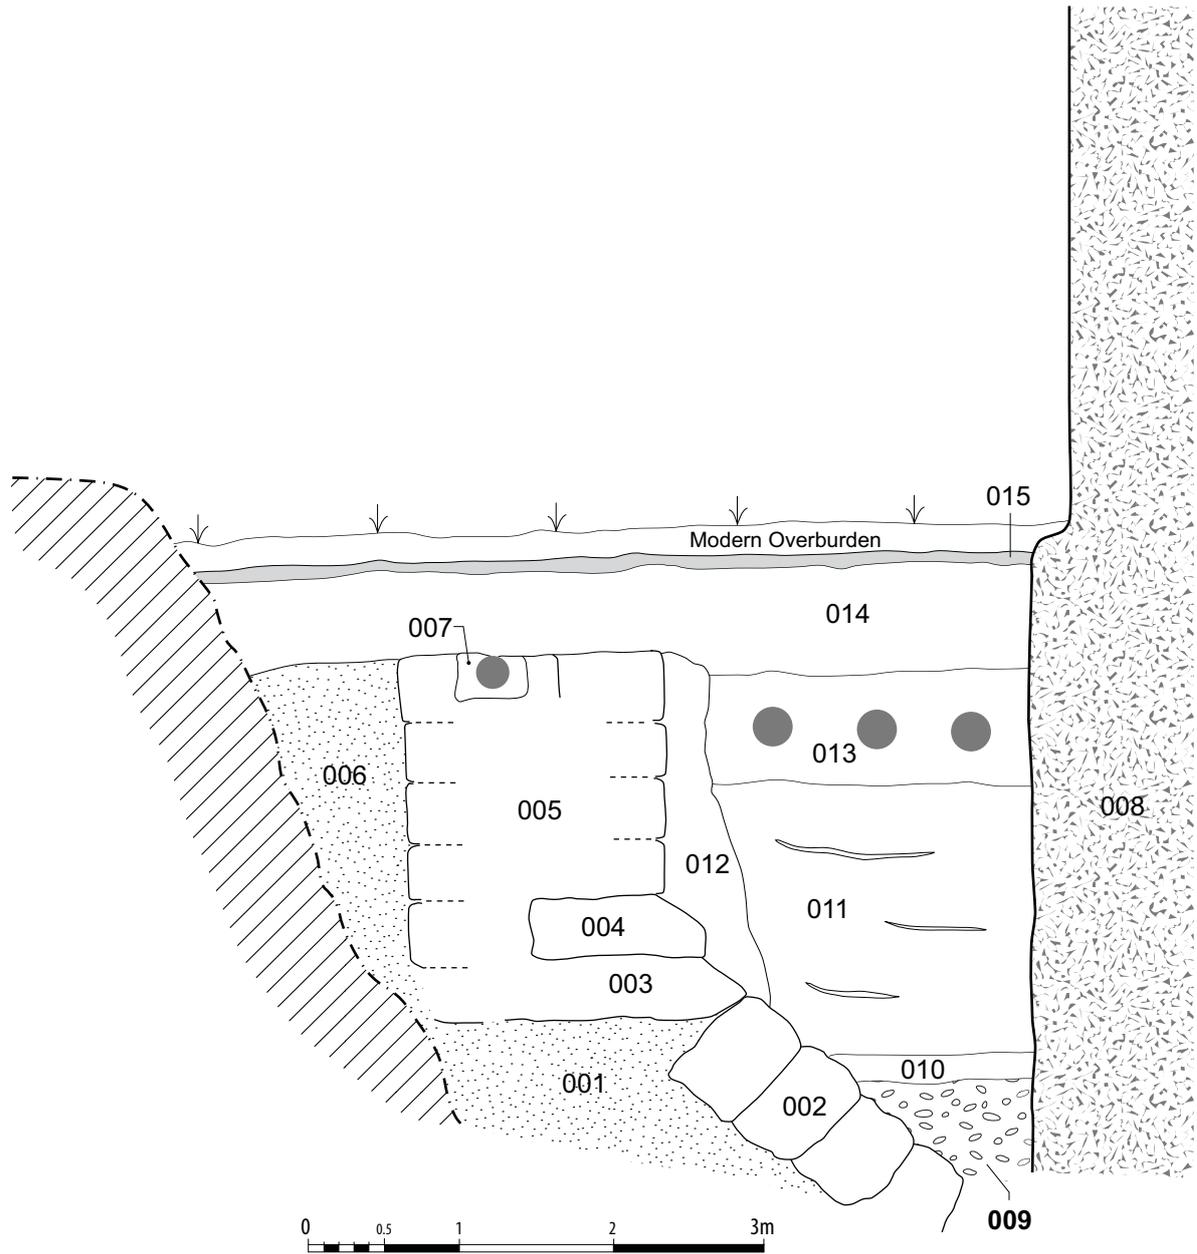
- 3.1.1 Thirteen trenches and three test-pits were monitored as part of the archaeological watching brief. Numbers in bold and parentheses relate to the context numbers shown in Appendix 2. Fig. 4 provides a section of trench 2A, which was found to have the best preserved archaeological remains of all the test pits and trenches observed. The remains located within trench 2A are discussed below and as such the findings are representative of all the trenches that were monitored during the watching brief.

- 3.1.4 The physical relationship of the base of the ashlar wall (**005**) and the stone pitching (**002**), which would have formed the exterior of the harbour breakwater, was noted in trench 2A (Fig. 4 & 8). The harbour wall was recorded as having a stugged, partially bevelled footing, comprising roughly hewn blocks of sandstone (**004**), 1.5m in length by c 1m wide. Two 0.10m diameter holes in the upper surfaces possibly suggested some form of locating dowels may have been used during the construction process. The bevelled edge was external facing, pitching outside the westerly elevation of the ashlar harbour wall (**005**) at an approximate angle of 30°. The pitching on these blocks continued for 0.20m before a vertical face met a second bevelled block (**003**) which protruded a further 0.25m westward, pitching at the same angle. This arrangement of large blocks created a tapering toe to the exterior of the harbour wall and abutted the stone pitching of the breakwater (**002**).

Fig 4 - Trench 2A: Northwest-facing section

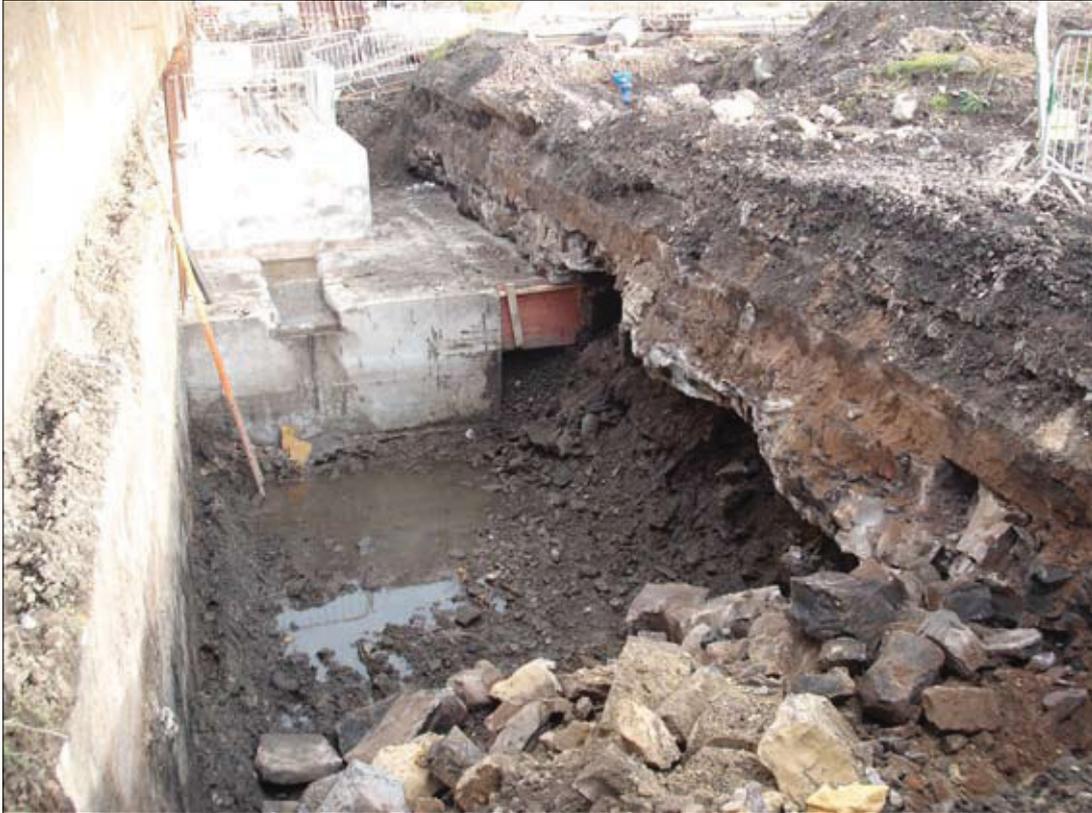
2.2.4 Each excavation involved the removal of all deposits up to the existing concrete seawall down to a depth of c 4.8m below the existing ground surface. Each trench was approximately 6m in length by 4.6m wide at its base, tapering at an angle of approximately 60° to the ground surface, which in effect increased the width of each trench to c 6m. A sequence of lightweight, reinforced concrete pours strengthened the existing seawall (Fig. 5).

Fig 5 - Shot of trench 11a post excavation: NW-facing section, showing concrete pour/reinforcement of harbour strengthening works

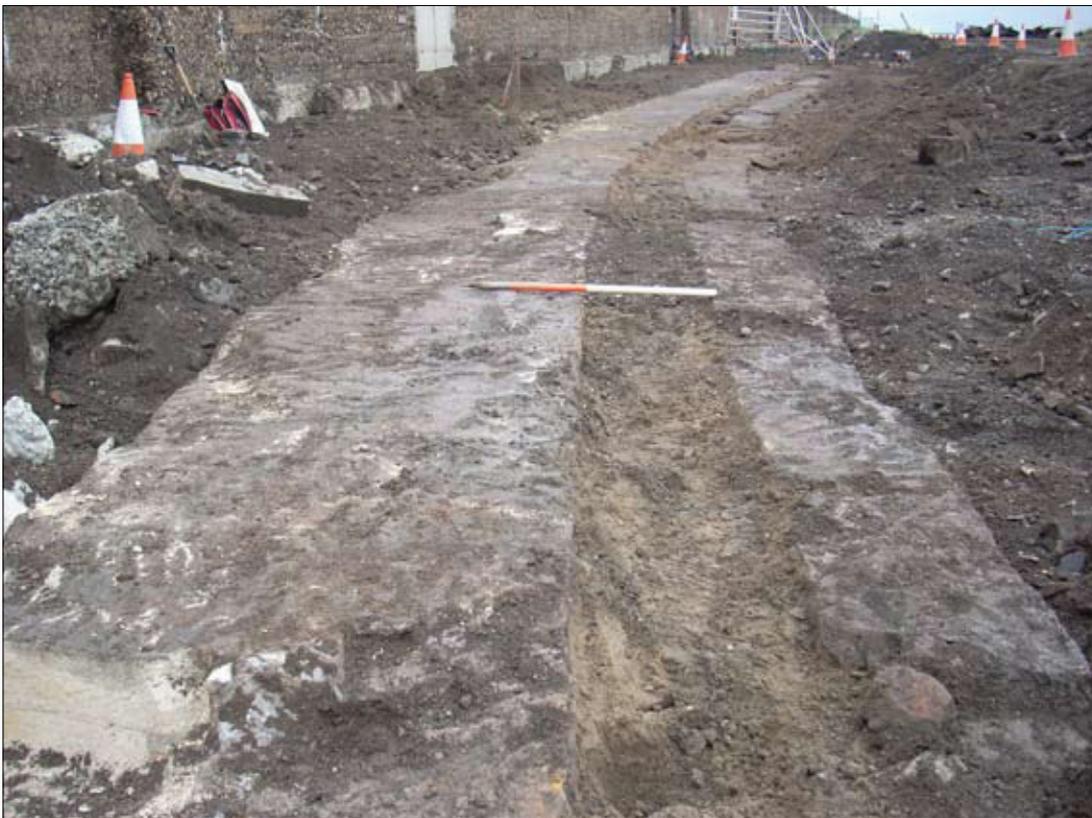
- 3.1.3 The width of the wall varied from 1.2m to 1.8m. At the current ground level a shallow pipe slot (**007**) was noted cut into the wall. This slot (Fig. 6 & 7) was in-filled after the pipe had been laid with orangey, medium to coarse grained building sand. The pipe is presumed to have been incorporated during a later phase of alteration sometime after the main construction of the ashlar wall or following its dismantling.

Fig 6 - Shot of ashlar wall 005 and pipe trench 007 in plan

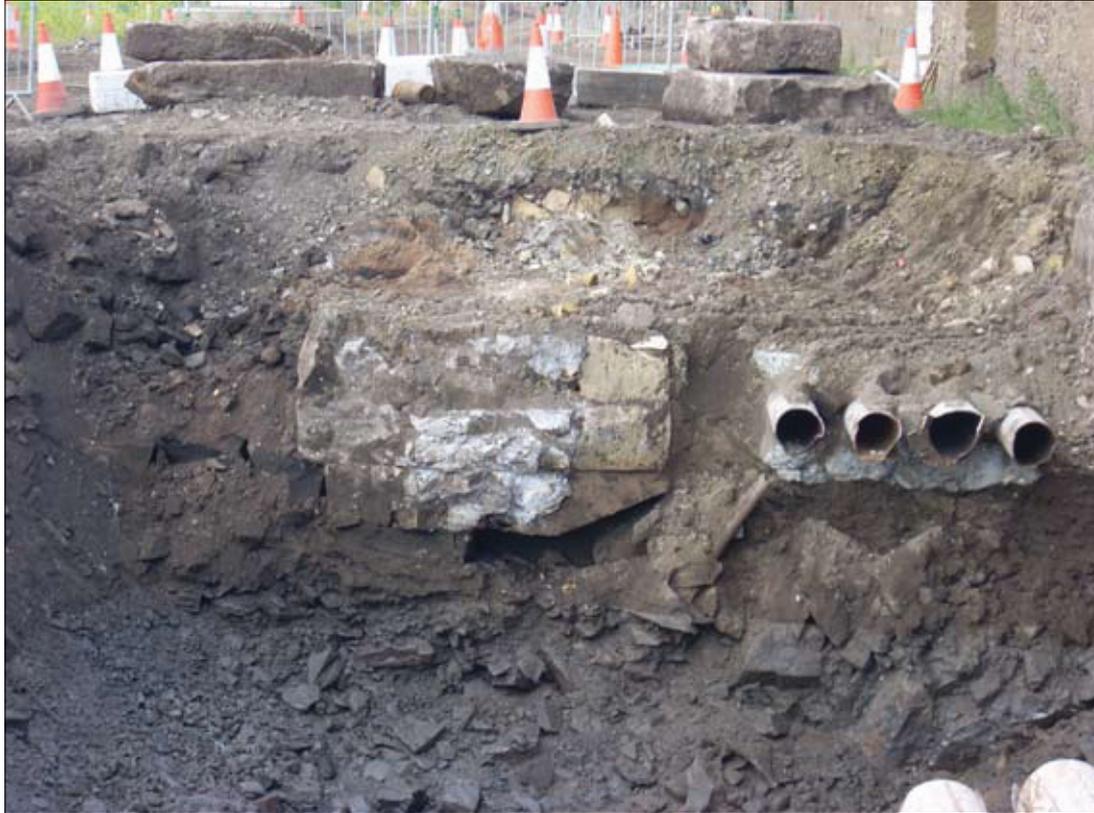
Fig 7 - Ashlar wall 005 and fuel pipes 013 after soil removal. North-facing section

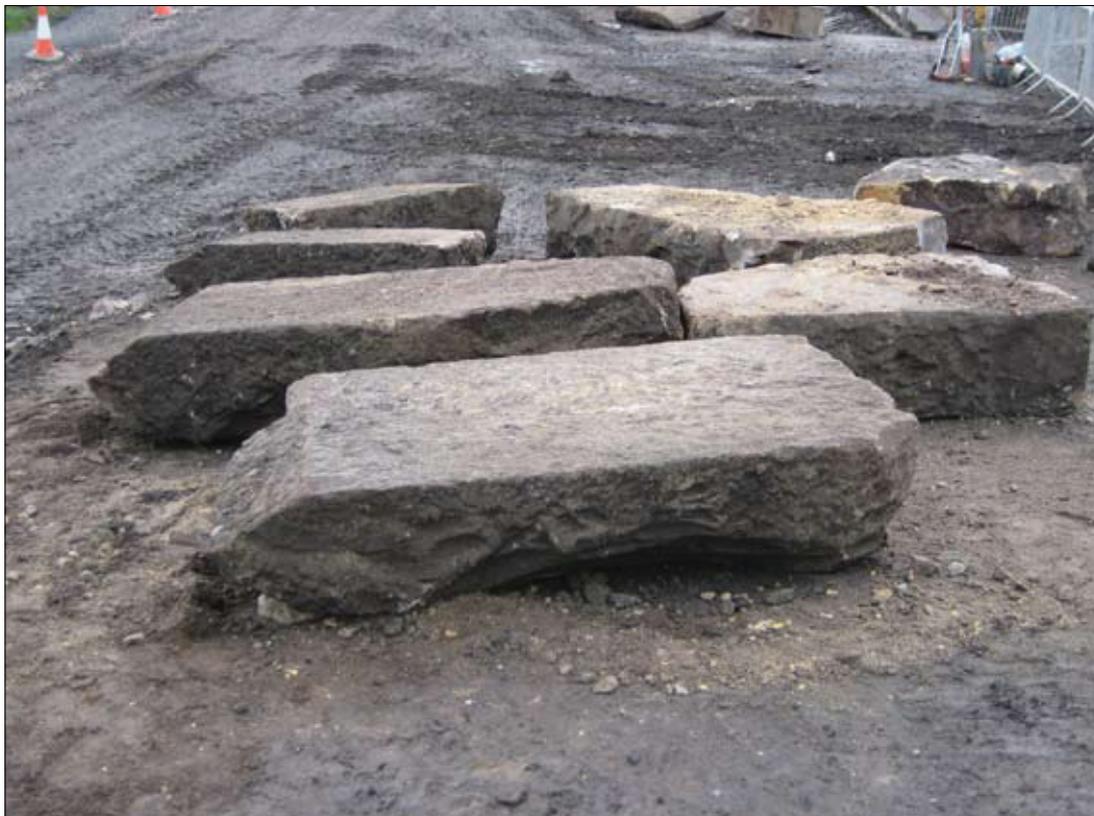
Fig 8 - Shot of bevelled stones 004 and 003

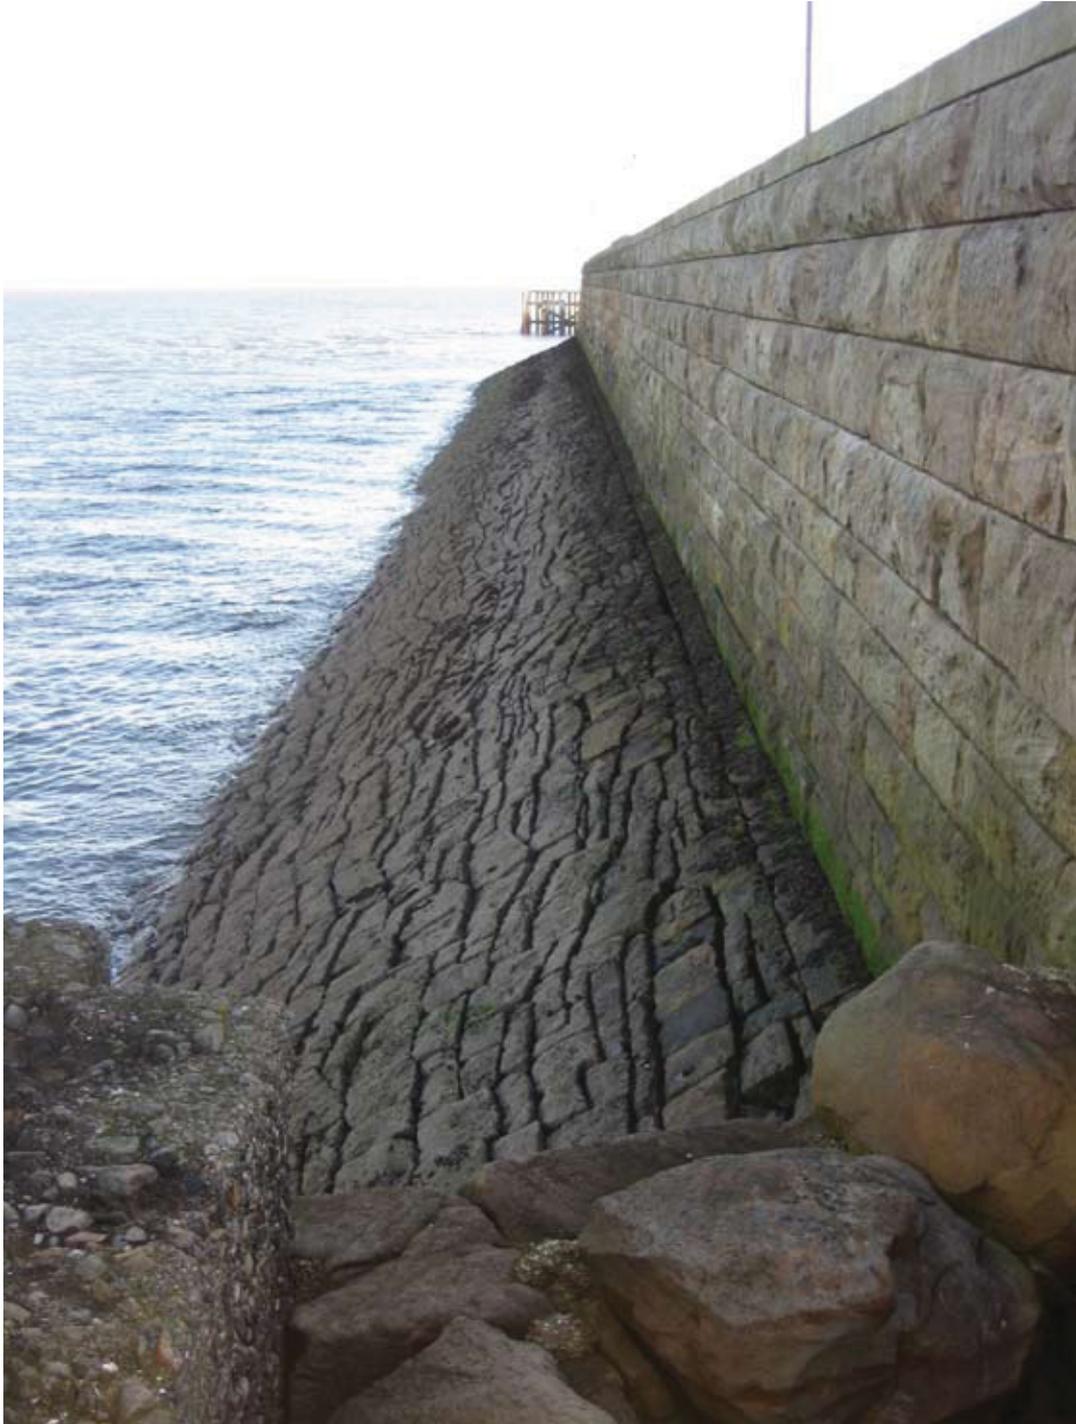
Fig 9 - General shot of external elevation of original harbour wall and stone pitching of Western Breakwater

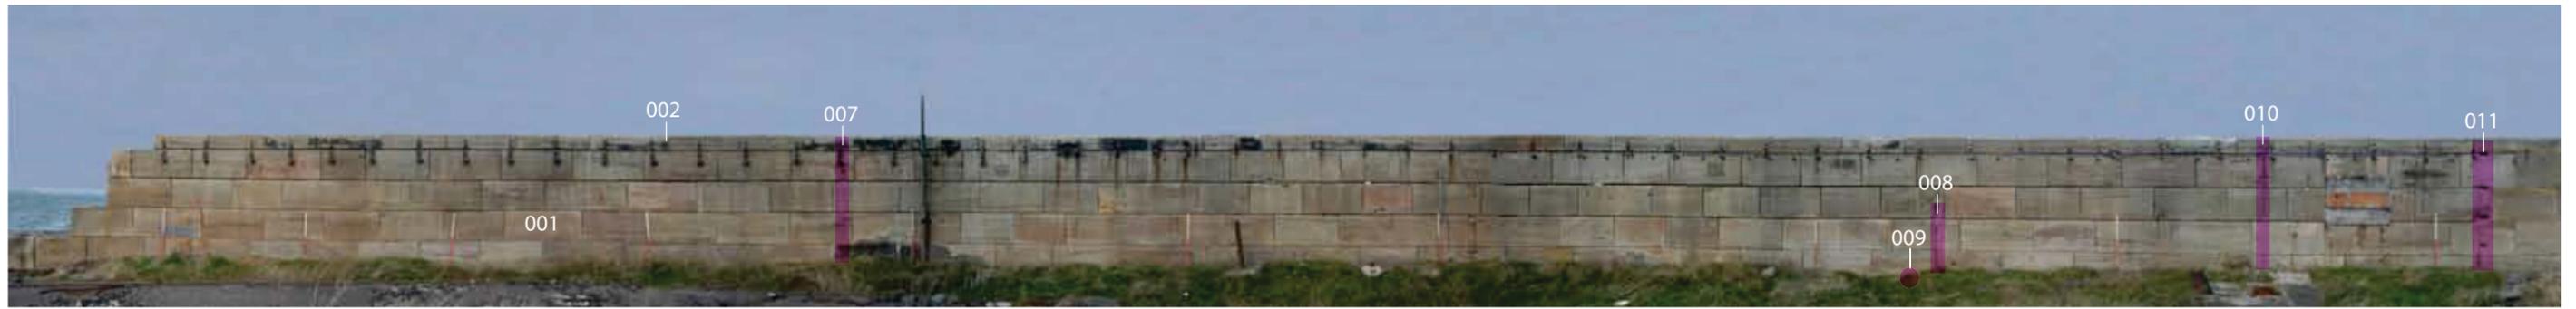
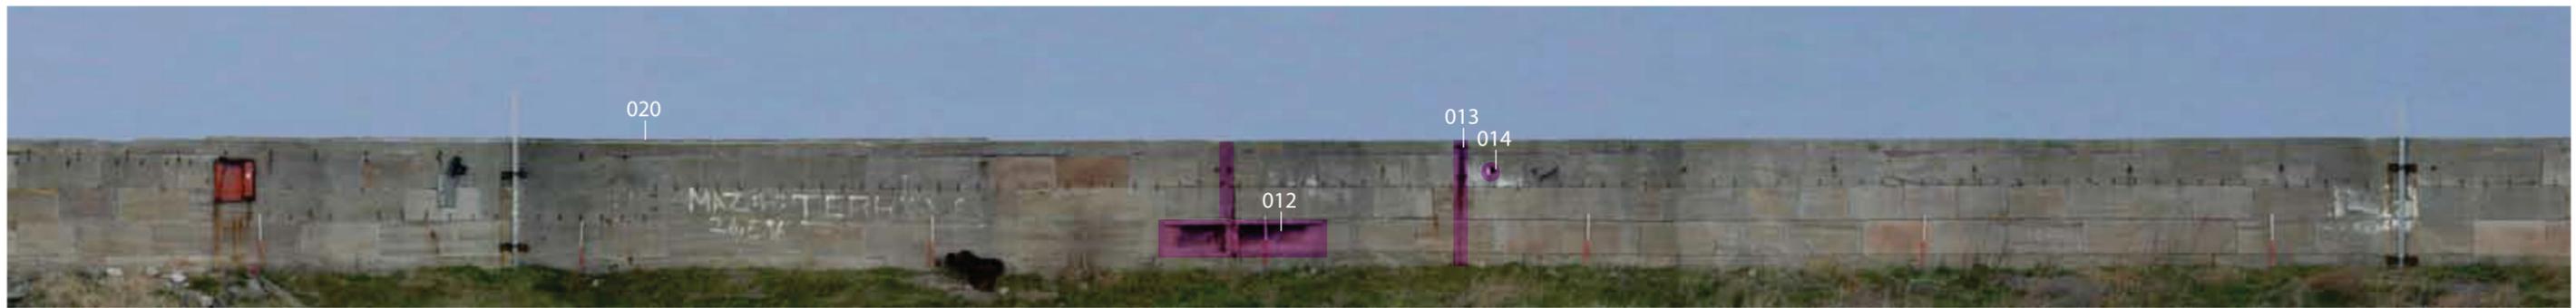
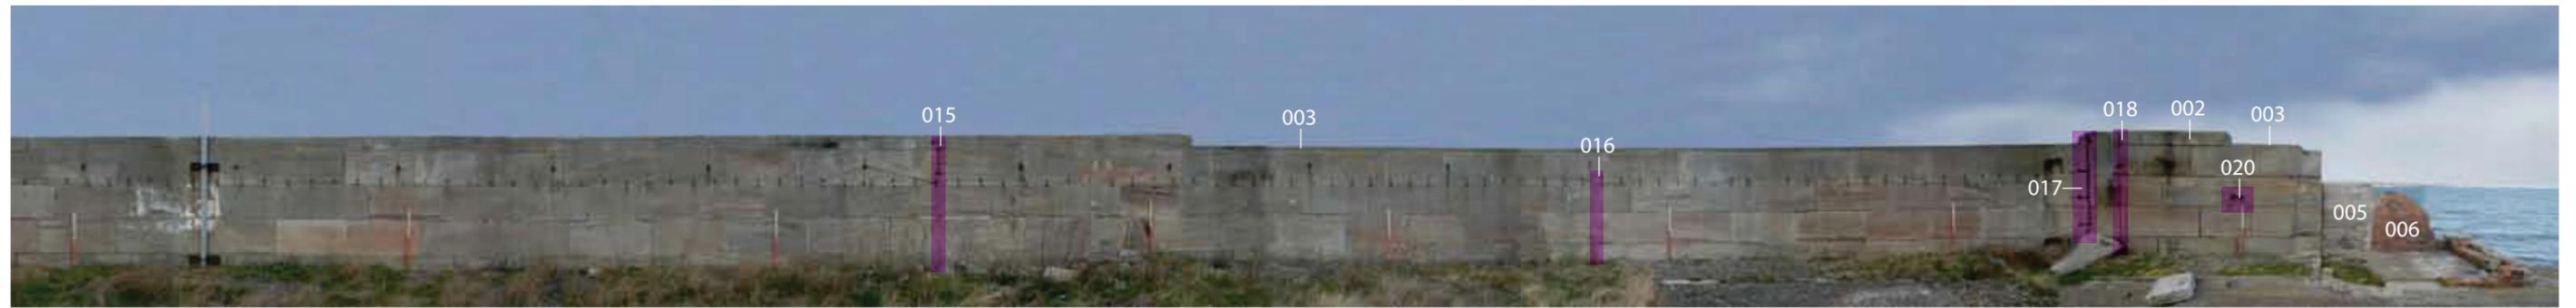
<p>IFA-registered archaeological organisation</p>	Key:	Fig. No: 10	Revision: A	Title: West-facing Harbour Wall	Drawn by: LW	Page No:

2.3.1 Figure 1 shows the position of the wall section that was recorded. Figure 10 shows the photographic montage of the internal face of the wall. A 150m length of wall was photographed.

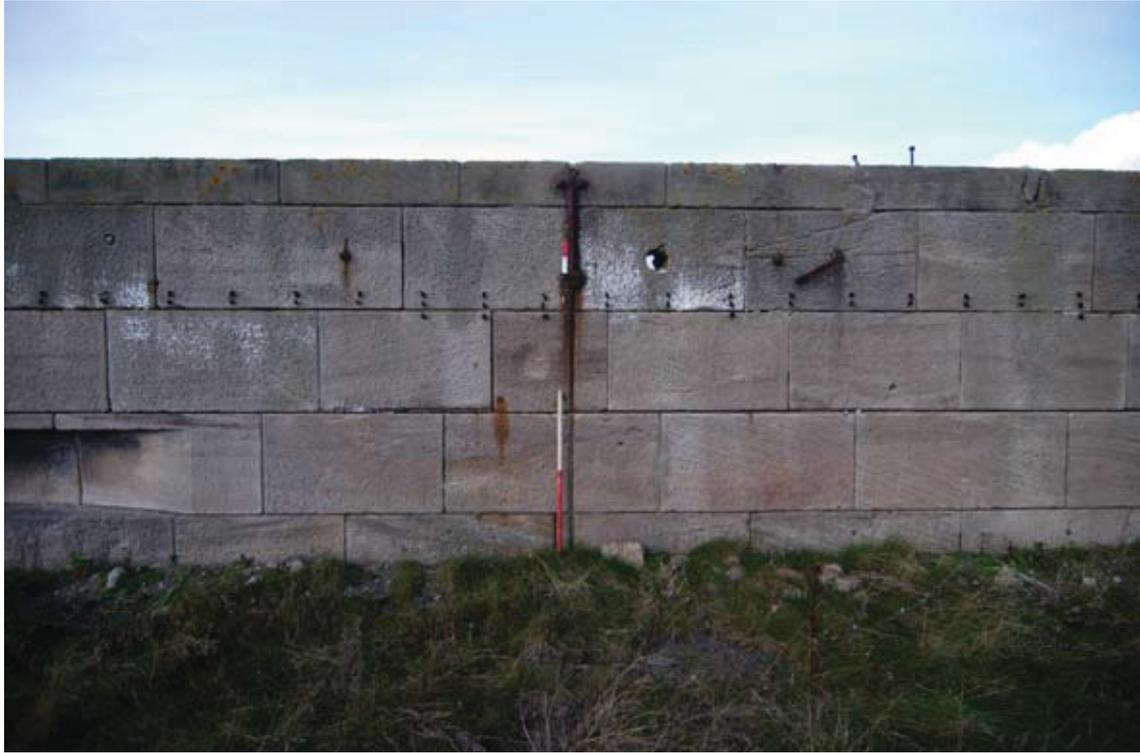
Fig 11 - Groove (013) cut into the wall for a lamp stand

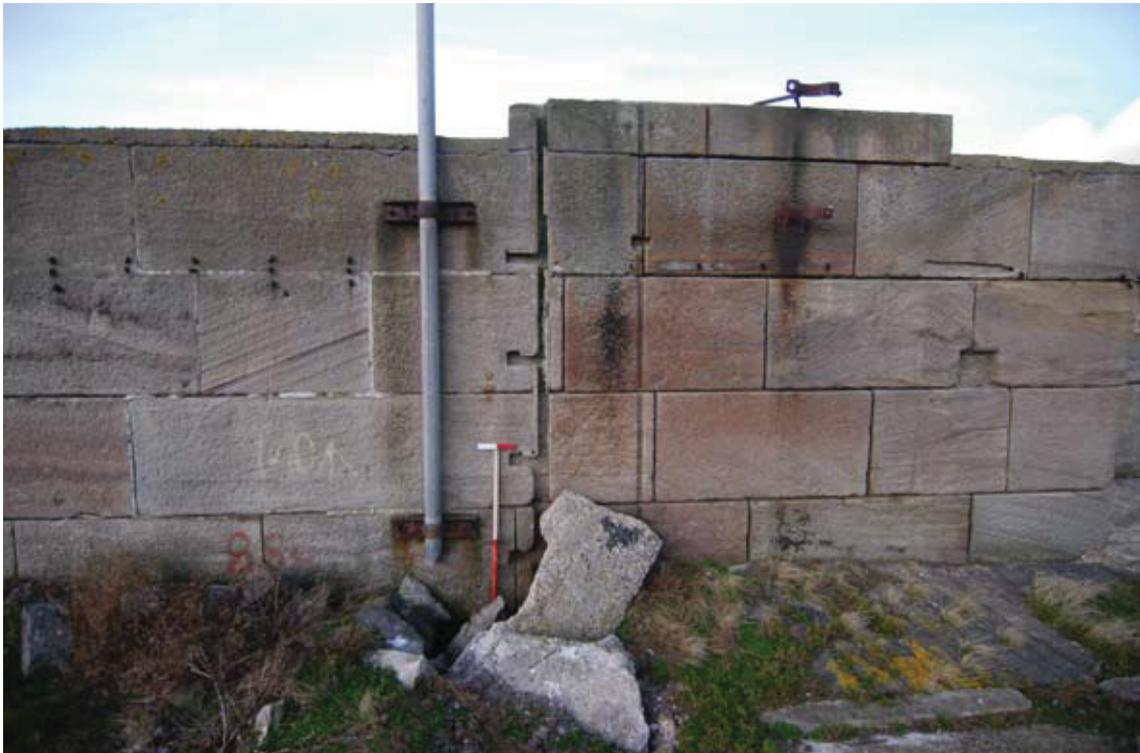
Fig 12 - Groove for a pipe fixture (017) and lamp stand (018)

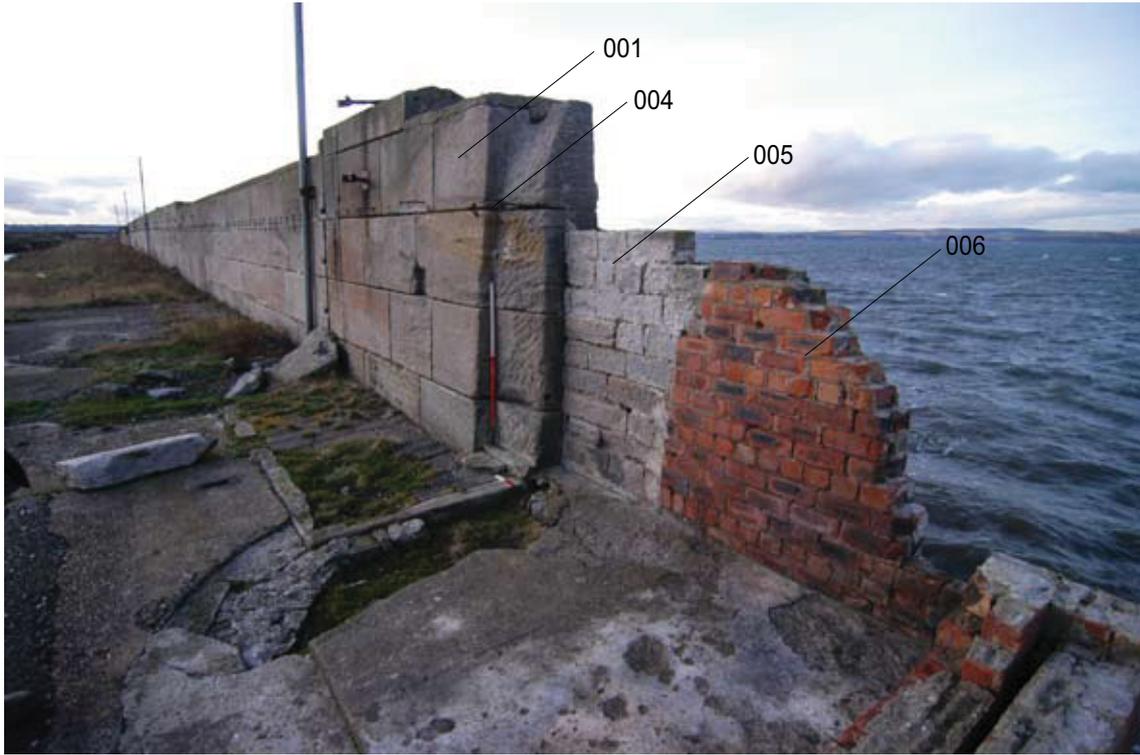
- 3.2.6 At the end of the breakwater, the remains of a stone (**005**) and brick (**006**) structure (Fig. 13) were recorded. The structure measured 2.3m long by 1.38m high by 2.3m wide and contained a concrete floor (Fig. 15). The northern gable contained a cavity, 0.06m wide, and the outer portion was probably a later extension.
- 3.2.7 These walls are probably all that remains of the buildings visible on an aerial photograph from 1971. These remains probably encompass at least two separate phases of construction at the tip of the Western Breakwater, and cover the partially visible remains of a presumed circular housing for a light beacon depicted on the 1899 Admiralty map (Cressey 2003a).

Fig 13 - Detail shot of tip of breakwater wall

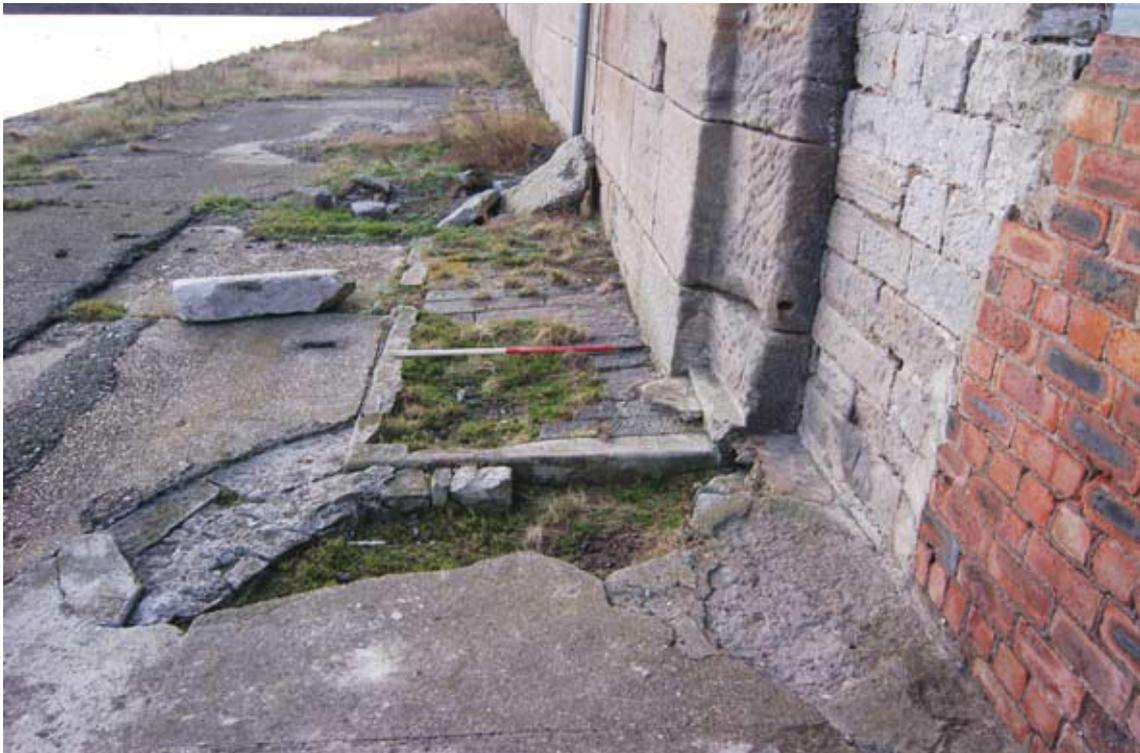
noted for the lamp stands, was observed within the face of the wall. The function of this cut is unclear, although its shape suggests it was associated with a circular or hinged feature that had to move within this space. At a later date, and for reasons unknown, the centre was blocked with red brick (Fig. 16). A carved recess (**004**, Fig. 13) at the northern end of the wall is associated with a curved area of stone on the pier. This feature is likely to have been the remains of a small stone building, possibly a beacon at the end of the pier, although its function remains unknown (Fig. 14).

Fig 14 - Wall remains associated with inset (004)

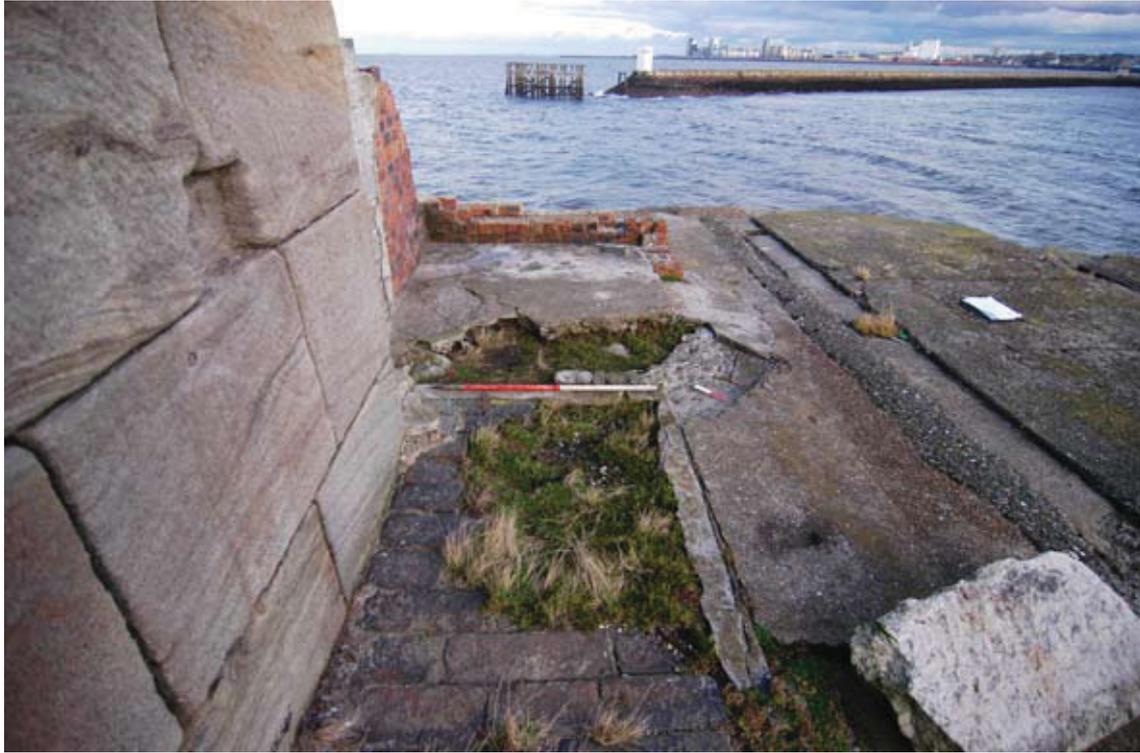
Fig 15 - Brick structure (006) at north of pier

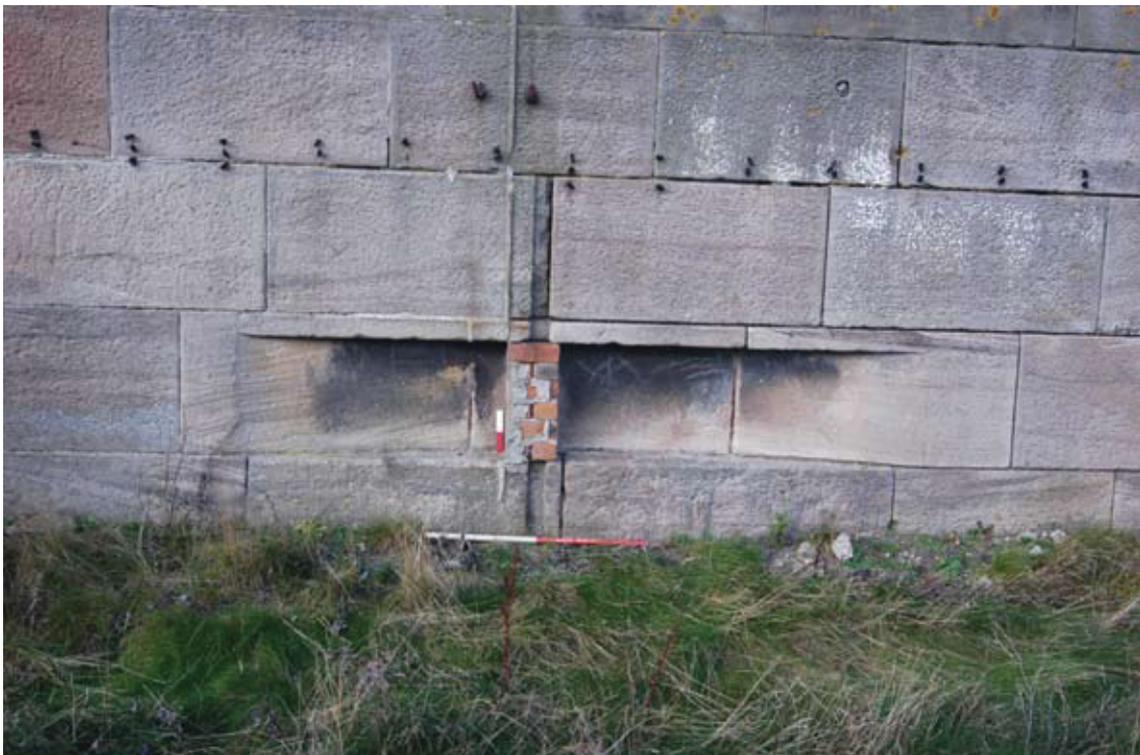
- 3.2.5 The wall includes the scars of a number of fixtures and fittings including modern posts and wooden notice boards (Appendix 1). The remains of five lamp stands (**007**, **010**, **013**, **015**, and **018** Fig. 10) were recorded. Part of an iron post survived in groove **013** (Fig. 11) and contained a hollow lead pipe. It is unclear whether these are the remains of gas or electrical lamps, but the associated brackets survive on the southern extent of the wall. Three other grooves (Fig. 12) cut into the wall (**008**, **011** and **017**) are probably associated with other service pipes being attached to the wall. A large arched horizontal cut (**012**) with an associated vertical groove (Fig. 16), very similar to that

Fig 16 - Arched feature (012)

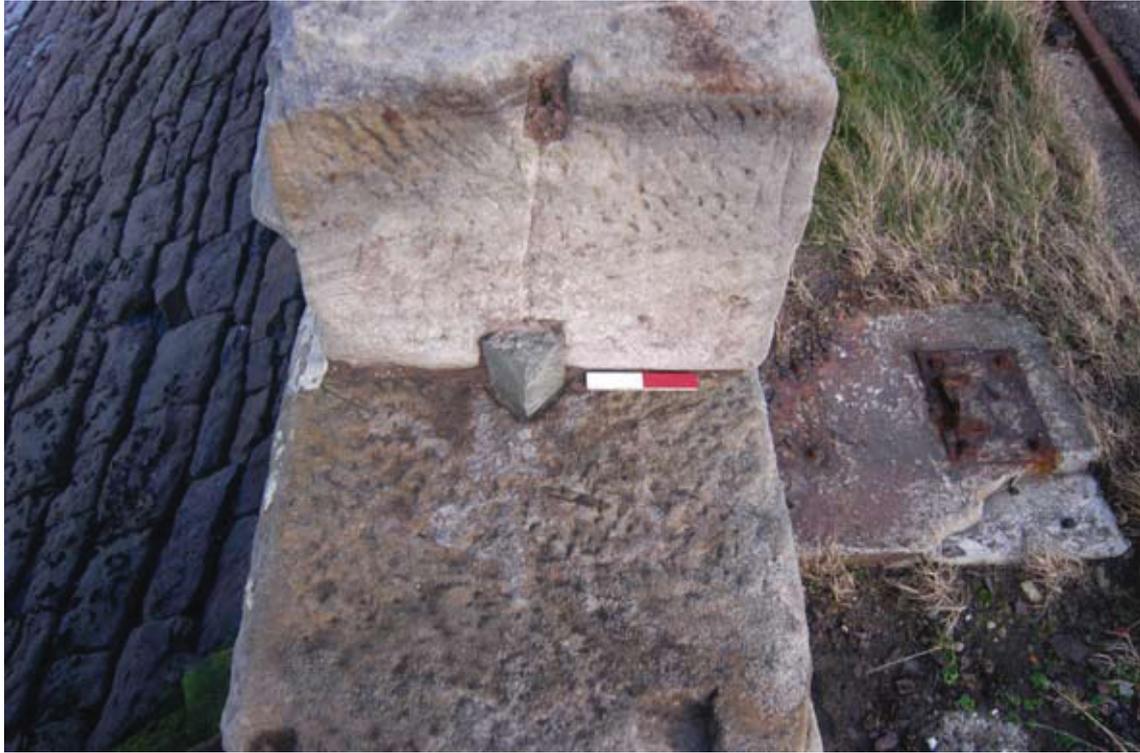
Fig 17 - In situ keystone

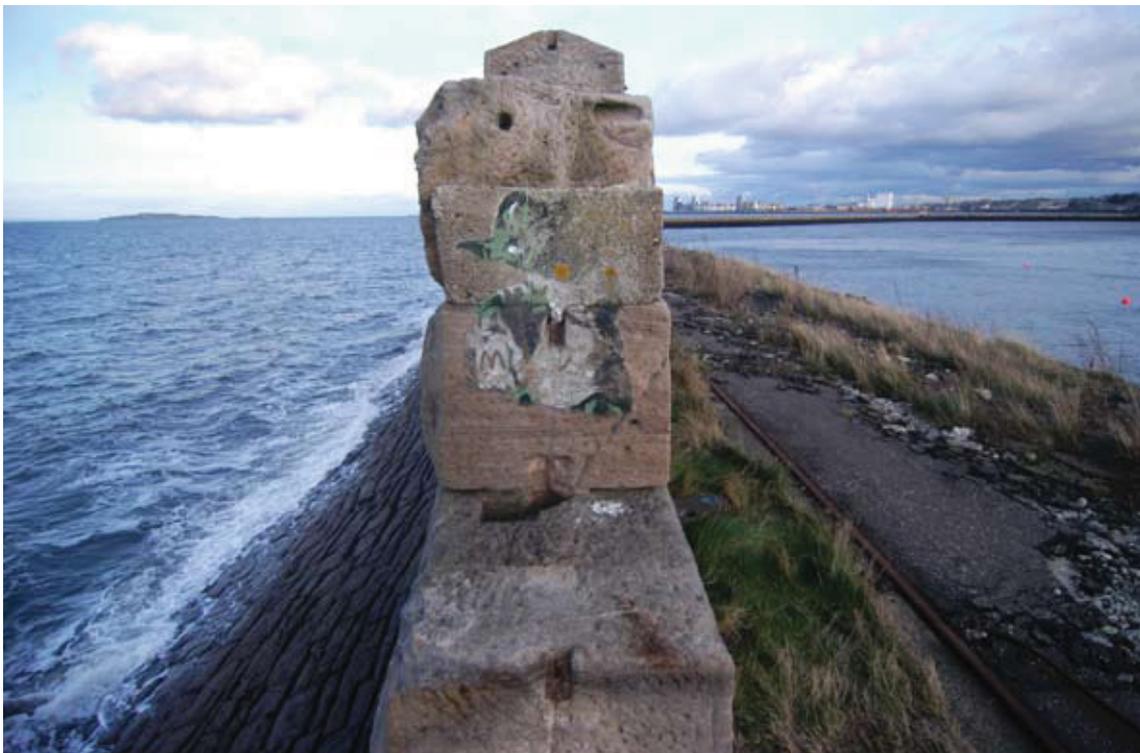
Fig 18 - Profile of wall showing cramp, keystone, and partial joggle joint

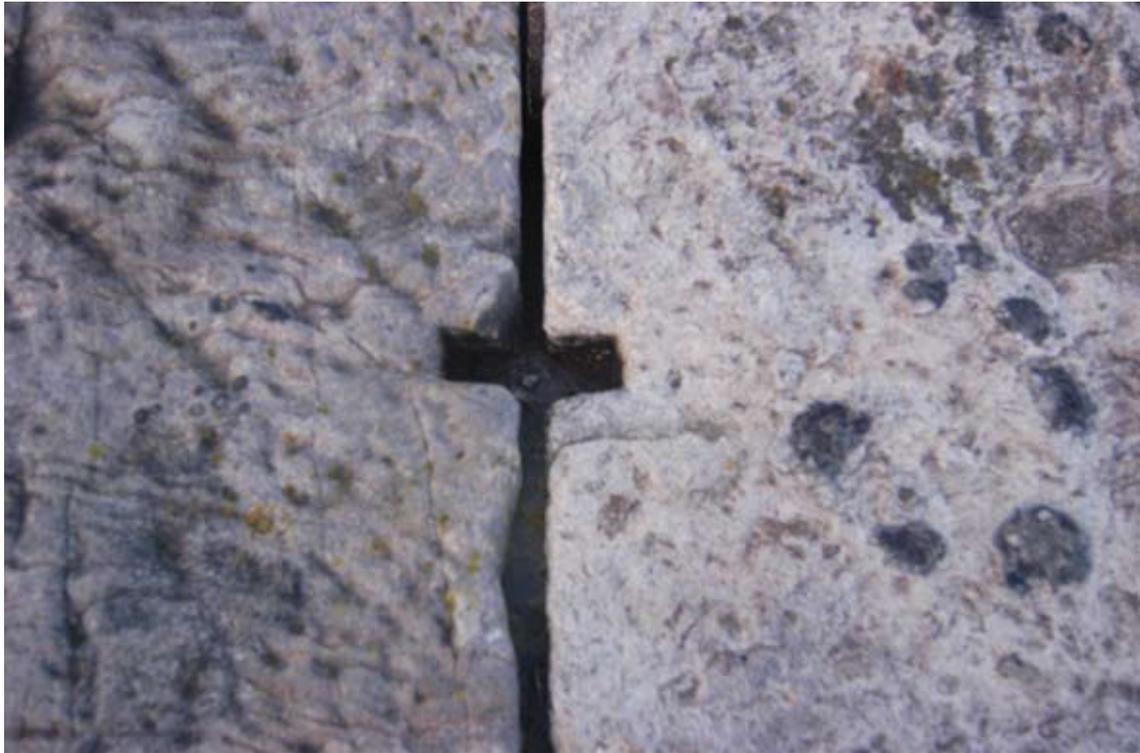
Fig 19 - Close-up of cramp joint
