15 Marlborough Street, Portobello

Historic Building Survey

Report No. 1853

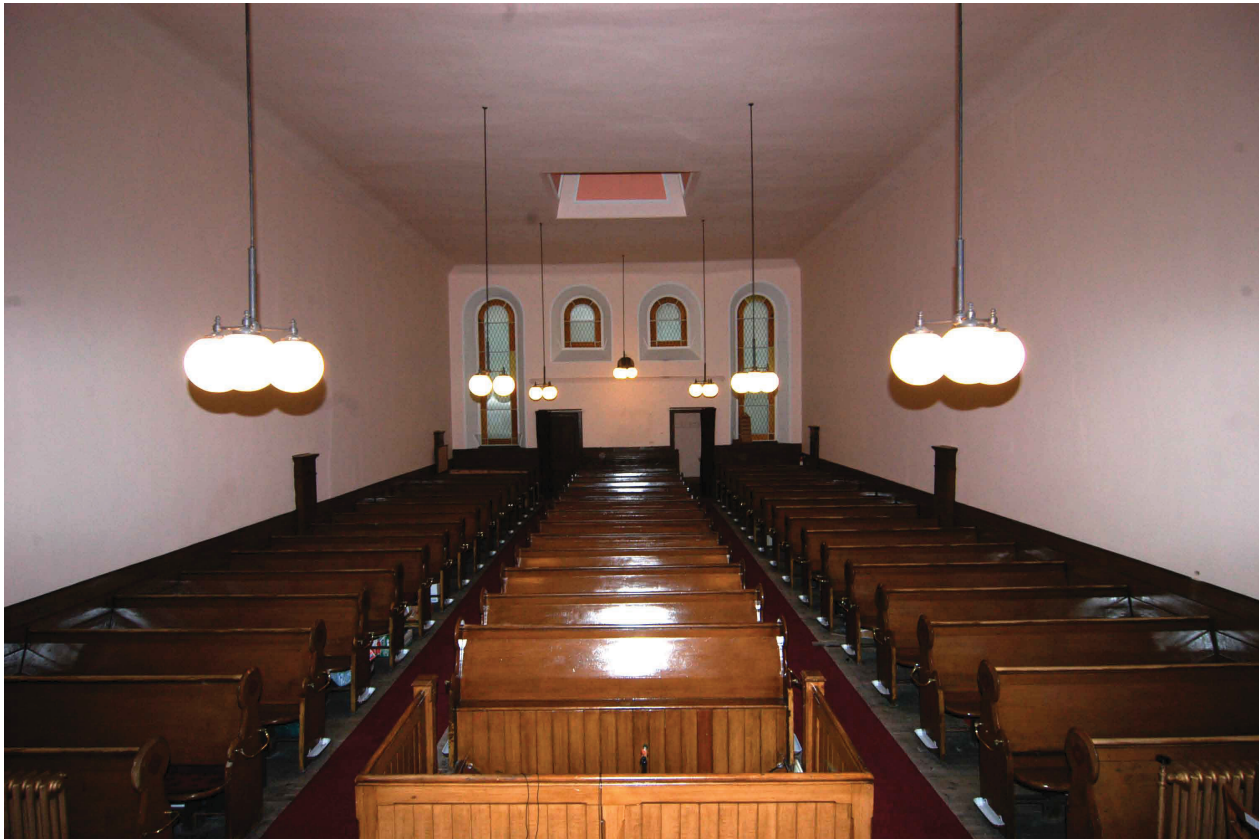
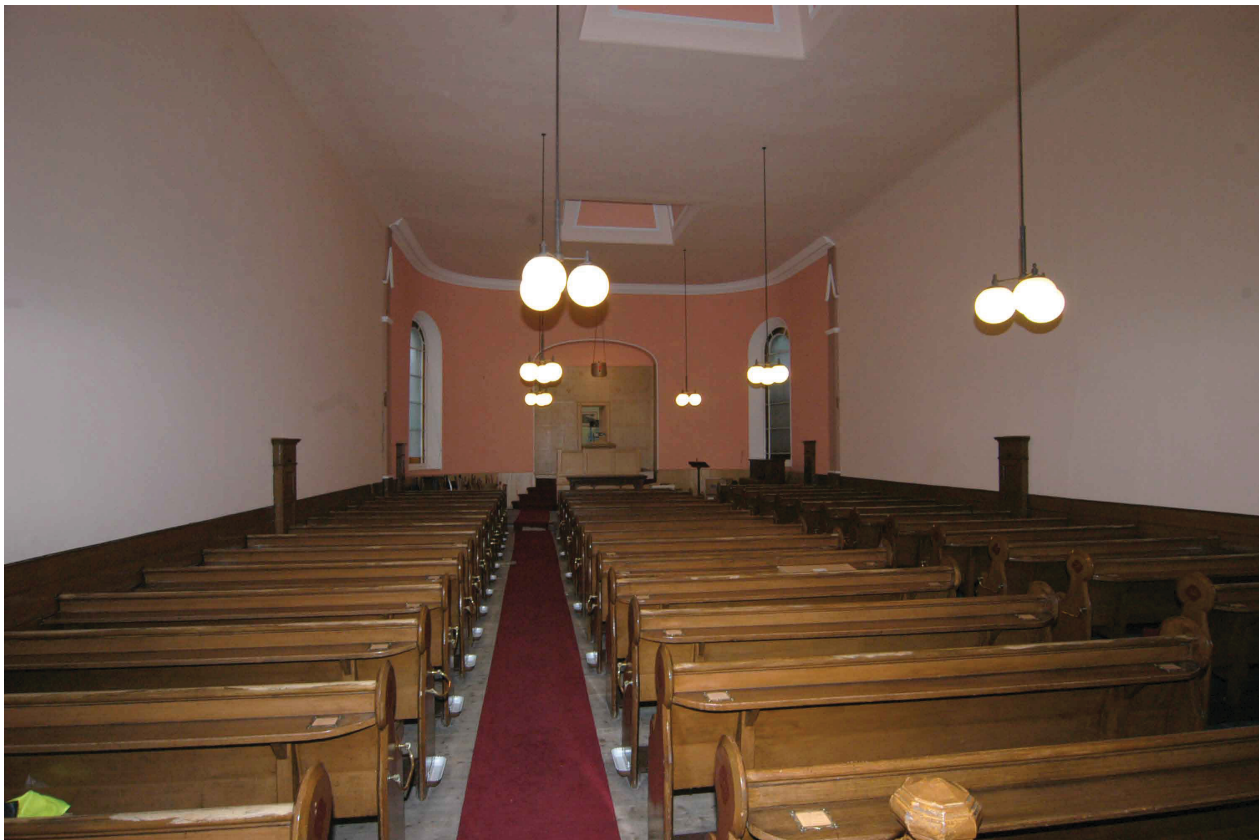
- 3.2.5 The congregation area (1) (Figs 8 & 9) is rectangular with a semi-circular east end. The nave has three rows of pews separated by two aisles. A rectangular pit (Fig 12) for an electric organ is situated at the head of the central row of pews. The altar and pulpit (Fig 11) are simple and set into a shallow recess which gives access to the vestry (2). A large timber table occupying the front of the pulpit contains a plaque (Fig 13) which reads: “*Presented to Portobello Congregational Church, by the members of The Musical Association. 24th September 1899.*” From the base of the walls to a height of 1.5m the walls of the church are timber clad. Above the cladding the walls are painted plaster. The ceiling (Fig 10) is flat with two flared square light vents. A memorial (Fig 14) to the WW1 fallen¹ and a clock were mounted at the east end of the church, although both of these had been removed prior to the survey.

Figure 8: View of church from altar

Figure 9: View of church from entrance

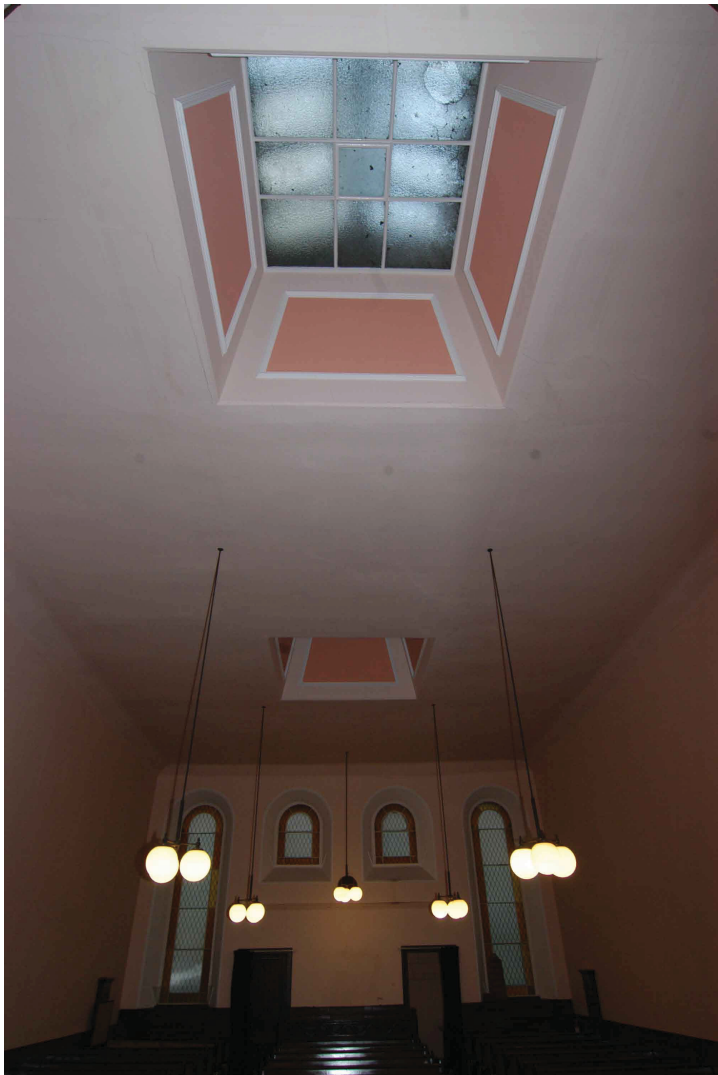
Figure 10: Church ceiling detail

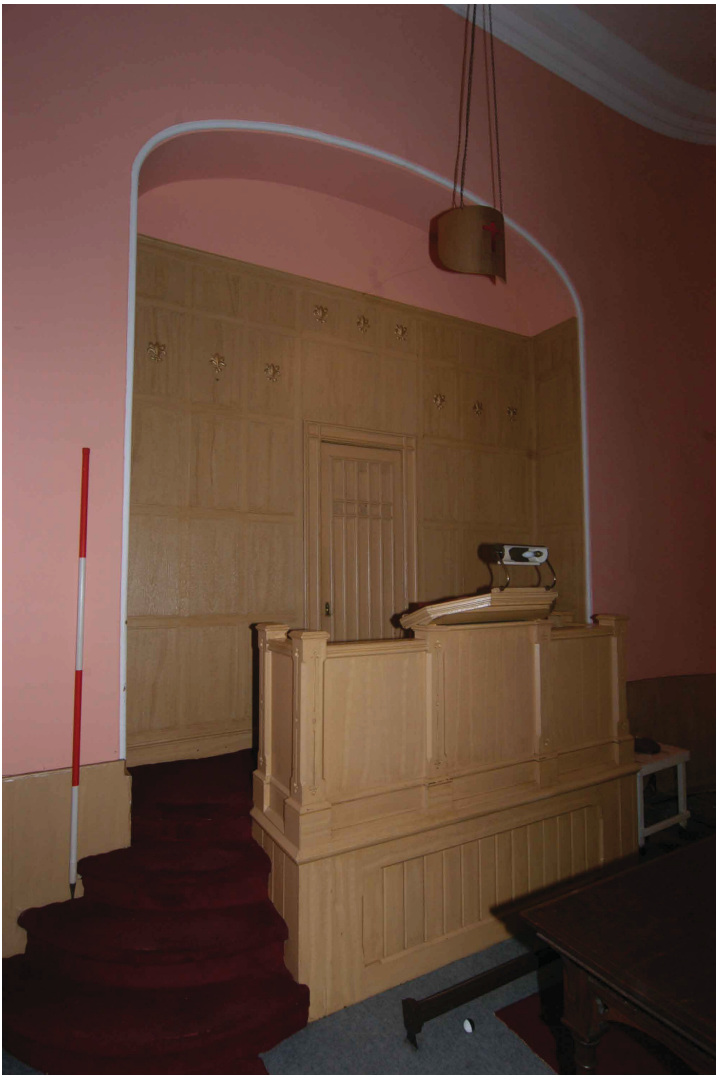
Figure 11: Altar detail

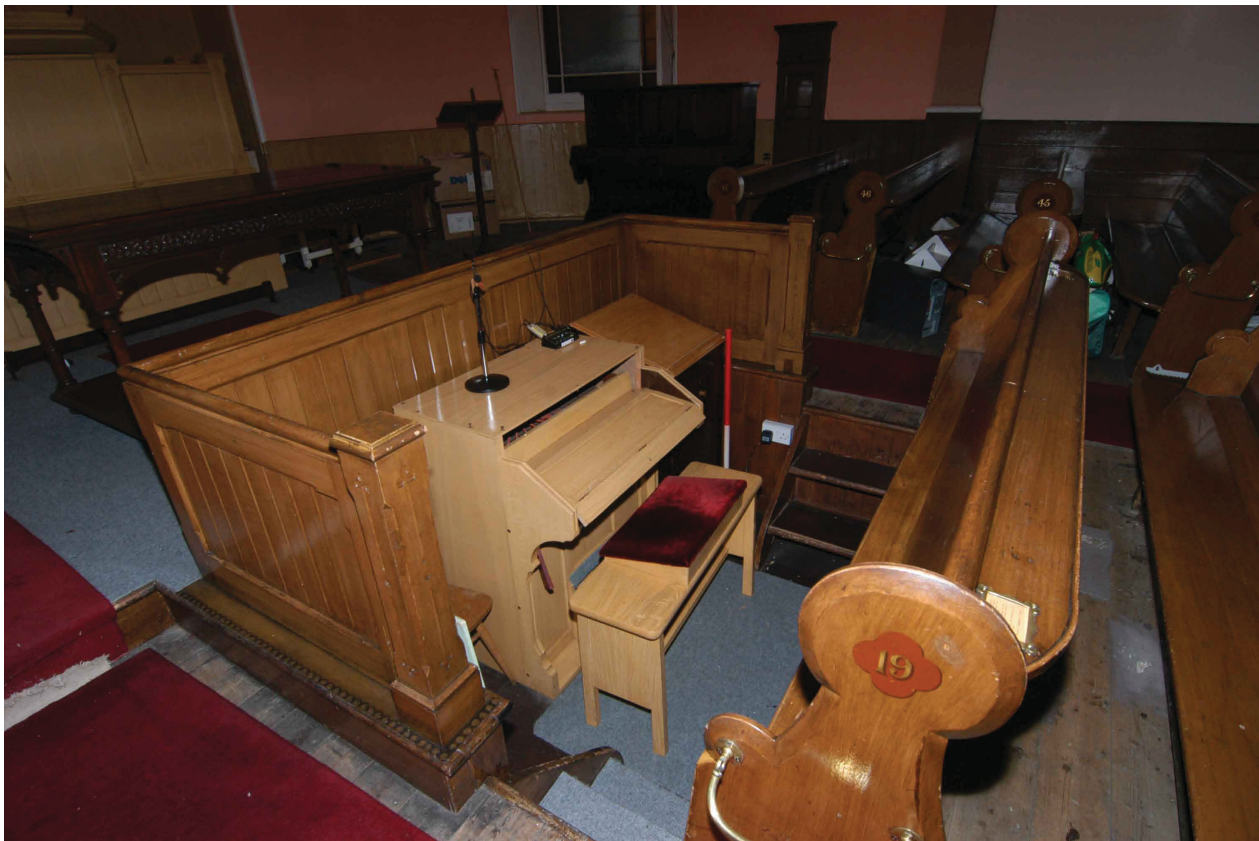
Figure 12: Organ pit detail

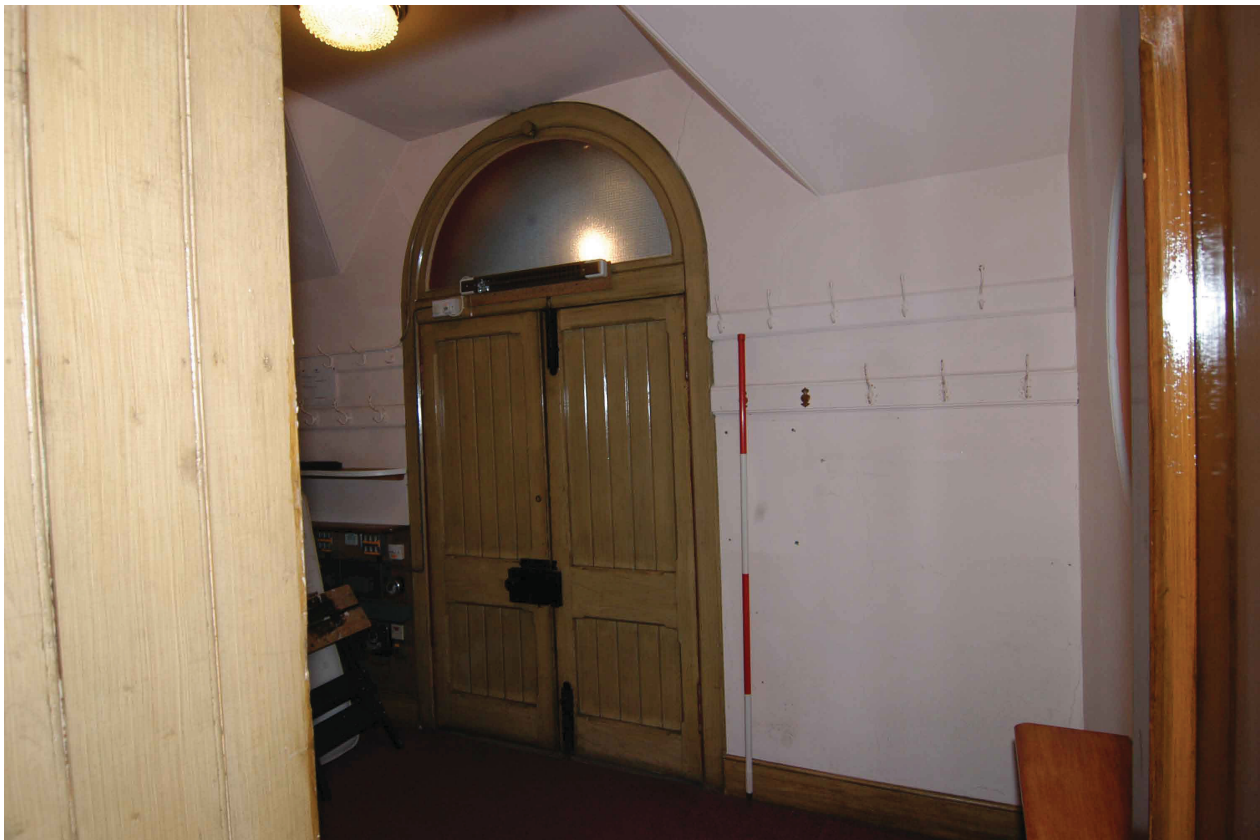
- 3.2.6 The church is accessed from the street through the vestibule (2). The west facing elevation contains the entrance which comprises double doors with an arch topped transom (Fig 15). The east facing elevation contains a rectangular central recess (Fig 17) which would have been the original double-doored entrance to the church prior to the construction of the vestibule. It is currently blocked and contains a table. The entrance doors to the aisles sit either side of the recess. The north and south facing elevations mirror each other, with a centrally placed round window with an inward splayed setting (Fig 16). Cast iron radiators are fitted below each window.

Figure 15: Interior of front entrance to vestibule

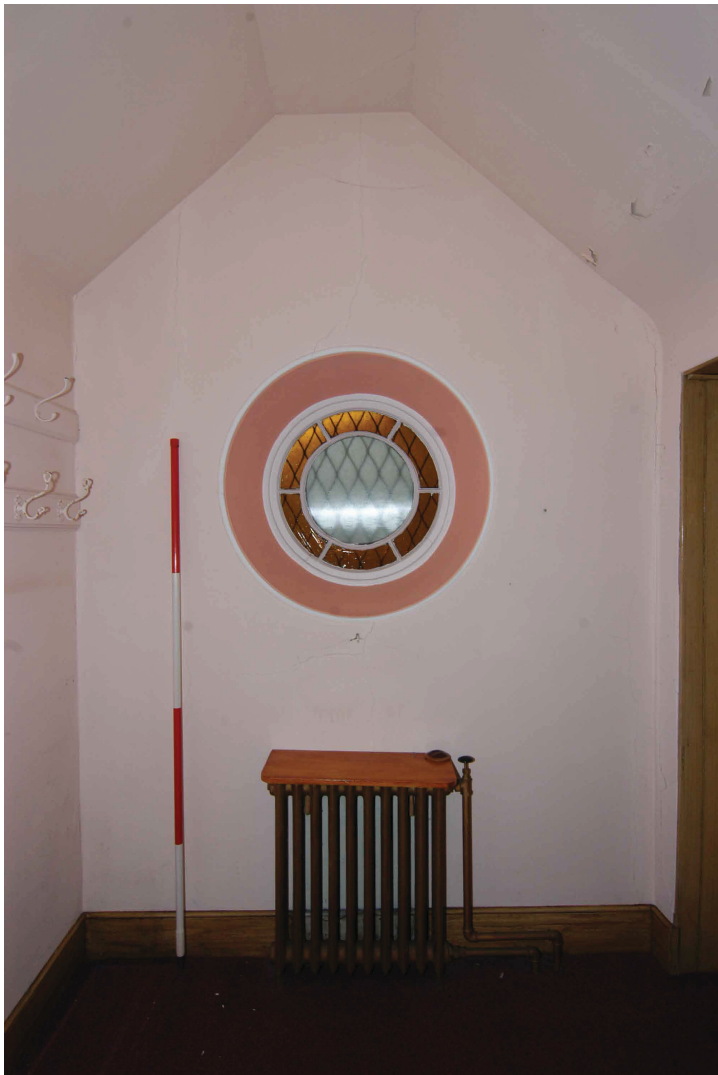
Figure 16: Interior north-facing elevation of vestibule

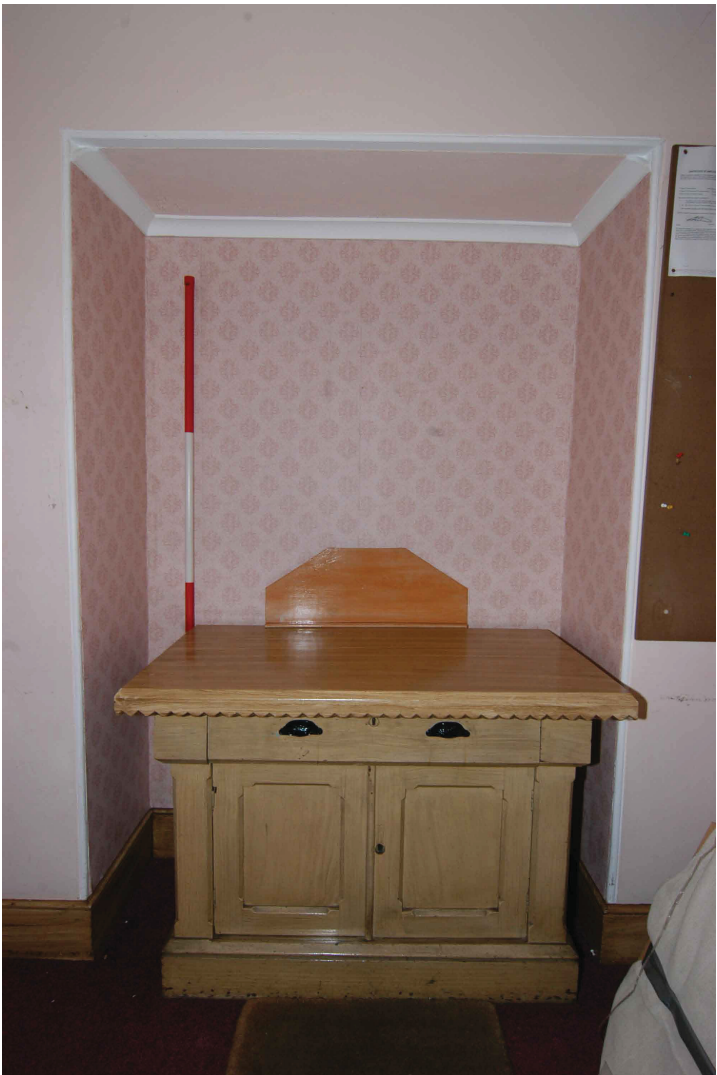
Figure 17: Recess of probable original entrance door

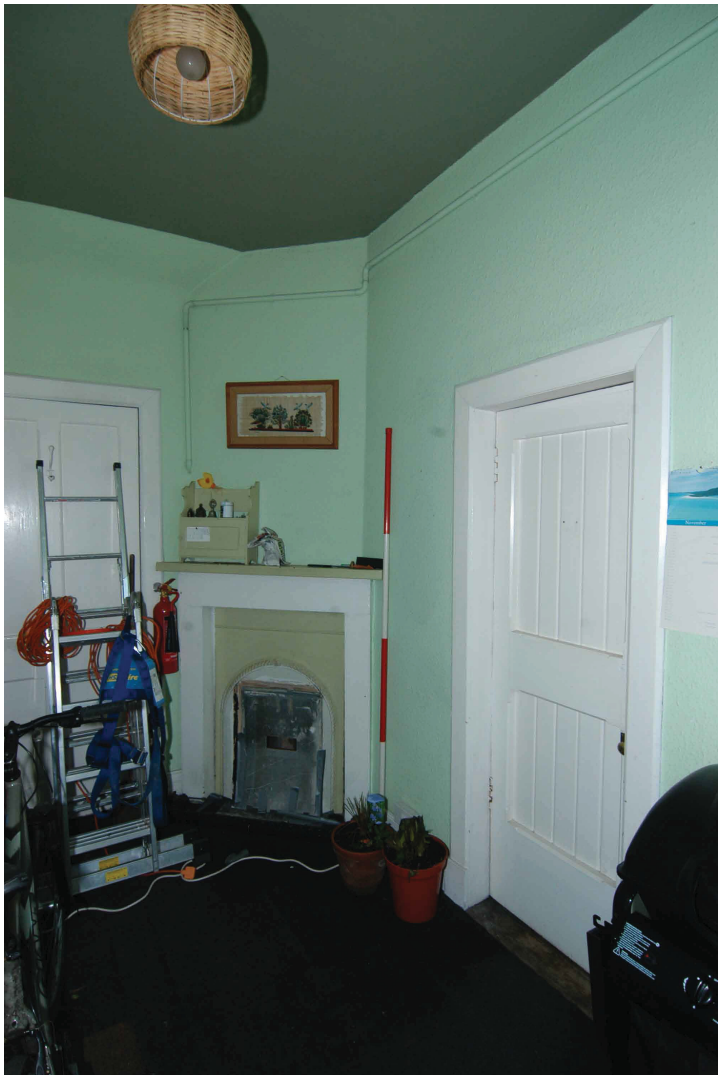
- 3.2.7 The vestry (3) is located on the west side of the church and is accessed from the main congregational area (1) via a door within the recess behind the pulpit. It is plainly decorated and features a fireplace set into the angle between the south facing and west facing elevations (Fig 18). A door on the south facing elevation leads to a small WC (4). The north facing elevation (Fig 19) has a window and door, the door gives access to a small lean-to entrance vestibule (5) on the south side of the church.

Figure 18: Interior south facing elevation of vestry

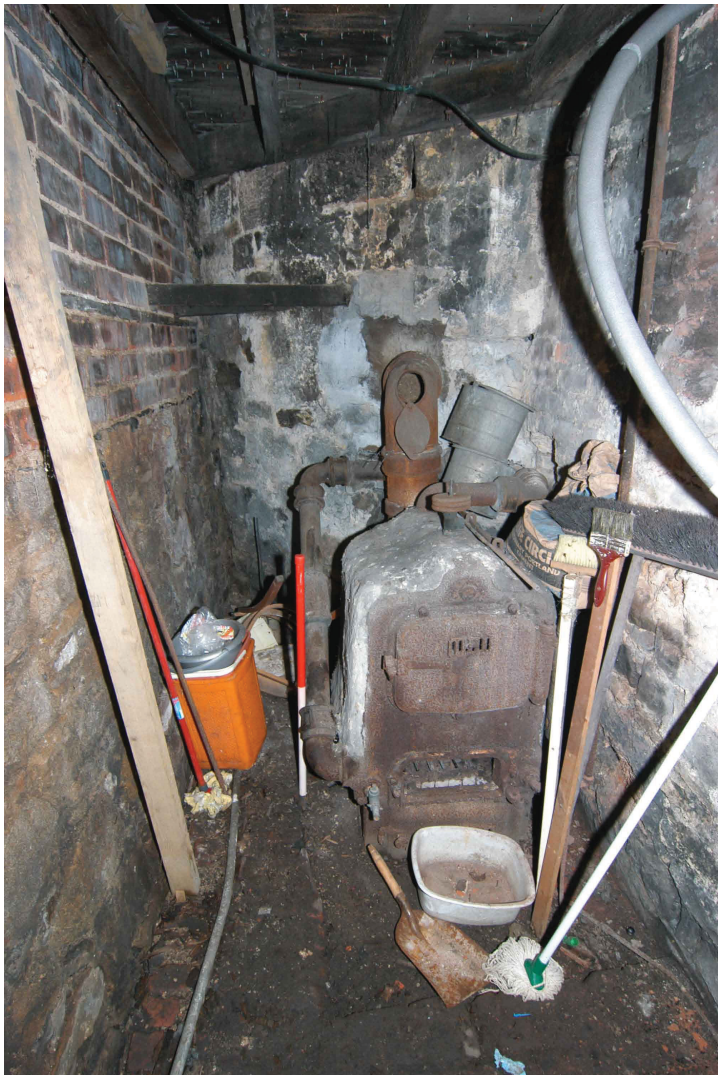
- 3.2.8 A boiler room (6) (Fig 20) is located below floor level and set in the angle of the exterior of the curve on the north side of the west end of the church. It is accessed from the hall kitchen via a door and an iron ladder, and contains a large coal fired boiler. The lower part of the walls of the boiler room were constructed of randomly laid rubble with brick upper courses and timber battens used as wall plates.

Figure 20: Interior of boiler room

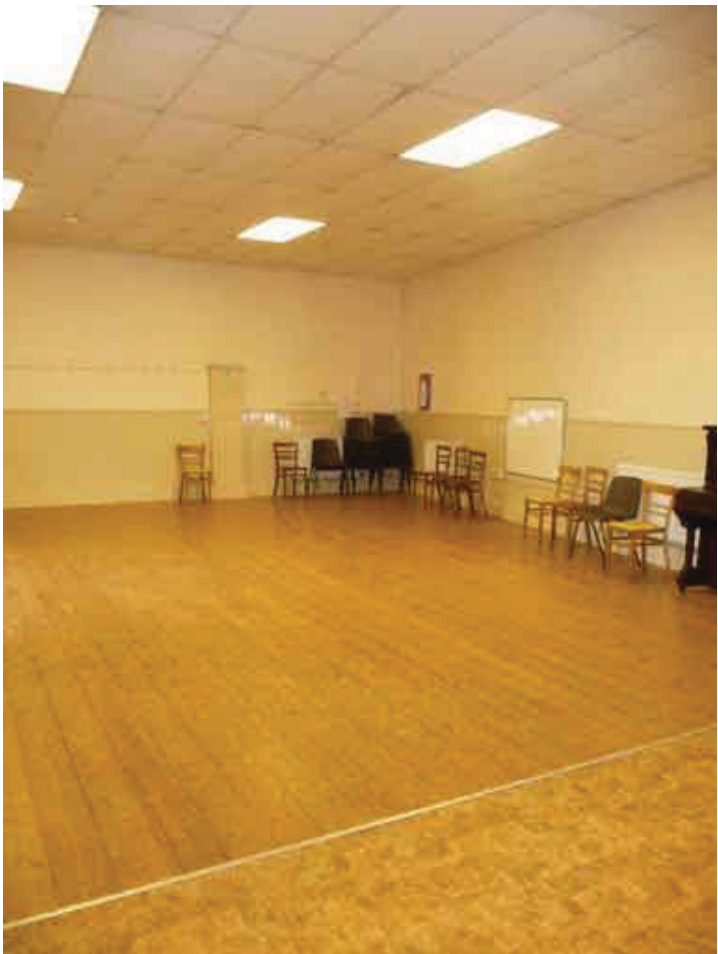
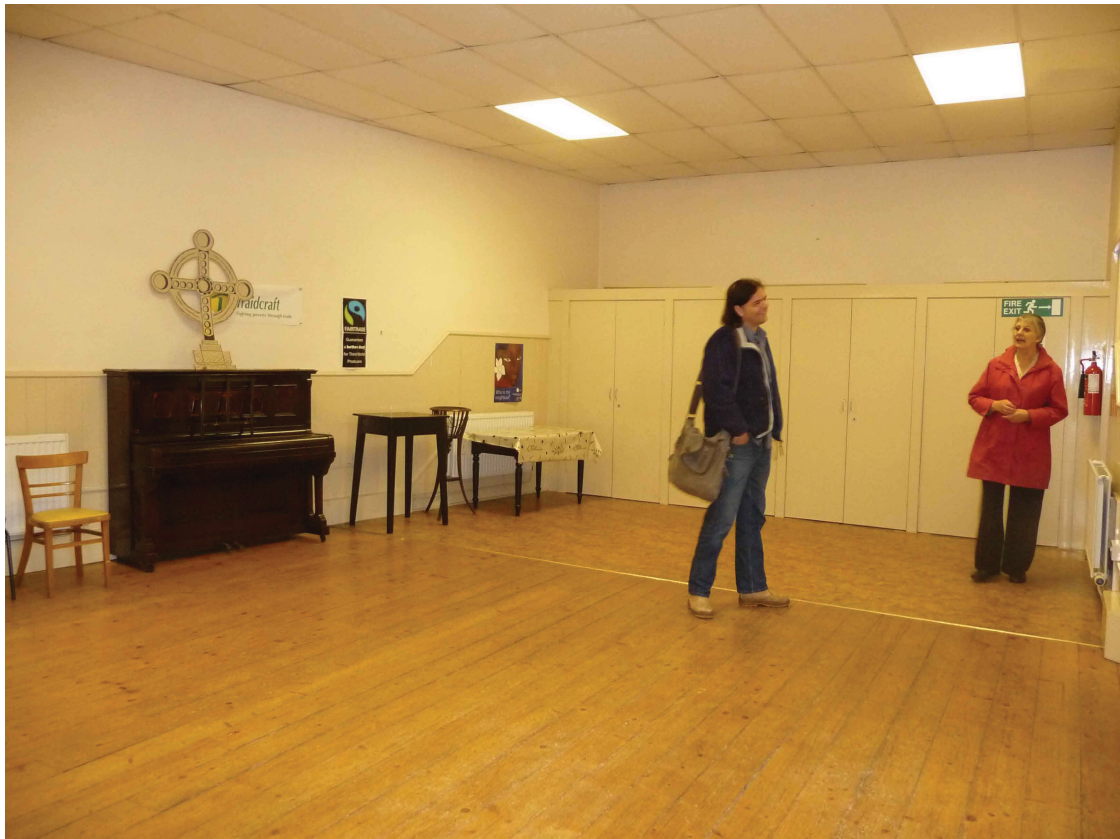
The hall (Figs 21 & 22) is sub-rectangular and is floored with timber floorboards and cork effect linoleum. The west facing elevation has two windows and two doors, one leading to the kitchen, the other leading to the WC. The walls are timber clad around the base with occasional decorative mouldings (Fig 23). The tops of the walls are plastered and painted. A suspended false ceiling has been fitted.

Figure 21: Church hall, general view of south end (Photo courtesy of Richard Berry, 2009)

Figure 22: Church hall, general view of north end (Photo courtesy of Richard Berry, 2009)

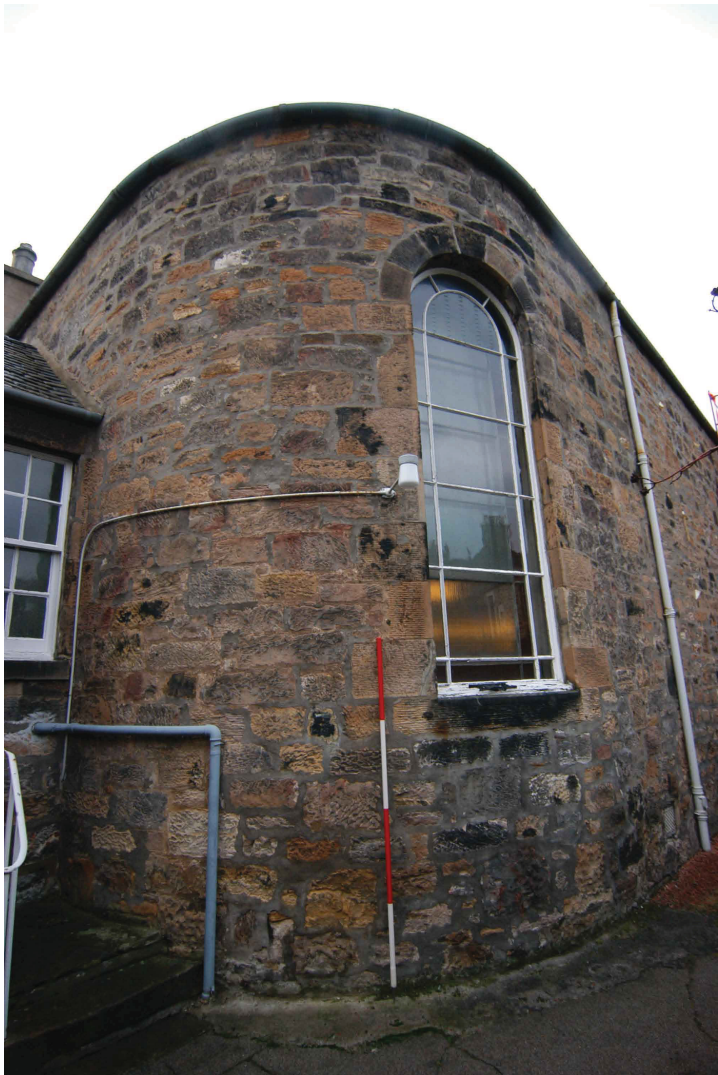
- 3.2.2 The church is aligned east to west and faces onto the street. It is built using sandstone blocks of various colours and finishes from smooth ashlar to roughly hewn. Many blocks have varied and random stugging patterns which indicate the inclusion of re-used stone in the build. It is mortar-bonded but

had extensive areas of repointing and filleting using concrete cement. Comprehensive details of the church exterior can be found on the Statutory List description.

Figure 25: Exterior view of curved east end and window

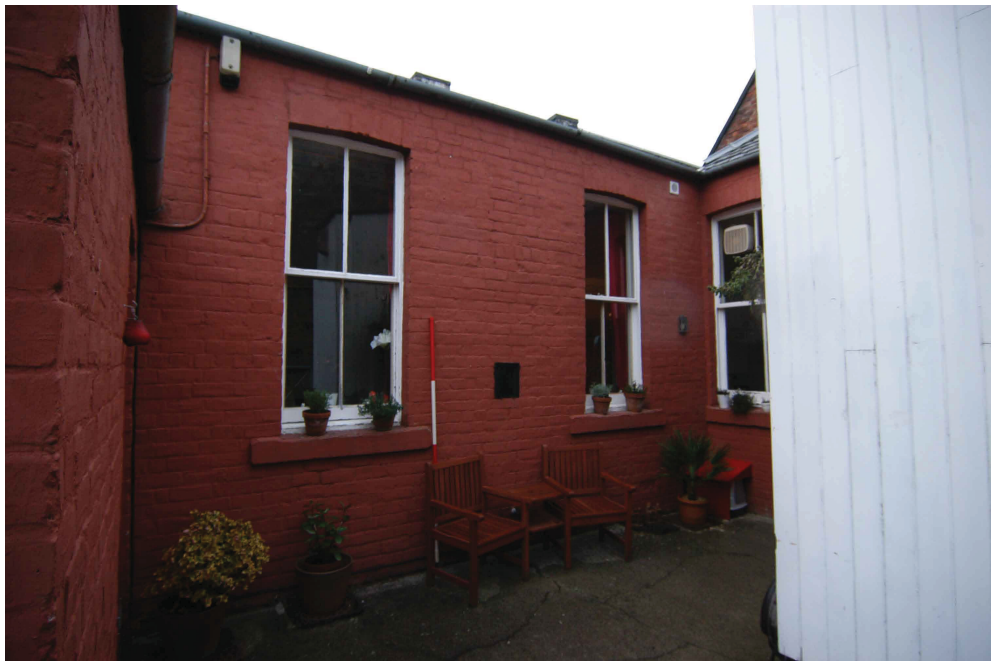
- 3.2.3 The hall is located to the rear of the church and comprises an asymmetrical three-winged building enclosing a small yard and connected to the church along the northern boundary wall. The walls are 3.9m high, brick built and unrendered, with a low hipped roof covered in grey slates.

Figure 27: Exterior view of Church hall

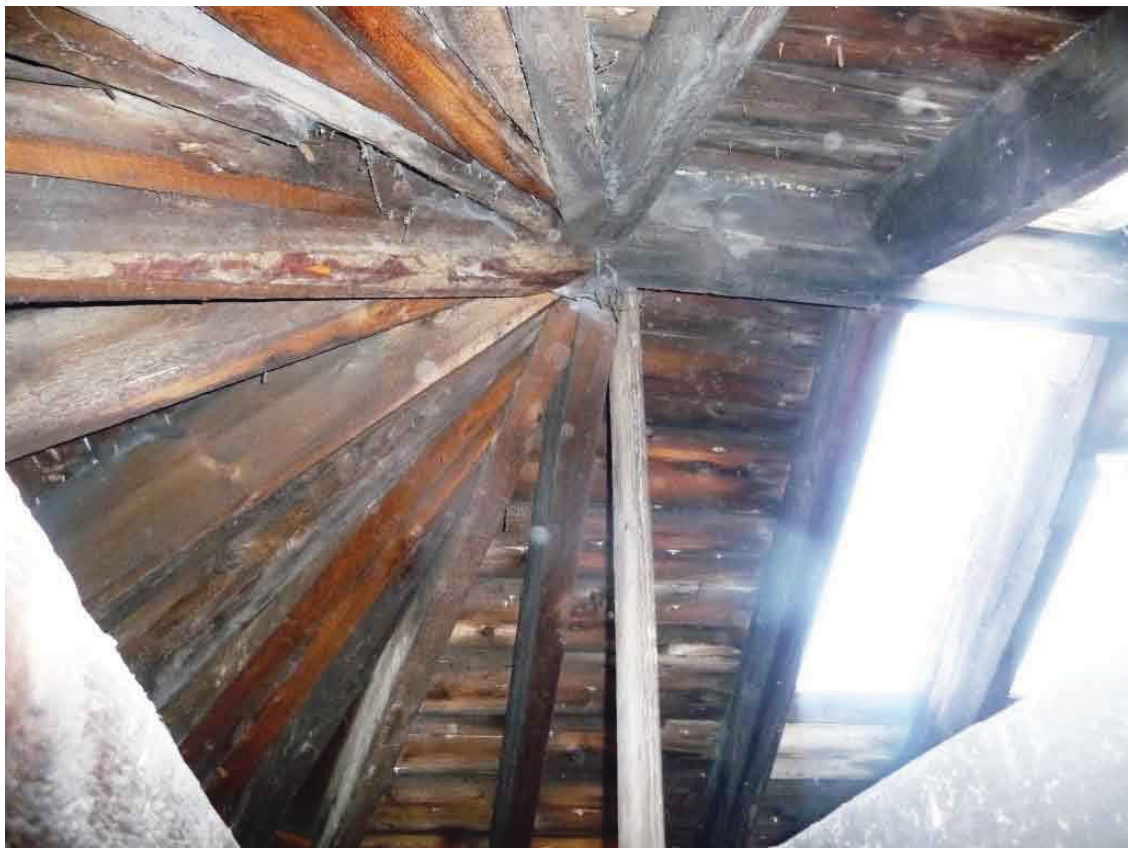
- 3.2.11 The roof of the church was inspected from photographs only, and is of A-frame truss construction. The semi-circular west end of the church has a fantail truss (Fig 28). The east facing end of the roof truss has diagonal braces (Fig 29) which appear to indicate that the roof may have been originally hipped, although the upper surface of the timbers have no apparent sign of having had sarking boards attached, neither is their construction particularly robust, having plain mitred joints rather than dovetails or scarfs which would be expected on the principal rafters. It is likely that the church has always had a pitched construction behind the facade, and these angled rafters have been used for extra reinforcement.

Figure 28: Detail of curved end roof truss (Photo courtesy of Richard Berry, 2009)

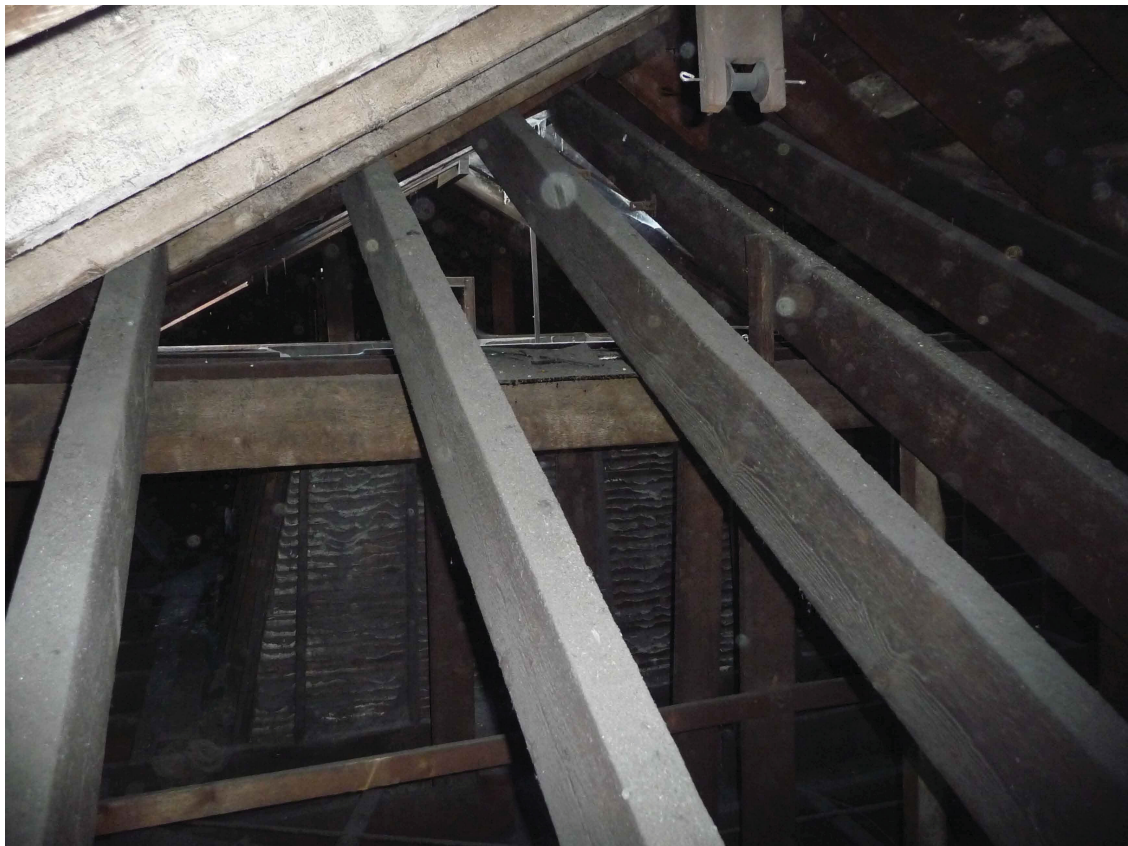
Figure 29: Detail of reinforcing truss (Photo courtesy of Richard Berry, 2009)
