ST JAMES' CHURCH, MIDHOPESTONES,  
SOUTH YORKSHIRE

ARCHAEOLOGICAL INVESTIGATION AND RECORDING

Report no: 2009/359.R03  
Version: Final  
Date: September 2010  
Author: Shaun Richardson & Ed Dennison

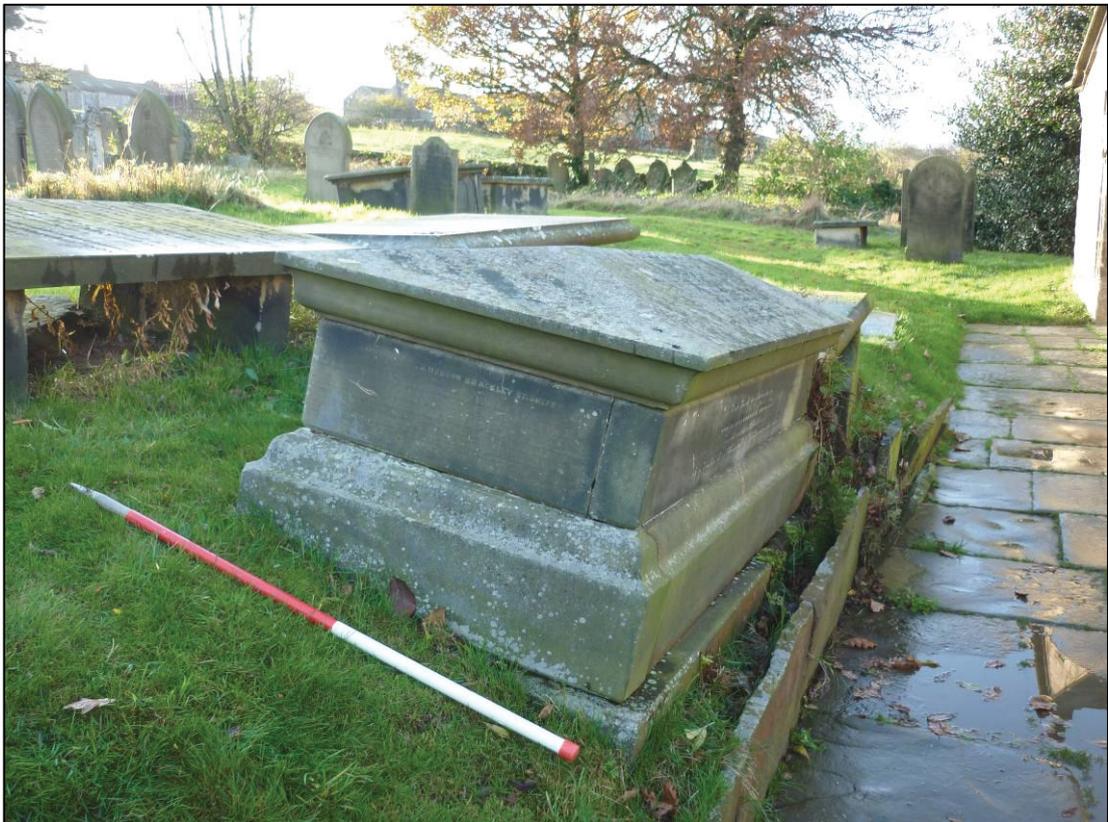
Plate 2: Monument B (Walker family) prior to repairs, looking W.

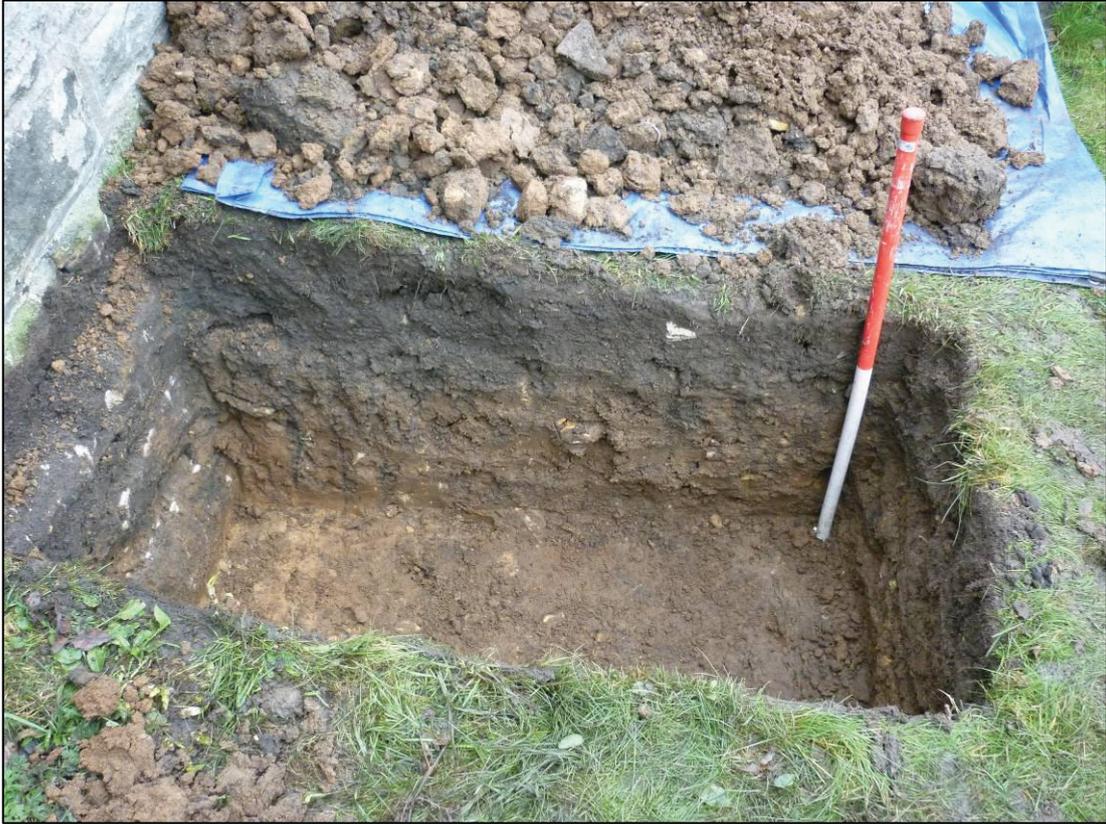
- 5.5 In Trenches 1 and 2, a sticky firm reddish-brown silty clay (003 in Trench 1 and 006 in Trench 2) with occasional angular pieces of iron-stained gritstone/sandstone up to 0.10m in size lay beneath the subsoil (see plate 3). In both these trenches, this silty clay butted the footings of the church wall (see below), and overlay a compacted gritty orange sandy clay with frequent angular stone inclusions (004 in Trench 1 and 007 in Trench 2), which passed beneath the footings themselves (see plate 4). The gritty orange sandy clay almost certainly represents a natural deposit. In Trench 3, the subsoil (008) overlay a similar reddish-brown silty clay (009) to that described above, although in this case it extended both beneath the base of the trench and the footings themselves. However, in Trench 4, the deposits underlying the subsoil (010) were somewhat different - the subsoil here overlay a compacted layer of mid-brown silty clay (011) with frequent inclusions of angular stone pieces and lime up to 0.10m in size, which butted the adjacent footings. The silty clay (011) in turn overlay a stiff compacted clean reddish-brown sandy clay (012), which continued beneath the footings and the base of the trench; again, this is most probably a natural deposit. No *in situ* burials were encountered in any of the trenches, with only Trench 3

Plate 3: Trench 1 - west facing section, looking E.

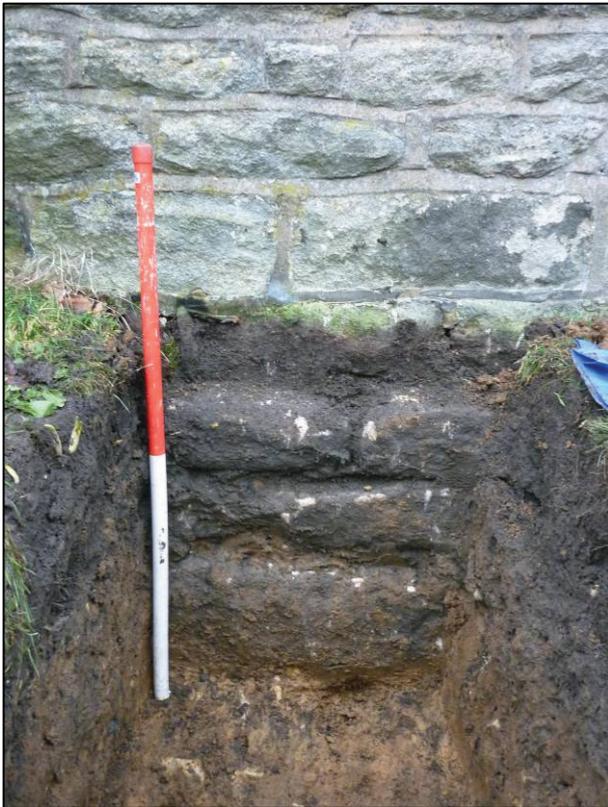
Plate 4: Trench 1 - footings, looking N.

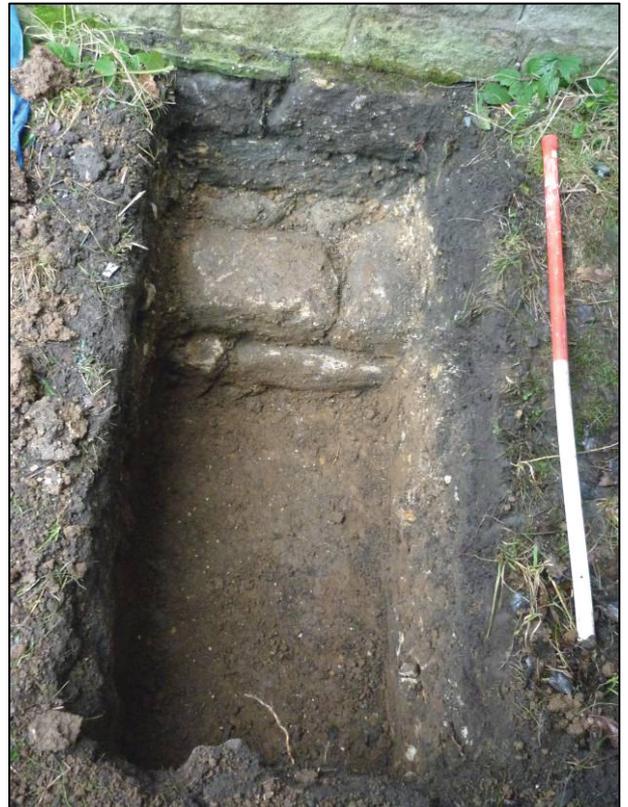
Plate 5: Trench 4 - footings, looking E.

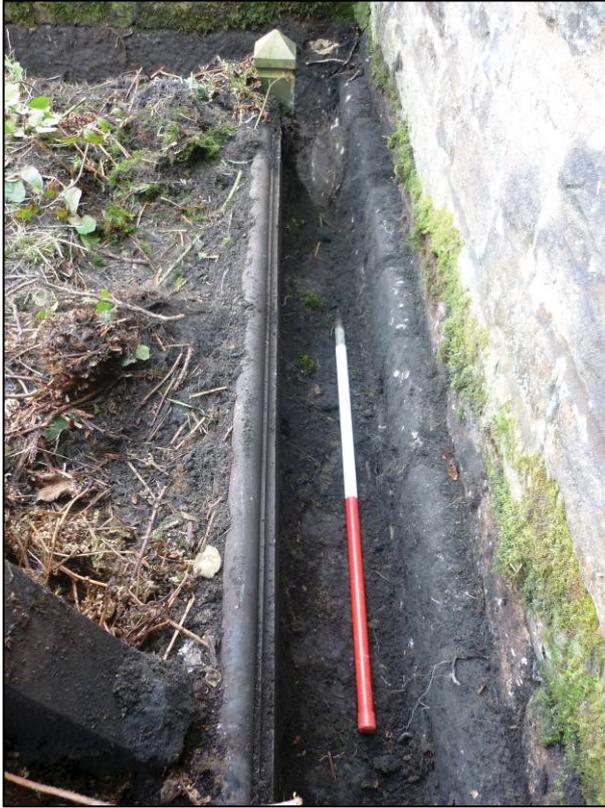
Plate 6: French drain along north side of church, between buttresses, showing exposed plinth, looking E.

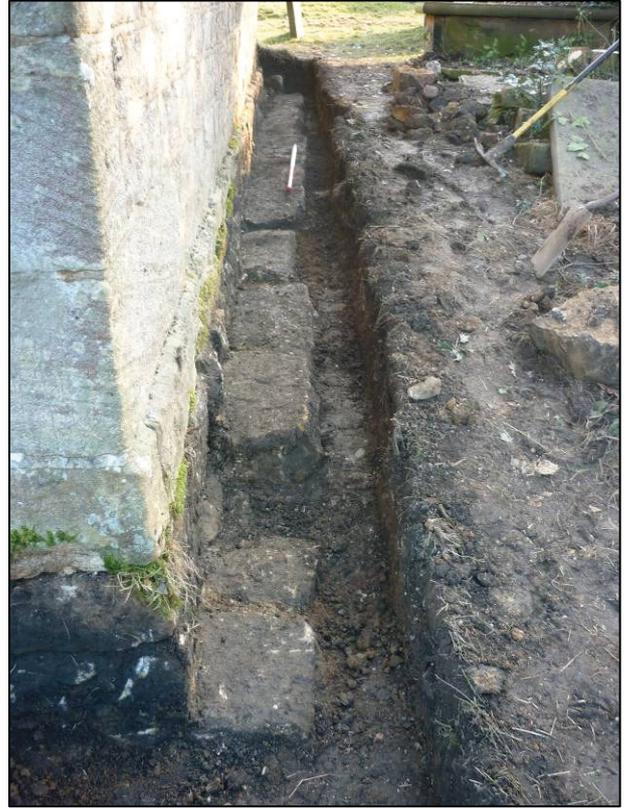
Plate 7: French drain along west gable of church, showing exposed foundations, looking S.

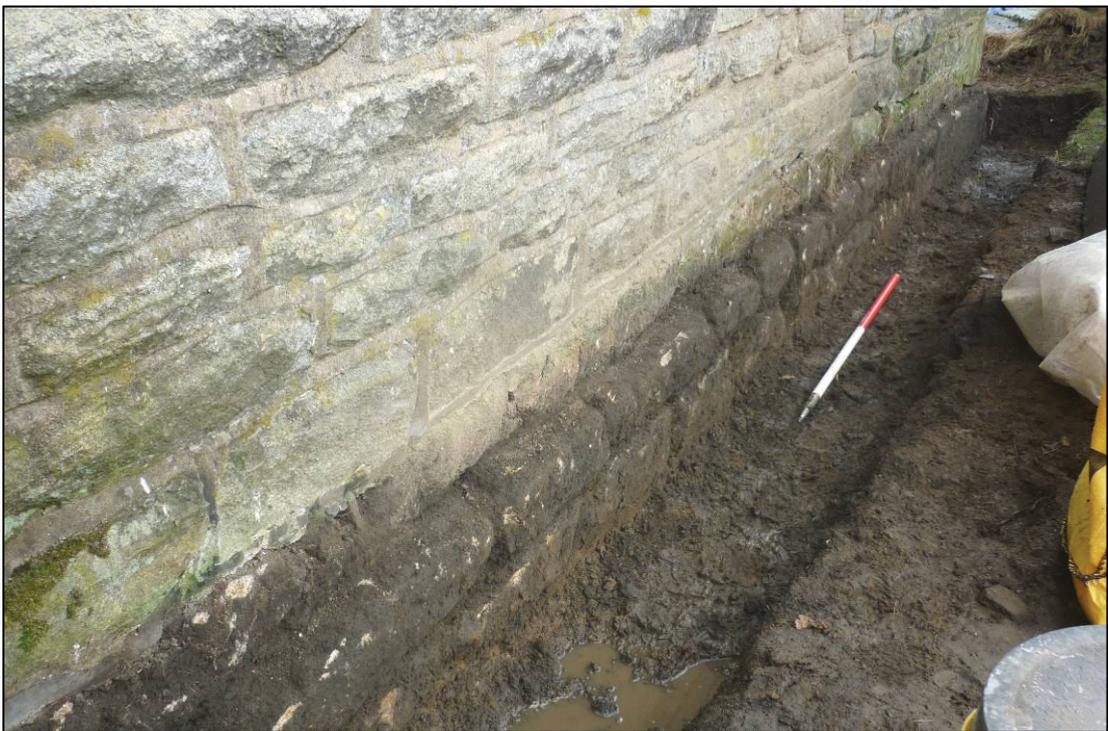
Plate 8: French drain, south side of church, showing exposed plinth, looking NE.

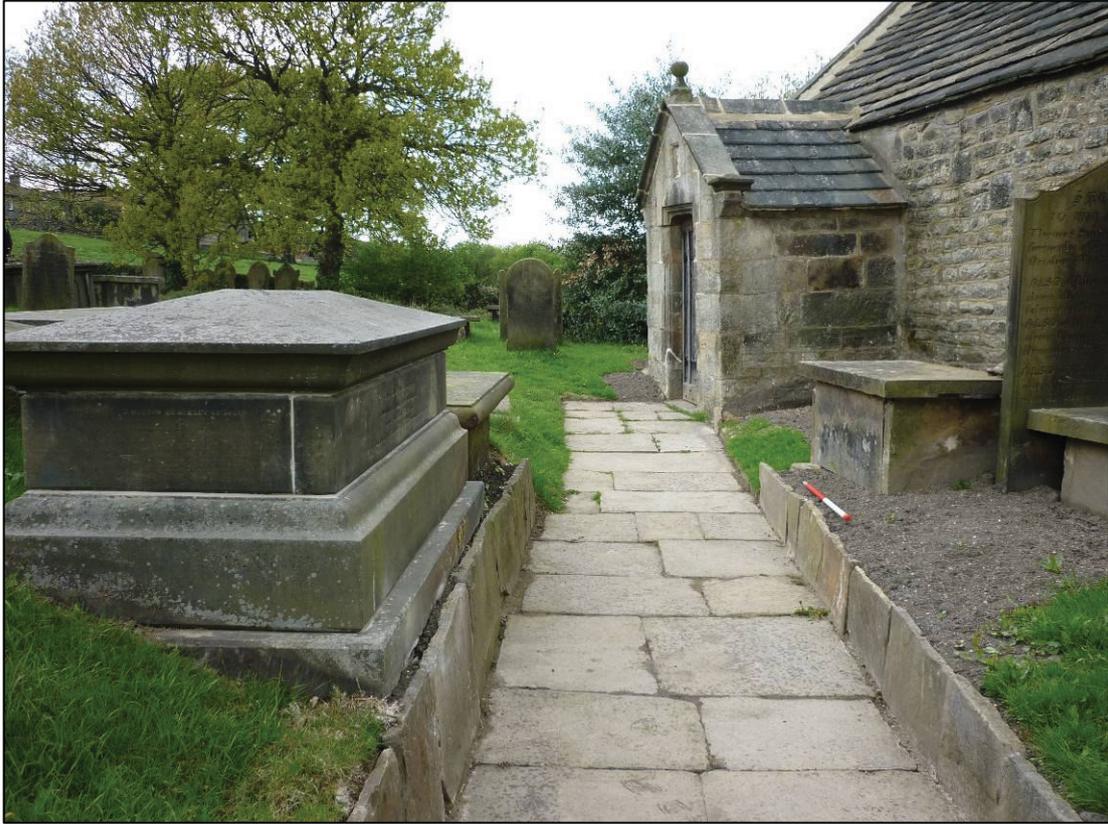
Plate 9: Repaired path and monuments, looking W.

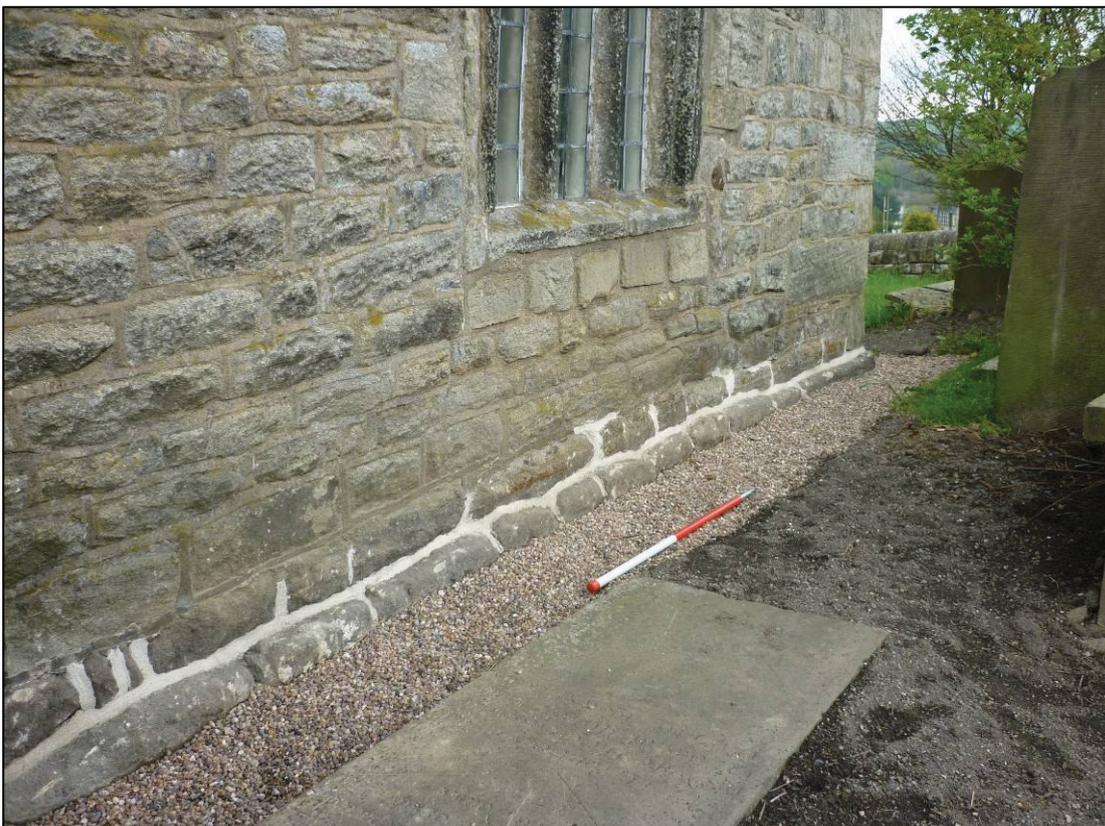
Plate 10: Completed French drain to south side of church, looking NE.
